July 30, 2024

Re: Estates of Lake Creek-Storm Sewer CCTV Videos  
Infrastructure Acceptance  
City of Montgomery

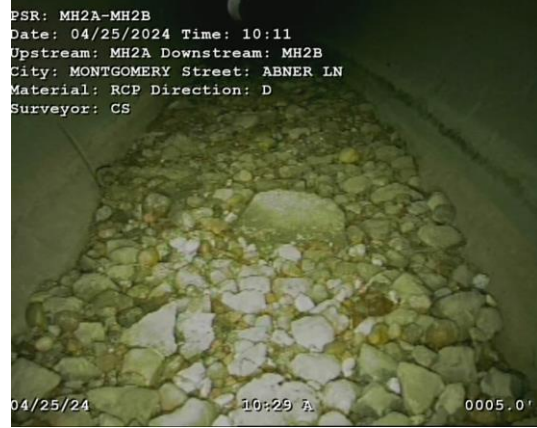
**Pipe: Upstream Manhole 2A - Downstream Manhole 2B**

Figure 1: Rock Buildup

- Replace all HDPE storm piping with Reinforced Concrete Pipe.
- Heavy clean all piping with deposits of debris causing a restriction of flow.
- Removal of all large obstructions located within pipes or manholes.
- Replacement of all piping with holes or moderate to significant cracking.

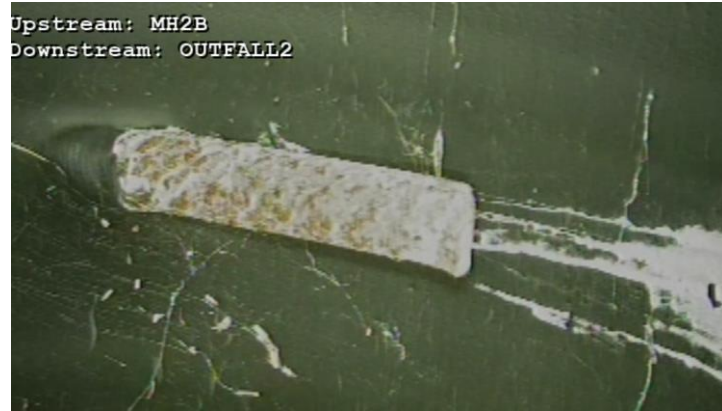
**Pipe: Upstream Manhole 2B - Downstream Outfall 2**

Figure 2: Rebar Penetration

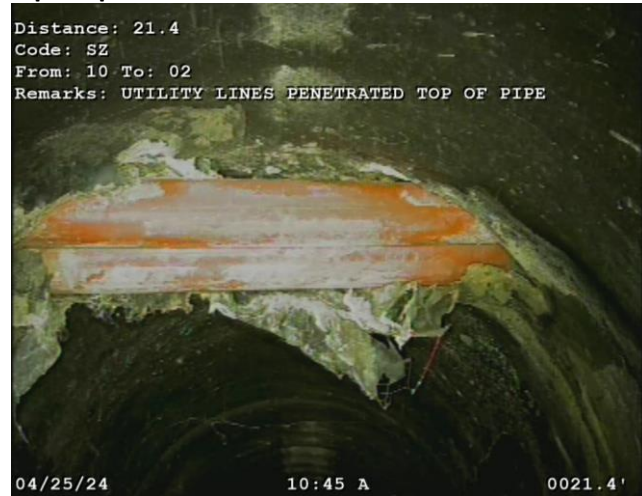
**Pipe: Upstream Manhole 2B - Downstream Outfall 2**

Figure 3: Utility Line Penetration
