February 21, 2025

**Subject: WWTP Lagoon Inspections**

Barge Design Solutions, Inc. (Barge) is pleased to provide this inspection report for the February 13, 2025, inspection of the upper and lower wastewater treatment plant lagoons for the City of Mount Pleasant. The purpose of these inspections was to note visual indications of potential slope instability, excessive seepage, and other factors that may compromise or impair the stability of the wastewater lagoons as well as to observe previous work progress to stabilize slopes and erosion areas. Jason Winningham, P.E., and Ian Varney, E.I.T., of Barge performed the inspections. A trip report with photos, observations, and recommended actions is attached to this letter.

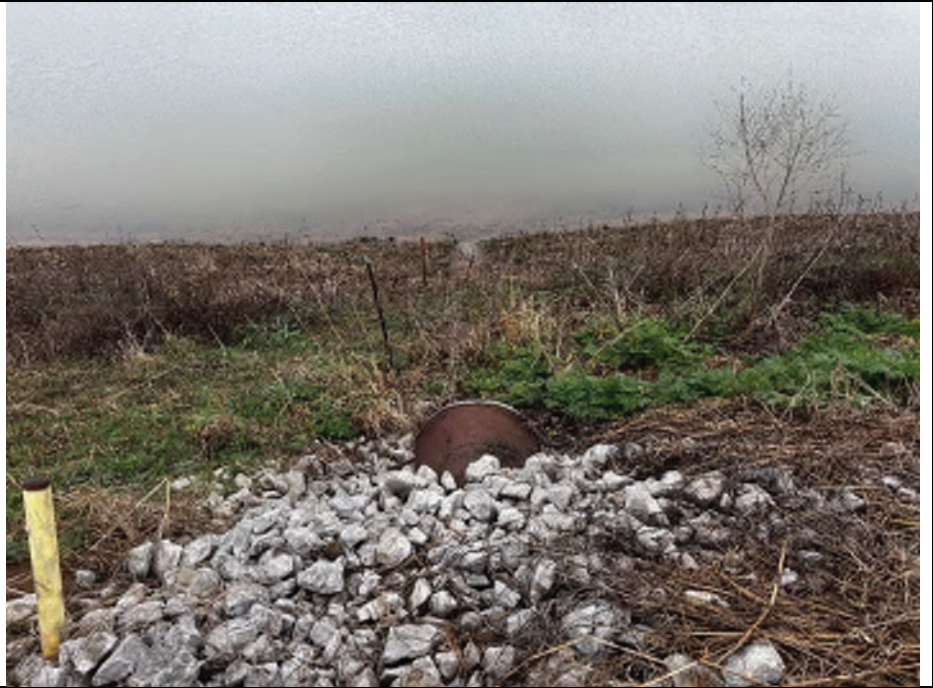
Photograph: 1

Lower Lagoon – outlet  
pipes leading to pump  
station

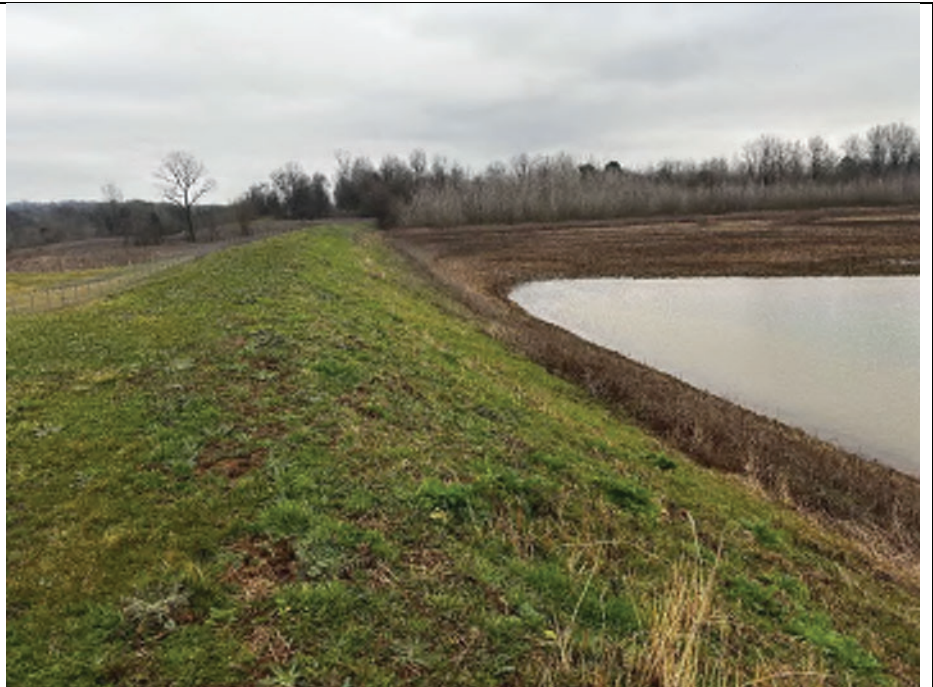
Photograph: 2

Small trees and woody vegetation on the berm embankments were recommended to be removed with minimal root ball disturbance during the previous inspection. Vegetation growth on the banks will compromise the lagoon bank stability due to the plant's roots growth. Site personnel has removed all trees from the bank of the lagoon, stopping at the southern tree line as requested by the previous inspection by the Tennessee Department of Environment and Conservation.

Lower lagoon – View of  
northeastern berm.  
Woody vegetation on the  
berm has been removed.

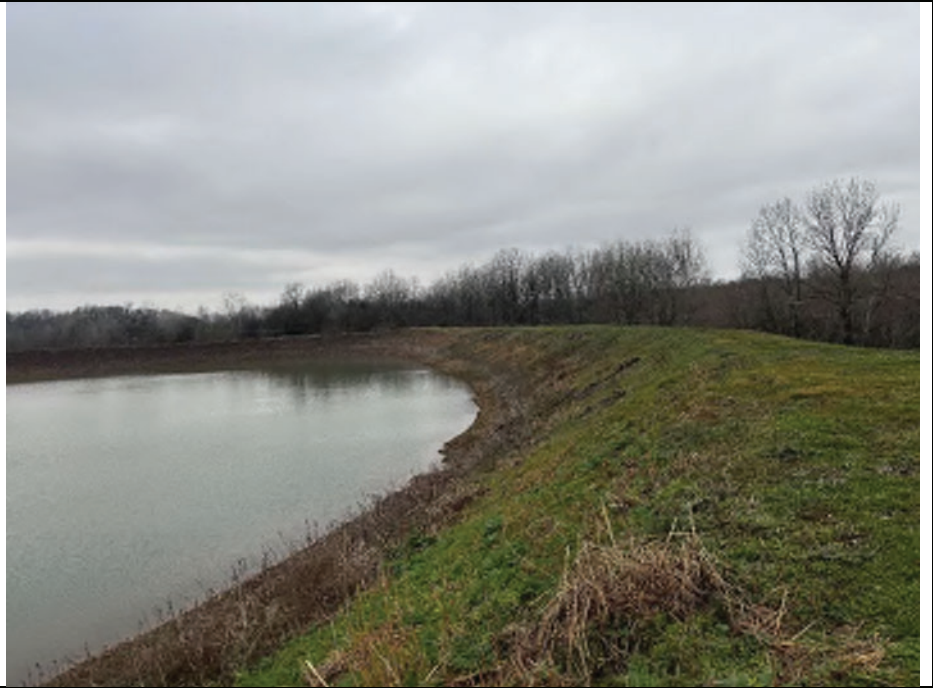
Photograph: 3

Lower Lagoon – View of northern berm from the west. Woody vegetation on the berm has been removed.

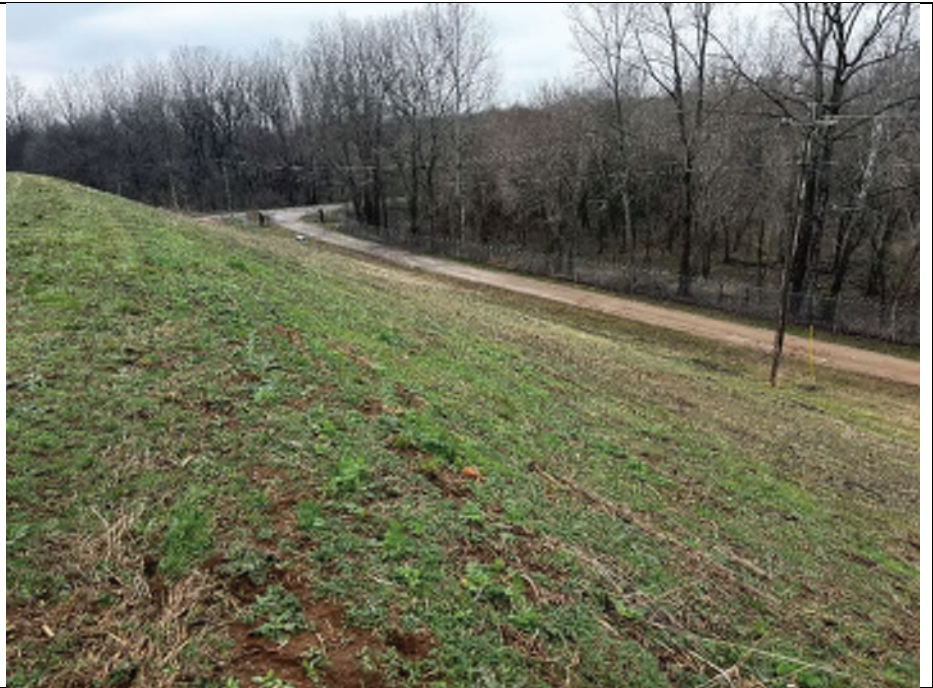
Photograph: 4

Lower lagoon – Northern site access road and stable northern slope. Water was observed on the entrance road from rainfall the past 24 hours.

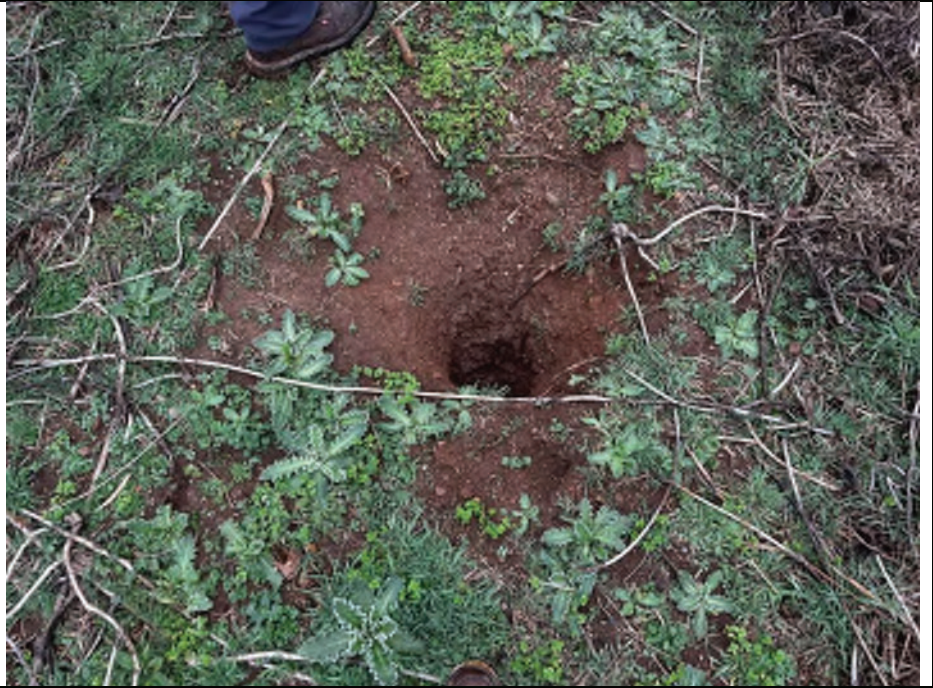
Photograph: 5

Continued pest control to address burrowing animals is required to reduce the borrow population at the lagoon as well as address beaver activity adjacent to the lagoon to prevent stormwater runoff into the lagoon. These burrowing animals can puncture the lagoon, leading to the City's wastewater

leaking from containment.

Lower Lagoon – Evidence of animal activity such as burrowing was observed intermittently along the west berm of the lower lagoon.

- Continue pest control of burrowing animals.

It is recommended to remove burrows and stabilize these areas.

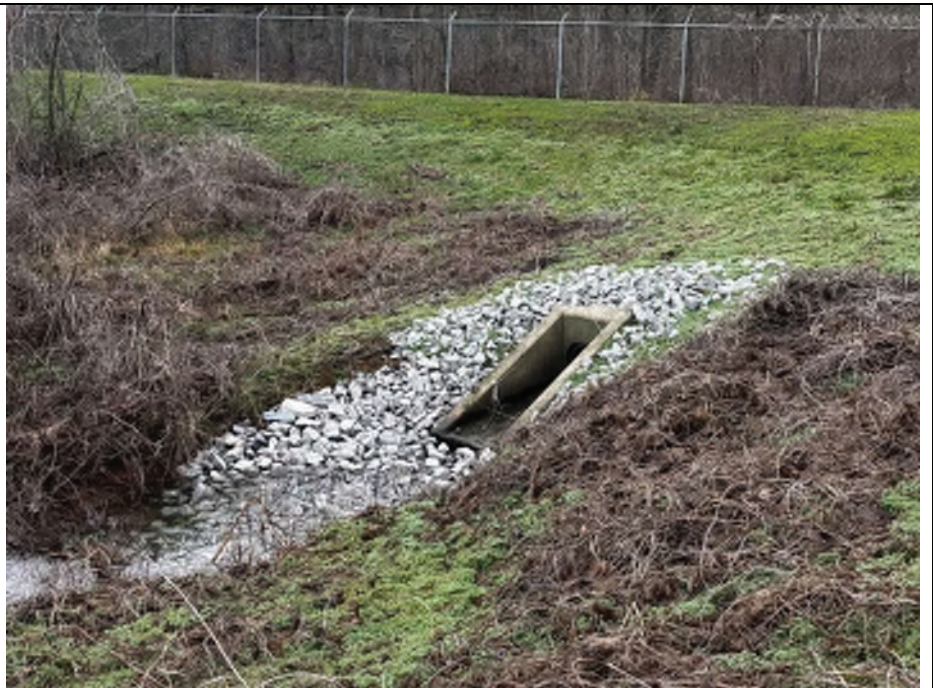
**Description:**

The previous inspection noted that vegetation was established around the headwall at the influent pipe to the lower lagoon near the southwest corner. The area has been improved by the installation of riprap around the headwall to prevent erosion.

Lower Lagoon – inflow structure.

Erosion was previously observed around the headwall. This area has been repaired with riprap.

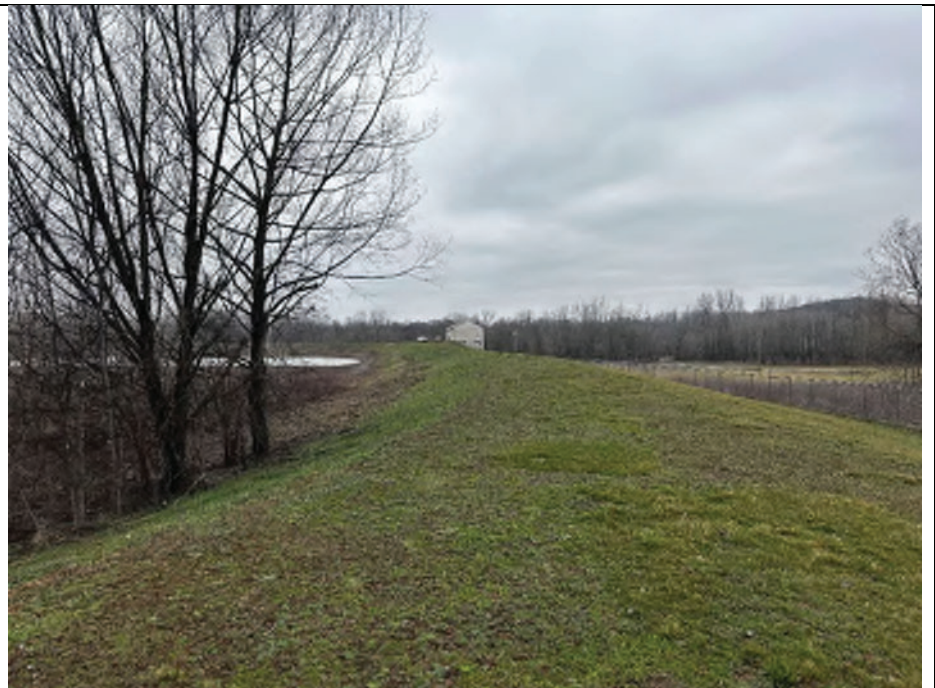
Photograph: 8

Lower Lagoon – View of east berm.

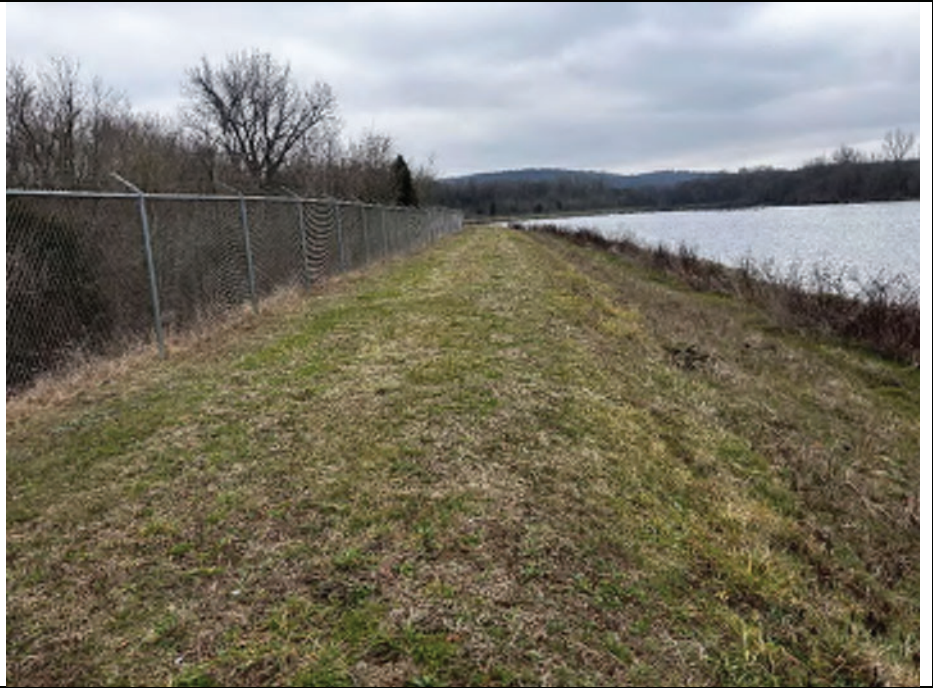
Photograph: 9

Upper Lagoon – View of east berm.

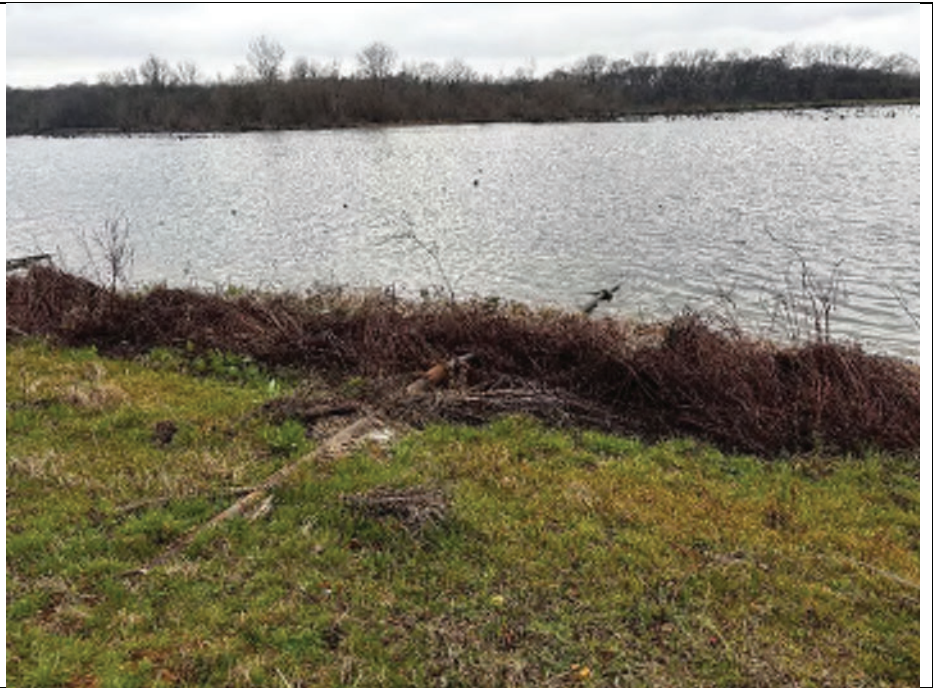
Photograph: 10

Upper lagoon – Old aerator pipe in the southeastern portion of the site. The aerator is not in use.

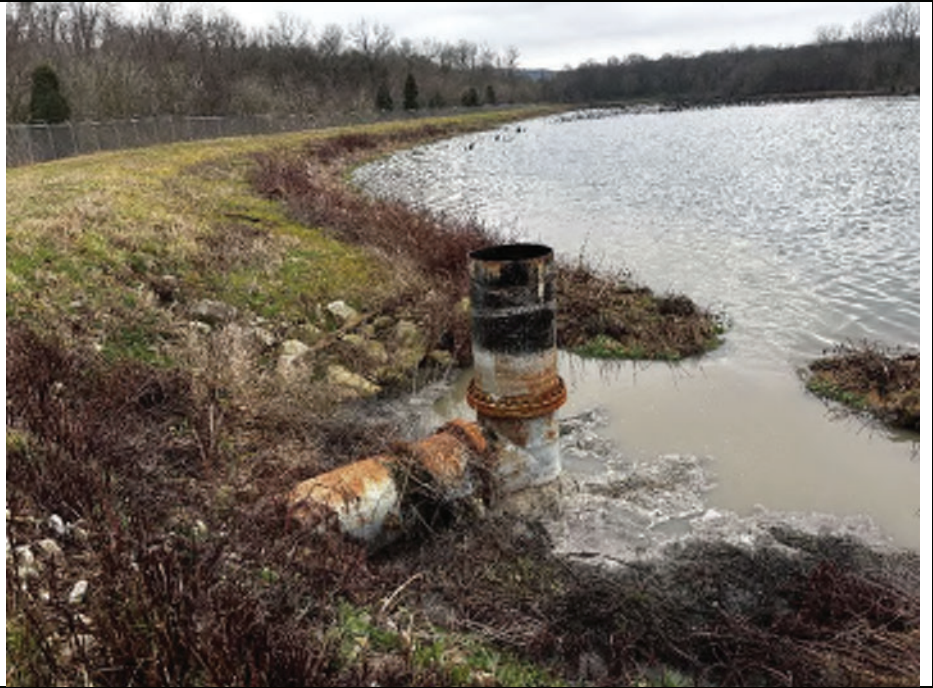
Photograph: 11

Upper lagoon – Inlet pipe in the southeastern portion of the upper lagoon.

Solids and scum were observed on the surface.

Sewage odor was observed in this area.

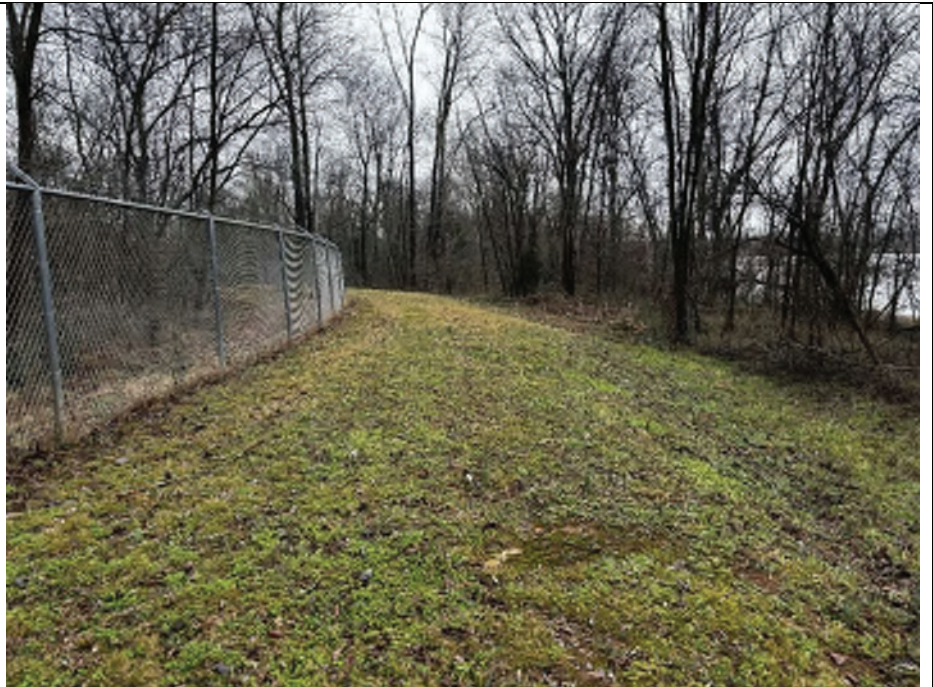
Photograph: 12

Upper Lagoon – Southwest corner of the upper lagoon berm.

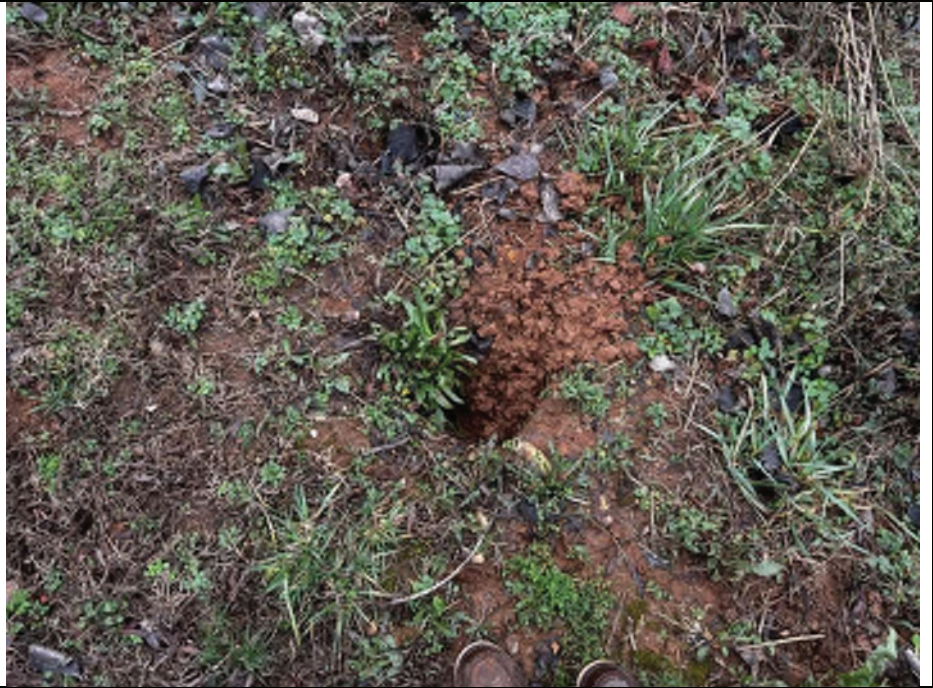
Photograph: 13

Upper Lagoon – Evidence of animal activity such as burrowing was observed along the south berm of the lower lagoon.

- Continue pest control of burrowing animals.
- Complete the northern fencing.

It is recommended to remove burrows and stabilize these areas.

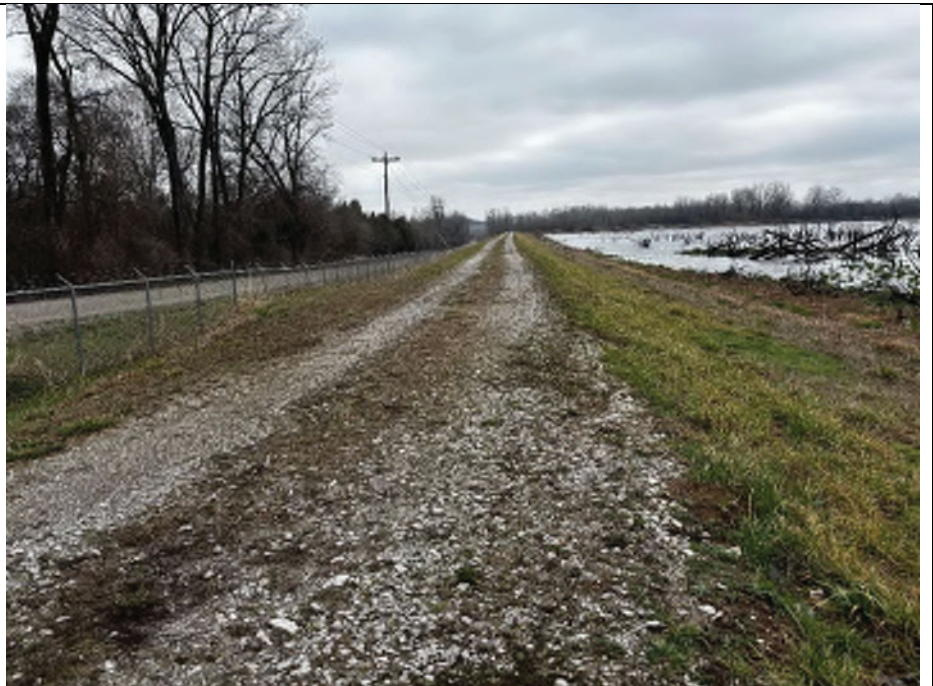
Photograph: 14

Upper Lagoon – View of western berm and access road off of Hoover Mason Road.

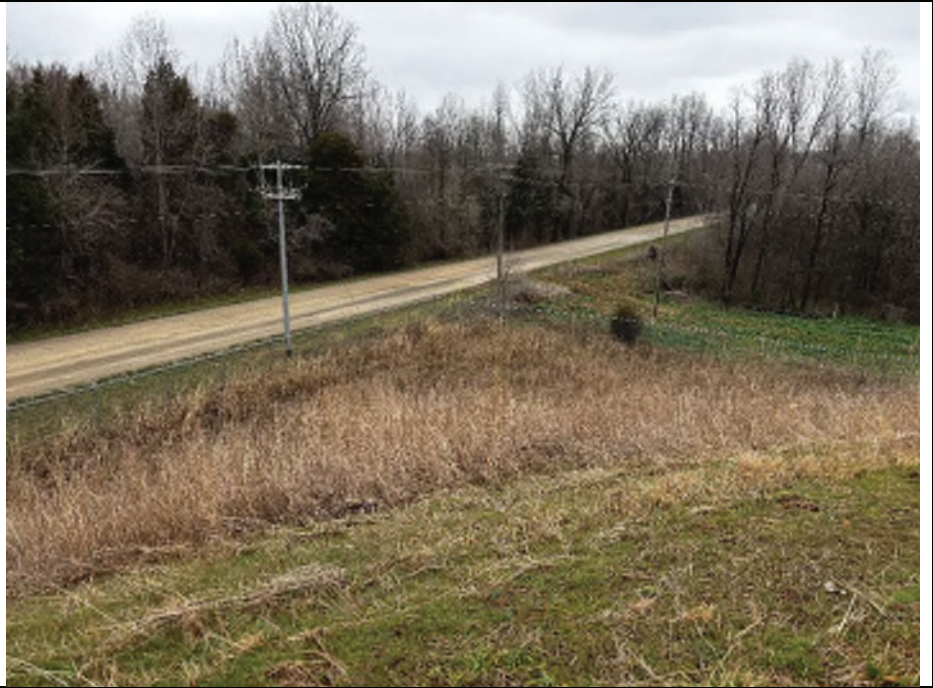
Photograph: 15

Upper Lagoon - North side of upper lagoon, facing west.

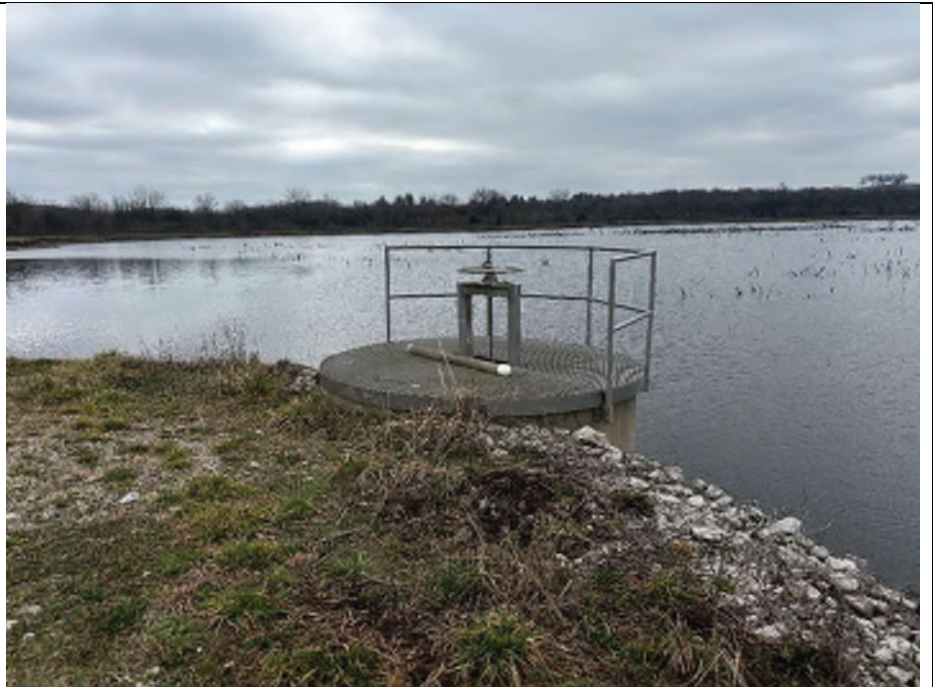
Photograph: 16

Upper Lagoon – Lagoon outfall pipe.

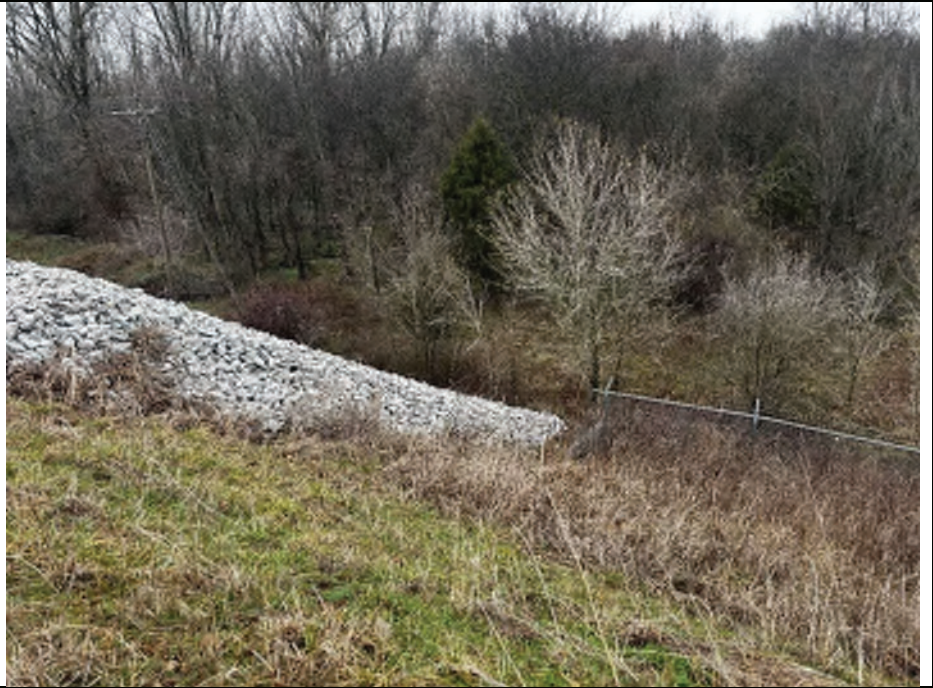
Photograph: 17

Riprap placed along the upper lagoon's northern embankment appears to be in good condition. Completion of the fence along this improved area is recommended. The fence will keep larger nuisance animals and trespassers out of the lagoon area.

Upper Lagoon - Slope from north side of upper lagoon, facing northwest.

Fence is incomplete. It is recommended to finish the installation of the fence.

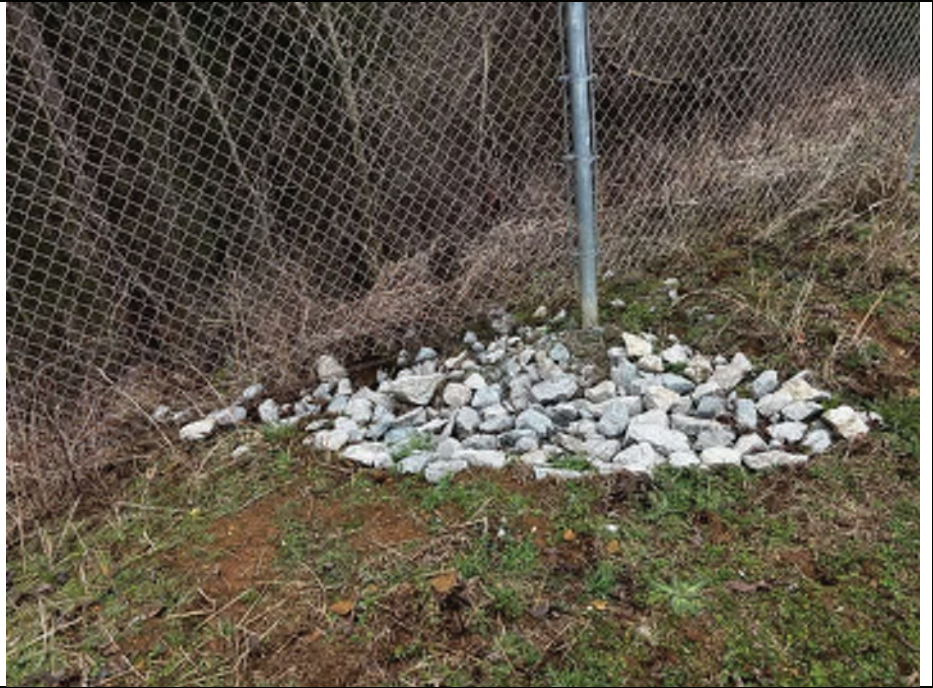
**Description:**

A hole under the fence from animal activities and stormwater was observed by the fence in the northeastern berm in the previous inspection. This area was stabilized with riprap and in good condition during this inspection.

Photograph: 21

Erosion observed at the fence in northeast berm due to animal activity.
