**High Tank
Needles Water Department
Report of Findings
From the
Diving Operations
Conducted on**

May 16, 2025

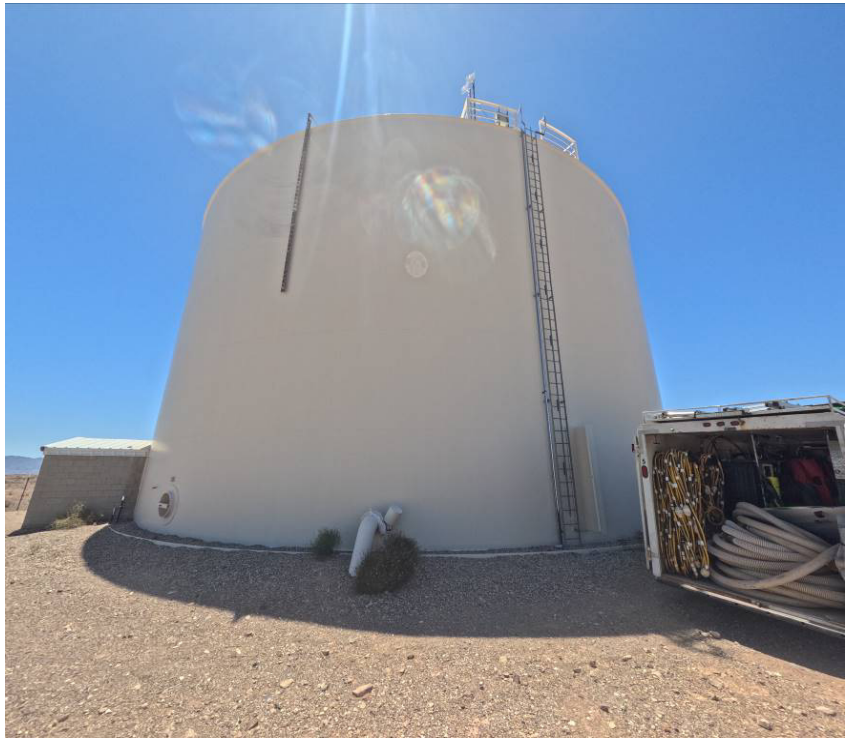
Description:
Exterior Wall appeared to be in good condition with a minor amount of corrosion.

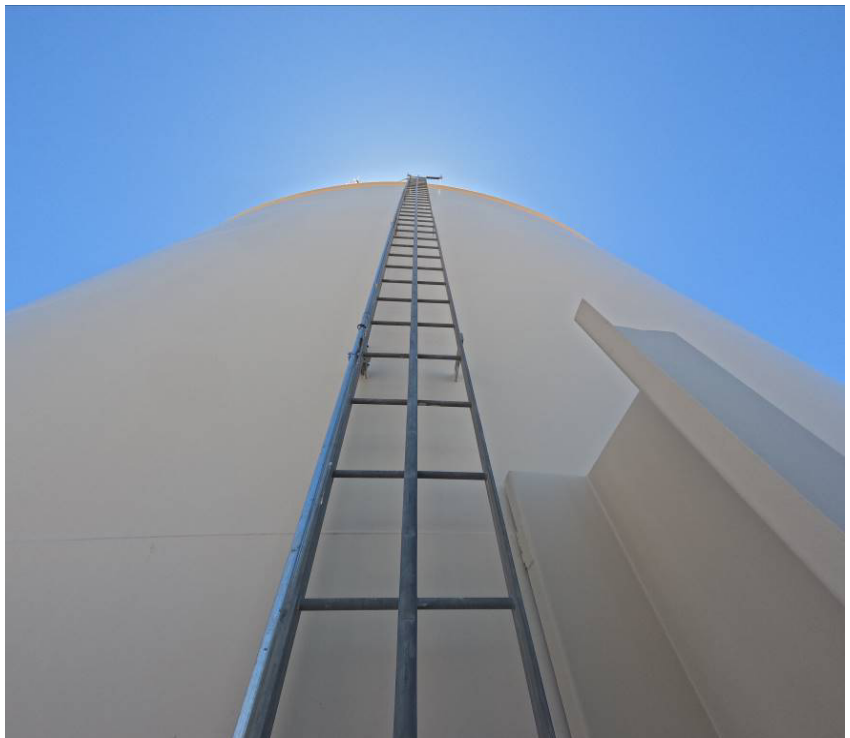
Description:
Exterior Ladder appeared to be in good condition with a minor amount of corrosion.

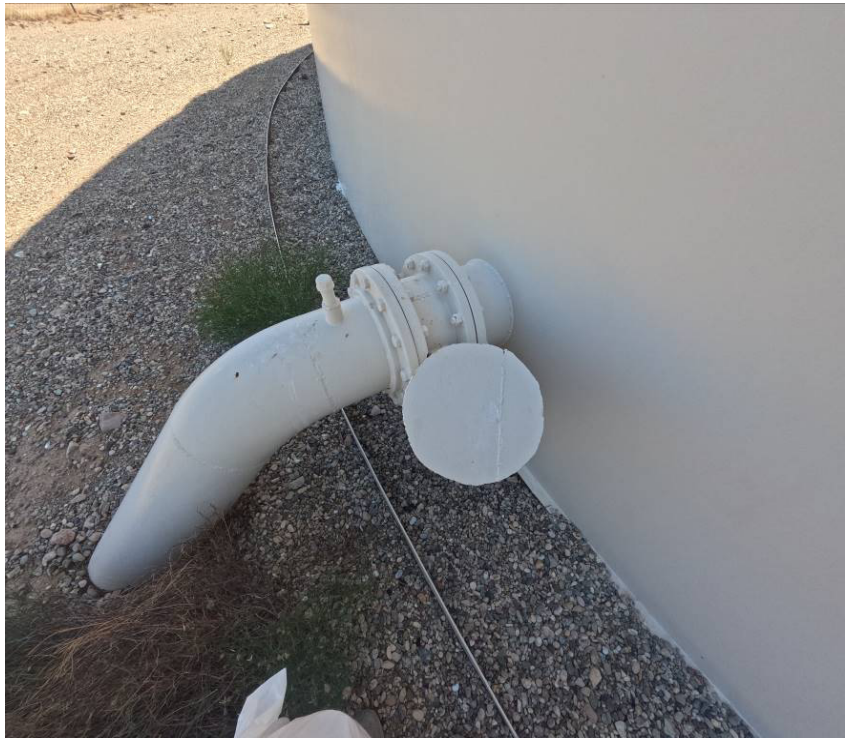
Description:
Inlet / Outlet appeared to be in good condition with a minor amount of corrosion.

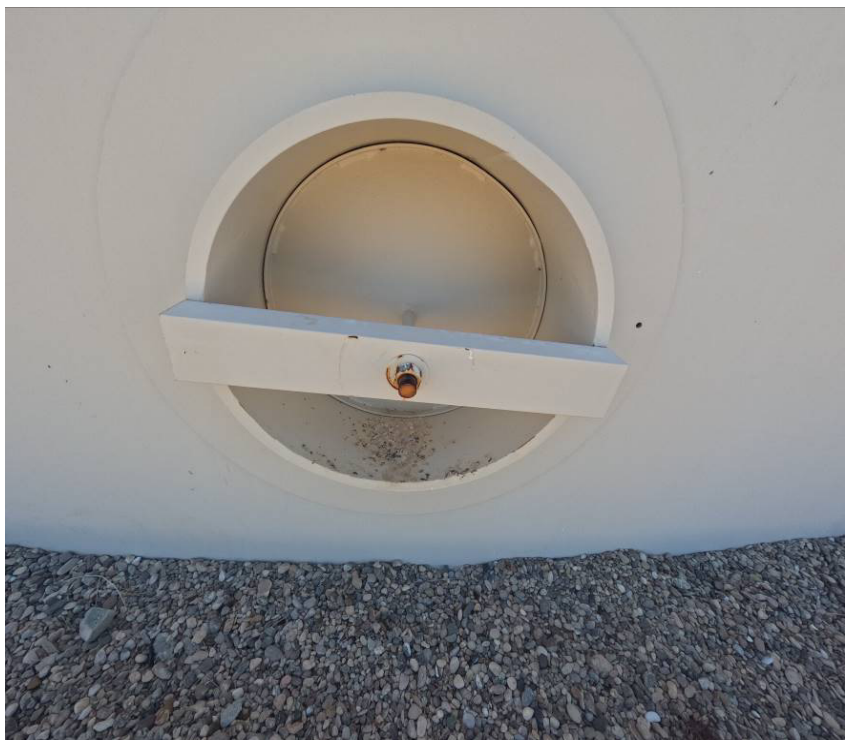
Description:
Man Way appeared to be in good condition with a minor amount of corrosion.

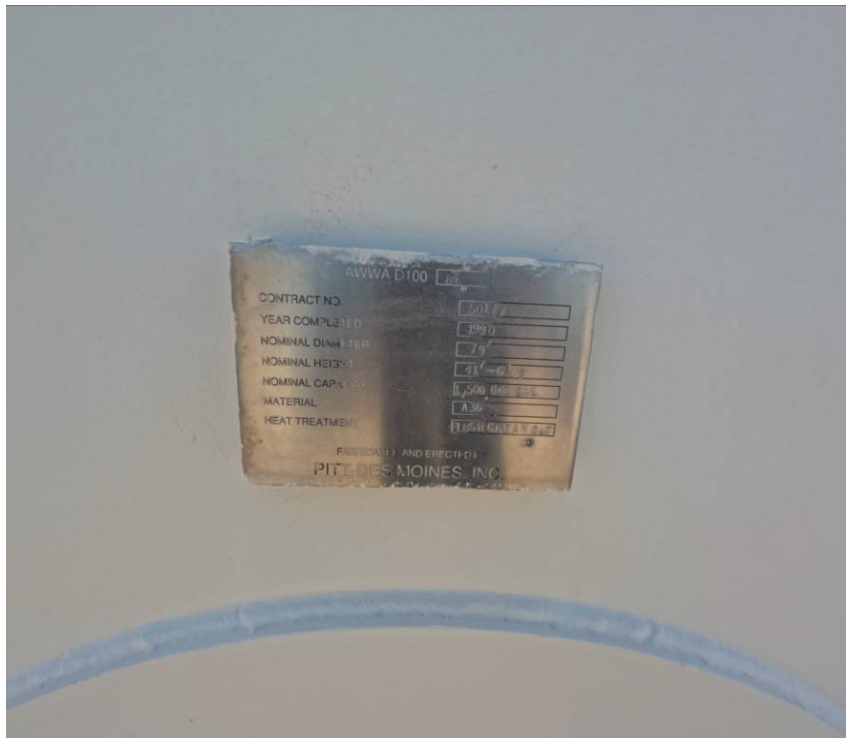
Nomenclature Plate appeared to be in good condition and readable.

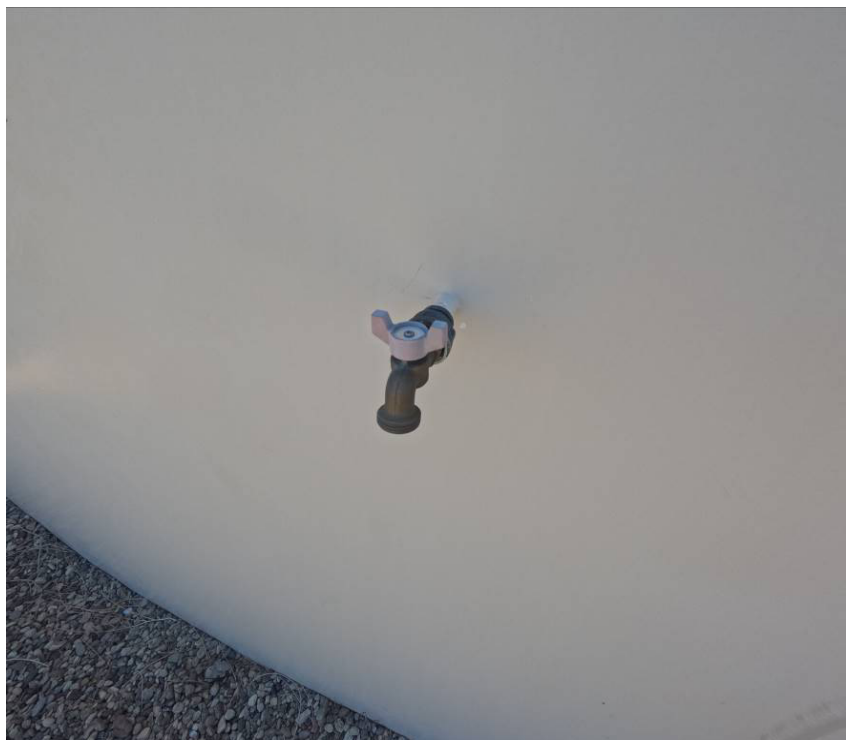
Water Tap appeared to be in good condition with a minor amount of corrosion.

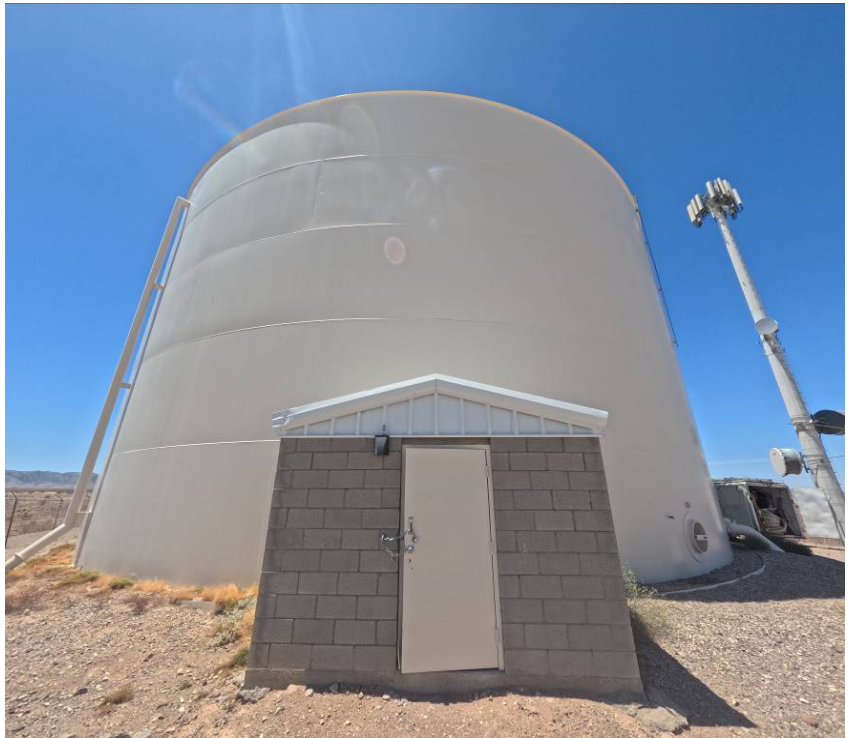
Description:
Exterior Wall appeared to be in good condition with a minor amount of corrosion.

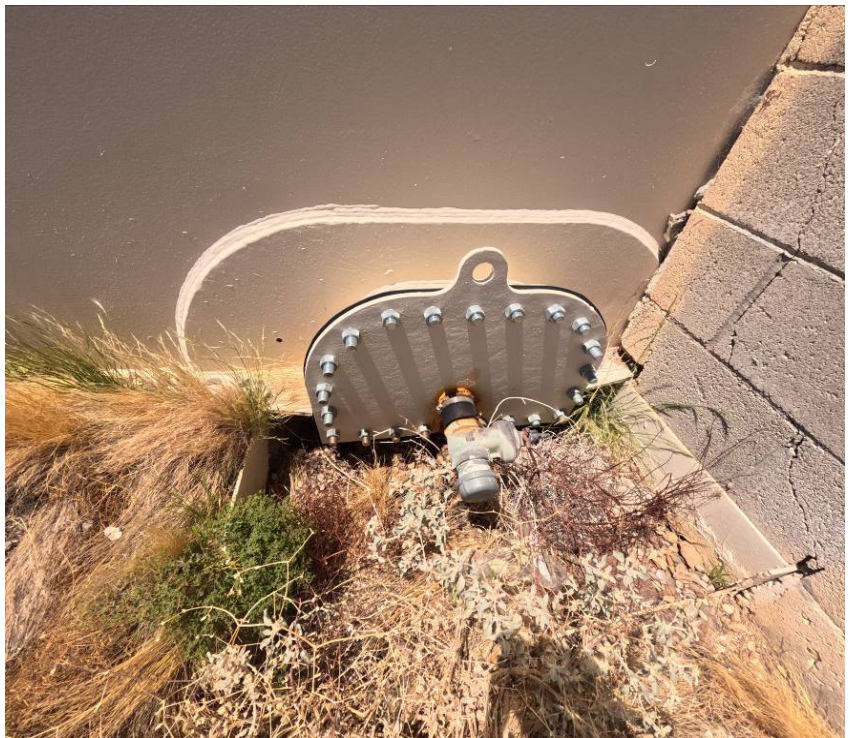
Description:
Capped-Off Penetration appeared to be in good condition with a minor amount of corrosion.

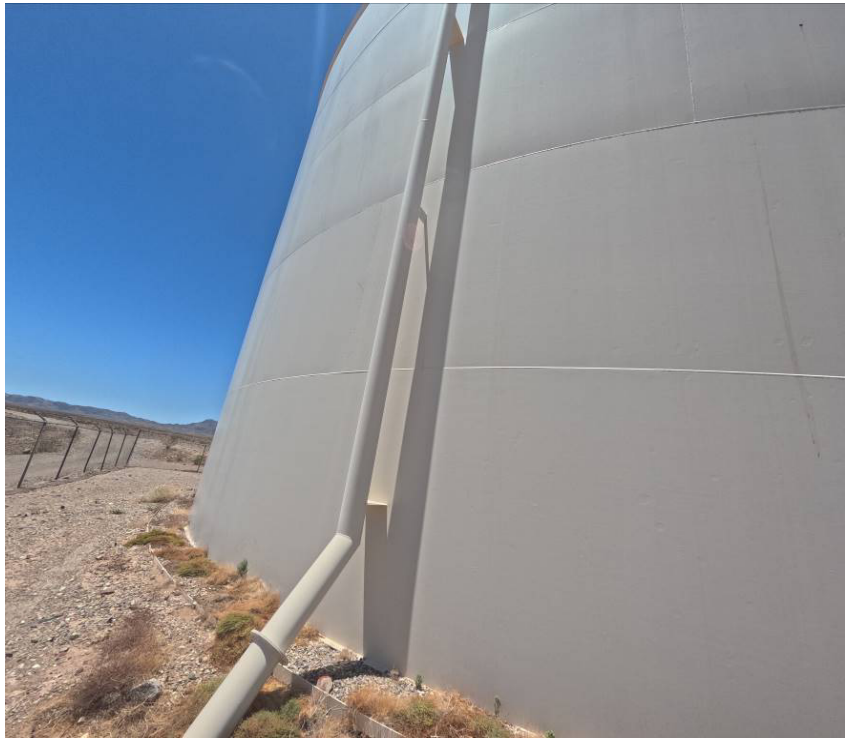
Description:
Overflow appeared to be in good condition with a minor amount of corrosion.

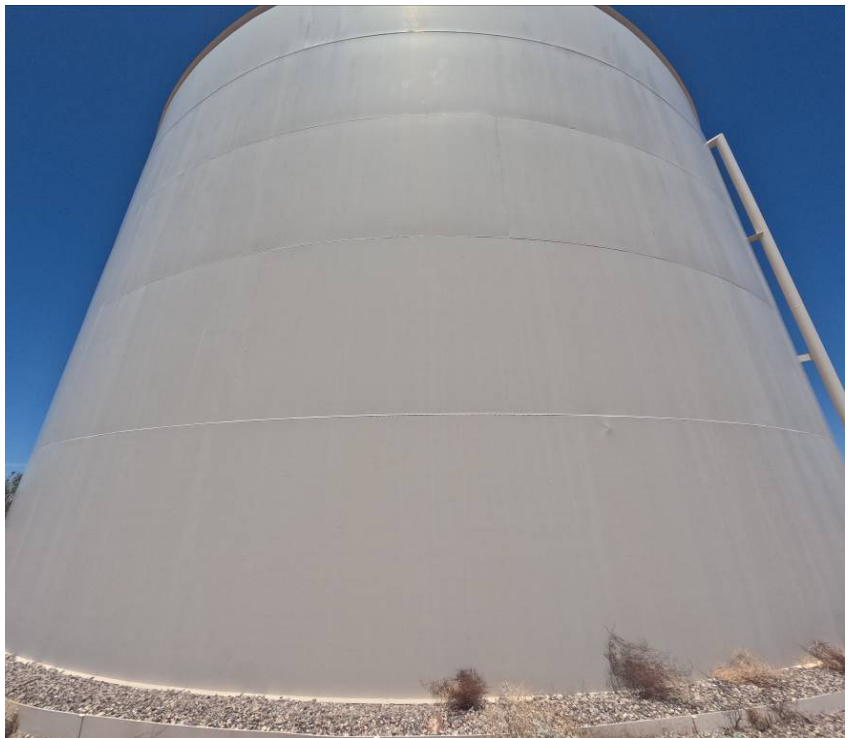
Description:
Exterior Wall appeared to be in good condition with a minor amount of corrosion.

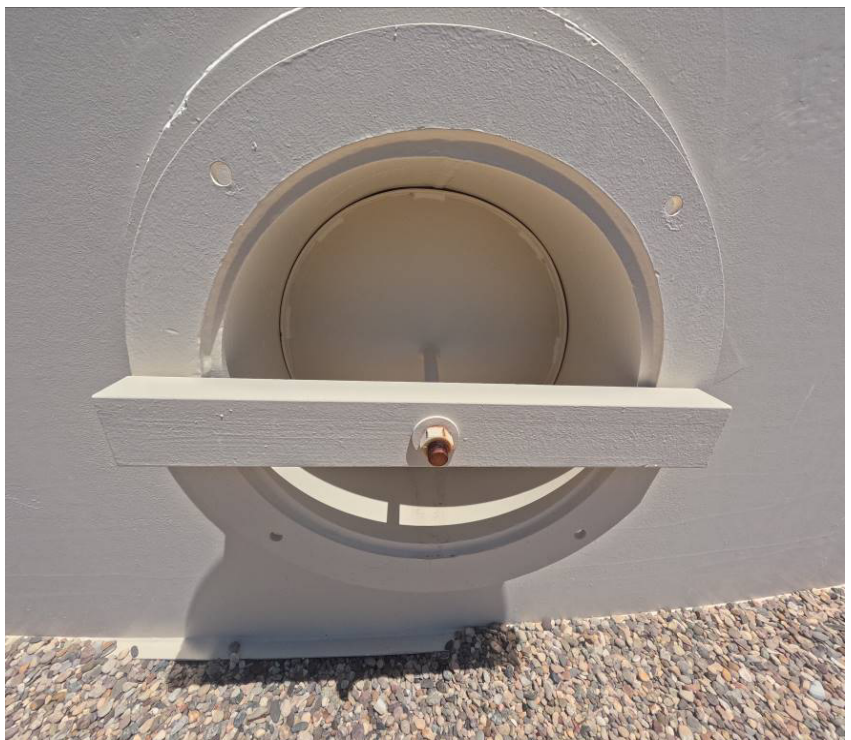
Man Way appeared to be in good condition with a minor amount of corrosion.

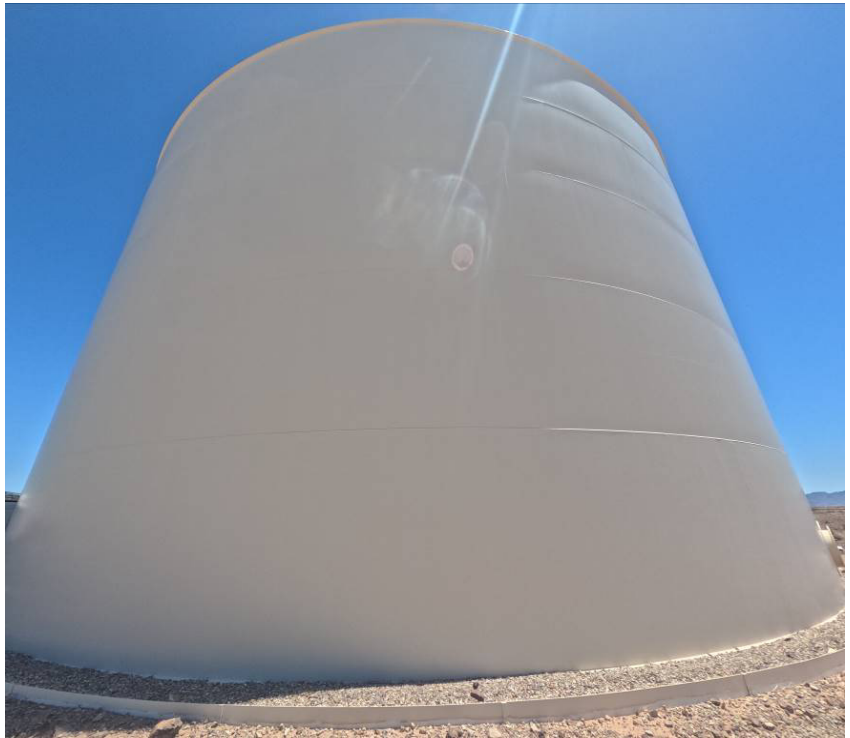
Description:
Exterior Wall appeared to be in good condition with a minor amount of corrosion.

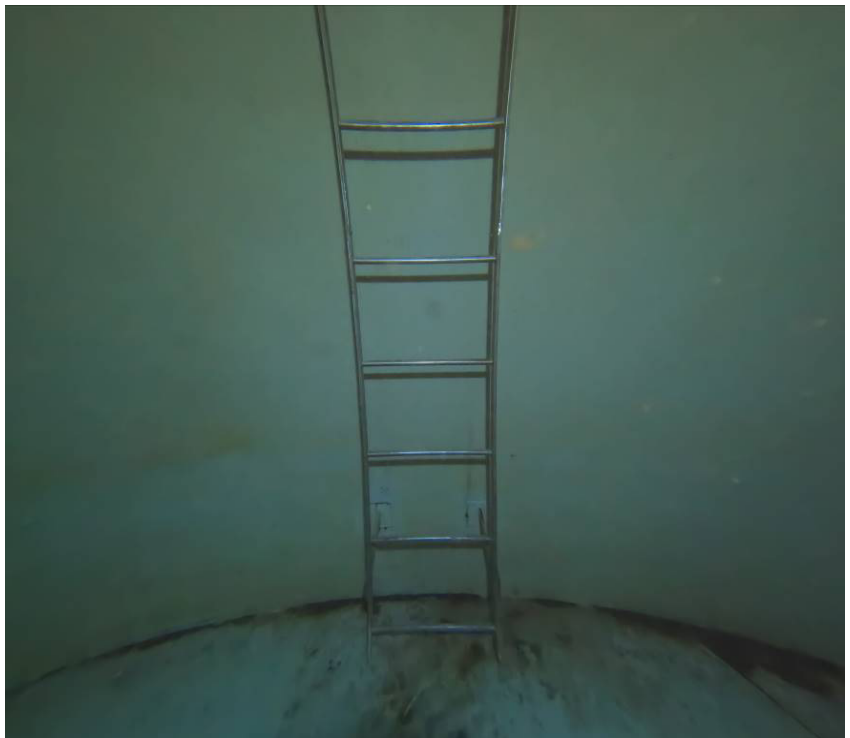
Description:
Interior Ladder appeared to be in good condition with a minor amount of corrosion.

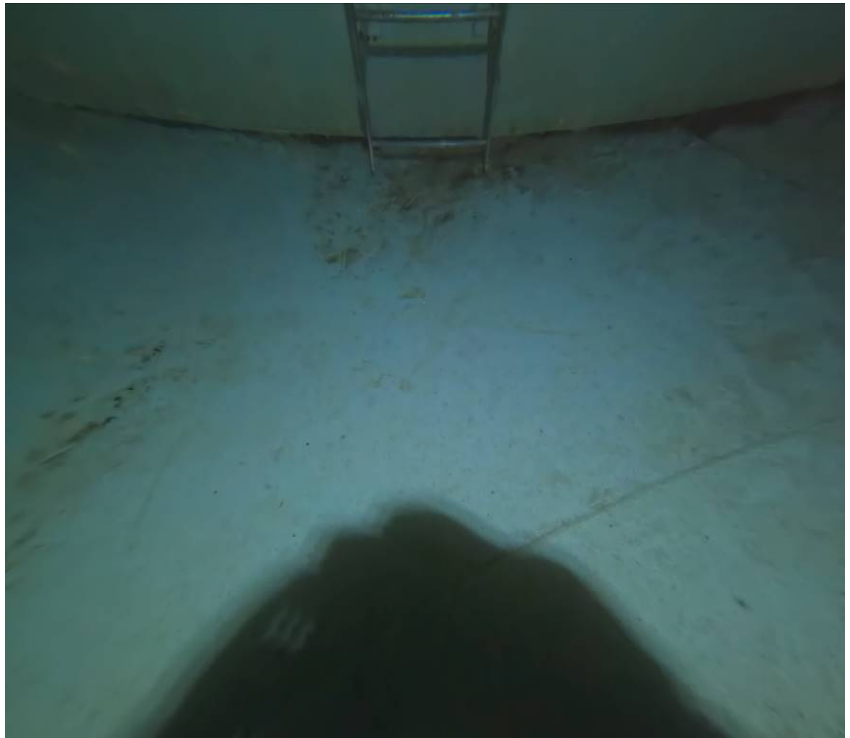
Description:
Floor appeared to be in good condition with a minor amount of corrosion.

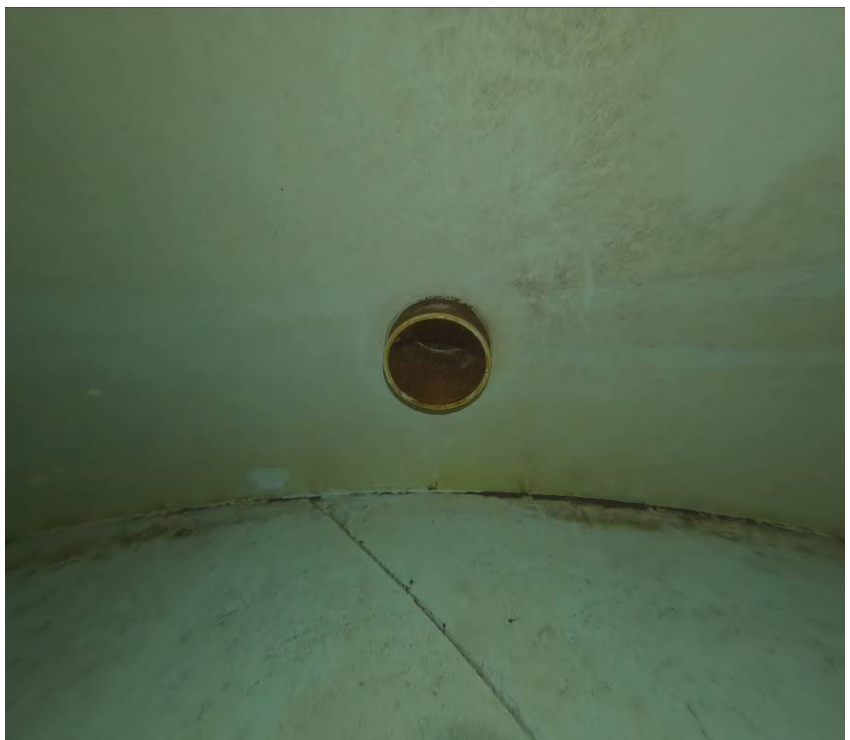
Description:
Inlet / Outlet appeared to be in good condition with a minor amount of corrosion.

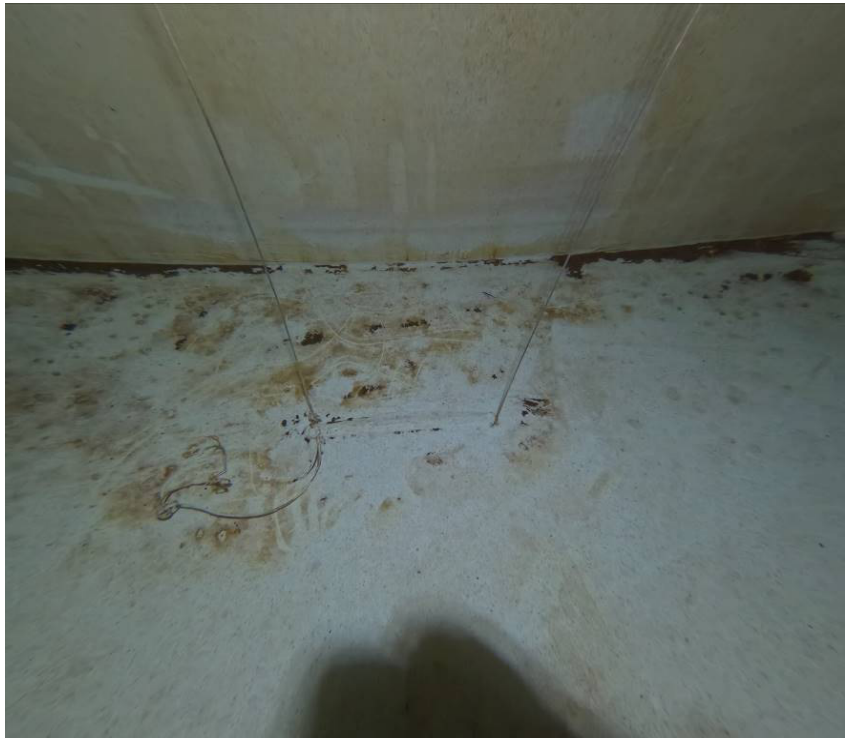
Description:
Liquid Level Indicator Base appeared to be in good condition with a minor amount of corrosion. A cable appeared to be broken.

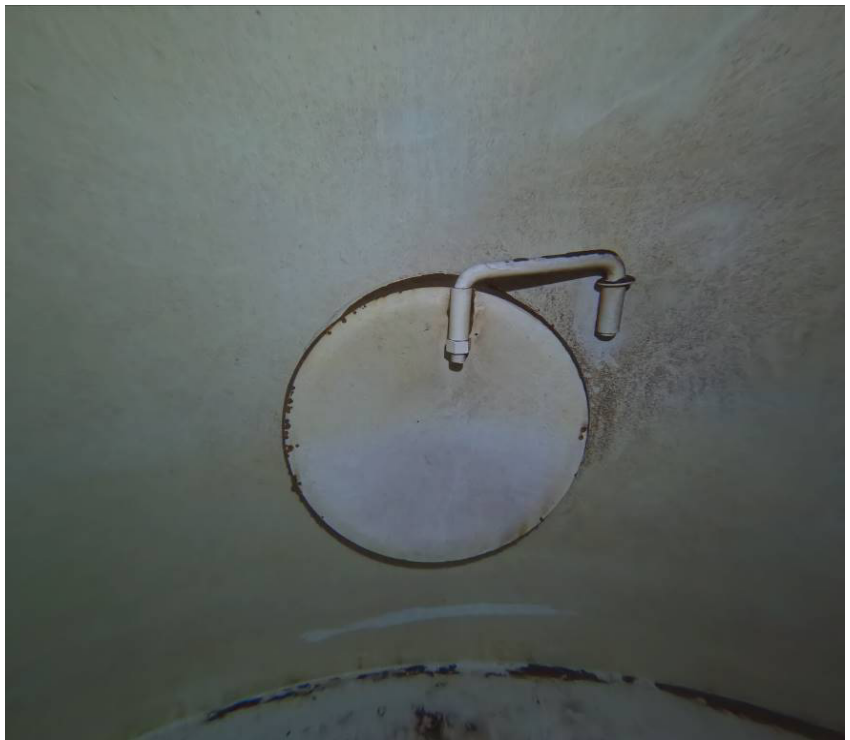
Description:
Man Way appeared to be in good condition with a minor amount of corrosion.

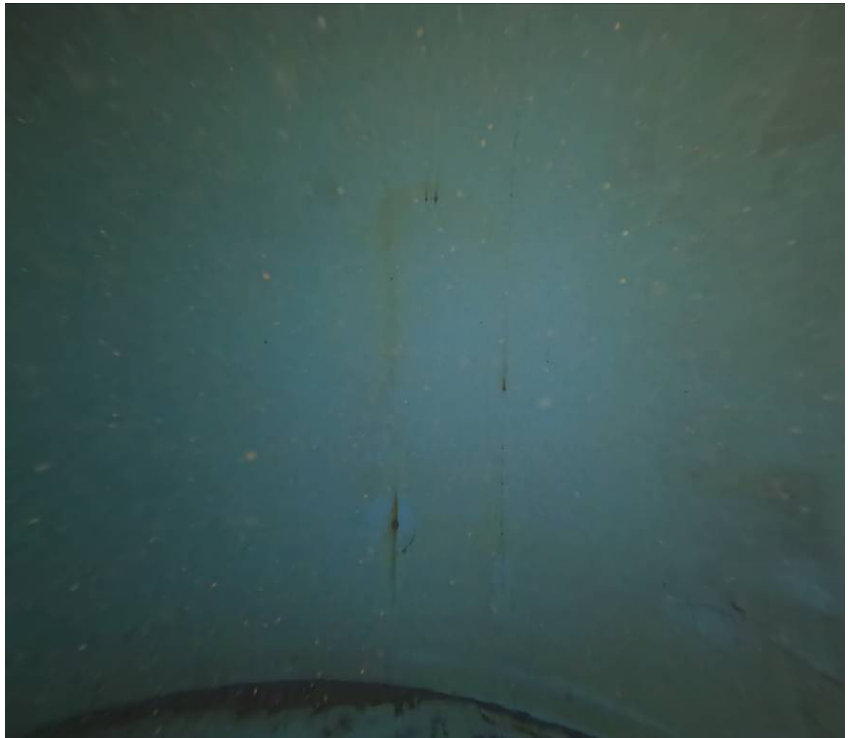
Description:
Wall appeared to be in good condition with a minor amount of corrosion.

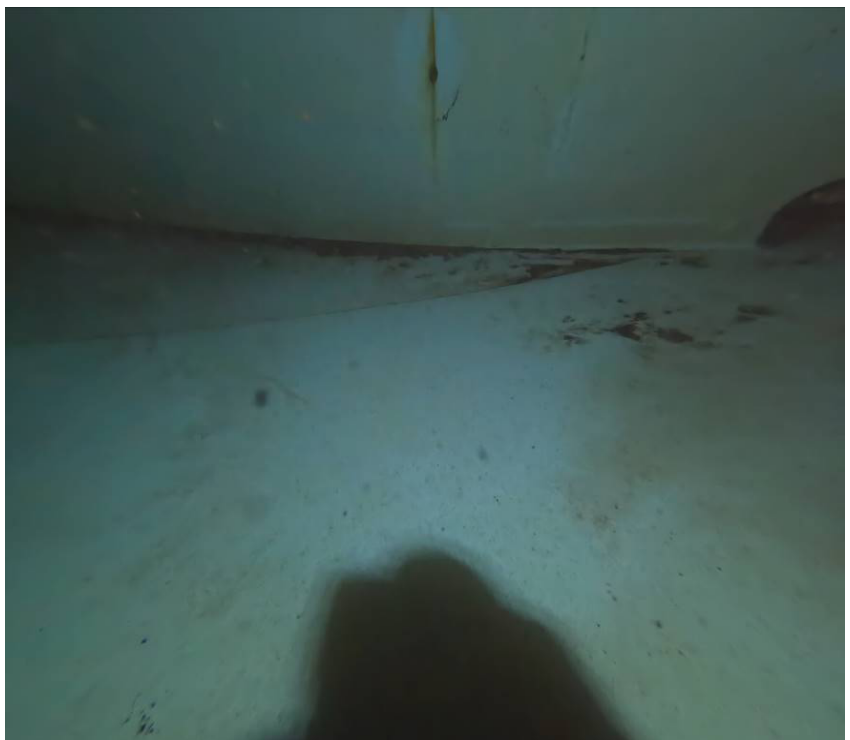
Description:
Floor appeared to be in good condition with a minor amount of corrosion.

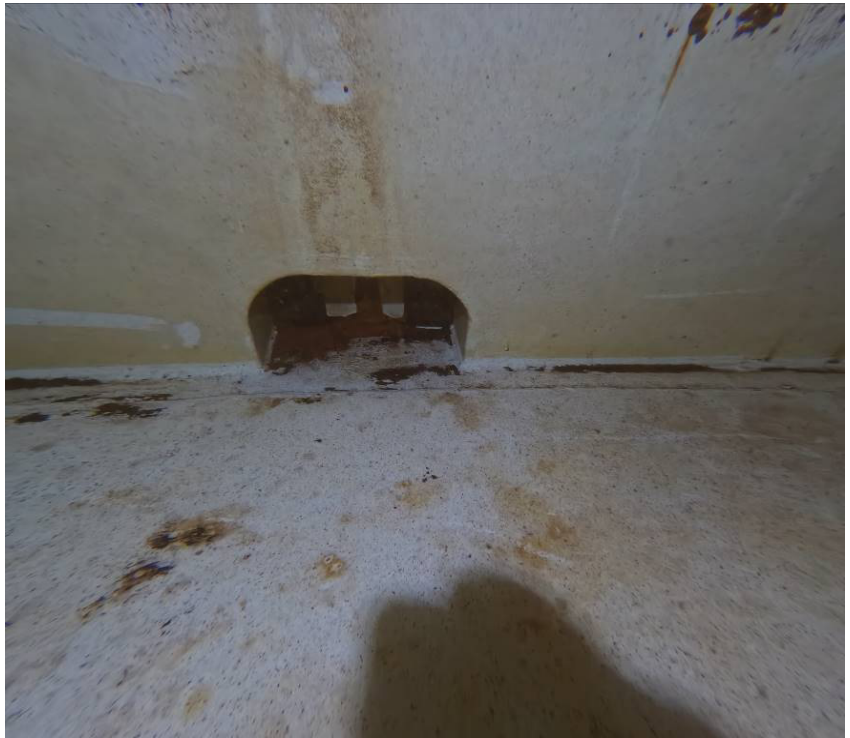
Description:
Capped-Off Penetration appeared to be in good condition with a minor amount of corrosion.

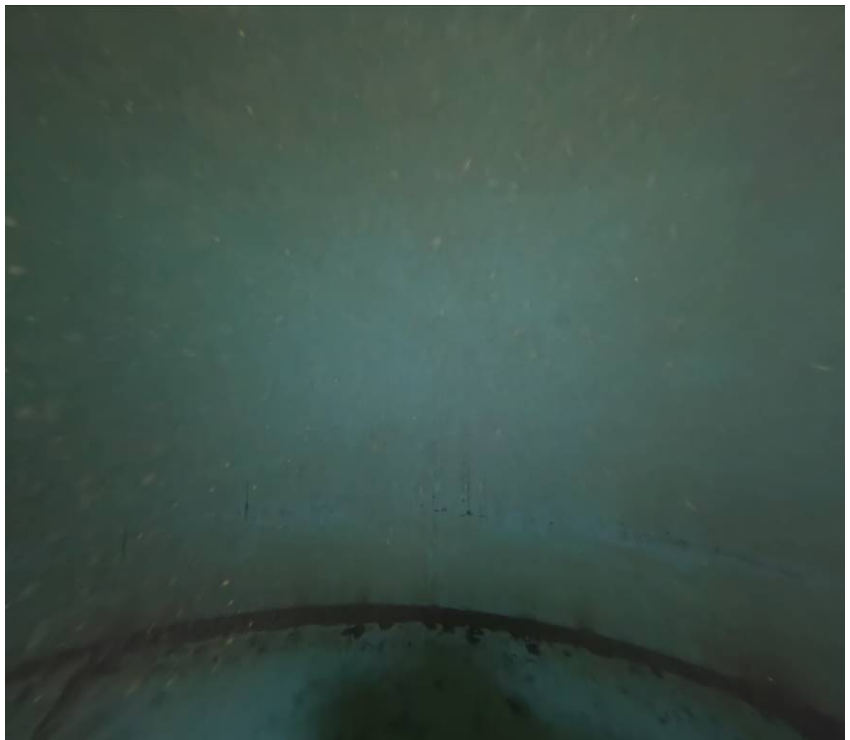
Description:
Wall appeared to be in good condition with a minor amount of corrosion.

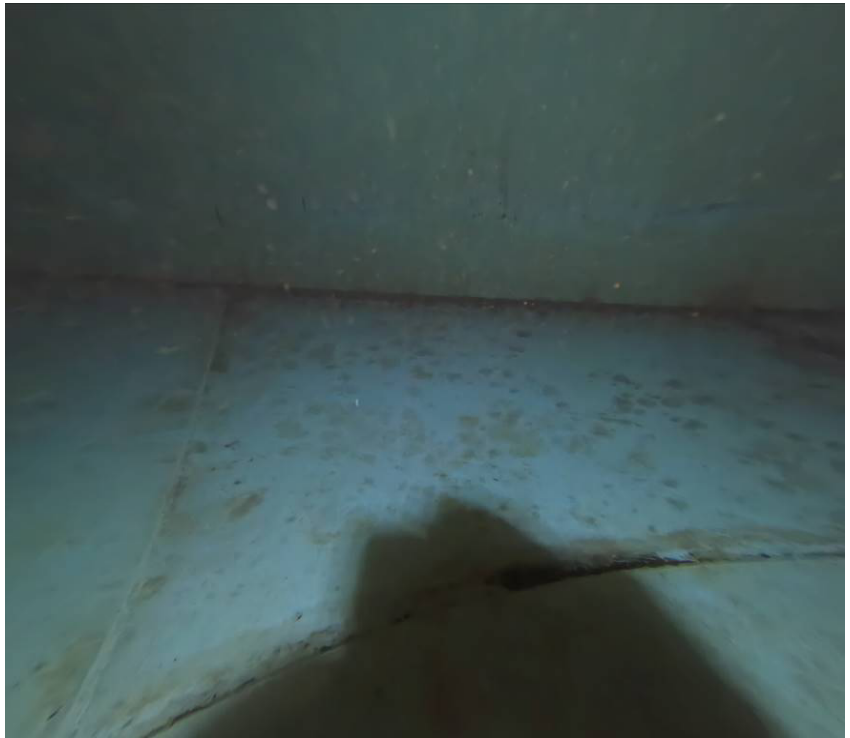
Description:
Floor appeared to be in good condition with a minor amount of corrosion.

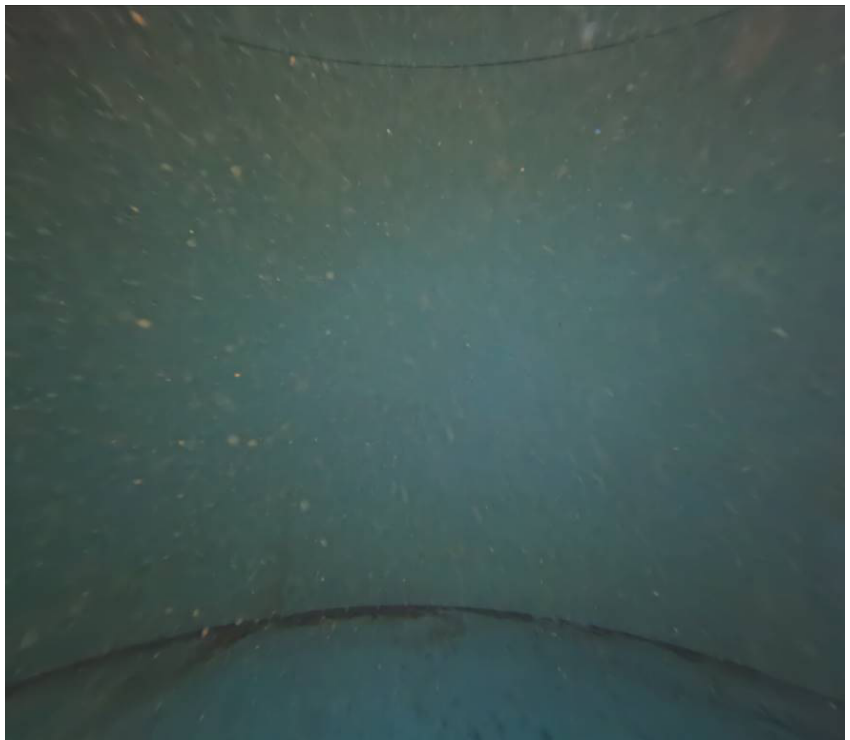
Description:
Wall appeared to be in good condition with a minor amount of corrosion.

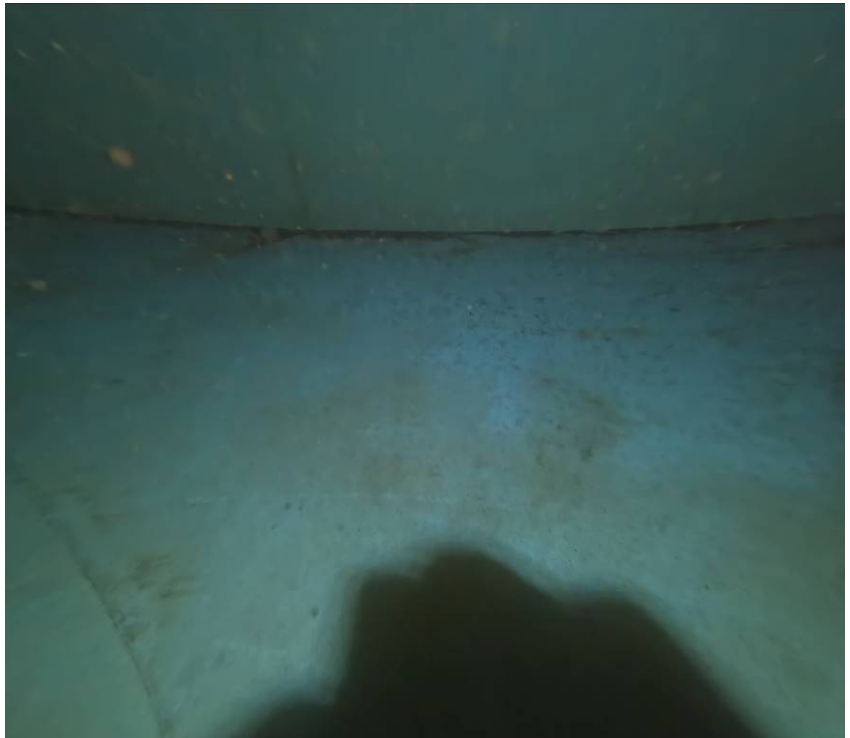
Description:
Floor appeared to be in good condition with a minor amount of corrosion.

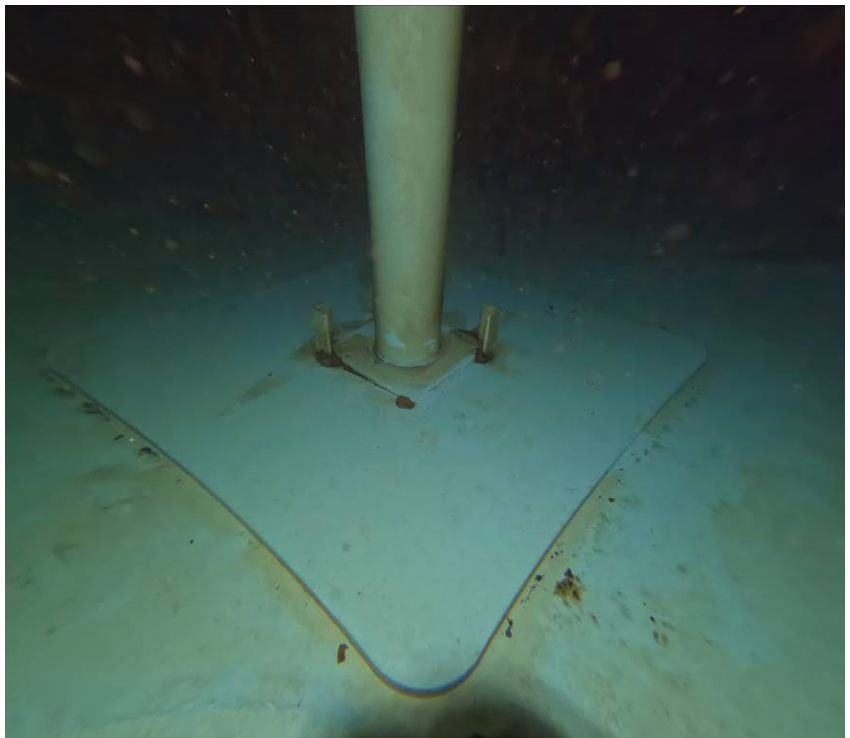
Description:
Column appeared to be in good condition with a minor amount of corrosion.

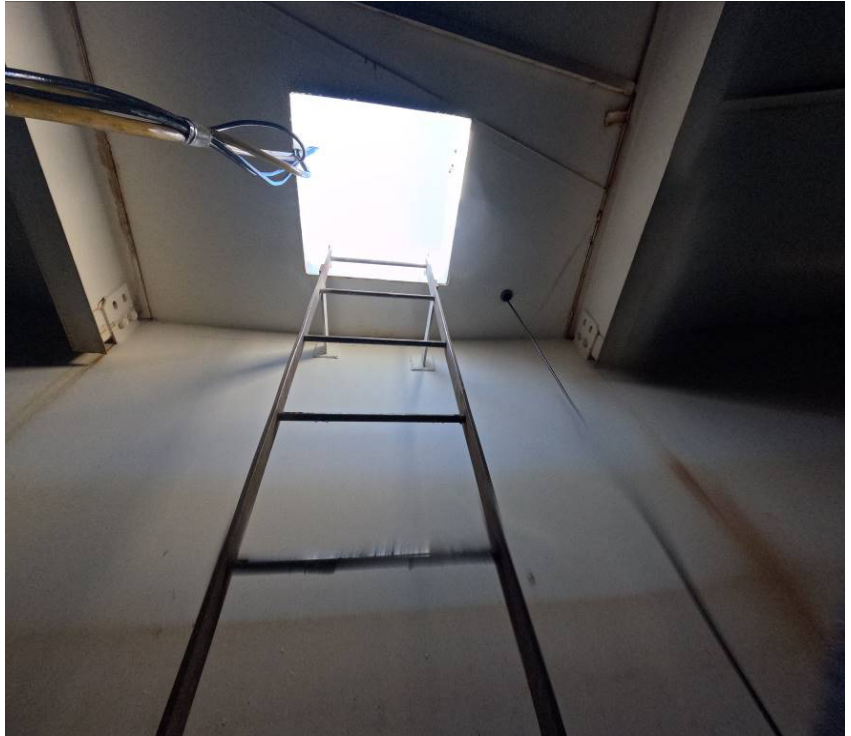
Description:
Ceiling appeared to be in good condition with a minor amount of corrosion.

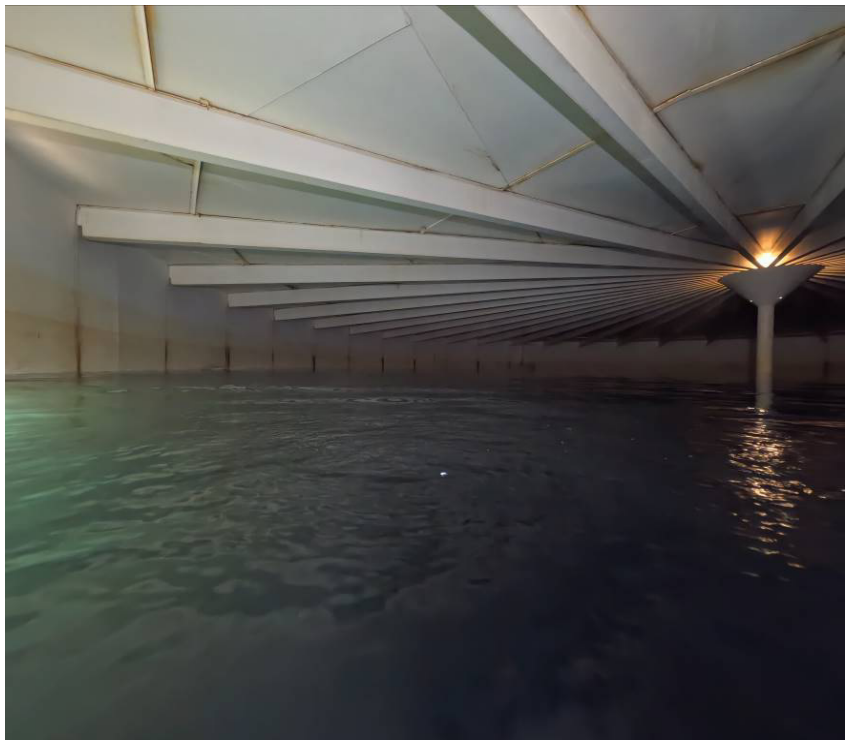
Description:
Ceiling appeared to be in good condition with a minor amount of corrosion.

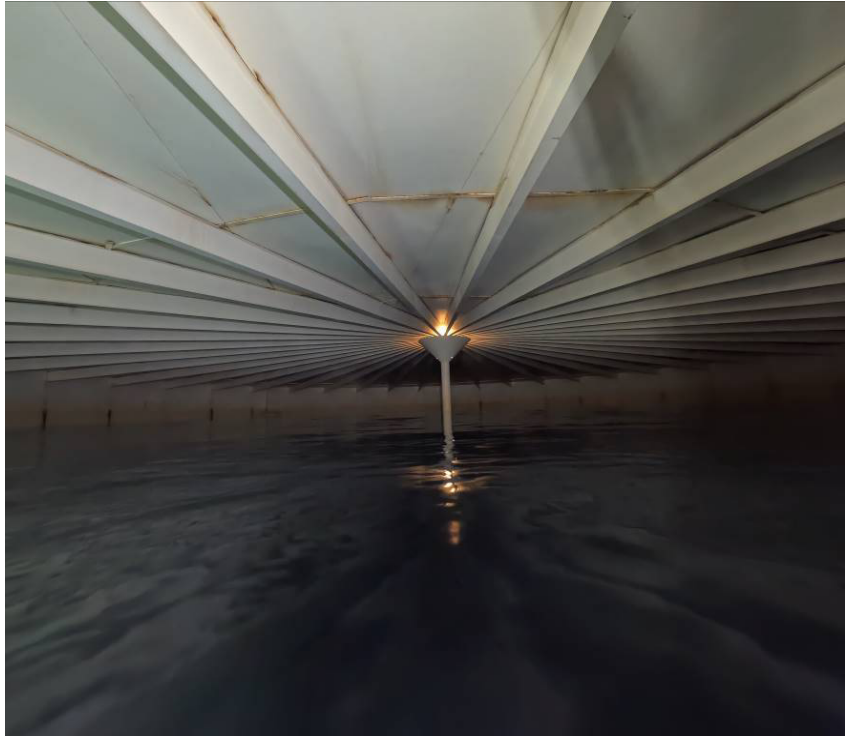
Description:
Ceiling appeared to be in good condition with a minor amount of corrosion.

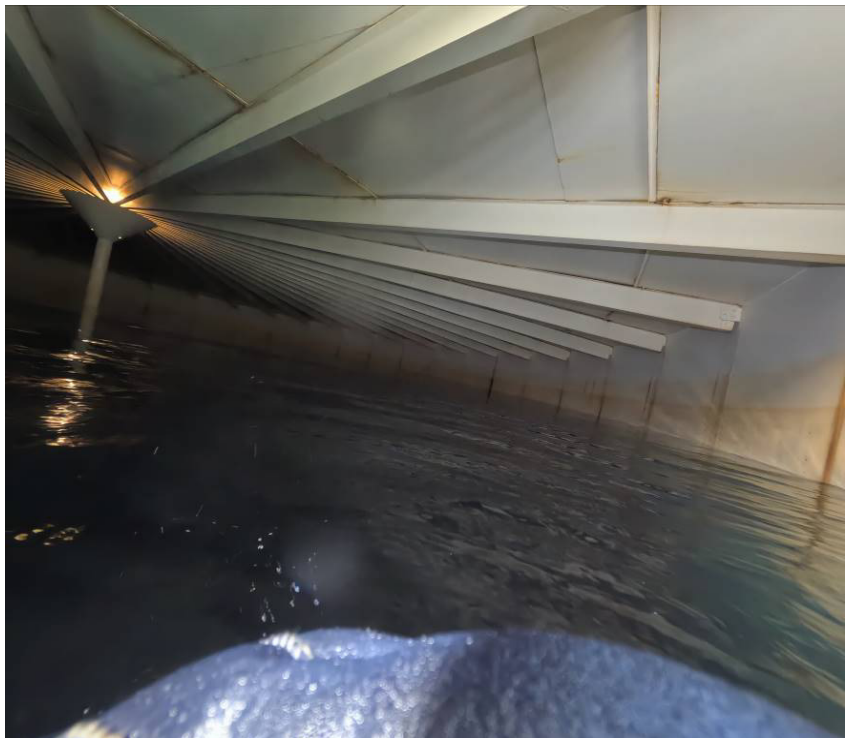
Description:
Ceiling appeared to be in good condition with a minor amount of corrosion.

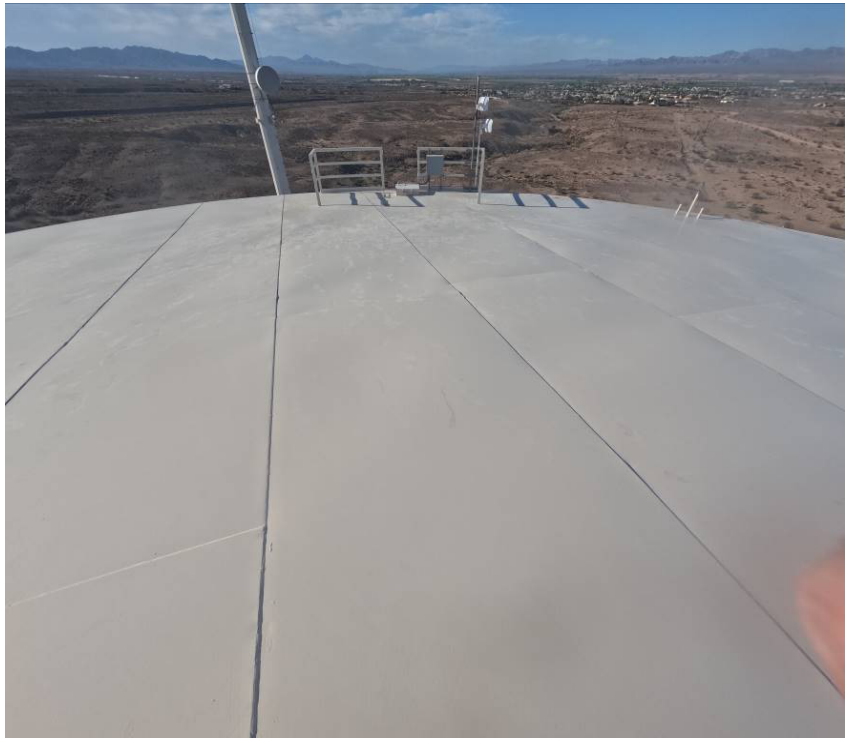
Description:
Roof appeared to be in good condition with a minor amount of corrosion.

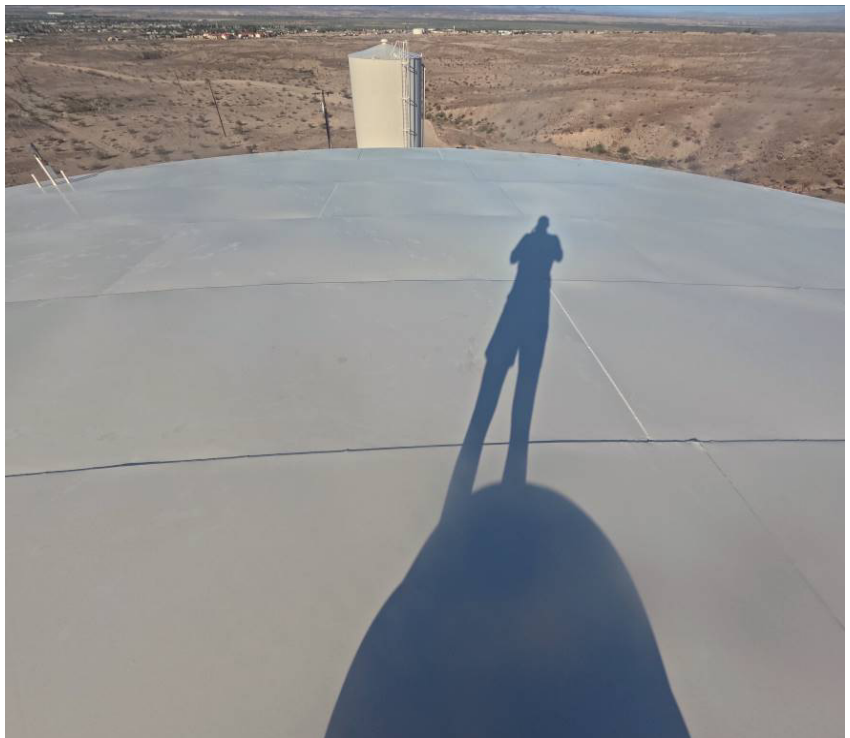
Description:
Roof appeared to be in good condition with a minor amount of corrosion.

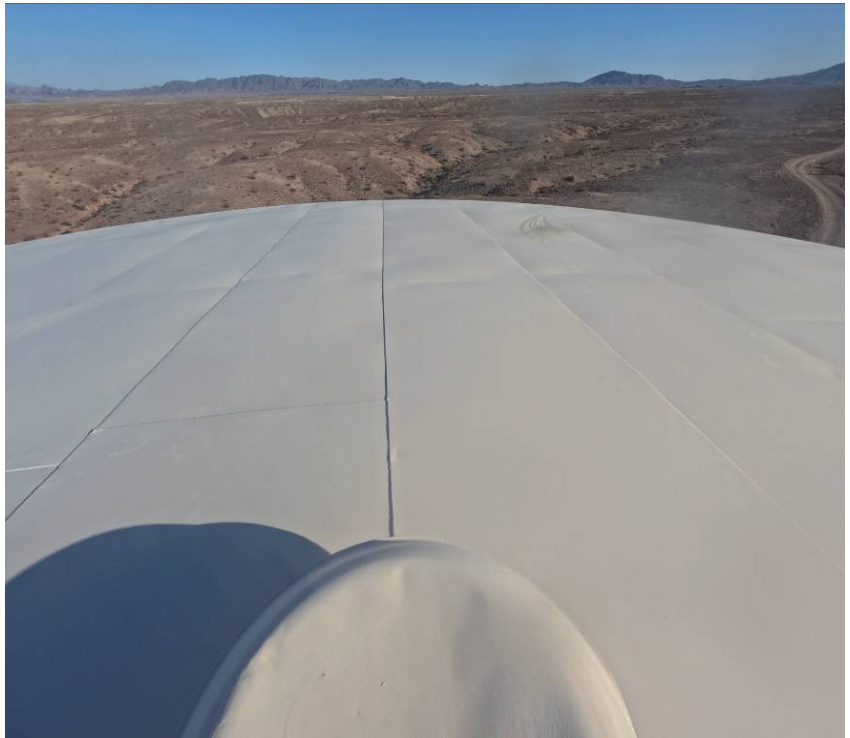
Description:
Roof appeared to be in good condition with a minor amount of corrosion.

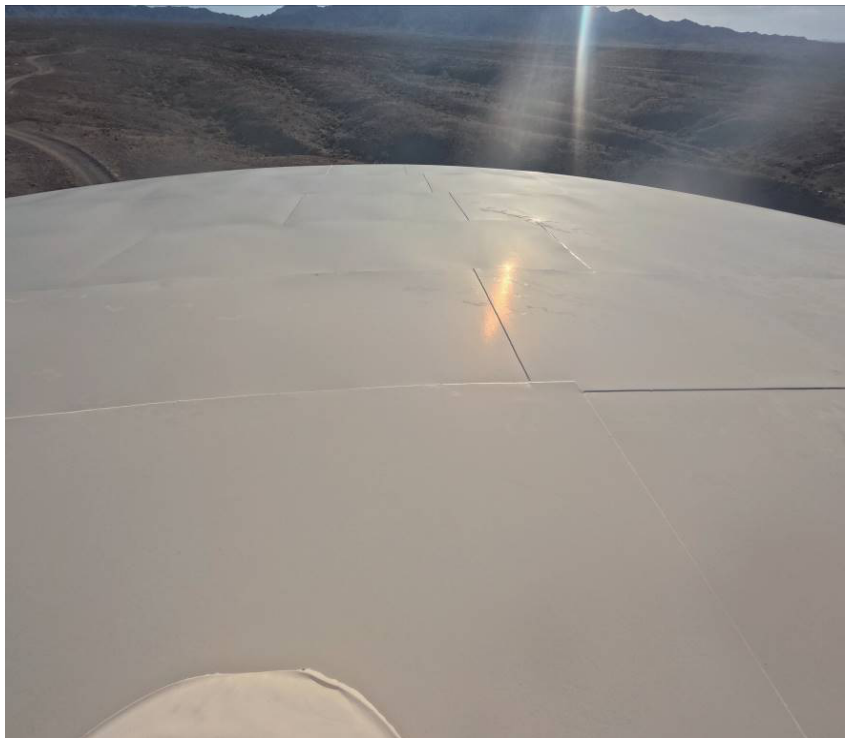
Description:
Roof appeared to be in good condition with a minor amount of corrosion.

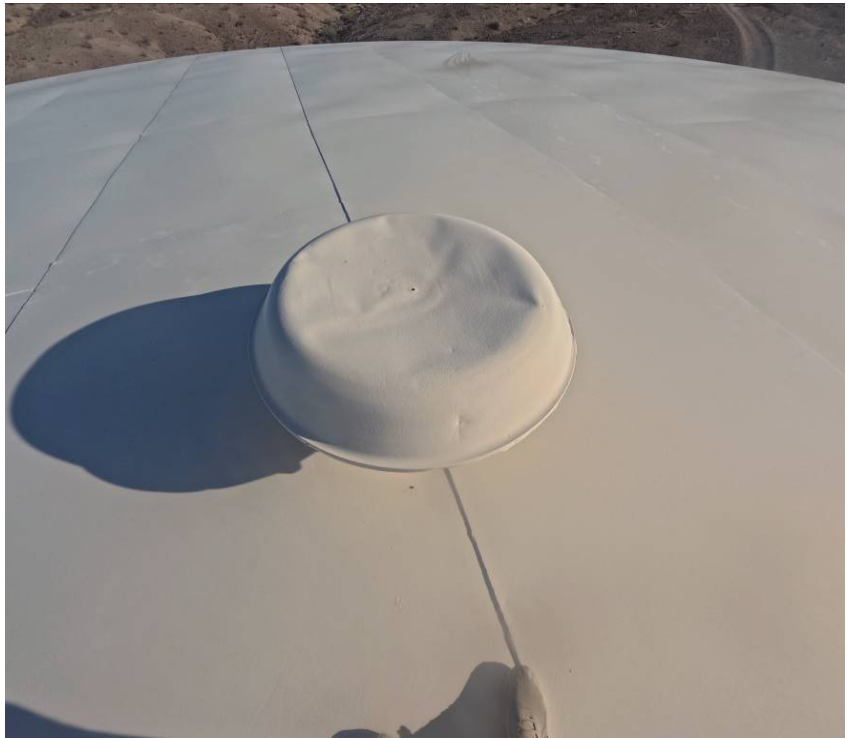
Description:
Vent appeared to be in good condition with a minor amount of corrosion.

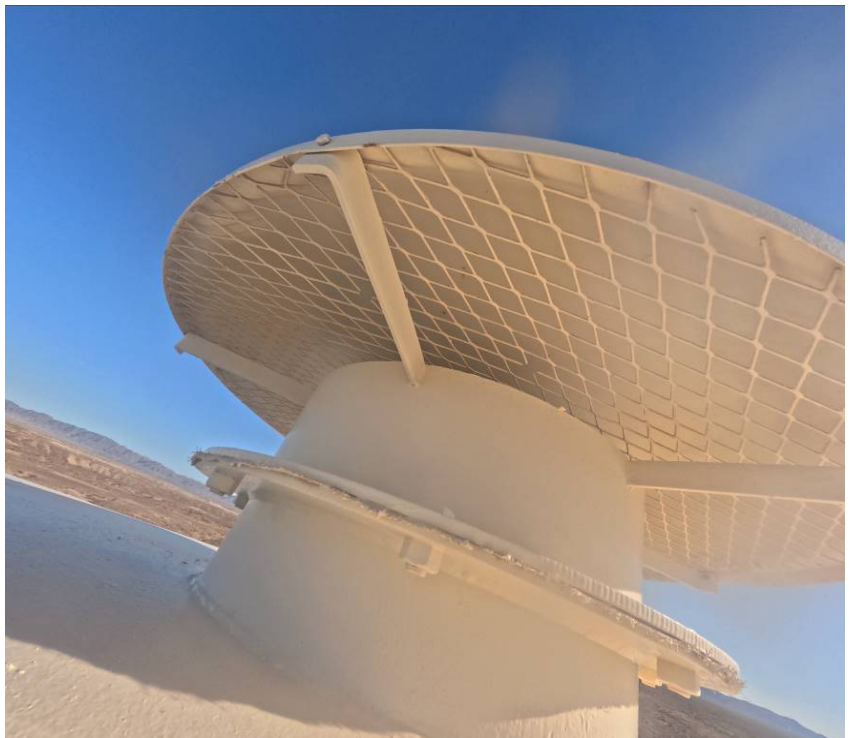
Description:
Vent Screen appeared to be in good condition with a minor amount of corrosion.
