**High Tank
Needles Water Department
Report of Findings
From the
Diving Operations
Conducted on**

May 16, 2025

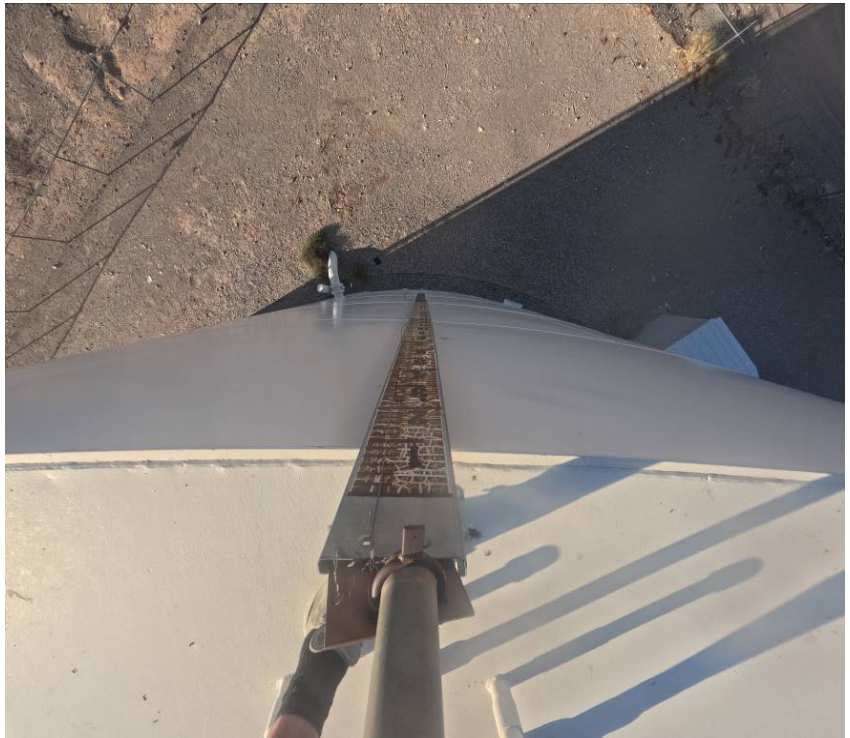
Description:
Liquid Level Indicator Reader Board appeared to be in poor condition with a moderate amount of corrosion. An interior cable appeared to be broken.

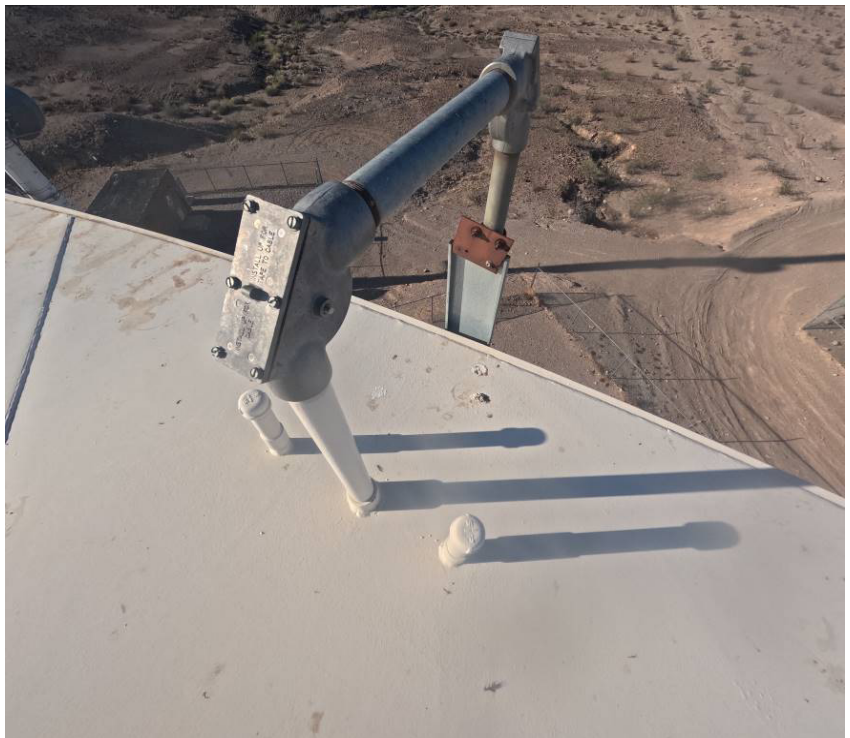
Description:
Liquid Level Indicator Penetration appeared to be in poor condition with a minor amount of corrosion. An interior cable appeared to be broken.

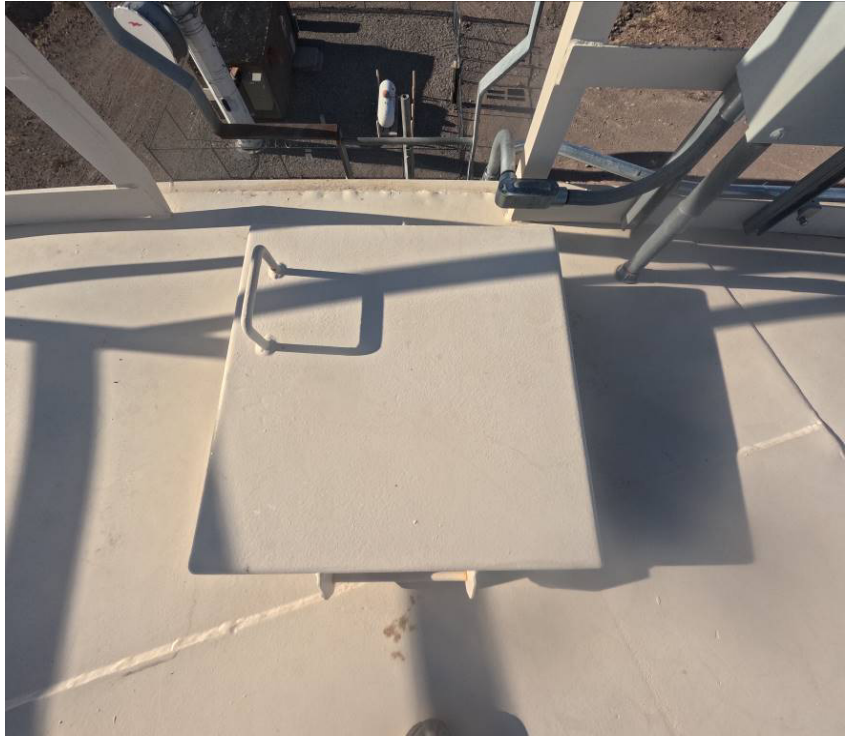
Description:
Entry Hatch appeared to be in good condition with a minor amount of corrosion.

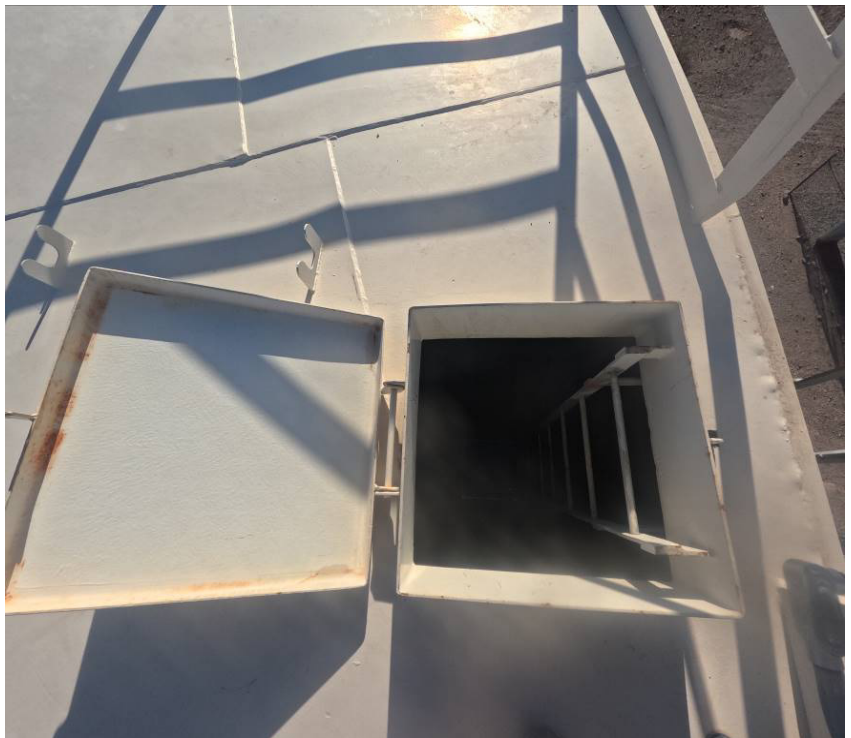
Description:
Entry Hatch appeared to be in good condition with a minor amount of corrosion. Weather stripping did not appear to be present.

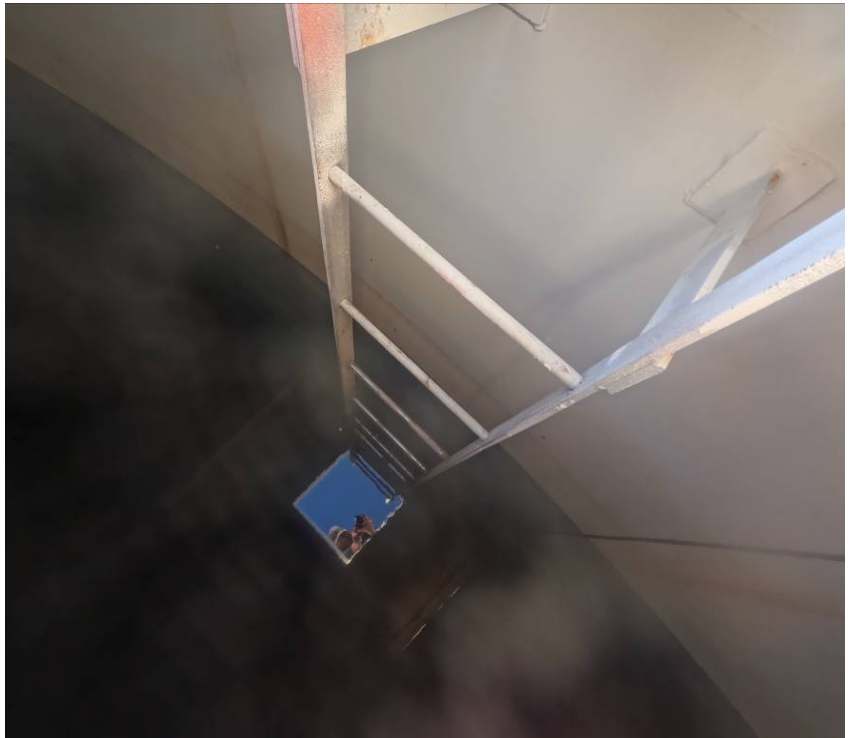
Description:
Interior Ladder appeared to be in good condition with a minor amount of corrosion.
