West Tank
Needles Water Department
Report of Findings
From the
Diving Operations
Conducted on

May 14, 2025

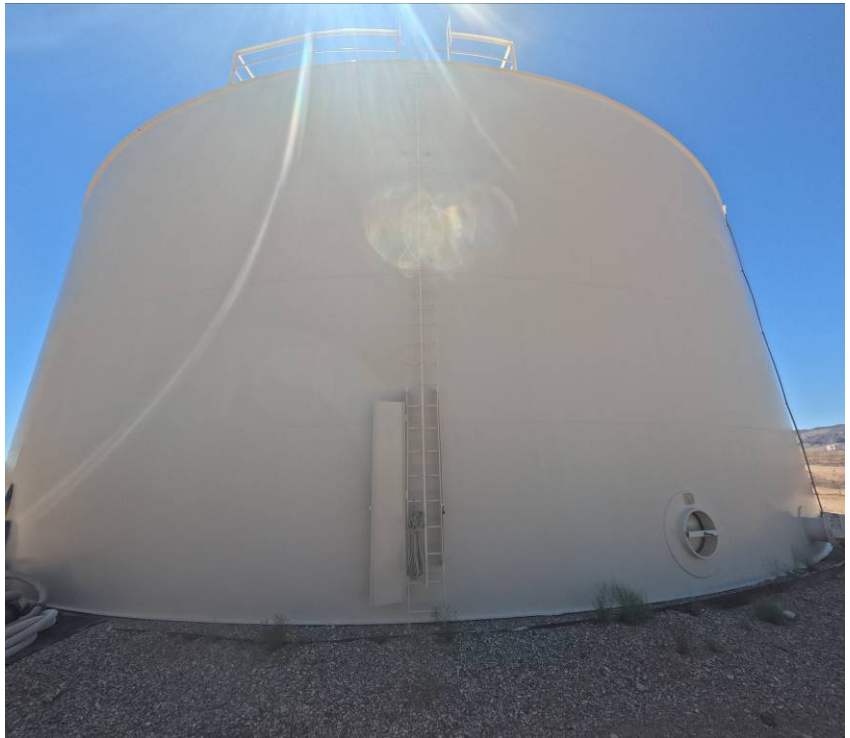
Description:
Exterior Wall appeared to be in good condition with a minor amount of corrosion.

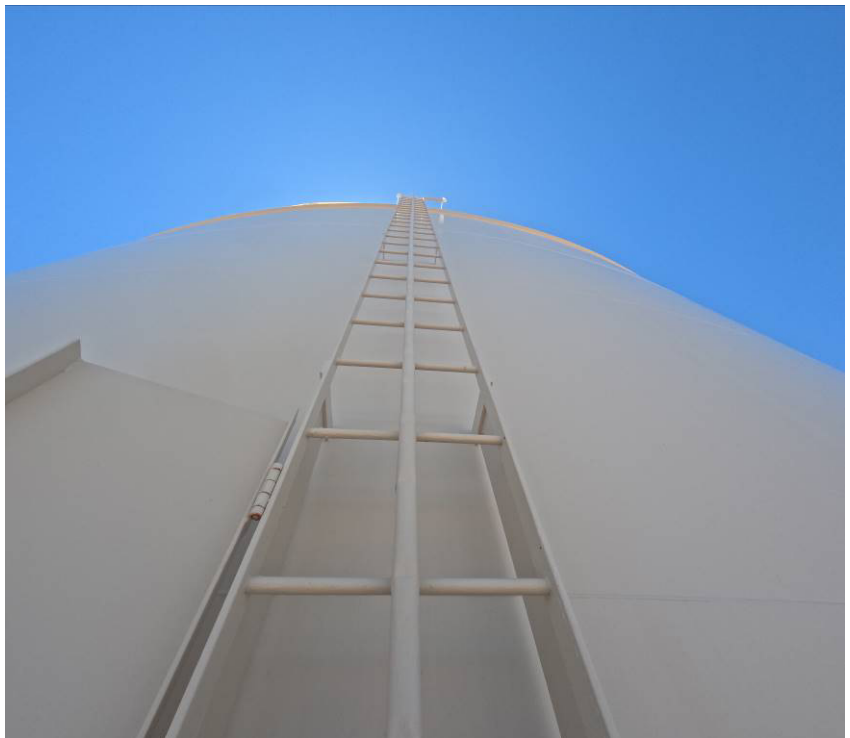
Description:
Exterior Ladder appeared to be in good condition with a minor amount of corrosion.

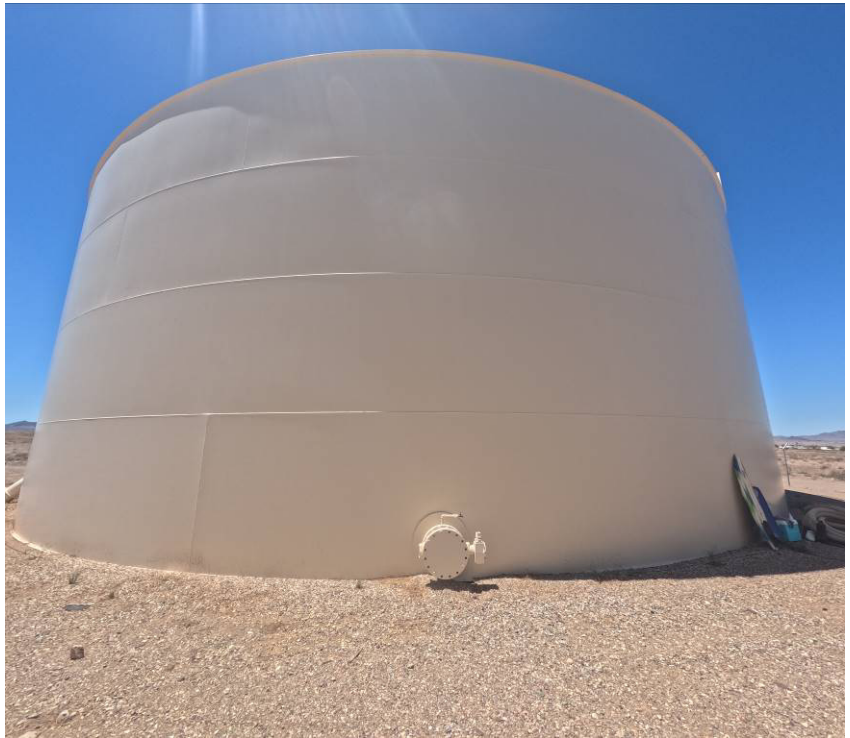
Description:
Exterior Wall appeared to be in good condition with a minor amount of corrosion.

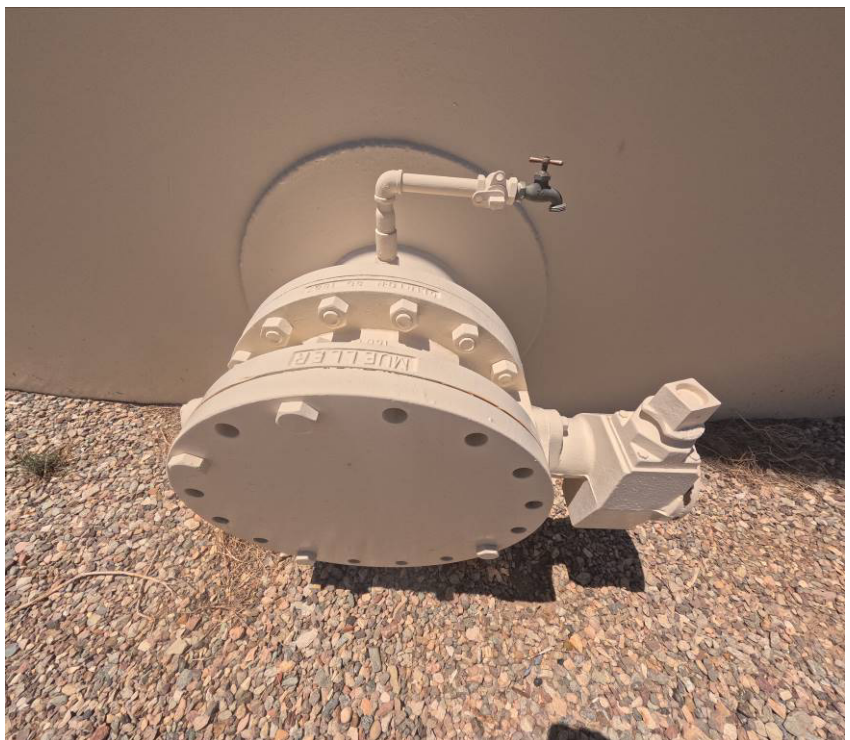
Description:
Capped Off Penetration appeared to be in good condition with a minor amount of corrosion.

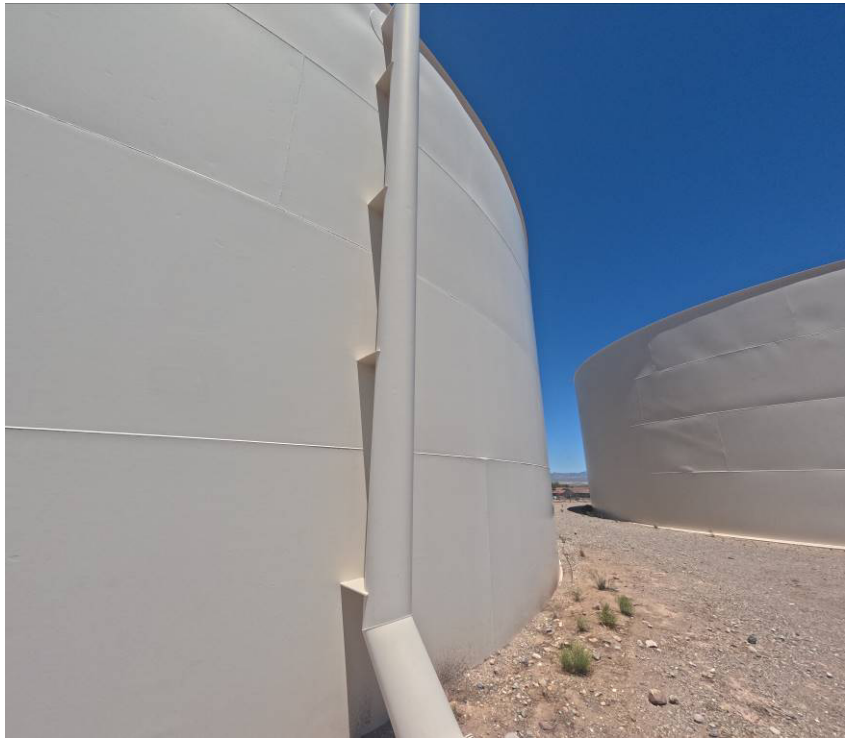
Description:
Overflow appeared to be in good condition with a minor amount of corrosion.

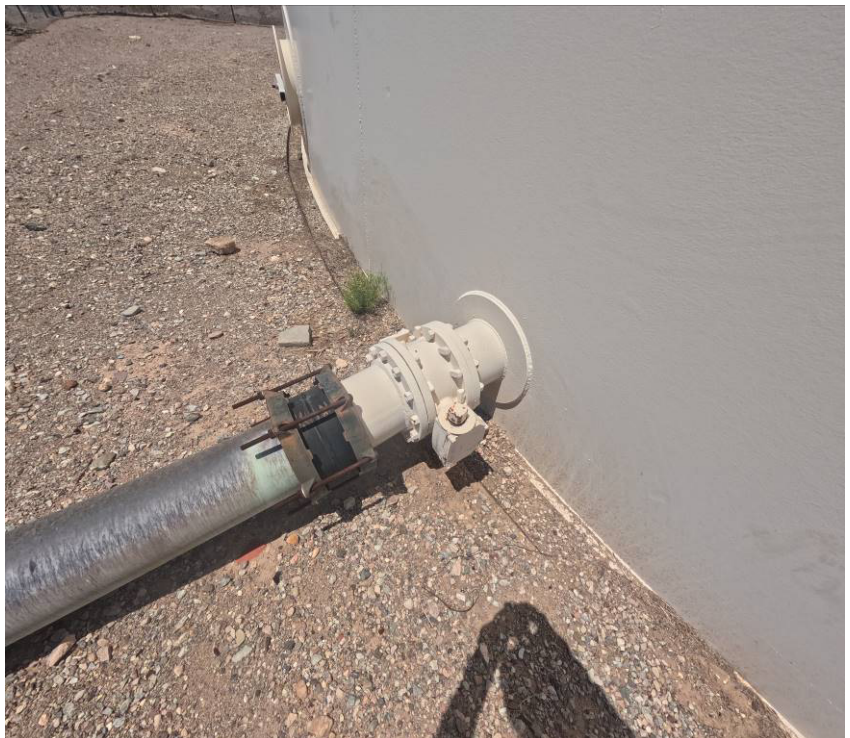
Description:
Drain appeared to be in good condition with a minor amount of corrosion.

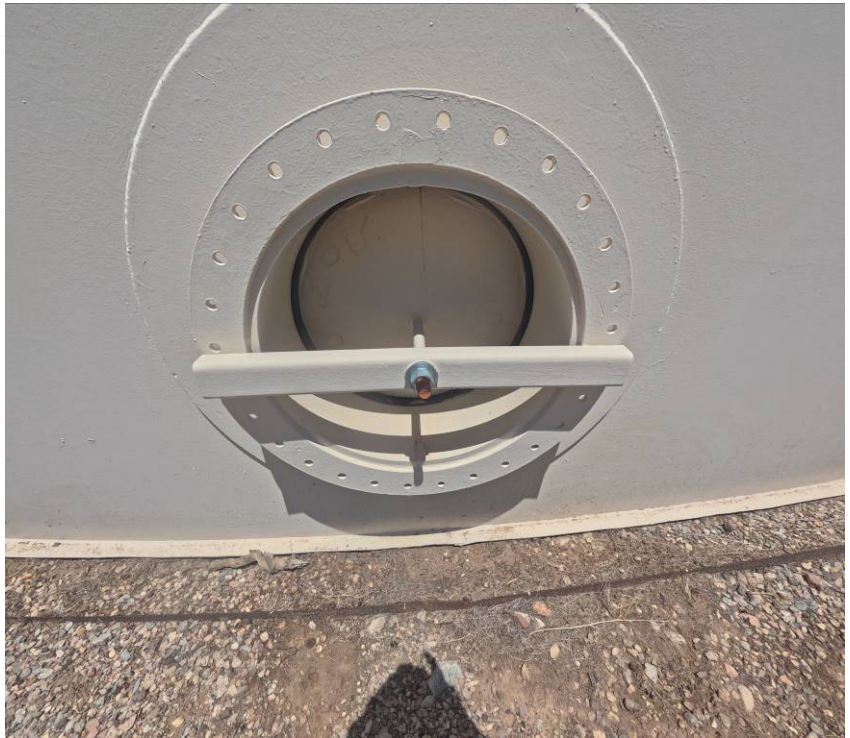
Description:
Man Way appeared to be in good condition with a minor amount of corrosion.

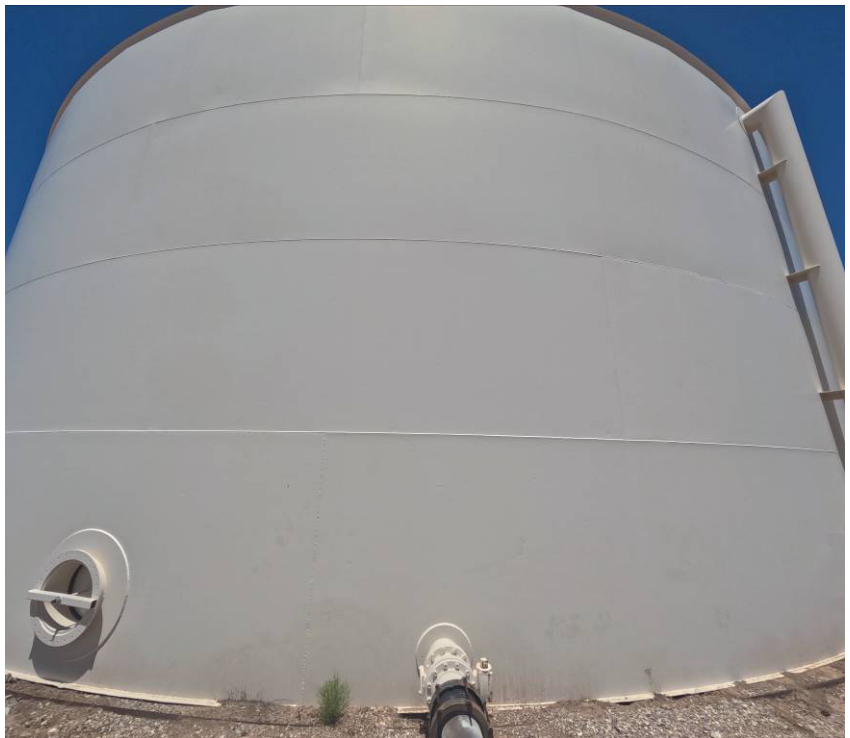
Description:
Exterior Wall appeared to be in good condition with a minor amount of corrosion.

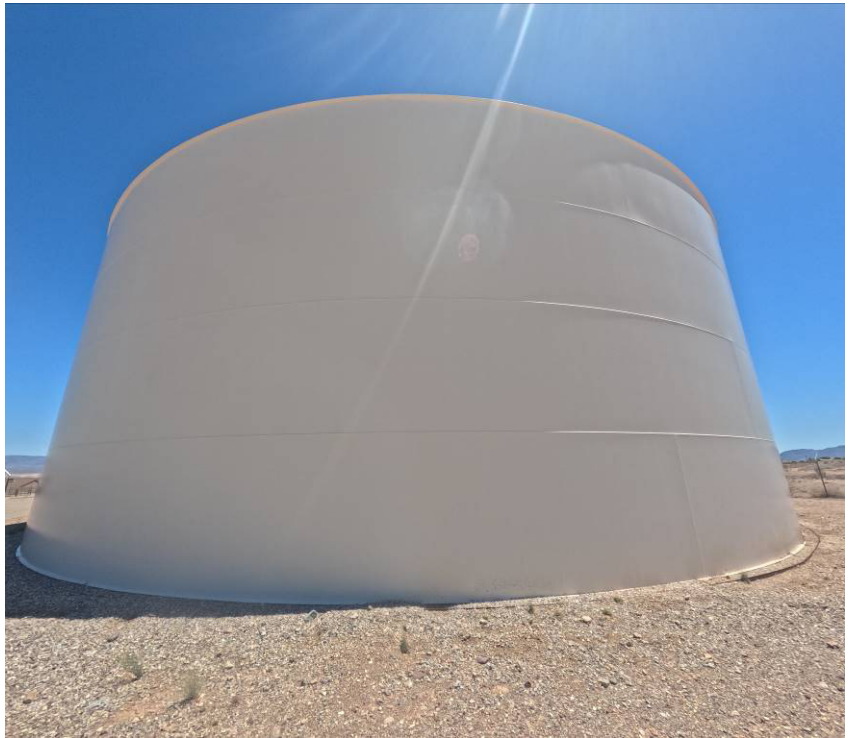
Description:
Exterior Wall appeared to be in good condition with a minor amount of corrosion.

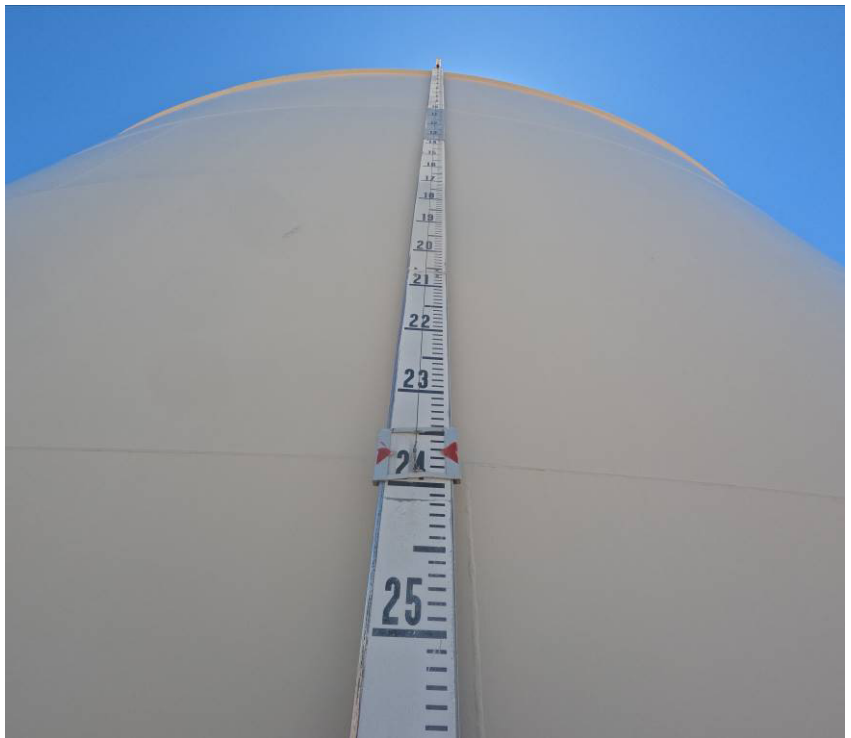
Description:
Liquid Level Indicator Reader Board appeared to be in good condition with a minor amount of corrosion.

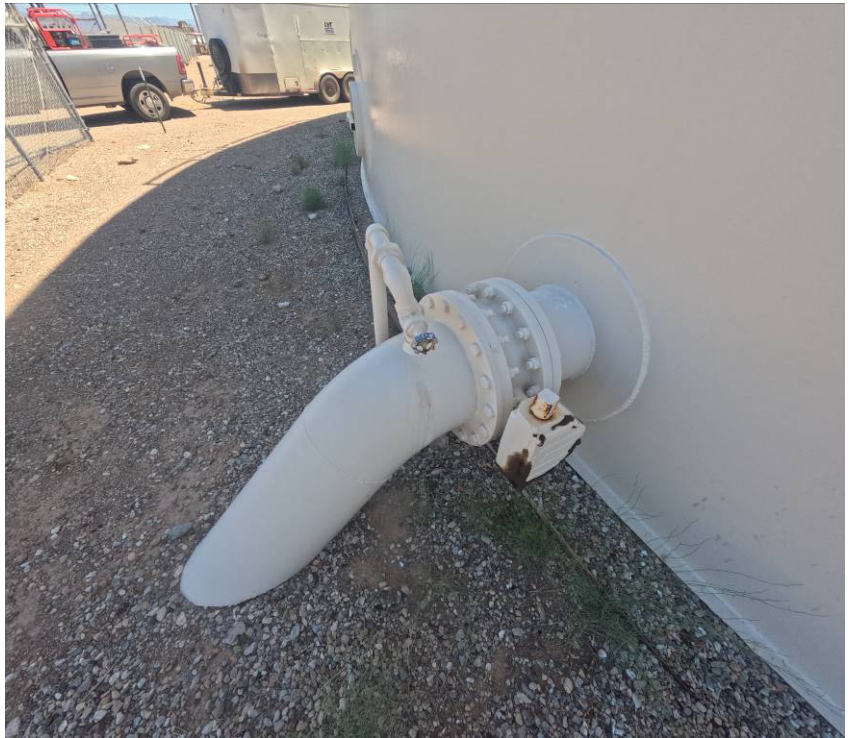
Description:
Inlet / Outlet appeared to be in good condition with a minor amount of corrosion.

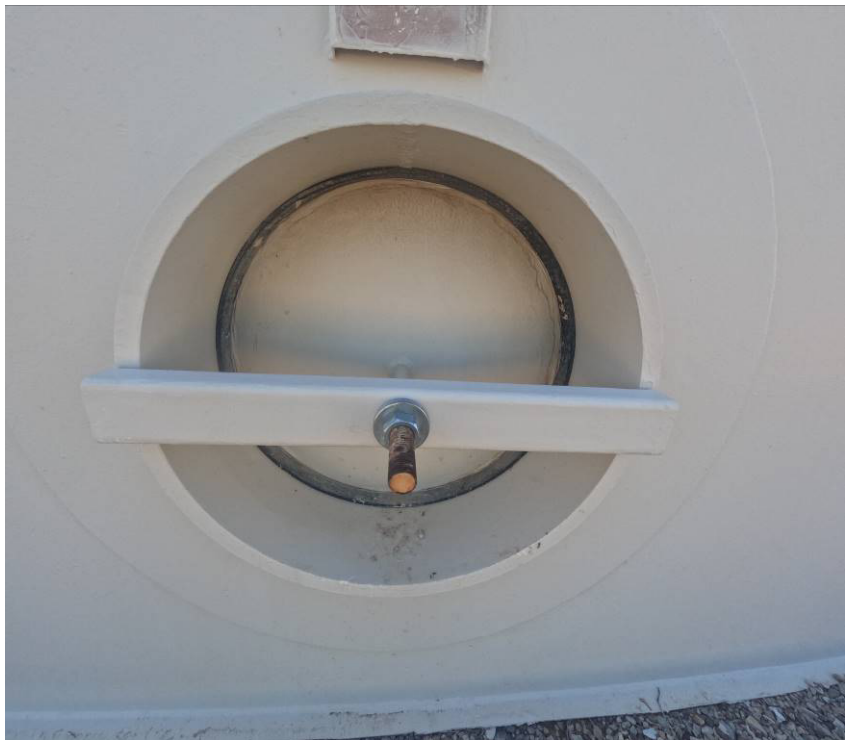
Description:
Man Way appeared to be in good condition with a minor amount of corrosion.

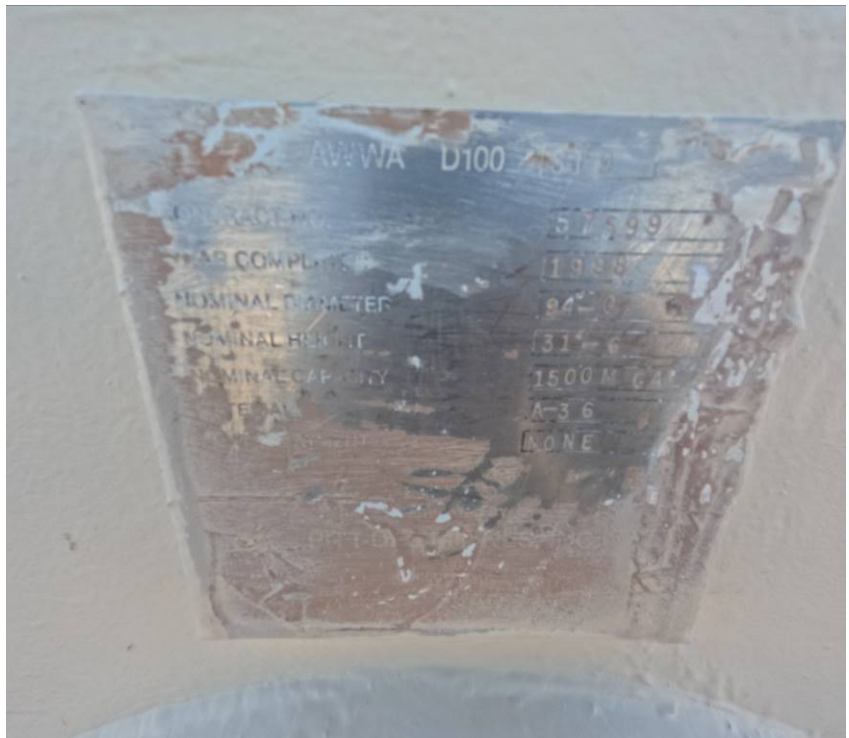
Nomenclature Plate appeared to be in good condition with minor amount of corrosion and was readable.

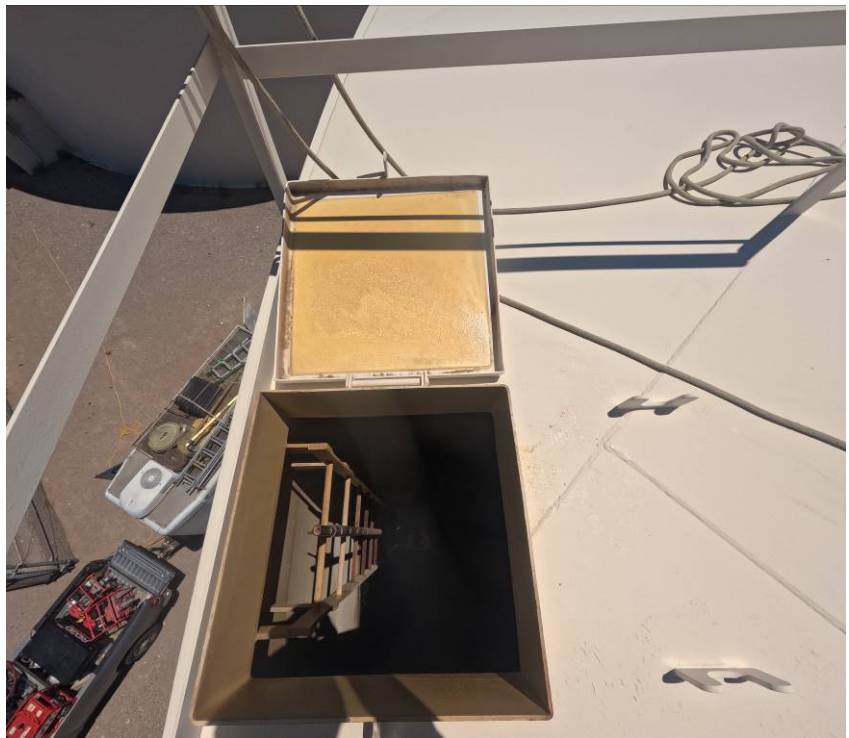
Entry Hatch appeared to be in good condition with a minor amount of corrosion. No weather stripping appeared to be present.

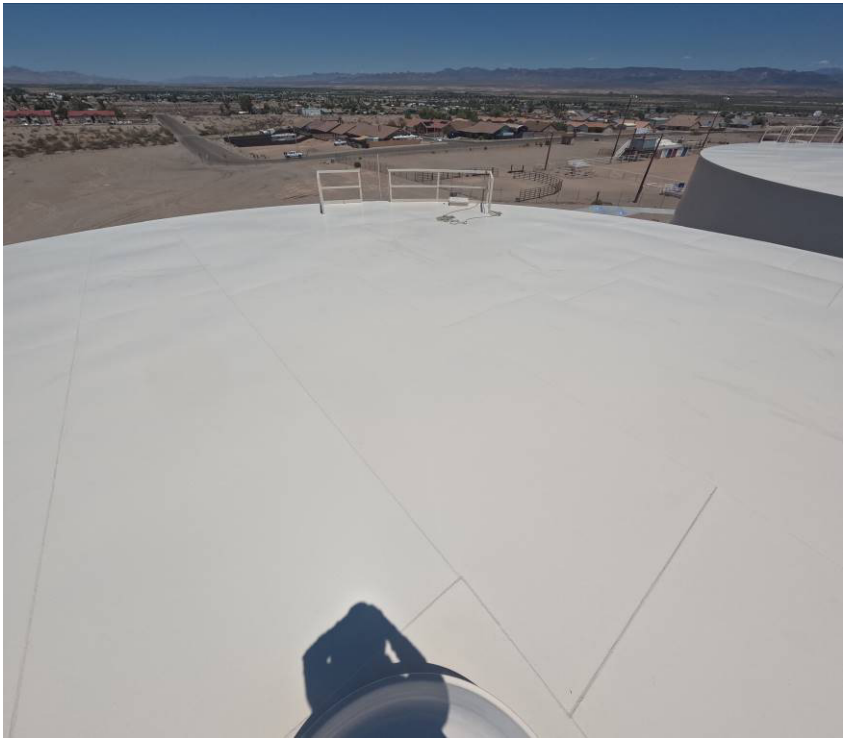
Description:
Roof appeared to be in good condition with a minor amount of corrosion.

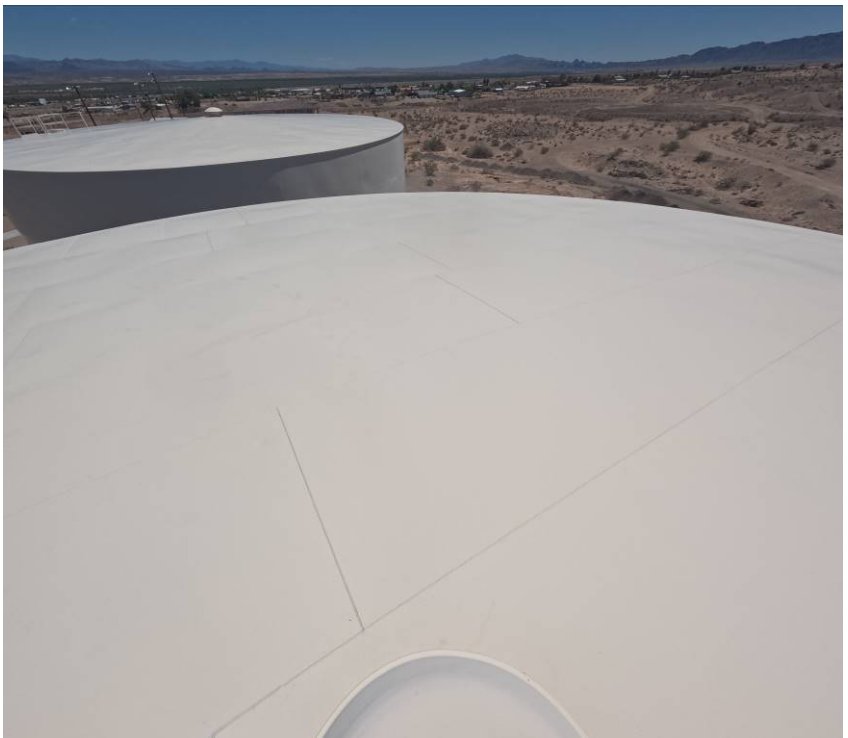
Description:
Roof appeared to be in good condition with a minor amount of corrosion.

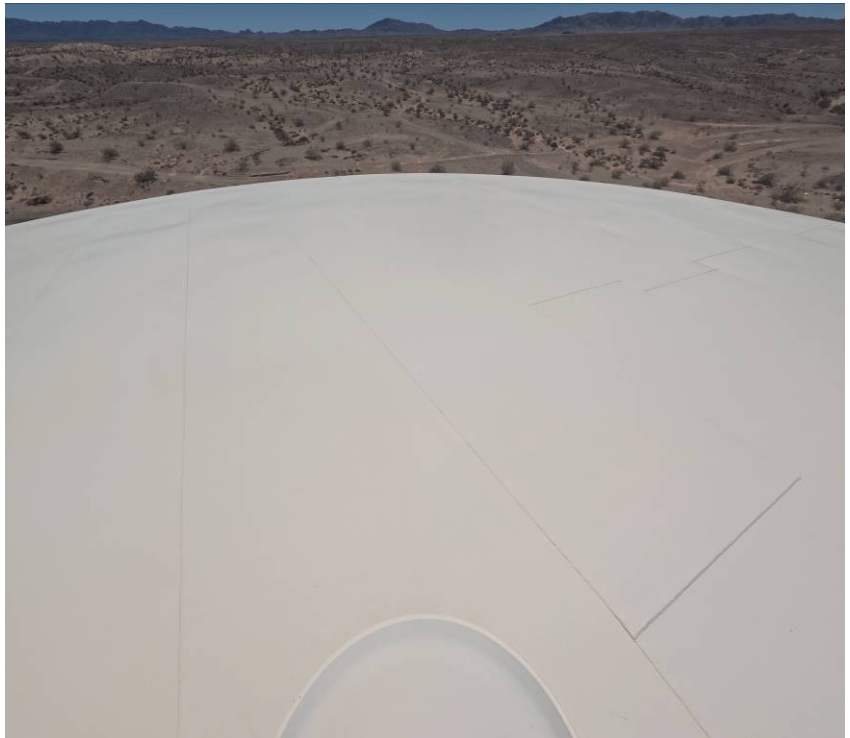
Description:
Roof appeared to be in good condition with a minor amount of corrosion.

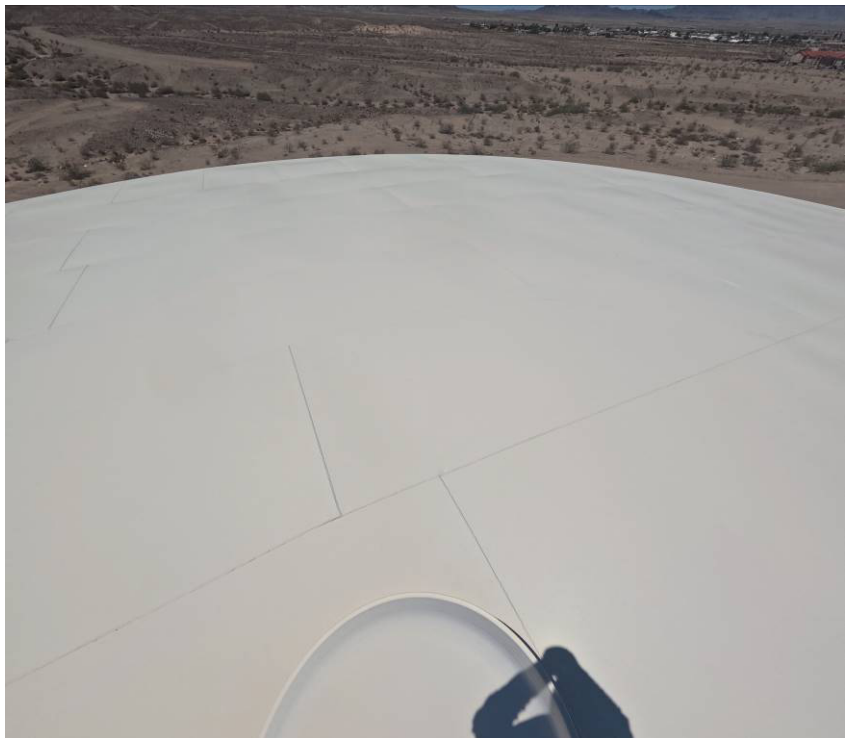
Description:
Roof appeared to be in good condition with a minor amount of corrosion.

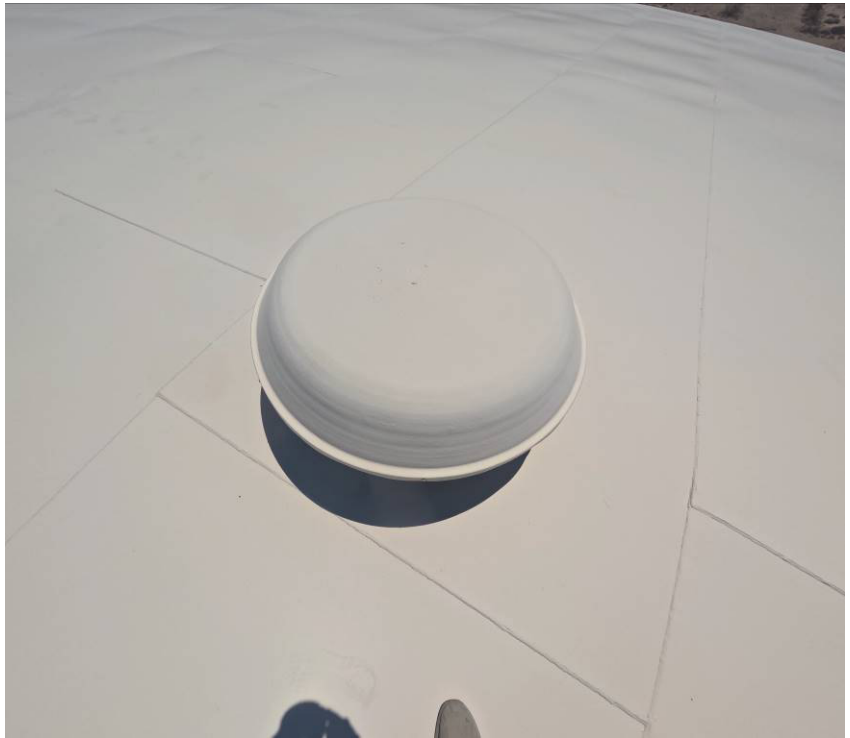
Description:
Vent appeared to be in good condition with a minor amount of corrosion.

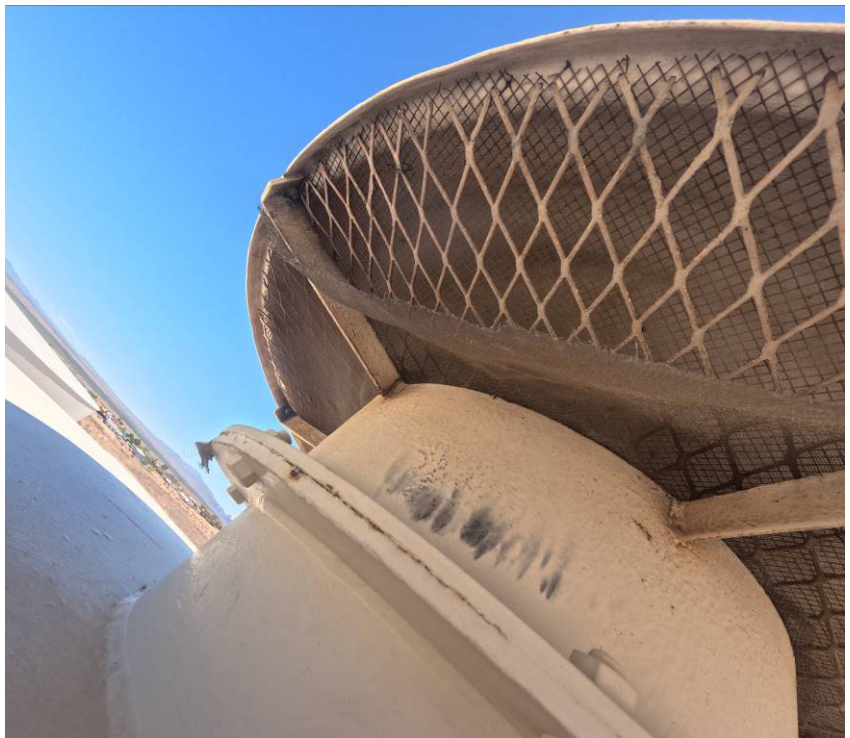
Description:
Vent Screen appeared to be in good condition with a minor amount of corrosion.

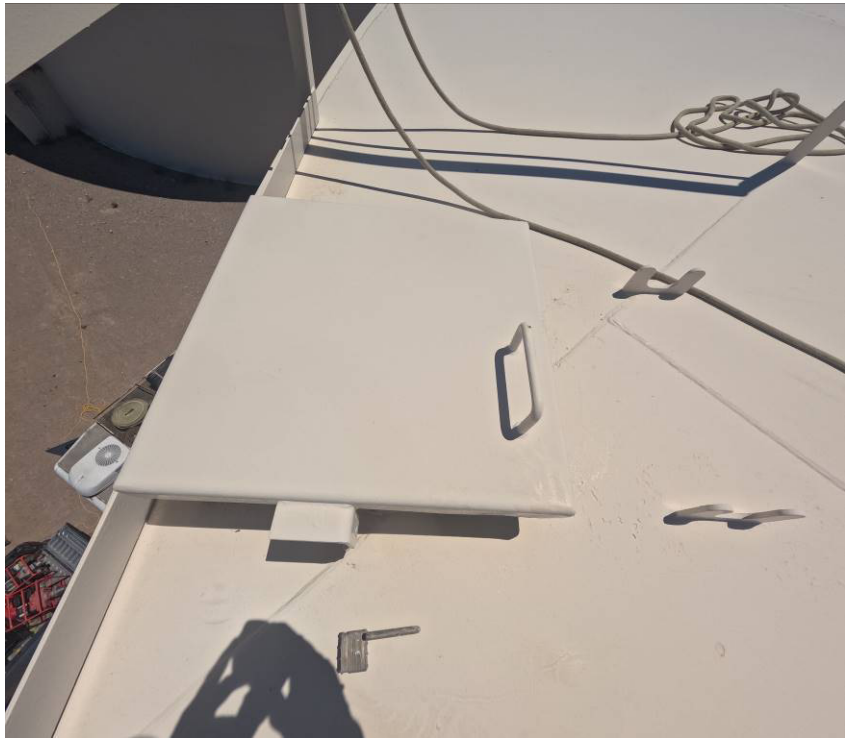
Description:
Entry Hatch appeared to be in good condition with a minor amount of corrosion.

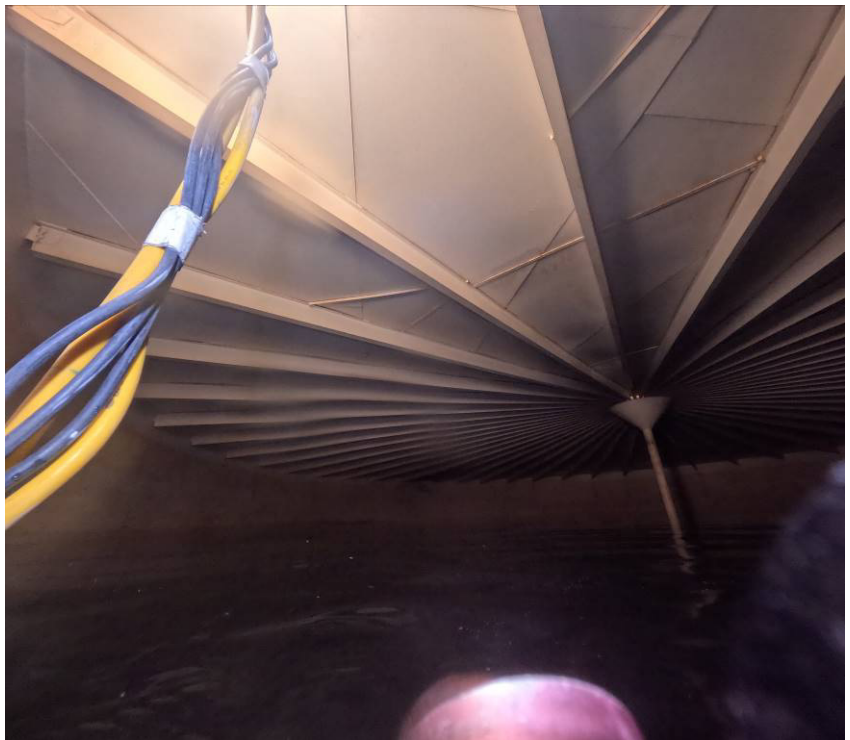
Description:
Ceiling appeared to be in good condition with a minor amount of corrosion.

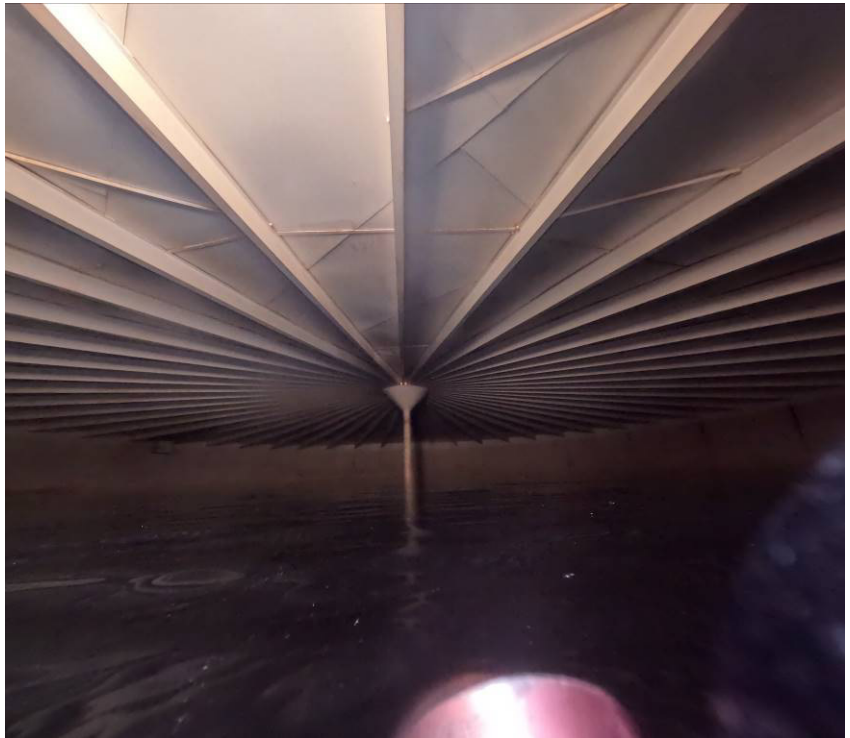
Description:
Ceiling appeared to be in good condition with a minor amount of corrosion.

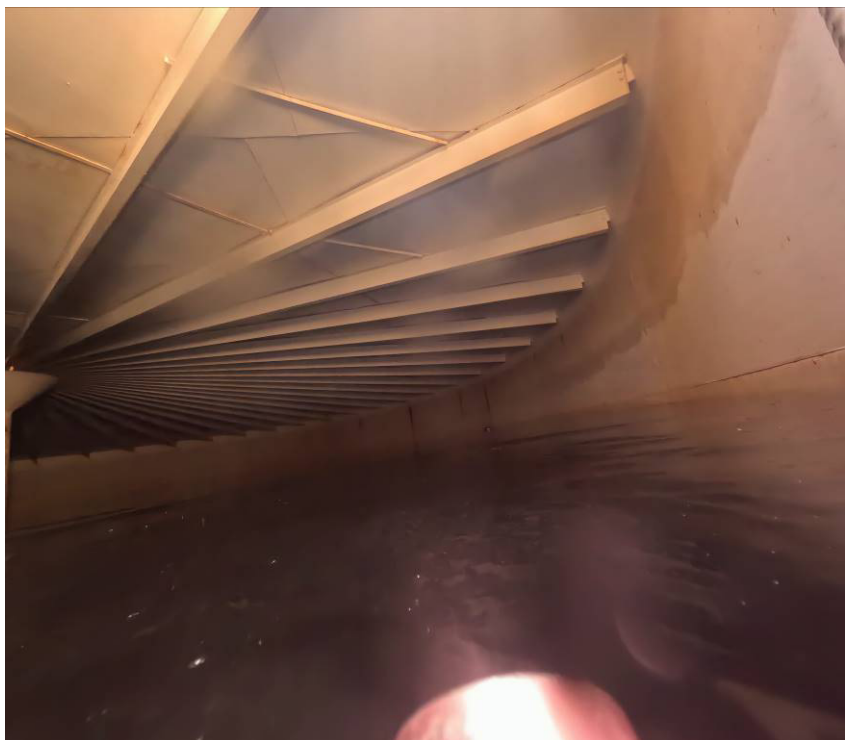
Description:
Ceiling appeared to be in good condition with a minor amount of corrosion.

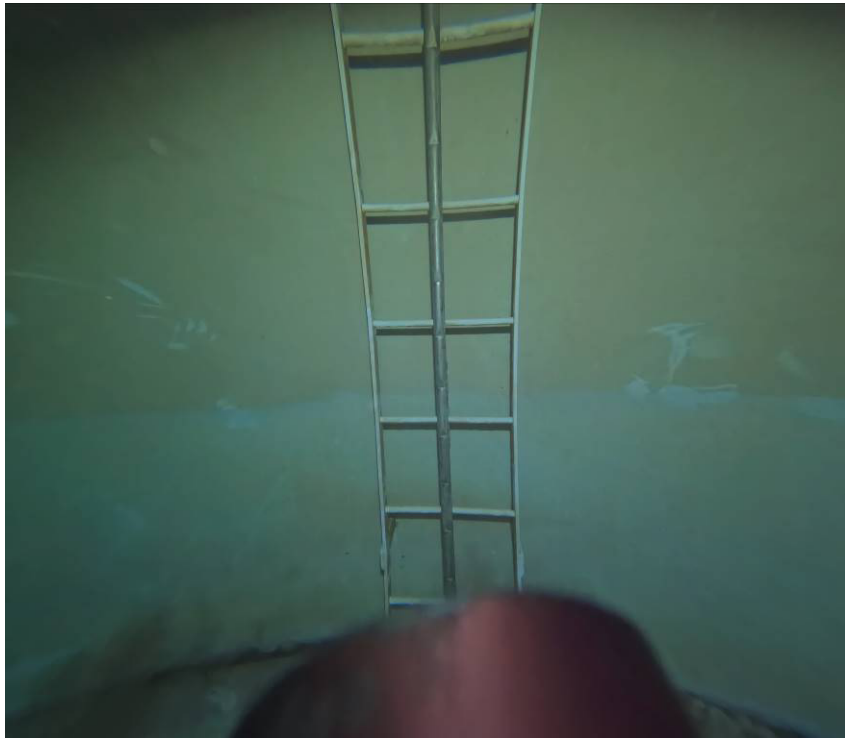
Description:
Entry Ladder appeared to be in good condition with a minor amount of corrosion.

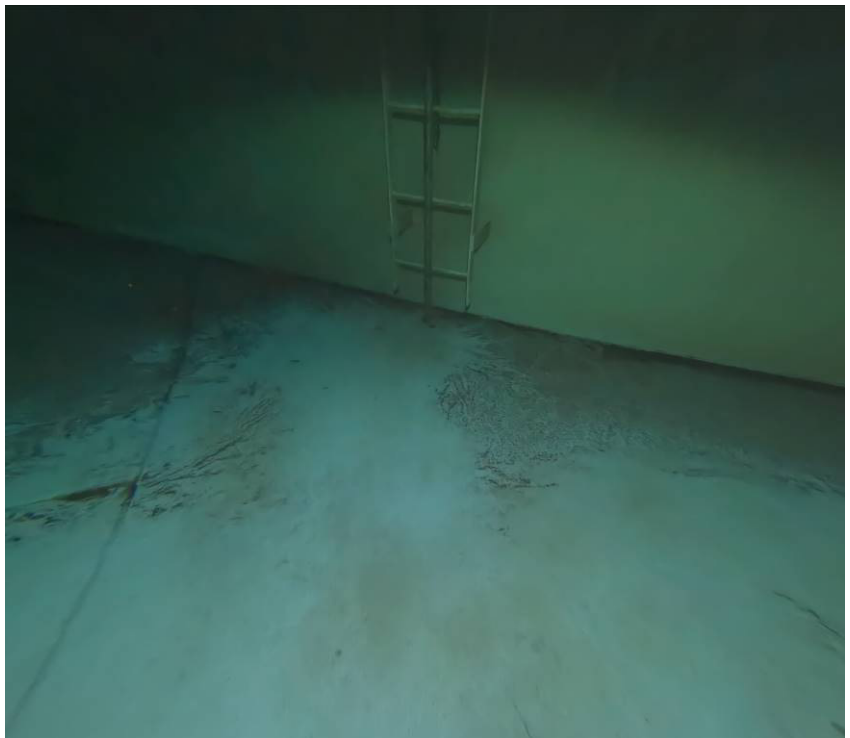
Description:
Floor appeared to be in good condition with a minor amount of corrosion.

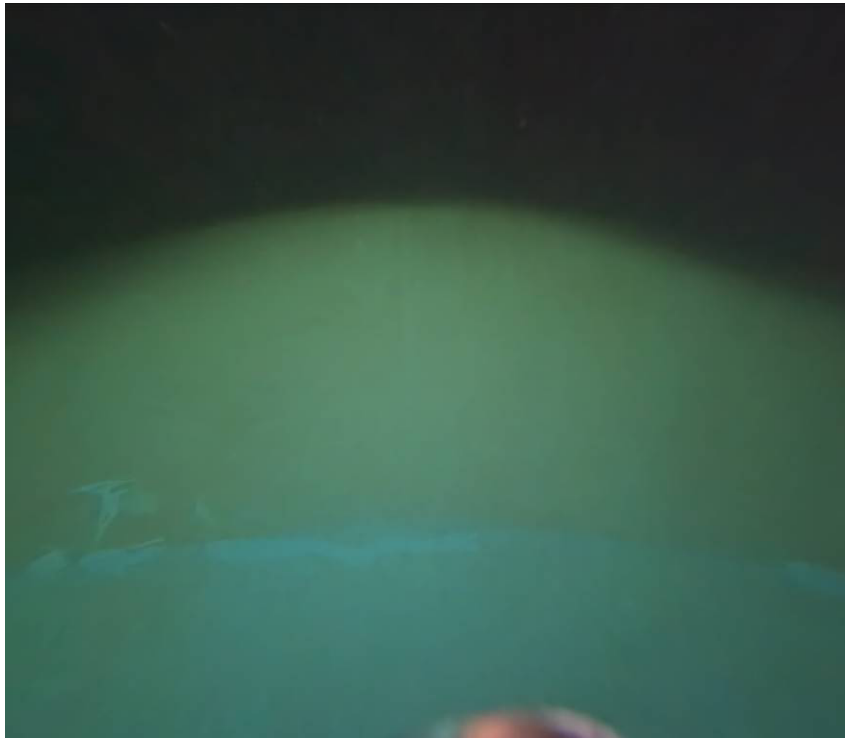
Description:
Wall appeared to be in good condition with a minor amount of corrosion.

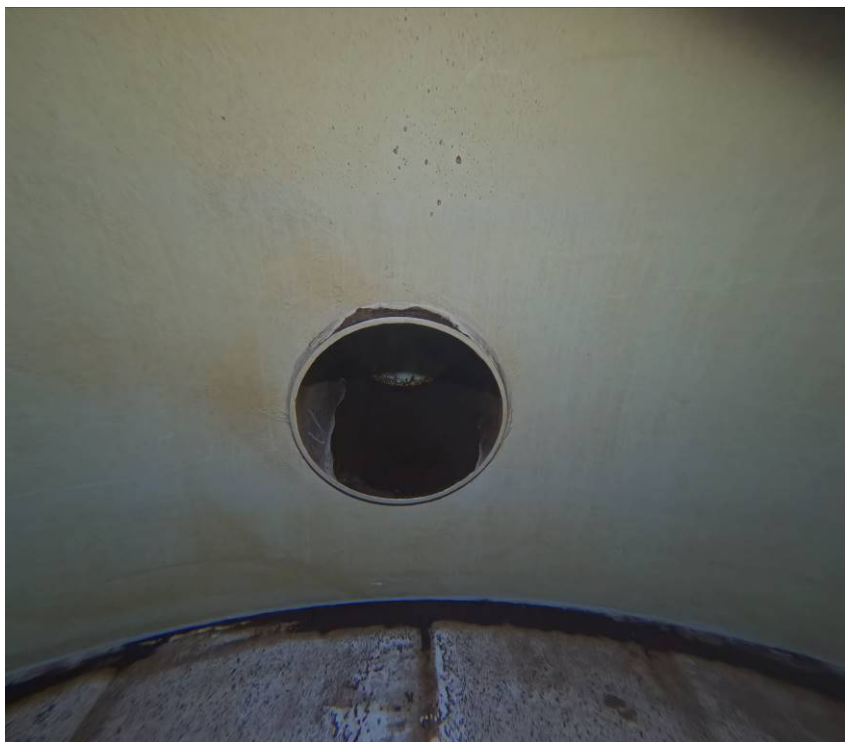
Description:
Man Way appeared to be in good condition with a minor amount of corrosion.

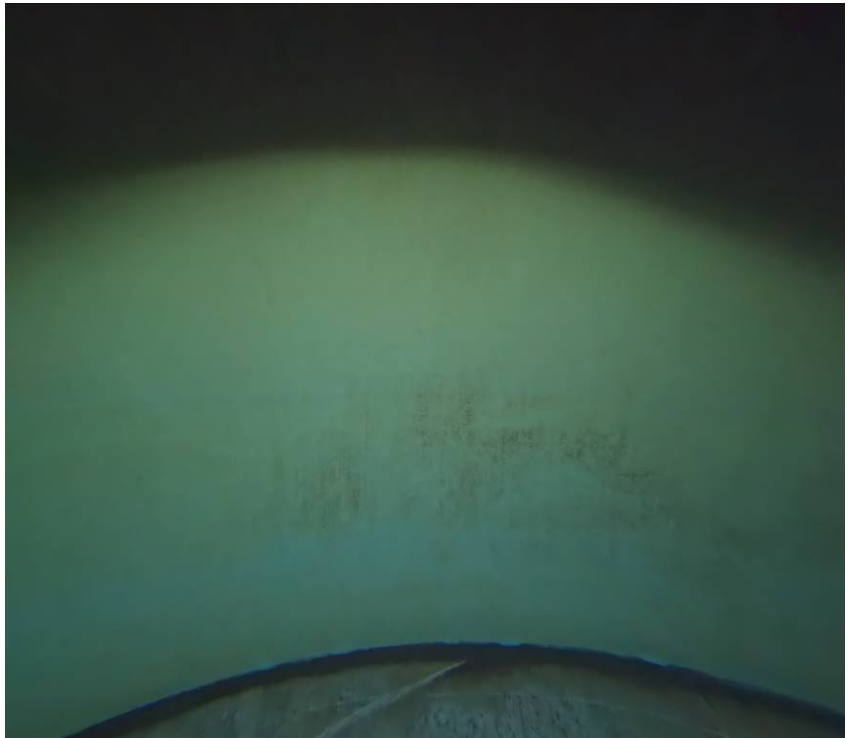
Description:
Wall appeared to be in good condition with a minor amount of corrosion.

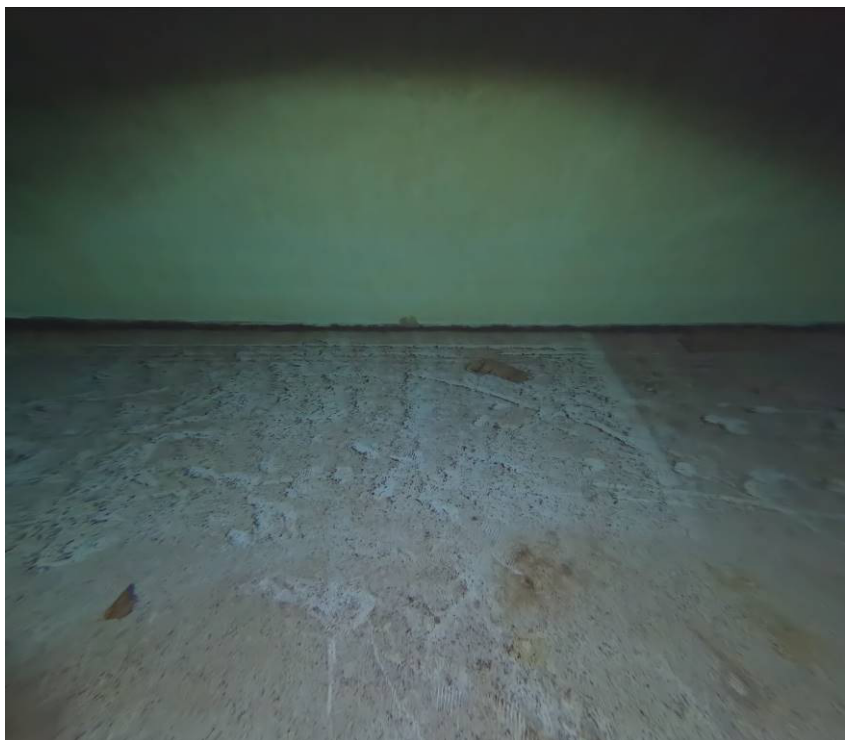
Description:
Floor appeared to be in good condition with a minor amount of corrosion.

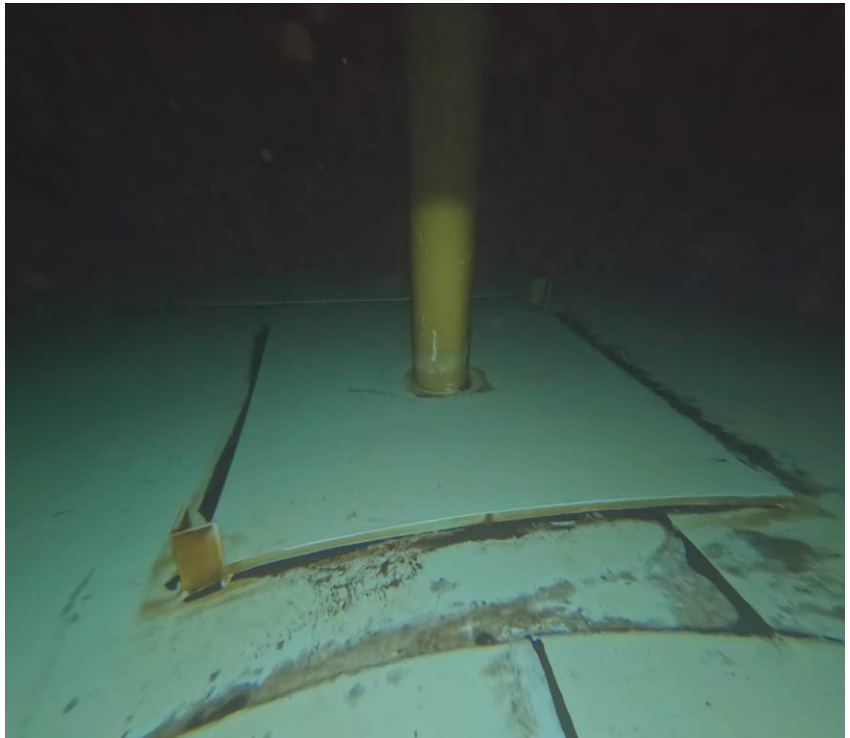
Description:
Column appeared to be in good condition with a minor amount of corrosion.

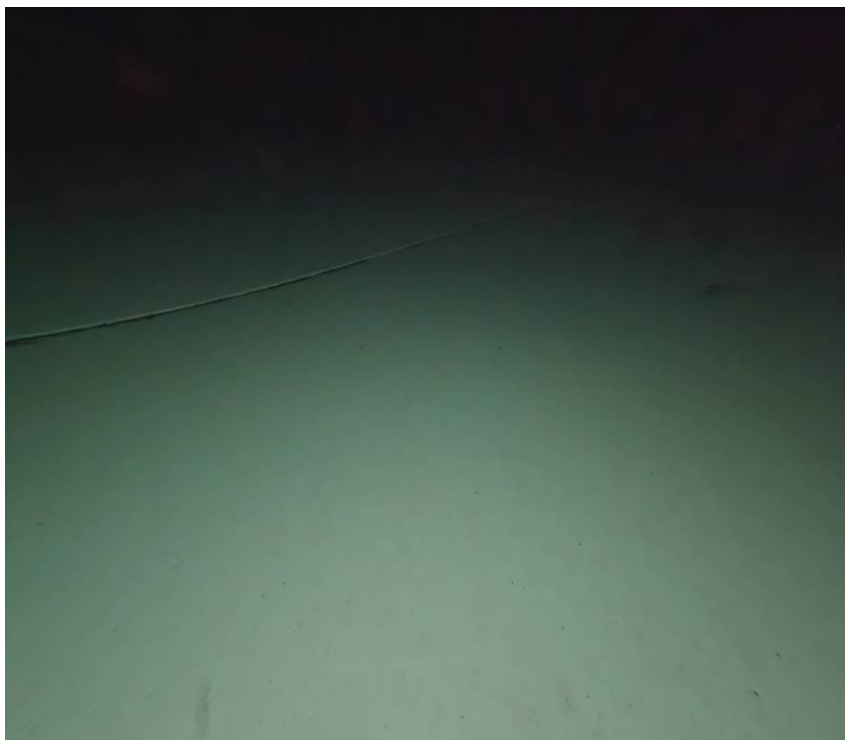
Description:
Floor appeared to be in good condition with a minor amount of corrosion.

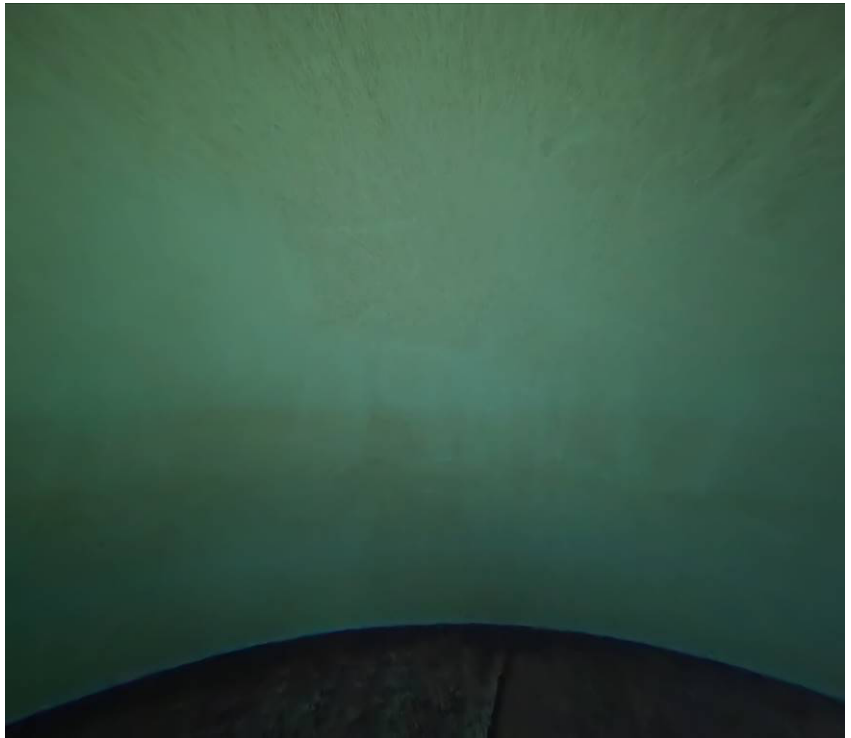
Description:
Wall appeared to be in good condition with a minor amount of corrosion.

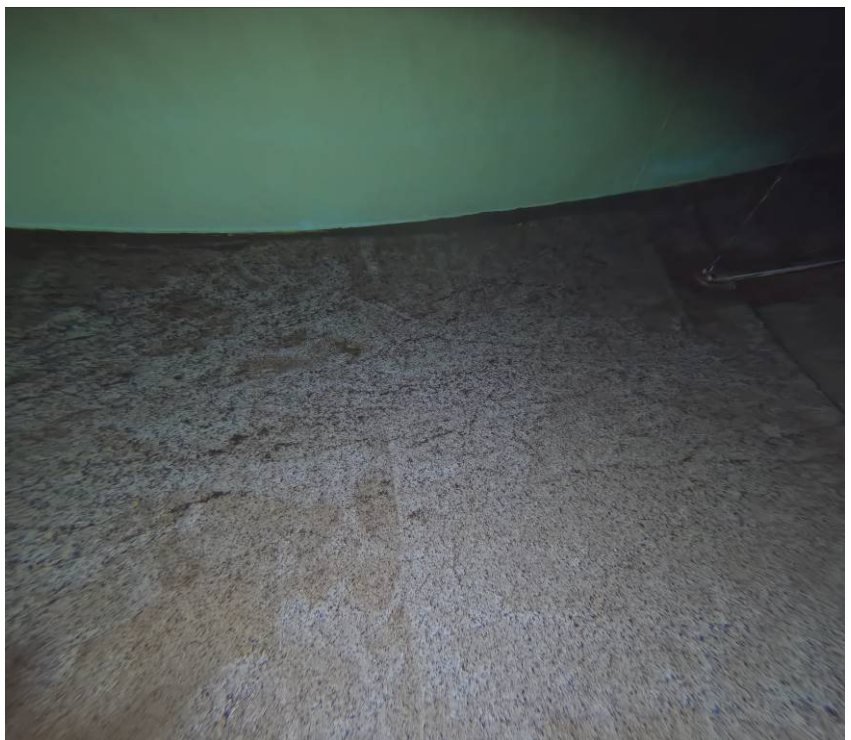
Description:
Floor appeared to be in good condition with a minor amount of corrosion.

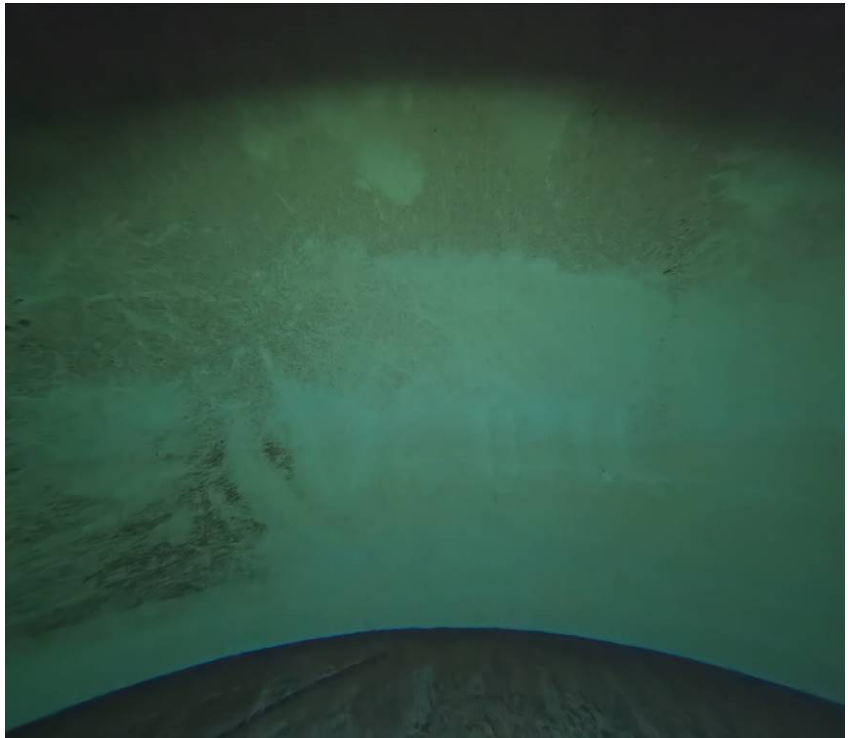
Description:
Wall appeared to be in good condition with a minor amount of corrosion.
