West Tank
Needles Water Department
Report of Findings
From the
Diving Operations
Conducted on

May 14, 2025

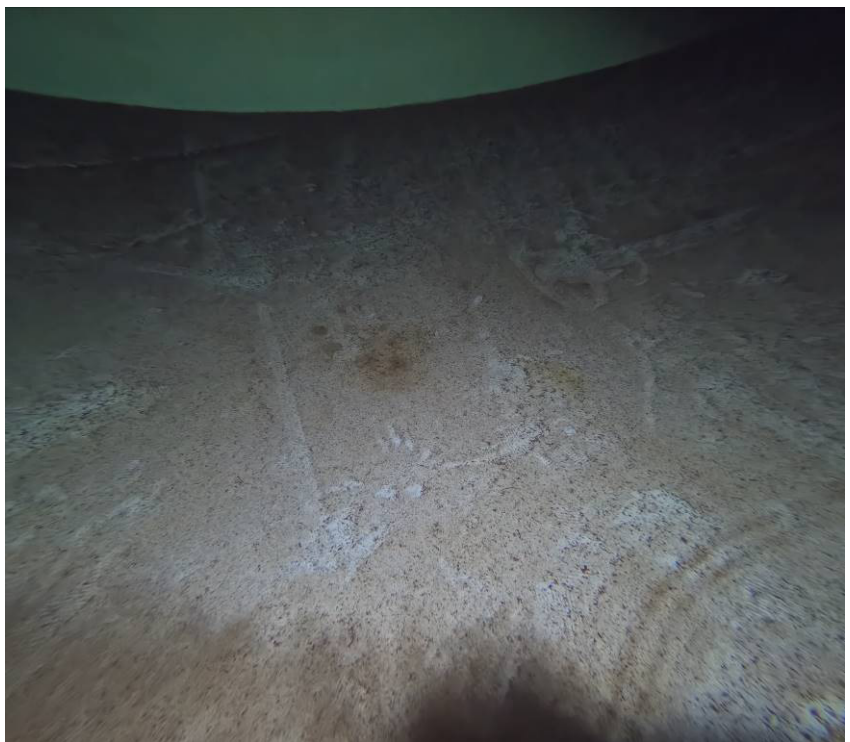
Description:
Floor appeared to be in good condition with a minor amount of corrosion.

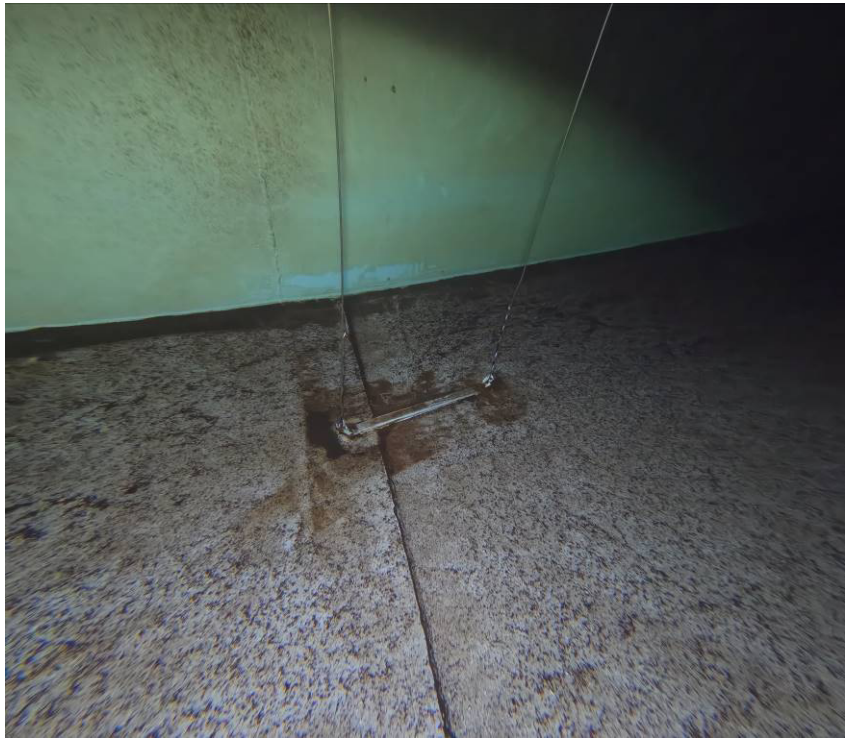
Description:
Liquid Level Indicator Base appeared to be in good condition with a minor amount of corrosion.

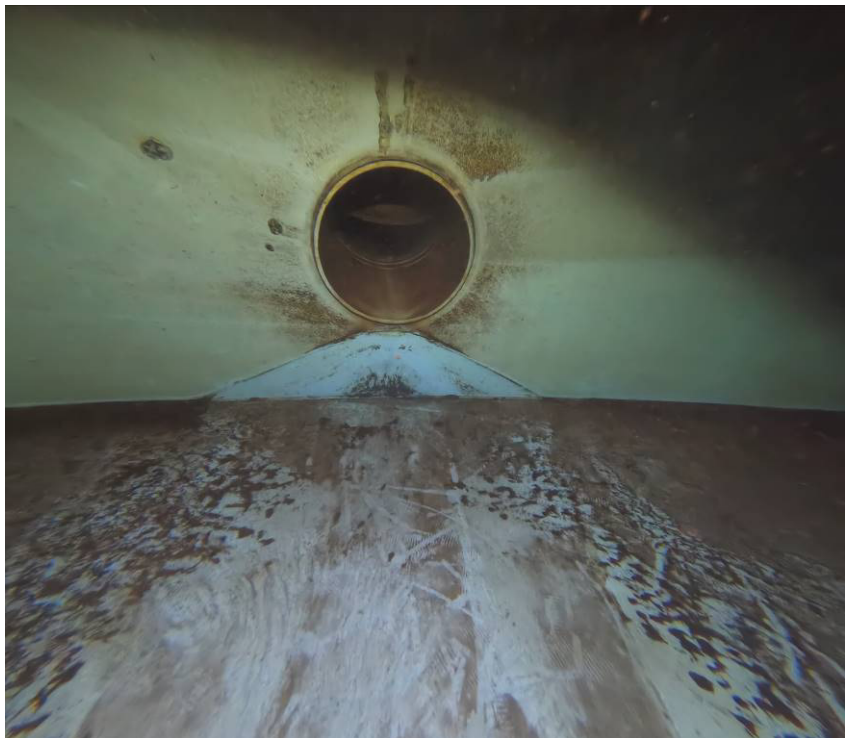
Description:
Inlet / Outlet appeared to be in good condition with a minor amount of corrosion.

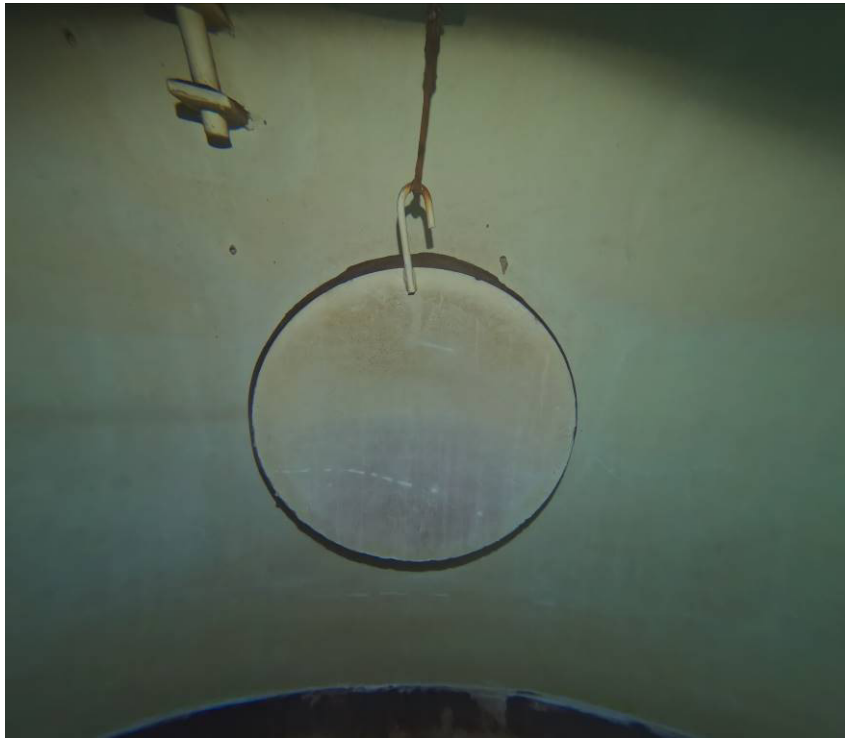
Description:
Man Way appeared to be in good condition with a minor amount of corrosion.
