**East Tank**  
**Needles Water Department**  
Report of Findings  
From the  
Diving Operations  
Conducted on  
**May 16, 2025**

**LiquiVision**  
**Technology**  
**DIVING SERVICES**

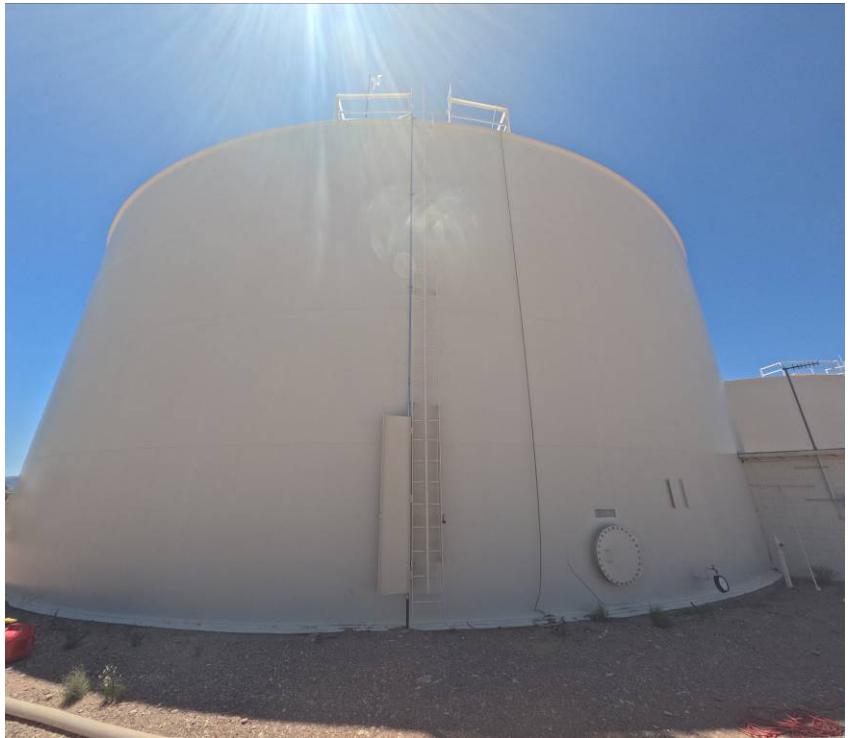
**Description:**  
Exterior Wall appeared to be in good condition with a minor amount of corrosion.

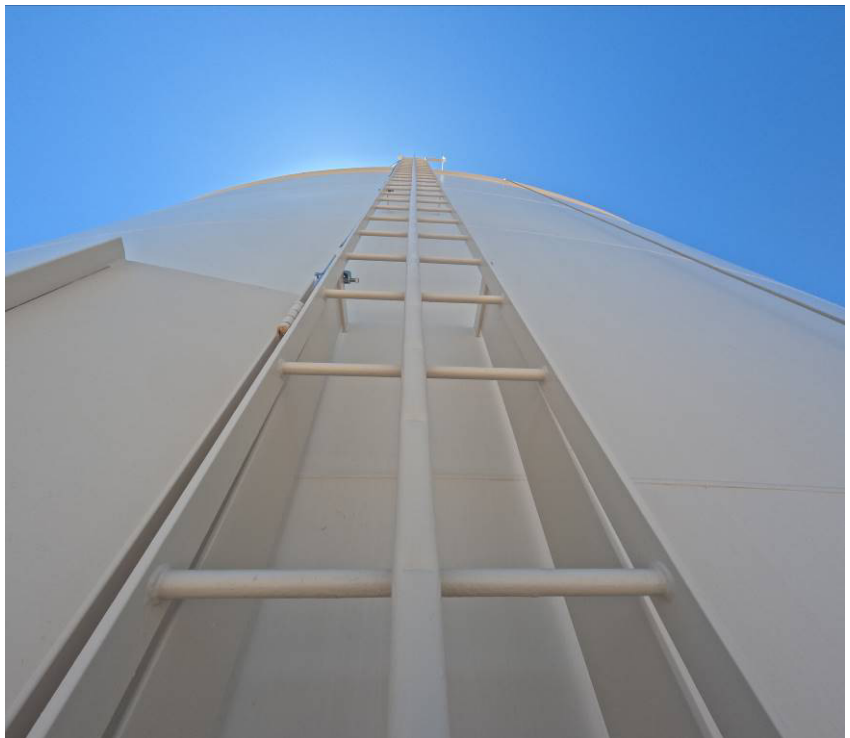
**Description:**  
Exterior Ladder appeared to be in good condition with a minor amount of corrosion.

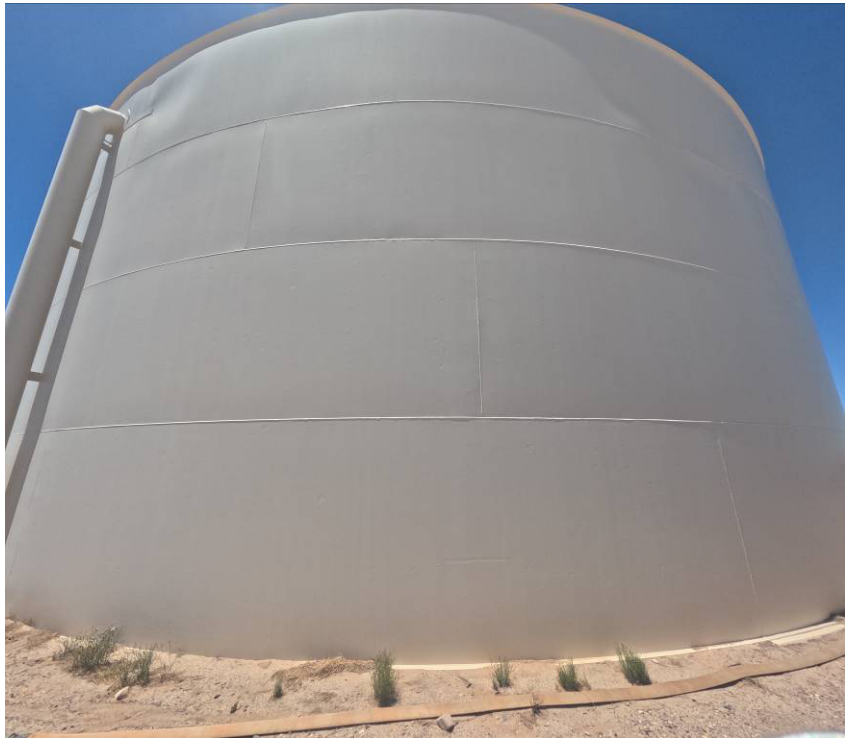
**Description:**  
Exterior Wall appeared to be in good condition with a minor amount of corrosion.

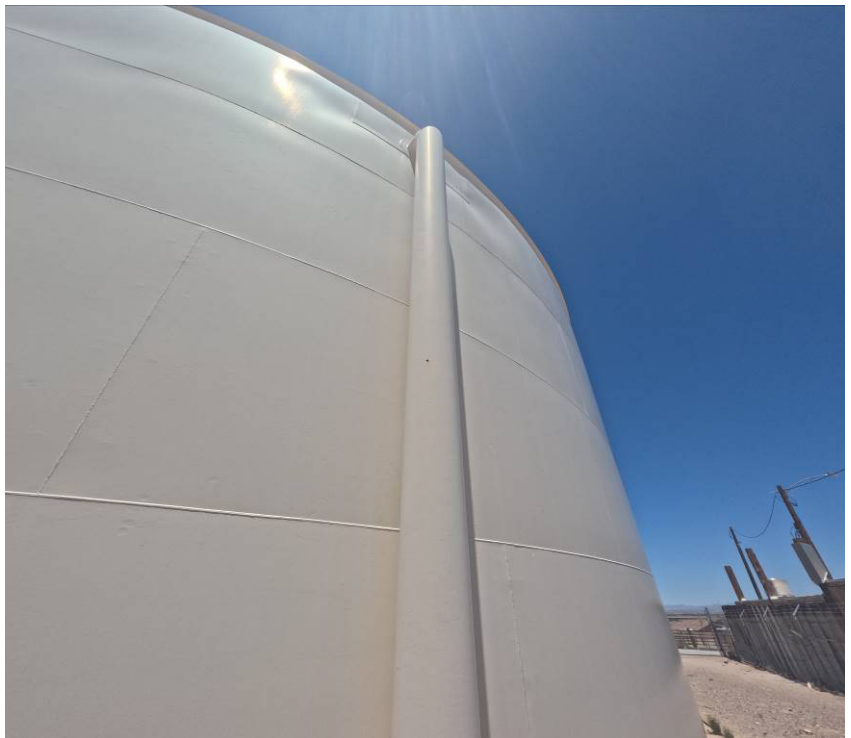
**Description:**  
Overflow appeared to be in good condition with a minor amount of corrosion.

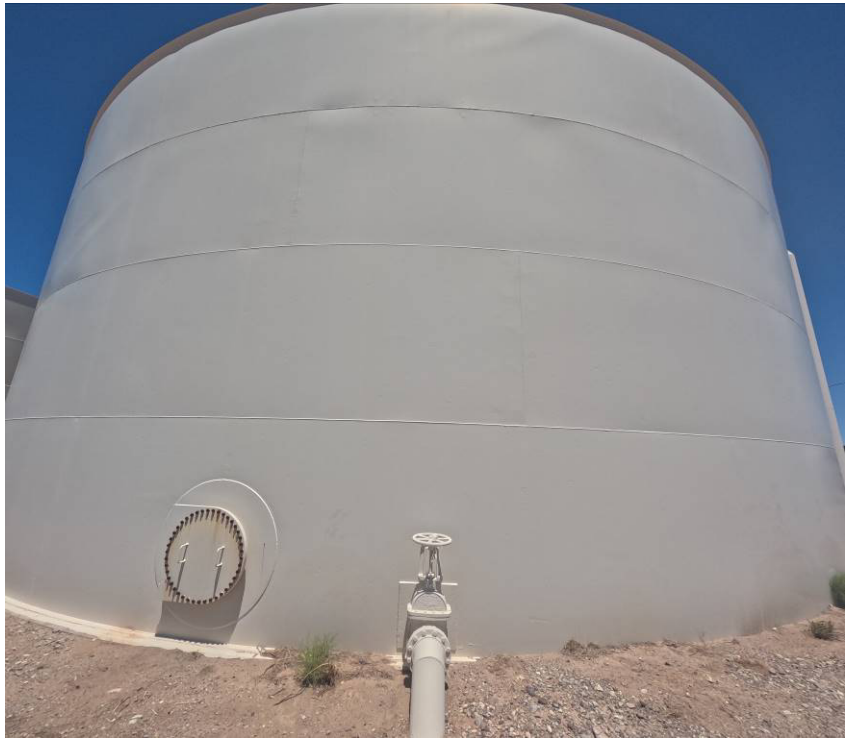
**Description:**  
Exterior Wall appeared to be in good condition with a minor amount of corrosion.

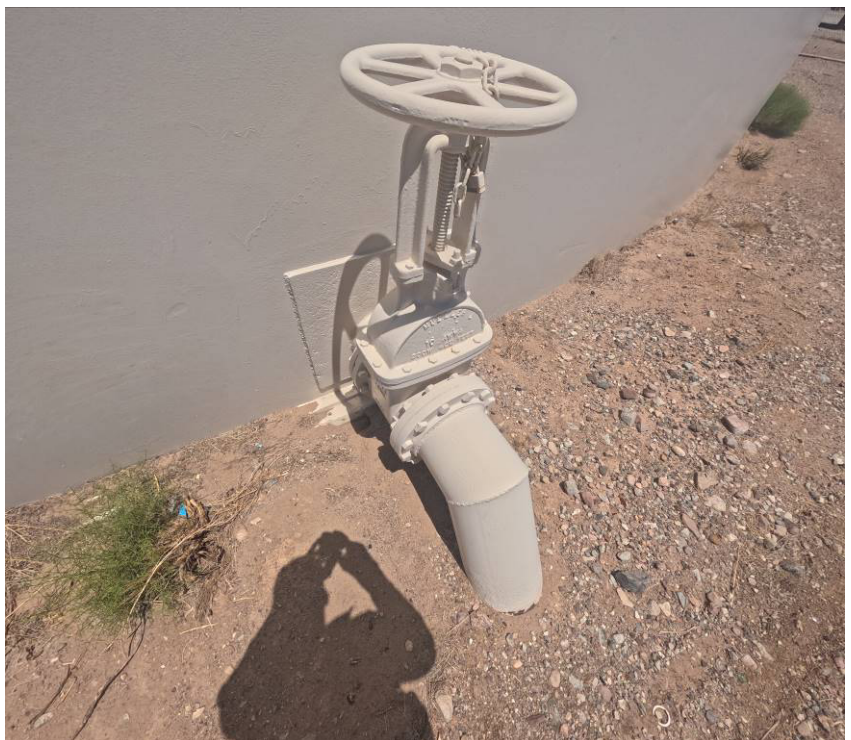
**Description:**  
Inlet / Outlet appeared to be in good condition with a minor amount of corrosion.

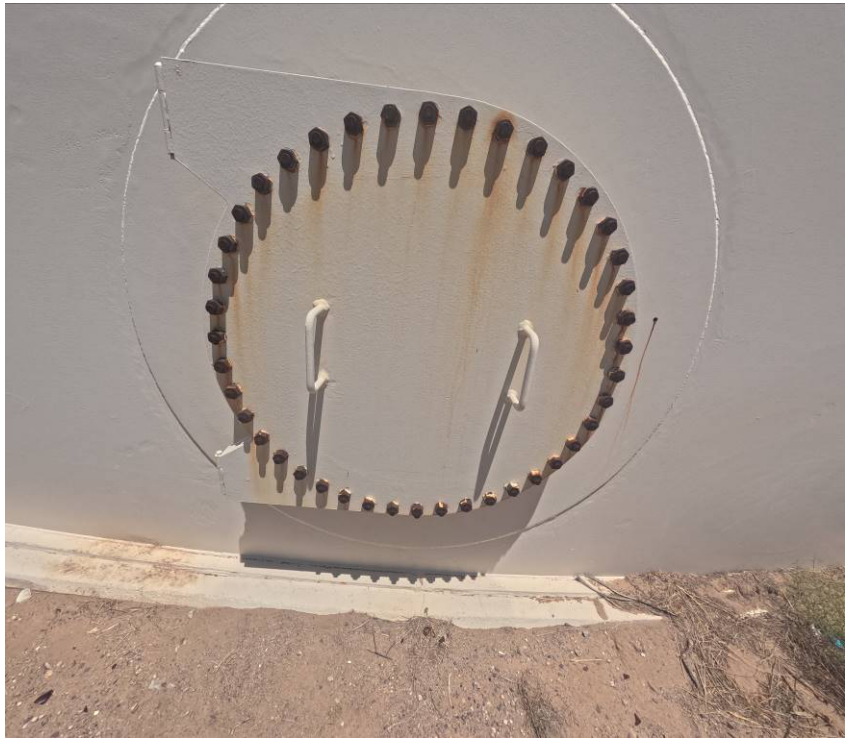
**Description:**  
Man Way appeared to be in good condition with a minor amount of corrosion. Staining was observed.

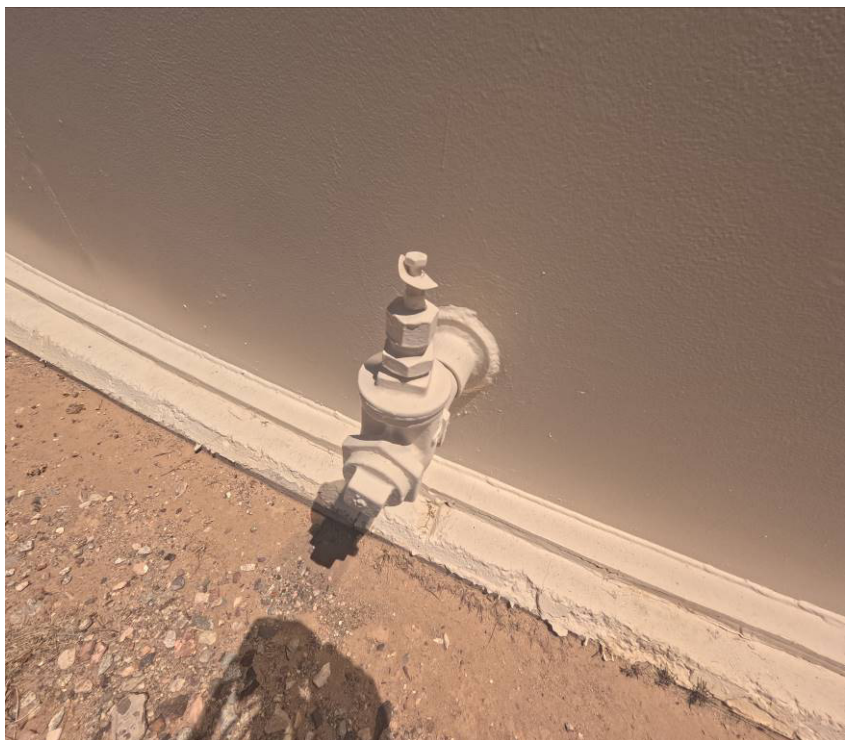
**Description:**  
Capped Off Penetration appeared to be in good condition with a minor amount of corrosion.

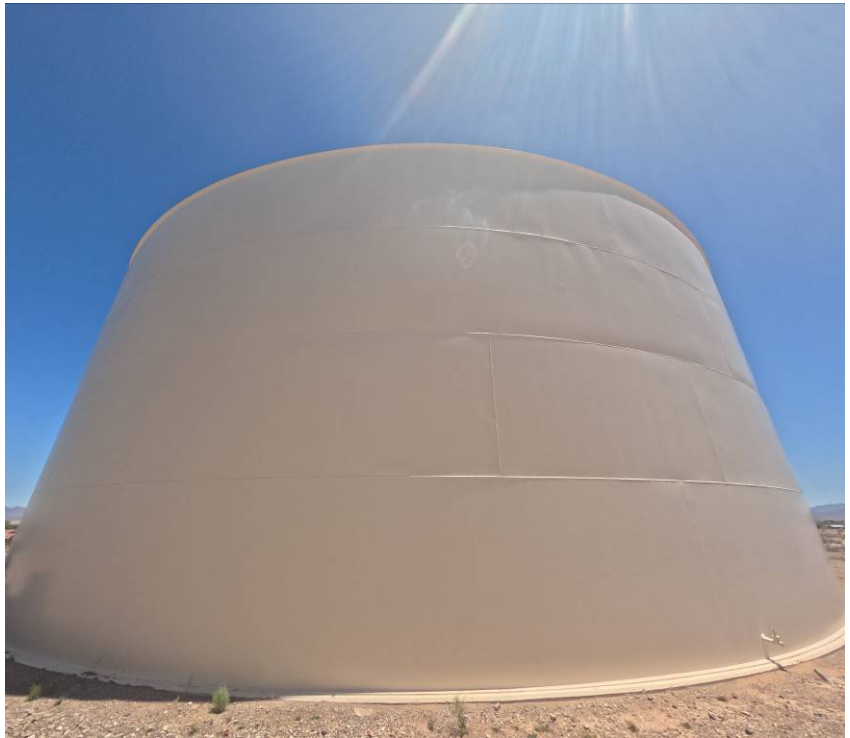
**Description:**  
Exterior Wall appeared to be in good condition with a minor amount of corrosion.

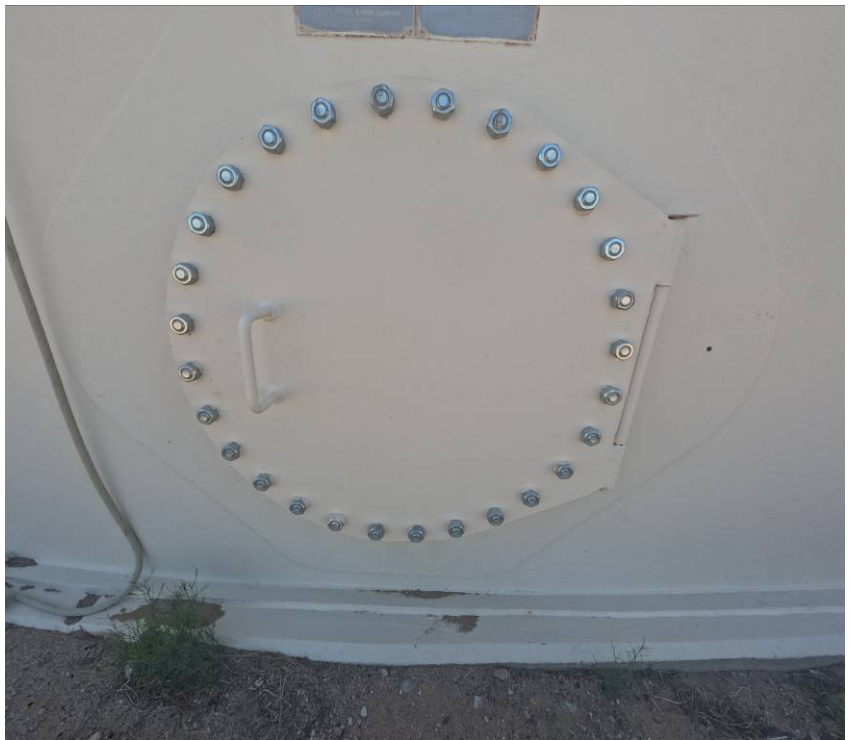
**Description:**  
Man Way appeared to be in good condition with a minor amount of corrosion.

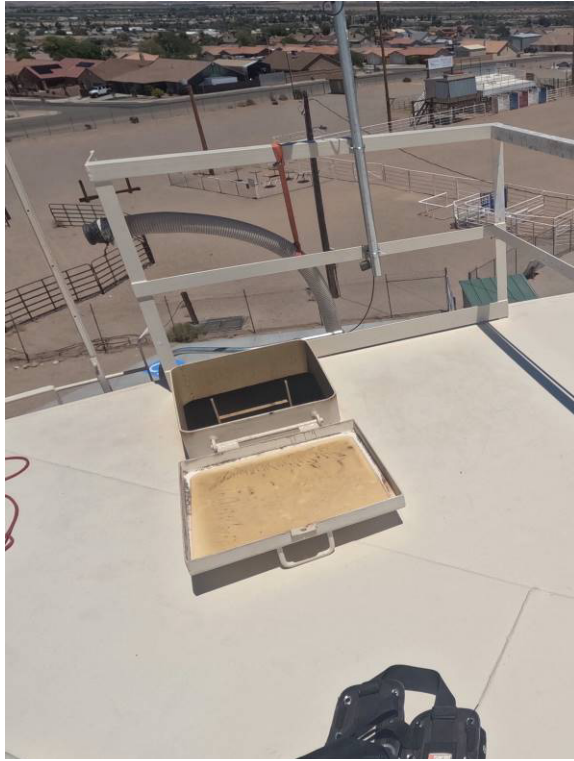
**Description:**  
Entry Hatch appeared to be in good condition with a minor amount of corrosion. Weather strip did not appear to be present.

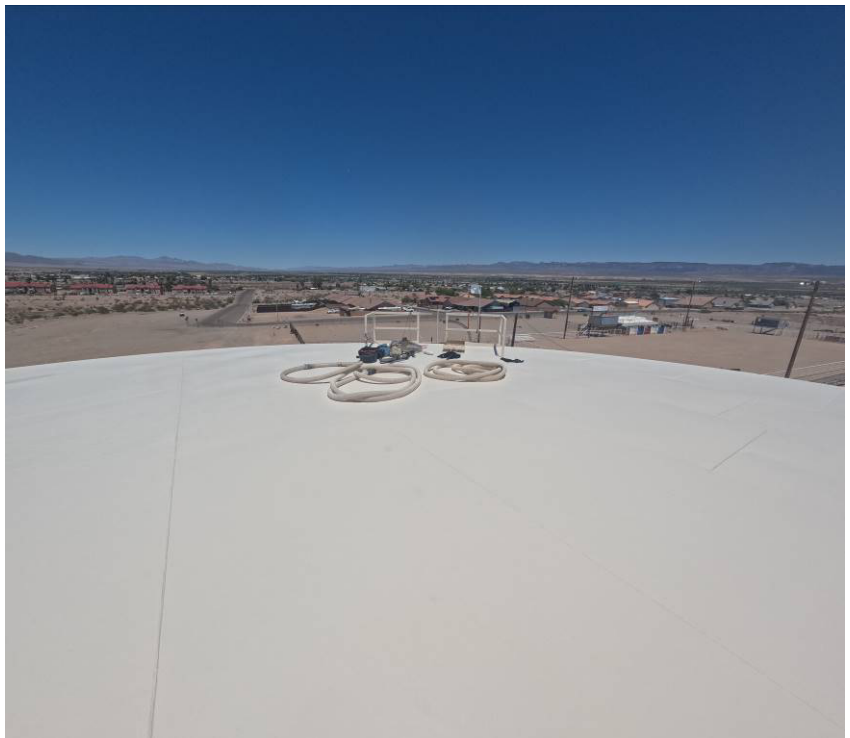
**Description:**  
Roof appeared to be in good condition with a minor amount of corrosion.

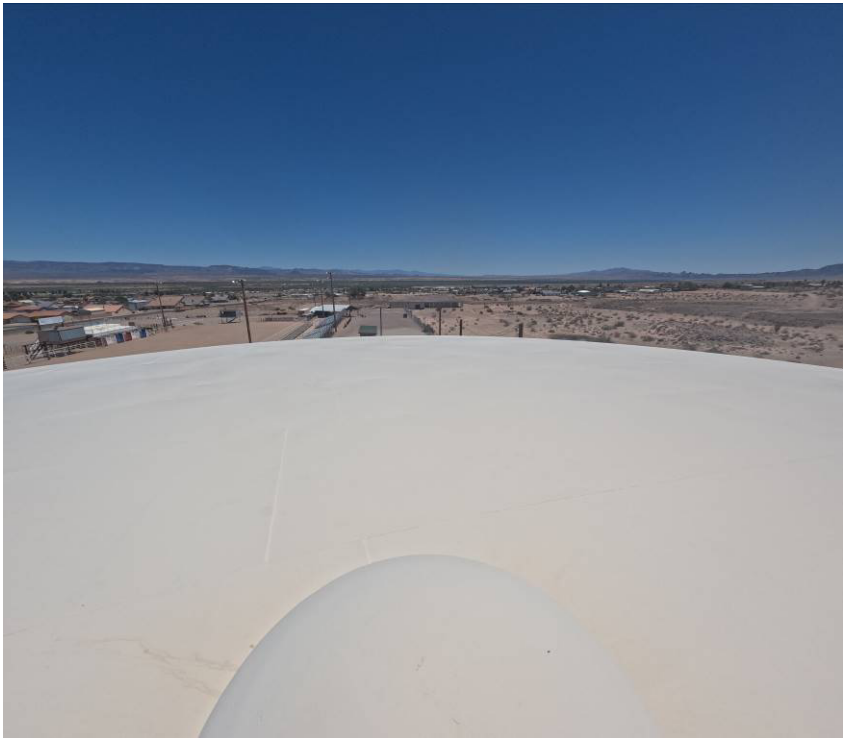
**Description:**  
Roof appeared to be in good condition with a minor amount of corrosion.

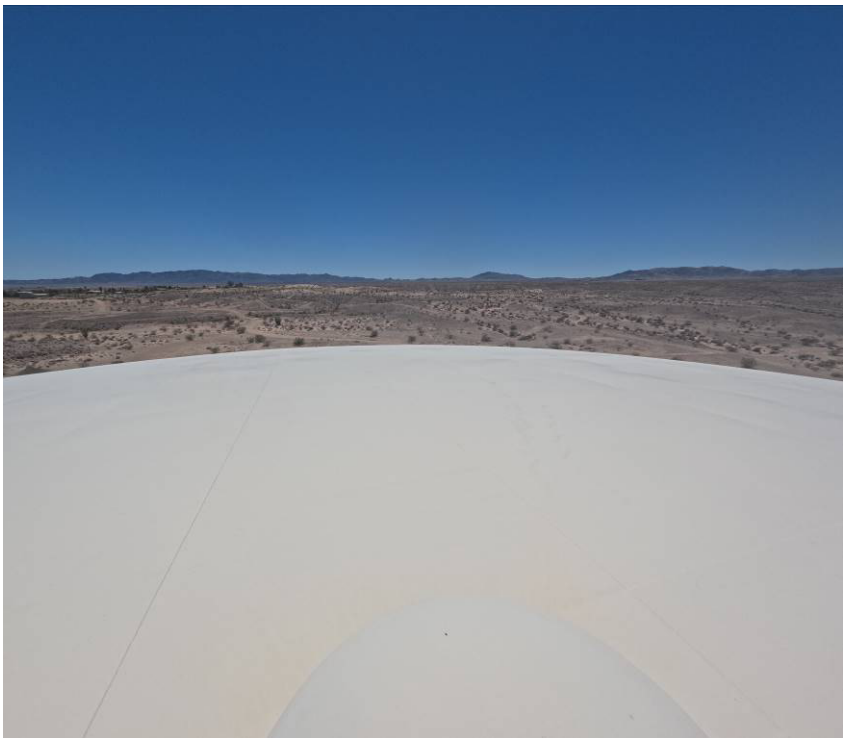
**Description:**  
Roof appeared to be in good condition with a minor amount of corrosion.

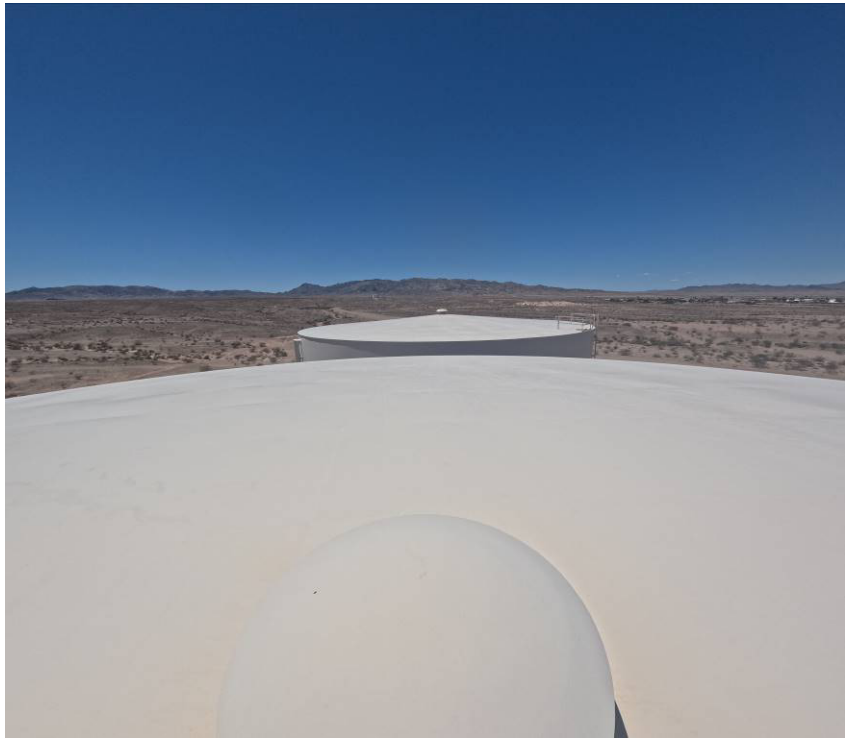
**Description:**  
Roof appeared to be in good condition with a minor amount of corrosion.

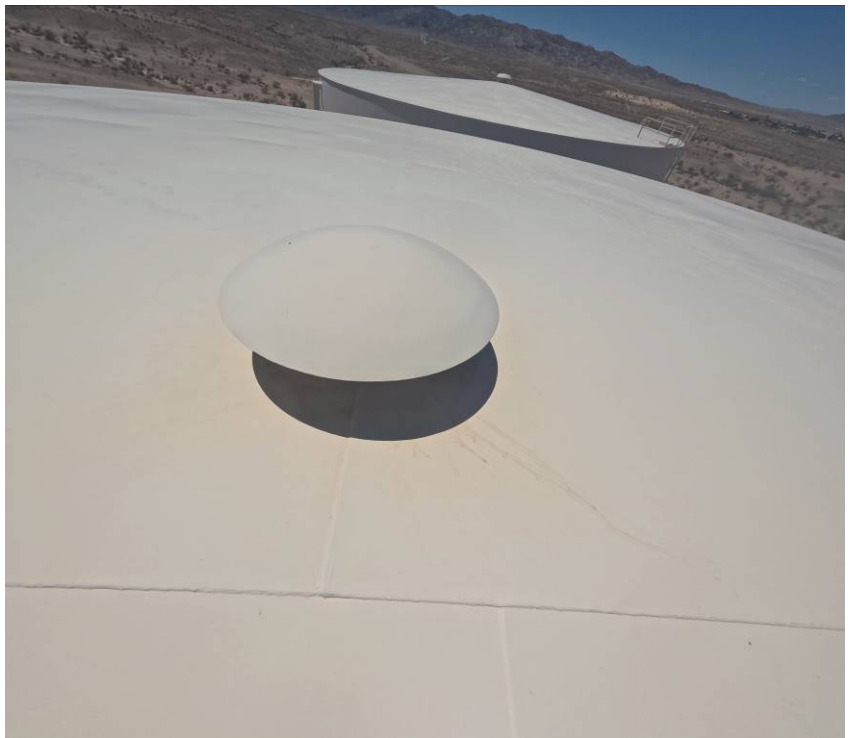
**Description:**  
Vent appeared to be in good condition with a minor amount of corrosion.

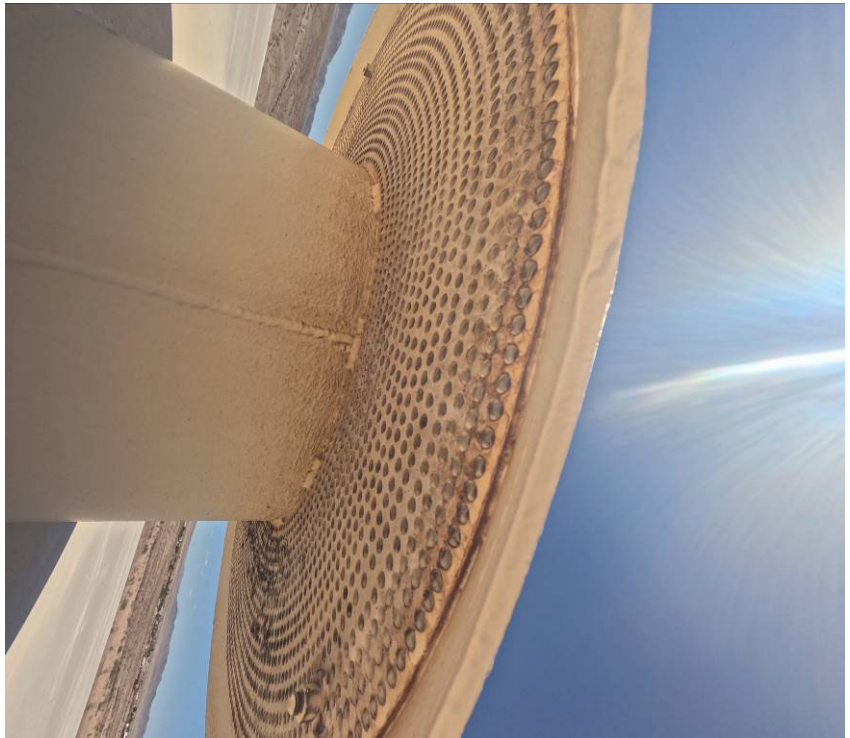
**Description:**  
Vent Screen appeared to be in good condition with a minor amount of corrosion.

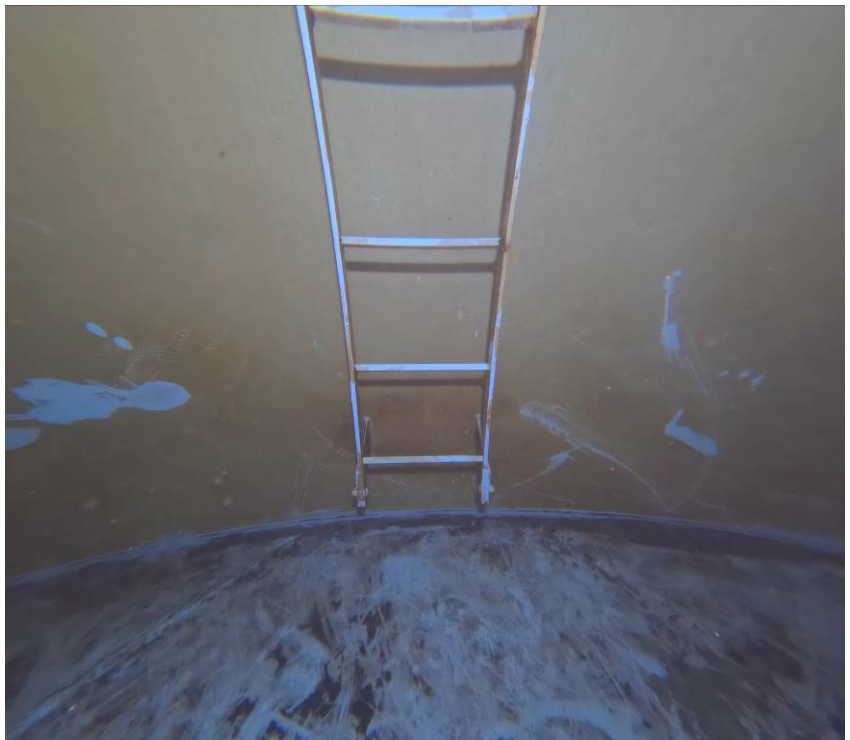
**Description:**  
Interior Ladder appeared to be in good condition with a minor amount of corrosion.

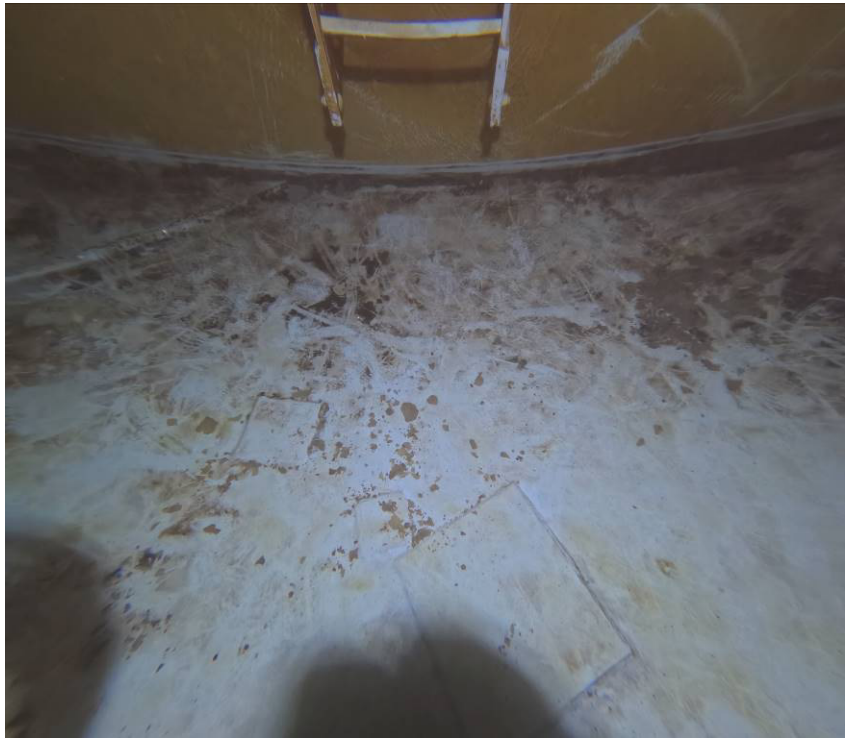
**Description:**  
Floor appeared to be in good condition with a minor amount of corrosion.

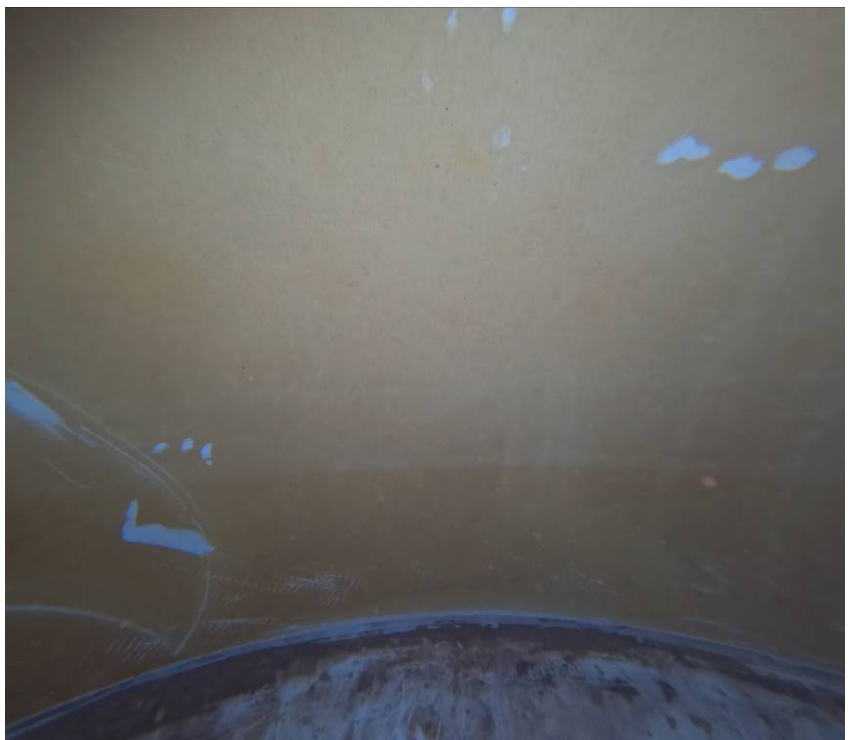
**Description:**  
Wall appeared to be in good condition with a minor amount of corrosion.

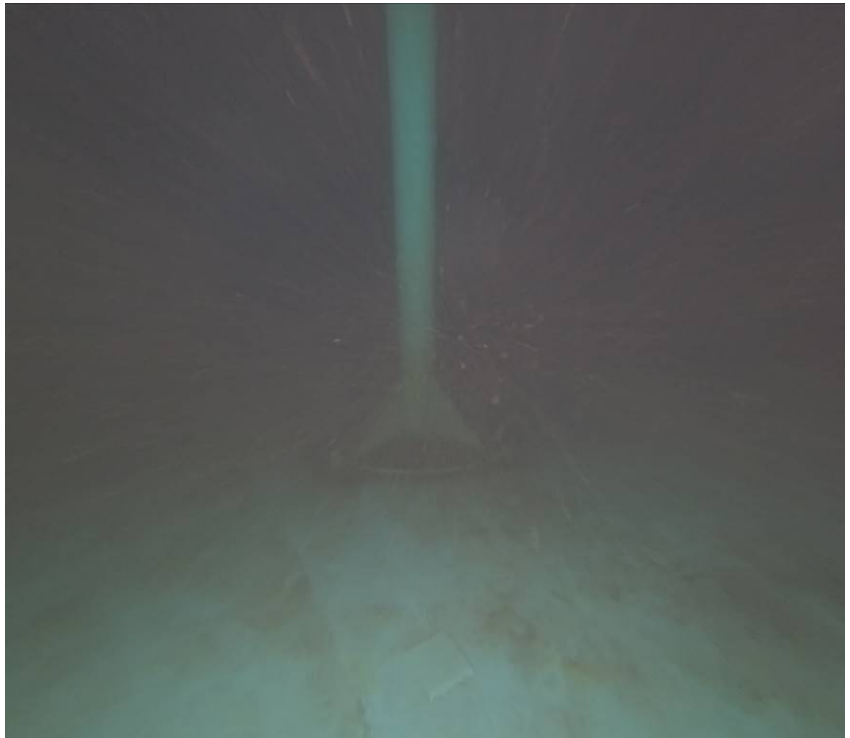
**Description:**  
Column appeared to be in good condition with a minor amount of corrosion.

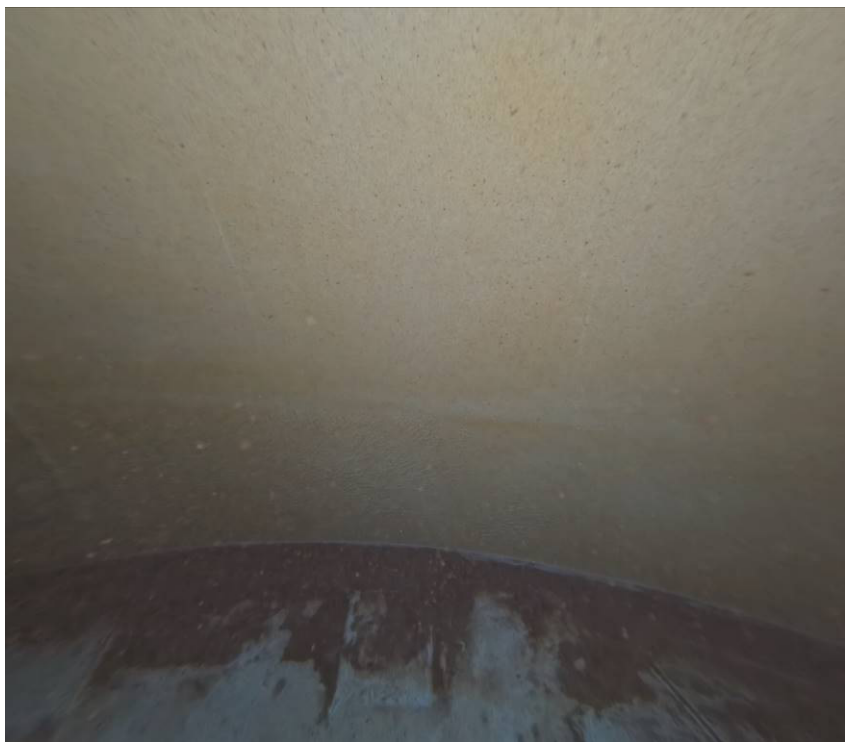
**Description:**  
Wall appeared to be in good condition with a minor amount of corrosion.

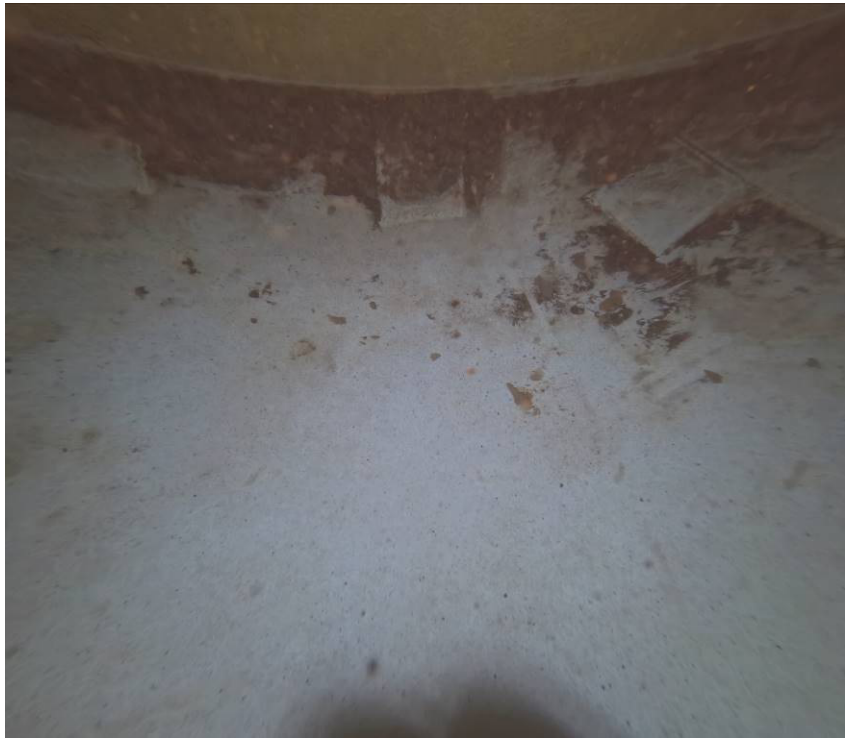
**Description:**  
Floor appeared to be in good condition with a minor amount of corrosion.

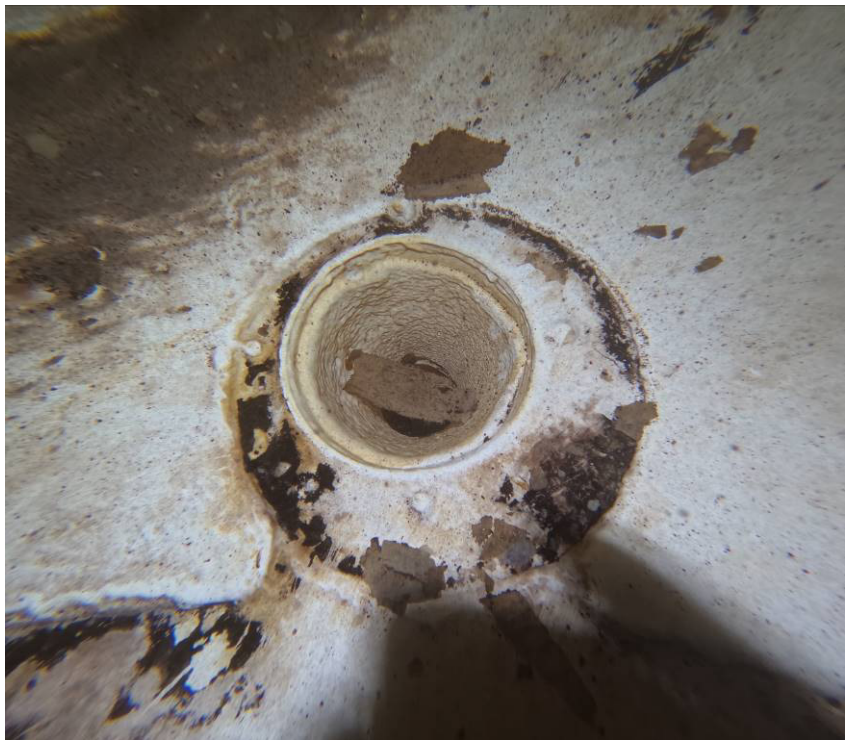
**Description:**  
Drain appeared to be in good condition with a minor amount of corrosion.

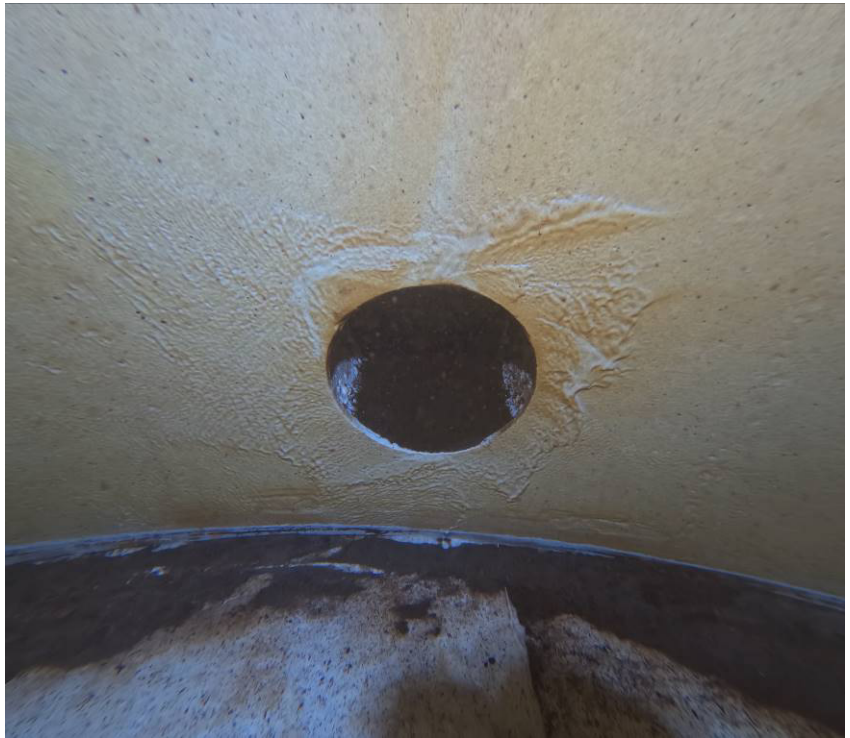
**Description:**  
Inlet / Outlet appeared to be in good condition with a minor amount of corrosion.

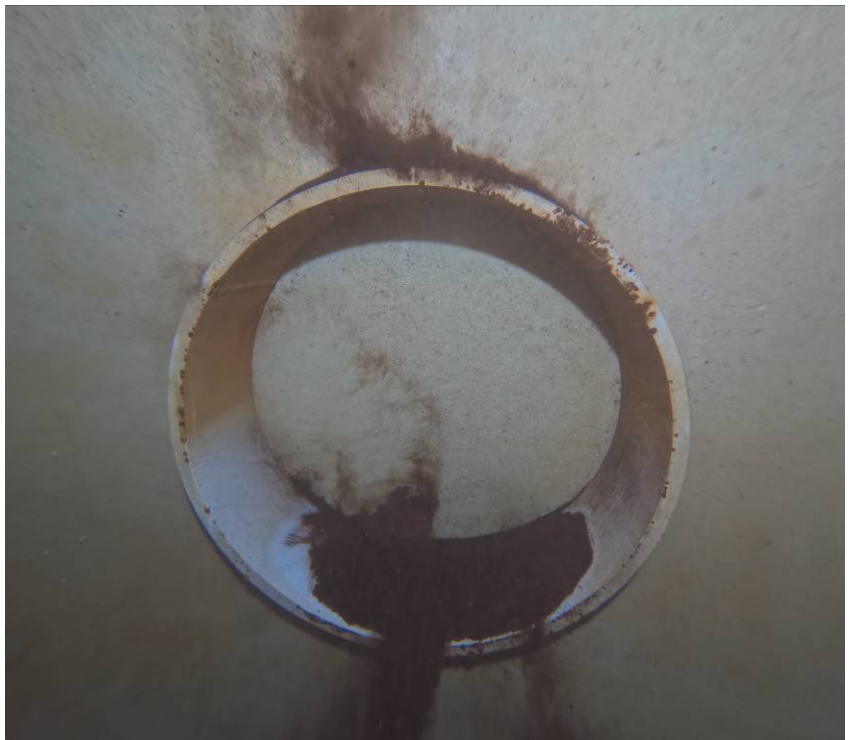
**Description:**  
Man Way appeared to be in good condition with a minor amount of corrosion.

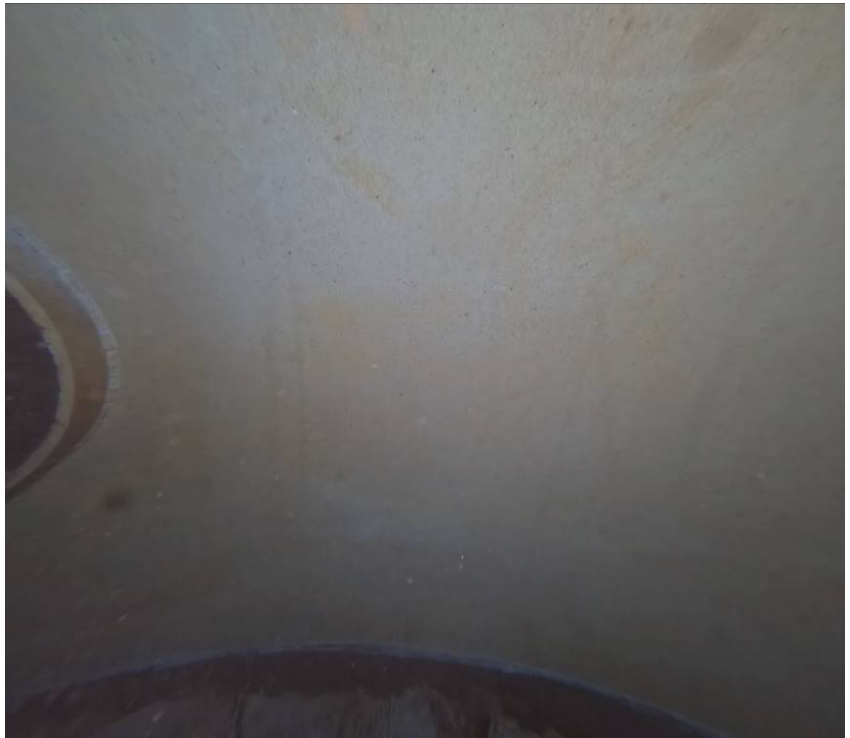
**Description:**  
Wall appeared to be in good condition with a minor amount of corrosion.

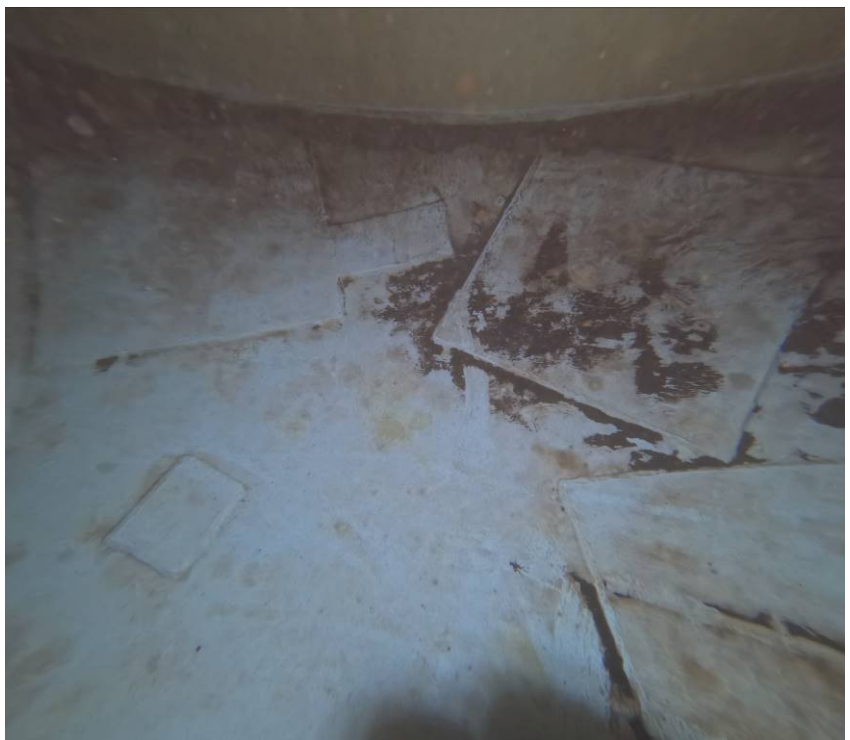
**Description:**  
Floor appeared to be in good condition with a minor amount of corrosion.

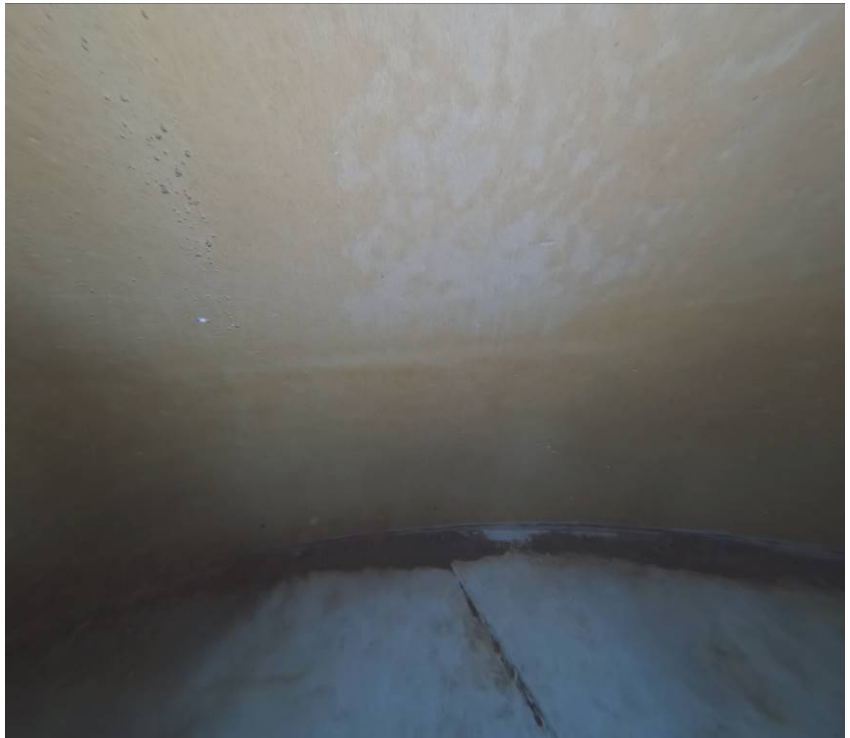
**Description:**  
Wall appeared to be in good condition with a minor amount of corrosion.

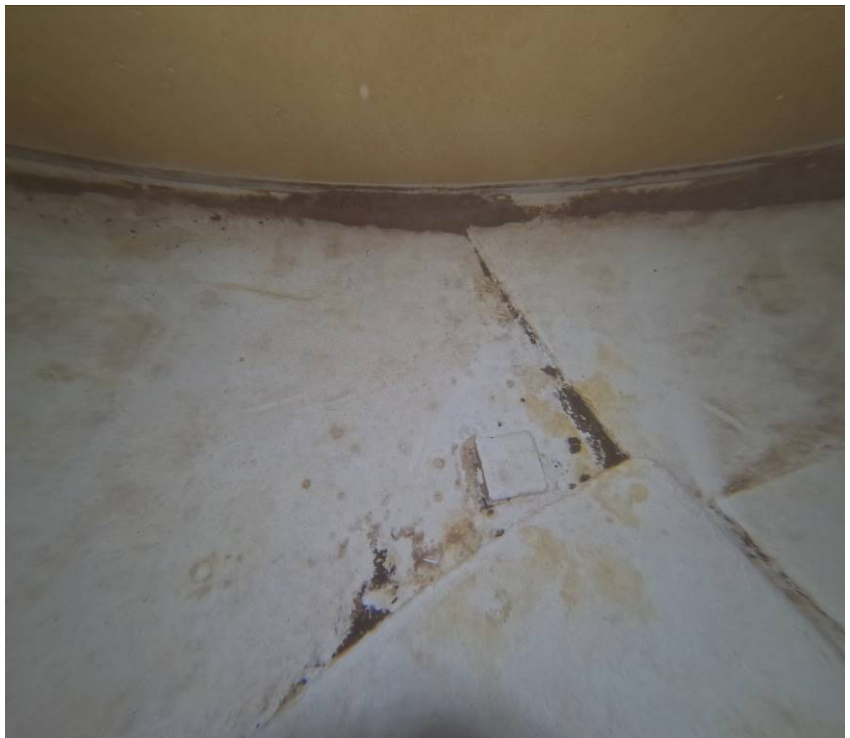
**Description:**  
Floor appeared to be in good condition with a minor amount of corrosion.

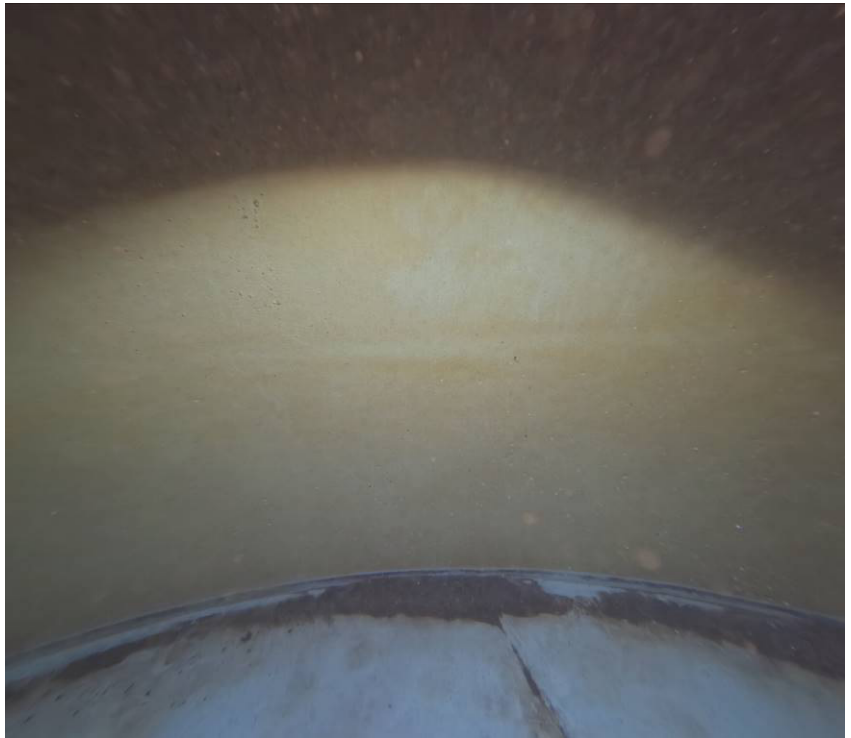
**Description:**  
Wall appeared to be in good condition with a minor amount of corrosion.

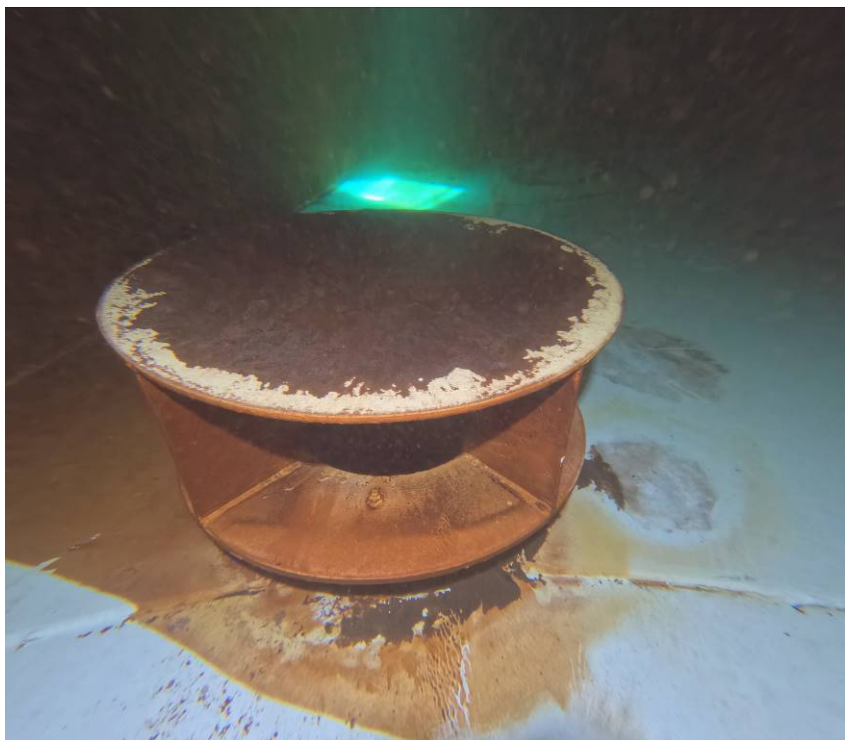
**Description:**  
Outlet appeared to be in good condition with a minor amount of corrosion.

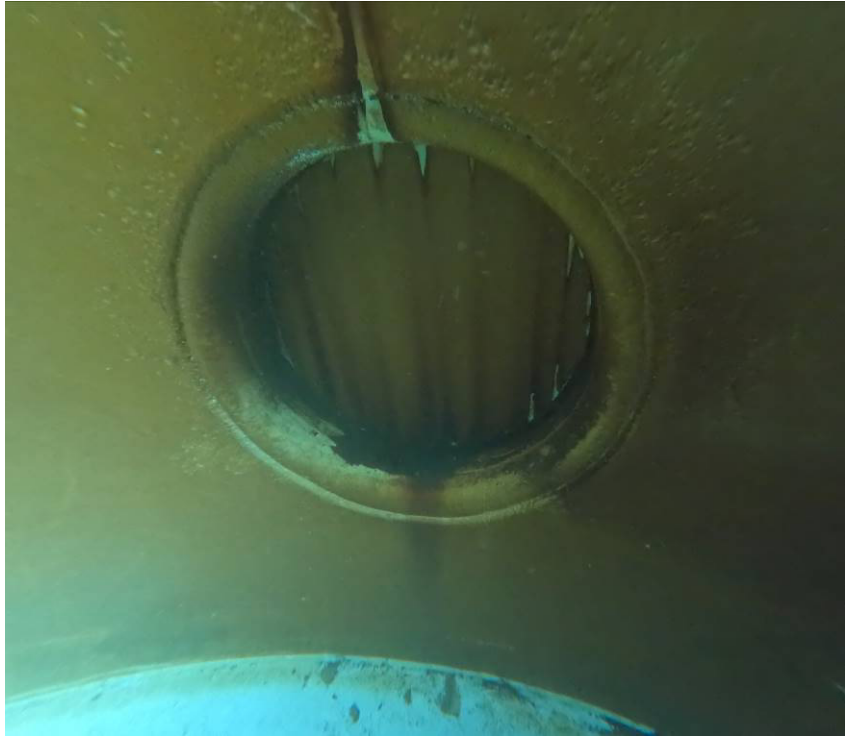
**Description:**  
Man Way appeared to be in good condition with a minor amount of corrosion.

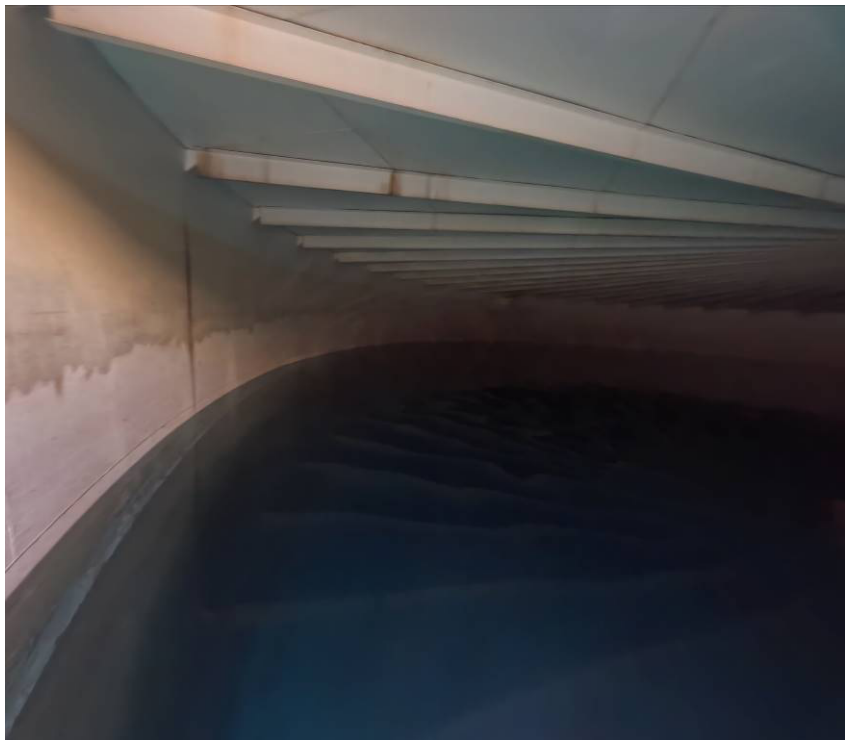
**Description:**  
Ceiling appeared to be in good condition with a minor amount of corrosion.

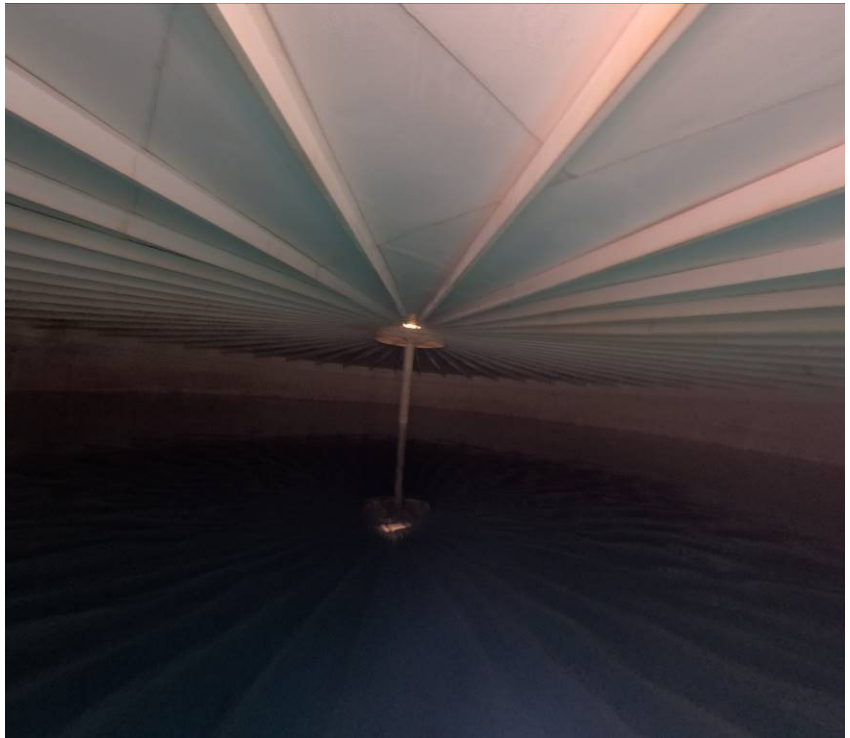
**Description:**  
Ceiling appeared to be in good condition with a minor amount of corrosion.
