**East Tank**  
**Needles Water Department**  
Report of Findings  
From the  
Diving Operations  
Conducted on  
**May 16, 2025**

**LiquiVision**  
**Technology**  
**DIVING SERVICES**

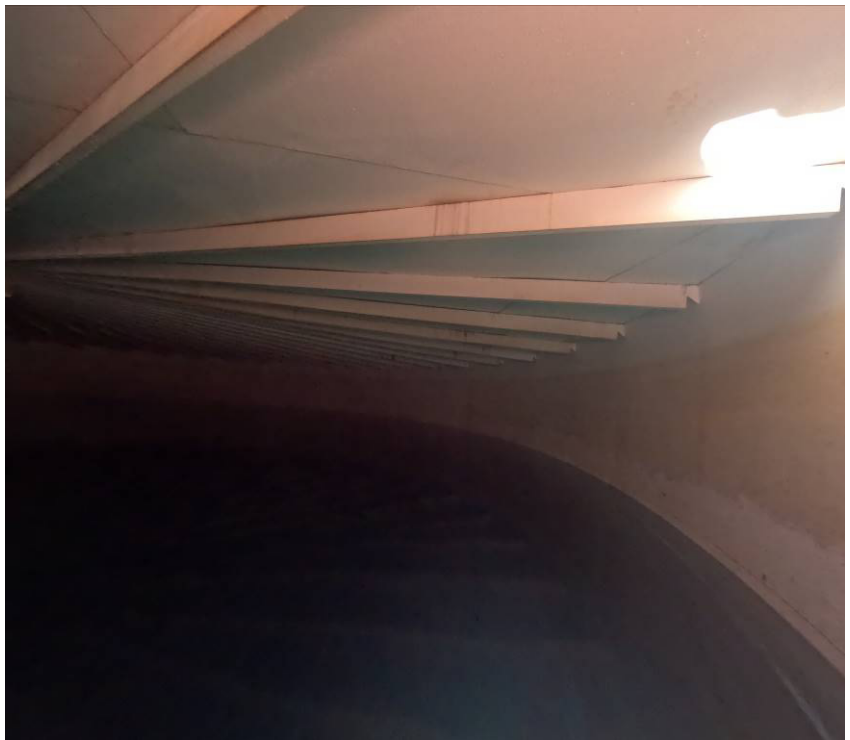
**Description:**  
Ceiling appeared to be in good condition with a minor amount of corrosion.
