Inspection report for the property at
401 Virginia Street New Meadows, Idaho 83654

This report is prepared exclusively for **Julie Good (Mayor)**
Inspected On: **11-14-2025**

McCall Home Inspections
208-866-1578

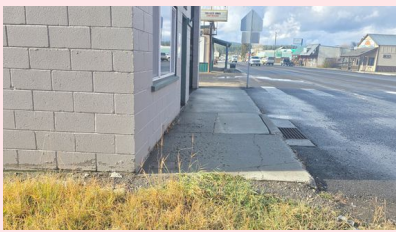
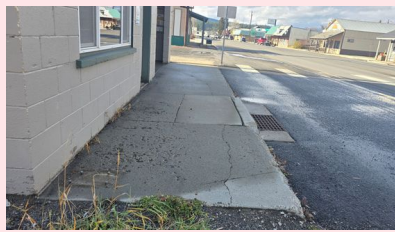
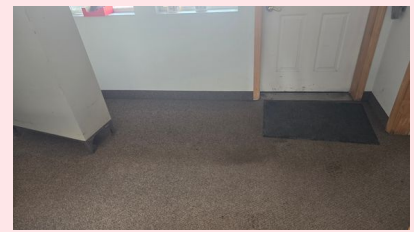
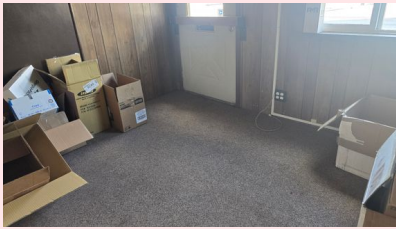
⚠️ **G-1 Grounds:**

The front concrete is sloping toward the building - see north side. Standards recommend a quarter inch per foot slope away from the building or better to prevent water draining toward the building. Signs of water drainage toward the building and moisture intrusion were evident as rust on the entry door and carpet stains. Concrete replacement and/or a water collection drain installation is recommended. Have this further evaluated and repaired as recommended by a qualified contractor.

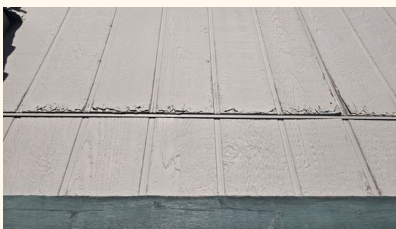
failed paint & water damage

The wooden portions of the exterior siding and trim needs to be re-painted to preserve and maintain the siding system. Any water damaged siding should be replaced as needed prior to prep and paint. Specialized paint is required for concrete block. Budget for re-painting the exterior in the near term. Examples of specific observations noted during inspection include:

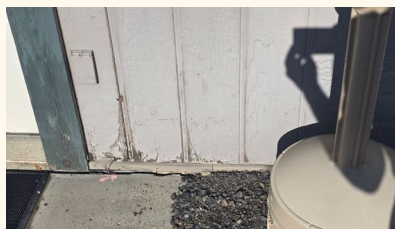
failed paint & water damage

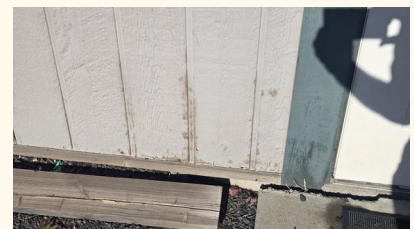
failed paint

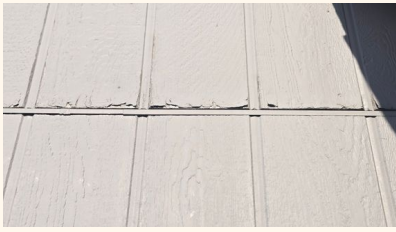
failed paint

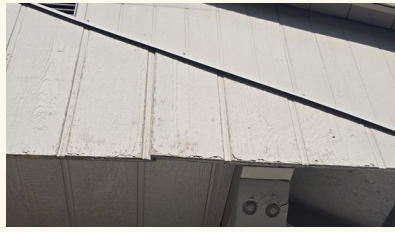
failed paint

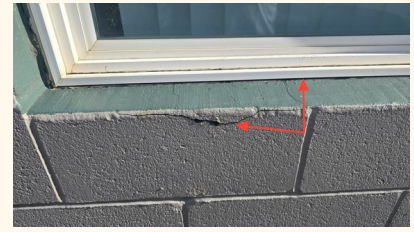
masonry sealant needed

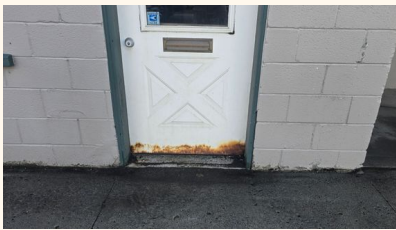
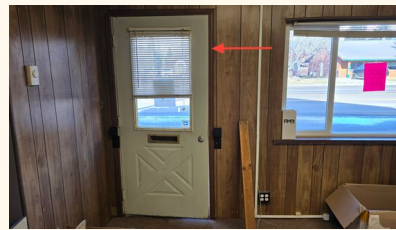
✂ E-3 Exterior:

The northeast steel door exterior is rusting and should be replaced. Additionally, this door was not square and contacts the door frame when operated.

out of square - hits frame

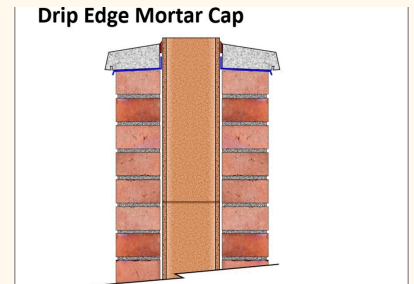
✂ RG-1 Roof & Gutters:

simple metal cap

🔧 **(RG-1) Recommended Repair:** The unused concrete chimney should be capped to prevent water and ice from entering and damaging the masonry. Hire a mason to further evaluate and install a masonry or metal chimney cap.

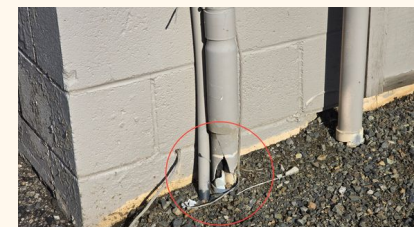
✂ ESD-1 Electric Service & Distribution:

The conduit for the electric service lateral is broken where it meets the asphalt. This has exposed the conductors and could pose a safety hazard. Hire a licensed electrician to make repairs.

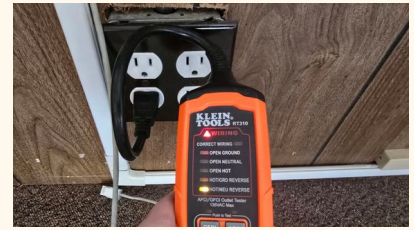
🔧 EDFW-1 Electric Distribution & Finish Wiring:

Reverse polarity was noted at the electrical receptacle at the front office wall. This is when the hot and the neutral have been wired backwards. This should be corrected by a licensed electrician.

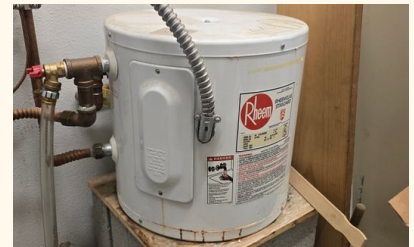
🔧 P-4 Plumbing:

This is the original water heater manufactured in 2001. According to industry standards, this water heater has entered a less reliable phase of its service life. There is staining indicating the water heater has developed leaks. Recommend replacement for ongoing reliability.

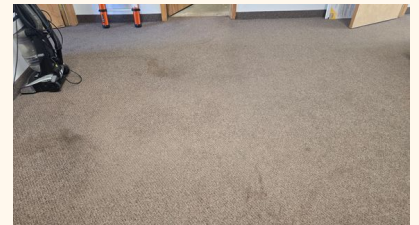
🔧 I-1 Interior:

The wall to wall carpeting is likely original and showing signs of age indicating it should be updated. See attached photos showing localized staining and wear.

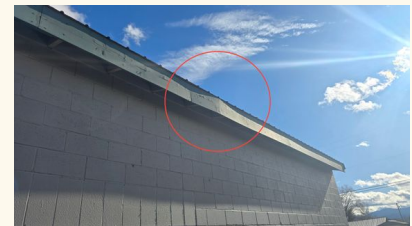
🔧 E-2 Exterior:

Warped fascia at west side observed. This appears to be mainly a cosmetic issue at this time. Recommend repair/replacement prior to having the exterior painted. A relief cut and new fasteners may suffice.

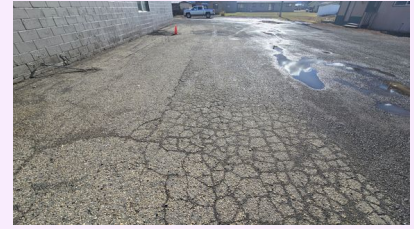
🏠 G-2 Grounds:

Asphalt areas were seen to be in poor overall condition with significant cracking, deterioration and undefined areas. While the lot is in useable condition, a logical improvement would be new asphalt parking areas with painted yellow lines for vehicle parking. Blue paint and decals should be displayed for the handicapped parking stall. These spaces should be marked with a wheelchair

symbol and are often wider to accommodate mobility devices.

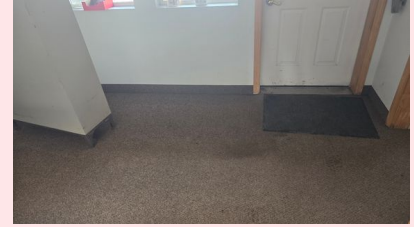
⚠️ (G-1) Major Concern: The front concrete is sloping toward the building - see north side. Standards recommend a quarter inch per foot slope away from the building or better to prevent water draining toward the building. Signs of water drainage toward the building and moisture intrusion were evident as rust on the entry door and carpet stains. Concrete replacement and/or a water collection drain installation is recommended. Have this further evaluated and repaired as recommended by a qualified contractor.

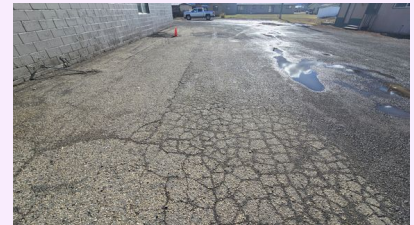
**(G-2) Suggested Improvement:** Asphalt areas were seen to be in poor overall condition with significant cracking, deterioration and undefined areas. While the lot is in useable condition, a logical improvement would be new asphalt parking areas with painted yellow lines for vehicle parking. Blue paint and decals should be displayed for the handicapped parking stall. These spaces should be marked with a wheelchair symbol and are often wider to accommodate mobility devices.

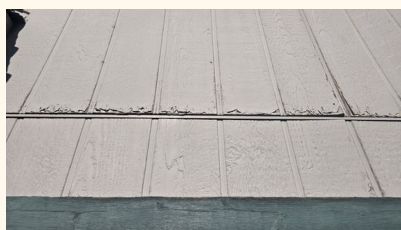
failed paint & water damage

**(E-1) Recommended Repair:** The wooden portions of the exterior siding and trim needs to be re-painted to preserve and maintain the siding system. Any water damaged siding should be replaced as needed prior to prep and paint. Specialized paint is required for concrete block. Budget for re-painting the exterior in the near term. Examples of specific observations noted during inspection include:

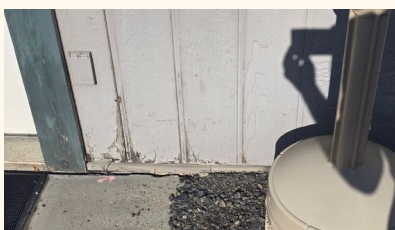
failed paint & water damage

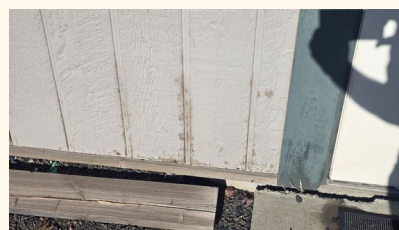
failed paint

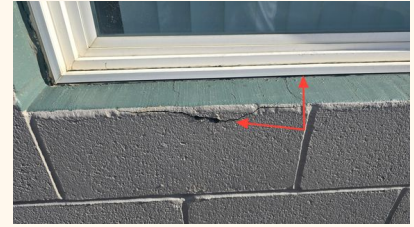
masonry sealant needed

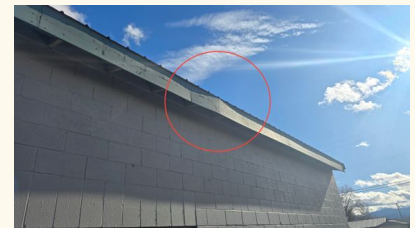
(E-2) Suggested Cosmetic Repair:

Warped fascia at west side observed. This appears to be mainly a cosmetic issue at this time. Recommend repair/replacement prior to having the exterior painted. A relief cut and new fasteners may suffice.

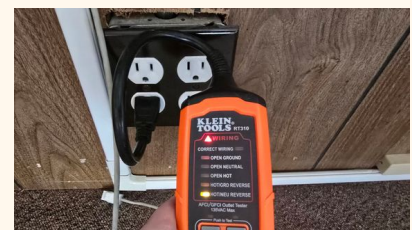
Reverse polarity was noted at the electrical receptacle at the front office wall. This is when the hot and the neutral have been wired backwards. This should be corrected by a licensed electrician.

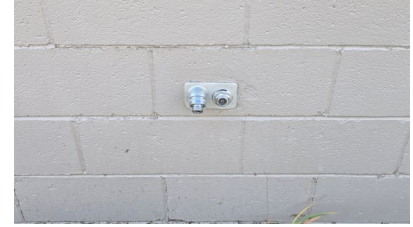
Handle missing at east hose bib. Hose bib not tested.

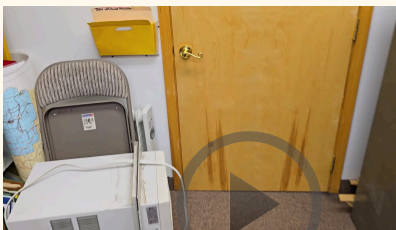
✂ (I-2) Recommended Repair: The east office door was not latching correctly and requires the strike height to be adjusted so the door latches closed.
