**Old Home Rescue**

# **Sullivan: 733 Chautauqua Ave**

# Project Overview

The on-site assessment of the building was completed on January 28, 2025

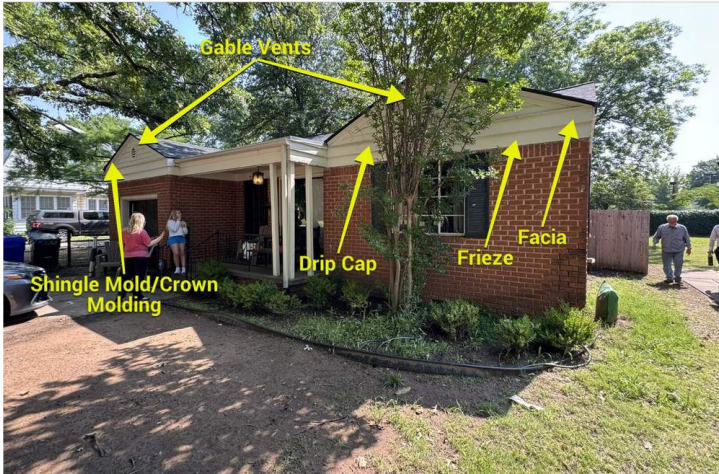
1

### Original Conditions

- Brick and mortar color conditions

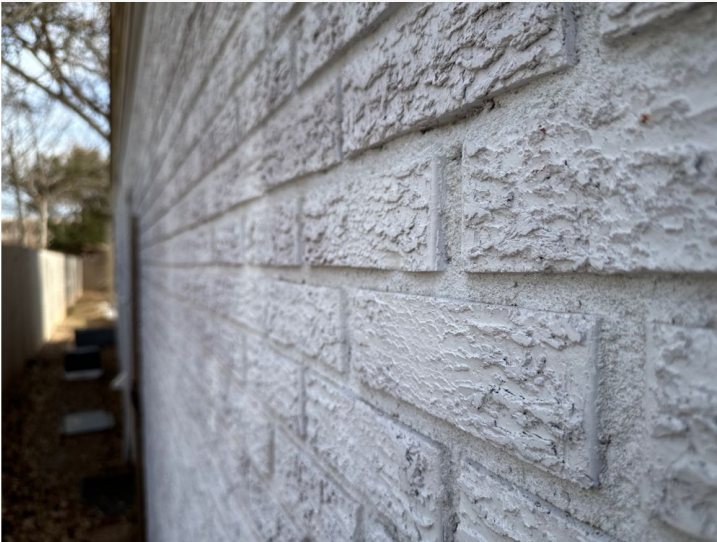
3

### Existing Conditions

- SW PrepRite ProBlock has been applied to brick and mortar
- Brick Face: Bark Face, which has a rough surface with many crevices

- In the particular project and prior experience, I believe that utilizing the Restorer tool, stainless wire brush attachment, and additional attachments provide the gentlest means to remove the paint from the brick.
- Utilizing this method will remove roughly 90-95% of the paint from the brick. It should be noted that small amounts of primer and paint will remain.

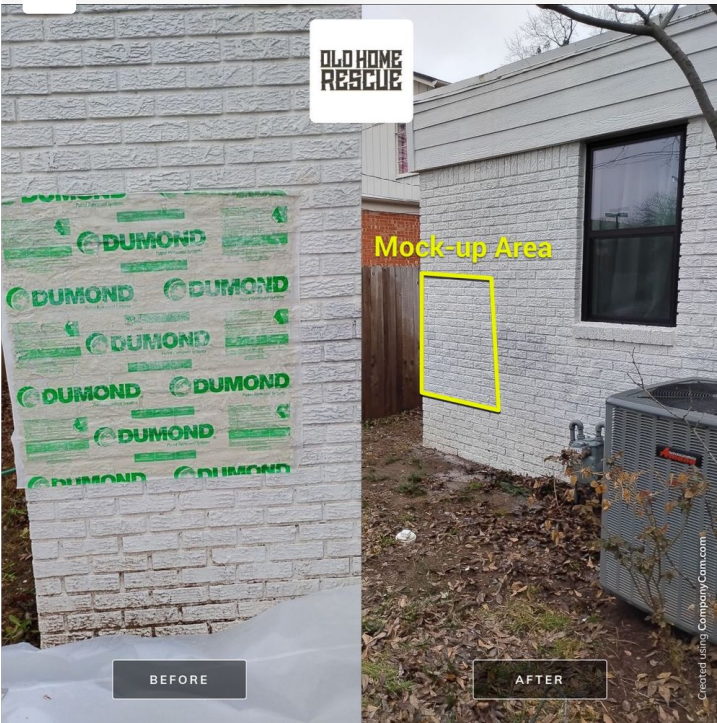
4

### Peel Away 1 Mockup

- Peel Away 1 mockup was unsuccessful in removing paint from brick

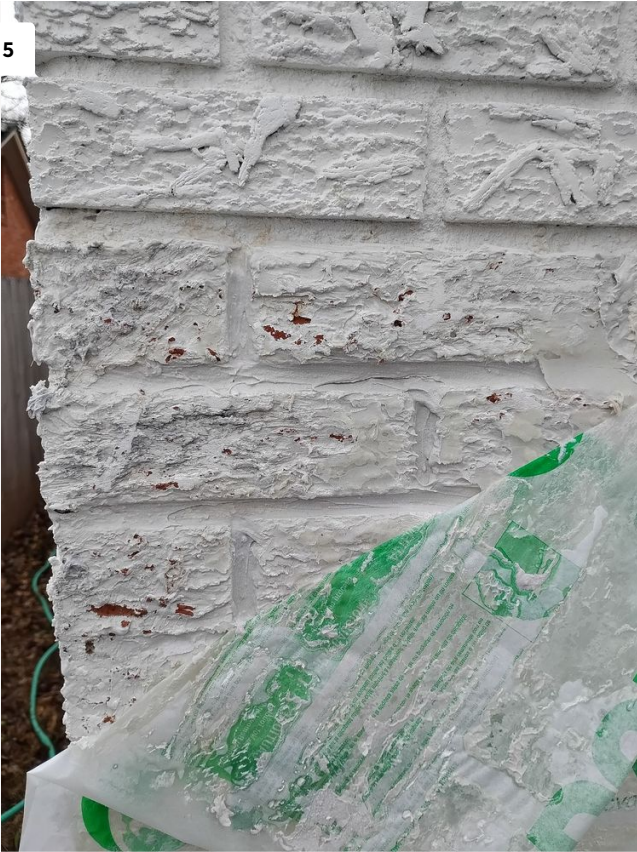
5

### Peel Away 1 Mockup

- Peel Away 1 was unsuccessful in removing paint from brick, likely due to the limited surface area for adhesion on the bark face brick.

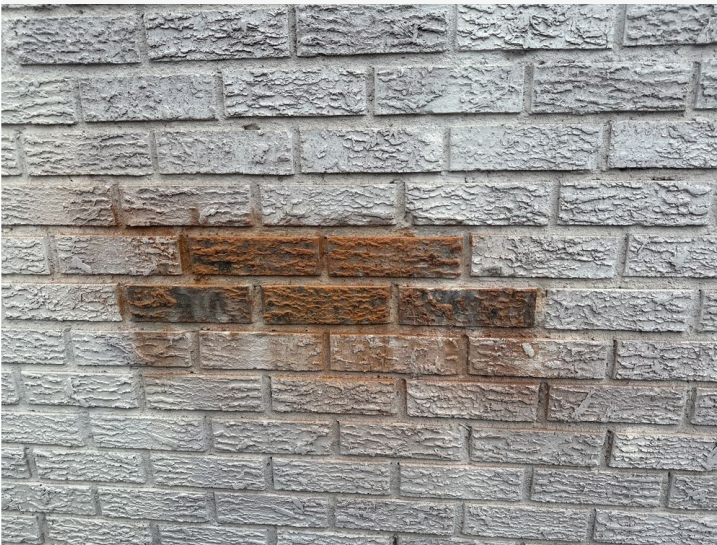
6

### Restorer Tool Mock-up

- Successful paint removal without damaging brick utilizing the Restorer tools with stainless wire brush attachment.

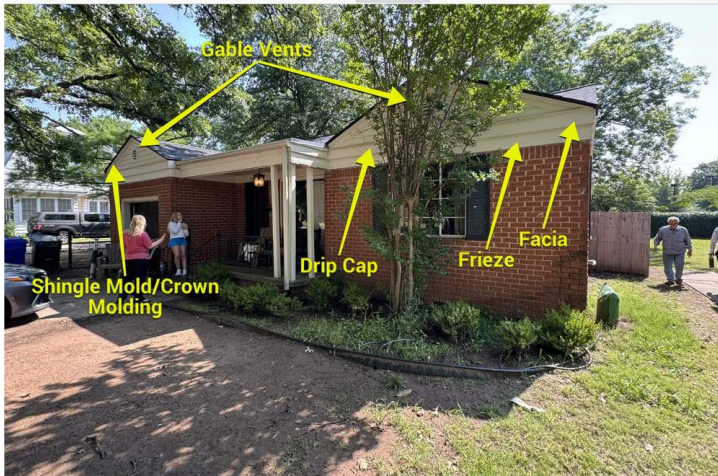
1

### Front Elevation

Character defining details in the cornice include the depth and layer found in the;

- Frieze
- Facia
- Drip cap
- Crown molding style shingle mold

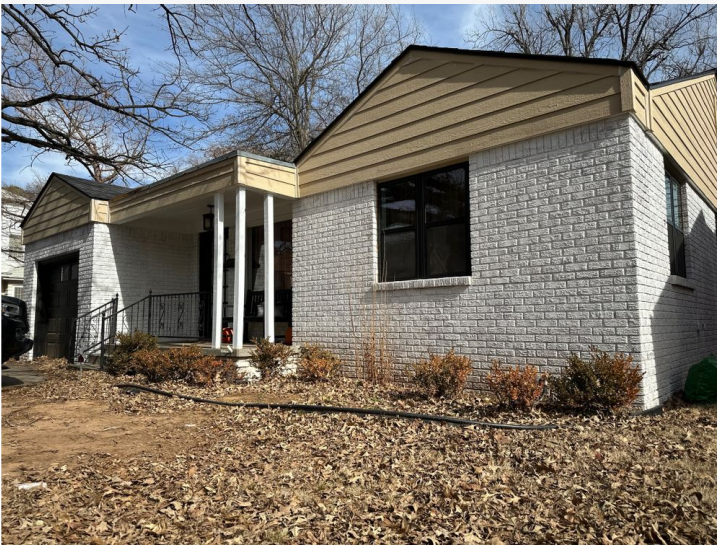
4

### Current Conditions

- Cedarmill (textured surface) LP SmartSide and Trim installed on all siding and cornice
- Removal of gable vents may impact the ventilation needed for the attic space to maintain roof warranty. Lack of intake and exhaust may cause pre-mature failure of the roof system.

- Replace gable vents, if missing, with a rot resistant wood, such as cedar that is primed before installation
- Shingle mold may have to be modified slightly to account for subtle eave that may be present.

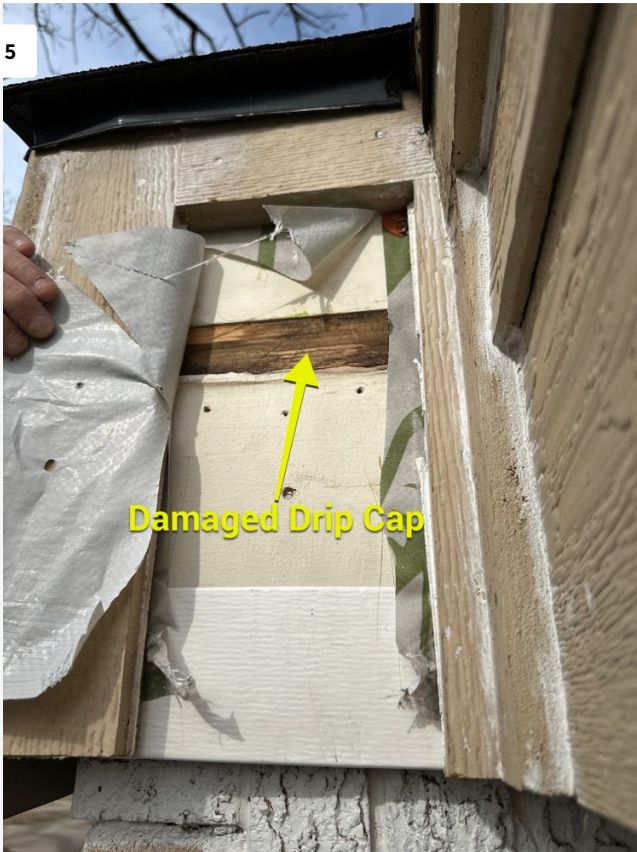
5

### Selective Demolition

- Flashing, house wrap, rigid foam insulation and LP siding and trim were installed over the original siding and cornice with damages likely occurring to any areas that protruded from the surface.

- Remove non-historic siding to evaluate current conditions of all siding and cornice for repairs
- Complete wood repairs with locally sourced drip cap and other items needs with fungicide treated, 360-degree primed wood.

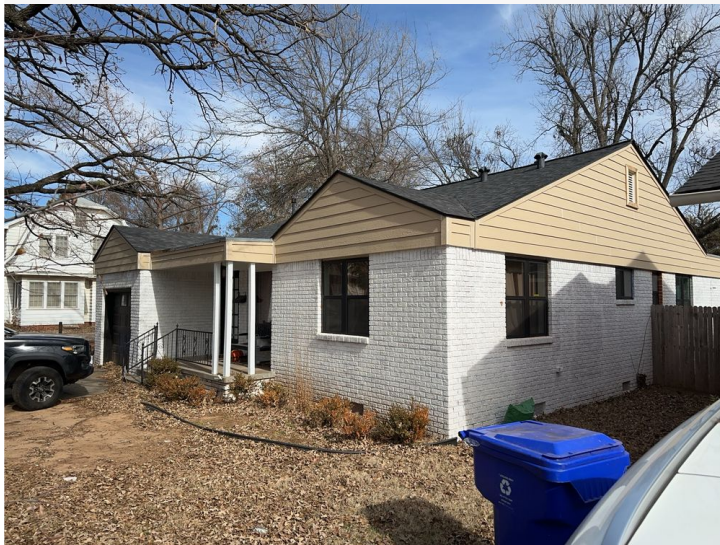
2

- Historic steel casement windows have been removed from the structure.
- Vinyl double hung windows have been installed into historic openings
- Current windows do not match appearance, muntin dimensions, lite size, or operation
- Installation of windows varies in completeness or correctness of installation

### Current Conditions

- Removal of existing windows
- Installation of Sun Windows Sun Clad Casement Window
- Type: Aluminum clad, Wood interior
- Aluminum Type: Extruded aluminum with integrated water management system to reduce failure
- Glass: Simulated simulated divided lite with shadow bar
- Exterior Glazing: 1" Putty glazing profile to closely resemble original muntin thickness
- Glass Type: LowE
- Lites: Match original window lite configuration
- All windows are operational
