Lower Imhoff Creek Bank Stabilization Project: Erosion Analysis

Norman, OK

July 25, 2022

Project #: 15NOR01 (Meshek)
Project #: 8275000431 (Wood)

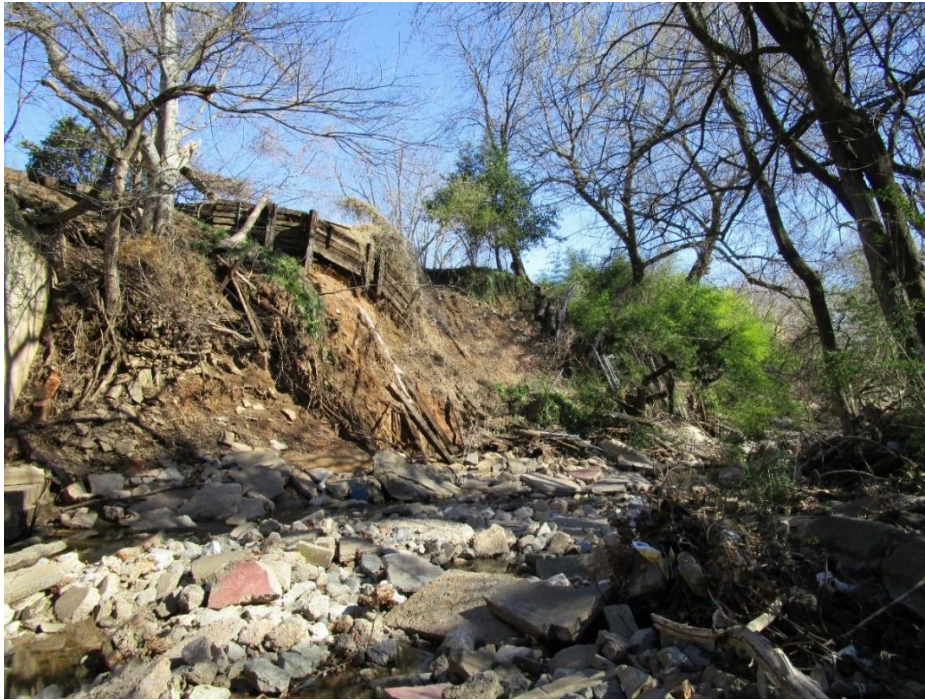
Imhoff Creek is a small urban watershed with approximately 4 square miles of contributing drainage area located within the City of Norman, Oklahoma. Much of the open channel system is concrete or articulated block lined improved channel. During storm events the excess runoff quickly accumulates causing rapid rising and receding flooding events that can be highly turbulent and very erosive to unprotected channel areas. Over the years the channel has developed numerous areas in which exposed vertical banks have been created by head-cutting along the unlined sections of the channel and scouring induced by vegetative debris thus creating erosive tendencies adjacent to or just downstream of the blockage areas. In some instances, erosion has caused vertical embankments to migrate, encroaching onto private property and jeopardizing critical infrastructure and residential structures. The stability of the existing bridge at Imhoff Road is being threatened by head cutting downstream of the bridge, which is being exacerbated by upstream scour and undermining of the structure. Figure 1-1 below exemplifies the 2016 embankment conditions downstream of Imhoff Road.

Figure 1-1: Left bank of Imhoff Creek just downstream of Imhoff Road, 2016

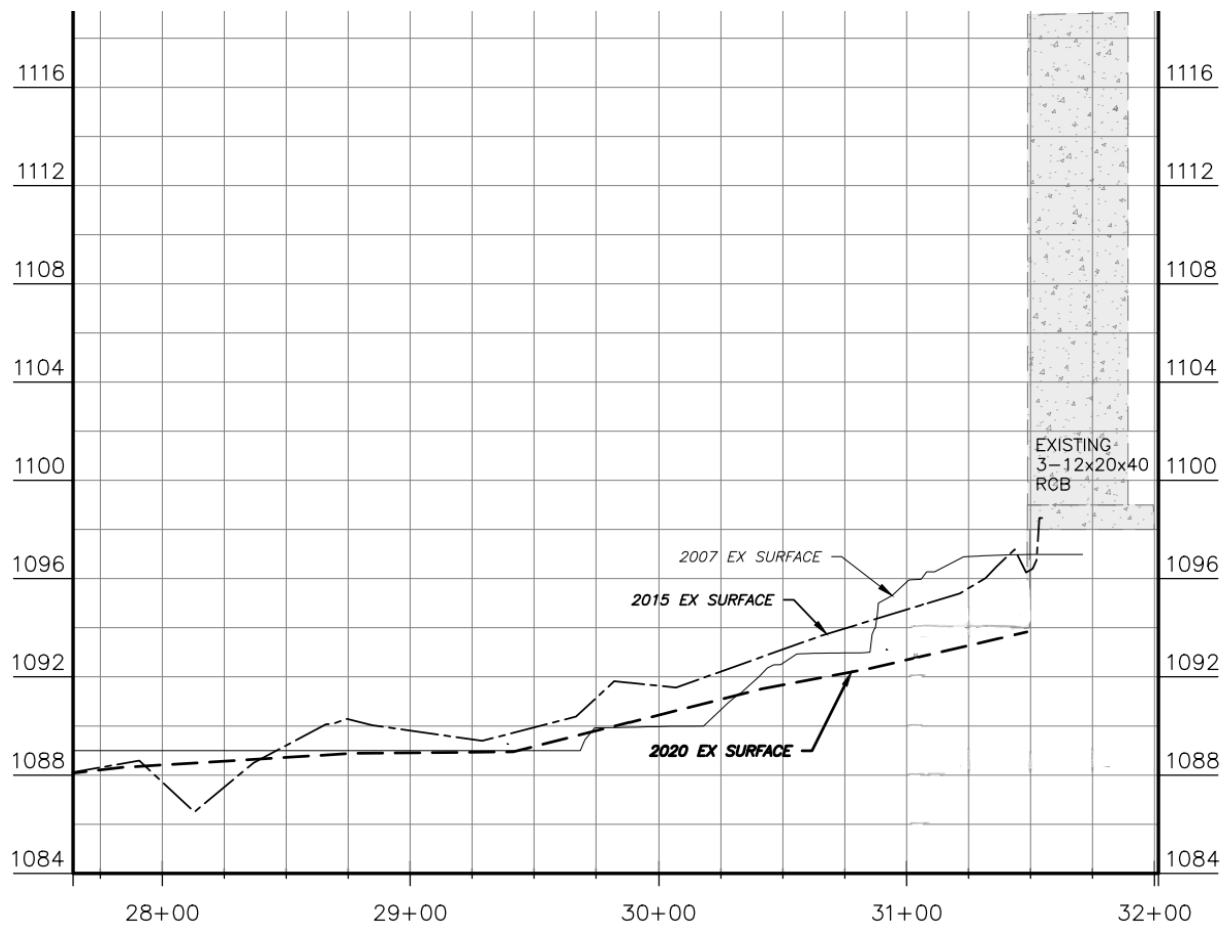
Figure 3-1: Stream bed profile

As seen in Figure 3-1, there is significant scour occurring just downstream of the bridge structure at Imhoff Road, as well as vertical head cutting. The scour immediately downstream of the bridge is shown to have eroded vertically at an average rate of 2.25 inches per year between 2007 and 2015, and an average rate of 6 inches per year from 2015 to 2020. As the drop at the downstream face of the structure continues to increase, the rate of erosion will continue to increase as well.

The head cut is moving upstream at an average rate of approximately 5 feet per year. At this rate, the head cut will begin to undermine the Imhoff Road bridge by 9 feet in approximately 30 years if no counteractive measures are taken.

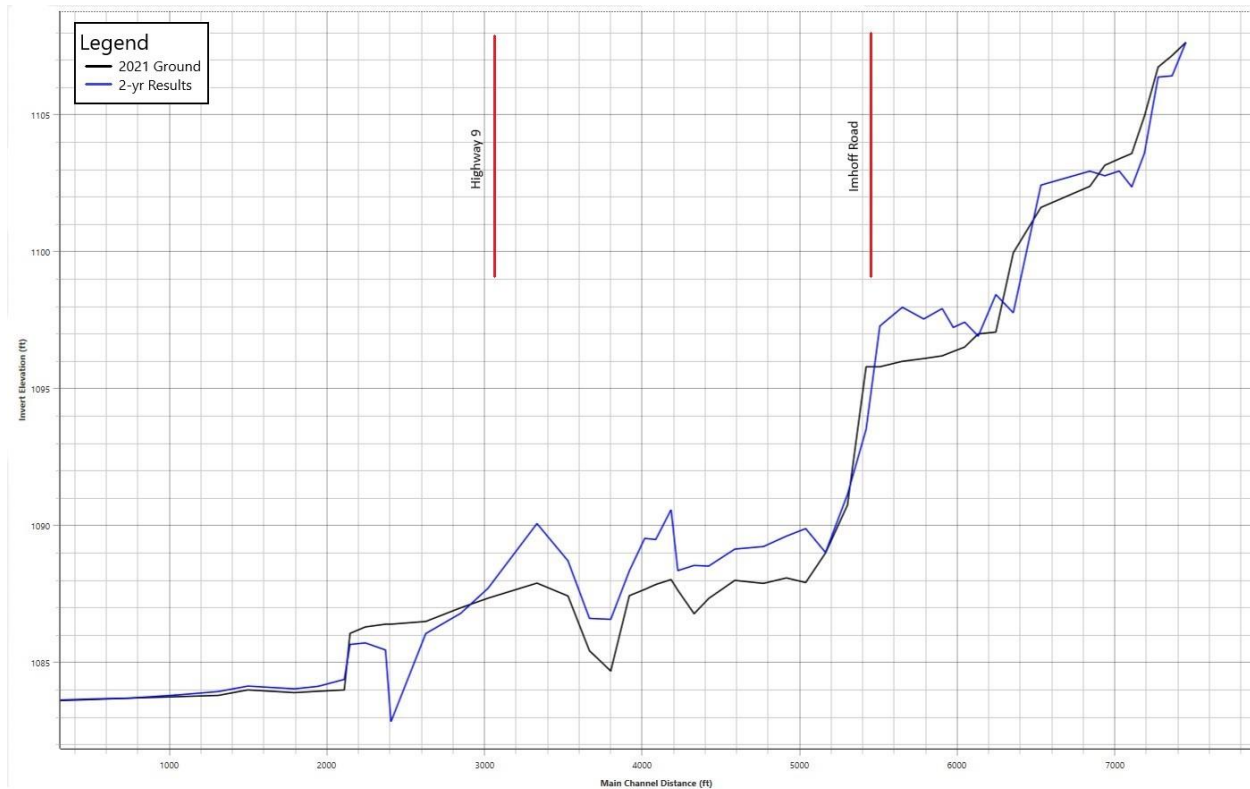
Figure 3-2: Sediment transport results for the 2-yr storm event

The results show that the head cutting just downstream of the Imhoff Road structure is likely to continue moving upstream and undermine the existing Imhoff bridge structure. There is also additional head cutting occurring upstream of Highway 9, which will continue to erode upstream towards Imhoff Road over time.

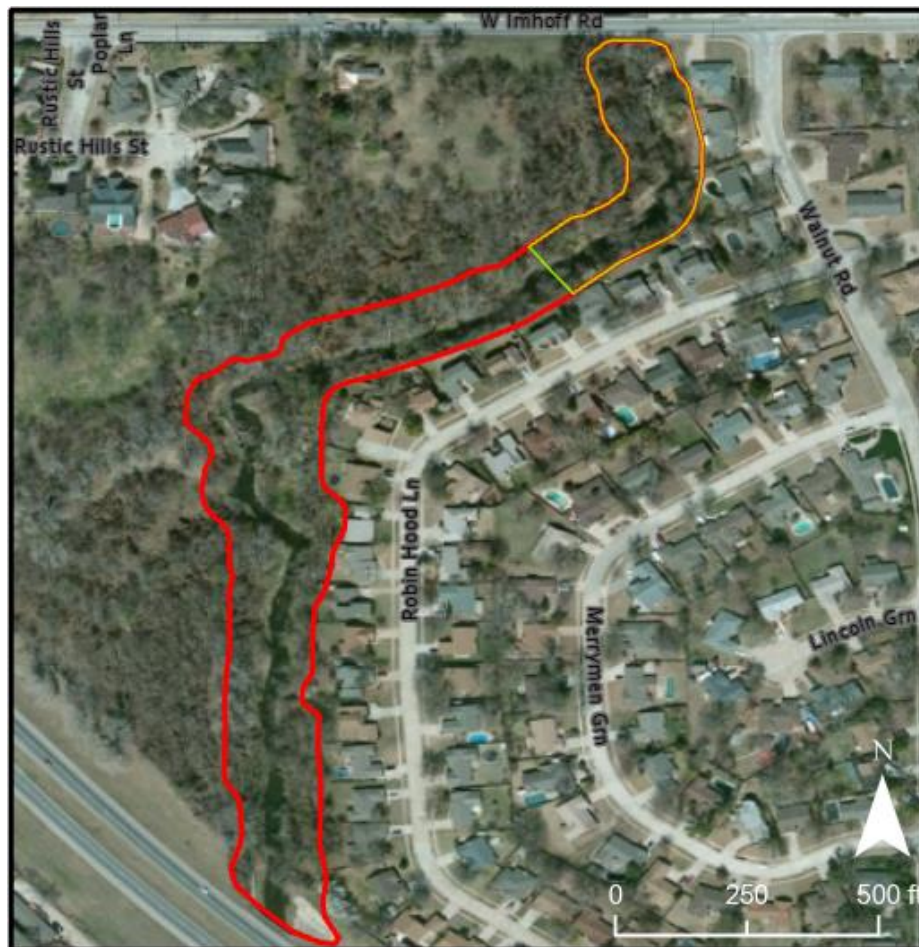
Figure 3-3: Area that was evaluated volumetrically

Volume Lost (ft ³)	Volume Lost (yd ³)	Reach Length (ft)	Bank Height (ft)	Time (yr)	Annual Lateral Erosion (ft/yr)	Annual Lateral Erosion (in/yr)	Annual Volumetric Erosion (yd ³ /yr)
Reach 1	170,030	6,297.4	2,075.3	20	6	0.68	8.19	1,049.6
Reach 2	44,797	1,659.1	515.3	22.6	6	0.64	7.7	276.5

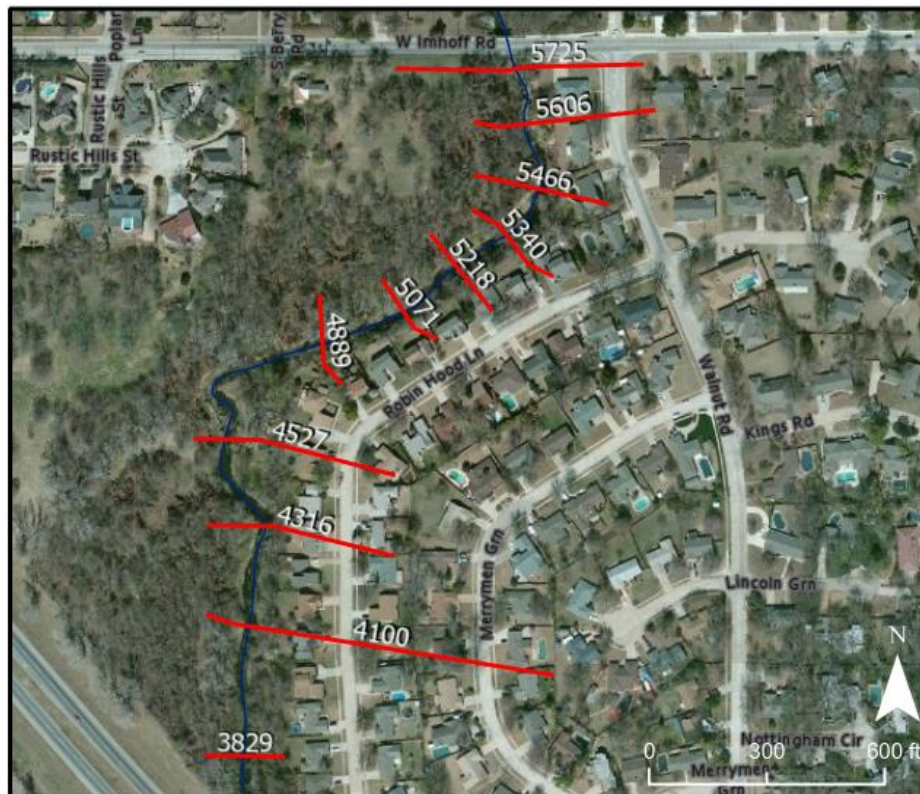
Figure 3-4: Locations of cross sections used to evaluate the lateral shift of the bank

Cross Section	Lateral Shift of the channel toe to the east (feet per year)	Lateral Shift of the top of the east bank to the east (feet per year)
5725	.9	1.02
5606	1.9	0.48
5466	0	0
5340	.95	1.34
5218	1.3	0.41
5071	0	1.5
4889	0	1.02
4527	.49	1.1
4316	0	1.68
4100	0	1.01
3829	.46	0.41
Average	.49	0.9

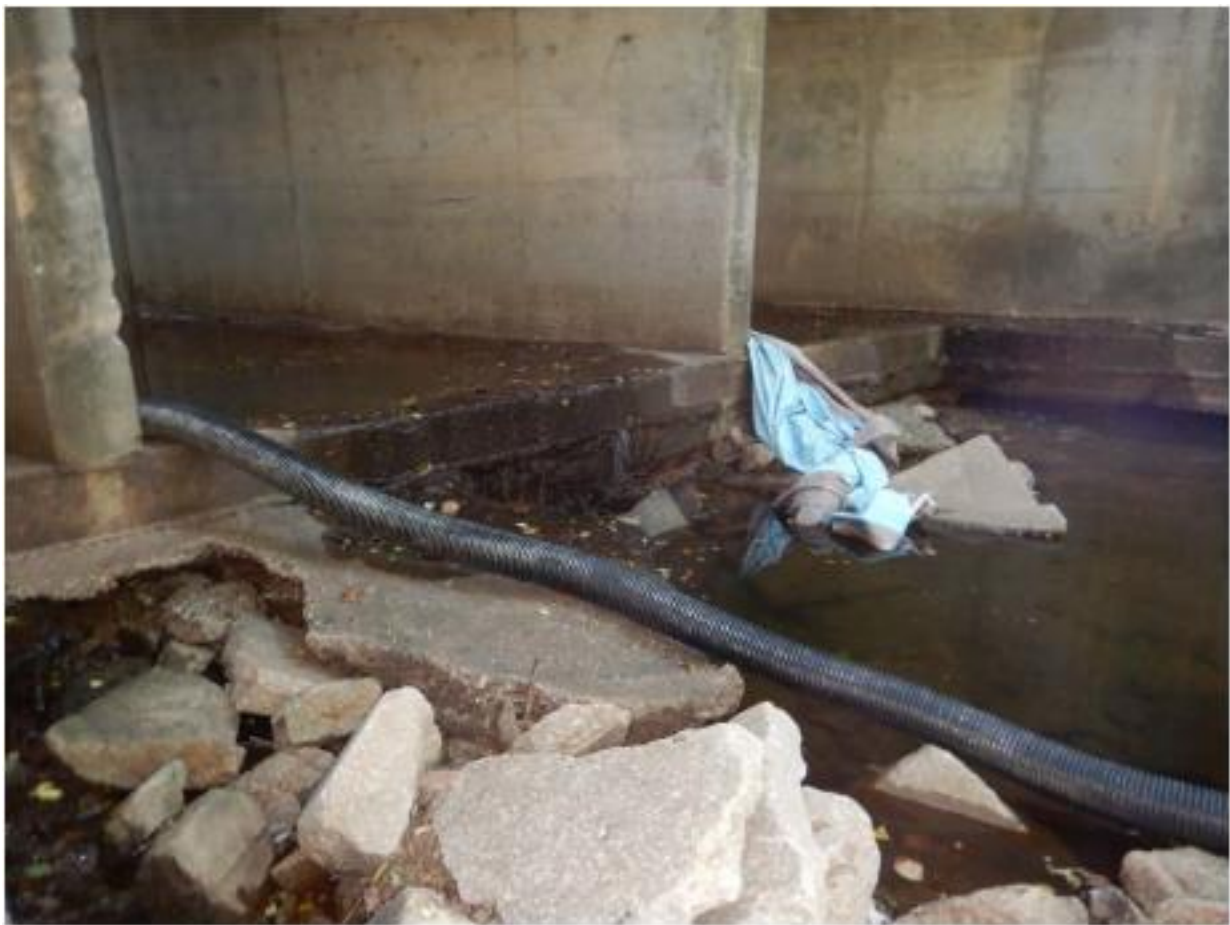
The Imhoff Road bridge was inspected in October of 2019 by Oklahoma Department of Transportation (ODOT) and rated scour critical. The inspection noted severe scour up to 1 ft at the upstream end with up to 1.5 ft of undermining and 2.25 ft of scour with up to 0.5 ft of undermining at the downstream end. Scour at the southeast wingwall was up to 4 ft with up to 3.3 ft of undermining. Figure 4-1 below shows the scour at the downstream end of the box, and Figure 4-2Figure 4-2 shows the undermining of the southeast wingwall. In September of 2021 the southeast wingwall failed, as shown in Figure 4-3.

Figure 4-1: Scour at the south end of the structure at Imhoff Road

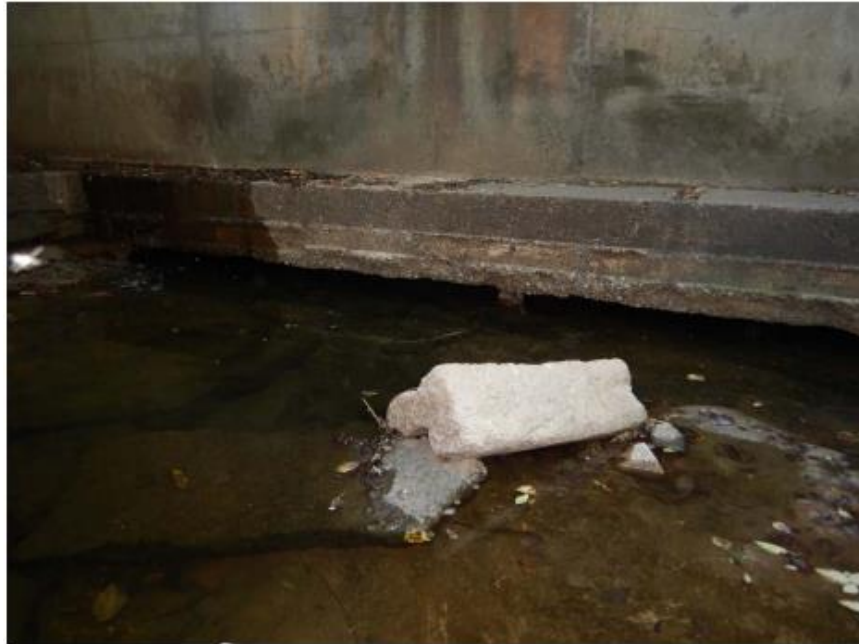
Figure 4-2: Undermining of the southeast wingwall of the structure at Imhoff Road

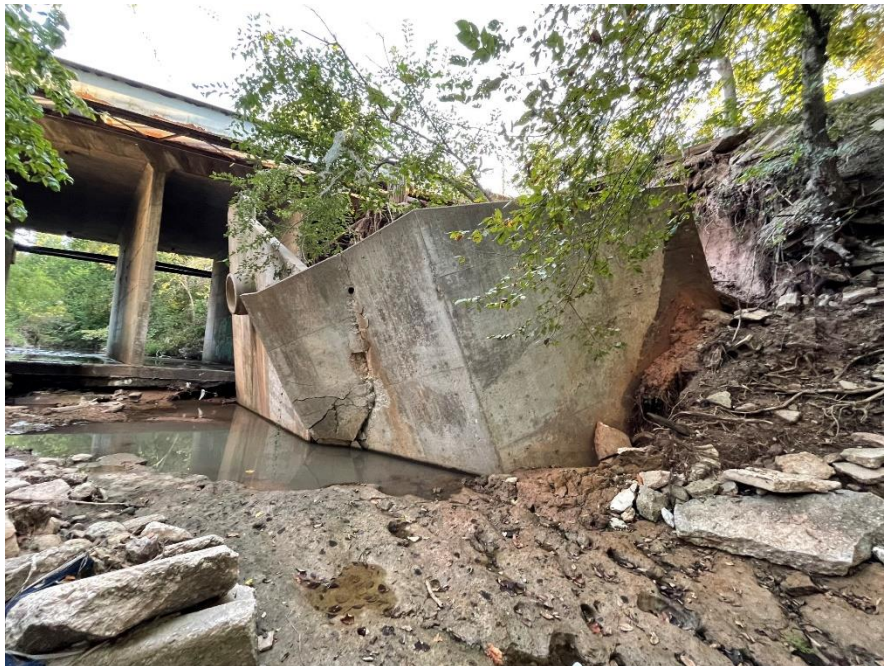
Figure 4-3: Failure of the southeast wingwall of the structure at Imhoff Road

An emergency repair is underway, replacing all four wingwalls and adding new aprons on the upstream and downstream end of the structure. Figure 4-4 below shows the location of the emergency apron on the downstream end of the structure, with a 4 ft drop at the structure face and a 6 ft sheet pile wall at the end of the 42.5 ft long apron.

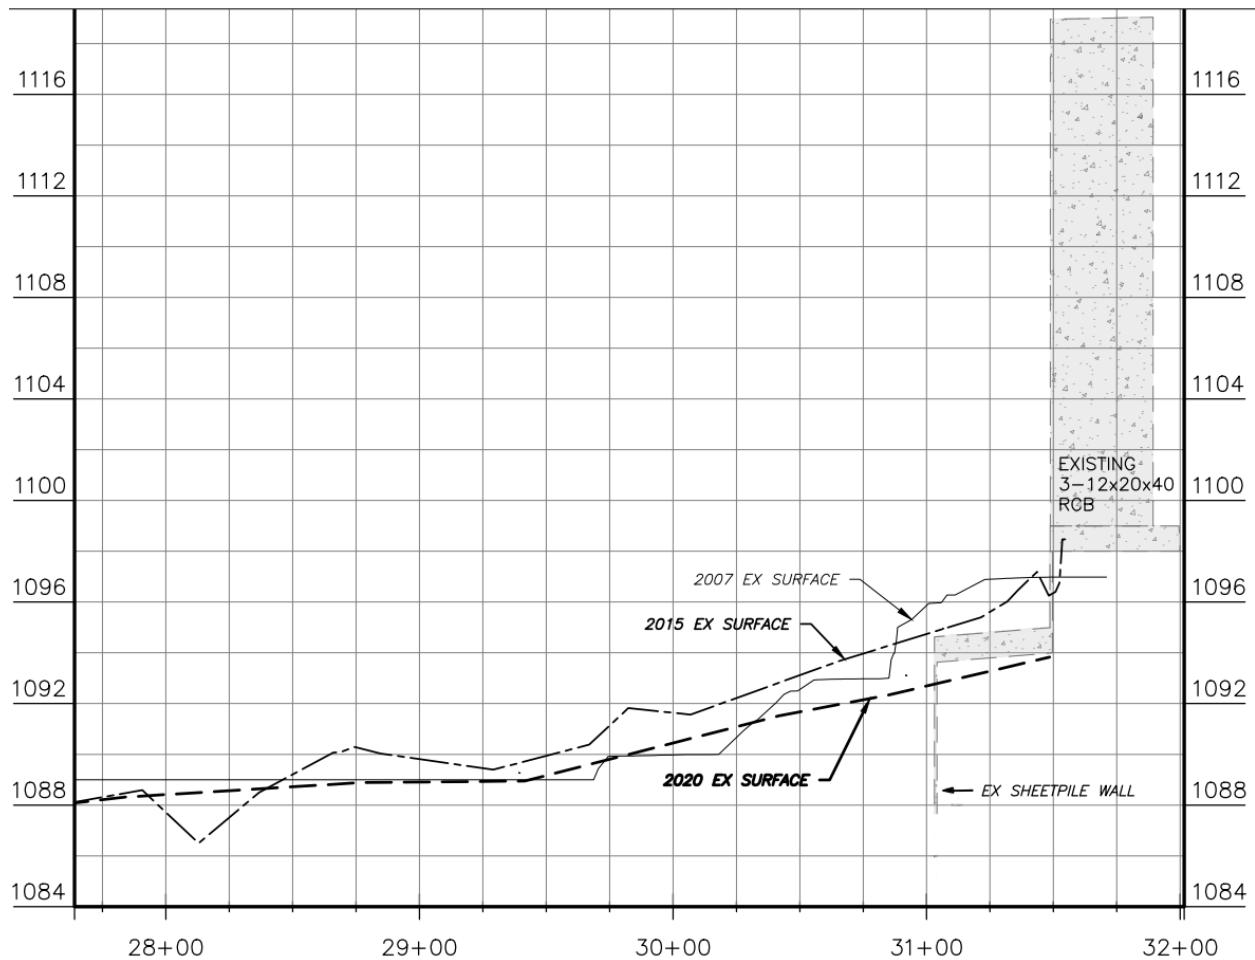
Figure 4-4: Profile view of downstream emergency repair

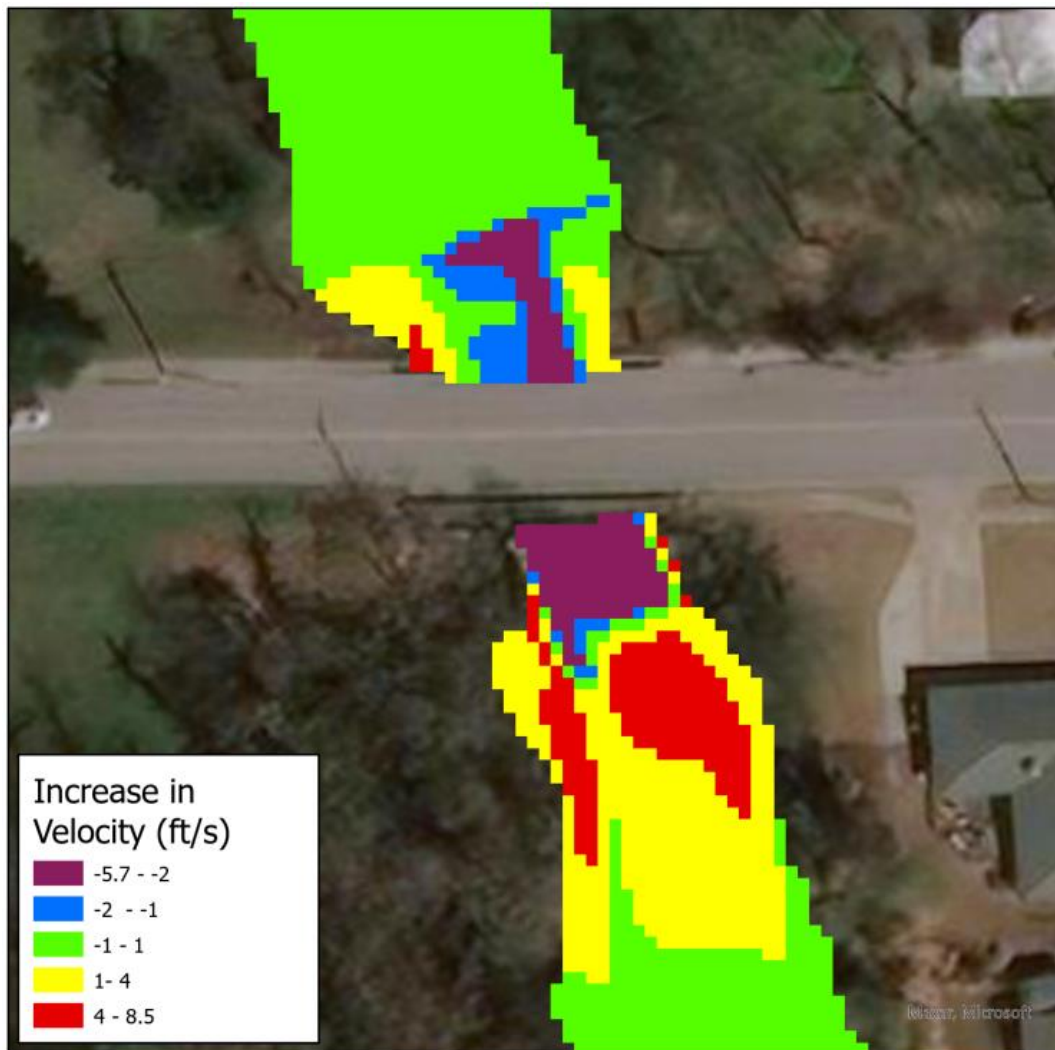
A comparison between current existing conditions and the emergency repair was done to determine the repair's effect on the stream flow and erosion. Figure 4-5 shows the increase in velocity due to the emergency repairs. While the velocity through the structure slightly decreased, the velocities increased 20-50% just downstream of the apron.

Figure 4-5: Increase in velocity due to the emergency repair

The increase in velocity will increase the rate of erosion in the area. Assuming the increased velocities will increase the rate of the head cut migration toward the Imhoff bridge structure by approximately 30%. Once the streambed head-cut reaches the bridge structure and the newly installed 6' sheet pile wall at the end of the apron, the bridge structure may be compromised in approximately 23 years. The engineer of record for the emergency bridge repairs estimates the life expectancy of those repairs to be approximately 15 years.

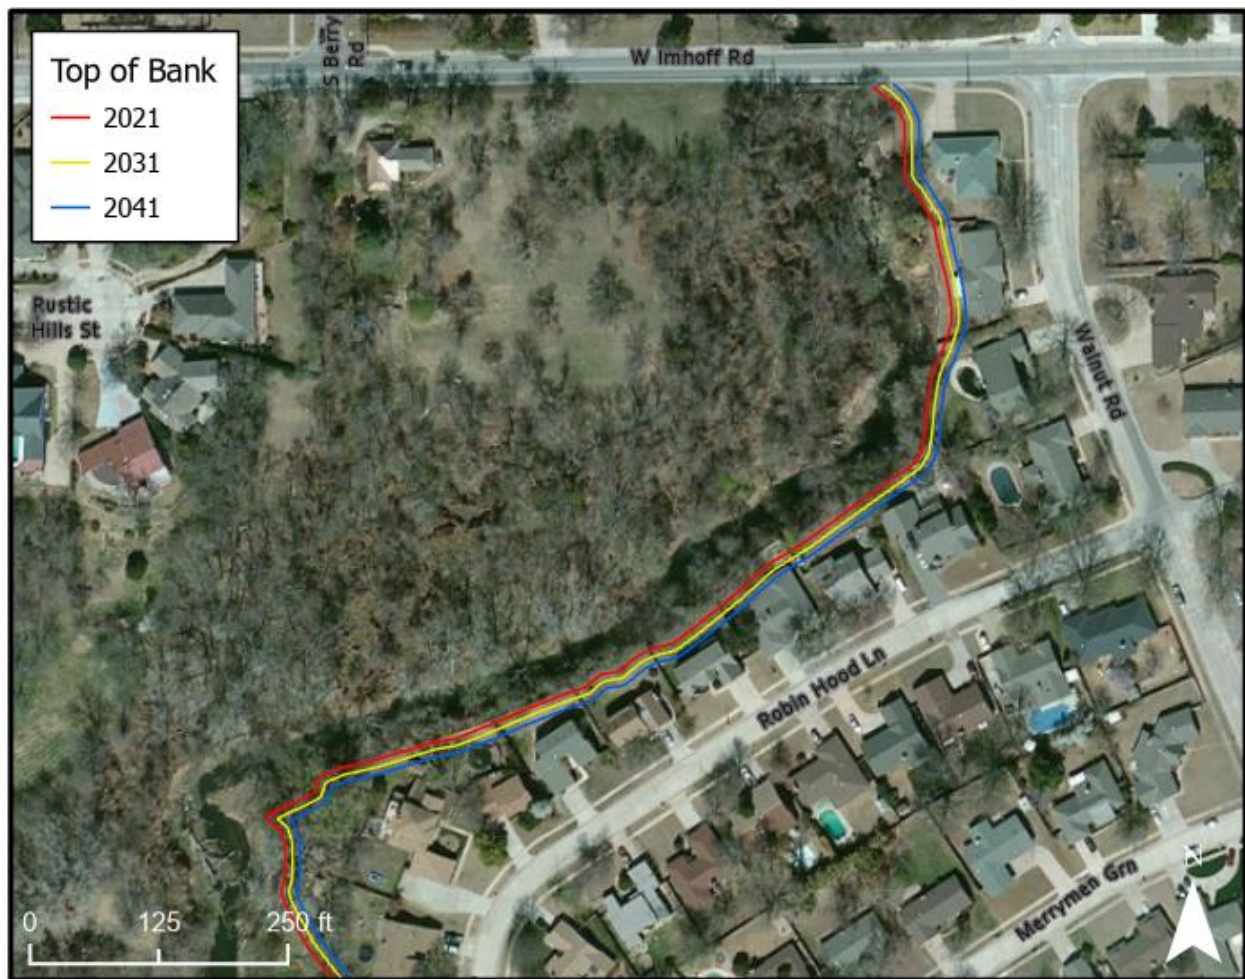
Assuming the average annual lateral rate of erosion of 0.7 feet per year from historical observations, Figure 5-1 below shows the current top of bank line, and the estimated top of bank line in 10 years and 20 years. The predicted future banks threaten two houses and five sewer lines in the next ten years. The degradation of the structure at Imhoff Road puts an additional sewer line at risk if the structure fails.

Figure 5-1: Future top of bank lines due to erosion
