July 28, 2021

Cc: Greg Mahan (Suez); Jim Beer (Hartwell Environmental)  
Re: Accelator Inspection (35\_7985)

The plant has four Softening Clarifiers, two of them provided by Suez (INFICLO) in 1965. These units are #16 IS, each with a design rate of 2,400 GPM. Lake Thunderbird is the source of your water, which is lime softened (to a pH of 10.3-10.5) along with ferric and polymer added. The plant switched from alum as the coagulant to ferric a couple of years ago. Plant treats the water from ~135 mg/l to ~75 mg/l as CaCO<sub>3</sub>.

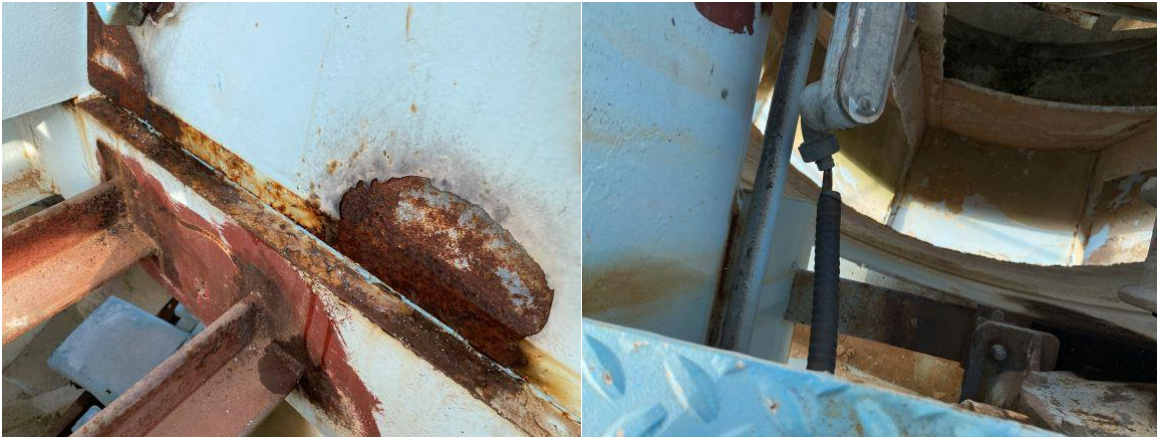
The profile of the pinion is showing some wear on the drained unit. The angle brackets for the pinion were only primed. This area needs some surface prep and paint. There is some loose conduit allowing water into the conduit

itself.

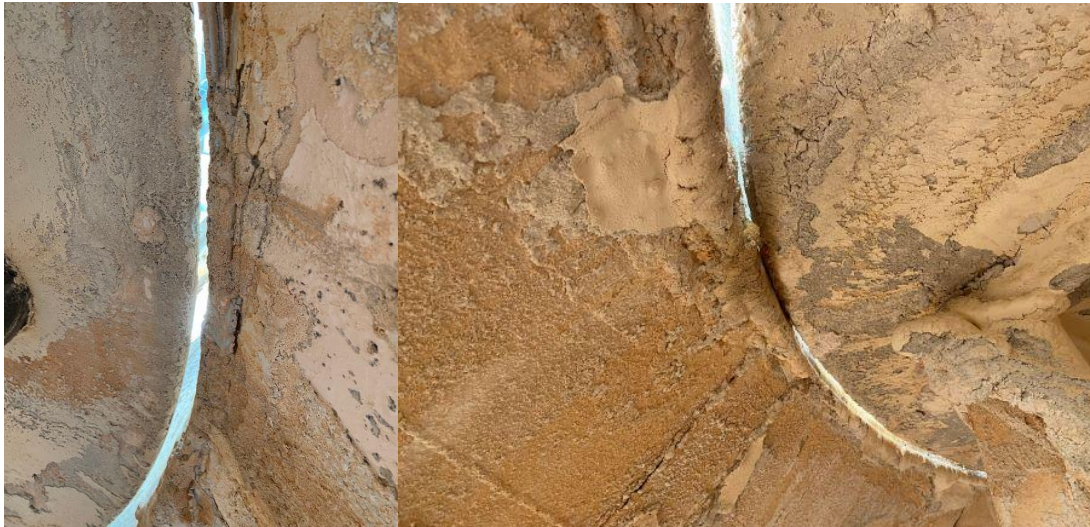
The gap between the hood structure and circular deckplate appears to be between 0 to 3". Over time, the hood structure should have some compression which results in a clearance between  $\frac{1}{2}$ " to 1". However, your clearance is much larger. Fixing this issue relates to making sure that the side rollers and the rack and track are aligned. When happens with this large opening is that excessive flow bypass the secondary mix zone.

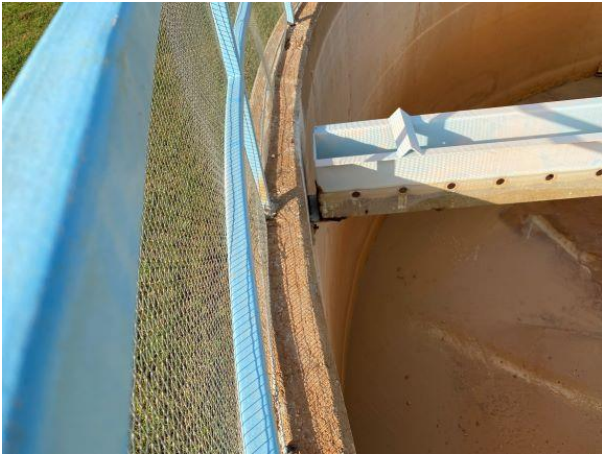
The outboard end of the launder (especially the first 7-8 inches from the bottom of the trough are rusted and deteriorated. The same is true for the launder support angles (especially the areas where the trough sits on the bracket.)

One of the IS Accelators was drained to be inspected. The most important observation is that there were areas of pitting of the steel and severe corrosion. None of this has effected the performance yet, but will some time on the future. I could not find any leaks in the launders. The use of ferric as a coagulant will increase this deterioration rate. In my opinion, the launder and outer wall brackets are most need of repair (or replacement of the brackets).

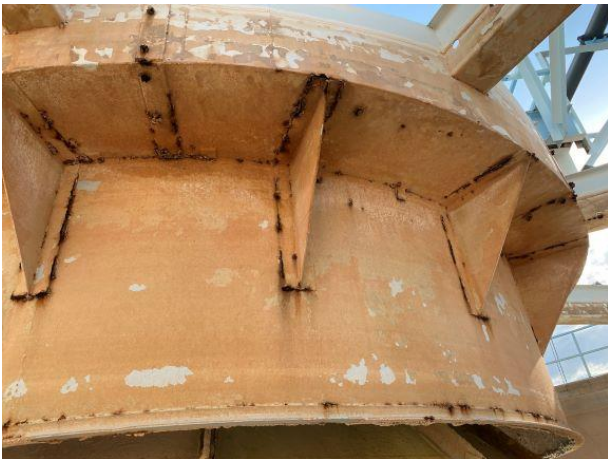
There is rusting in many places, especially at weld points. These have not started to leak, but will sometime in the future.

Underside of annular flume gussets and outer draft tube.

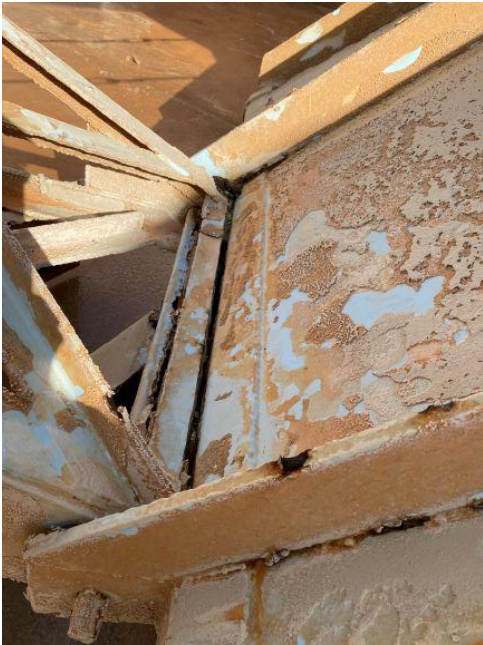
Where sheets are welded to a rafter and the scraper brackets to the rotating mechanism

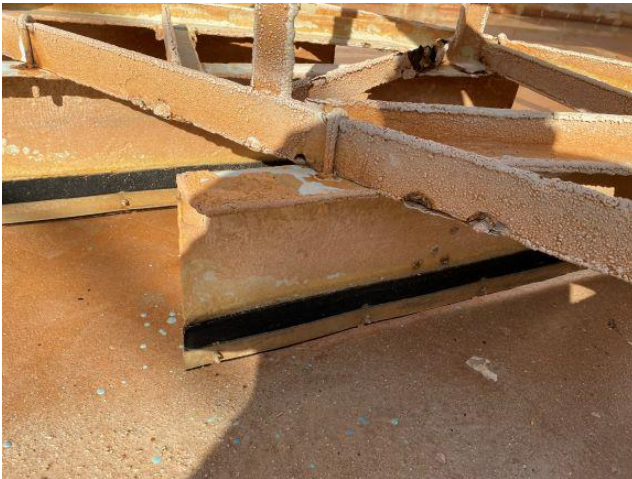
Steel pitting in scraper truss

You will need to get a structural person to determine if the steel can be effectively reprofiled and painted again.

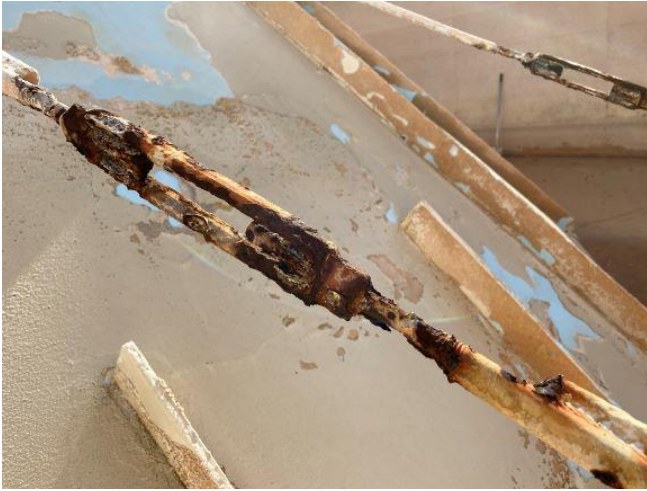
Turnbuckles severely corroded
