# Candidates for MDOT Bridge Program Funding

***Re: MDOT Local Bridge Program – Asbury Bridge over Middle Rouge River***

**BRIDGE SAFETY INSPECTION REPORT**

#### **4. Application Requirements for Ashbury Drive over Middle Br Rouge River**

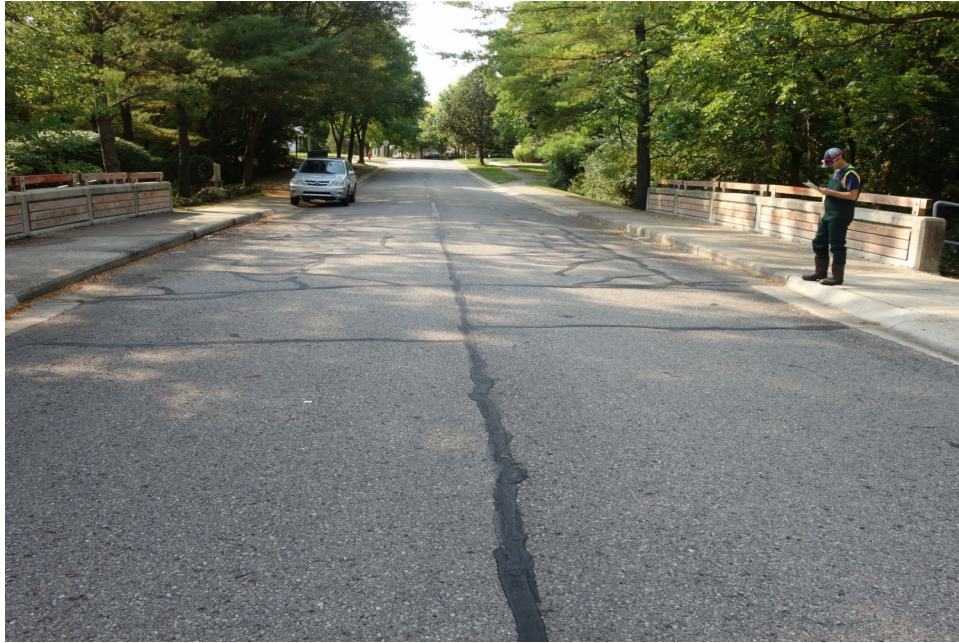
| | 09/22 | 09/23 | 09/24 | |
|---|---|---|---|---|
| <b>18. Approach<br/>Pavement</b> | 7 | 6 | 6 | <p>Isolated cracks throughout with some sealed and some unsealed. General wear of HMA surface. (09/24)</p> <p>Isolated cracks throughout with some sealed and some unsealed. General wear of HMA surface. (09/23)</p> <p>Sealed longitudinal crack in north approach. No cracks in south approach. General wear in HMA. (09/22)</p> |

North Approach Looking South

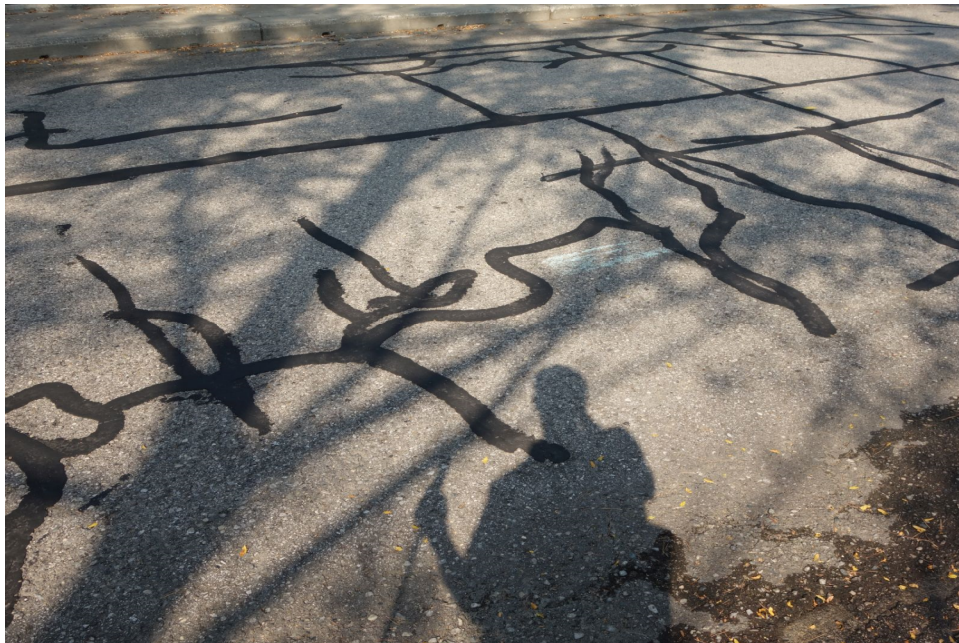
| | 09/22 | 09/23 | 09/24 | |
|---|---|---|---|---|
| <b>1. Surface (SIA-58A)</b> | 6 | 6 | 5 | HMA surface with general cracking throughout. SE quad has break up of HMA at east curb line. General scaling of HMA surface along both curb lines. Random cracking throughout HMA with some unsealed. No waterproofing membrane evident. (09/24)<br>HMA surface with sealed longitudinal crack at centerline. Two other sealed longitudinal cracks near mid span. Previously unsealed crack have been sealed. SE quad has break up of HMA at east curb line. General scaling of HMA surface along west curb line. Random cracking throughout HMA with some unsealed. (09/23)<br>HMA surface with sealed longitudinal crack at centerline. Two other sealed longitudinal cracks near mid span. Previously unsealed crack have been sealed. SE quad has break up of HMA at east curb line. General scaling of HMA surface along west curb line. (09/22) |

Typical Deck Surface

| Recommendation Type | Priority | Description |
|---|---|---|
| Deck Patching | L | Seal cracks in surface. |

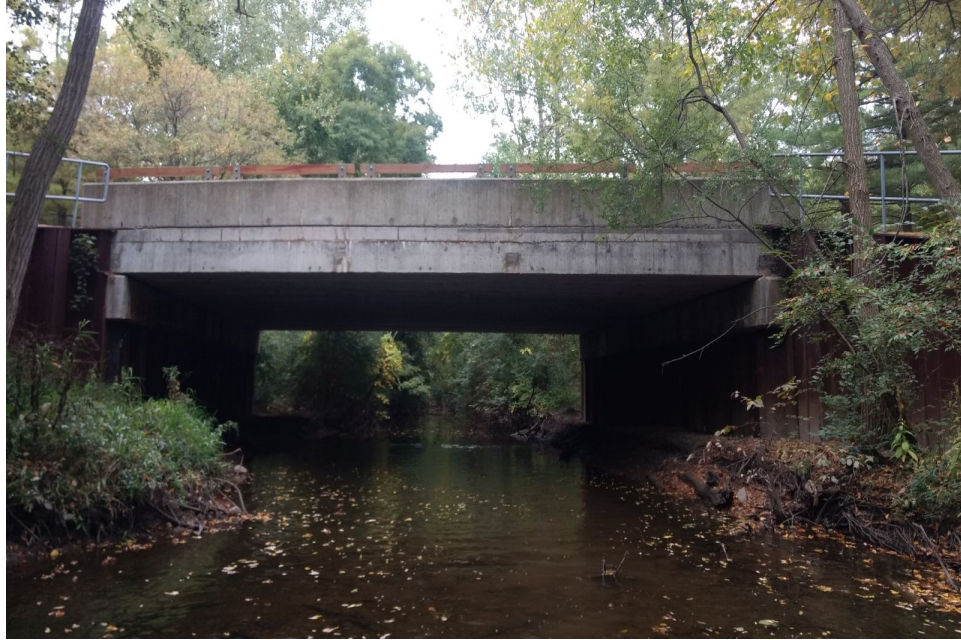
South Elevation

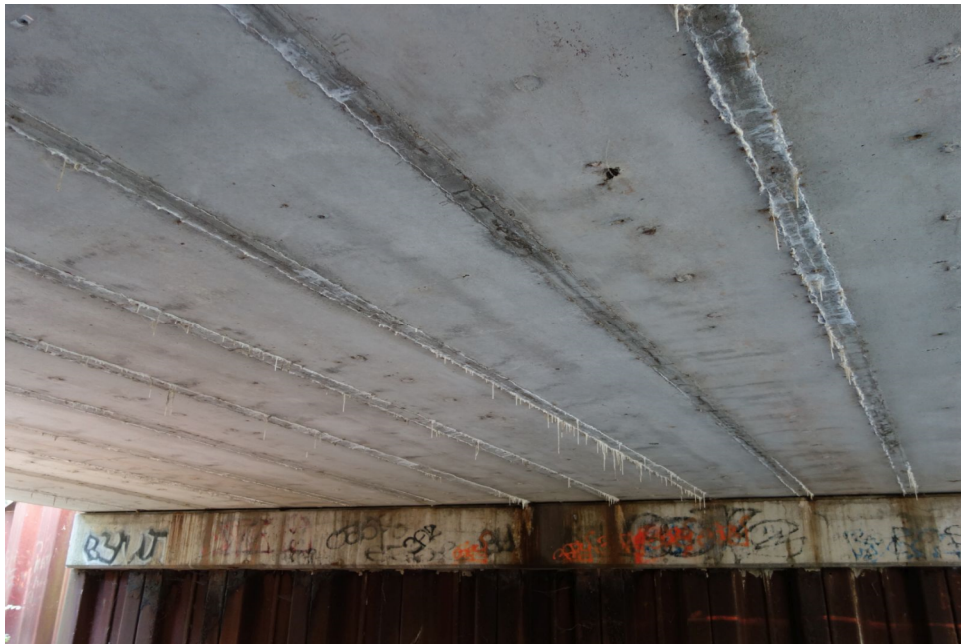
| | 09/22 | 09/23 | 09/24 | |
|---|---|---|---|---|
| <b>6. Deck Bottom Surface (SIA-58B)</b> | N | N | N | Side-by-side box beams. Leaking between all beams. Stalactites present at most beam lines and leachate at all of them. (09/24)<br>Side-by-side box beams. Leaking between all beams. Stalactites present at most beam lines and leachate at all of them. (09/23)<br>Side-by-side box beams. Leaking between all beams. Stalactites present at most beam lines and leachate at all of them. (09/22) |

Typical Deck Underside

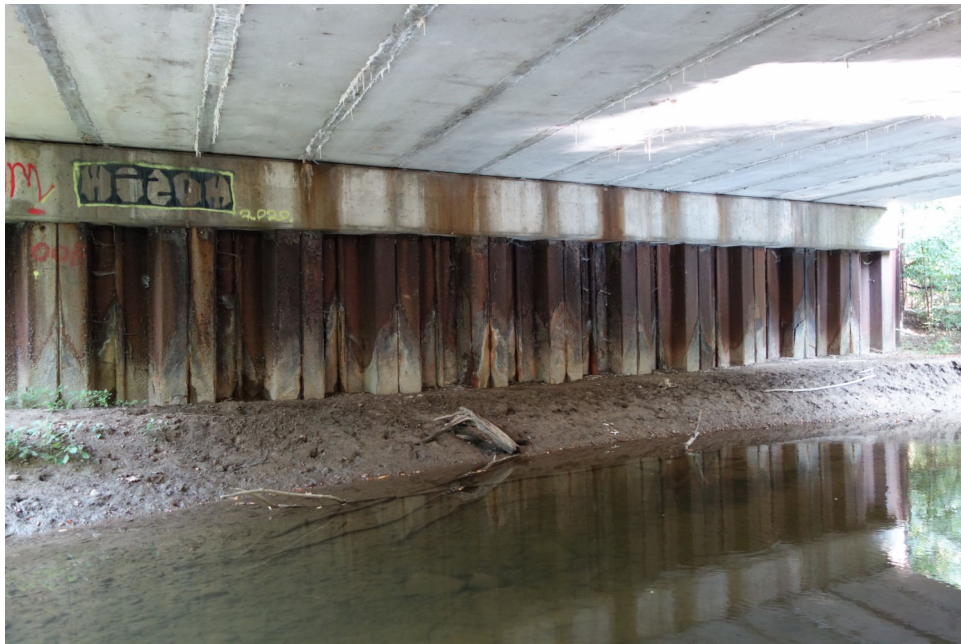
| <b>13. Abutments<br/>(SIA-60)</b> | 4 | 4 | 4 | <p>Pack rust and scaling at base and top near beams is evident on both abutments and has progressed since the previous inspection. Some vertical cracks in concrete pile cap. Evidence of leaking from ends. Holes in sheet piling of north abutment near the middle of the base. Pack rust and scaling on north abutment is allowing water through but no material. Section loss is minor and there is leaching between the sheets of the southern abutment sheet piling. Hole near top of sheet pile reveals that the bridge is on pipe piles and the sheet piles are used as earth retention only. (09/24)</p> <p>Pack rust and scaling at base and top near beams is evident on both abutments and has progressed since the previous inspection. Some vertical cracks in concrete pile cap. Evidence of leaking from ends. Holes in sheet piling of north abutment near the middle of the base. Pack rust and scaling on north abutment is allowing water through but no material. Section loss is minor and there is leaching between the sheets of the southern abutment sheet piling. Hole near top of sheet pile reveals that the bridge is on pipe piles and the sheet piles are used as earth retention only. (09/23)</p> <p>Pack rust and scaling at base and top near beams is evident on both abutments and has progressed since the previous inspection. Some vertical cracks in concrete pile cap. Evidence of leaking from ends. Holes in sheet piling of north abutment near the middle of the base. Pack rust and scaling on north abutment is allowing water through but no material. Section loss is minor and there is leaching between the sheets of the southern abutment sheet piling. Hole near top of sheet pile reveals that the bridge is on pipe piles and the sheet piles are used as earth retention only. (09/22)</p> |

North Abutment

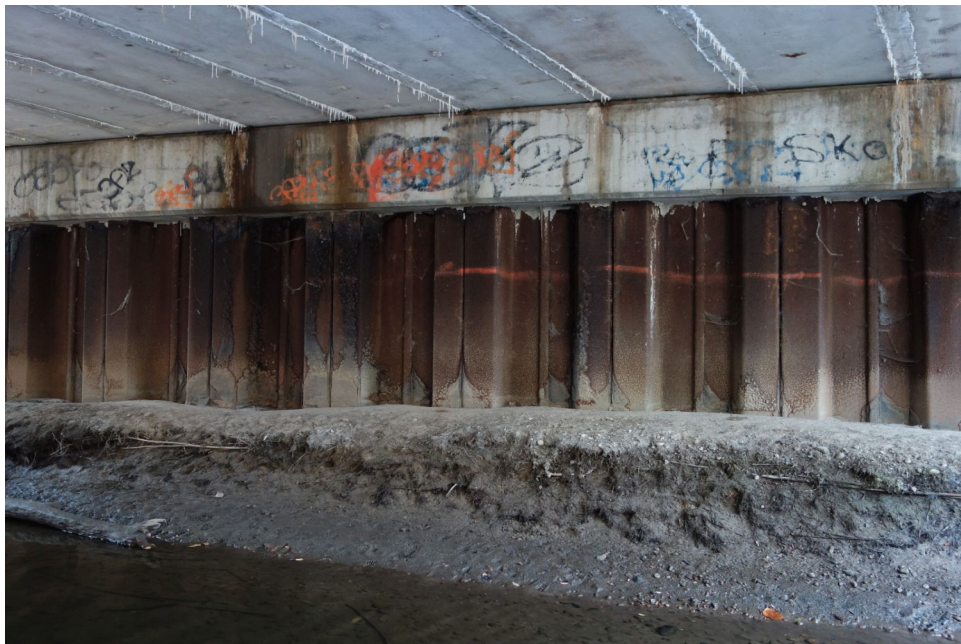
South Abutment

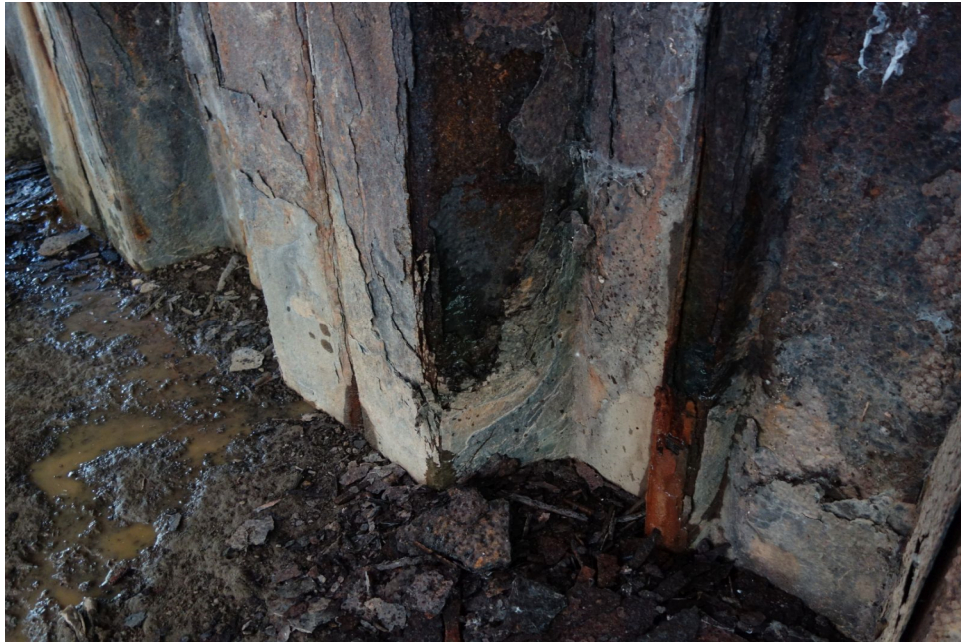
North Abutment Sheeting Section Loss and Rusting

The current structure is a single span adjacent concrete box beam bridge. The overall condition of the bridge is poor and rated a 4. The superstructure is in good condition. The surface is HMA with sealed cracks in fair condition. The concrete box beams have leaching between beams and a few cracks on the fascia beams with leaching. The abutments are in poor condition and rated a 4. The abutments are pipe pile supported concrete caps, with steel sheet piling below the concrete cap to retain the approach backfill. The sheet piling has extensive pack rust at the base. The north abutment sheet piling has holes near the middle of the base and the pack rust and scaling on the north abutment is allowing water through. Pack rust and section loss on the south abutment is moderate and there is leaching between pile sheets. The rate of deterioration has accelerated since the last inspection.

| Recommendation Type | Priority | Description |
|---|---|---|
| Substr Repair | M | Replace abutment sheet pile facing with more permanent solution. |

Due to the poor condition of the abutment sheet piling, a partial substructure replacement is recommended. As the sheet piling continues to deteriorate, backfill material will spill through the abutment, causing sinkholes in the approaches. Repairing the existing holes is not recommended as the existing sheet piling will continue to deteriorate outside of the repairs. The bridge is supported on piles and a pile cap. The pile cap is in good condition and does not need to be replaced. A new concrete earth retaining system will be poured to protect and provide bracing to the existing piles and replace the existing sheet pile. To replace the substructure, the approaches and approach fill must be removed. New HMA and waterproofing membrane will be placed on the

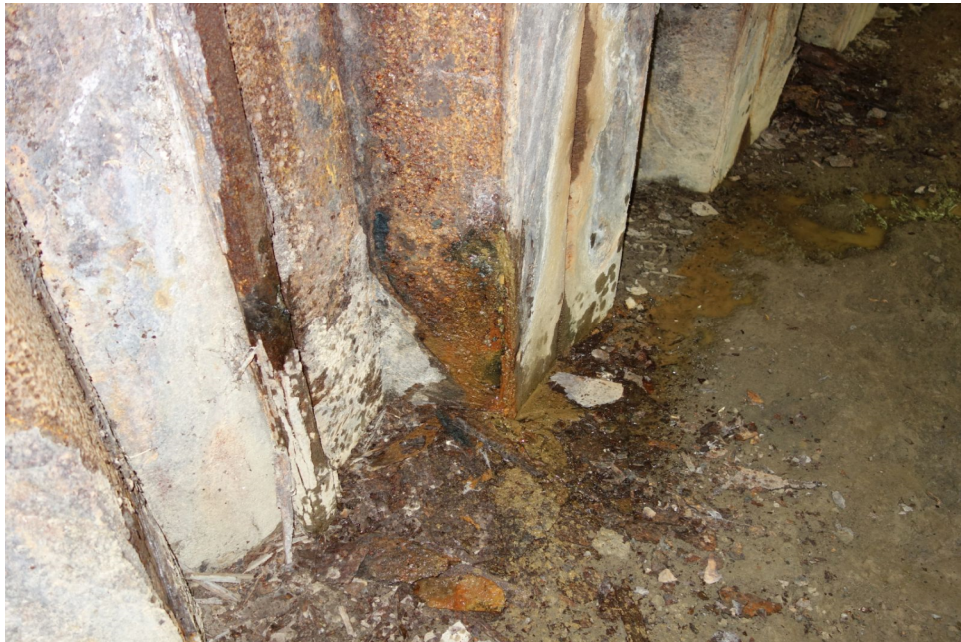
South Abutment Sheeting Section Loss and Rusting
