# Department of Public Works Water and Sewer Division

## Pre-Stressed Concrete Pipe Assessment and Inspection Program 2019

# Condition Assessment Report

The City of Novi (Novi) contracted Pure Technologies, a Xylem brand (Pure Technologies), to conduct a condition assessment of the 36-, 30-, and 24-inch Novi Road PCCP Water Transmission Main located in Novi, Michigan. The Novi Road PCCP Water Transmission Main consists of prestressed concrete cylinder pipe (PCCP), specifically lined cylinder pipe (LCP).

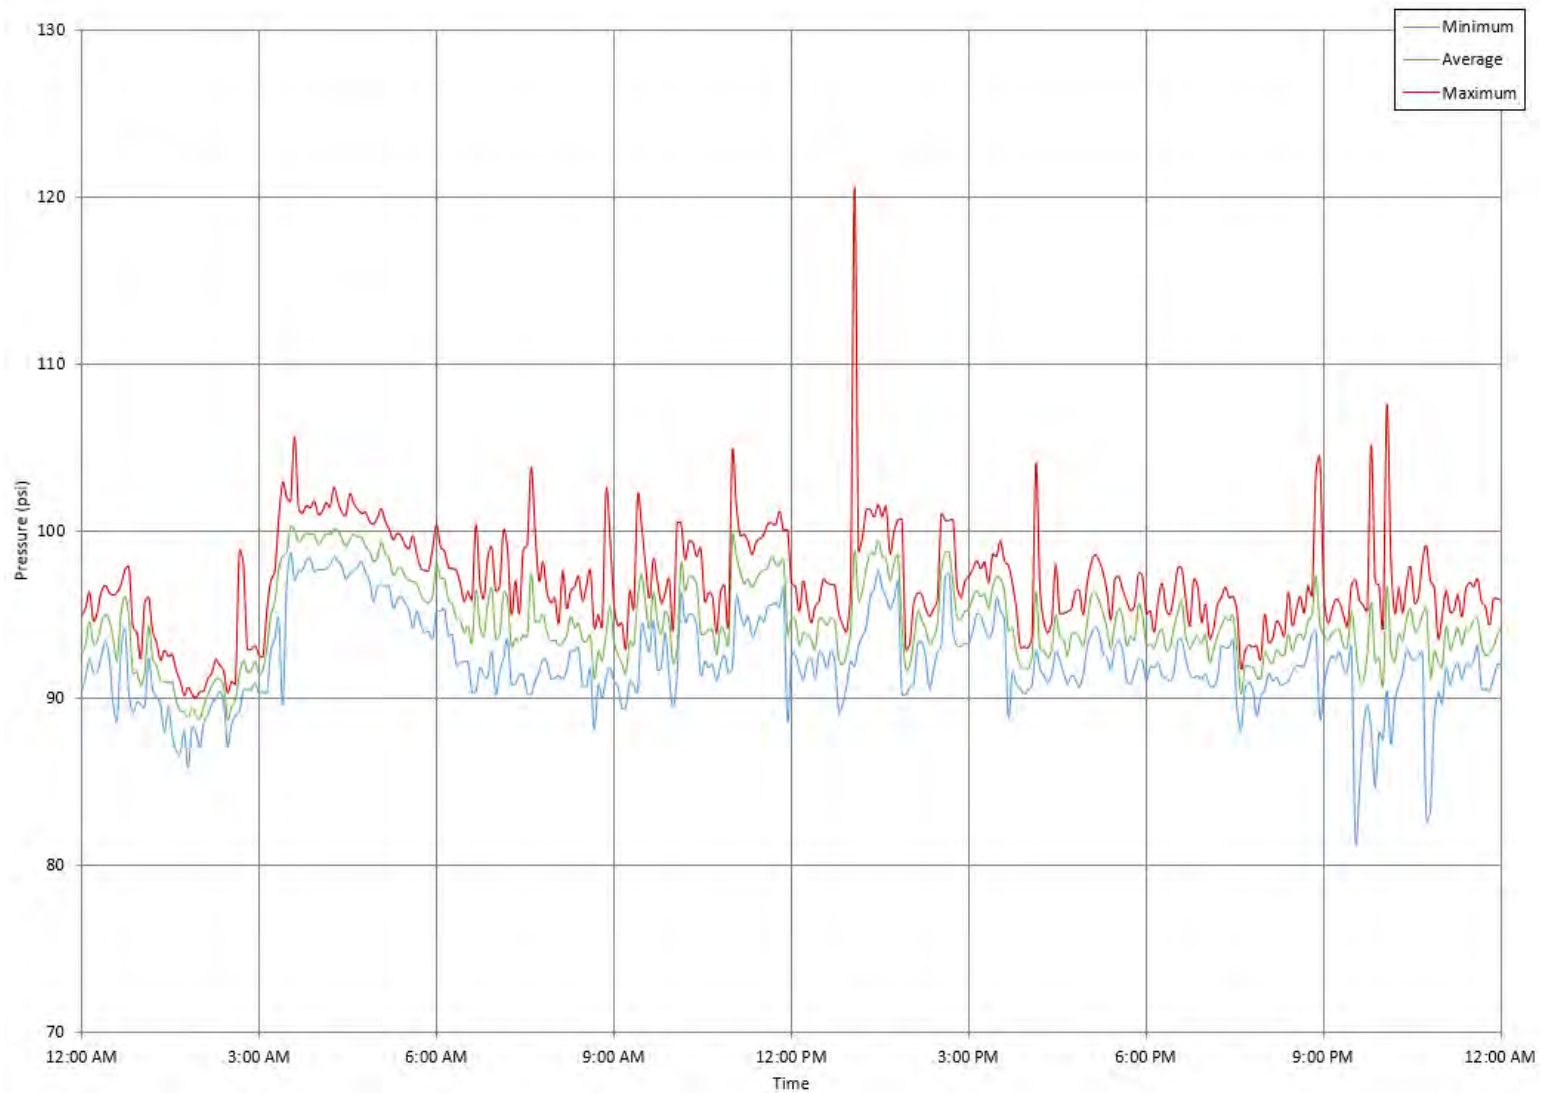
Two (2) high sample-rate transient pressure events were recording during the monitoring period which appear to coincide with pump shutoff operations. A sample week of transient pressure data is shown in Figure 4.4 and a sample day is shown in Figure 4.5. Figure 4.6 shows the apparent pump shutoff that triggered a high sample-rate recording. This coincides with the minimum pressure recorded over the monitoring period. Figure 4.7 shows the day that the maximum pressure over the monitoring period was recorded.

Figure 4.7: Novi Road Transmission Main (near NV-04) TPM Data - Maximum Pressure Recording (3/27/20).

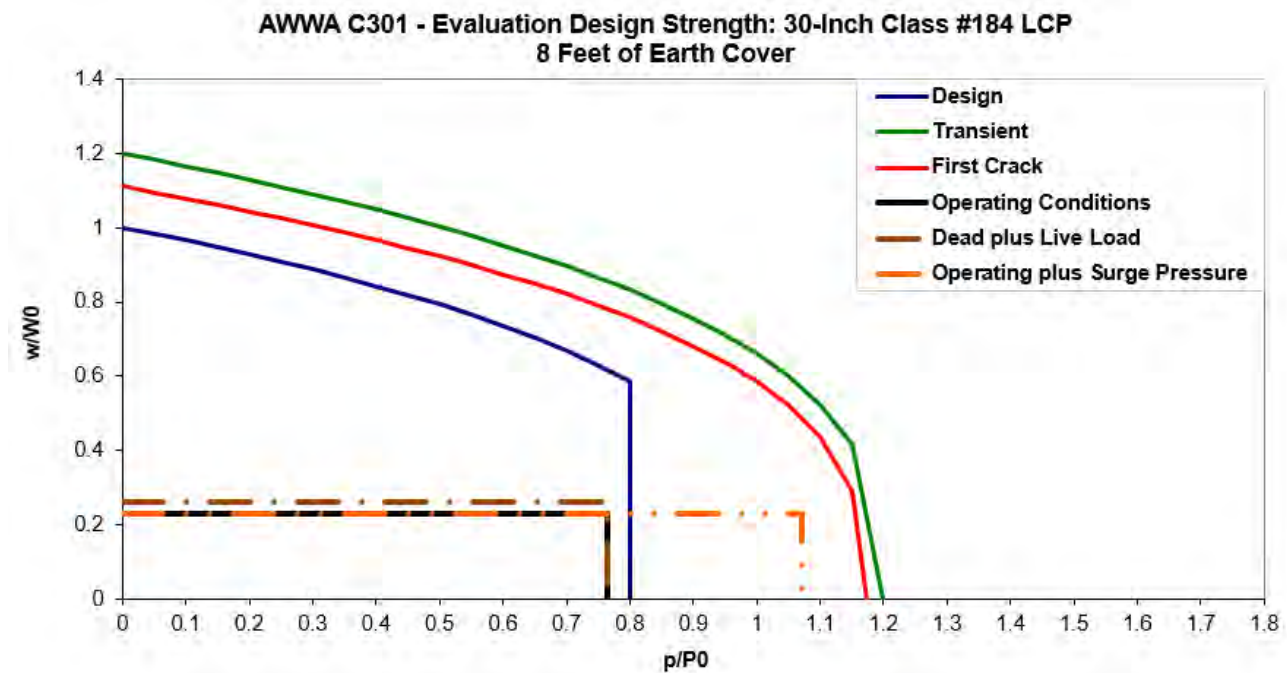
- The criteria for core decompression and the criteria for coating cracking were above the allowable limits.
  - o The AWWA C304 analysis for the 30-inch LCP Class # 184 with 8-feet depth of cover indicated that one (1) of the Serviceability Limit State criteria, Core Decompression was not satisfied.

Figure 5.2: AWWA C301-Curve for the 30-inch Class #184 LCP pipe with 8 feet of Earth Cover.

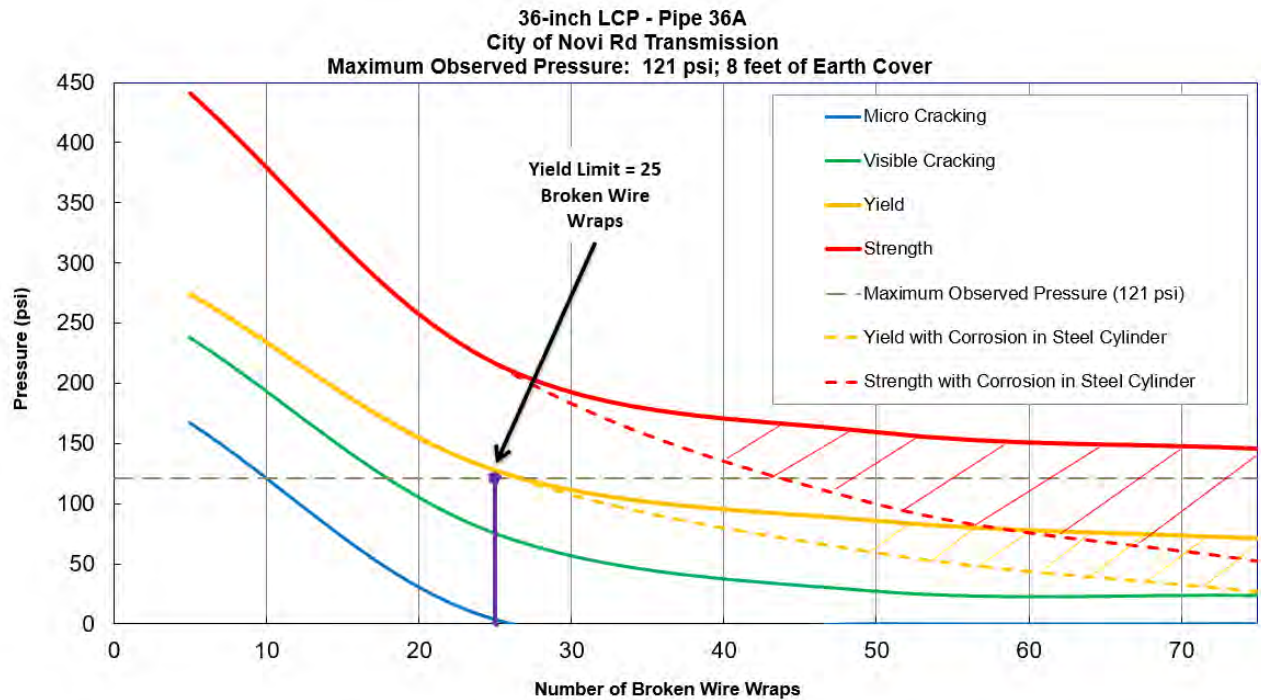
- The Pipe Performance Curves were developed for 36-, 30- and 24-inch LCP pipes across various ground covers and the limits were determined using the maximum observed pressure of 121 psi. No distress was identified during 2024, therefore FEA evaluation for pipe 36-inch Class A LCP inspected in 2020 concluded:

- o One (1) pipe exceeded the yield limit at the maximum observed operating pressure.
  - o Zero (0) pipes exceeded the strength limit at the maximum observed operating pressure.

Figure 5.8: Performance curve for the 36-inch Class A LCP pipe at maximum observed pressure.
