# City of Novi Sanitary System Critical Infrastructure

| CUSTOMER REF/PO# | JOB TITLE | SLP | SHIPPING TYPE |
|---|---|---|---|
| QUOTE | CITY OF NOVI, LIBERTY PARK STATION, FLYGT NP3153 PUMP, WASTE WATER | NRP/JBD | FREIGHT ALLOWED |

**RE: Flygt 3152.091 Liberty Park Sewage Pump #1**  
**Serial Number: S0320025**  
**Customer Reference Order #: N/A**  
**Kennedy Industries #: 133395**

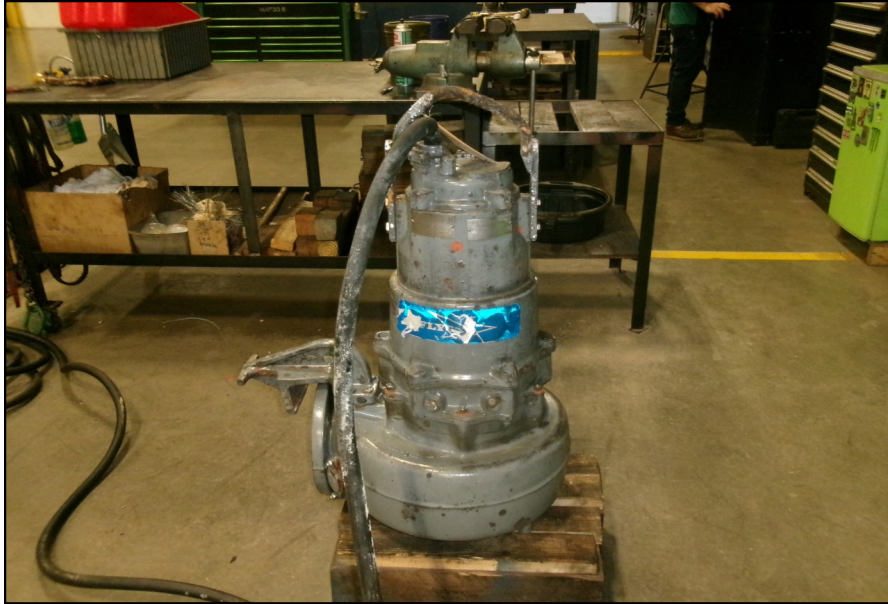
## PUMP

- Pump at disassembly.
- Pump does not rotate freely by hand.
- Pump is 23 years old.

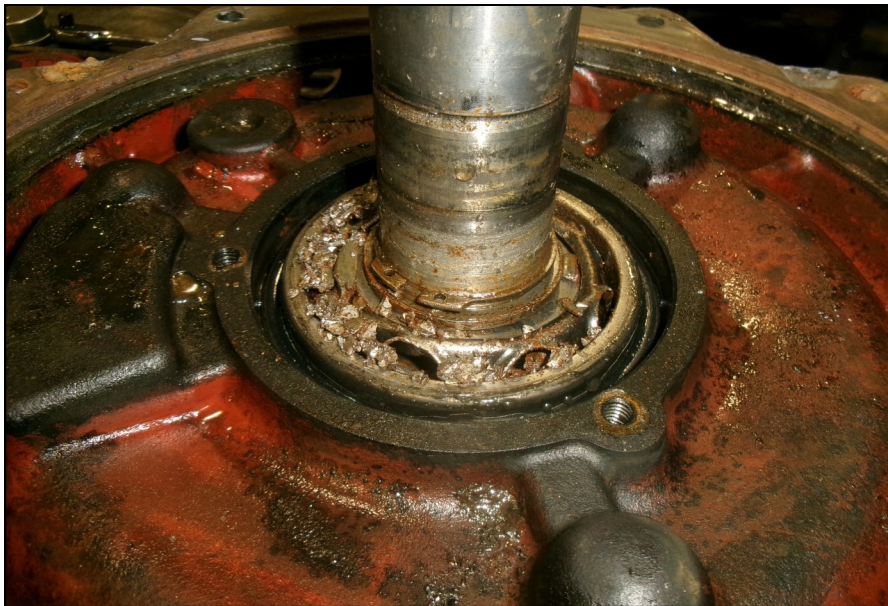
## PUMP

- Mechanical seal failure allowed water into the oil housing, eventually contaminating the internal pump components
- Mechanical seals, bearings, and O-ring would be replaced with new.

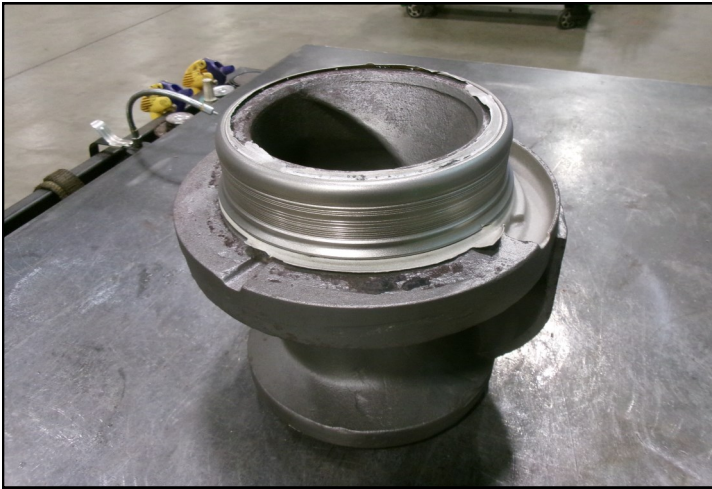
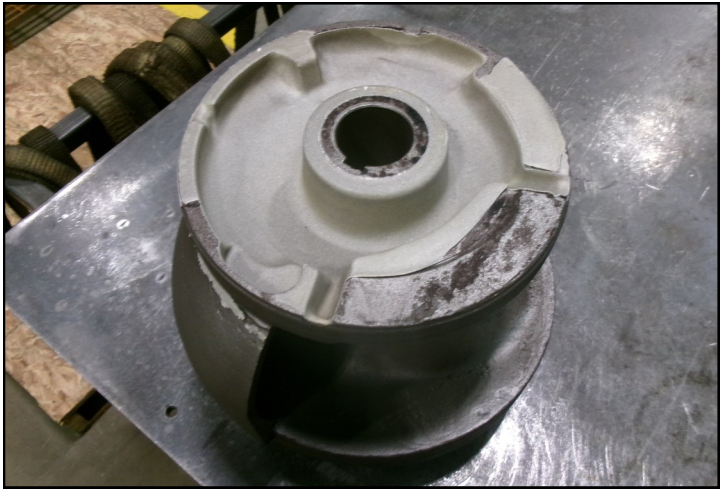
## IMPELLER

- Impeller ring is heavily grooved and would be replaced with new.
- Impeller is damaged and beyond repair.
- Impeller would be replaced with new.

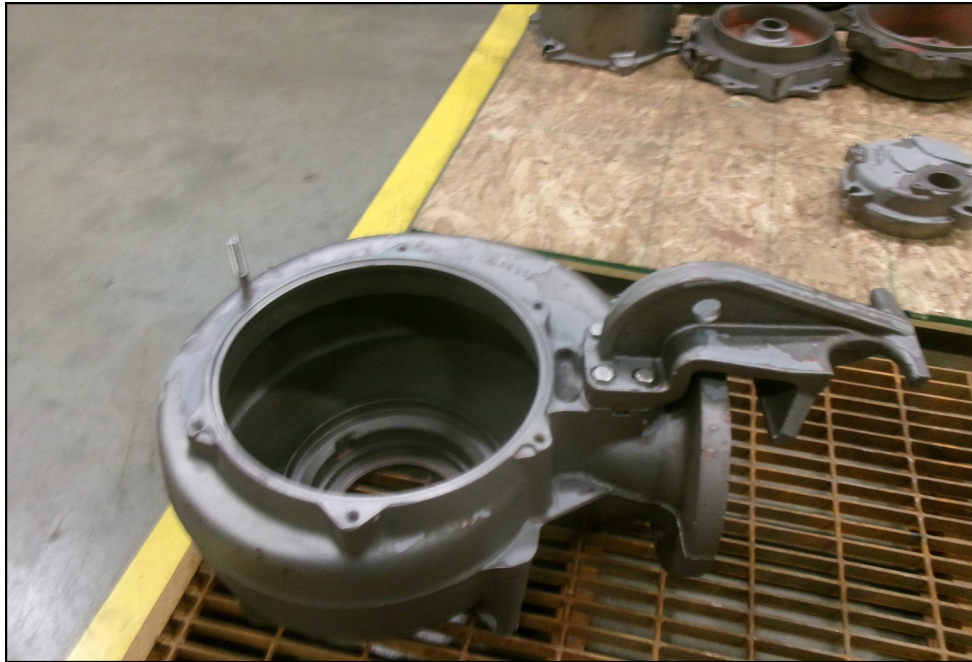
## VOLUTE

- Wear ring is worn and beyond repair.
- Wear ring would be replaced with new.
- Volute is in good condition and would be reused.

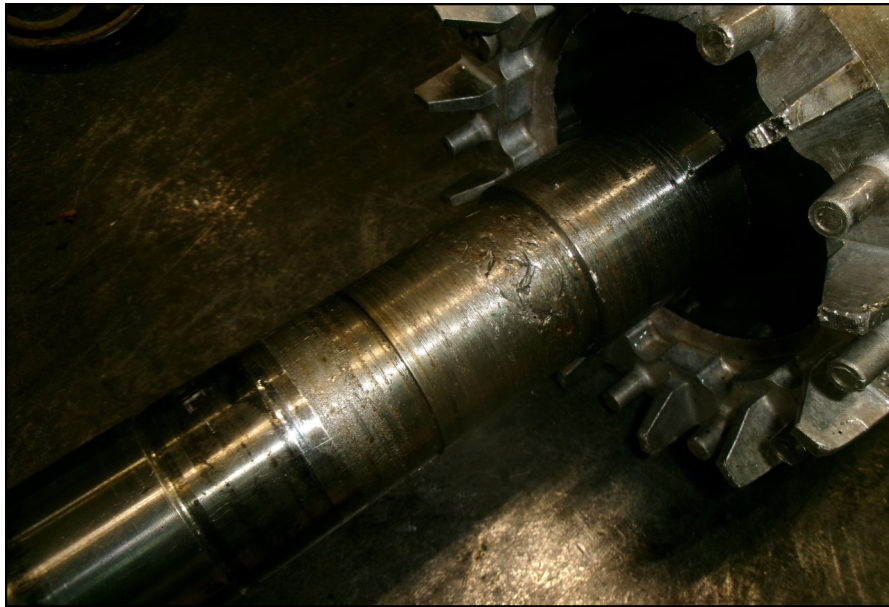
## ROTOR

- Rotor was damaged at the bearing and mechanical seal fits and is beyond repair.
- Rotor would be replaced with new.

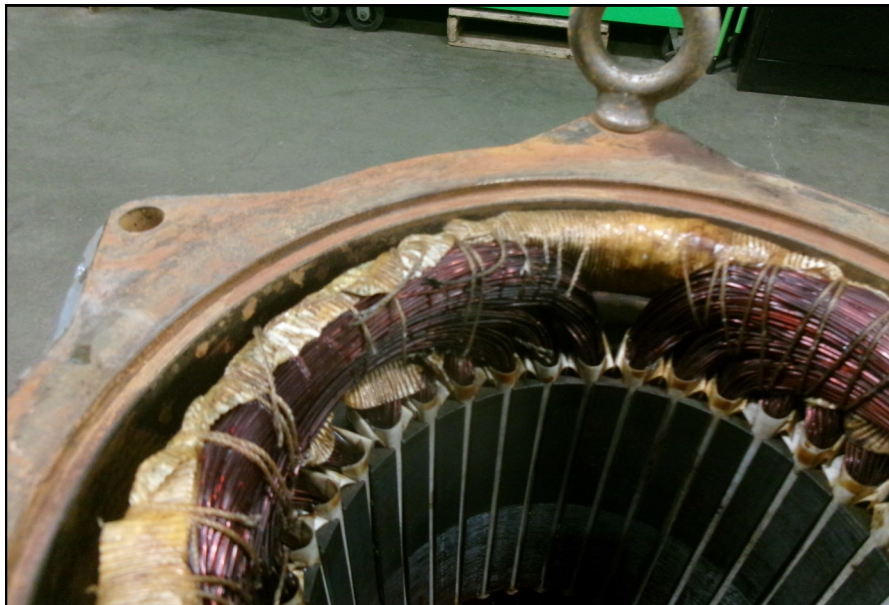
## STATOR

- Stator failed all initial testing.
- After bake and test stator failed all electrical testing.
- Stator would be replaced with new.

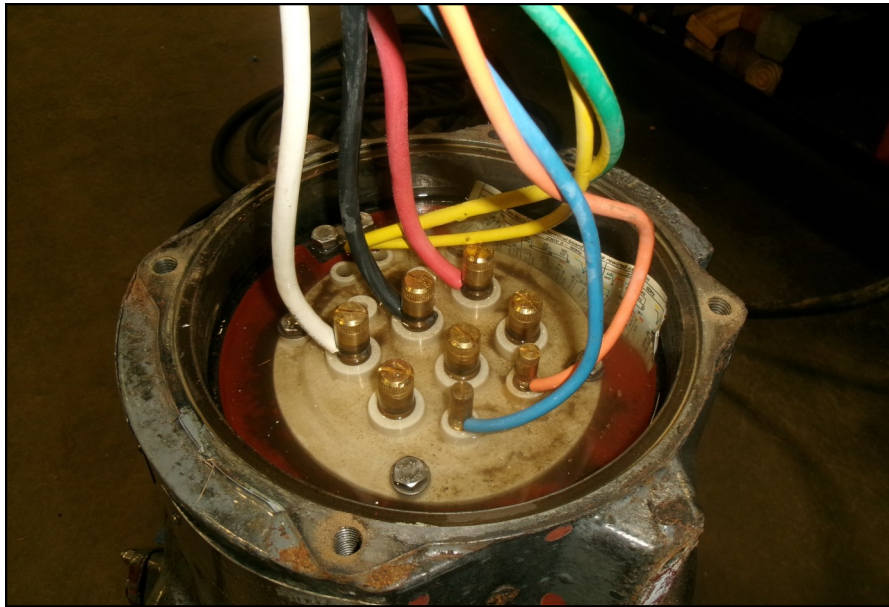
## TERMINAL BOARD

- Terminal board is contaminated.
- Terminal board would be replaced with new.

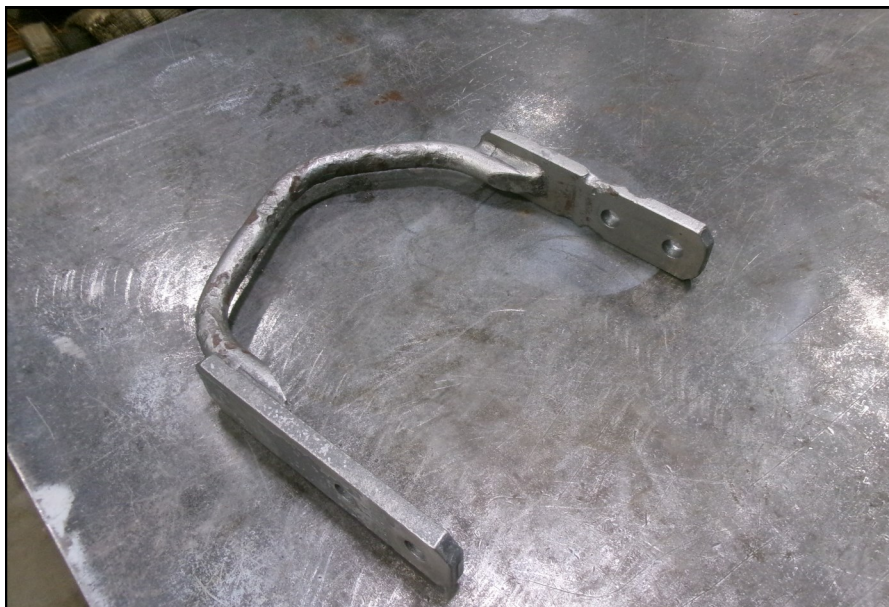
## LIFTING HANDLE

- Lifting handle is damaged.
- Lifting handle would be replaced with new.

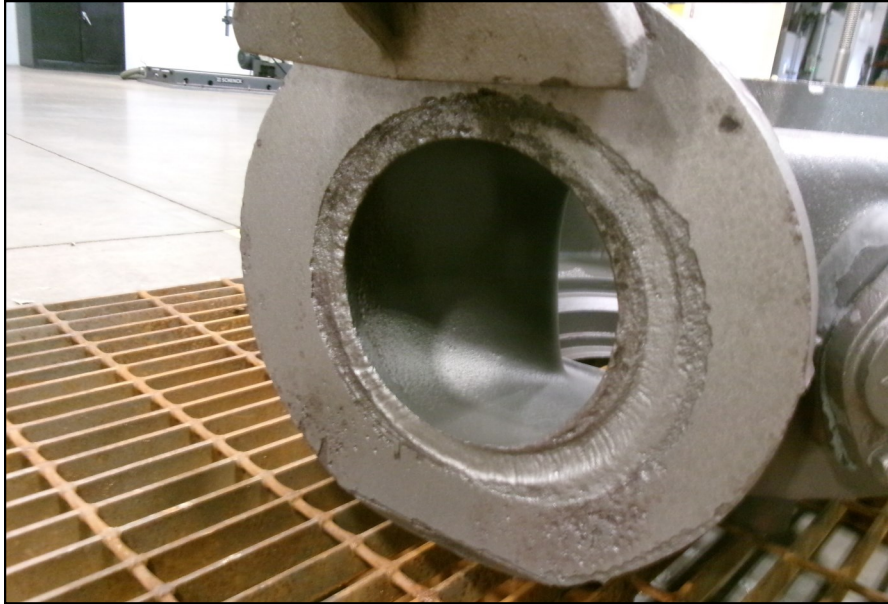
## DISCHARGE

- Volute discharge face is pitted and eroded.
- Polymer Steel would be applied and hand blended to restore flatness.

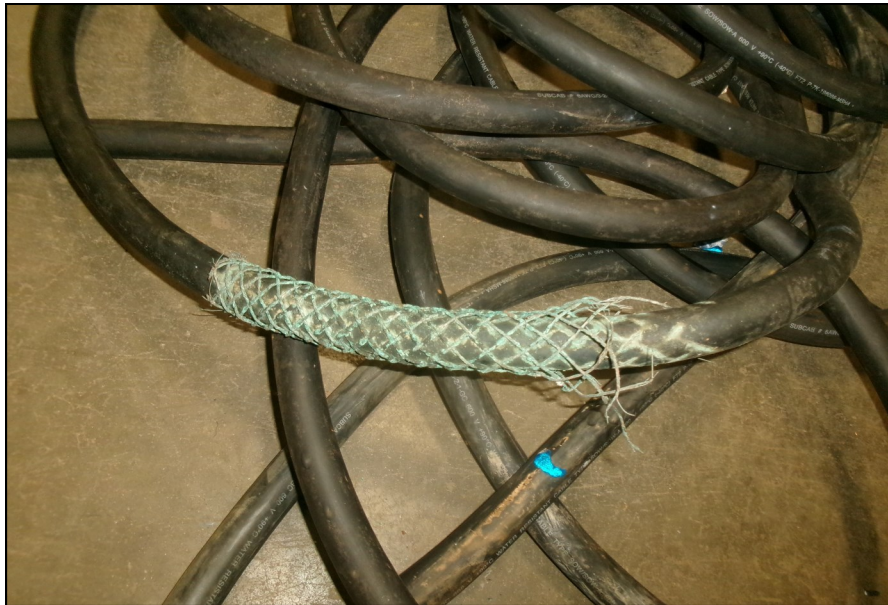
## CABLE

- Cable failed electrical testing and was saturated with water.
- Cable would be replaced with new.
