**MICHIGAN DEPARTMENT OF TRANSPORTATION**

**STR 13828**

**BRIDGE SAFETY INSPECTION REPORT**

| ASHBURY DRIVE | 42.4427 / -83.4728 | 635489000067B01 | Poor Condition(4) | |

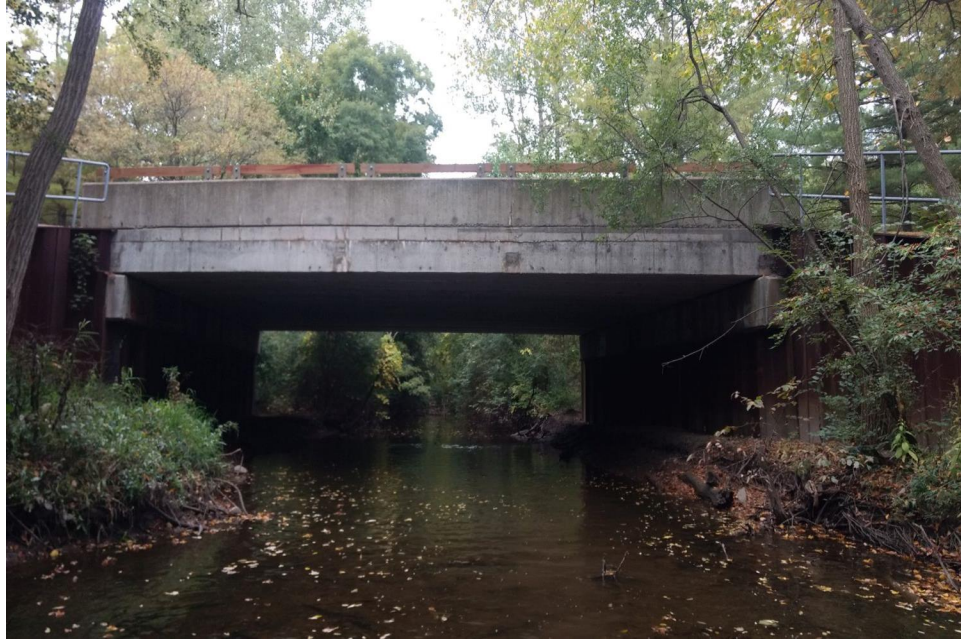
| <b>9. Stringer<br/>(SIA-59)</b> | 7 | 7 | 7 | Leaching between beams but no distress to beams. Few cracks on fascias at 4' spacing with leaching. (09/23)<br>Leaching between beams but no distress to beams. Few cracks on fascias at 4' spacing with leaching. (09/22)<br>Leaching between beams but no distress to beams. Few cracks on fascias at 4' spacing with leaching. (09/20) |

South Elevation

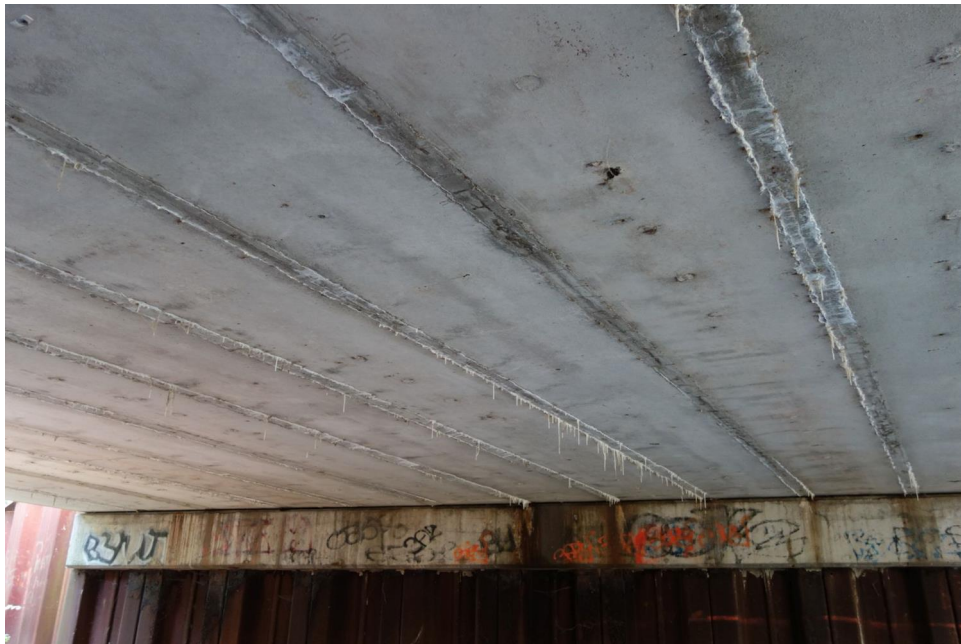
| | 09/20 | 09/22 | 09/23 | |
|---|---|---|---|---|
| <b>6. Deck<br/>Bottom<br/>Surface<br/>(SIA-58B)</b> | N | N | N | Side-by-side box beams. Leaking between all beams. Stalactites present at most beam lines and leachate at all of them. (09/23)<br>Side-by-side box beams. Leaking between all beams. Stalactites present at most beam lines and leachate at all of them. (09/22)<br>Side-by-side box beams. Leaking between all beams. Stalactites present at most beam lines and leachate at all of them. (09/20) |

Typical Deck Underside

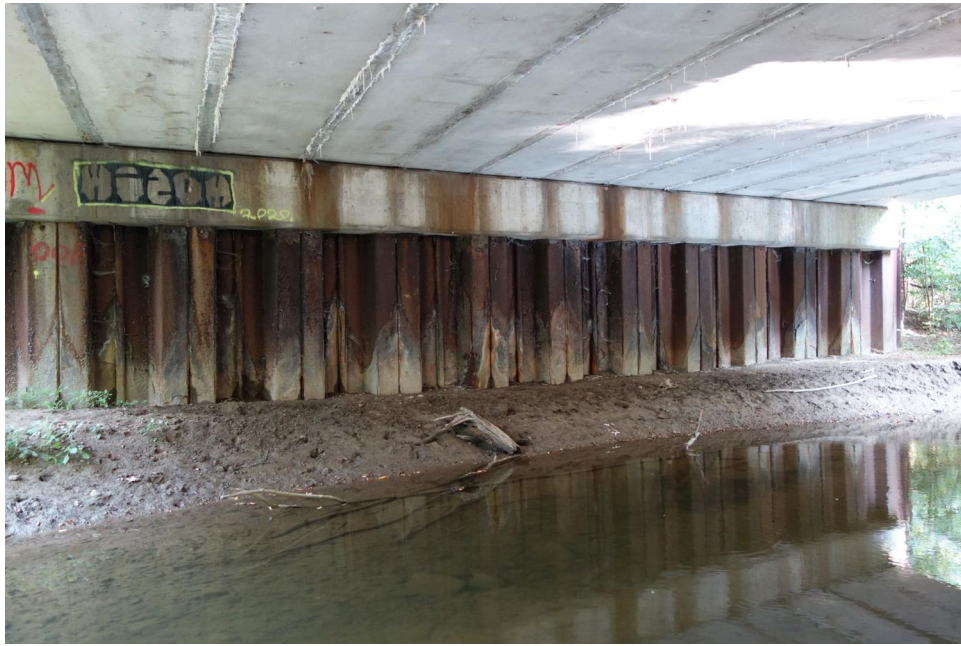
| <b>13. Abutments<br/>(SIA-60)</b> | 5 | 4 | 4 | Pack rust and scaling at base and top near beams is evident on both abutments and has progressed since the previous inspection. Some vertical cracks in concrete pile cap. Evidence of leaking from ends. Holes in sheet piling of north abutment near the middle of the base. Pack rust and scaling on north abutment is allowing water through but no material. Section loss is minor and there is leaching between the sheets of the southern abutment sheet piling. Hole near top of sheet pile reveals that the bridge is on pipe piles and the sheet piles are used as earth retention only. (09/23)<br>Pack rust and scaling at base and top near beams is evident on both abutments and has progressed since the previous inspection. Some vertical cracks in concrete pile cap. Evidence of leaking from ends. Holes in sheet piling of north abutment near the middle of the base. Pack rust and scaling on north abutment is allowing water through but no material. Section loss is minor and there is leaching between the sheets of the southern abutment sheet piling. (09/22)<br>Steel sheet piling has pack rust at base and at top near beams. Section loss is minor and there is leaching between the sheets. Some vertical cracks in concrete pile cap. Evidence of leaking from ends. (09/20) |

North Abutment

| <b>Recommendation Type</b> | <b>Priority</b> | <b>Description</b> |
|---|---|---|
| Substr Repair | M | Replace abutment sheet pile facing with more permanent solution. |

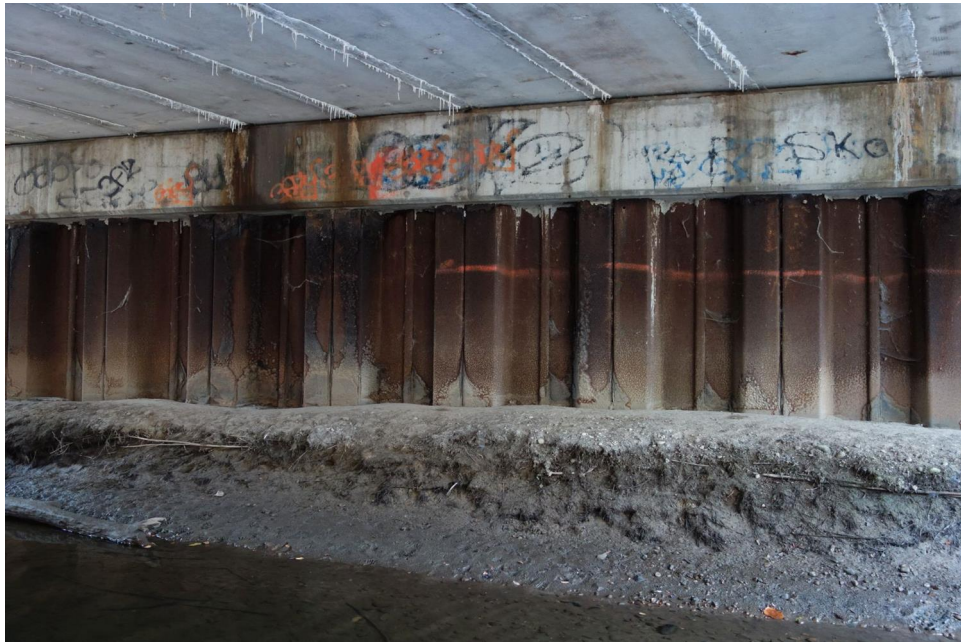
South Abutment
