# MEMORANDUM

**TO:** CHARLES BOULARD, COMM. DEVELOPMENT DIRECTOR  
**FROM:** VICTOR CARDENAS, CITY MANAGER  
**SUBJECT:** RESIDENTIAL PROPERTY MAINTENANCE PROGRAM,  
ZONES – 9,10 & 17 UPDATE  
**DATE:** DECEMBER 17, 2025

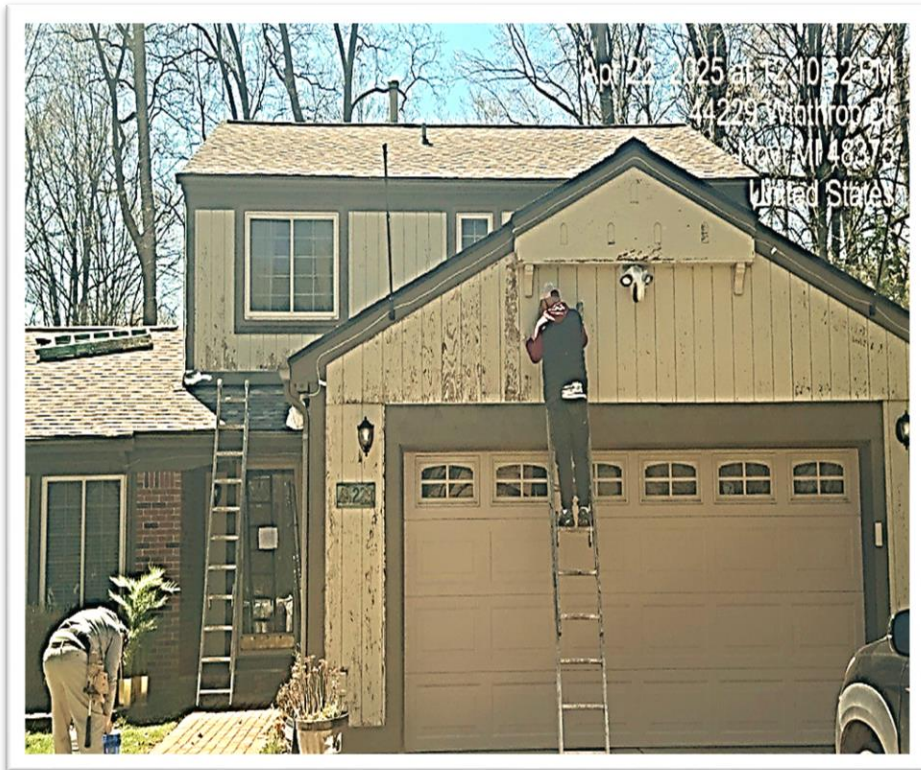
**Before- Protective treatments of paint, siding, and trim were peeling, rotting, and deteriorating.**

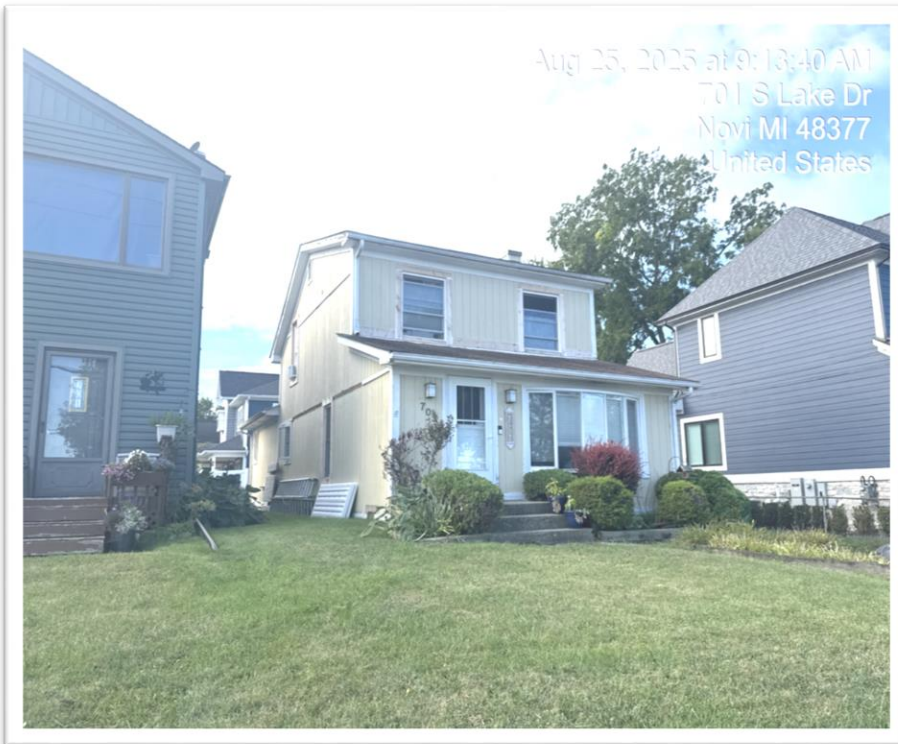
**Before-** Wood rotting on entire house, peeling, flaking and chipping paint. Window trim is missing, rotted, and needs repairs.

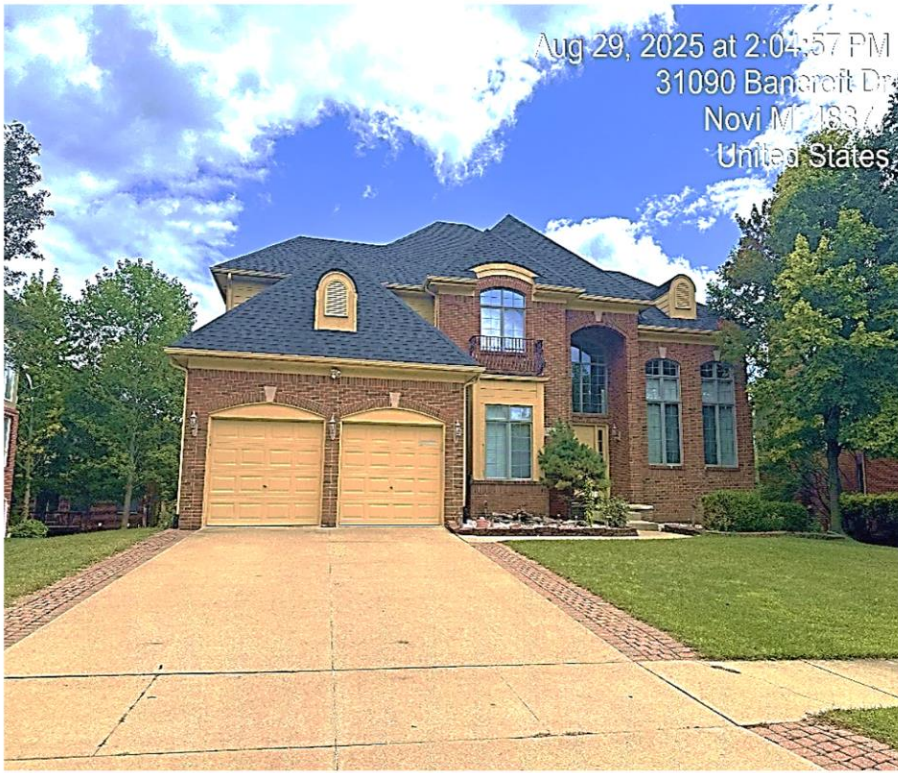
**Before-** Exterior surfaces have peeling, flaking, and chipped paint. Rotting wood on cornices, trim and dormer vents. Garage door has peeling paint and missing moldings.

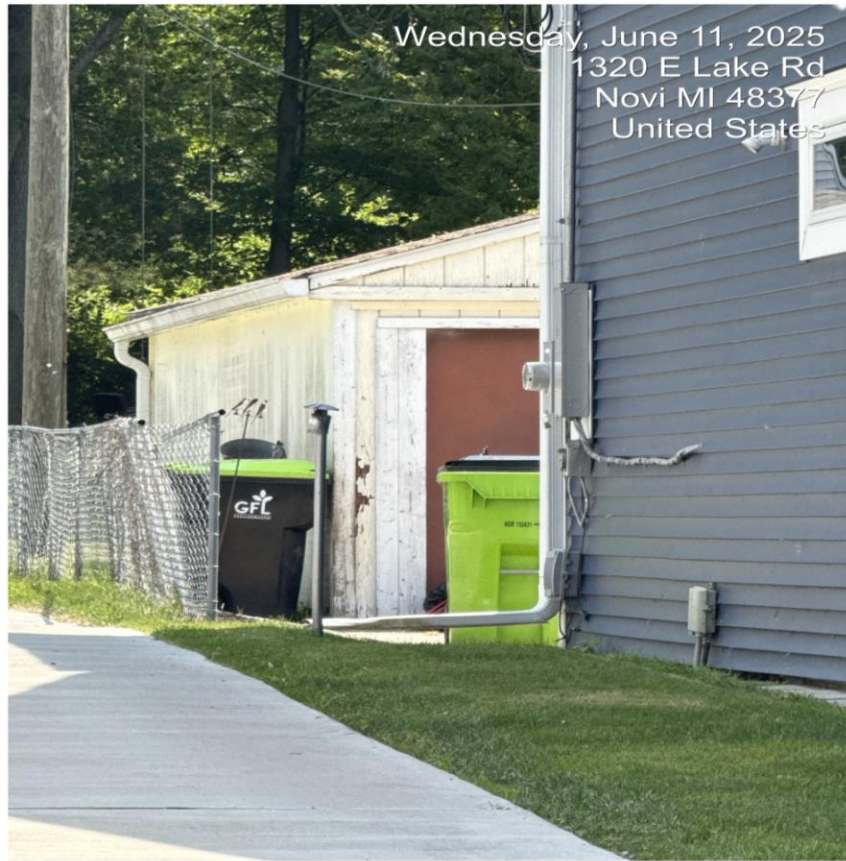
**Before- Accessory Structure (Garage) has peeling, flaking, rotted, and chipped paint. The garage door has rust and the downspout is loose.**

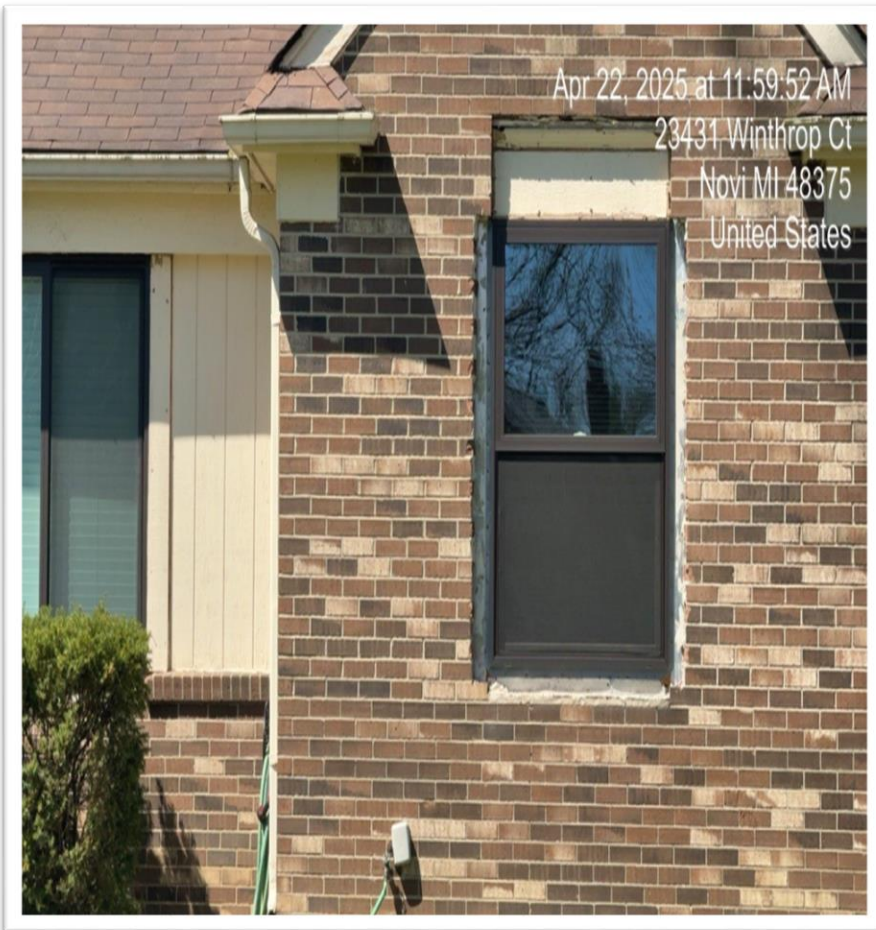
**Before – Window has peeling paint, rotted trim boards, wood rot above window and damaged windowpane**
