CITY OF NEW PRAGUE FACILITY NEEDS STUDY

ASSESSMENT REPORT

City Hall, Police, Parks

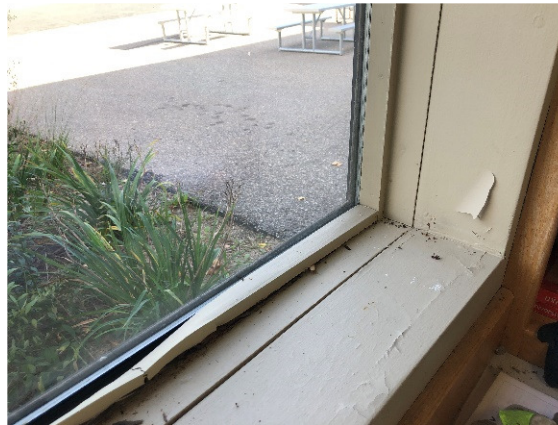
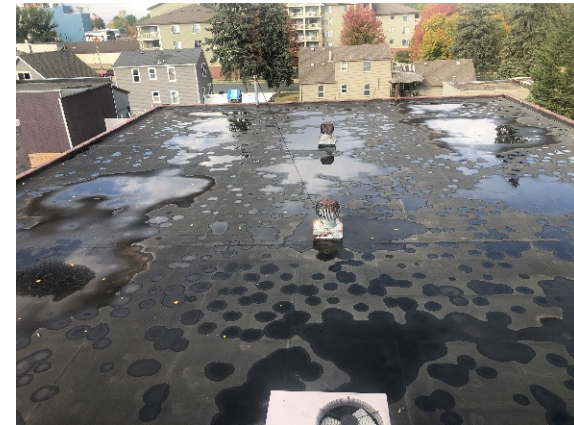
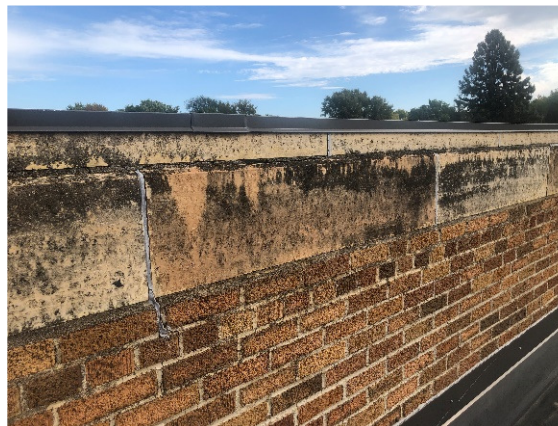
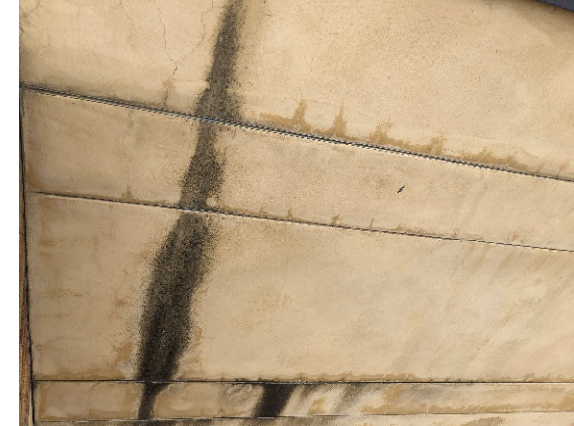
Windows are single pane and showing signs of deterioration.

Aprox. 20% of the stone and brick facades are cracking or have mortar joints that are deteriorating. Tuckpointing is recommended in affected areas.

The existing stucco or EIFS walls are showings signs of water intrusion causing discoloration, cracking, and spalling in several areas.

The existing membrane roof system over City Hall and Police is approx. 15-20 years old and will need to be replaced in the next 5-10 years. (Verify)

The existing overhead doors in police and parks have reached their useful life and should be replaced.

The membrane roof over the Parks garage does not have proper sloped insulation. Ponding throughout the roof was observed. A new roof with new sloped insulation is needed.

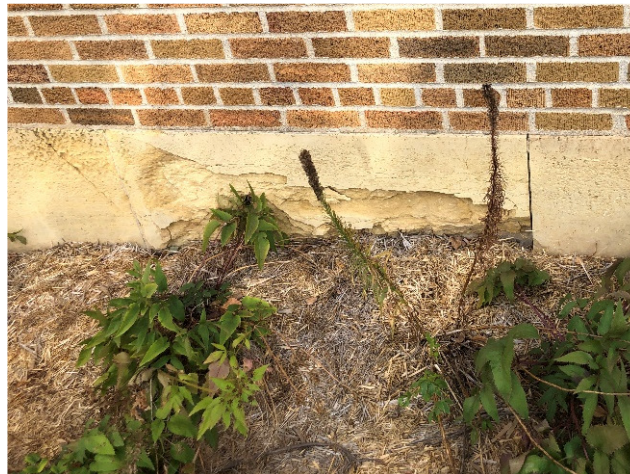
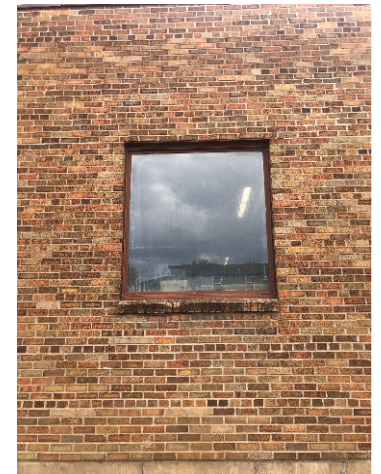
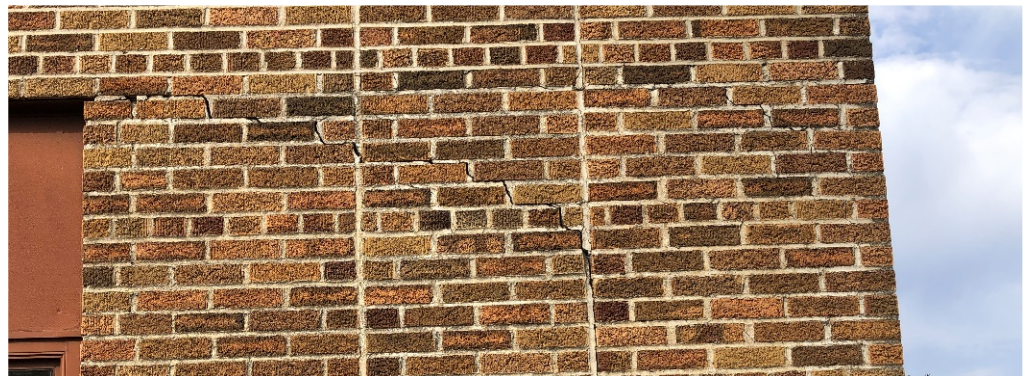
Windows are single pane and showing signs of deterioration.

Aprox. 20% of the stone and brick facades are cracking or have mortar joints that are deteriorating. Tuckpointing is recommended in affected areas.

The existing stucco or EIFS walls are showing signs of water intrusion causing discoloration, cracking, and spalling in several areas.

The existing membrane roof system over City Hall and Police is approx. 15-20 years old and will need to be replaced in the next 5-10 years. (Verify)

The existing overhead doors in police and parks have reached their useful life and should be replaced.

The membrane roof over the Parks garage does not have proper sloped insulation. Ponding throughout the roof was observed. A new roof with new sloped insulation is needed.

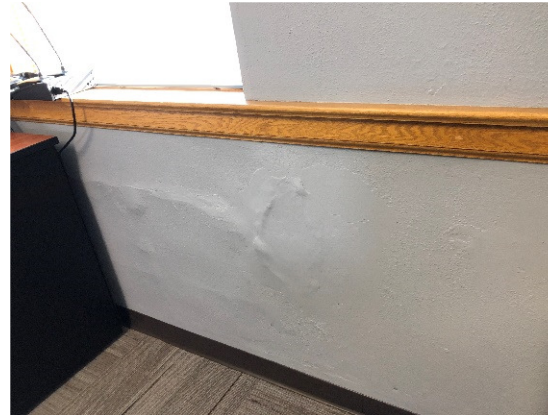
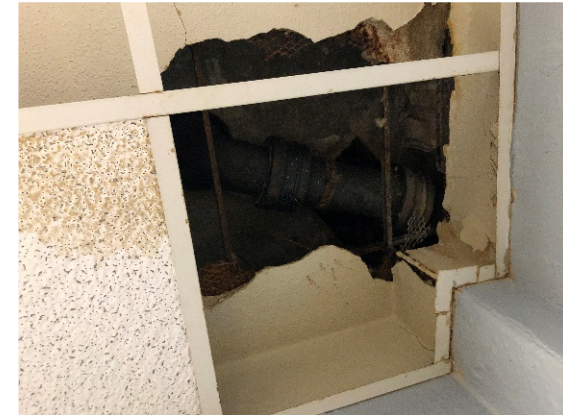
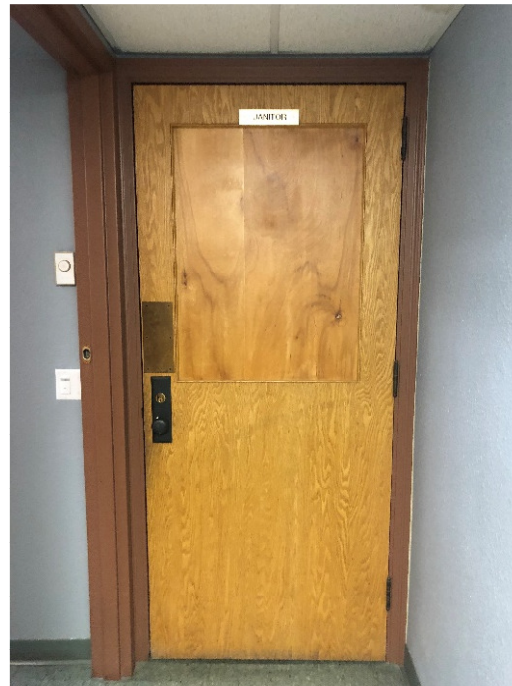
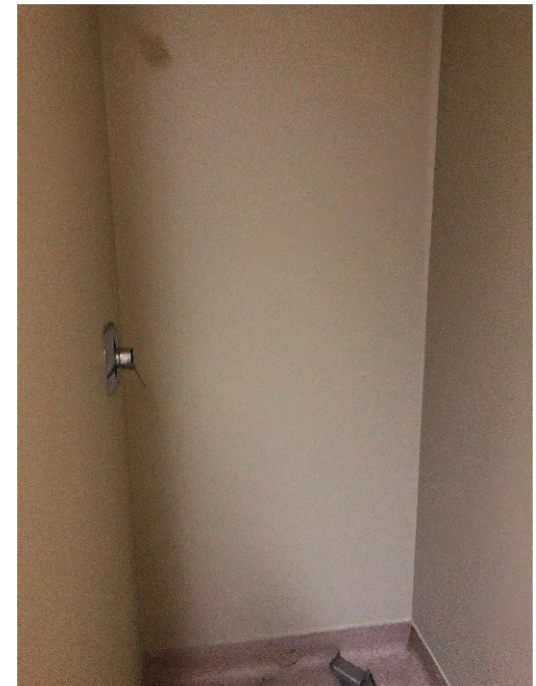
The concrete slab in the garage and maintenance areas do not have a salt-inhibiting sealer to protect the finished surface causing concrete to spall.

ACT ceilings throughout the facility are showing signs of age and should be replaced in conjunction with lighting replacement or HVAC upgrades.

A majority of the wood doors are showing signs of deterioration and should be replaced with new hardware.

Showers in police do not have tile on walls.

Several plaster walls throughout the facility are cracked and should be refinished or covered over in new sheet rock.

Approx. 60% of the carpet flooring and vinyl composite flooring throughout the facility is showing signs of wear and should be replaced soon.

Existing casework and woodwork throughout the facility are showing signs of deterioration and/or delamination.

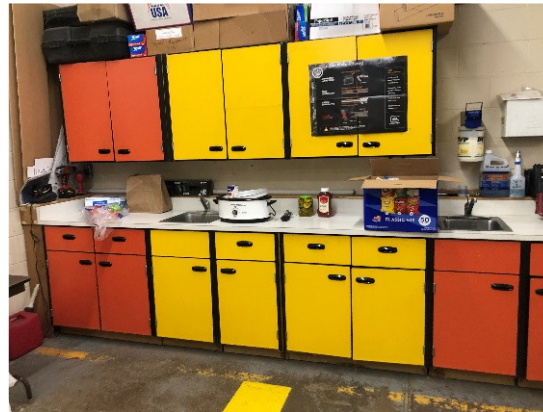
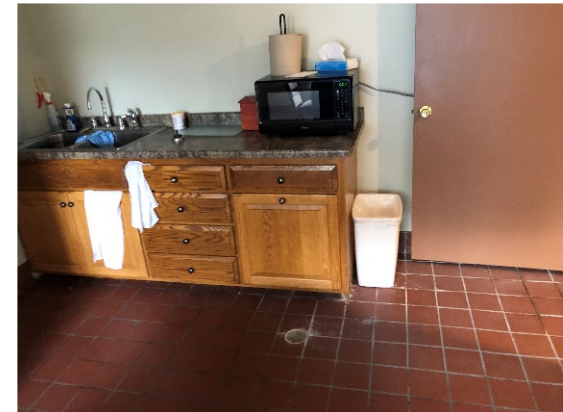
The concrete slab in the garage and maintenance areas do not have a salt-inhibiting sealer to protect the finished surface causing concrete to spall.

ACT ceilings throughout the facility are showing signs of age and should be replaced in conjunction with lighting replacement or HVAC upgrades.

A majority of the wood doors are showing signs of deterioration and should be replaced with new hardware.

Showers in police do not have tile on walls.

Several plaster walls throughout the facility are cracked and should be refinished or covered over in new sheet rock.

Approx. 60% of the carpet flooring and vinyl composite flooring throughout the facility is showing signs of wear and should be replaced soon.

Existing casework and woodwork throughout the facility are showing signs of deterioration and/or delamination.

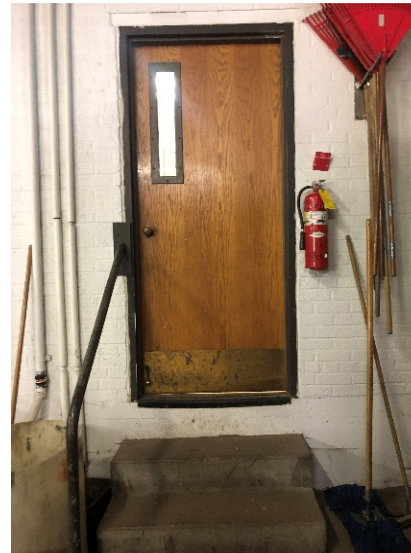
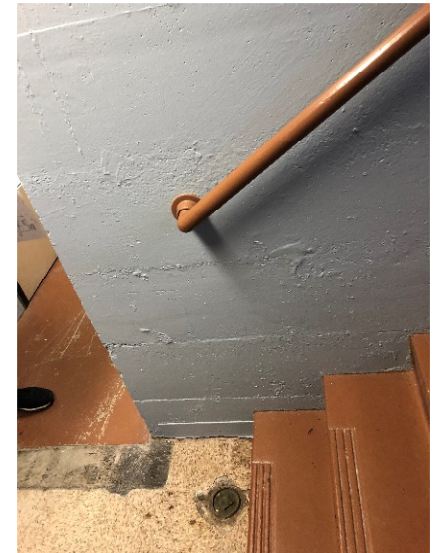
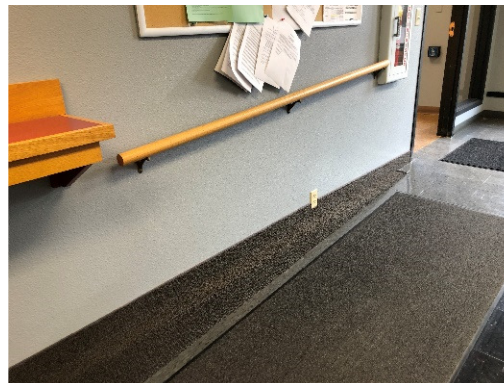
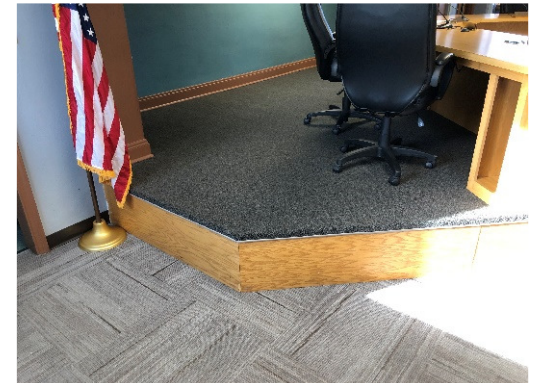
The handrails at ramps and stairs do not have the proper extensions and do not meet current ADA guidelines for accessibility.

The main stairs at City Hall have risers greater than 7". IBC requires risers to be a max. of 7" with tread depth min. 11".

A portion of the police space is only accessible by stair and should have a ramp or elevator to meet current accessibility codes.

The police toilet rooms do not have the required clearances to meet the ADA guidelines for accessibility.

The dias in Council Chambers does not have guard rails.

The roof access ladder and exterior roof ladders are not OSHA compliant.

Several existing doors have closers whose opening force exceed the recommended 5 pounds opening force.

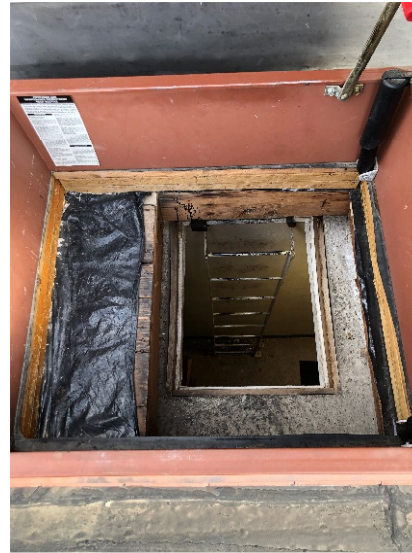
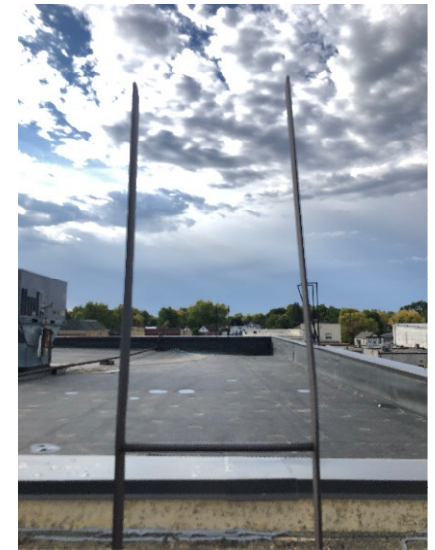
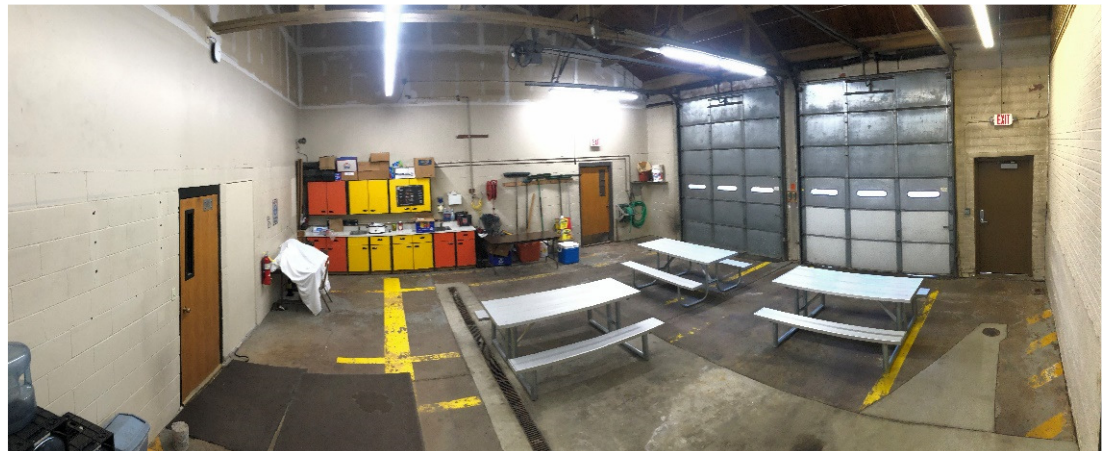
The handrails at ramps and stairs do not have the proper extensions and do not meet current ADA guidelines for accessibility.

The main stairs at City Hall have risers greater than 7". IBC requires risers to be a max. of 7" with tread depth min. 11".

A portion of the police space is only accessible by stair and should have a ramp or elevator to meet current accessibility codes.

The police toilet rooms do not have the required clearances to meet the ADA guidelines for accessibility.

The dias in Council Chambers does not have guard rails.

The roof access ladder and exterior roof ladders are not OSHA compliant.

Several existing doors have closers whose opening force exceed the recommended 5 pounds opening force.

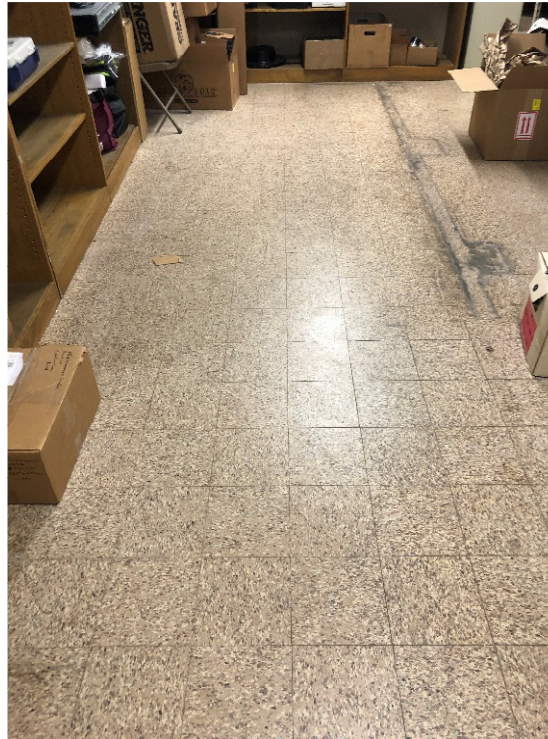
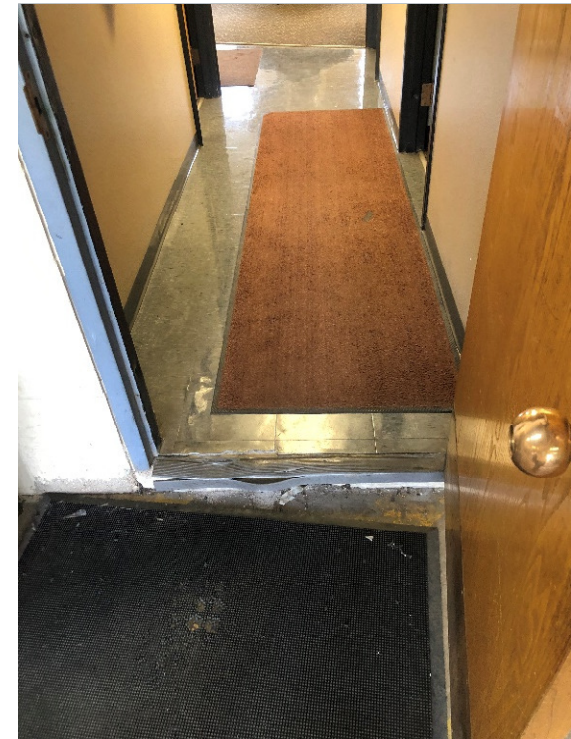
Fire barriers between police garage (S-2) and police office (B) are not in place.

Based on the vintage of the original building, it is likely that asbestos, lead, and other hazardous materials exist throughout the building. A hazardous material inspection should be completed.

The basement contains 8" x 8" vinyl tiles that typically contain asbestos adhesives. Any modifications to the basement floor would likely necessitate abatement of the floor.
