**Office of Bridges and Structures
Bridge Maintenance and Inspection Unit**

Bridge Condition Report

Bridge ID: 10TH ST SW NBI Number: 8920
District: 0 Inspection Group: Origin Design
Inspection Type: In-Depth
Inspection Date: 02/28/2023
Carrying: 10TH ST SW over OTTER CREEK
Location: 000000000
Approved By:

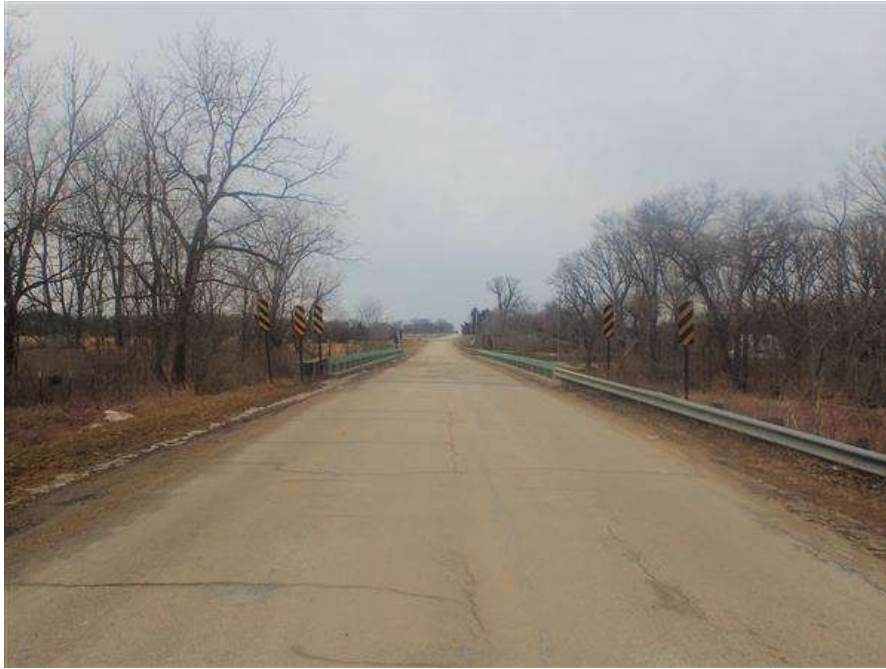
Photo Number: 1

ROAD VIEW LOOKING WEST

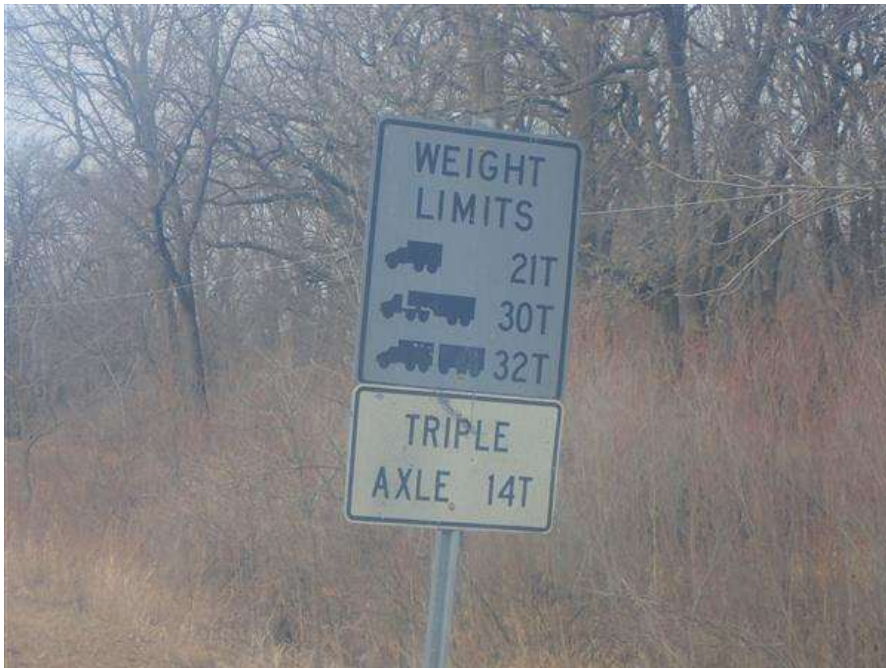
Photo Number: 2

Type	Legibility	Visibility	REMARKS
Advanced Posting	<u>Sign Missing</u>	<u>Sign Missing</u>	<u>NONE</u>
Posted Loads	<u>Poor</u>	<u>Good</u>	<u>FADED/WORN</u>
Narrow			<u>NONE</u>
One Lane			<u>NONE</u>
Object Markers	<u>Fair</u>	<u>Fair</u>	<u>FADED/WORN/TILTED</u>

WEIGHT EMBARGO SIGNAGE

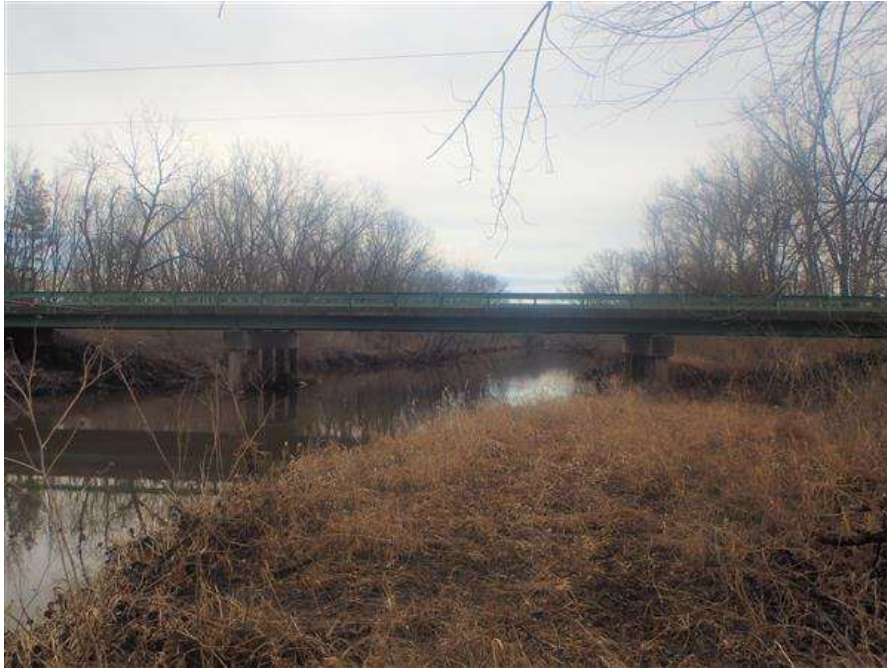
Photo Number: 3

SIDE VIEW LOOKING SOUTH

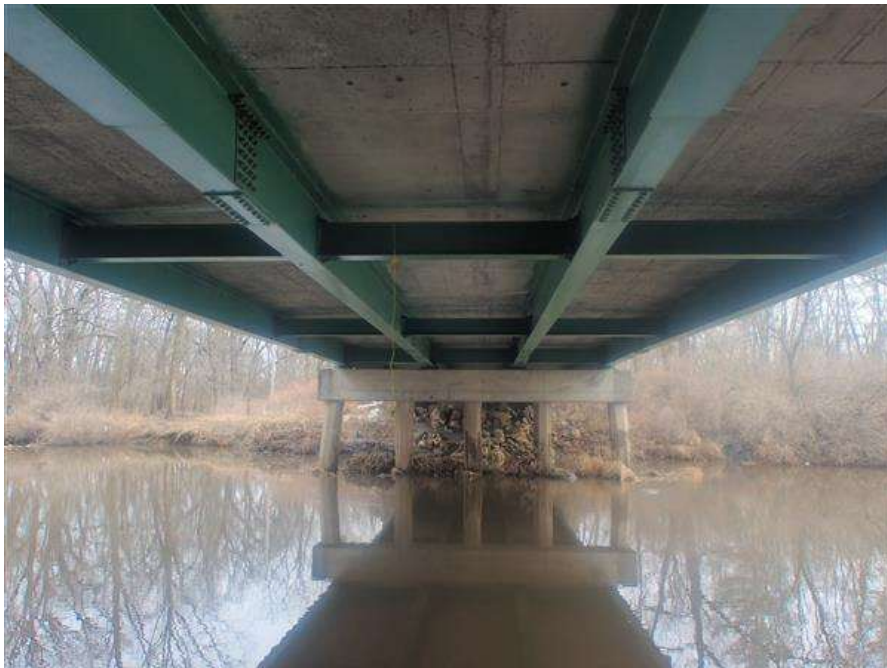
Photo Number: 4

UNDER LOOKING EAST

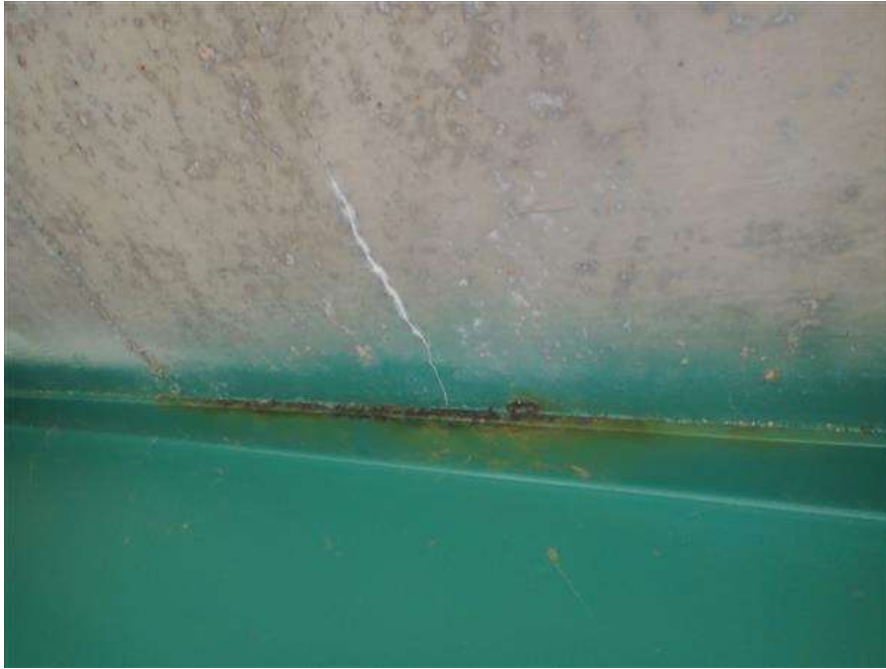
Photo Number: 5

TRANSVERSE CRACKING WITH EFFLORESCENCE AND CORROSION AT BEAM TOP FLANGE

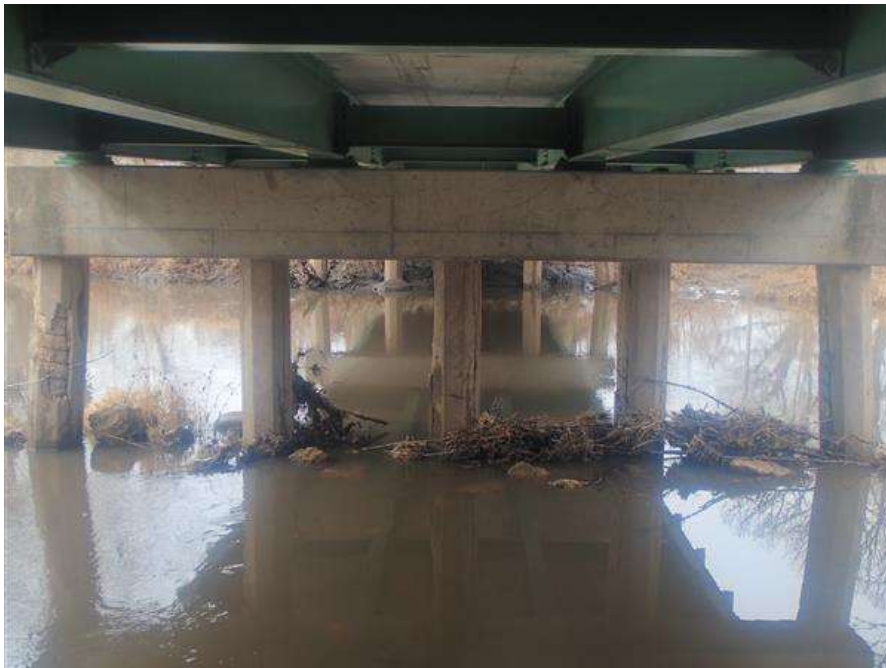
Photo Number: 6

SUBSTRUCTURE	CONDITION RATING	REMARKS
1. Abutments - Caps	6	
Wings	6	
Backwall	6	
Footing	N	
Piles		NOT EXPOSED.
Erosion	6	
Settlement	8	
2. Piers or Bents - Caps	6	HAIRLINE VERTICAL CRACKING AT EAST PIER CAP.
Columns	N	
Footings	N	
Piles	4	SEVERE DETERIORATION (VERTICAL CRACKING, DELAMINATIONS, AND SPALLING) OF EAST PIER PILE ENCASEMENTS WITH EXPOSED CIRCUMFERENTIAL REINFORCING.
Scour	6	
Settlement	8	
3. Concrete Cracking	4	EAST PIER PILE ENCASEMENTS SEVERELY CRACKING/SPALLING/DELAMINATED.
4. Steel Corrosion	5	CORROSION WITH SECTION LOSS OF CIRCUMFERENTIAL REINFORCING AND H PILES IN EAST PIER.
5. Timber Decay	N	
6. Debris on Seats	7	
7. Paint	N	
8. Collision Damage	8	
General Comments		
		(Remark required for NBI rating of 5 or less)
ITEM 60 SUBSTRUCTURE CONDITION RATING	4	CONCRETE SPALLING WITH EXPOSED REINFORCING AND H-PILES AT EAST PIER PILE ENCASEMENTS.

CRACKING, DELAMINATED, SPALLING WITH EXPOSED CIRCUMFERENTIAL REINFORCING AT EAST PIER PILE ENCASEMENTS

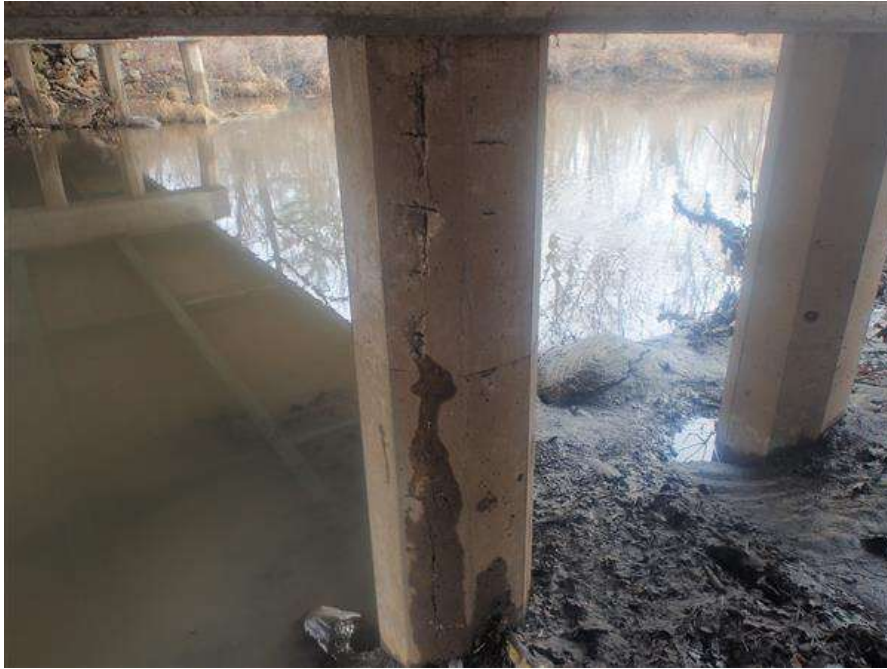
Photo Number: 7

VERTICAL CRACKING AT N3 PILE ENCASEMENT IN WEST ABUTMENT

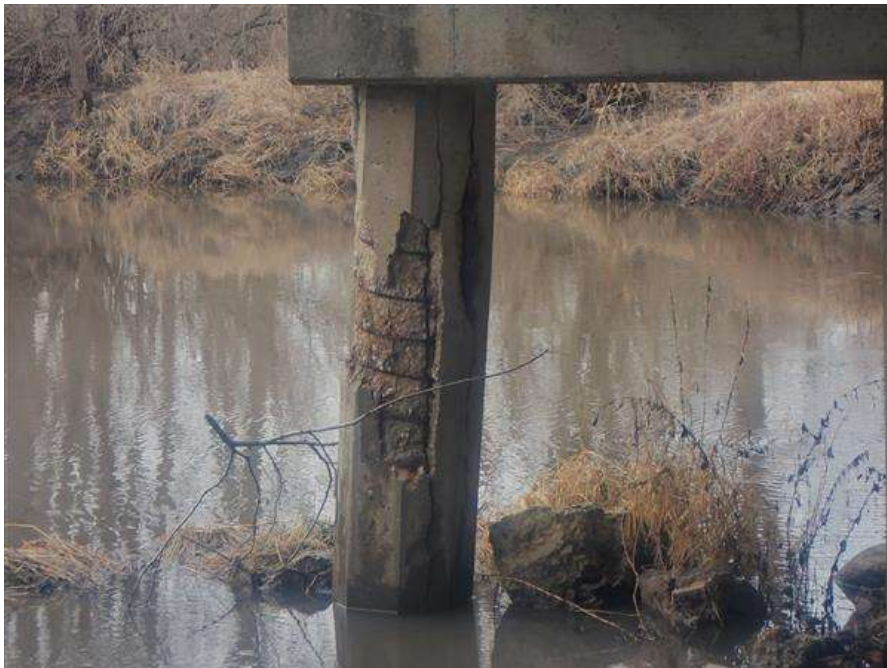
Photo Number: 8

CRACKING, DELAMINATED, SPALLING WITH EXPOSED CIRCUMFERENTIAL REINFORCING AT N5 PILE ENCASEMENT IN EAST PIER

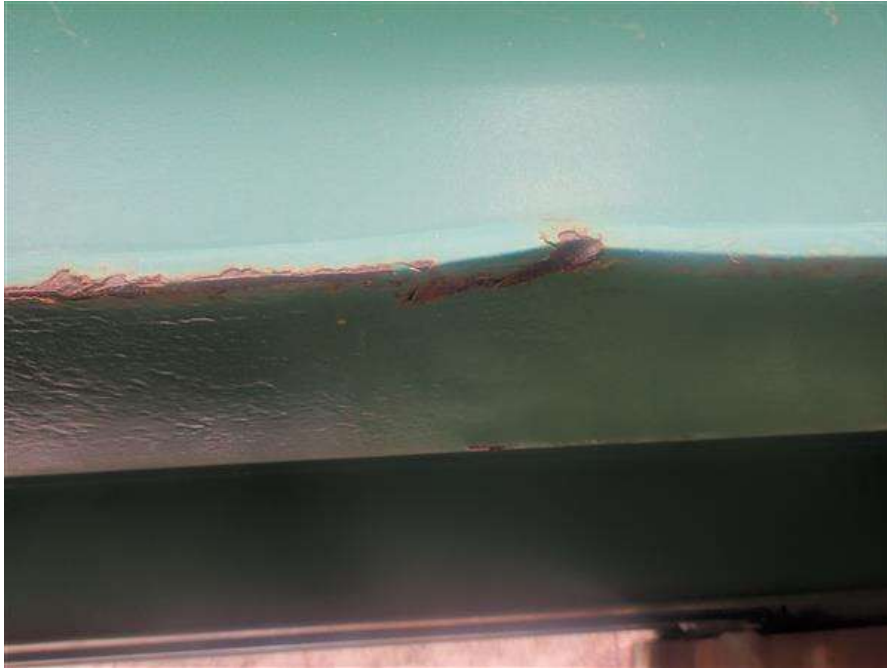
Photo Number: 9

IMPACT DAMAGE AT EXTERIOR FACE OF BOTTOM FLANGE AT N4 BEAM IN EAST SPAN NEAR ABUTMENT BEARING

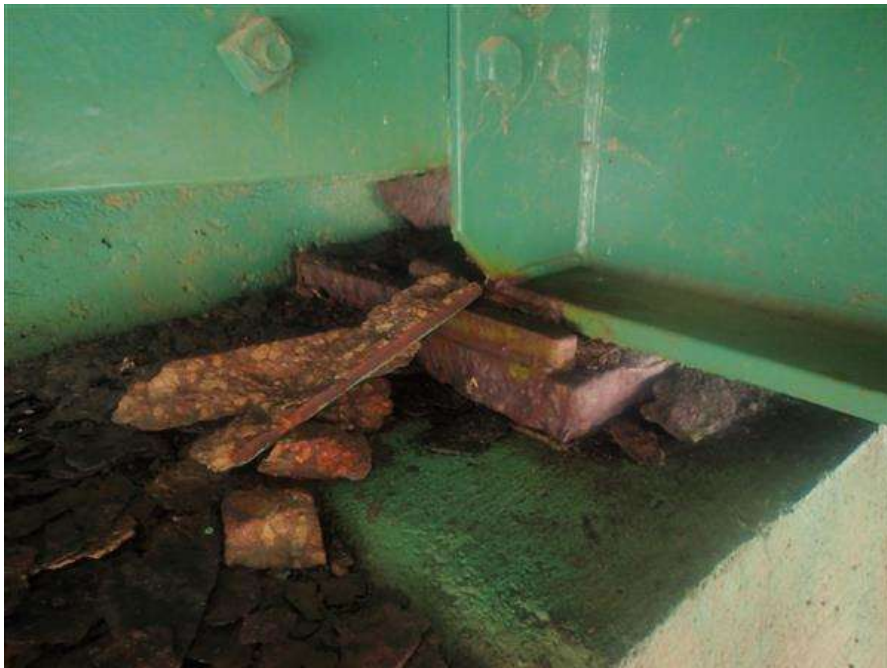
Photo Number: 10

ABUTMENT BEARINGS CORRODED WITH NO OBSERVED SECTION LOSS.

CORROSION AT ABUTMENT BEARINGS, TYPICAL

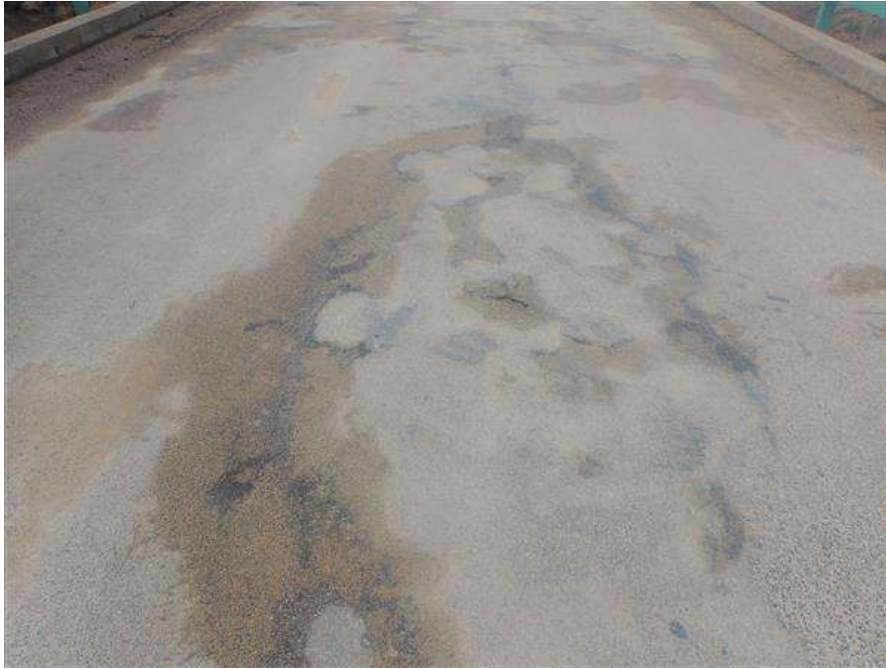
Photo Number: 11

ITEM 58 DECK CONDITION RATING	4	SPALLING CONCRETE WITH EXPOSED TRANSVERSE REINFORCING ON WEARING SURFACE. NUMEROUS DECK SPALLS PATCHED WITH AC AND AC OVERLAY ARE DETRIMENTAL TO CONCRETE DECK.
-------------------------------	---	---

AC OVERLAY DETRIMENTAL TO CONCRETE DECK
