Street Rehabilitation 2022

Transportation Mapping Focus Areas

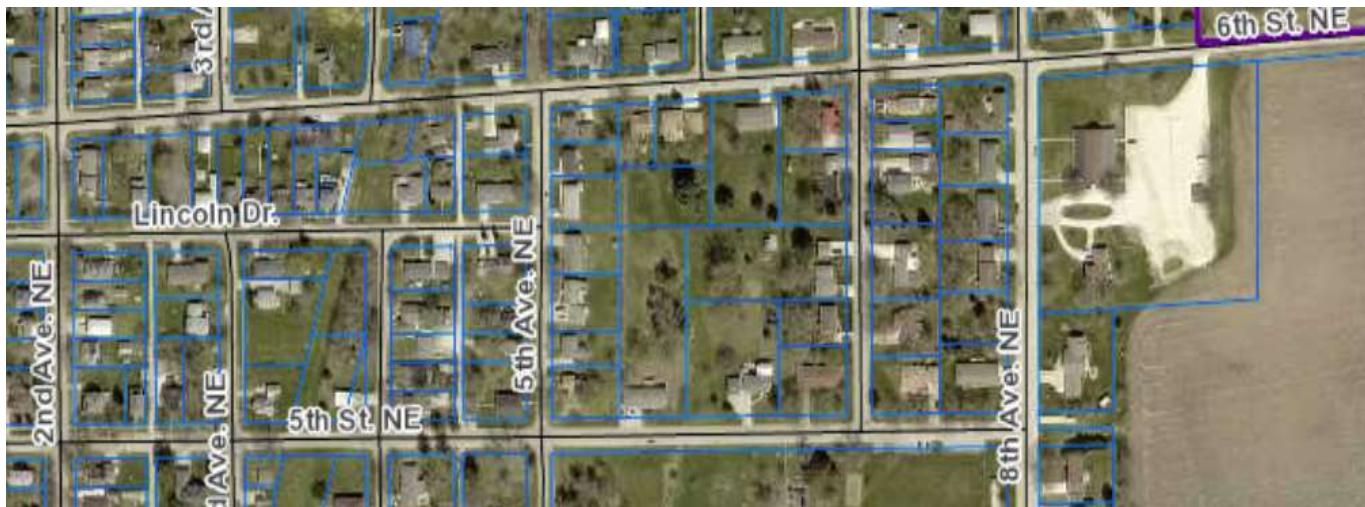
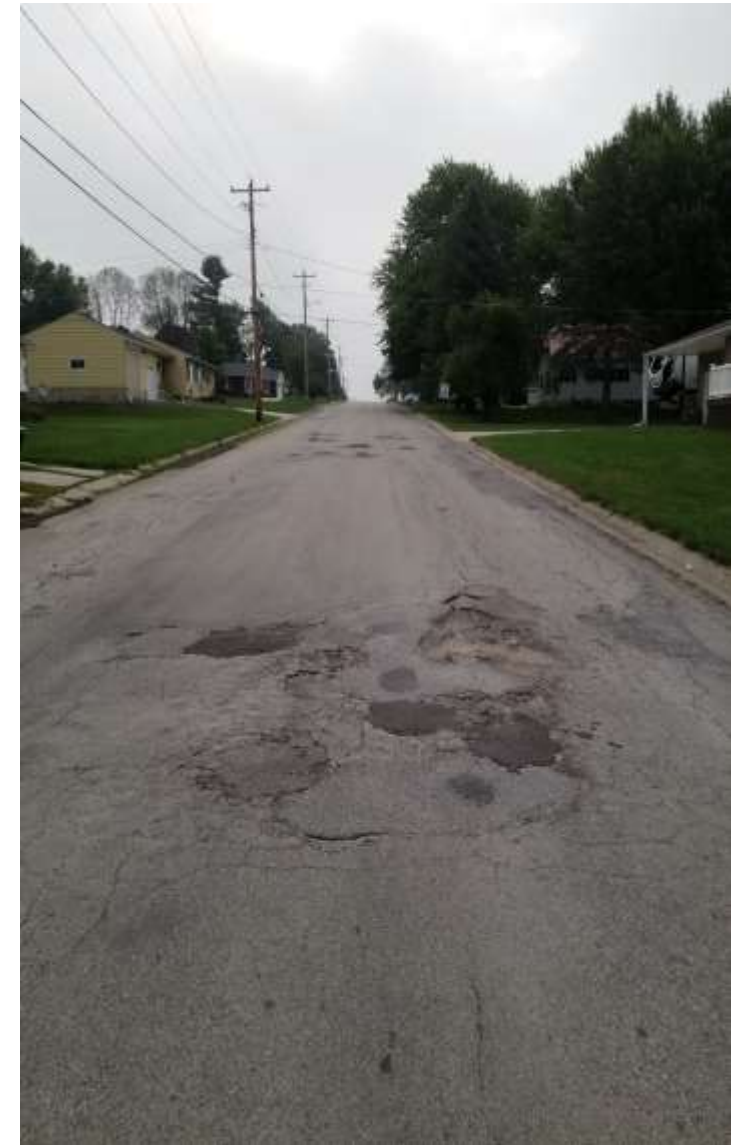
6th St NE – (2nd Ave to 8th Ave)

*650 linear ft of concrete and 1350 linear ft of Asphalt overlay

*would need 650 ft of water main replaced and 1280 ft of sewer inspected and possibly rehabbed

*possibly crack and seat and overlay concrete portion

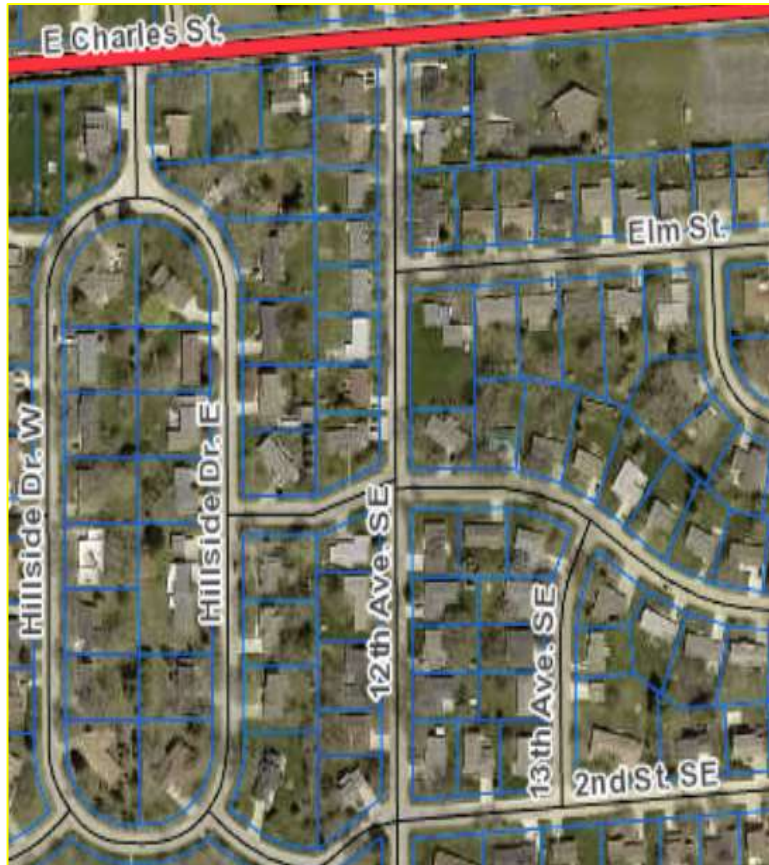
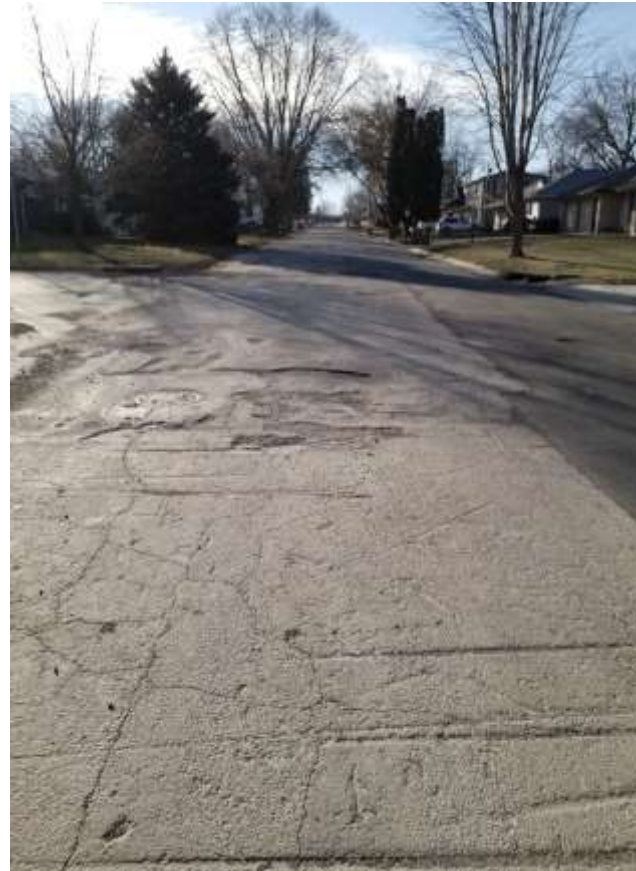
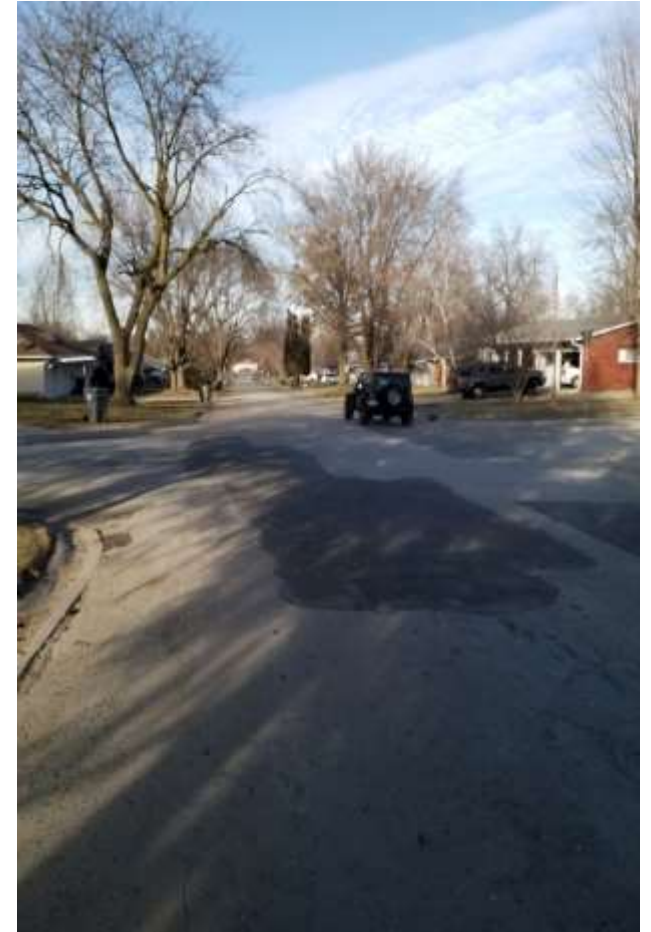
12th Ave SE – (E. Charles to 2nd St)

*1350 Linear feet at 34-ft width Asphalt overlay

*Would need 1500 ft of sanitary sewer inspected for condition

*Asphalt overlay estimate including a 1" leveling course followed by a 2" overlay

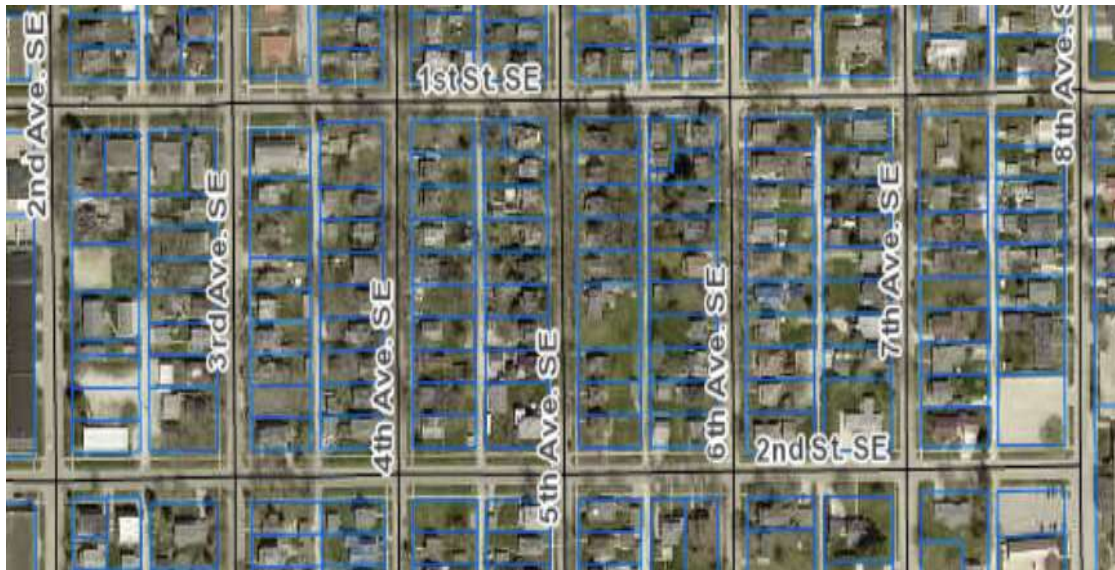
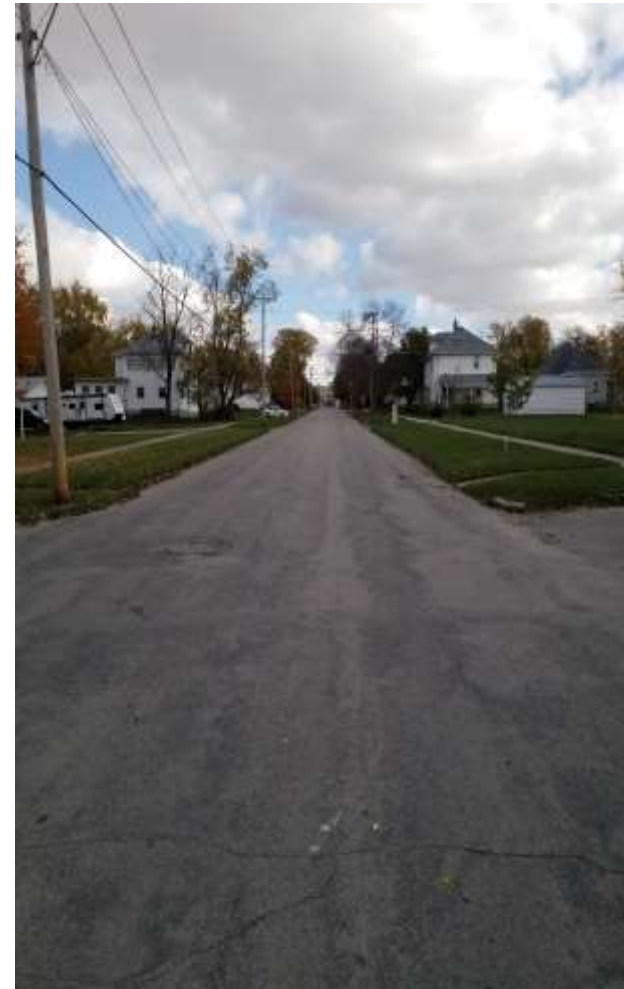
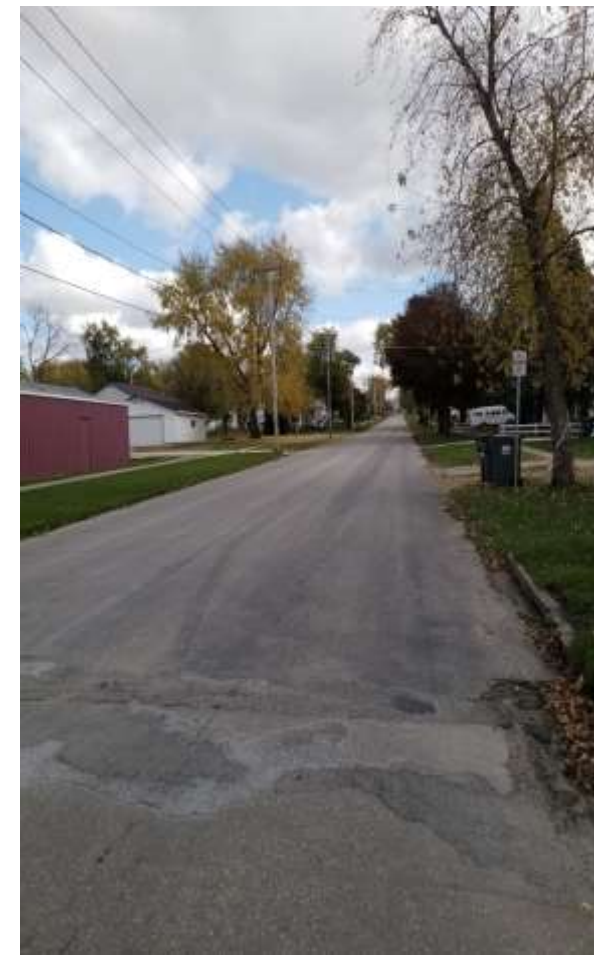
2nd St SE — (2nd Ave to 8th Ave)

*2150 linear ft at 30-ft width Asphalt overlay and complete curb replacement

*would need to inspect sewer crossings

*water main is back of curb

*Asphalt overlay estimate not including the necessary curb work including a 1" leveling course followed by a 2" overlay

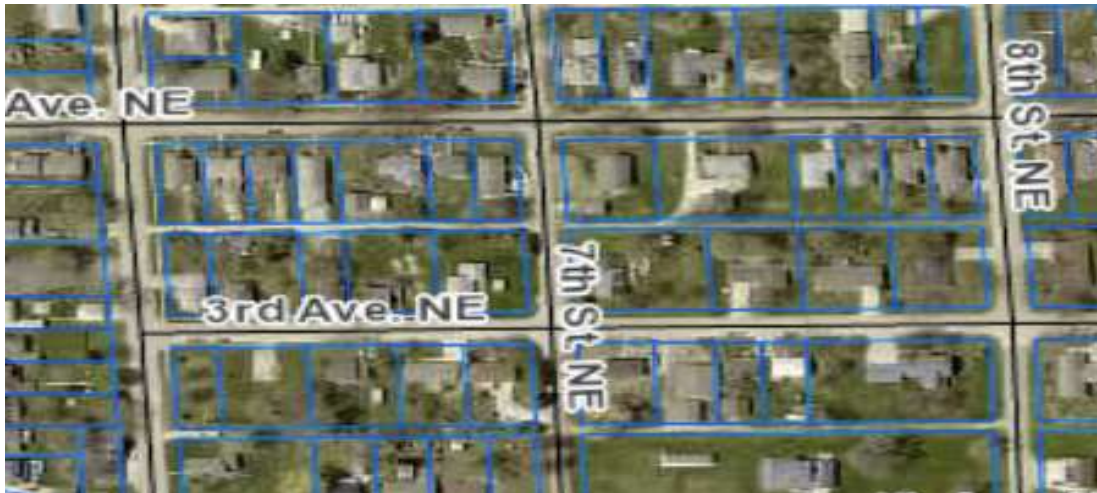
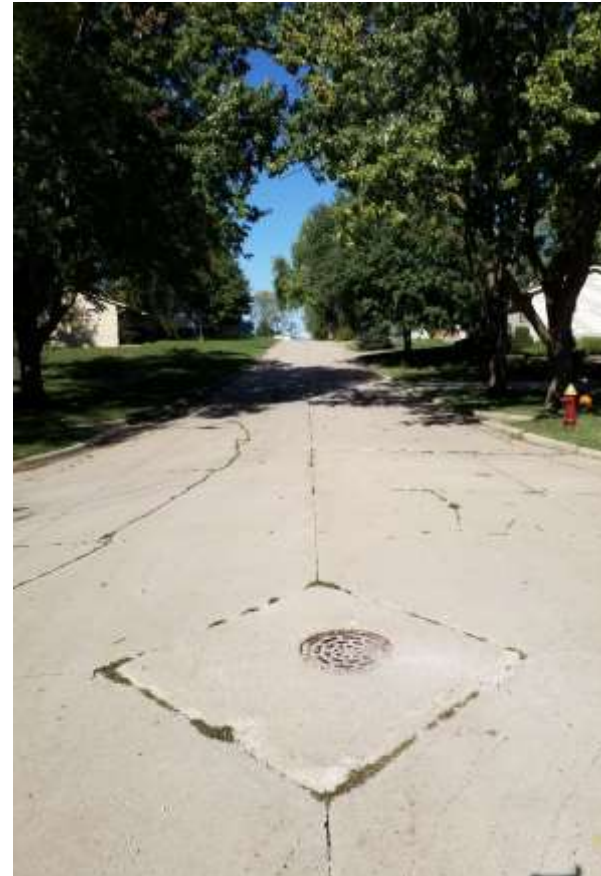
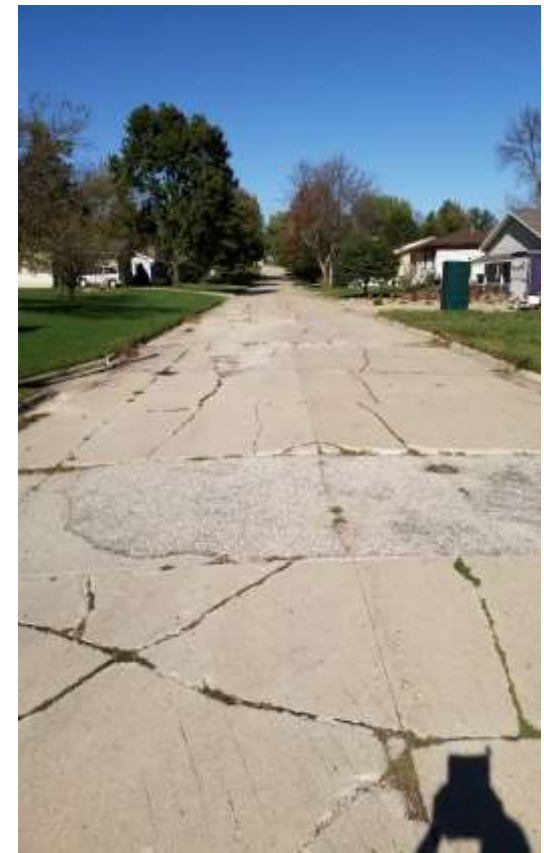
3rd Ave NE — (6th St to 8th St)

*950 linear ft at 32-foot

*would need 950 ft of water main replaced and 950 ft of sanitary sewer inspected and possibly rehabbed

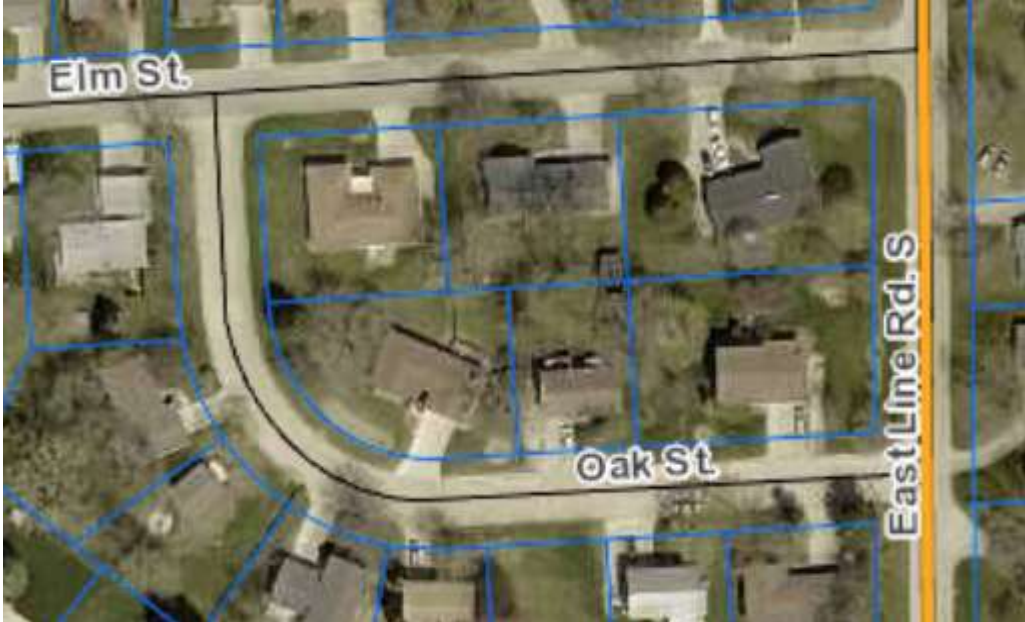
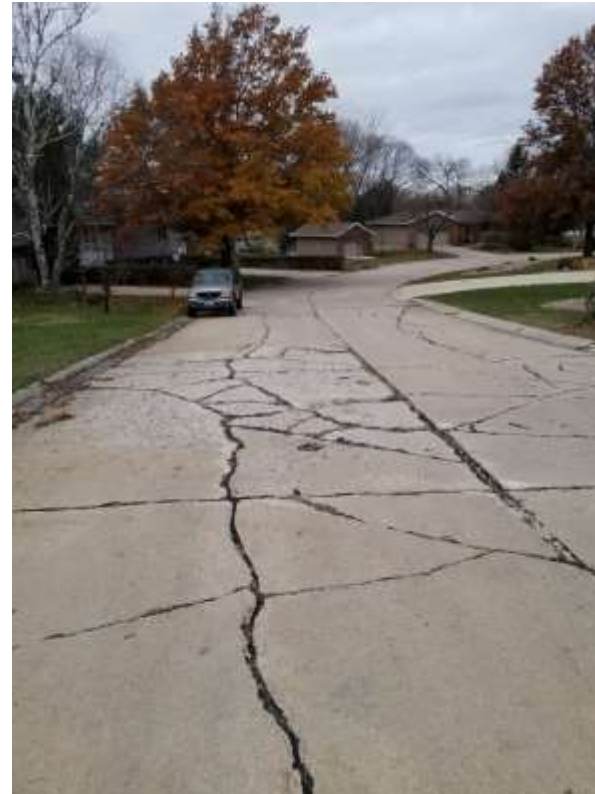
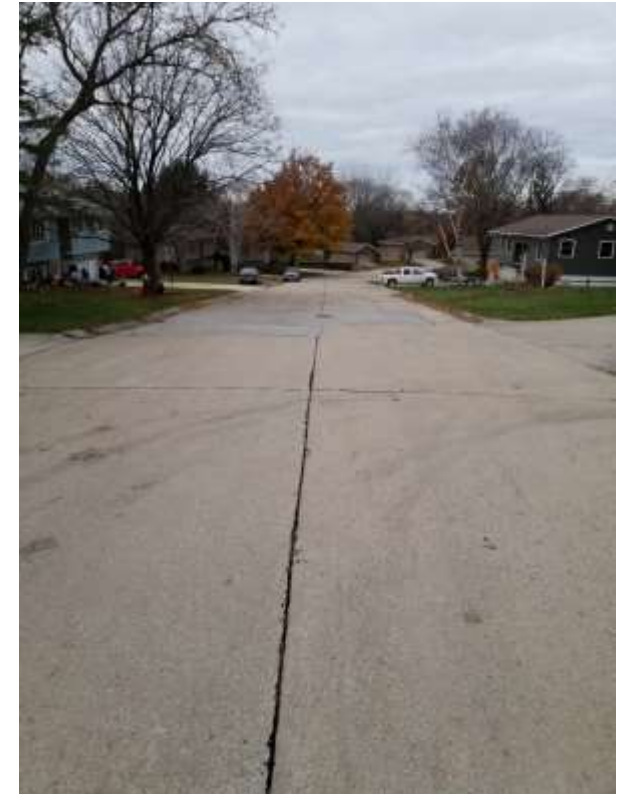
Oak St. (East Line Rd. to Elm St.)

- *636 Linear ft concrete at 34-ft width
- *Would need 562 ft of sanitary sewers that is questionable inspected
- *has 632 ft of 6" water main that has only had one leak in 20+ years and it was a blown-out corporation stop
- *Crack and seat estimate including a 1" leveling course followed by a 2" overlay

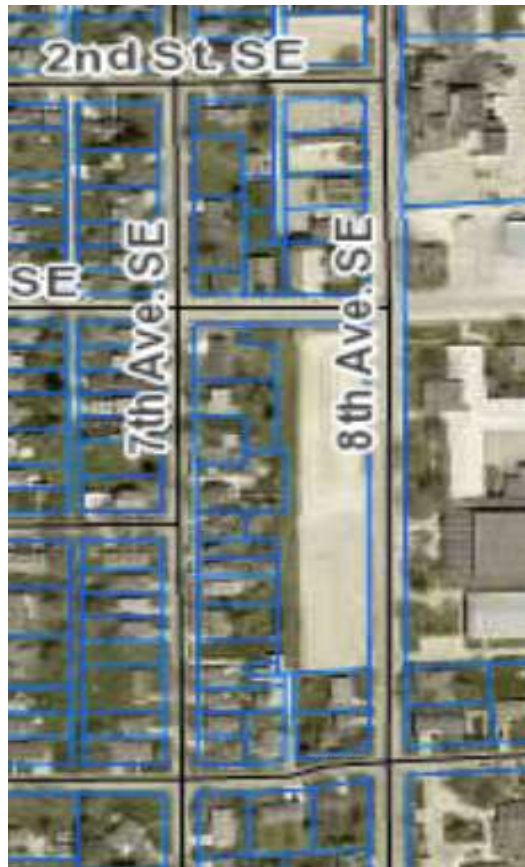
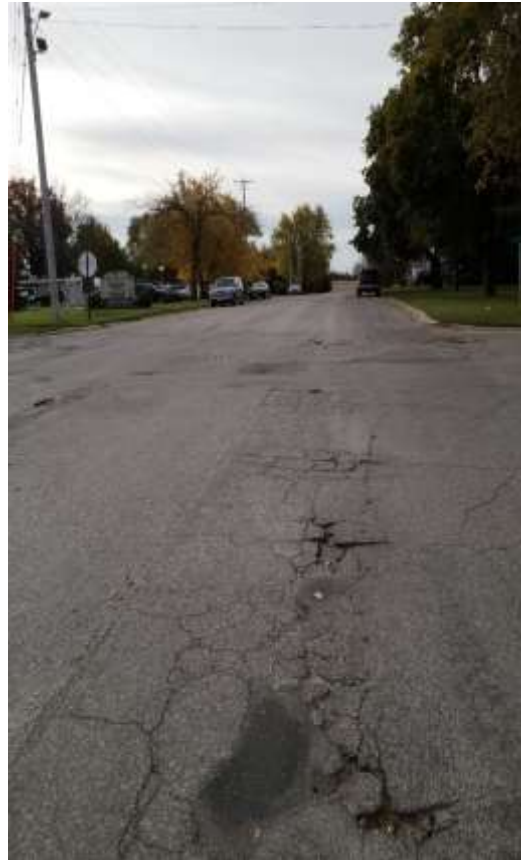
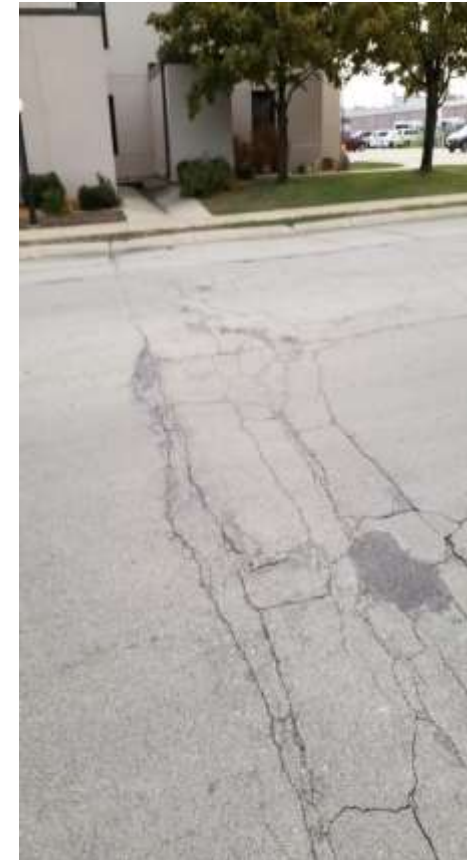
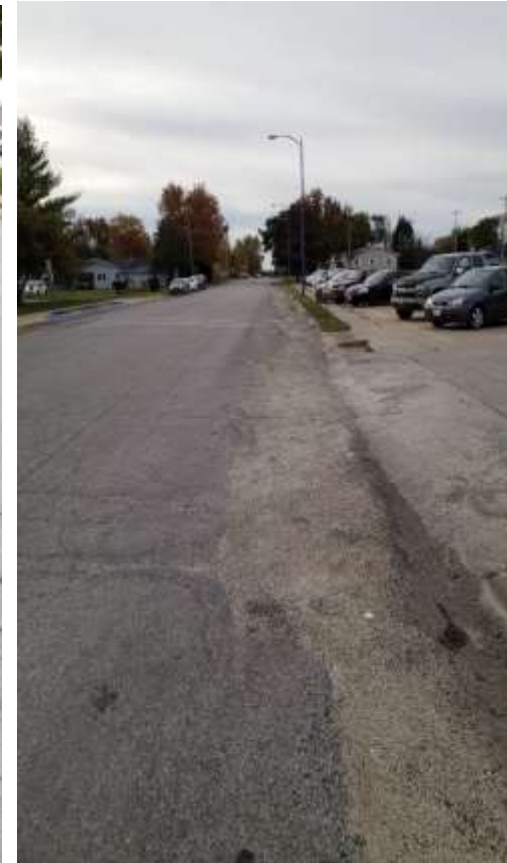
8th Ave SE - (2nd St to 5th St)

*1425 linear ft at 45 ft width

*Would need 1200 ft of water main replaced and 300 ft of sanitary sewer inspected and possibly rehabbed

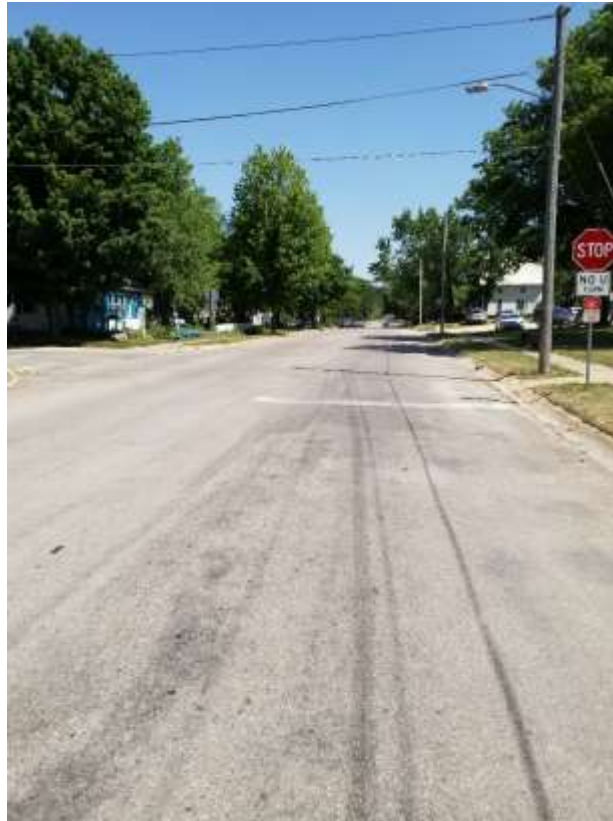
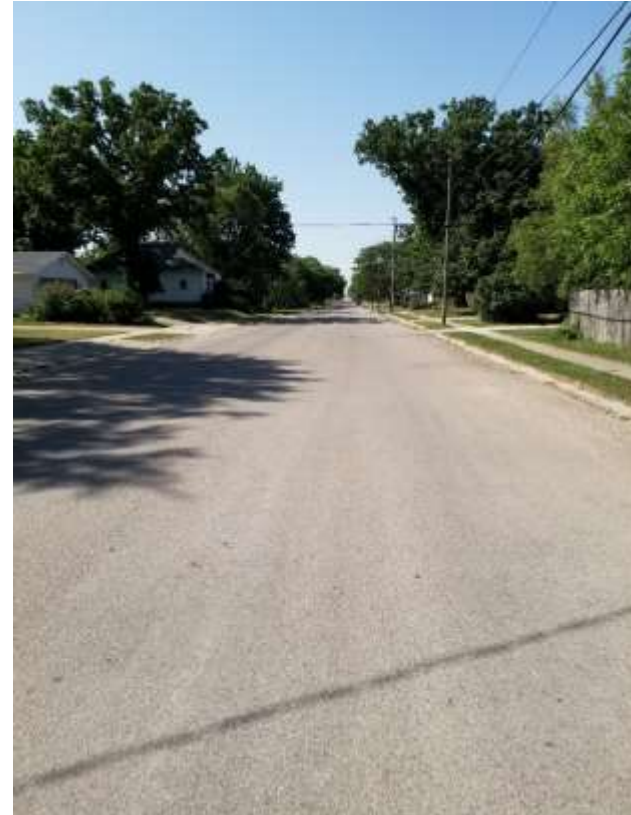
2,000 feet of water main replacement and 2,000 feet of sanitary sewer to be inspected and possibly rehabbed *in addition to* overlay cost below

6th Ave SW from West Charles to 4th Street SW 8,888 Sq Yards 1" leveling coarse followed by a 2" overlay
