Engineering – surveying
City of Oelwein
Attn: David Kral
Building Official
Re: 33 S. Frederick St.

At your request we have examined the building north of the demolished building at 33 S .Frederick. We were specifically looking at the following three areas of concern:

33 S. FREDERICK ST
OELWEIN, IOWA
CITY OF OELWEIN
BASEMENT INFILL DETAILS

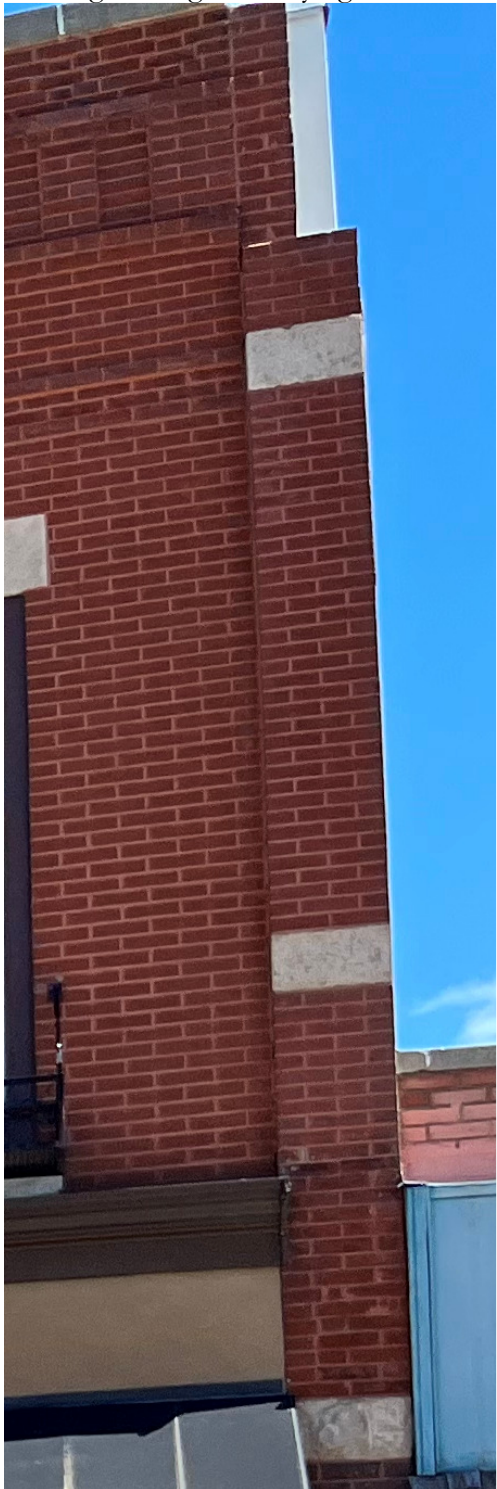
2. The second area of concern is the brick masonry corner at the SW corner of the existing building. This corner was damaged when a steel beam from the demolished building was allowed to fall, and this end rotation caused a large section of brick to be crushed and pulled out. I had taken pictures from my earlier visits and in comparing those pictures to the current condition it is obvious that the entire brick corner from the beam bearing to the roof has been broken free from the building face. I have enclosed copies of the before and after pictures. This brick corner section should be taken down and re-laid to establish the connectivity that existed prior to the demo.

Figure 1: Joint prior to demolition

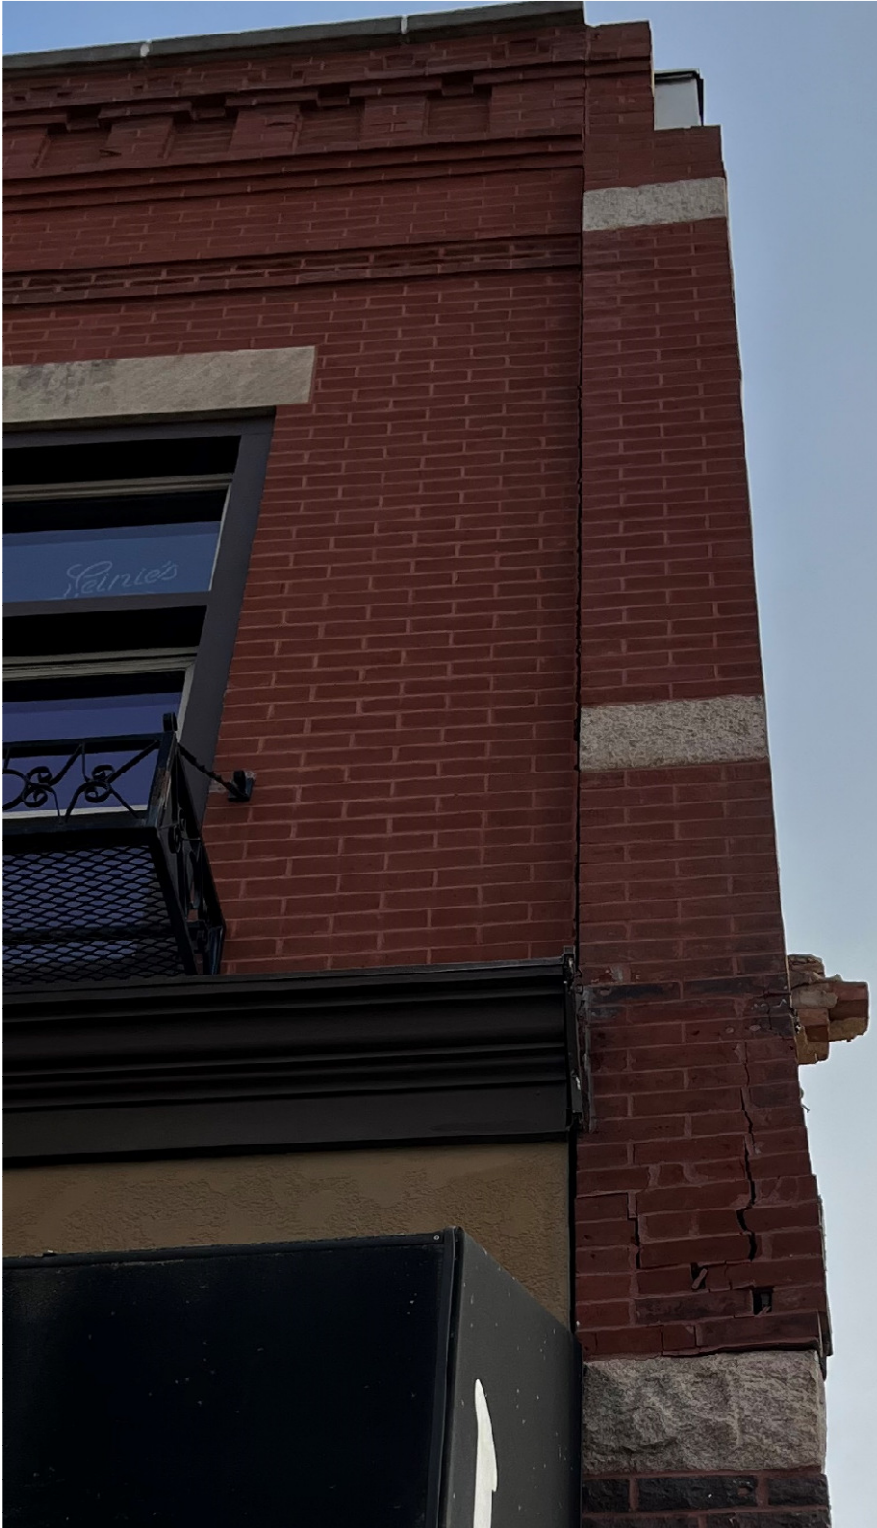
Figure 2: Opening in joint after demolition

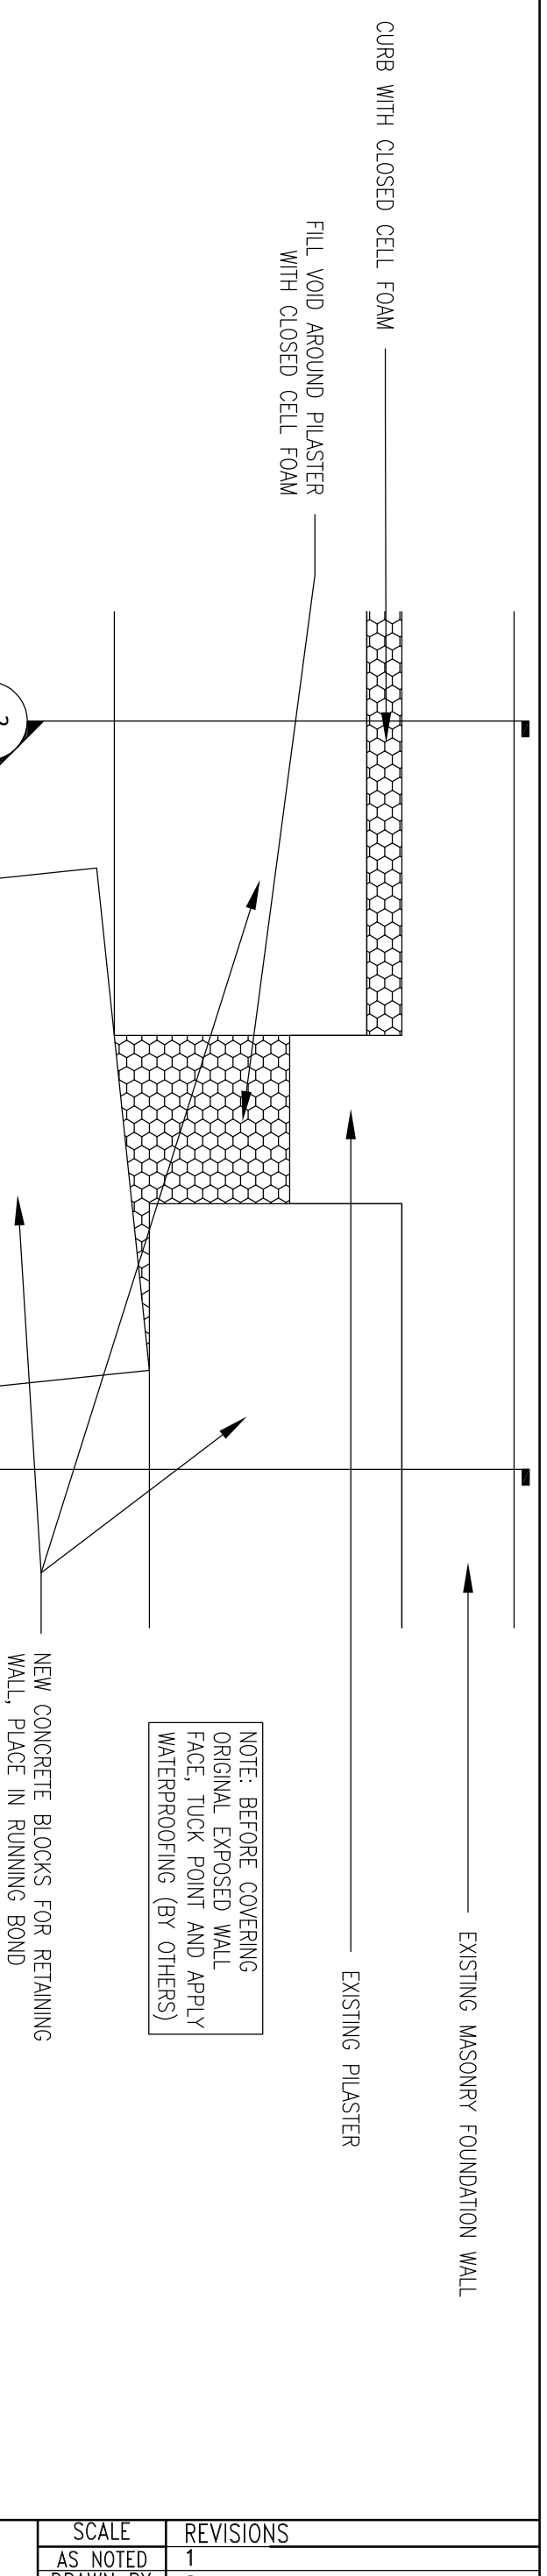
1
PARTIAL PLAN
Scale: 1/2" = 1'-0"

1. The existing south basement wall that was shared with the demoed structure. The majority of this wall is composed of limestone rubble with the mortar in the joints in extremely poor condition. There is a short section on the west end that appears to be cast-in-place concrete. These walls can not be backfilled against. We have enclosed details that depict placing a new wall of concrete bunker blocks in front of the existing wall.

NOTE: BEFORE COVERING ORIGINAL EXPOSED WALL FACE, TUCK POINT AND APPLY WATERPROOFING (BY OTHERS)
