**Office of Bridges and Structures
Bridge Maintenance and Inspection Unit**

Bridge Condition Report

Bridge ID: 10TH ST SW NBI Number: 8920
District: 0 Inspection Group: IIW, P.C.
Inspection Type: Routine
Inspection Date: 03/08/2021
Carrying: 10TH ST SW over OTTER CREEK
Location: 000000000
Approved By: Miller, Nathan

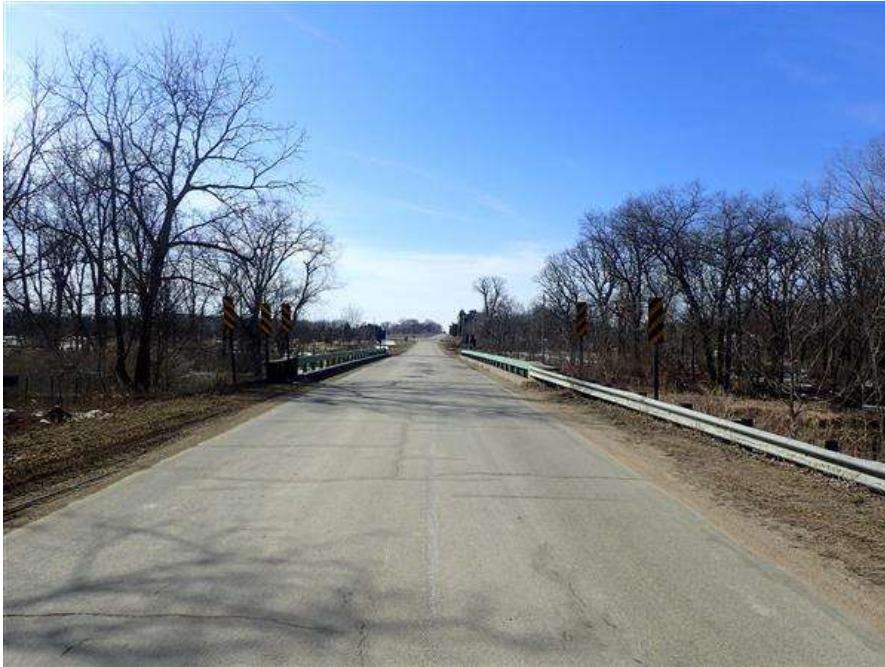
Photo Number: 1

ROAD VIEW LOOKING WEST

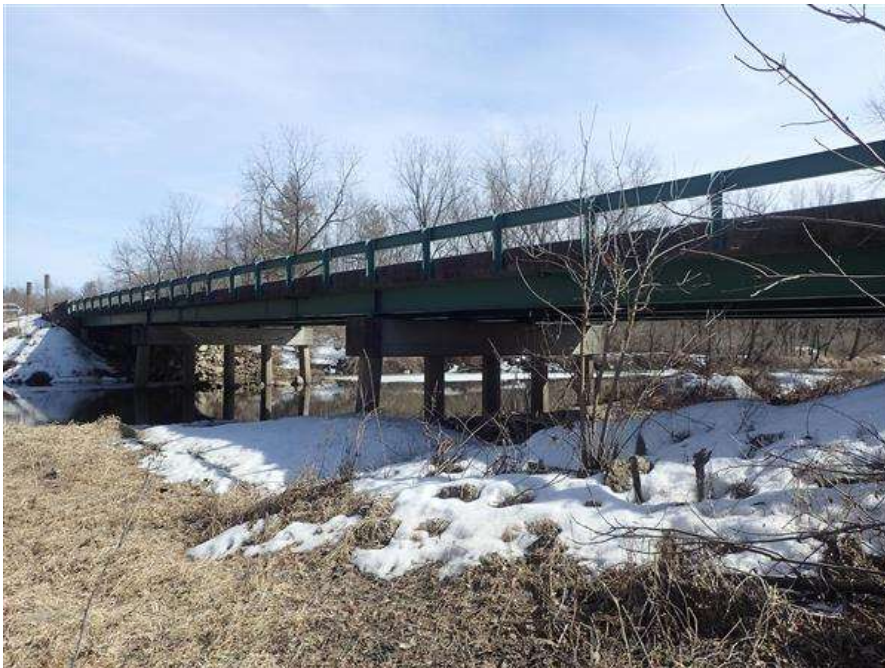
Photo Number: 2

SIDE VIEW LOOKING SOUTH

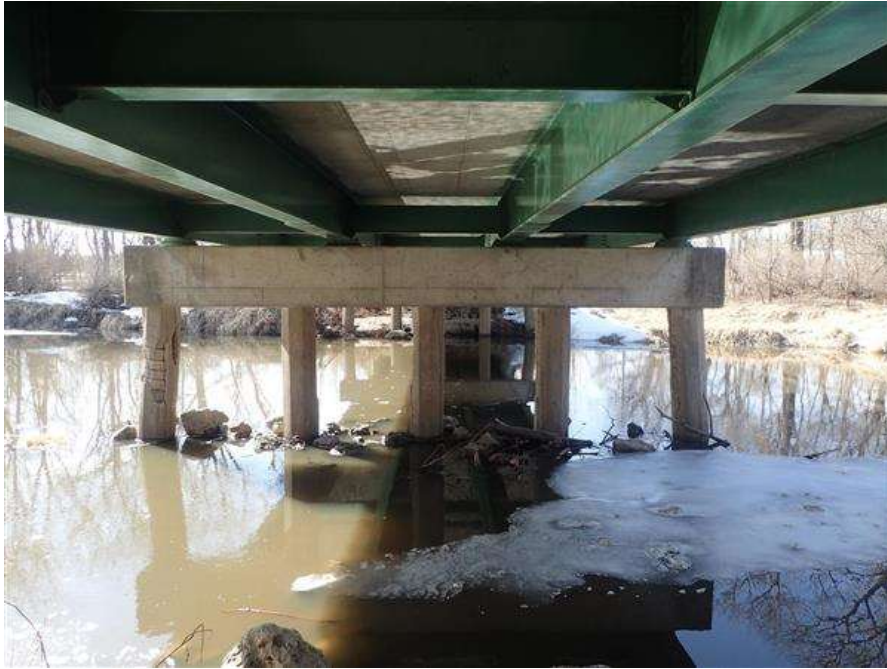
Photo Number: 3

UNDER LOOKING WEST

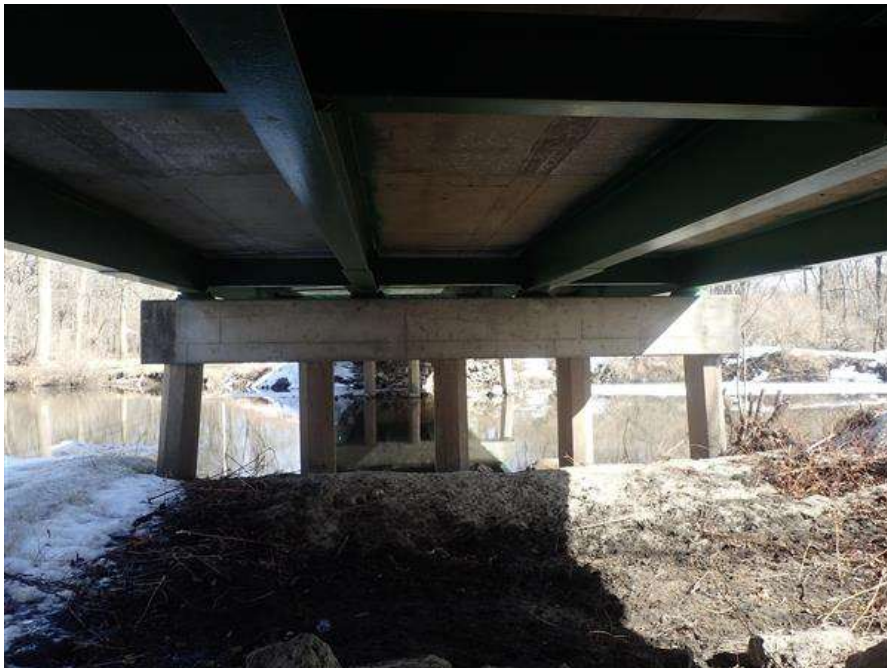
Photo Number: 4

UNDER LOOKING EAST

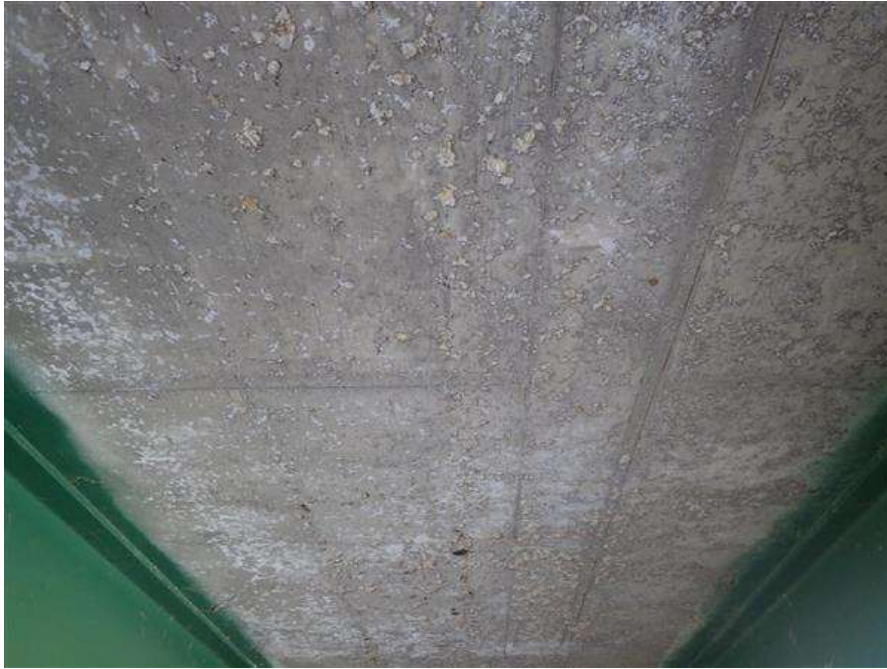
Photo Number: 5

DECK ITEM	CONDITION RATING	REMARKS
1. Wearing Surface	4	1/2" BITUMINOUS OVERLAY DETRIMENTAL TO CONCRETE DECK. SPALLED AND PATCHED ACROSS APPROXIMATELY 50% OF DECK.
2. Deck - Structural Condition	4	TRANSVERSE CRACKING WITH EFFLORESCENCE UNDERSIDE OF DECK.
3. Curbs	5	CRACKING AND SPALLING WITH EXPOSED REINFORCING.
4. Median	N	
5. Sidewalks	N	
6. Railings	6	CHANNEL RAIL SET BEHIND CURB.
7. Paint	7	ON RAIL.
8. Drains	5	DO NOT EXTEND BEYOND GIRDERS.
9. Utility Connections	N	
10. Joint leakage	5	
11. Expansion Joints and Devices	5	PACKED WITH A.C.
General Comments

SCALING UNDERSIDE OF DECK

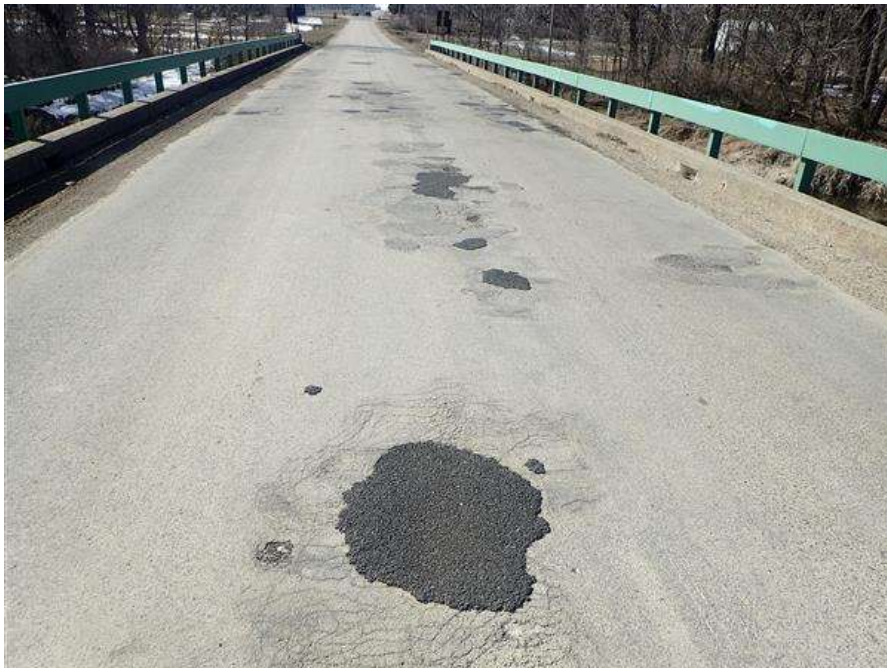
Photo Number: 6

ITEM 58 DECK CONDITION RATING 4 SPALLING CONCRETE WITH EXPOSED TRANSVERSE REINFORCING ON WEARING SURFACE. NUMEROUS DECK SPALLS PATCHED WITH AC ARE DETRIMENTAL TO CONCRETE DECK.

SPALLED AREAS PATCHED WITH AC, DETRIMENTAL TO DECK

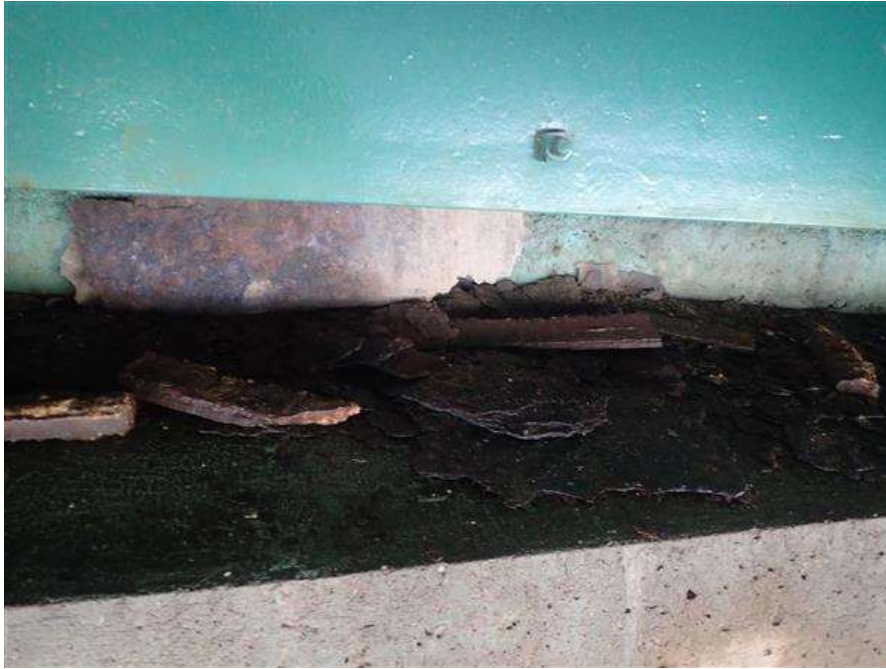
Photo Number: 7

DELAMINATING STEEL AT ABUTMENT DIAPHRAGMS

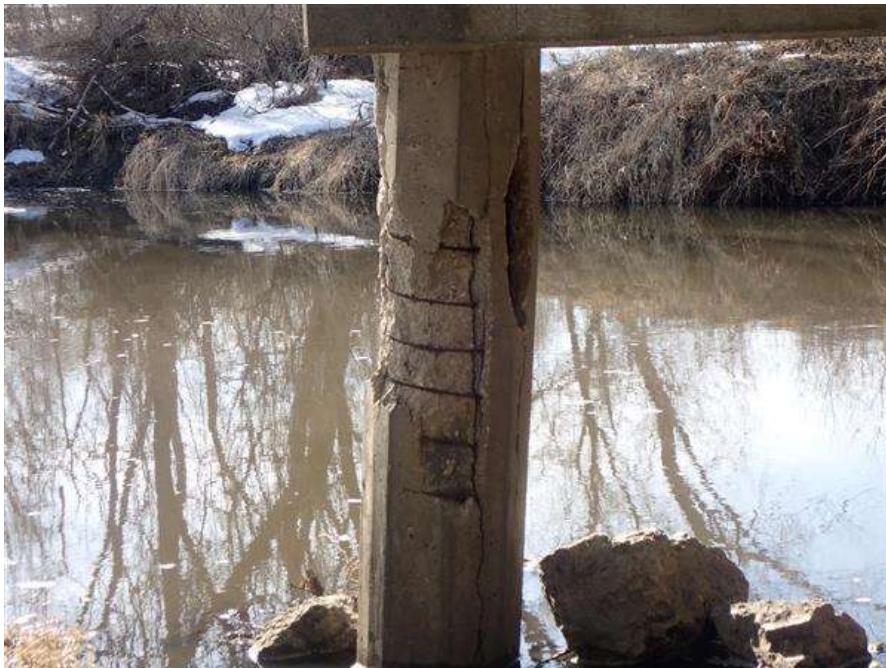
Photo Number: 8

5	CONCRETE SPALLING WITH EXPOSED REINFORCING AND H-PILES AT EAST PIER PILE ENCASEMENTS.
---	---

CRACKING AND DELAMINATING CONCRETE WITH EXPOSED CIRCUMFRENENTIAL REINFORCING AT N5 PILE IN EAST PIER

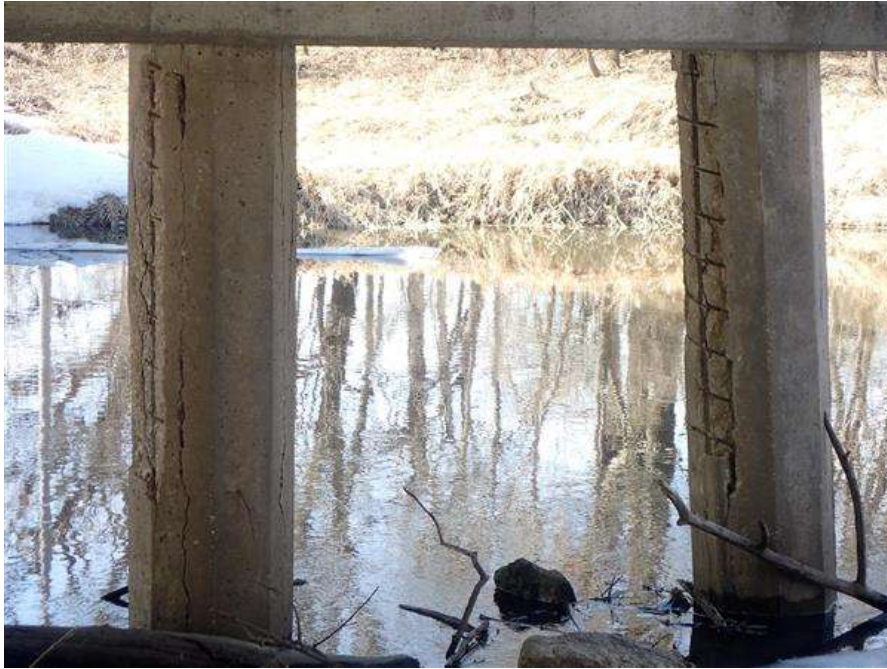
Photo Number: 9

CRACKING AND DELAMINATING CONCRETE WITH EXPOSED CIRCUMFRENENTIAL REINFORCING AT N1 AND N2 PILES IN EAST PIER
