# Preliminary Engineering Report

## Downtown Sidewalks

**PROJECT # 23-1206**  
July 24, 2024

**PRELIMINARY ENGINEERING REPORT  
FOR  
DOWNTOWN SIDEWALKS  
PREPARED FOR:  
CITY OF OELWEIN**

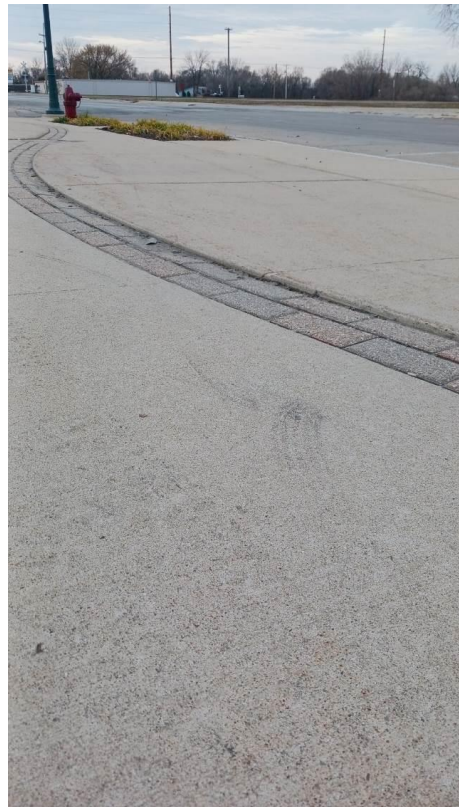
Pavement settling along paver band

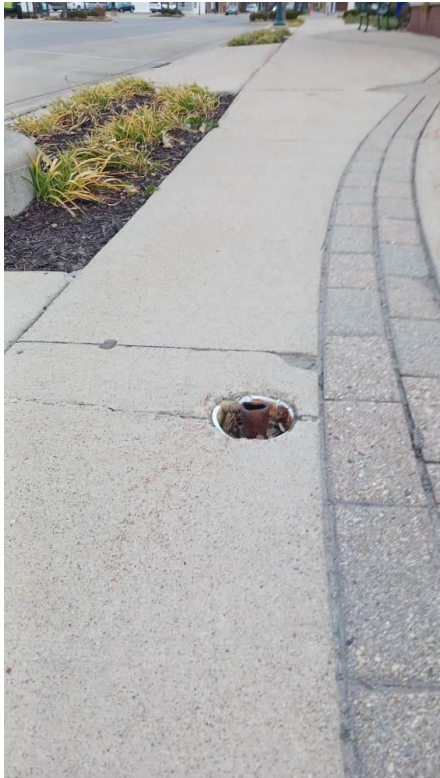
Curb stop boxes for water services were typically sleeved when the 2005 PCC sidewalk was constructed. Many of the boxes are either lower or higher than the adjacent surface. Those higher are likely pushed up by frost and then do not lower on their own. All of these can be a tripping or falling hazard. Any holes within the sidewalk should be 0.5" or less in size. Many curb stops are missing the curb box lid, which leaves a hole in the sidewalk of 4"+/- diameter.

Curb stop box protruding with opening around box

Curb stop boxes are recommended to be placed within a standard valve box riser (poured into the PCC) with standard valve box lid. This eliminates the box being above or below sidewalk elevation and open holes around the boxout. These are easily added during construction and provide great long-term protected access.

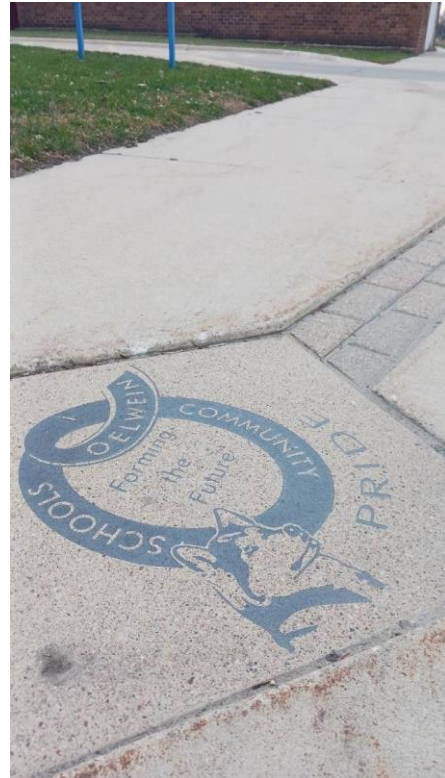
Paver and diamond settling, greater than 0.25"

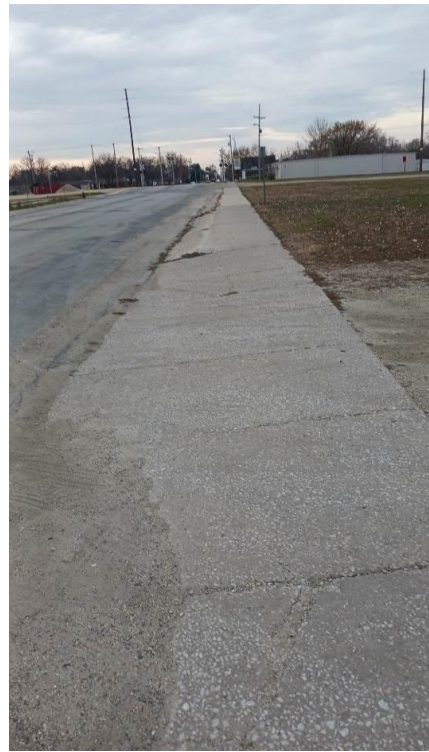
Cross slope greater than 2%

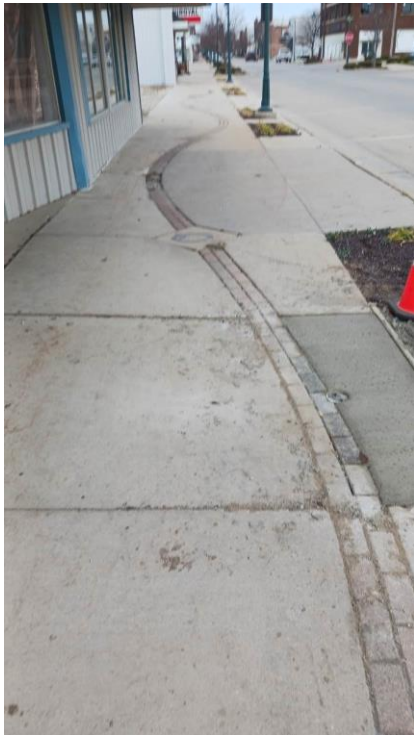
A few portions of sidewalk show settling, which leads to a low point within the sidewalk that does not drain. This ultimately leads to cracking of the PCC and quick deterioration along with icing in the winter months. Causes may be from inadequate compaction of utility trenches or coal vaults or general lack of compaction.

Settling of sidewalk creating a low point without drainage

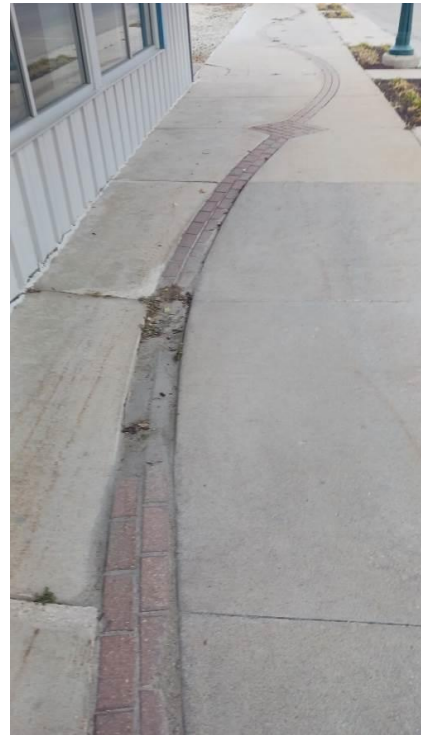
Paver band setting greater than 0.25

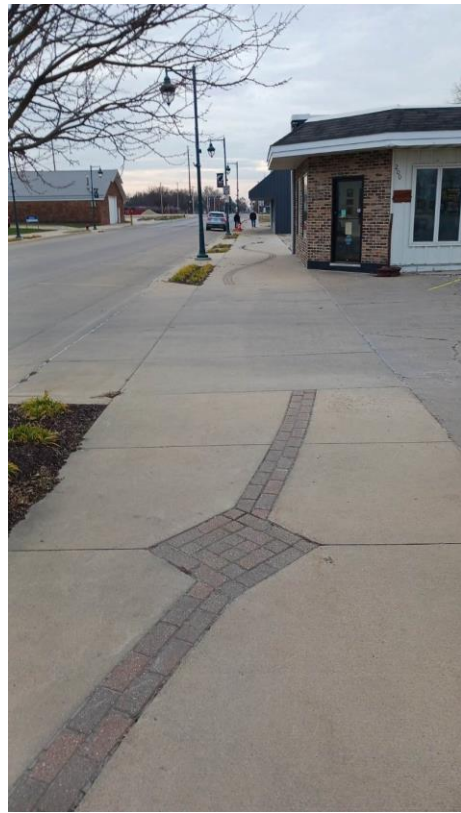
Paver settling greater than 0.25"

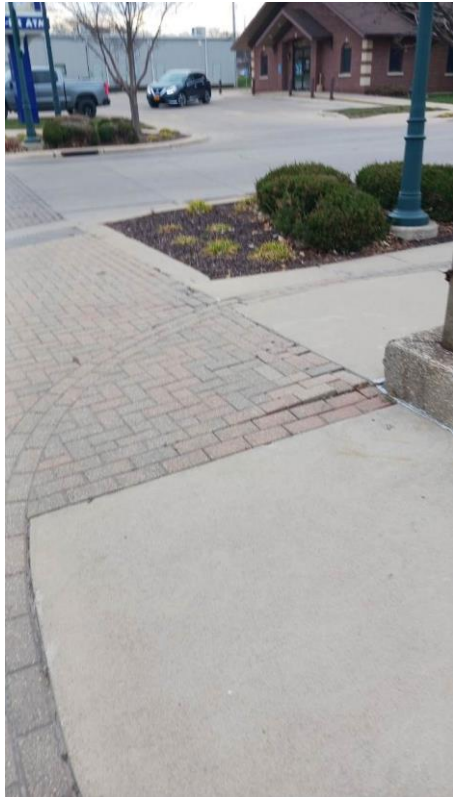
Heaving pavers with vertical displacement greater than 0.25"

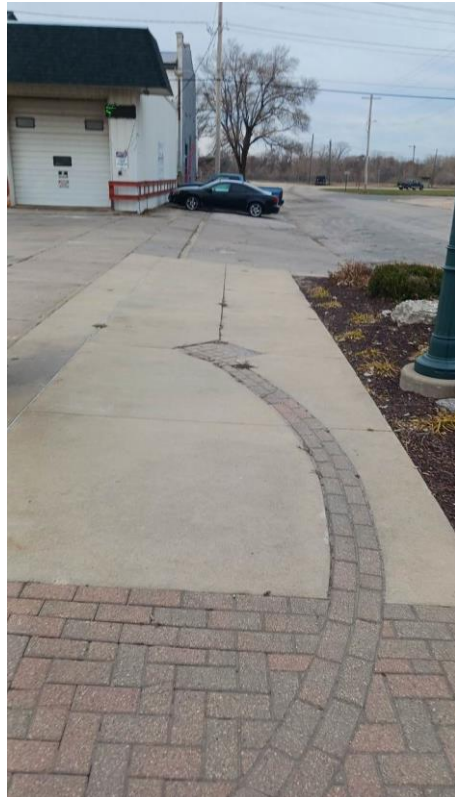
Cross slope greater than 0.25"

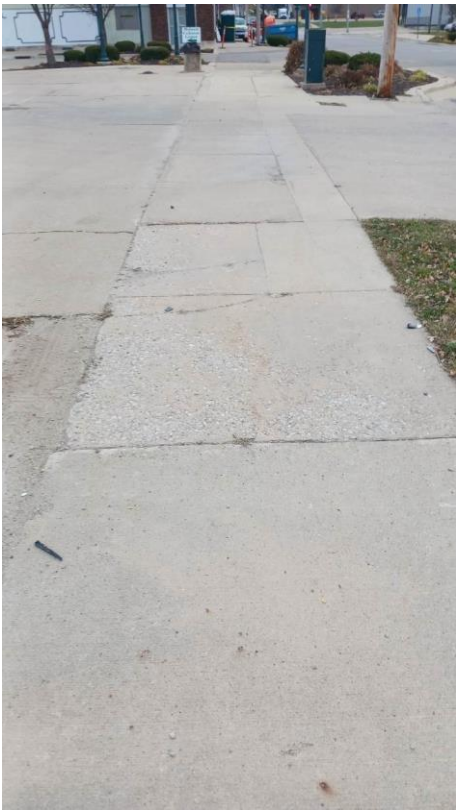
PCC displacement greater than 0.25"

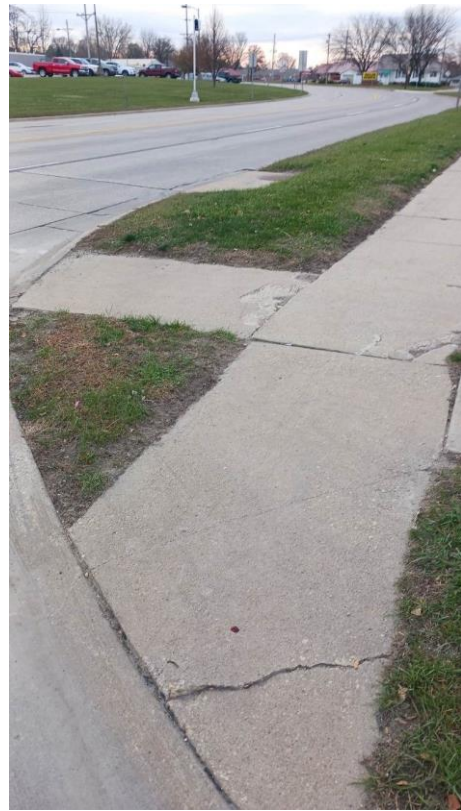
Non-compliant pedestrian ramp

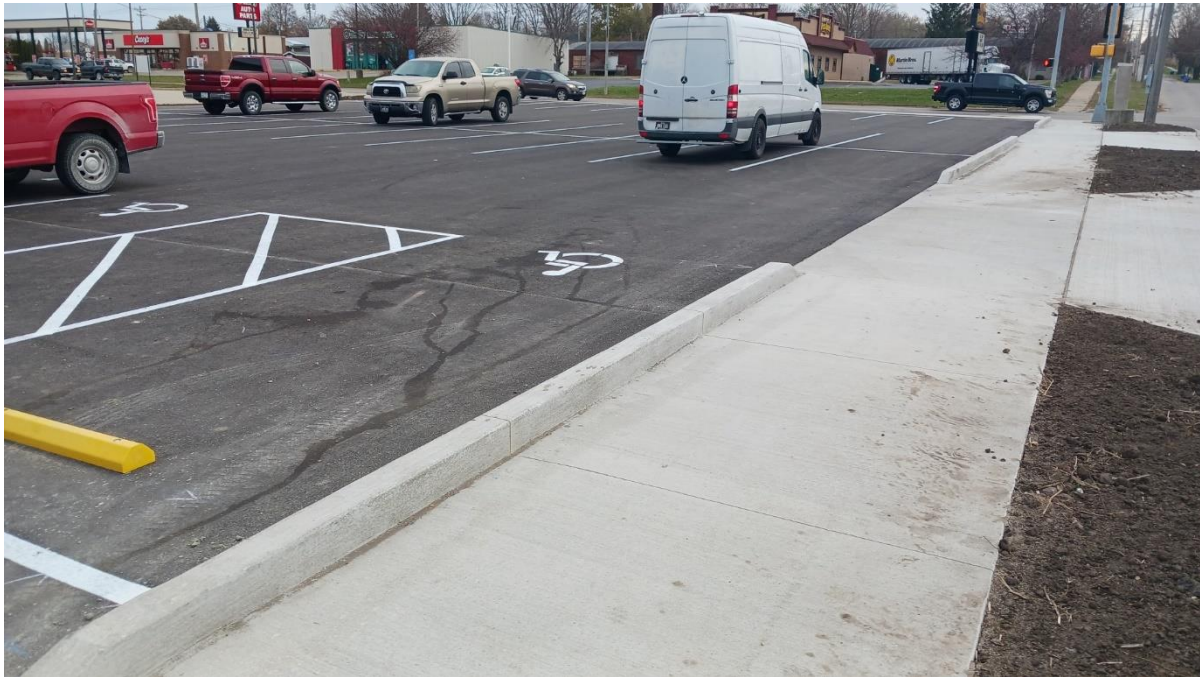
Compliant sidewalk

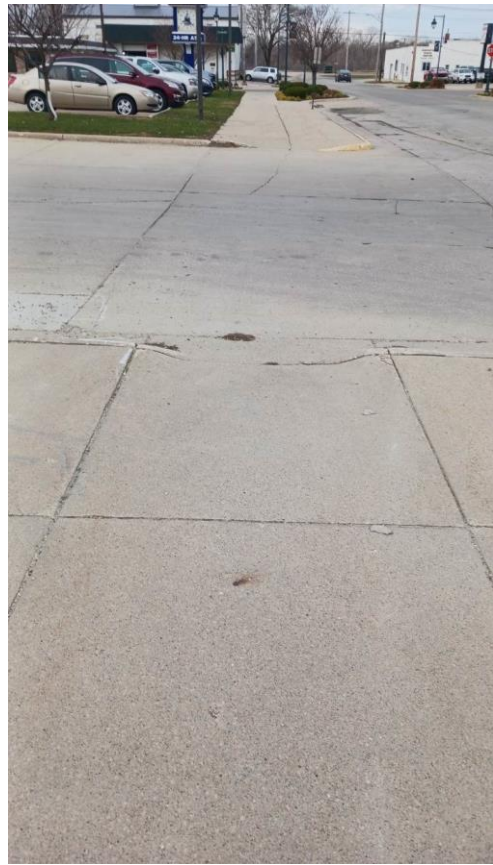
Non-compliant pedestrian ramp

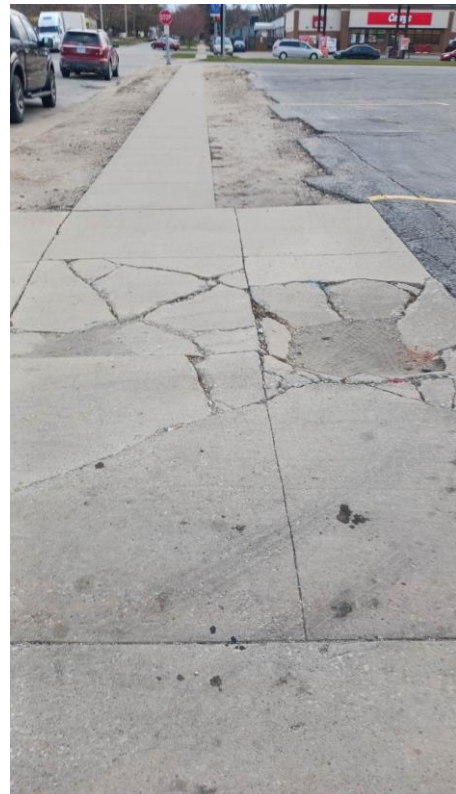
Severely broken PCC

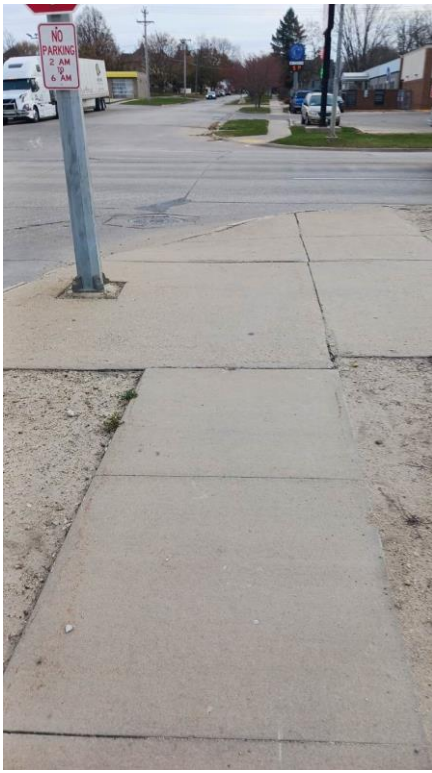
Non-compliant curb ramp

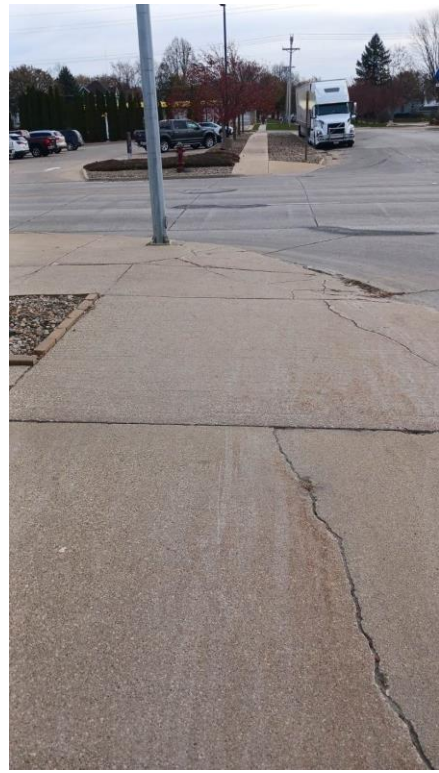
Non-compliant curb ramp

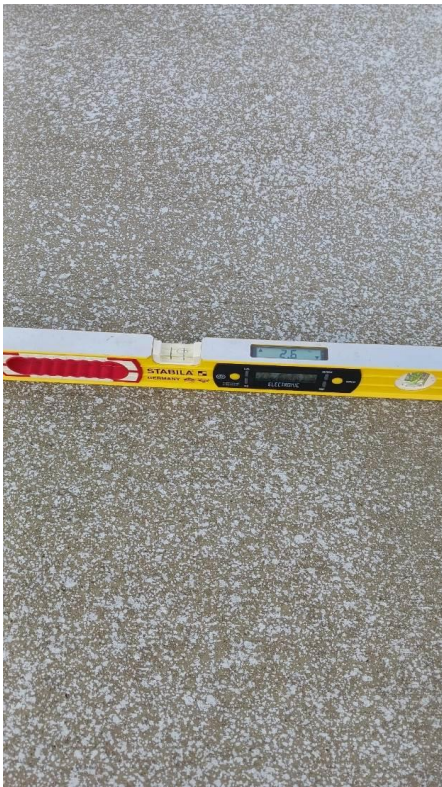
Cross slope greater than 2%

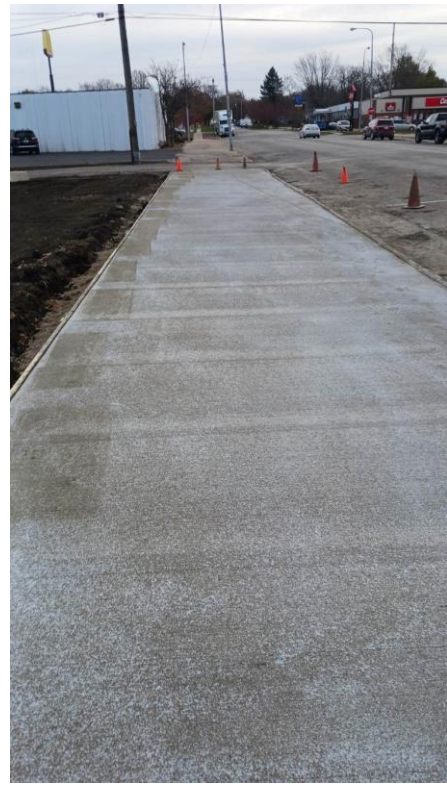
New sidewalk with greater than 2% cross slope

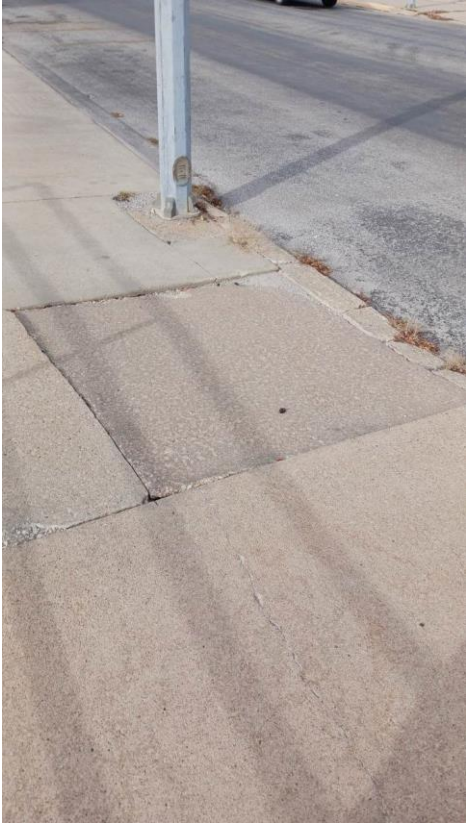
Settled PCC panel

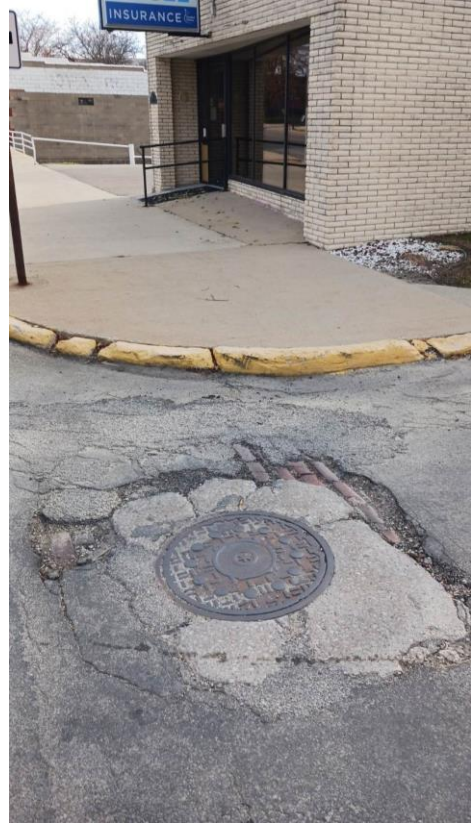
Non-compliant curb ramp

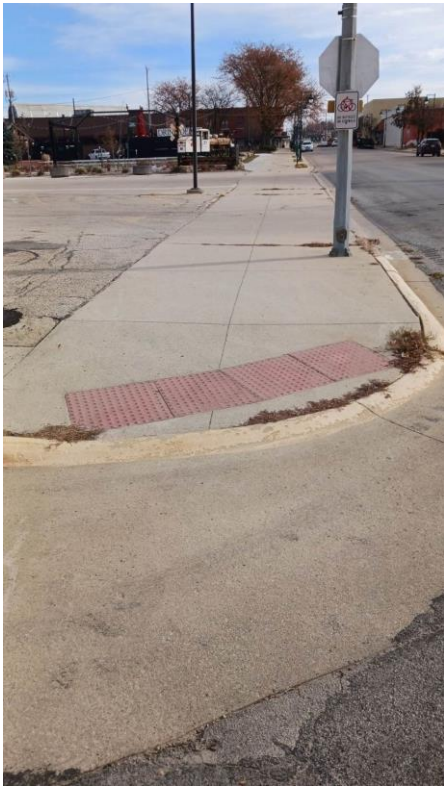
Curb height greater than 0.5"

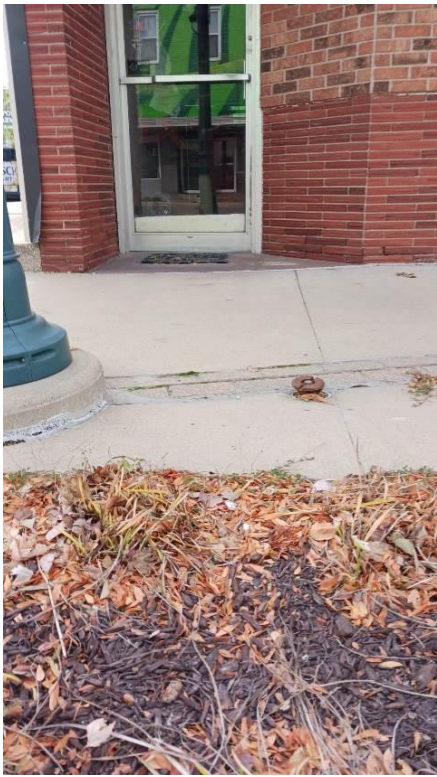
Protruding curb stop

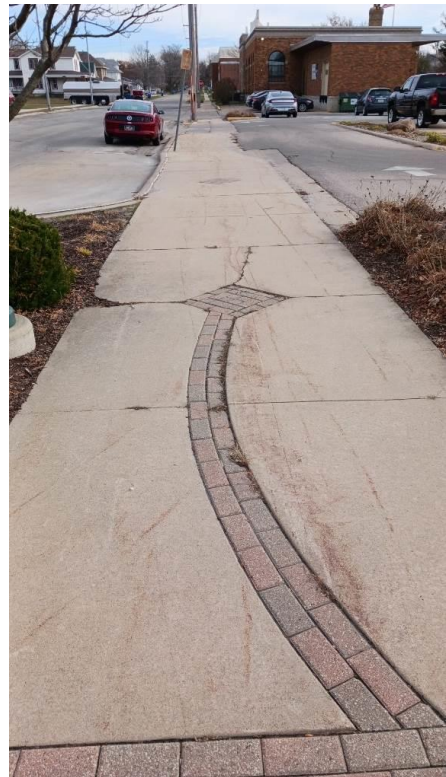
Paver and diamond settling

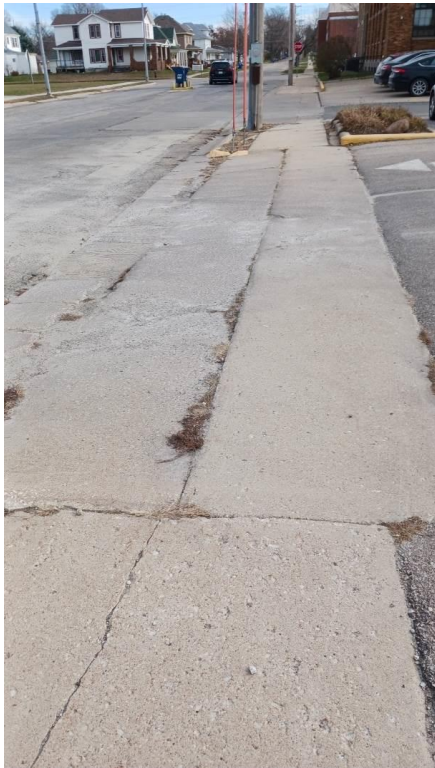
Panel displacement

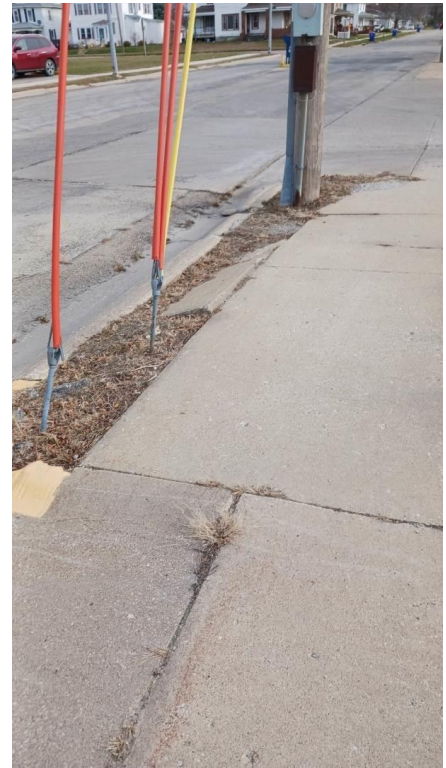
'Curb' within pedestrian walkway

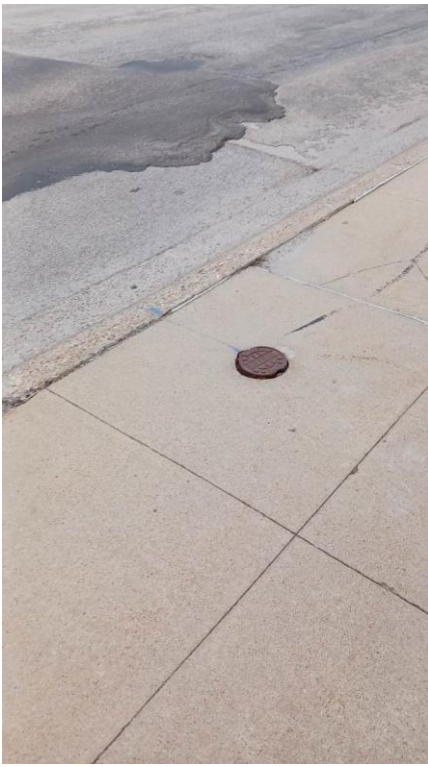
Protruding water valve

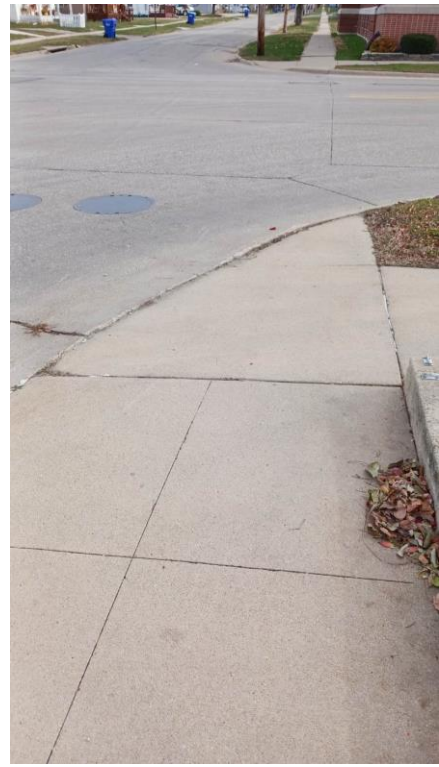
Non-complaint pedestrian curb ramp

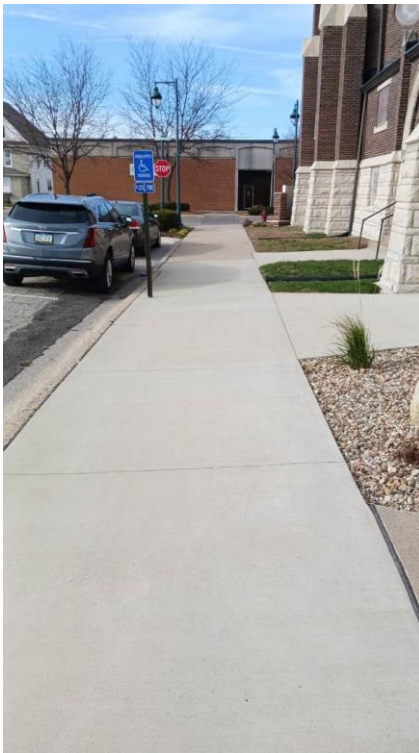
Cross slope in excess of 2%

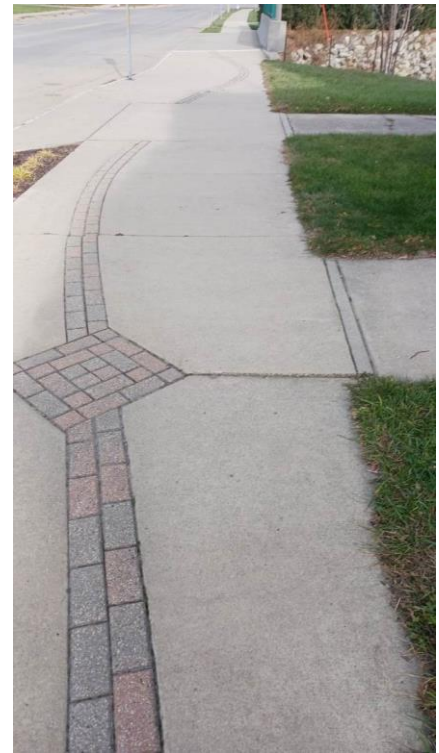
PCC displacement across paver band

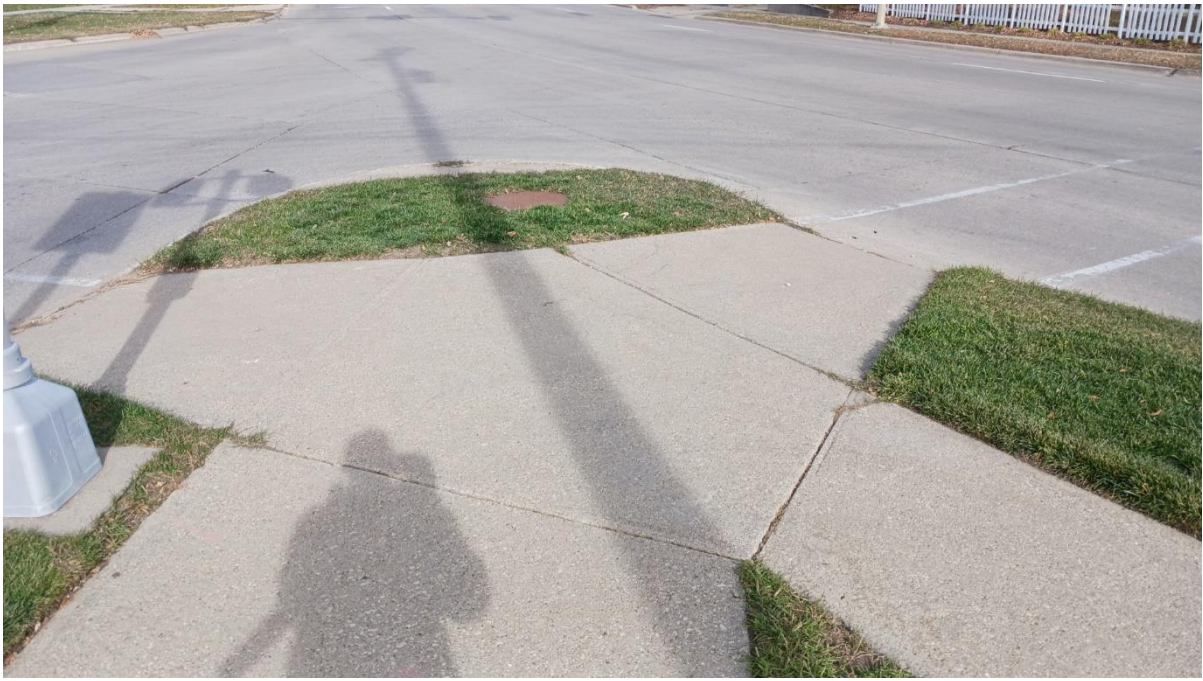
Non-compliant pedestrian curb ramp

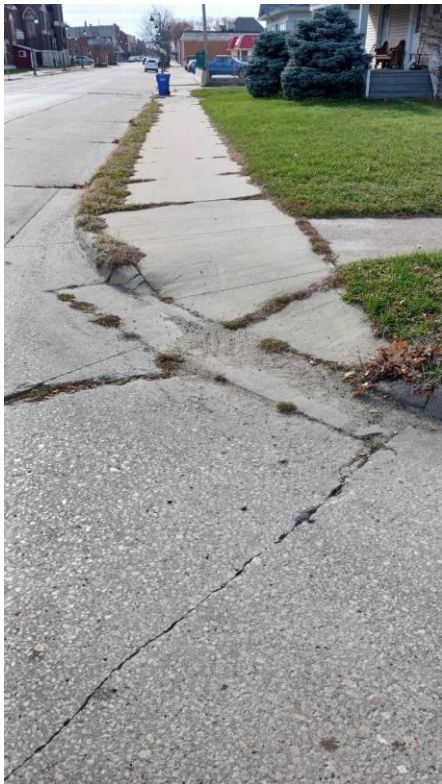
Non-compliant pedestrian curb ramp

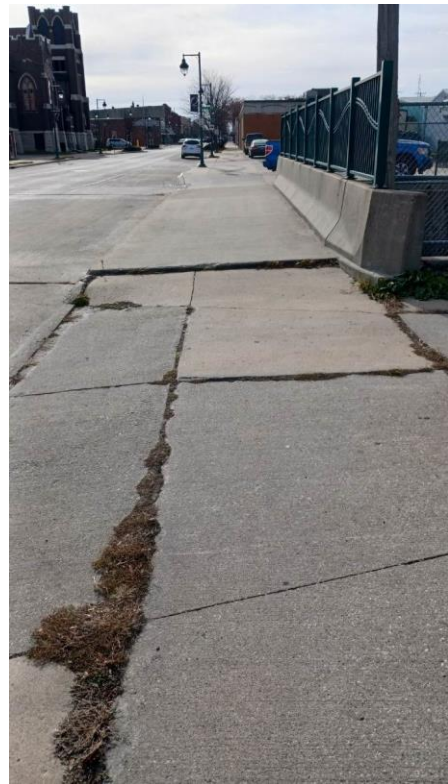
Vertical PCC displacement greater than 0.25" and cross slope greater than 2%
