PHASE I ENVIRONMENTAL SITE ASSESSMENT (ESA)

December 13, 2023

1799 Washington St (State ID: 22E29 01402)
aka 1795 Washington St
NE Portion of Former Stimson Lumber Mill Property - Parcel 2
Oregon City, OR 97045

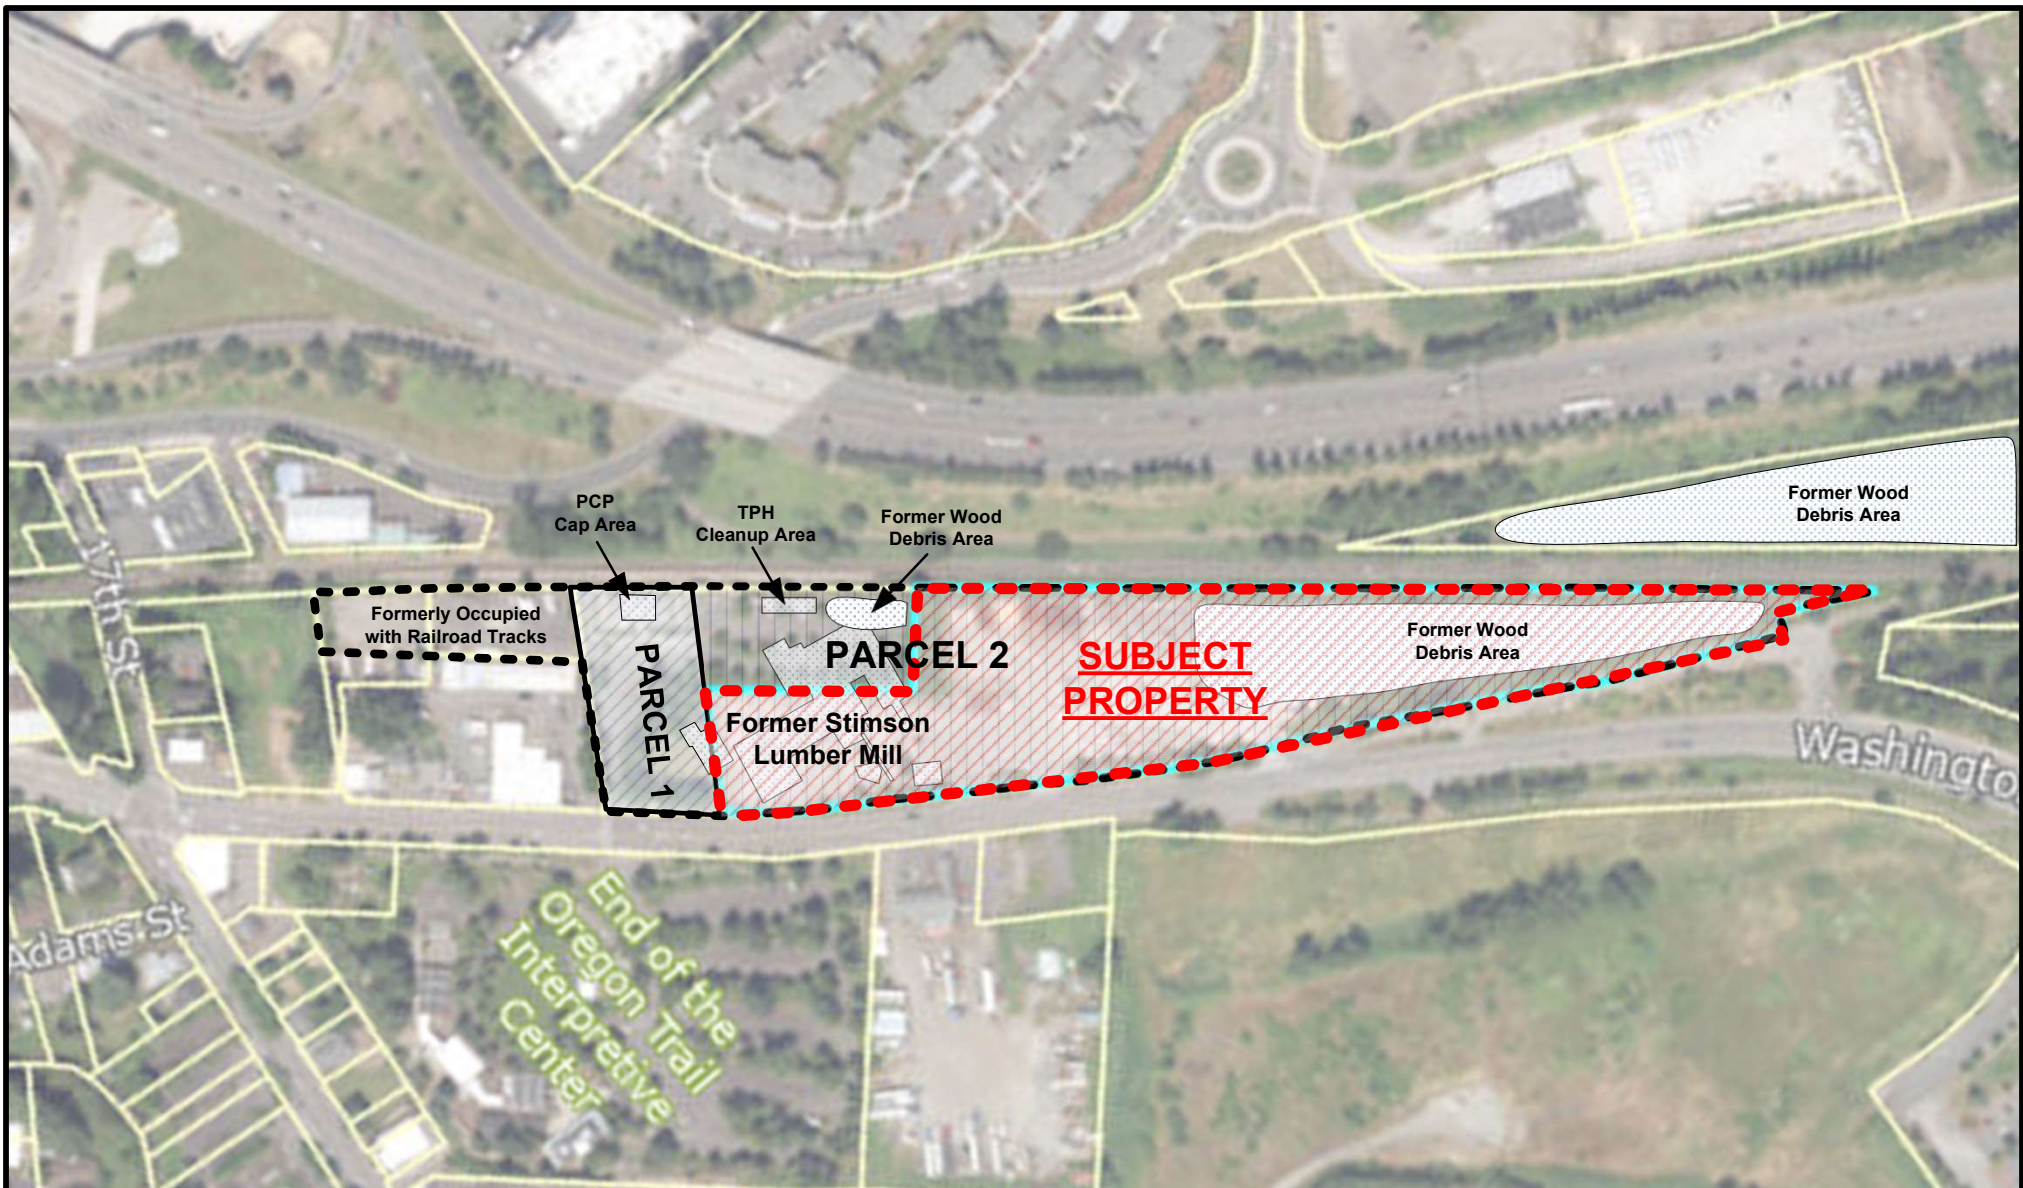
PCP = Pentachlorophenol (Log Stain Inhibitor - Dip Tank and Spray Area)
 TPH = Total Petroleum Hydrocarbons (Drum Storage Area)
