RE: Palmer Lake Fire Station  
Structural Condition Survey  
12 Valley Crescent St., Palmer Lake, CO 80133

Re: Palmer Lake Fire Station – Structural Condition Survey

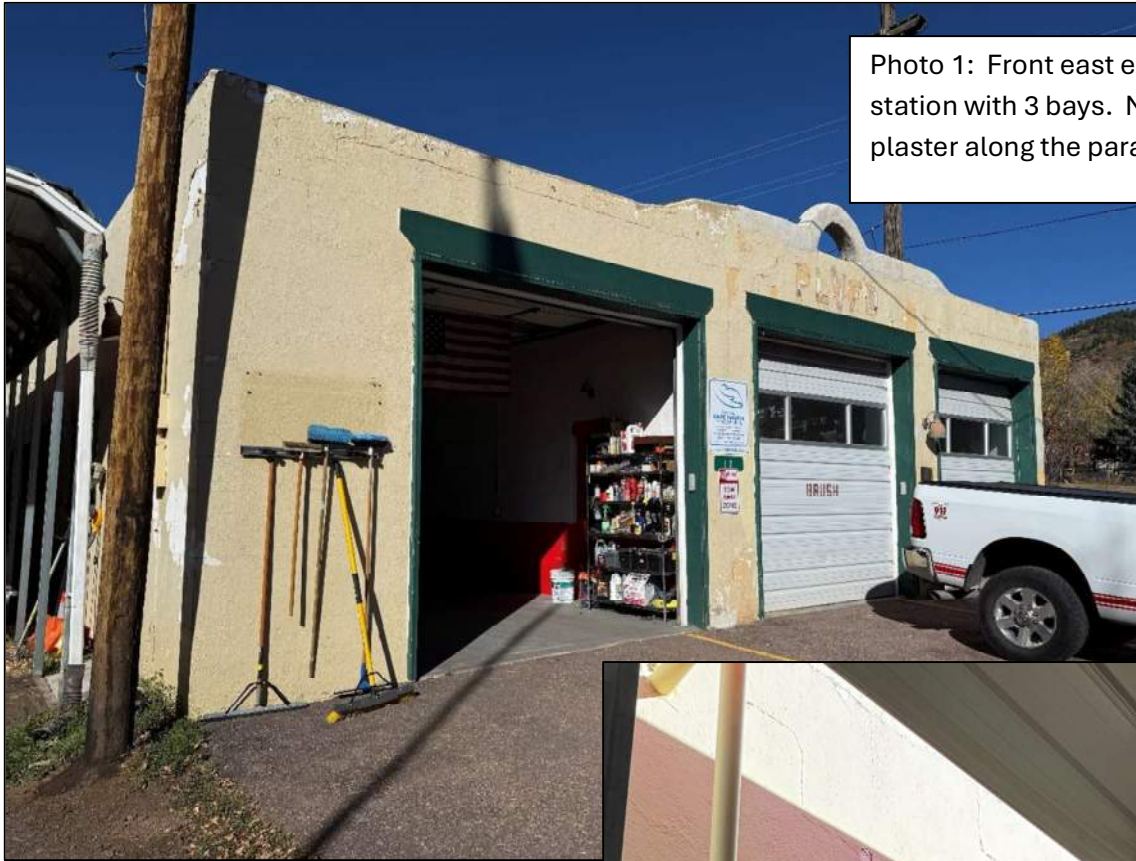
Photo 1: Front east elevation of fire station with 3 bays. Note cracks in the plaster along the parapet.

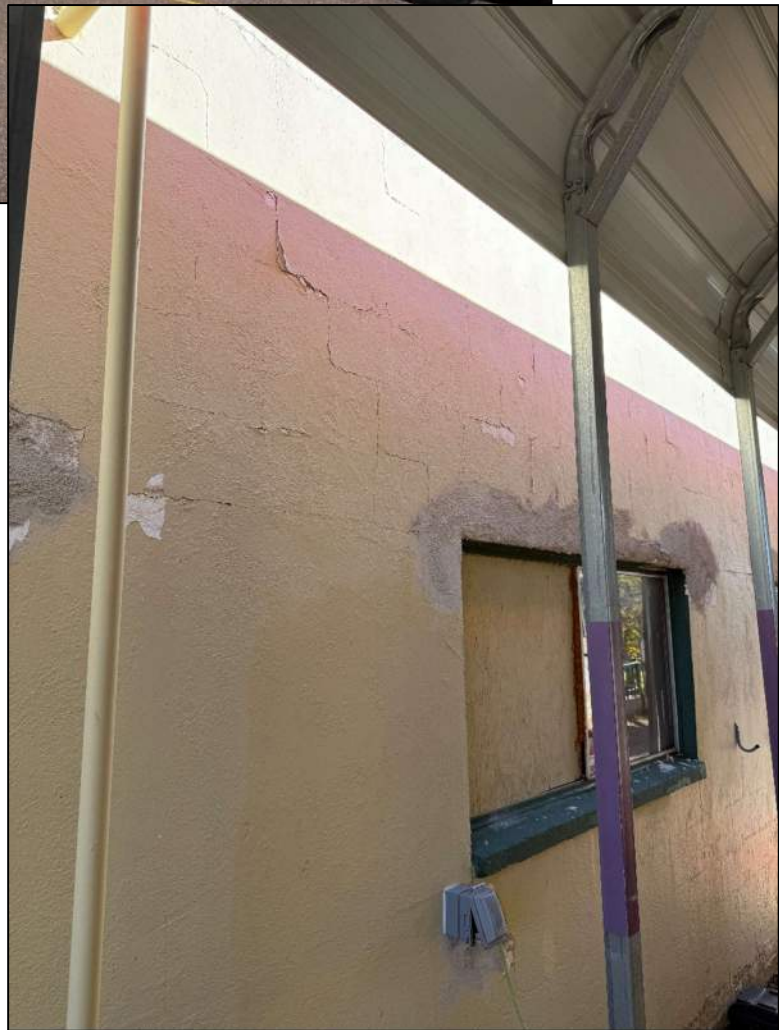
Photo 2: South wall looking northeast under the fire truck roof structure. Notice cracking in plaster defining the 8"x16" CMU blocks. Lots of plaster patches were presents.

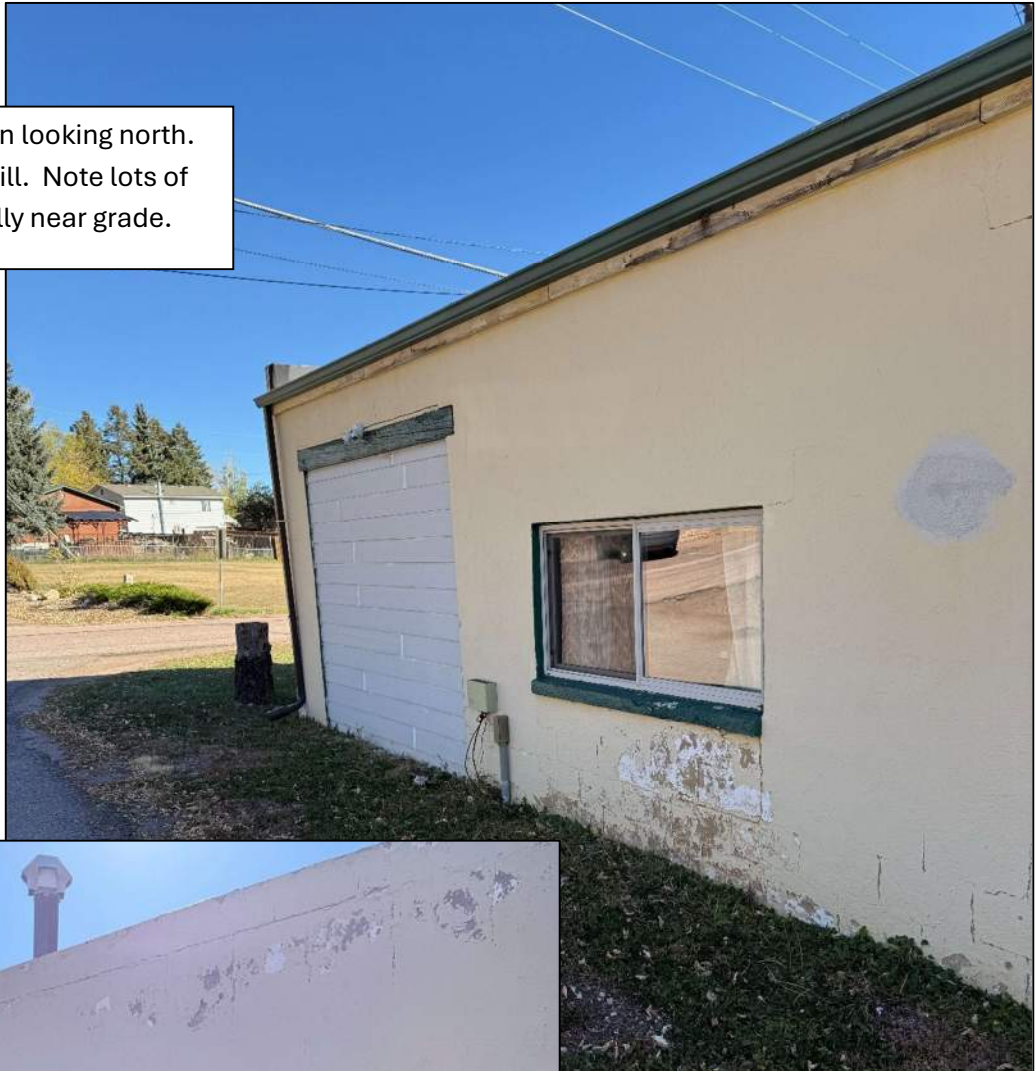
Photo 3: West elevation looking north.  
Note overhead door infill. Note lots of  
plaster cracks especially near grade.

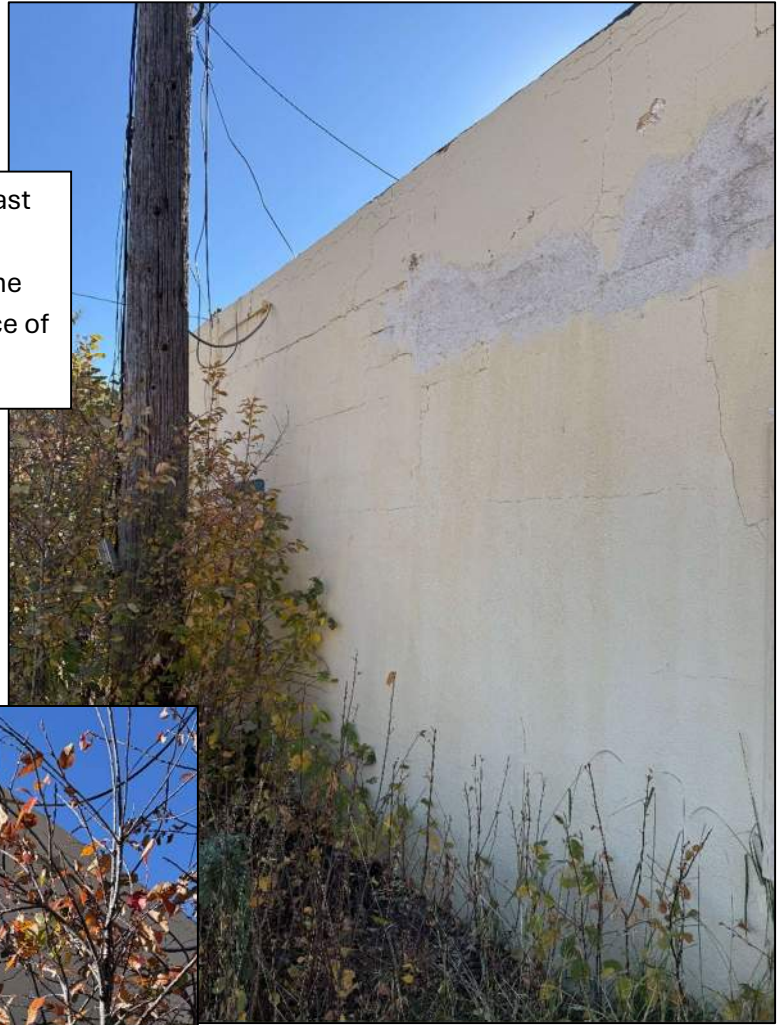
Photo 5: North elevation near the east end with significant cracking in the plaster and lots of patches. Most the cracking appear to be at the interface of the roof and parapet.

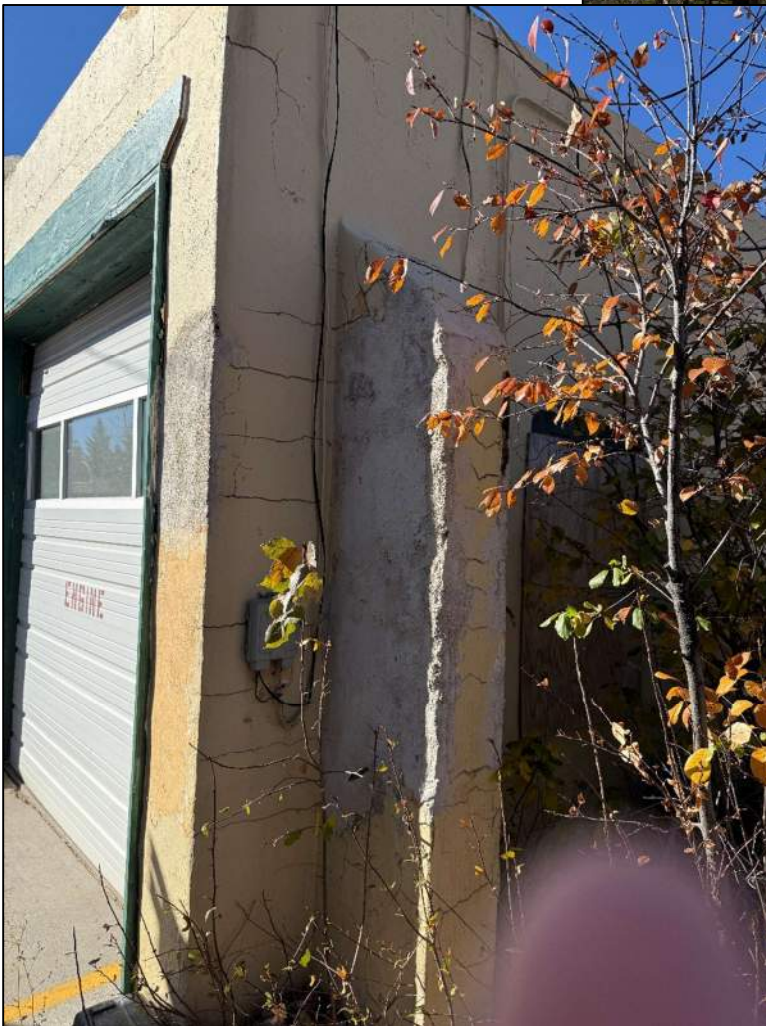
Photo 6: Northeast corner buttress. Lots of significant cracking in the plaster and patching that has occurred.

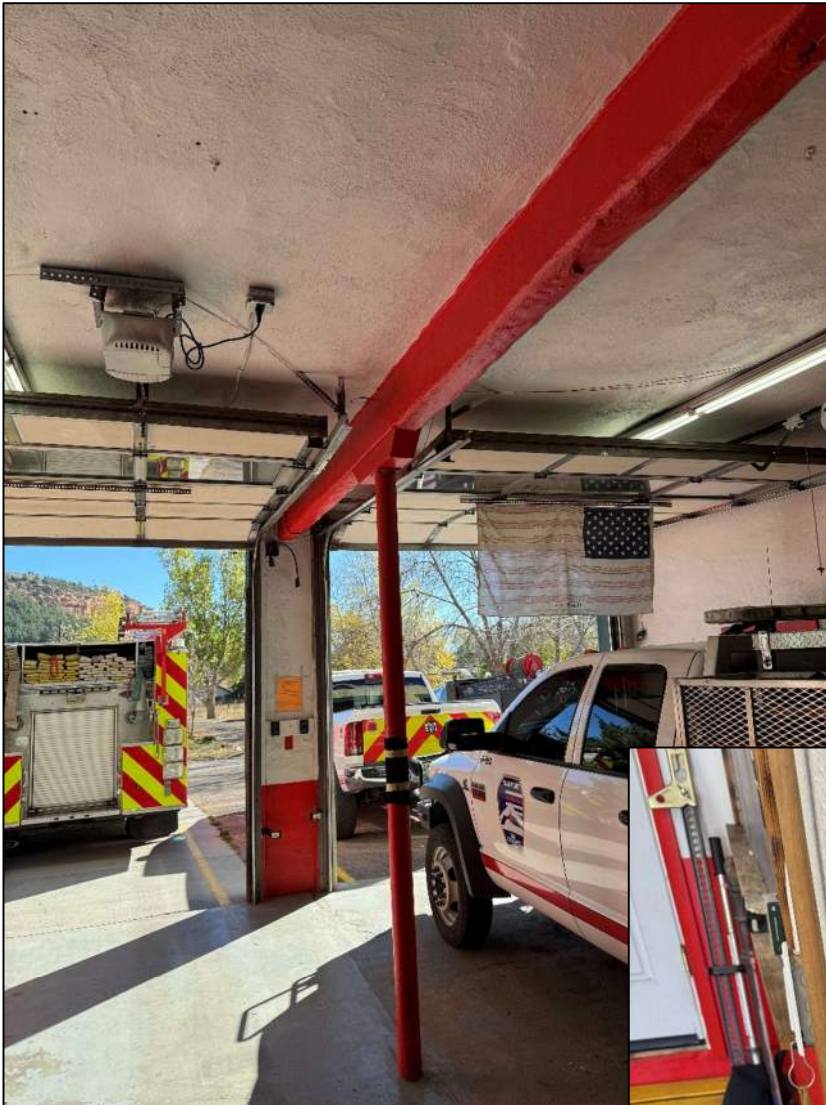
Photo 7: Inside Bays #2 and #3 looking east. Note red beam bisecting the bays and steel post. Plaster is on the ceiling and all wall surfaces.

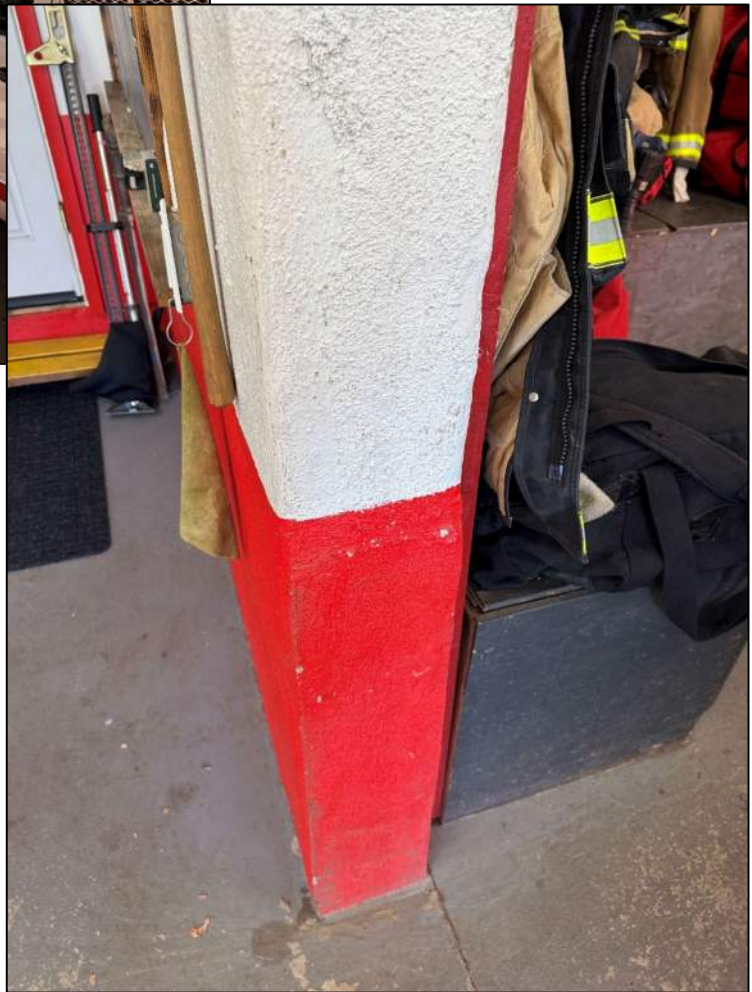
Photo 8: Demising wall between Bays #1 and #2. Likely 8" CMU that was the original exterior wall. Note concrete slab-on-grade floors.

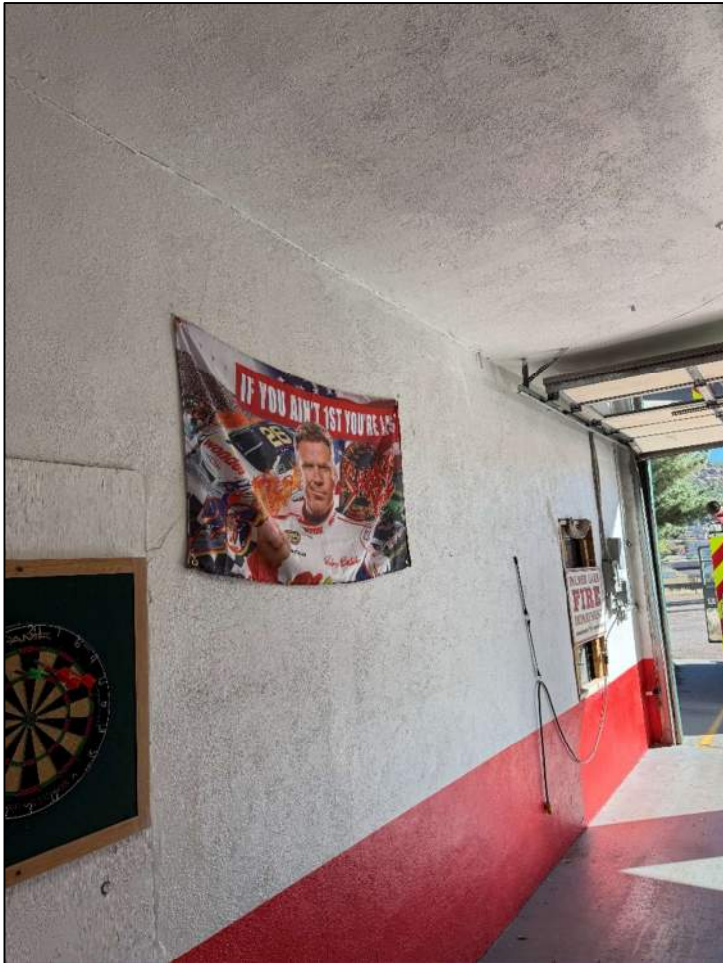
Photo 9: Interior north wall looking northeast. Note some minor cracking in the plaster mostly near a window infill.

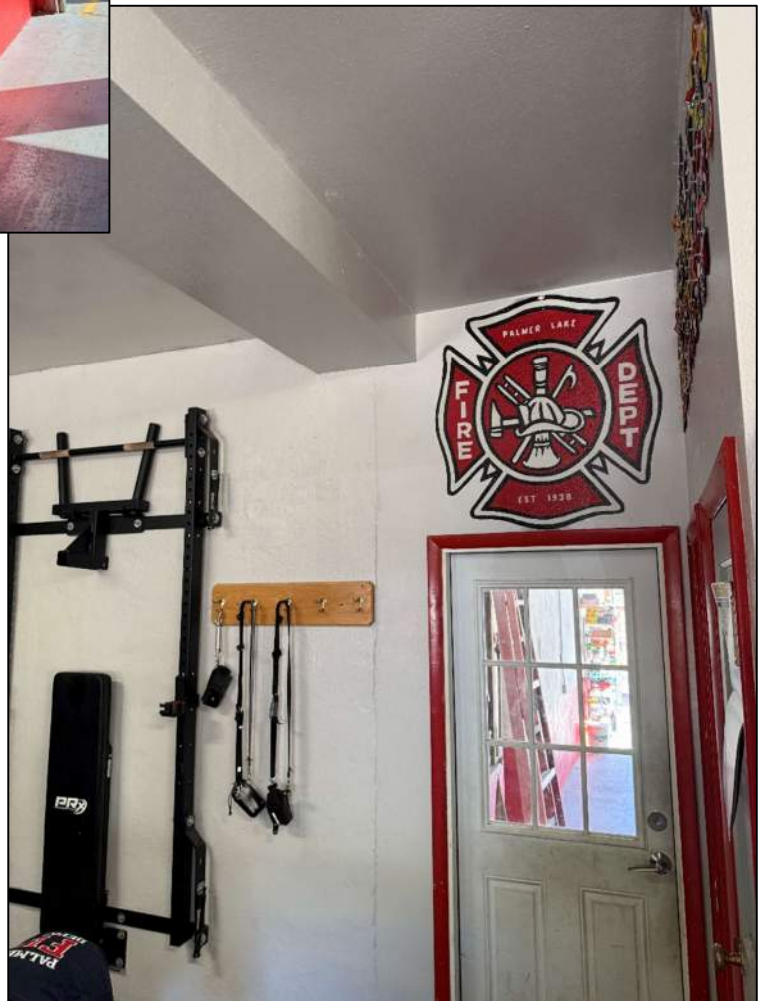
Photo 10: Beam and bearing location inside bunkhouse looking east.

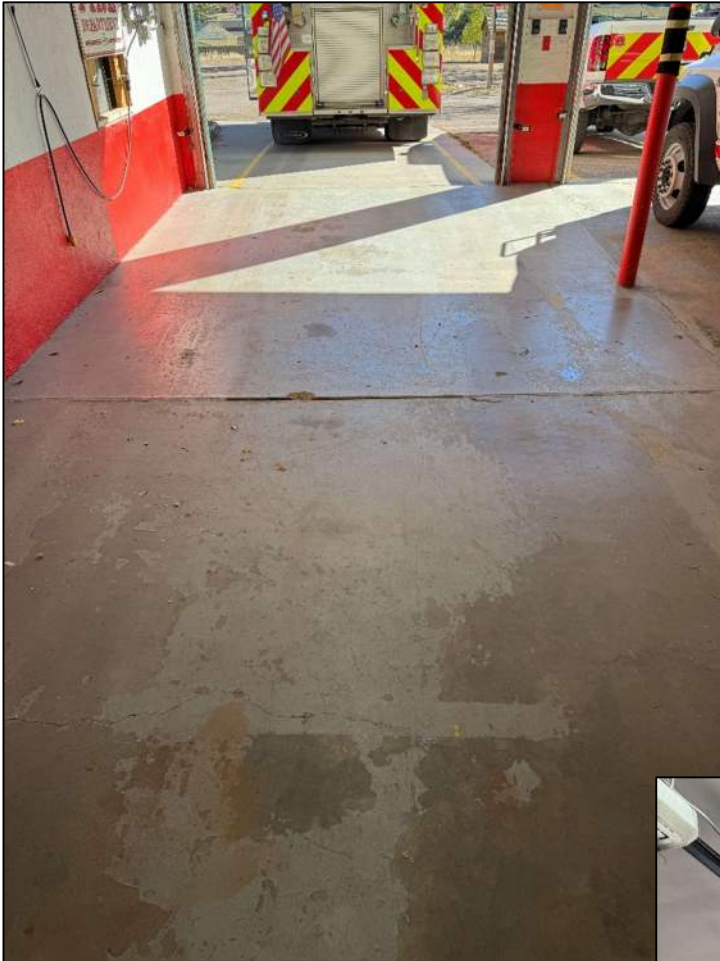
Photo 11: Slab-on-grade floor in Bay #3 looking east. Slab is in fair condition with some minor spalls. Slab is supposedly 14" thick and fairly new per staff.

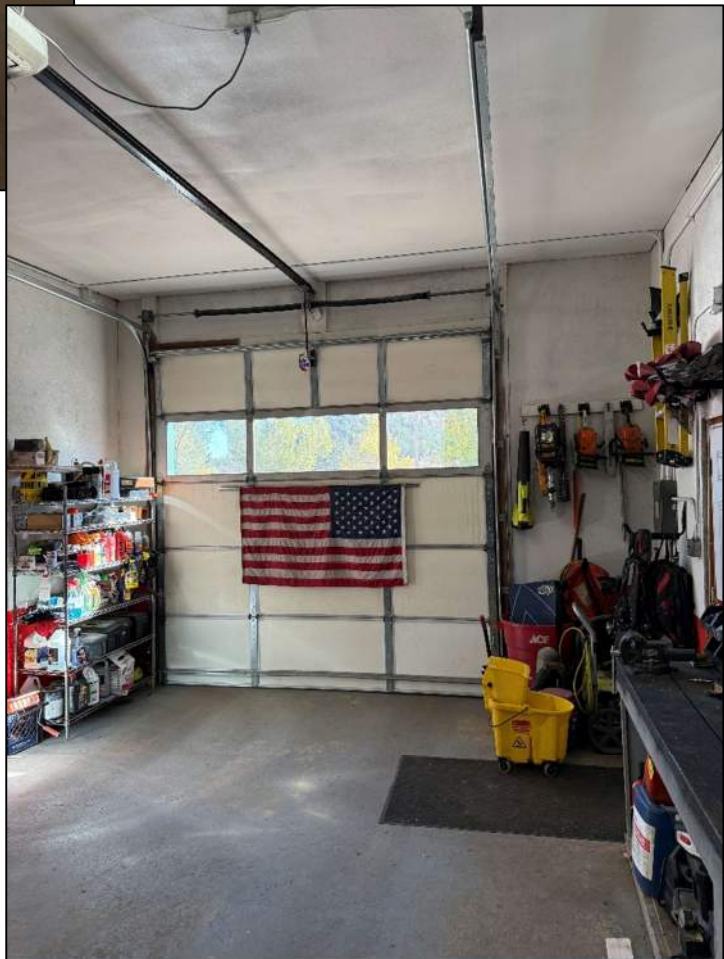
Photo 12: Slab-on-grade floor in Bay #1 looking east. Slab is in fair condition with some minor spalls and cracking. Slab is supposedly original construction circa 1960's.
