**TOWN OF PALMER LAKE
BOARD OF TRUSTEES - AGENDA MEMO**

DATE: April 27, 2023	ITEM NO.	SUBJECT:
Presented by: Town Administrator /Clerk		Direction for Use/Security of Elephant Rock Property

Elephant Rock Property - current evaluation

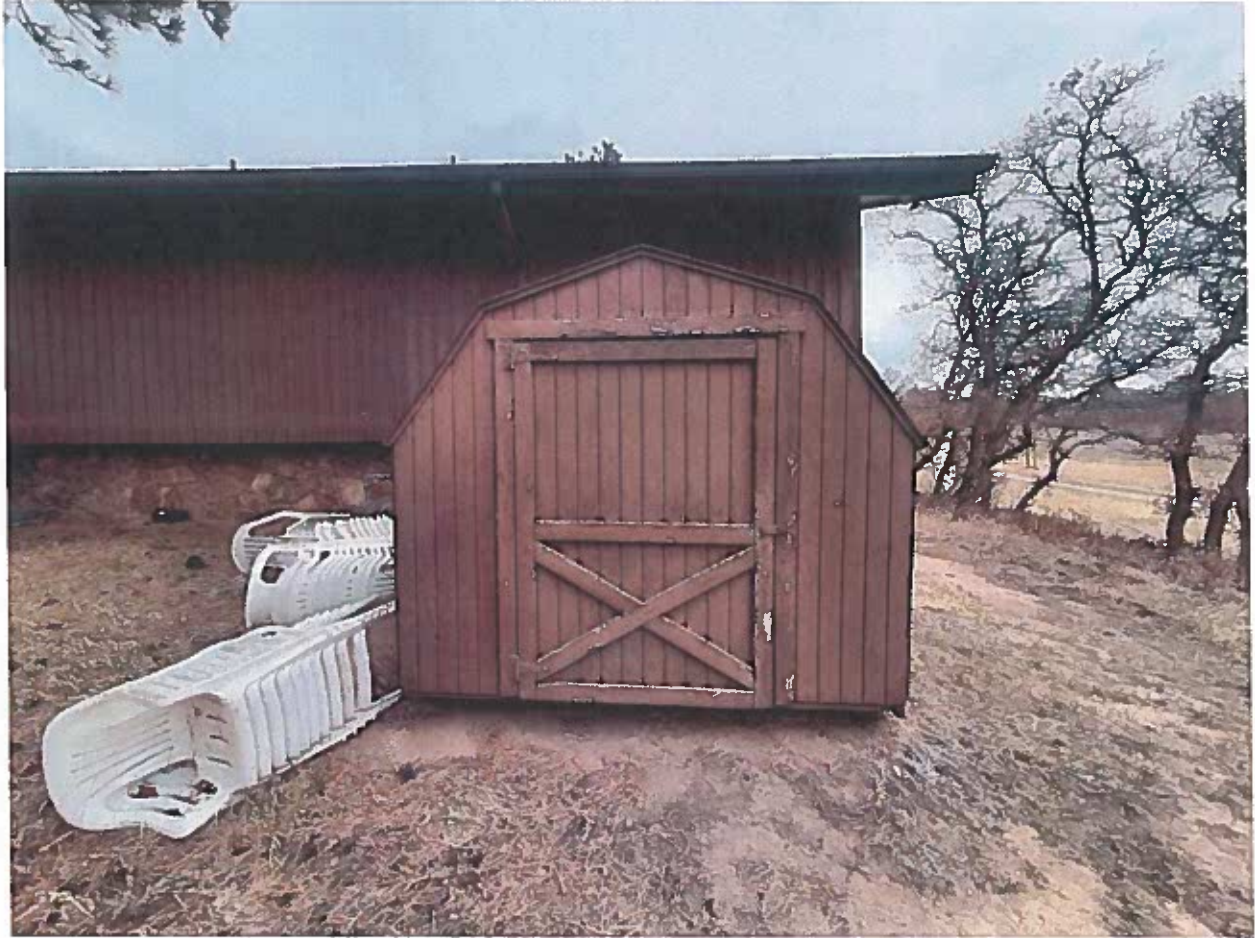
Shed – either move near maintenance structure for storage or remove entirely

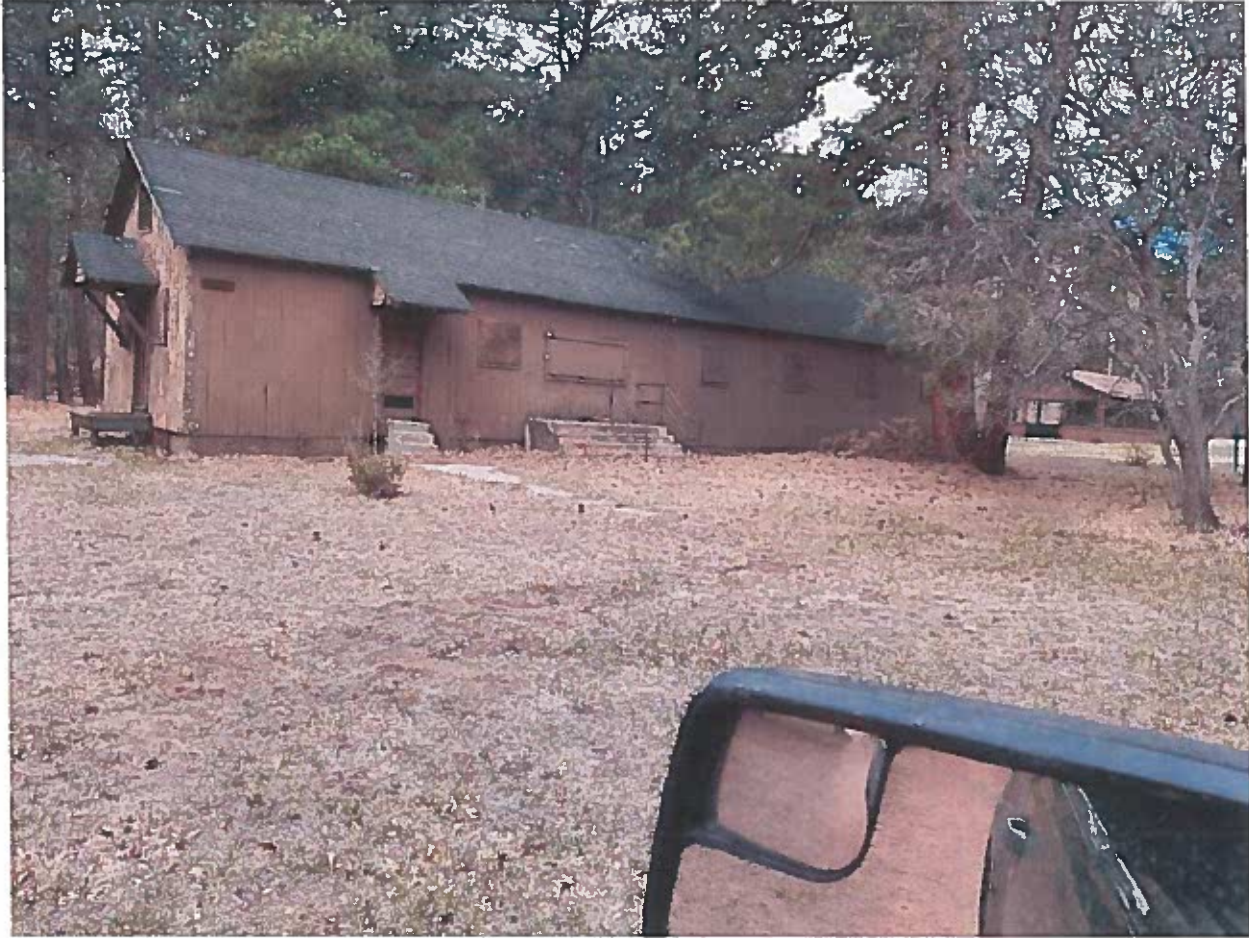
aka "eagles nest" and previously noted uninhabitable. If decided *not* to improve, remove altogether from the premises; this structure sits among the current dilapidating cabins.

It is this structure and six cabins to consider PD/FD training and demo/remove in the future.

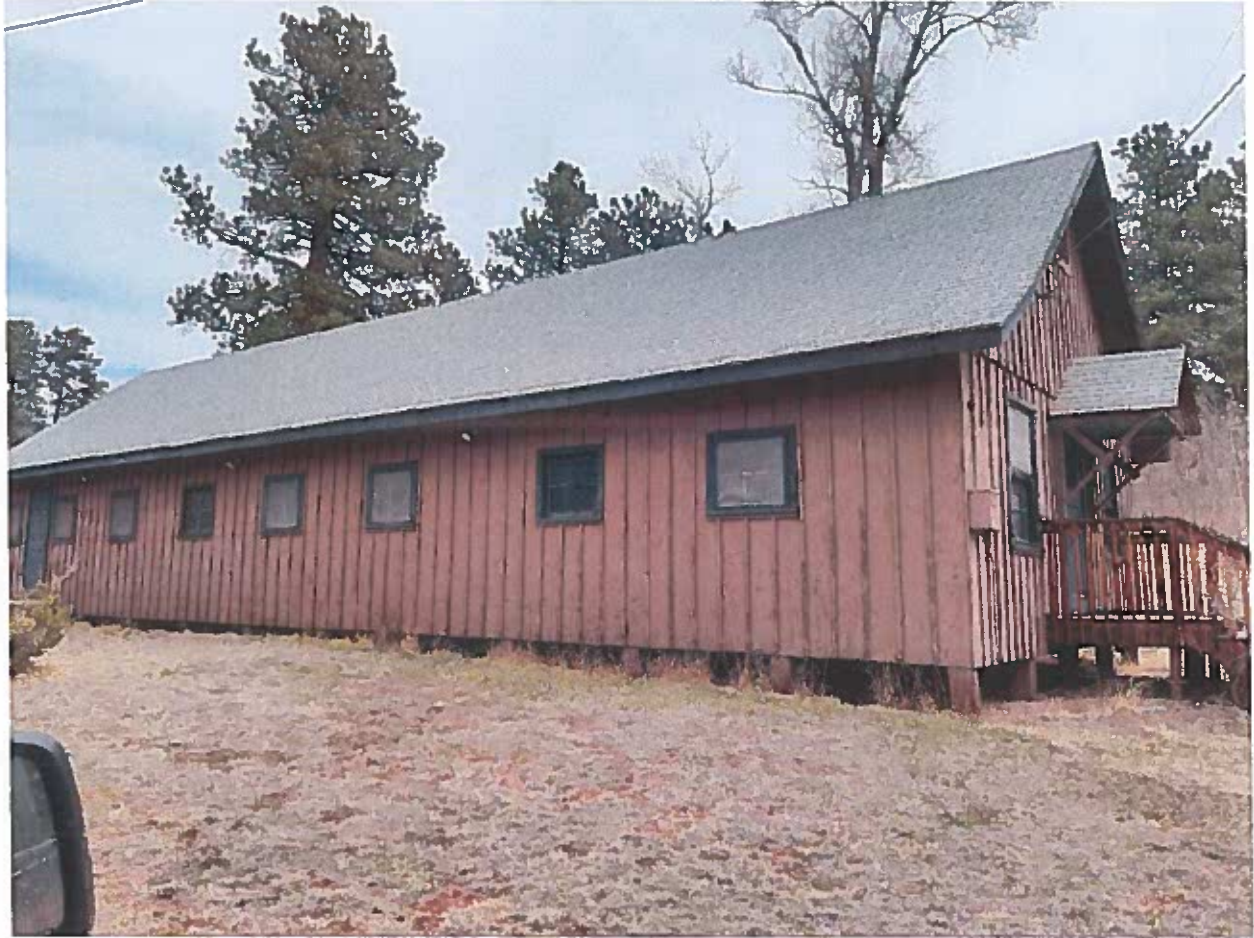
- a. Windows
 - i. Several windows (no protection)
- b. Doors
 - i. Single door on one end (damaged) (not locked, kicked in door jamb)
 - ii. Double door on the other end (locked from inside)

The chapel is in fair shape and should be secured from future damage.
