TRANSMISSION RELIABILITY

Island to Island: An Alaskan High-Voltage Submarine Cable Failure

A utility serving several isolated Alaskan communities works to repair a severed power lifeline to the mainland.

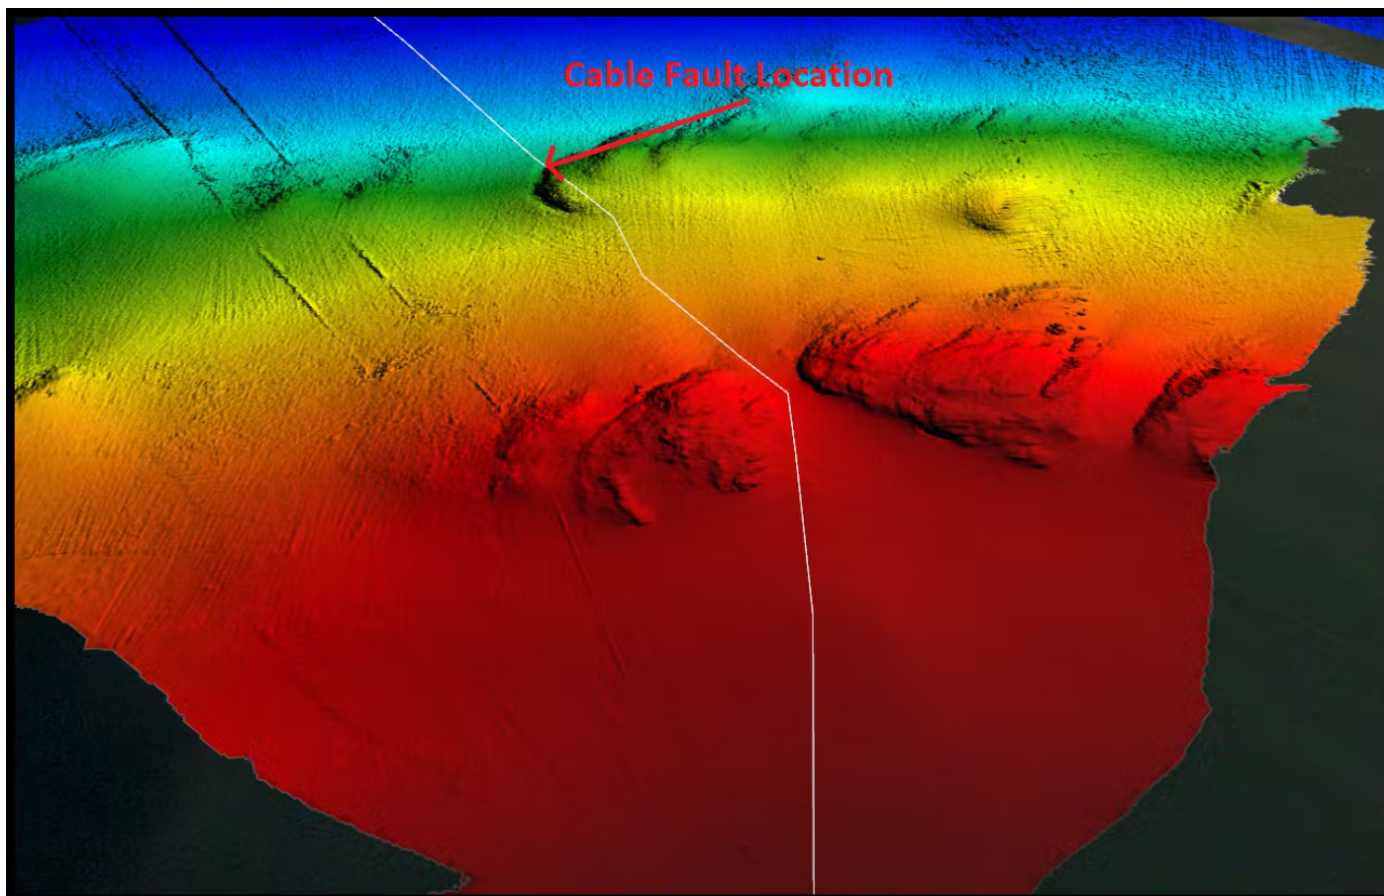
Before considering cable replacement, SEAPA investigated the possibility of performing a splice to effectively repair the failed cable. Time-domain reflectometer (TDR) tests were performed to identify the position of the fault. Test results signaled a negative reflection, indicating a break in the cable at nearly 2000 ft (610 m) offshore at a depth of 350 ft (107 m). A smaller positive reflection also was evident, which was either a possible ghost reflection or water ingress from gravity and density differentials between the seawater and oil.

A time domain reflectometer testing of the failed submarine cable in southeast Alaska.

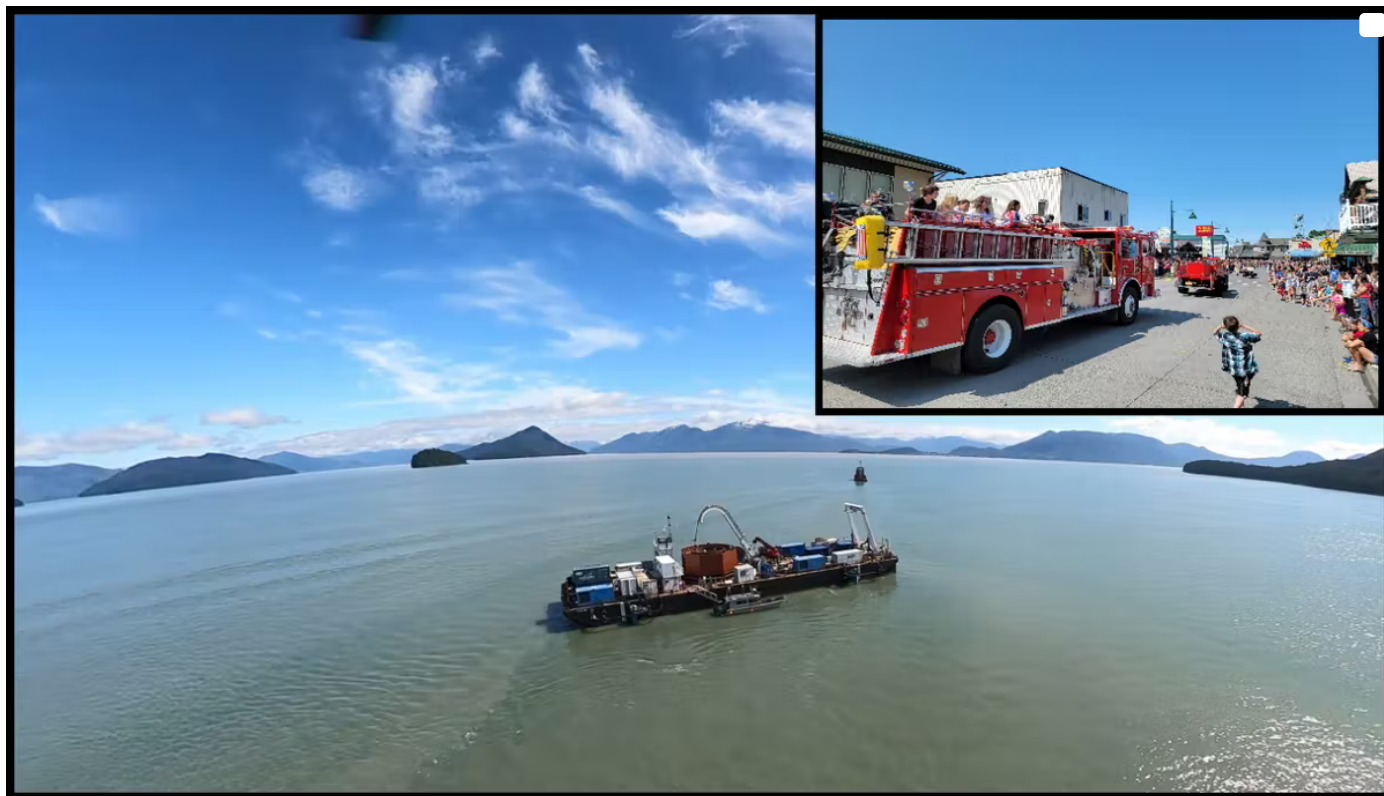
Installation of the 6kV XLPE Insulated cable on July 4, 2021.

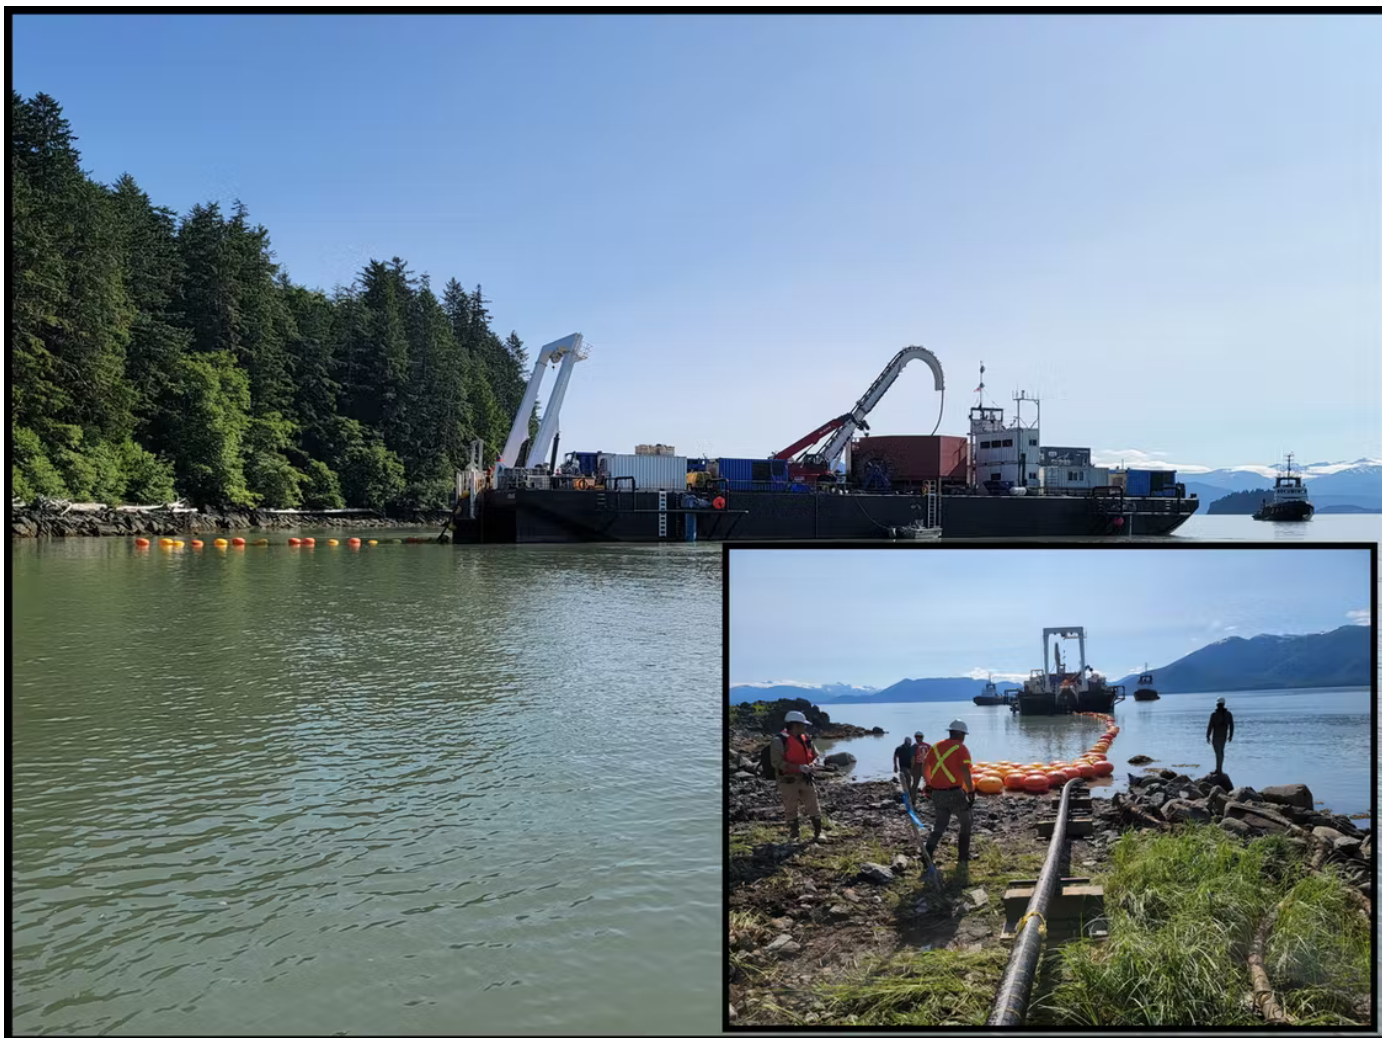
Installation of the 69 kV XLPE insulated cable, Vank Island, Alaska.

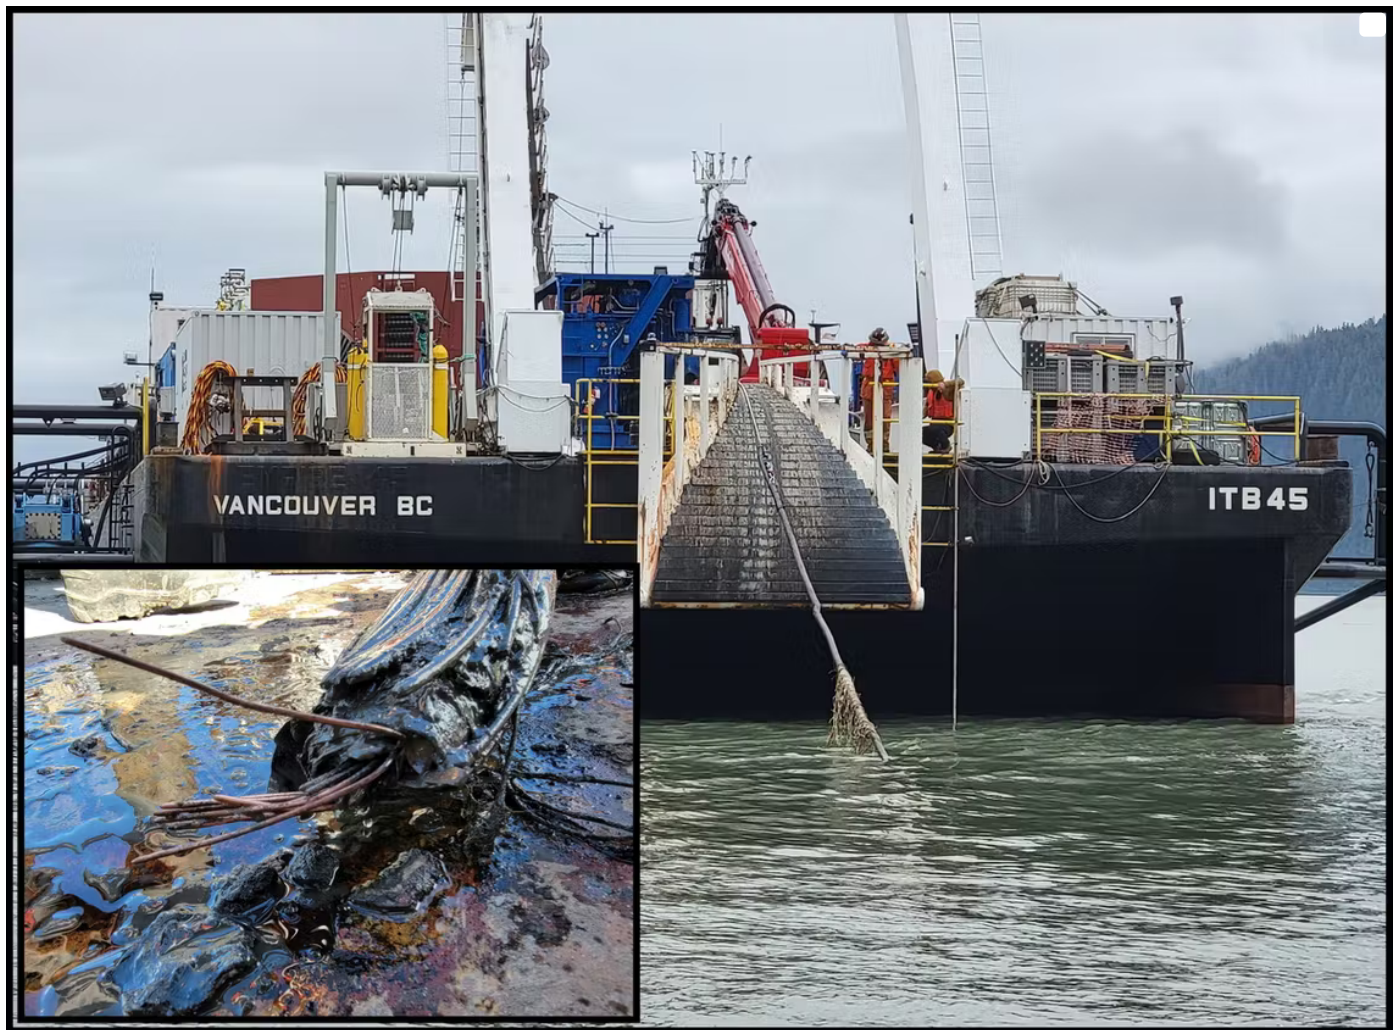
Removal of the oil-filled submarine cable near Wrangell, Alaska.
