CITY OF PORT LAVACA

SUBJECT: **CORRUGATED METAL PIPE CULVERTS IN CORPORATION DITCH UNDER CITY'S RAILROAD SPUR AT THE HARBOR OF REFUGE:**

Update on investigation into the condition of the Corrugated Metal Pipe storm sewer culverts in Corporation Ditch under the City's rail spur at the Harbor of Refuge:

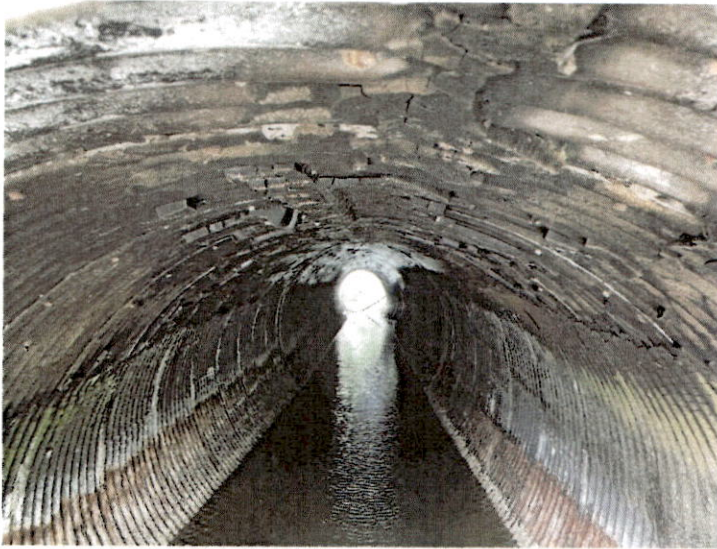
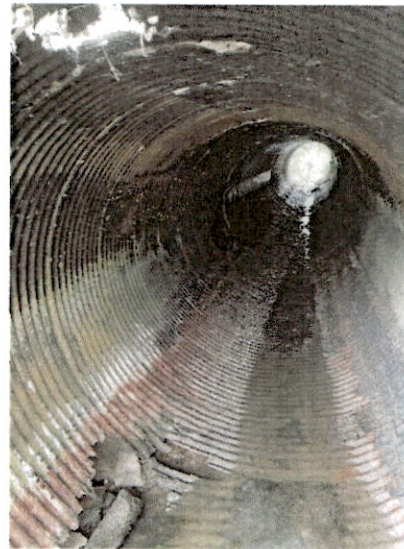
After a sink hole was discovered along the rail spur at the corporation ditch in the Harbor of Refuge tract, Jim took these photos of the two corrugated metal pipes (CMP) in the corporation ditch, under the rail. The sink hole was filled with limestone and has not opened up again since. The two culverts are installed at different flowline elevations, that's why one shows to have more water in it than the other. The photo on the right indicates that the downstream end of the pipe, which is most exposed to the elements, appears to be rusted completely through at the invert. The darker material at the tops of the pipes appear to be a thick mastic coating of some sort.

- On April 24, I reached out to Contech Engineered solutions who manufacture corrugated metal pipe to get their input. Their reply is as follows:
 - Based upon the photos provided there appears to be advanced corrosion in the invert of the pipe, with portions of the invert exhibiting complete metal loss. Due to that metal loss, the pipe needs some form of rehabilitation to provide full structural integrity.

- It will be important to determine if there has been appreciable metal loss in the portions of the pipe above the invert. Metal thickness can be determined using an ultrasonic thickness gauge (non-destructive), or by taking core samples of the pipe (destructive). Once the remaining metal thickness is determined it can be checked for structural adequacy.

- If the upper portions of the pipe are structurally sound, then the rehabilitation may only require invert repair. A simple invert repair to consider is the installation of reinforced concrete invert paving (see detail attached).

- If the upper portions of the pipe are not structurally sound, then the entire pipeline should be replaced or rehabilitated. Replacement would likely require full cut and cover techniques and disruption to the rail line above. Rehabilitation could entail slip lining a replacement pipe which could prevent disruption to the rail line. Several pipe types are suitable for slip lining and many can be designed to carry the full soil load and railroad loading.
