October 11, 2024

RE: Raymond Park Pond Assessment Report

Prosper, TX

WPM PROJECT: C04-24012-00

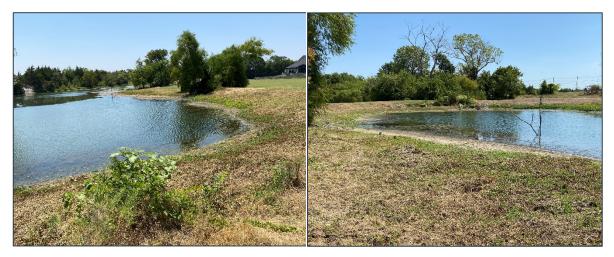
The upstream embankment was well-vegetated and in fair condition overall, with an approximate 3H:1V slope. Bank erosion was observed near the normal pool water surface elevation, presumably from long-term wave action. No signs of embankment settling, or movement were observed, especially near the scour damage on the downstream embankment.

Picture 5. Upstream embankment looking north

Picture 6. Upstream embankment looking south

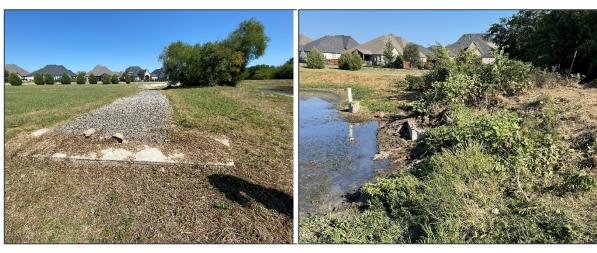
Picture 7. End of upstream embankment

Picture 8. Pond outfall structures

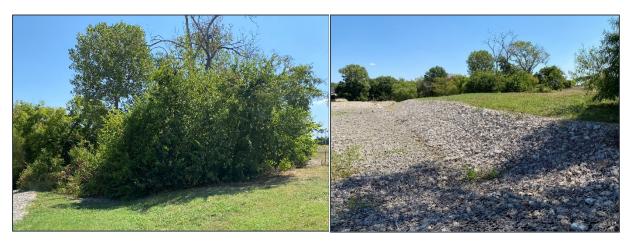
The northern side of the downstream embankment was shared with the pond service spillway and was protected by PVC coated gabion mattress lining the spillway. The embankment along the service spillway was approximately 200 feet in length with an average slope of 4:1. Minor tears in the gabion mattress were observed and are included in the repair recommendations at the end of this report.

The eastern side of the downstream embankment was approximately 100 feet in length, with an approximate average slope of 2:1, and was covered with trees and dense, woody vegetation. Erosion was observed at the toe of the outfall structure along the east side of the downstream embankment. The erosion was severe and caused by stormwater flow from the outfall structure. The outfall was perched midway up the downstream embankment which allowed stormwater flow to free fall into a scour hole filled with concrete and rock rubble riprap. The depth of the scour hole measured up to 3 feet deep, below the top of the riprap in the middle area. Walter P Moore observed seepage coming out of the eroded surface of the embankment beneath the outfall structure where the scour penetrated the farthest into the earth fill embankment.

Picture 9. Vegetation east side of embankment

Picture 10. Gabion spillway north of embankment

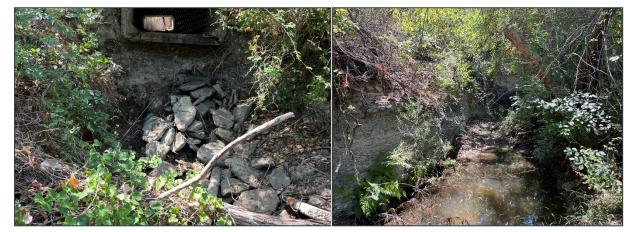
Picture 11. Erosion at toe of culvert downstream embankment

Picture 12. View east downstream of embankment

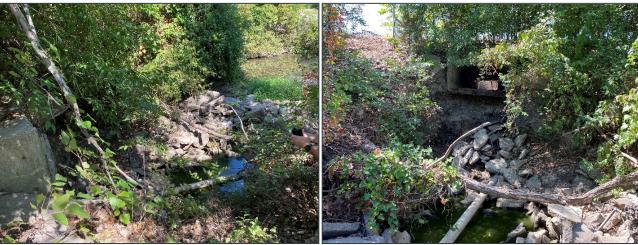
The 6'x3' box culvert outfall was located approximately one third of the way up the downstream embankment. The downstream embankment beneath the box culvert was completely eroded and scoured out. There was broken concrete riprap remaining on the embankment and lying beneath the outfall in the scour hole.

Walter P Moore found a 6-inch PVC pipe exposed, and unsupported through the middle of the scour hole beneath the 6'x3' box culvert. Walter P Moore could not confirm, but expected this PVC pipe connected to the PVC service inlet structure above in the pond and was visible for approximately 30 feet before it disappeared beneath the concrete riprap. The location of the downstream outfall and end of the 6" PVC pipe was not found and would have required jetting and cleaning to locate and inspect it any further. It was considered inoperable and abandoned for this assessment.

Picture 17. View east downstream from crest

Picture 18. Scour hole at toe of box culvert
