2025 Annual Field Inspection Report

# Pine River Flood Control System Richland Center, Wisconsin

*Prepared On:*  
January 7, 2026

Project #140258 - Task 1100

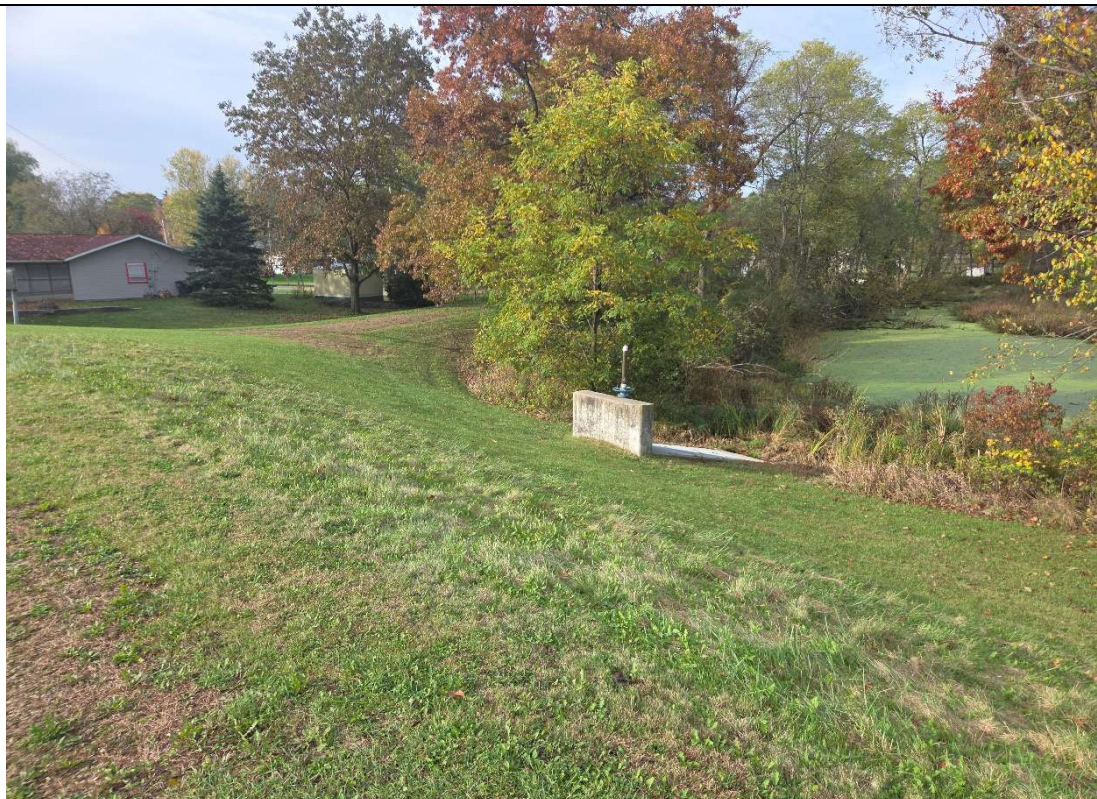
**Photograph: 6** | Flood gate in good working condition.

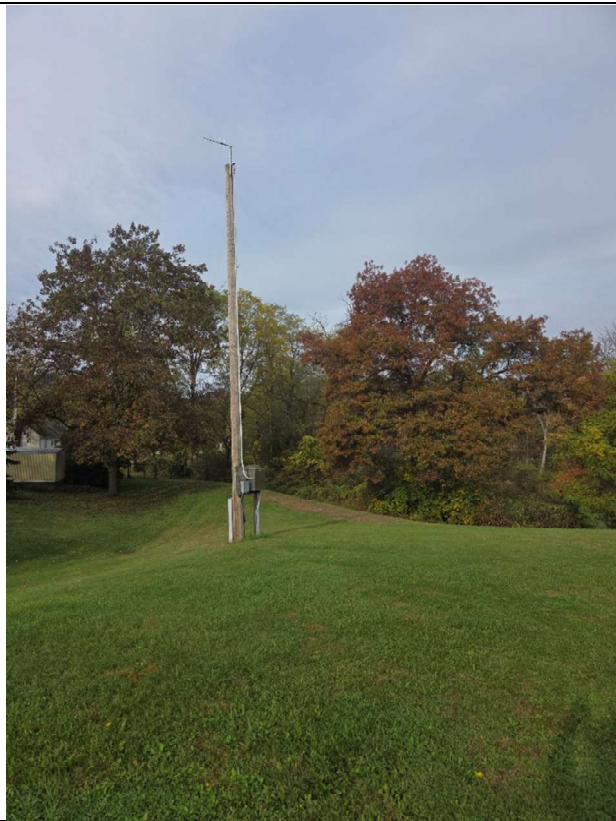
**Photograph: 7** | Control panel in good condition.

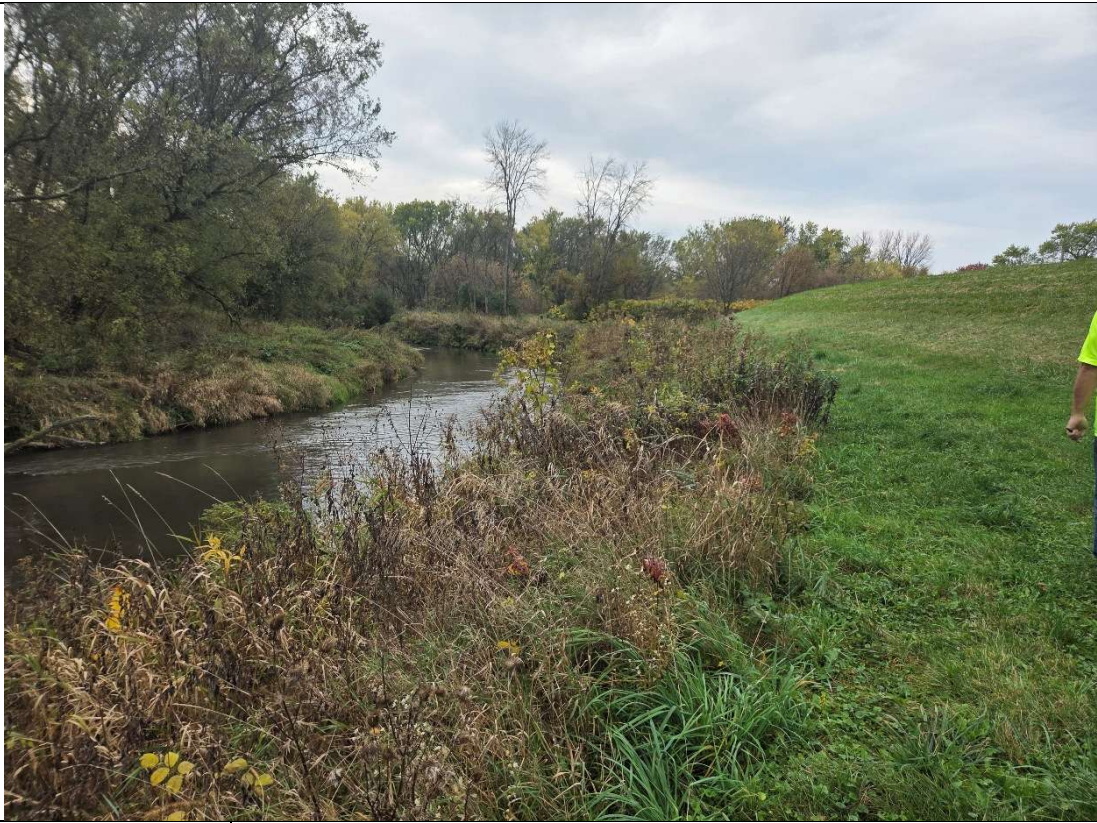
**Photograph:** 11

Photo taken approximately at Station 32+00 showing proximity of Pine River to dike.

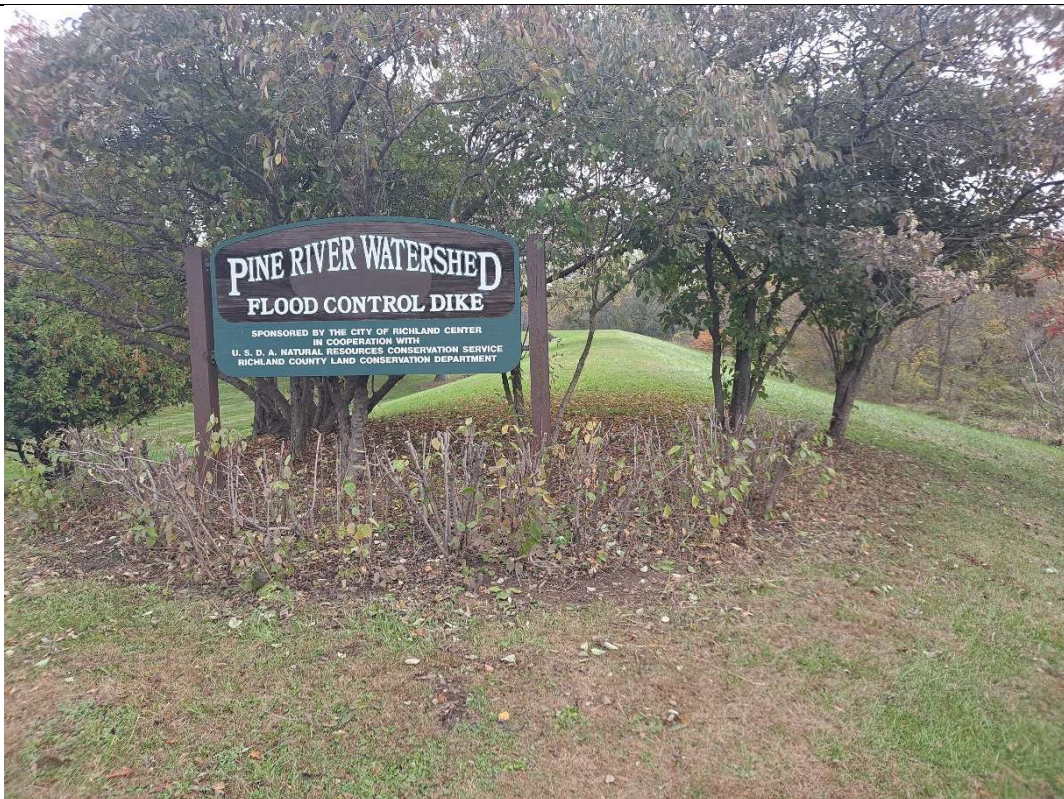
**Photograph: 19** Taken from STH 80 viewing sign to the northeast. Trees and shrubs to be removed at base. Roots to be left in place and treated.

- Remove trees and shrubs at base. Roots to be left in place  
and treated ..... Date: \_\_\_\_\_

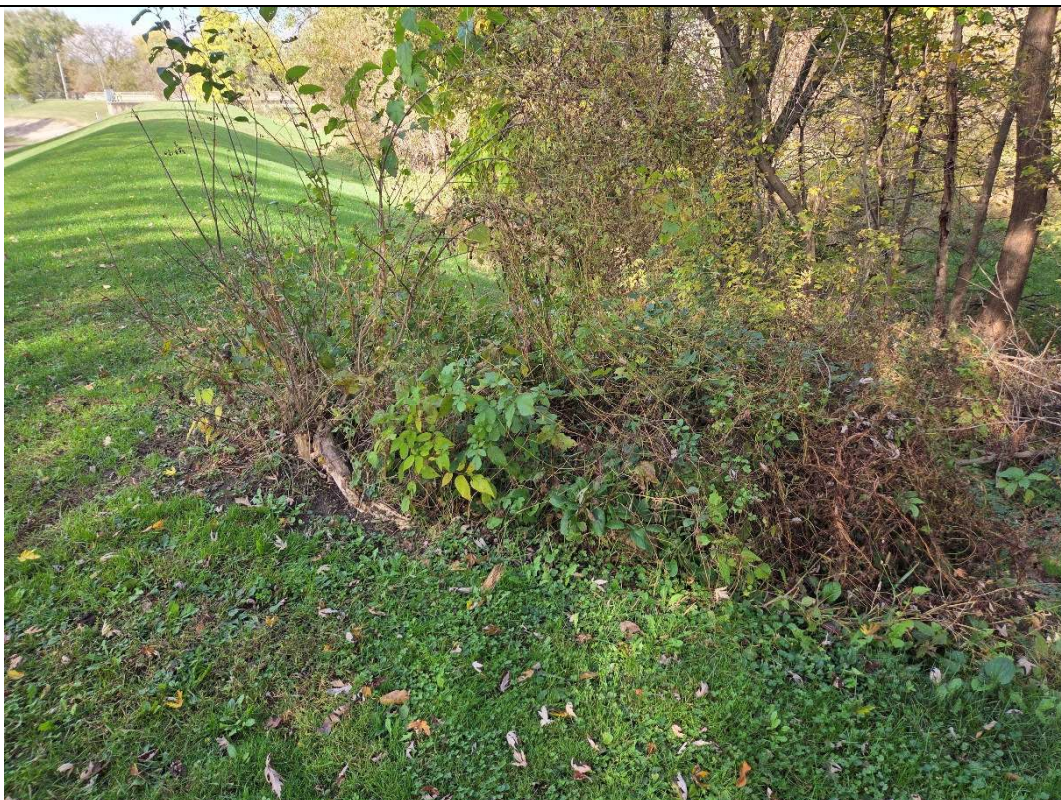
**Photograph: 24** Church Street Diversion photo, viewing in the westerly direction. Vegetation to be removed.

- Remove brush area on top of levee ..... Date: \_\_\_\_\_

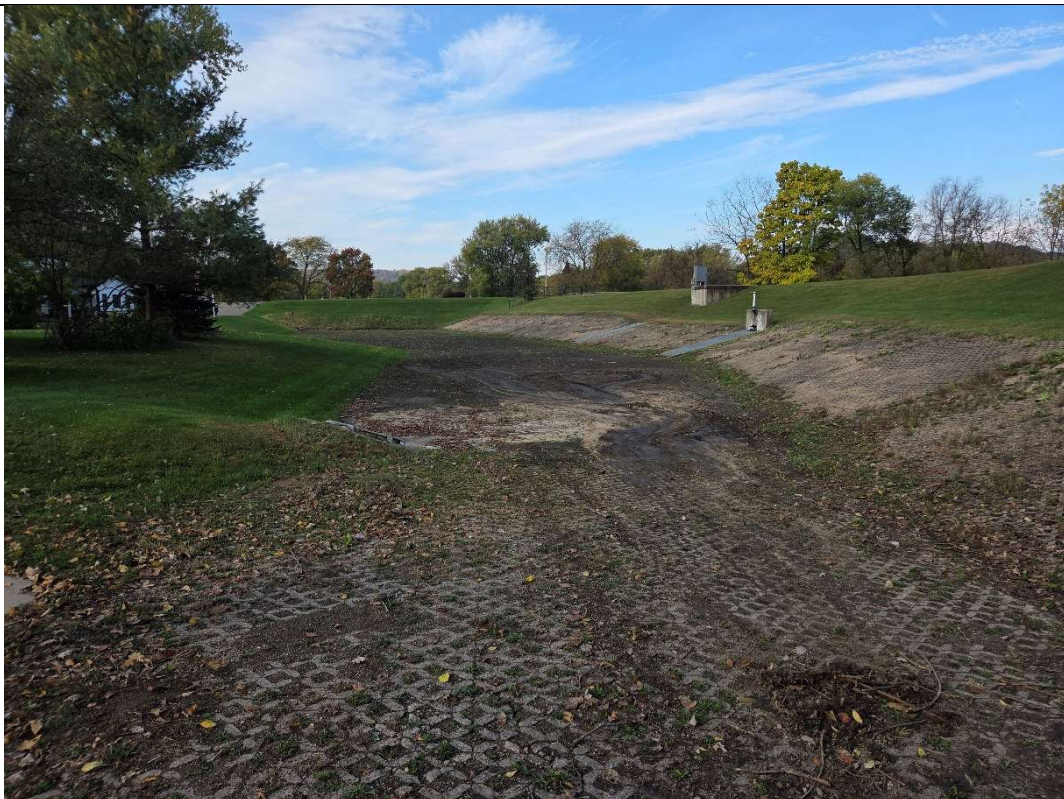
**Photograph: 25** Retention basin located south of dike between STH 80 and Church Street. Debris to be removed.

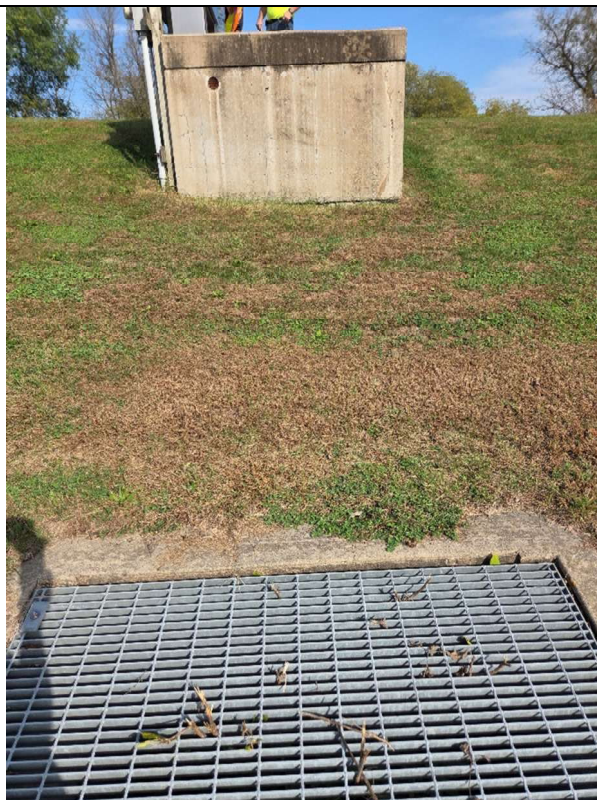
**Photograph: 26** Viewing gate valve and grate at retention basin. Debris to be removed.

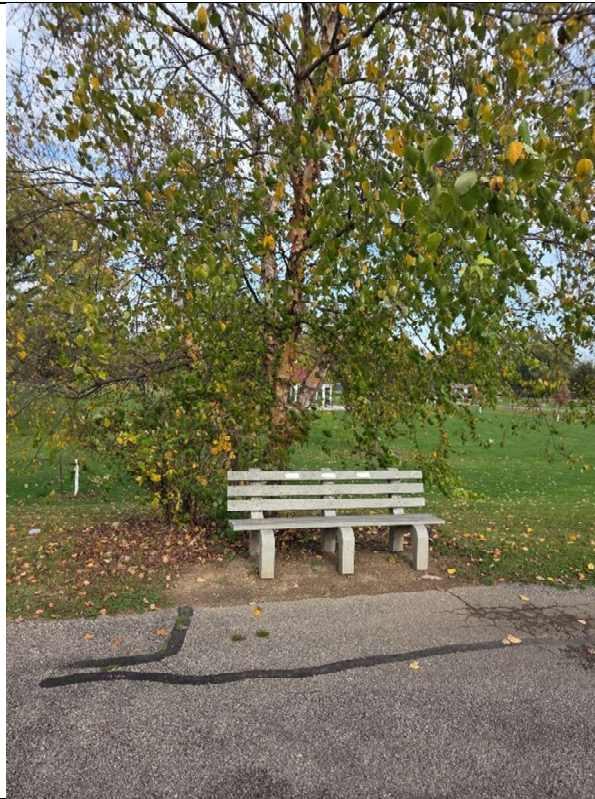
**Photograph:** 27

Photo taken viewing northerly between N Jefferson St and STH 14. Tree to be removed at base and roots treated.

- Remove tree at base and treat roots ..... Date: \_\_\_\_\_

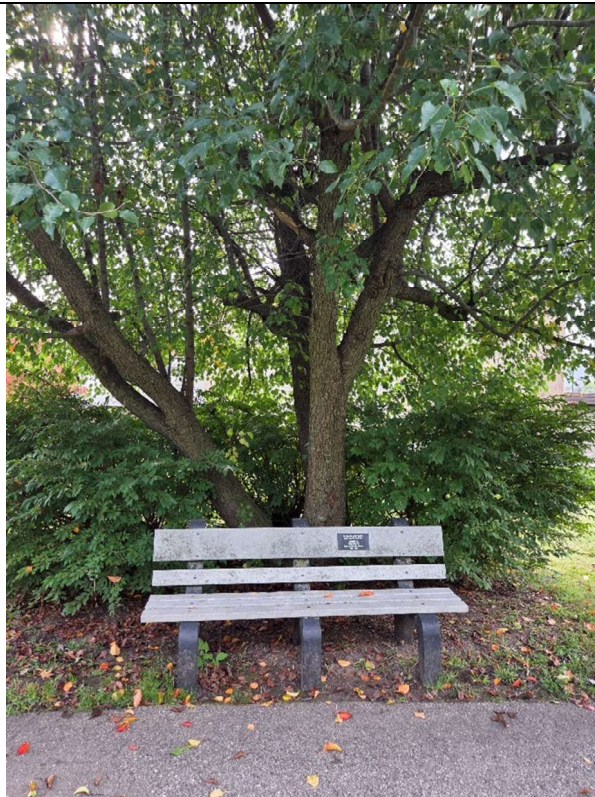
**Photograph:** 28

Photo taken viewing southerly between N Jefferson St and STH 14. Tree and shrubs to be removed at base and roots treated.

- Remove tree and shrubs at base and treat roots ..... Date: \_\_\_\_\_

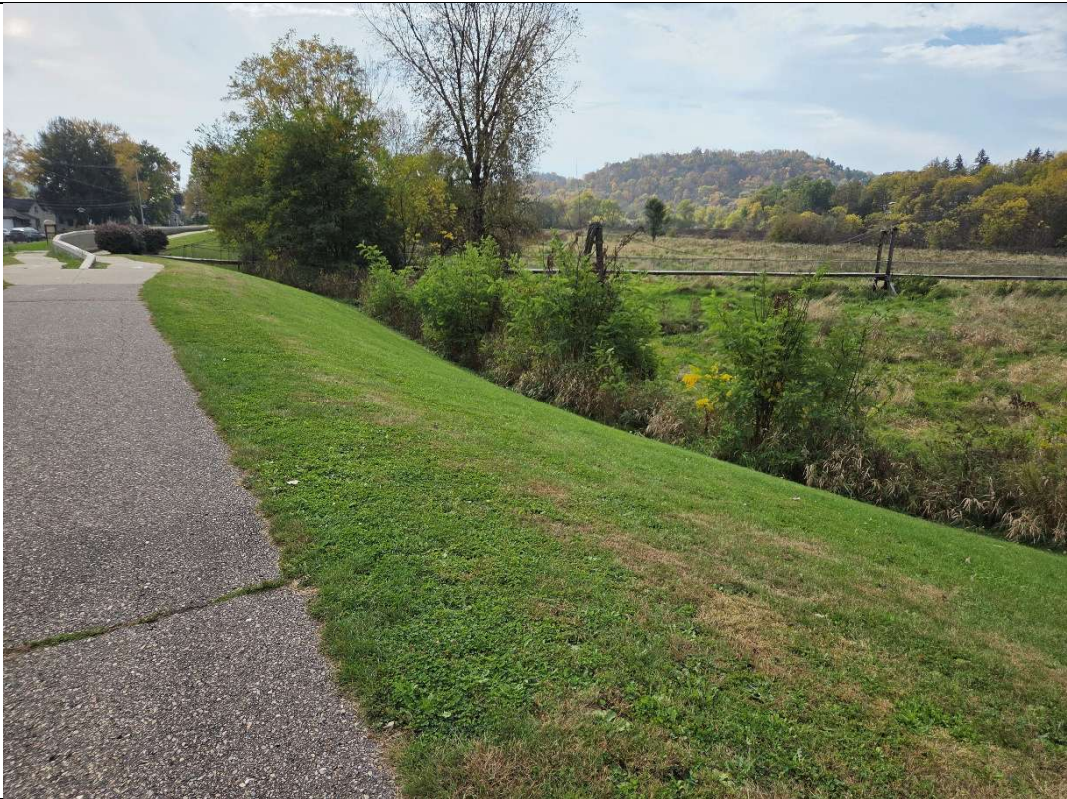
**Photograph: 31** Upper main dike photo, viewing southerly toward existing bridge. Trees and brush to be removed at toe of levee.

- Remove trees and brush at toe of levee ..... Date: \_\_\_\_\_

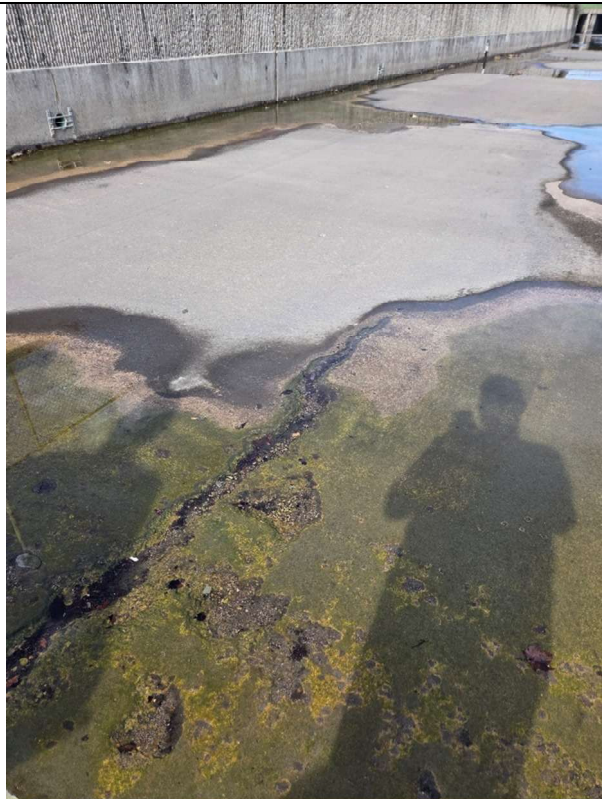
**Photograph: 34**

Photo of crack and spalling along concrete channel.

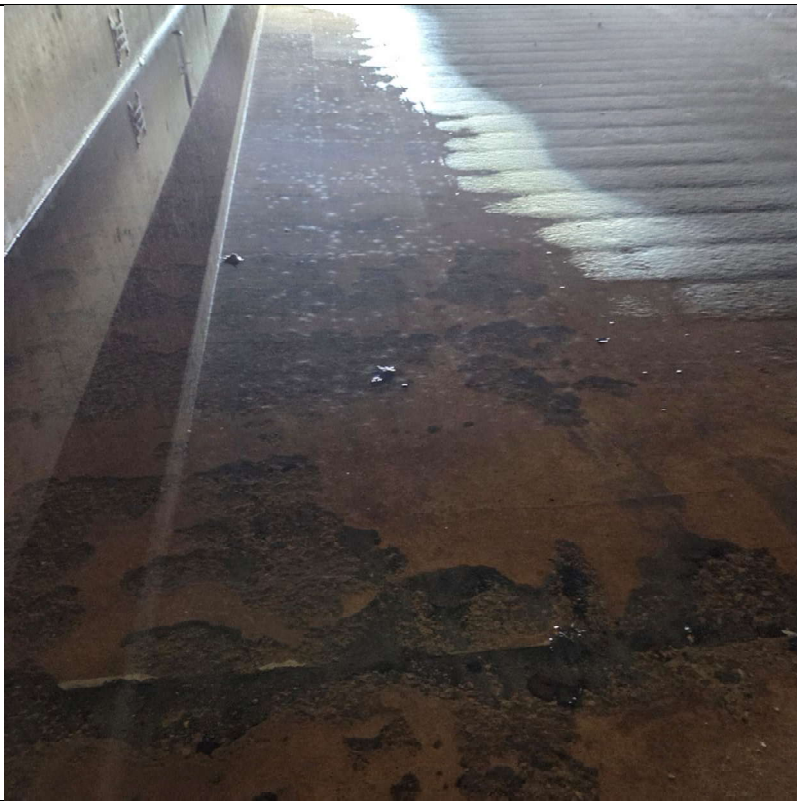
**Photograph: 35** | Photo of spalled concrete within channel concrete floor.

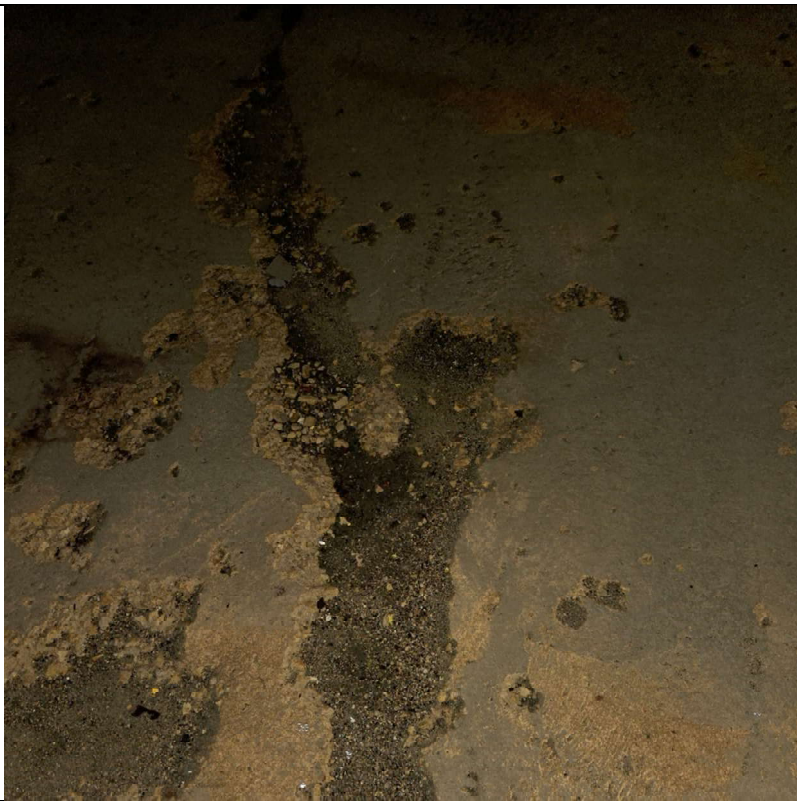
**Photograph: 37** | Spalled concrete within channel concrete floor.

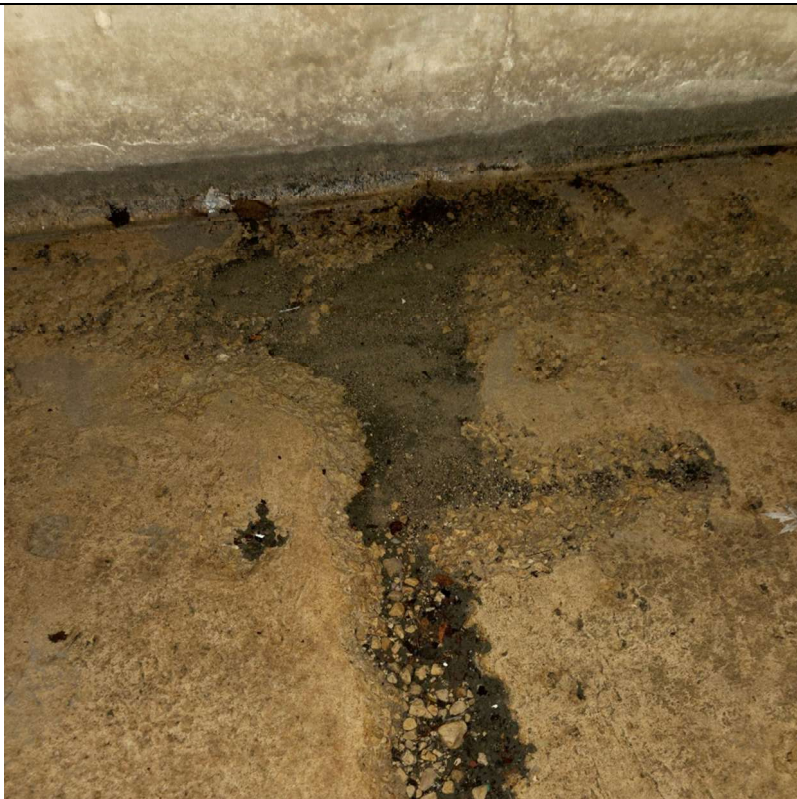
**Photograph: 38** | Spalled concrete within channel concrete floor.

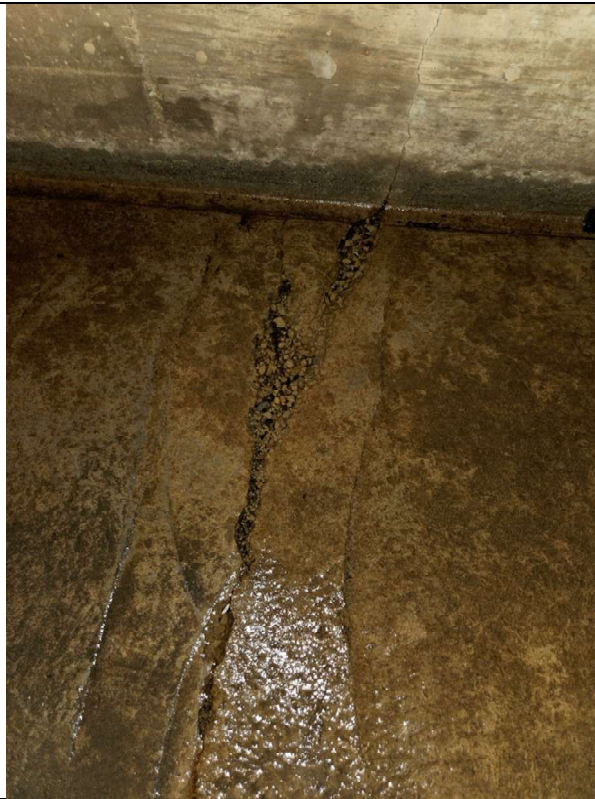
**Photograph:** 39      Spalled concrete within channel concrete floor.

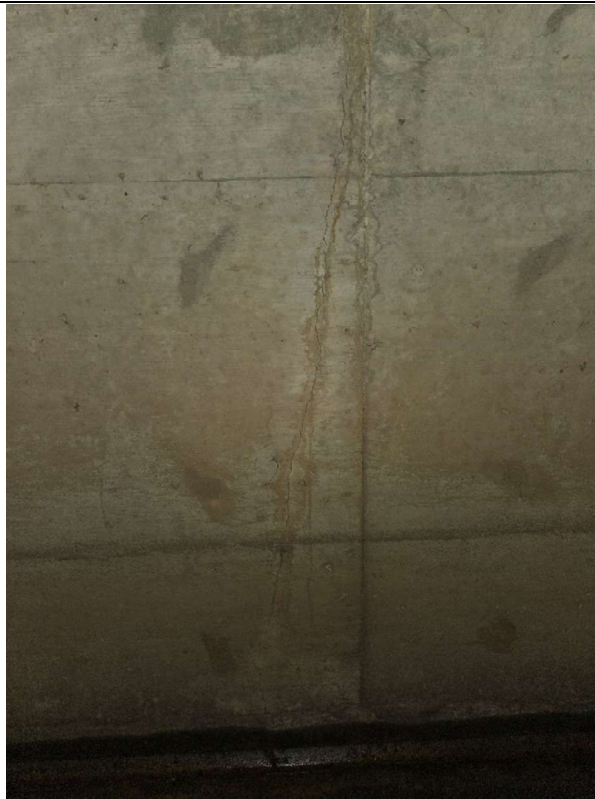
**Photograph:** 40      Photo of cracks in concrete channel.

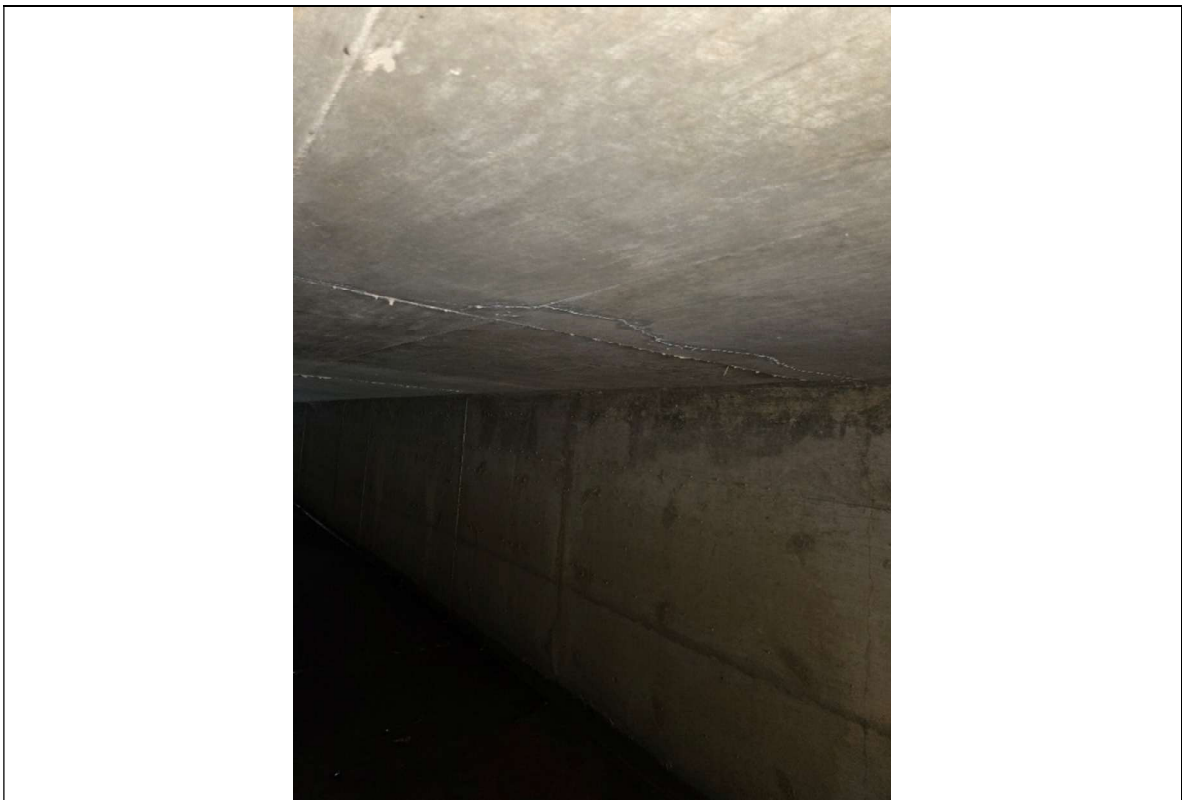
**Photograph: 42** | Photo of crack in concrete channel.

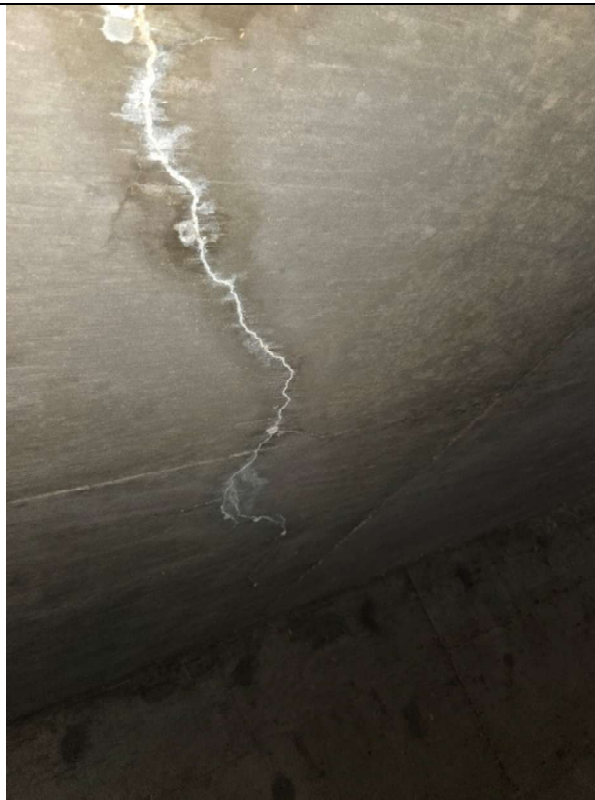
**Photograph: 43** Photo of crack in concrete channel.

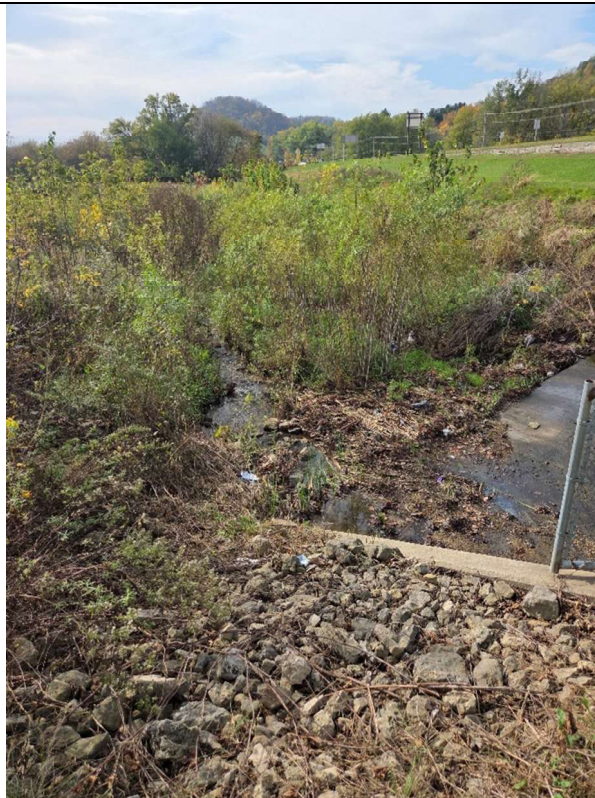
**Photograph: 44** Photo taken south the intersection of STH 14 and STH 80. Sediment and vegetation to be removed.

- Debris, sediment and vegetation to be removed at concrete channel discharge location. Station 65+00 of the Lower Main Dike segment.

- Remove vegetation and soil buildup within the channel during dry weather period of 2026. .... Date: \_\_\_\_\_

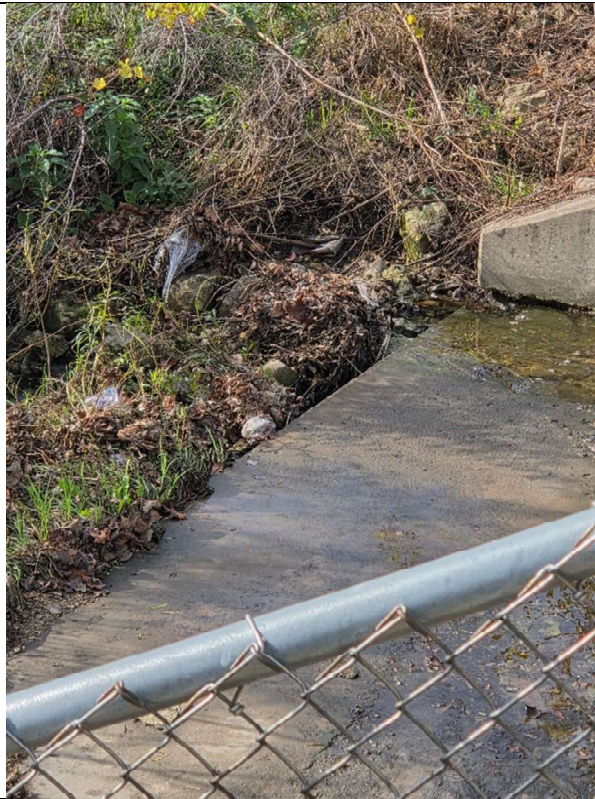
**Photograph:** 45

Photo taken south of the intersection of STH 14 and STH 80. Rip rap and fabric to be added to stop erosion.

- Add rip rap at end of concrete channel discharge location to prevent undermining of concrete structure. .... Date: \_\_\_\_\_
