Drain Out Maintenance Inspection

40,000 Gallon Ridgeway

Ridgeway Water Utility, Ridgeway

Inspection Performed on Tuesday, April 16, 2024

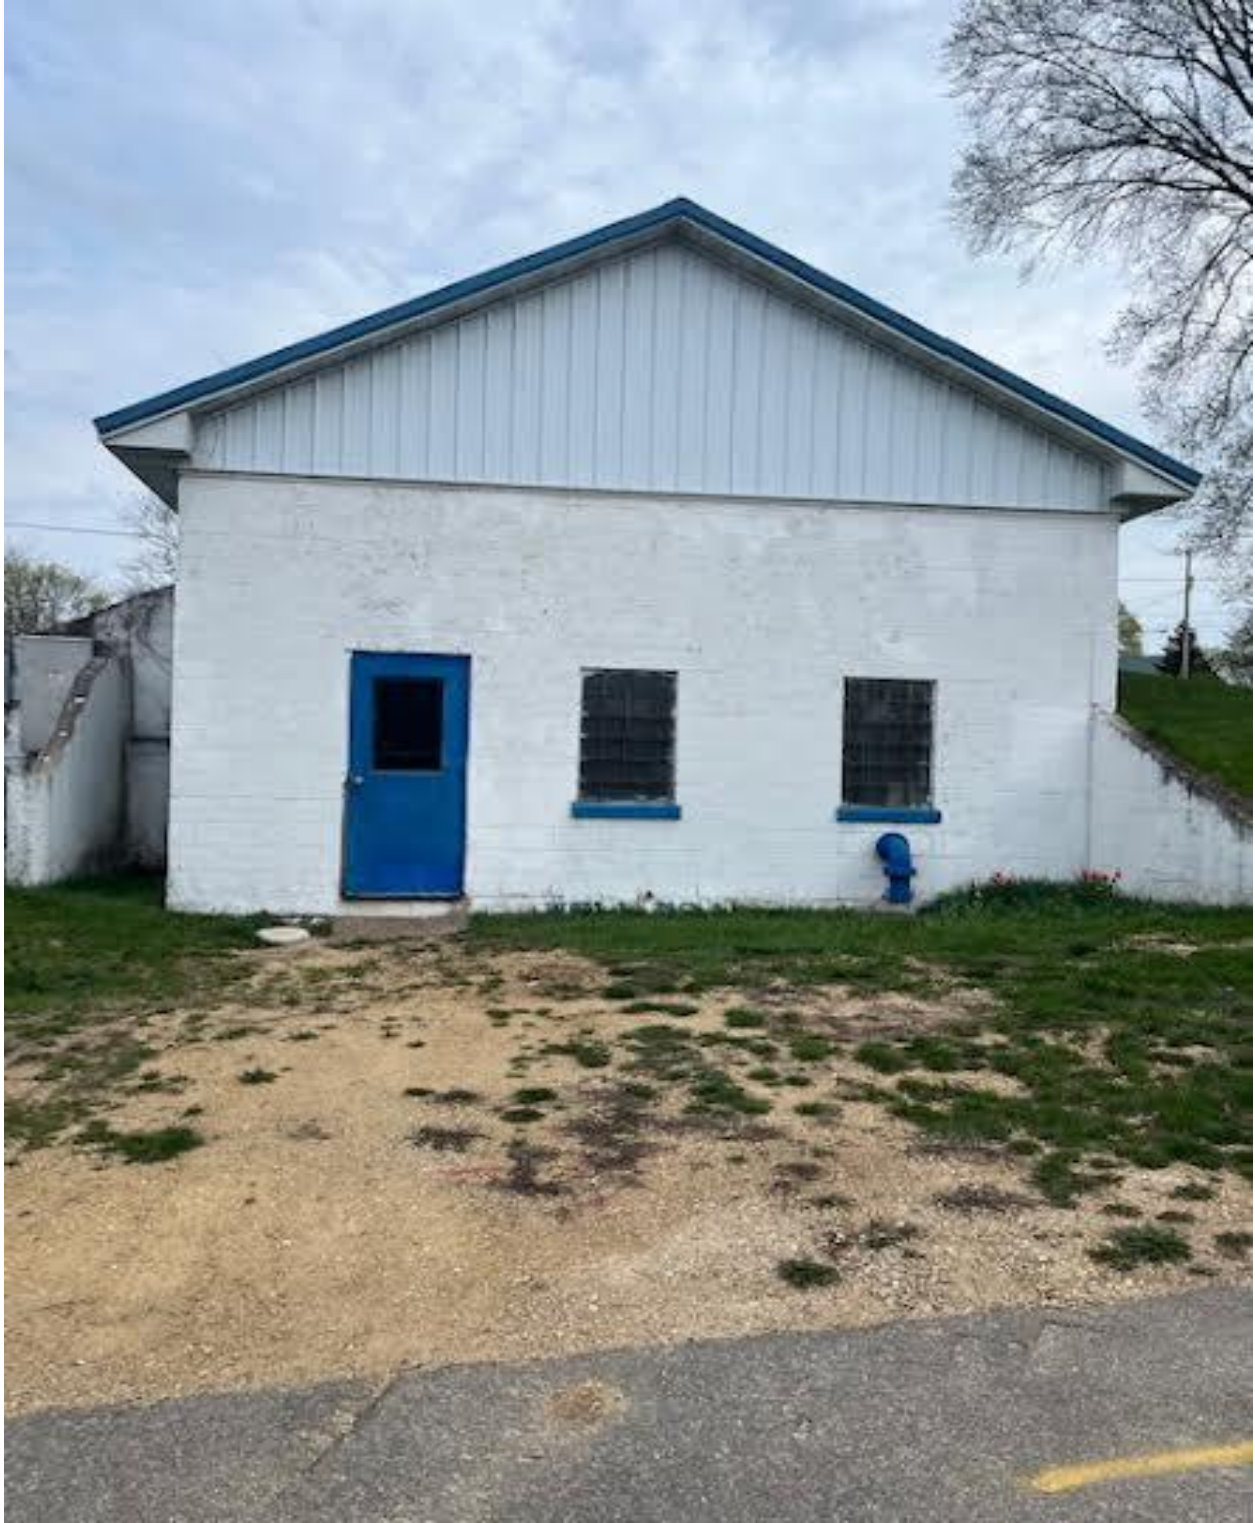
Well no 1 is in good condition.

Well No #1 - 40,000 Gallon Concrete Reservoir

There are no recommendations for well no 1.

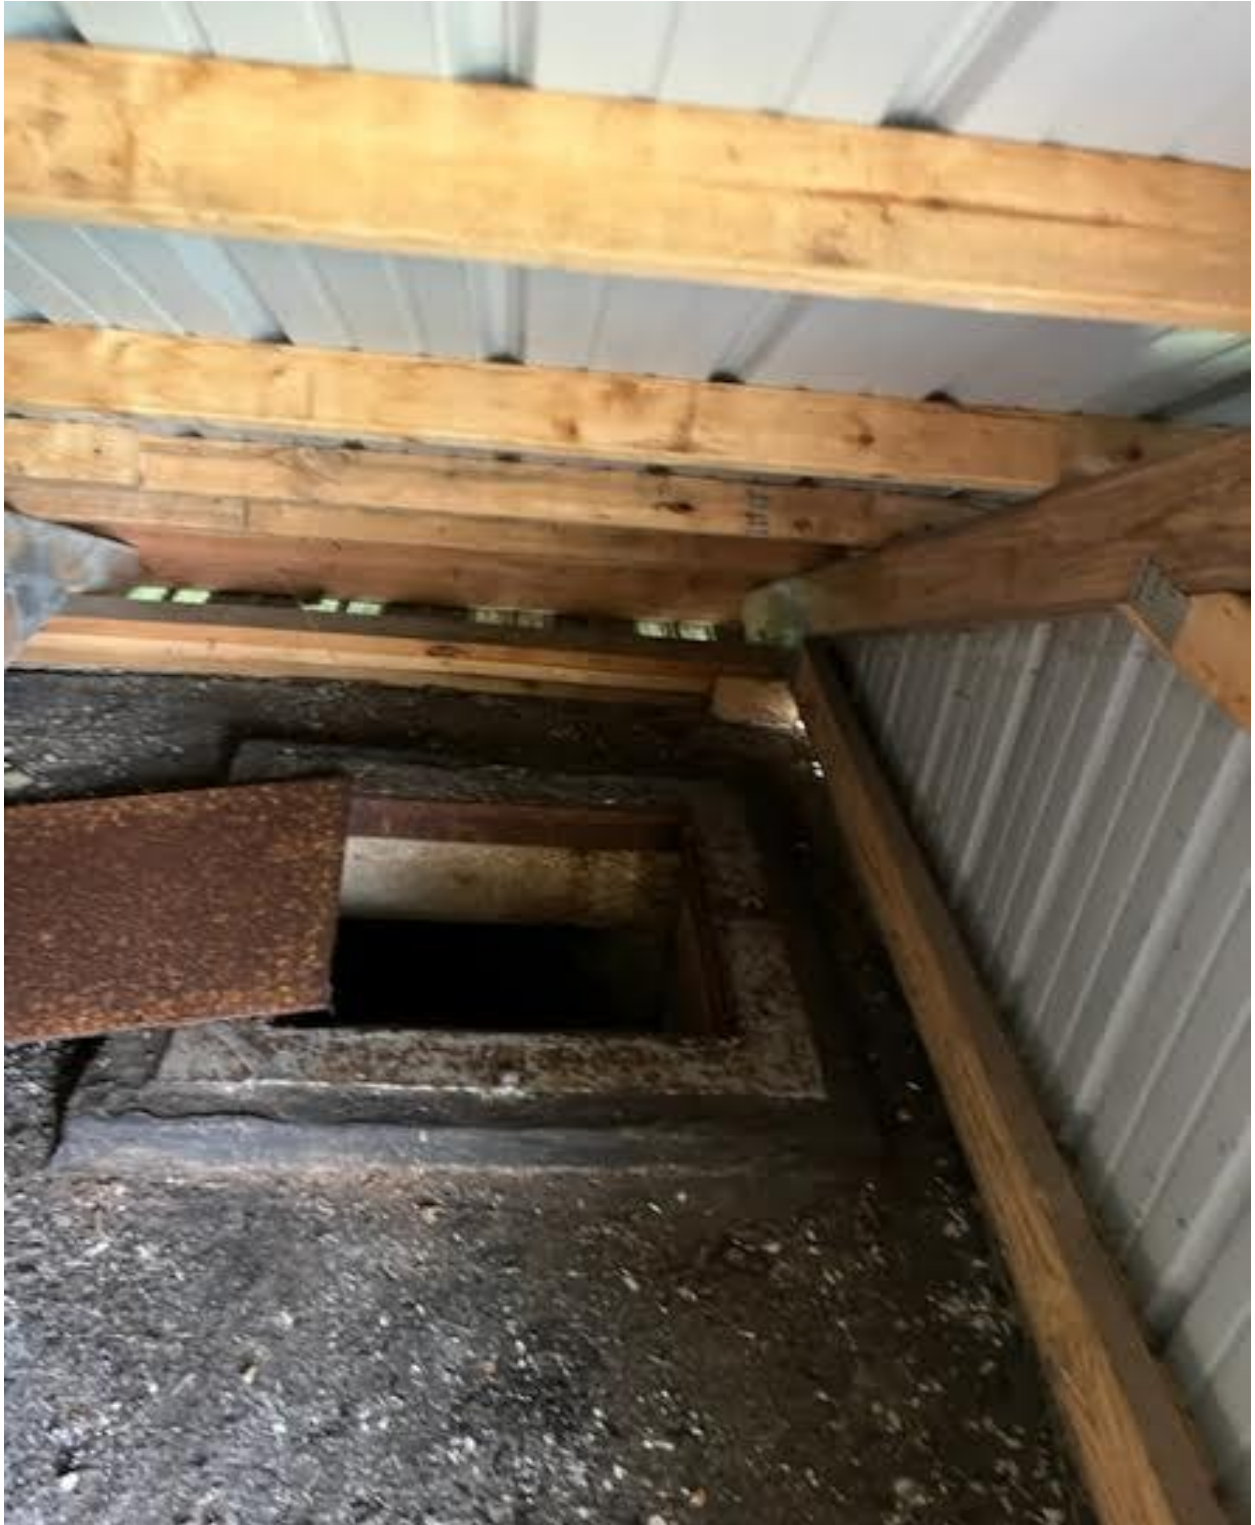
The northwest hatch is not attached to a hinge

Northwest Hatch 24" x 24"

Reinstall a hinge on the hatch.

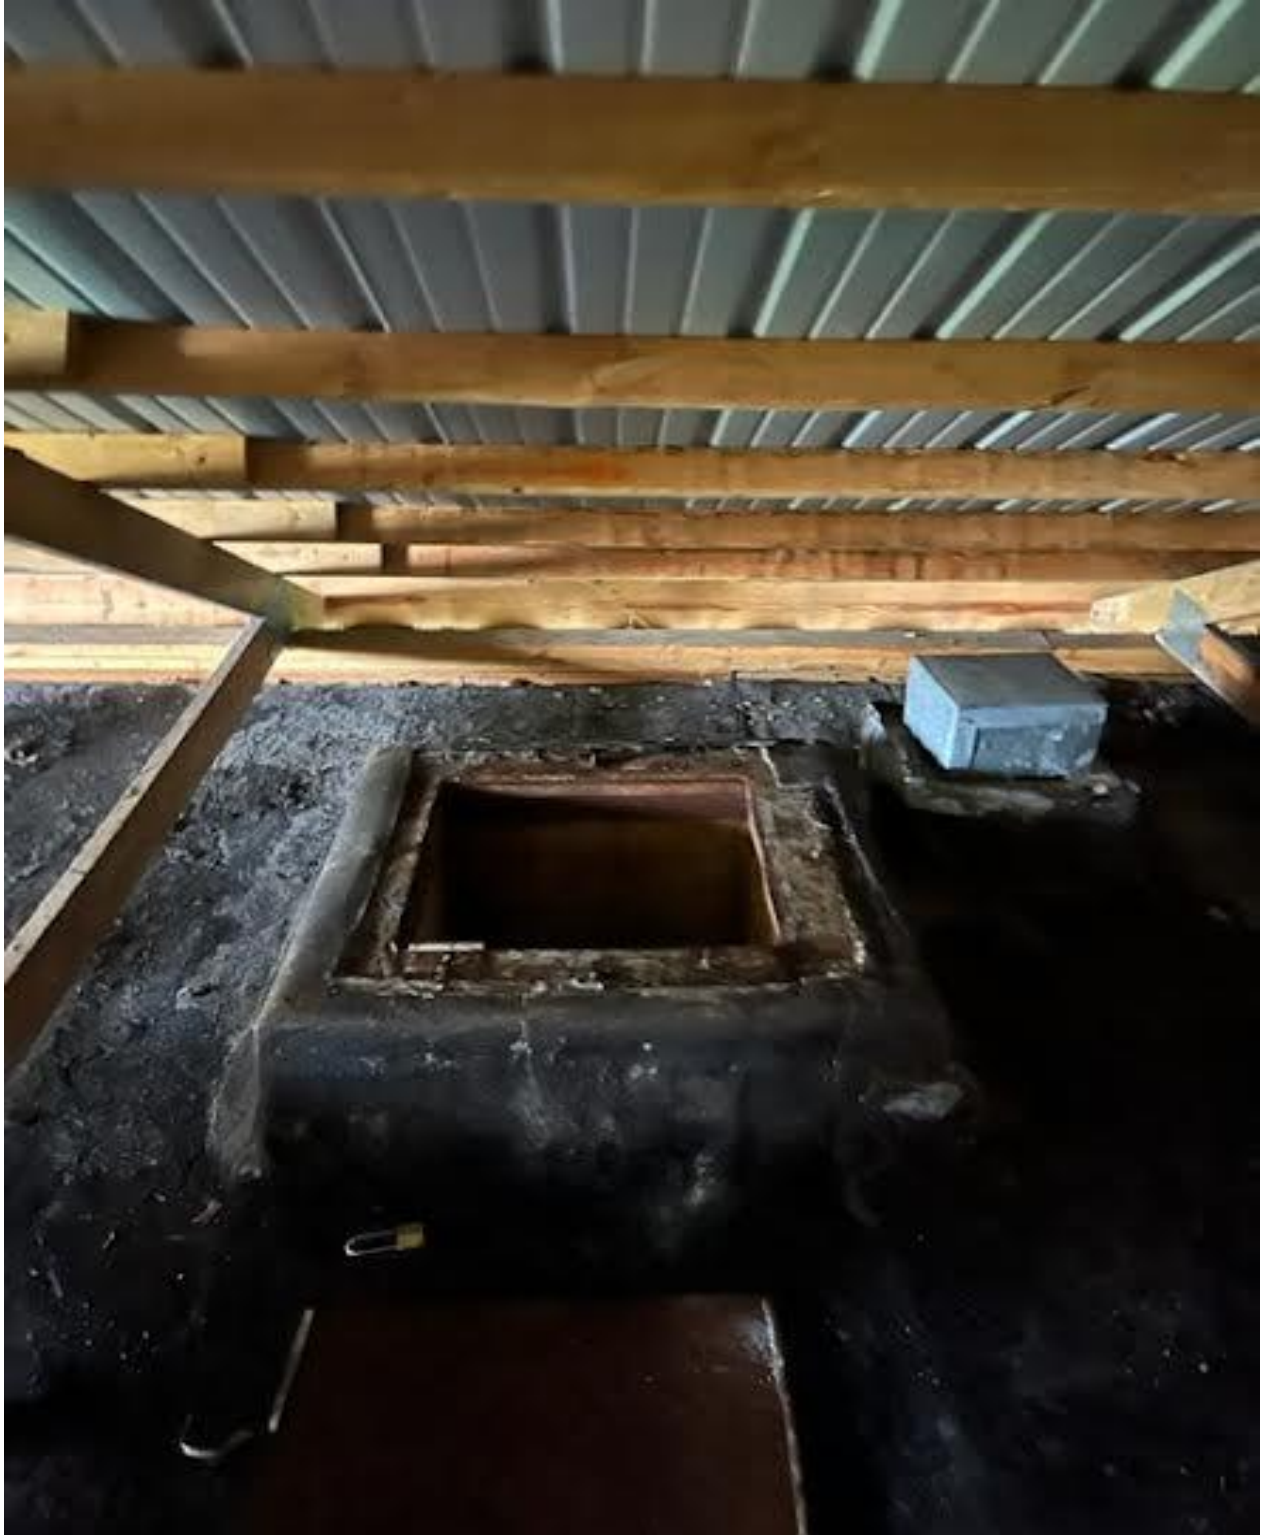
The southeast hatch is not attached to a hinge

Southeast Hatch 24" x 24"

Reinstall a hinge on the hatch.

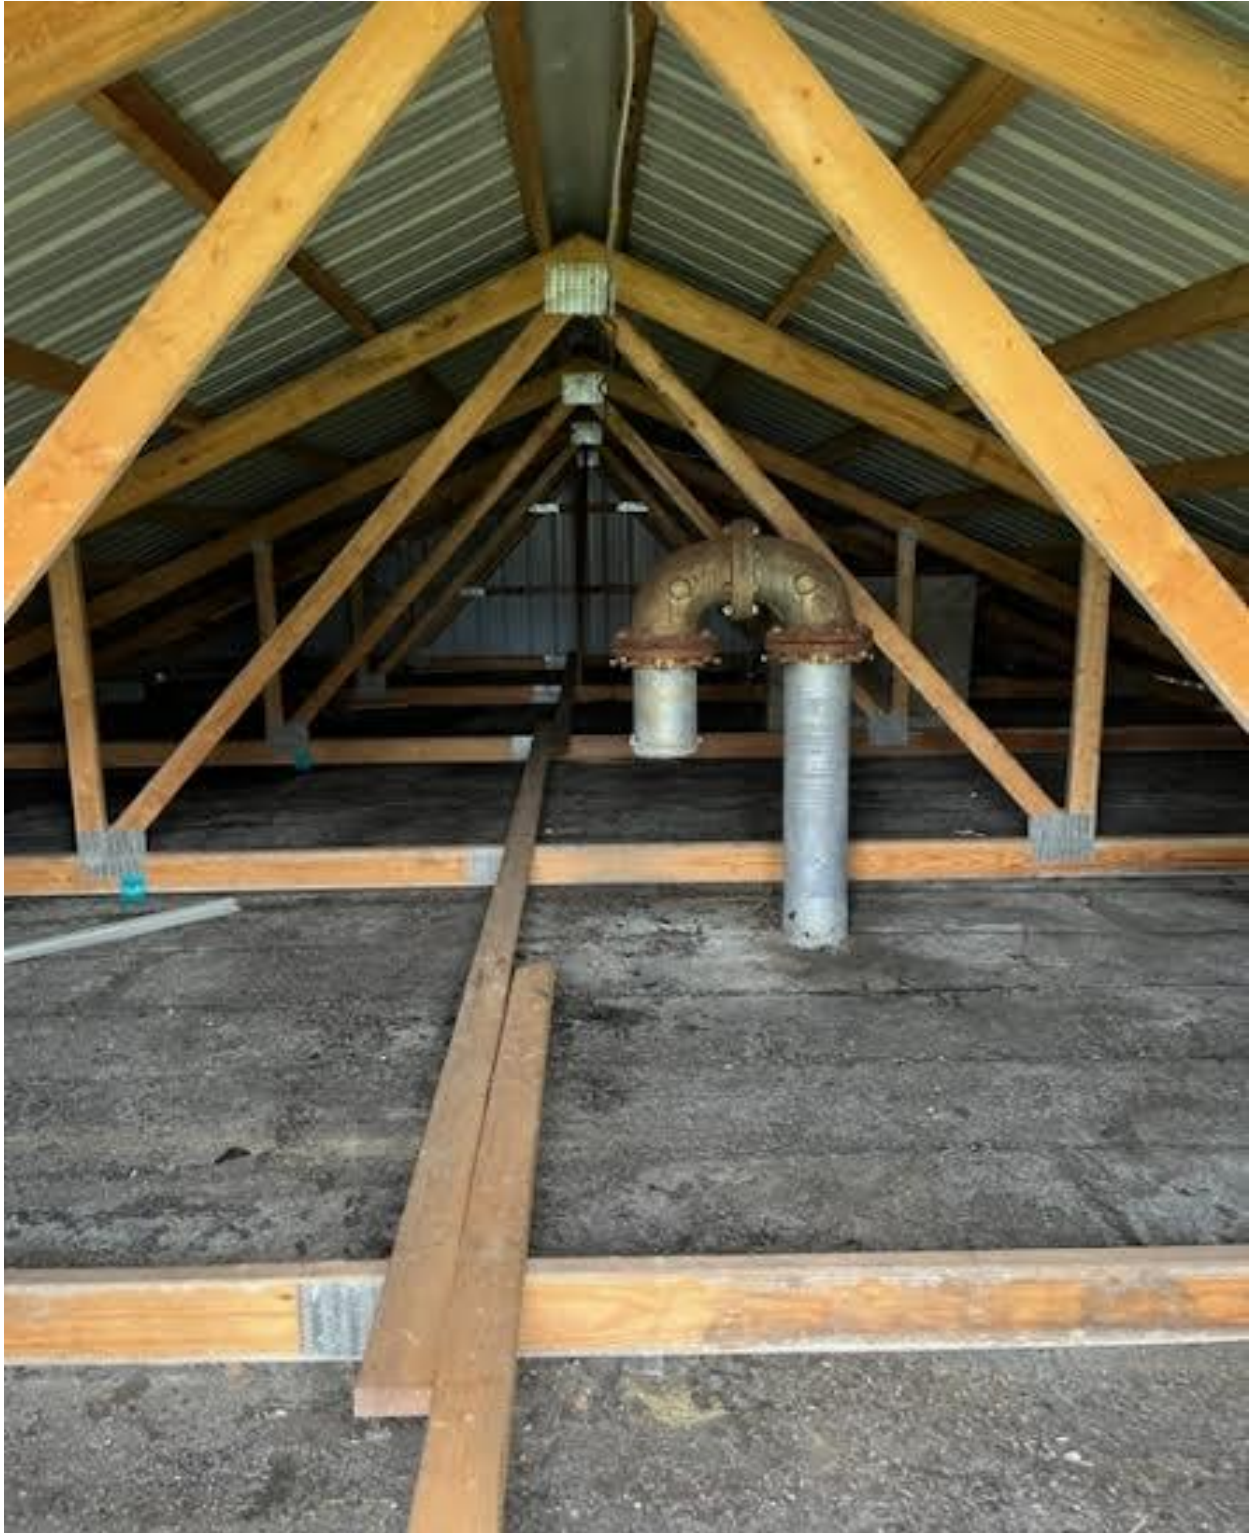
The roof vent is in good condition

Metal Air Vent is in Good Condition

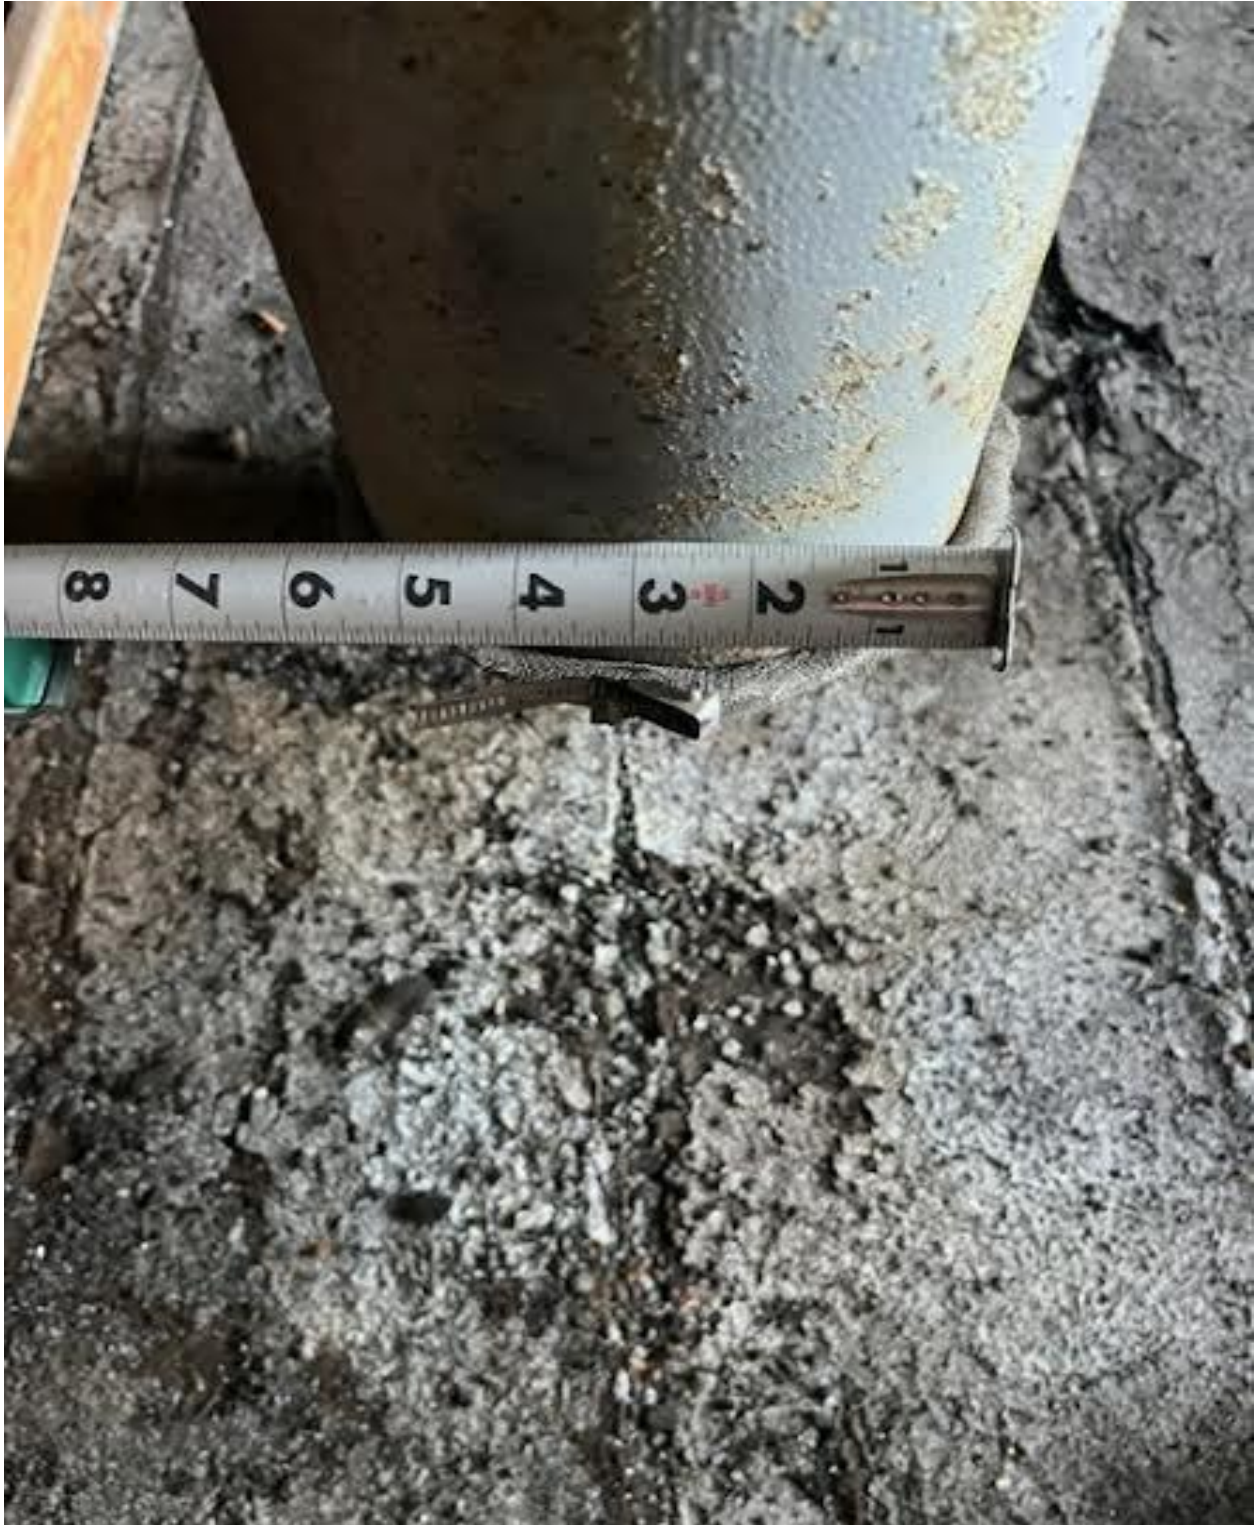
6" Diameter Air Vent

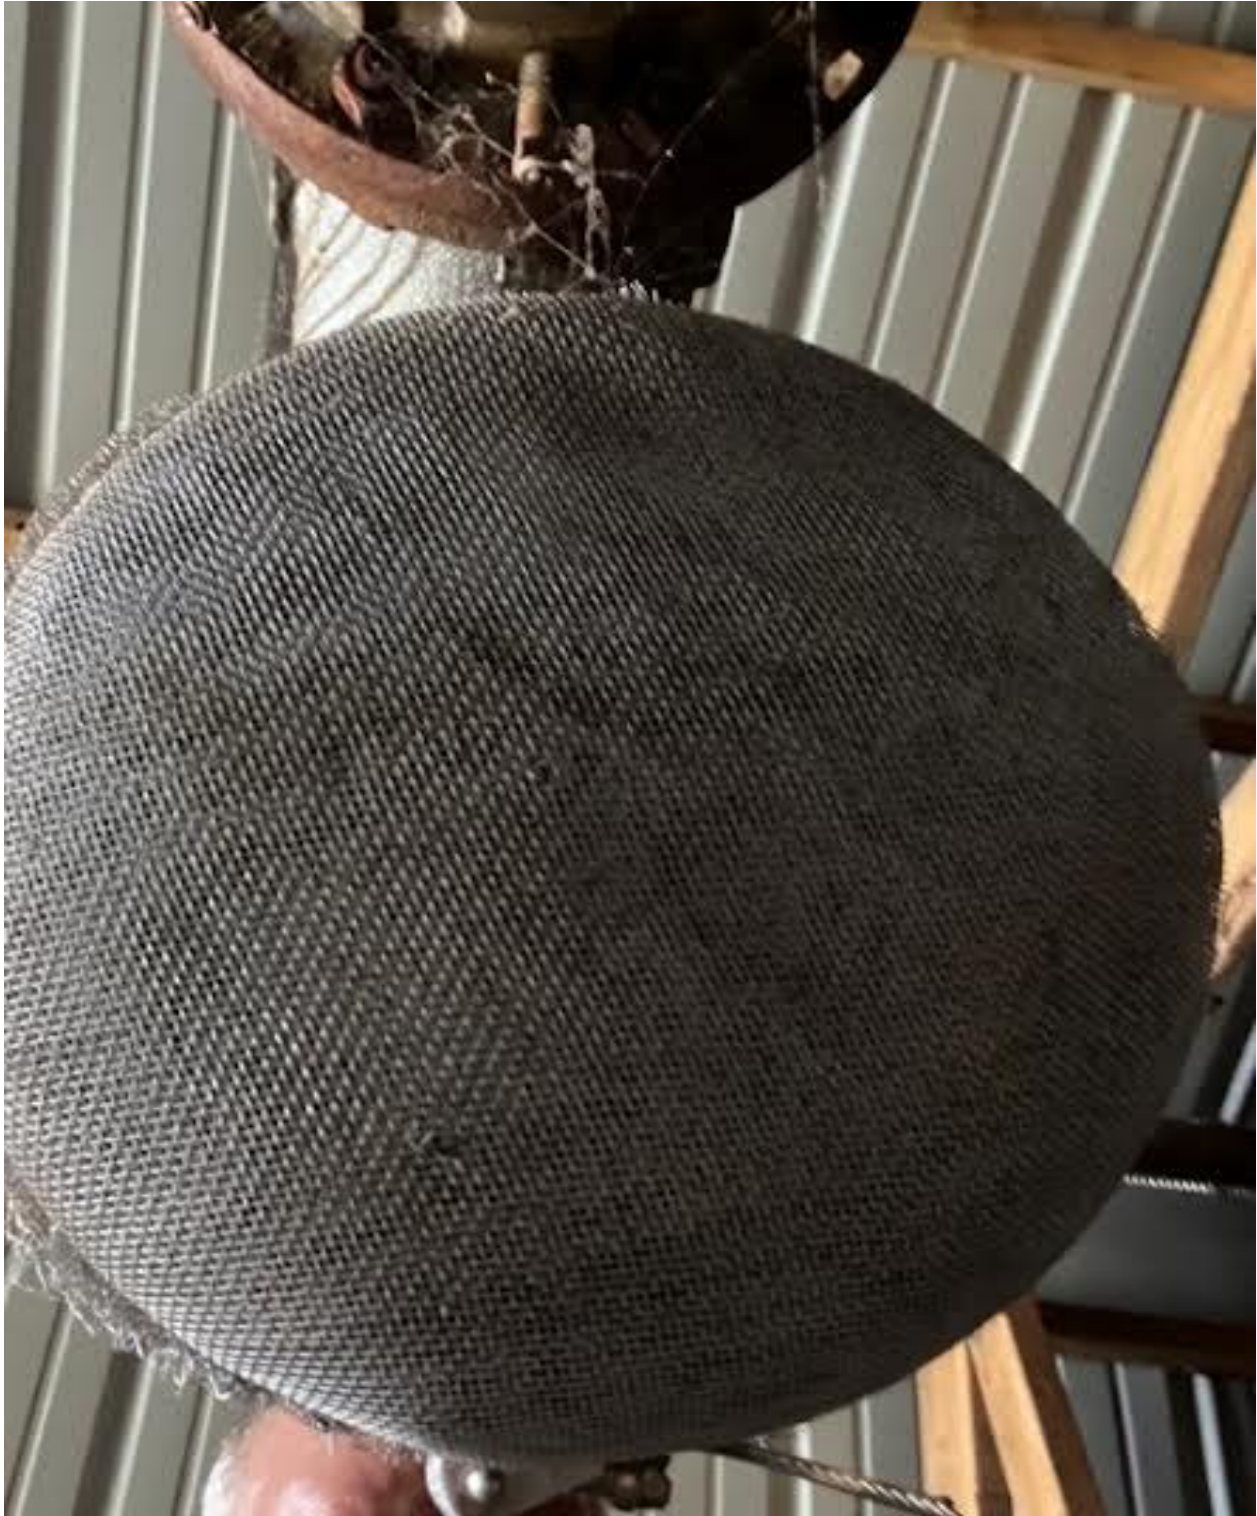
Vent Screen is in Good Condition

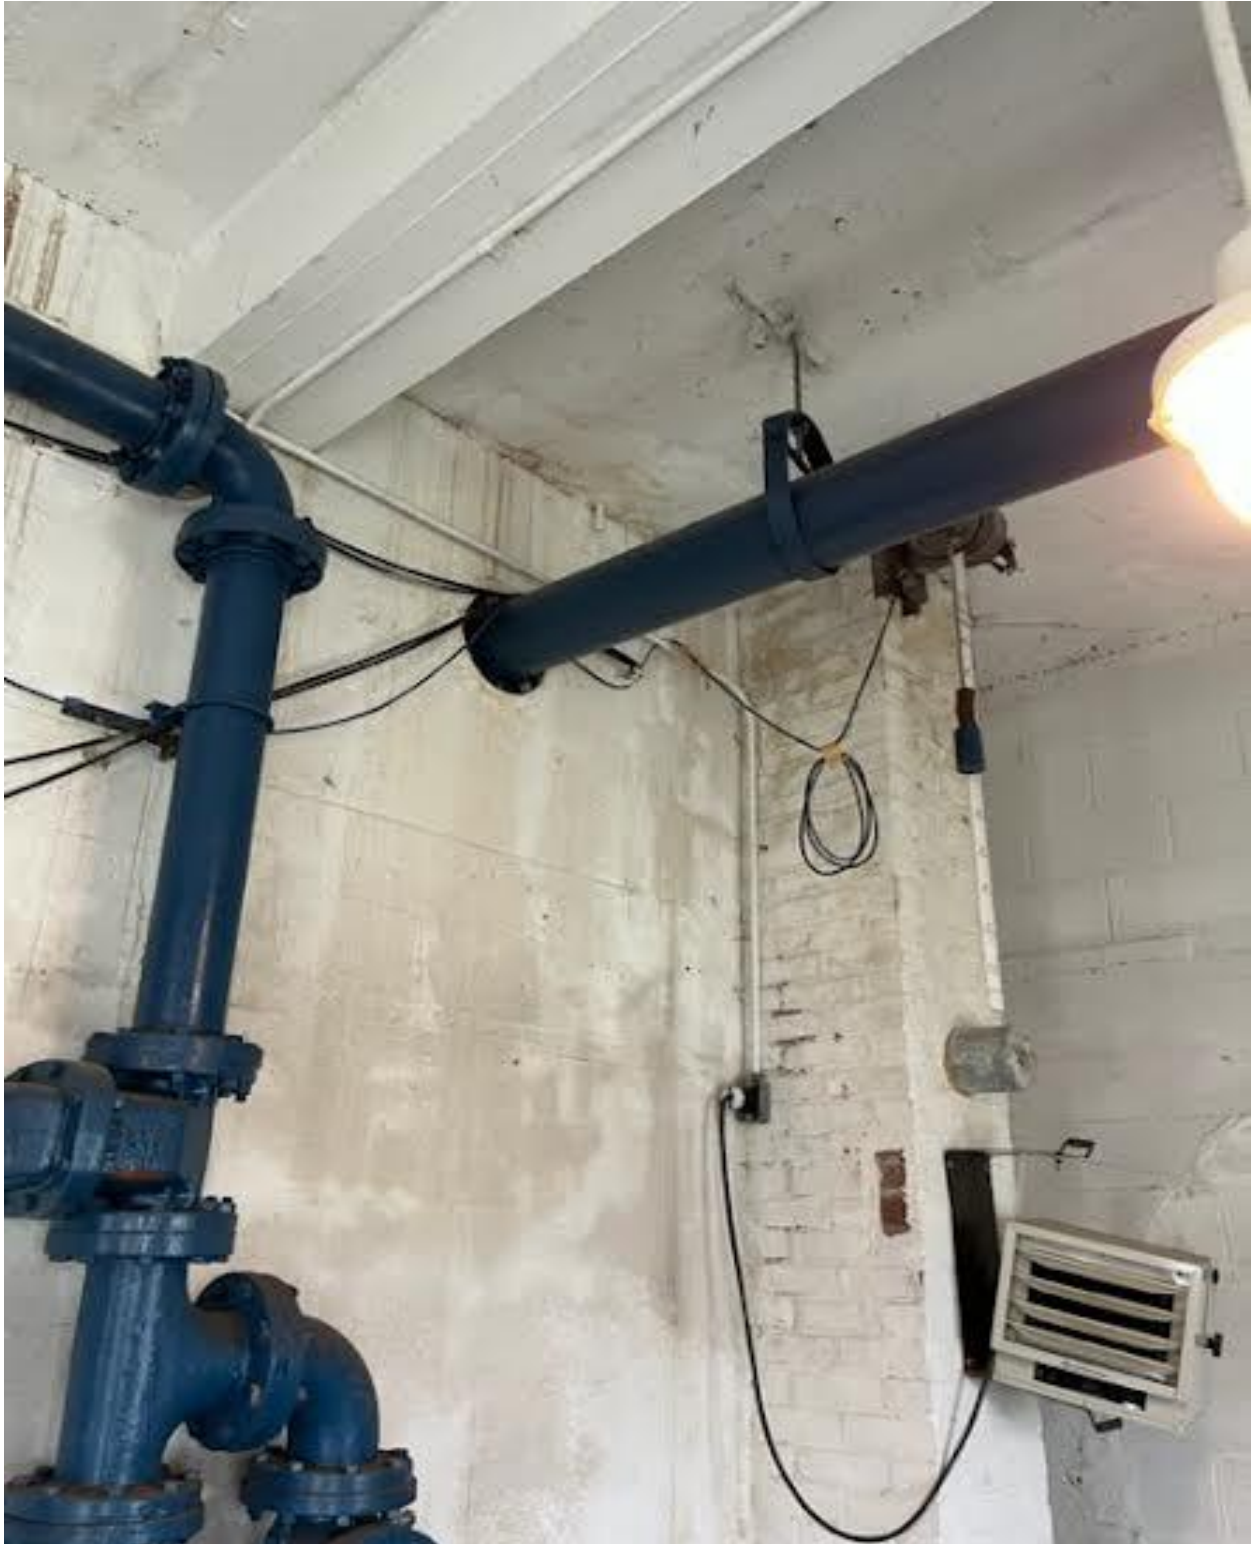
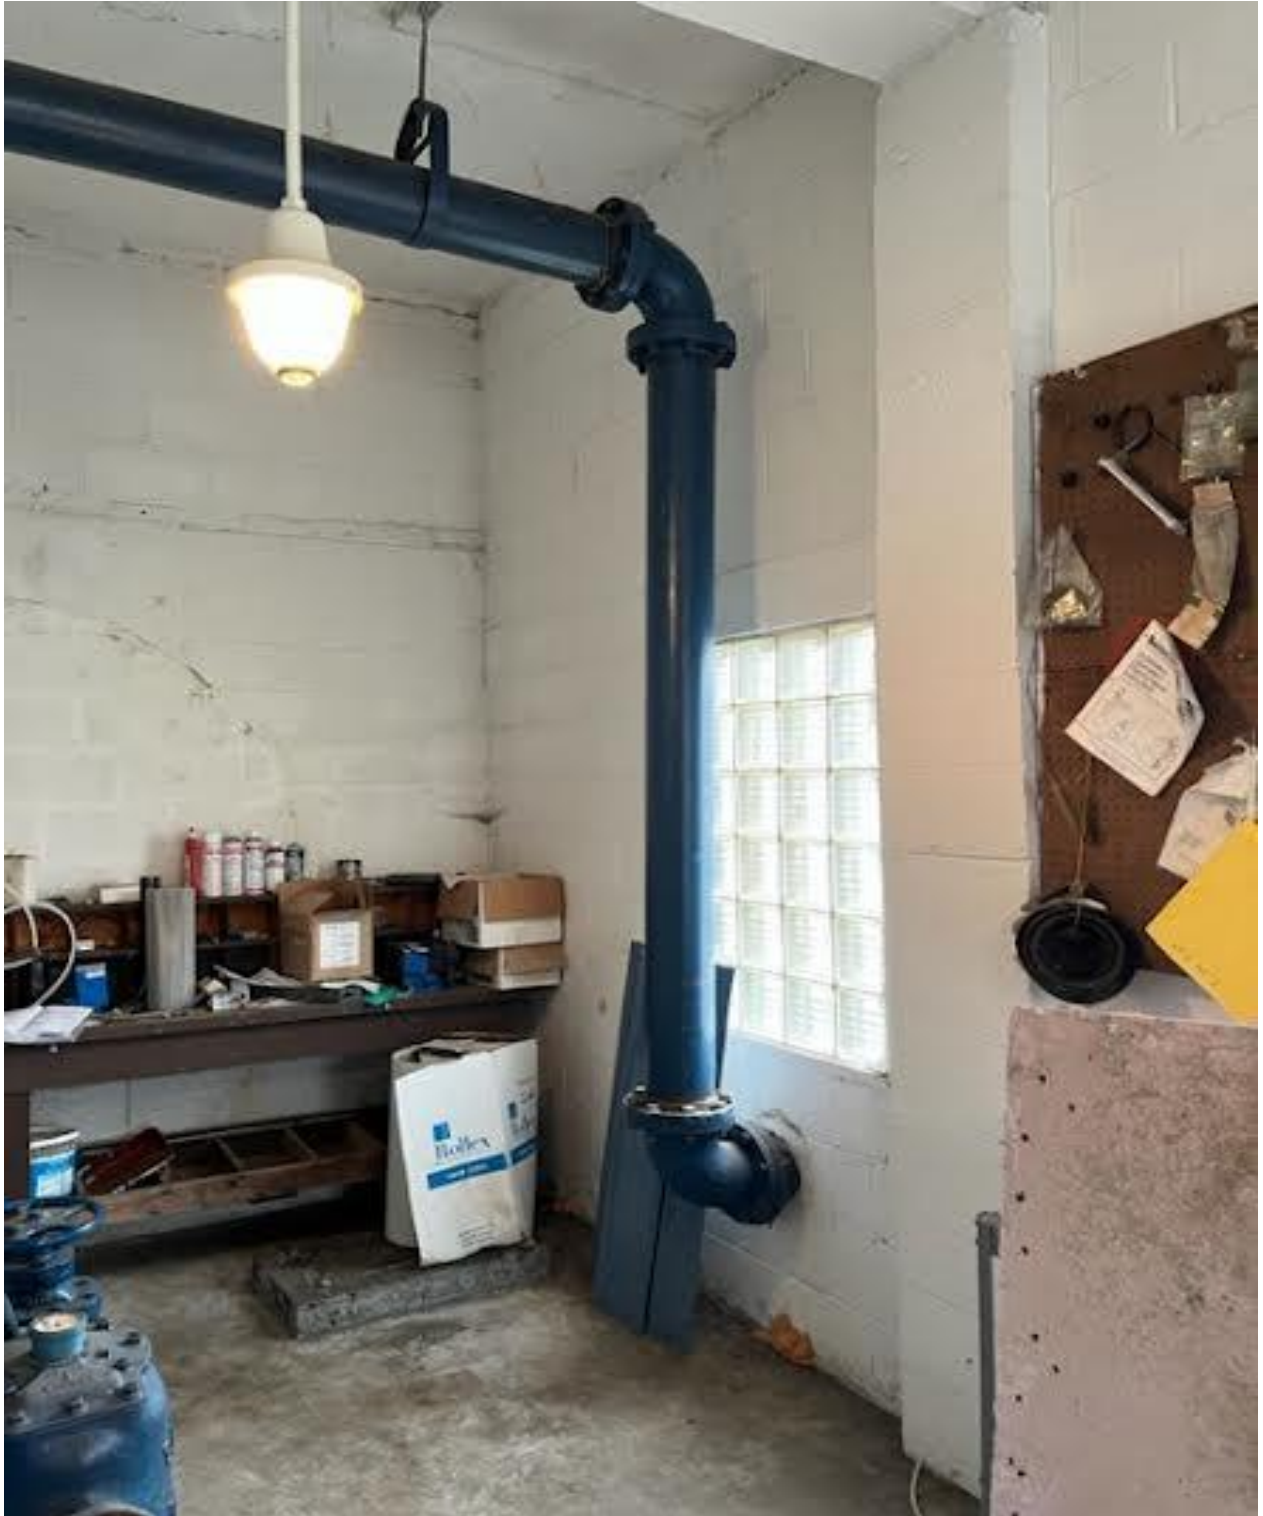
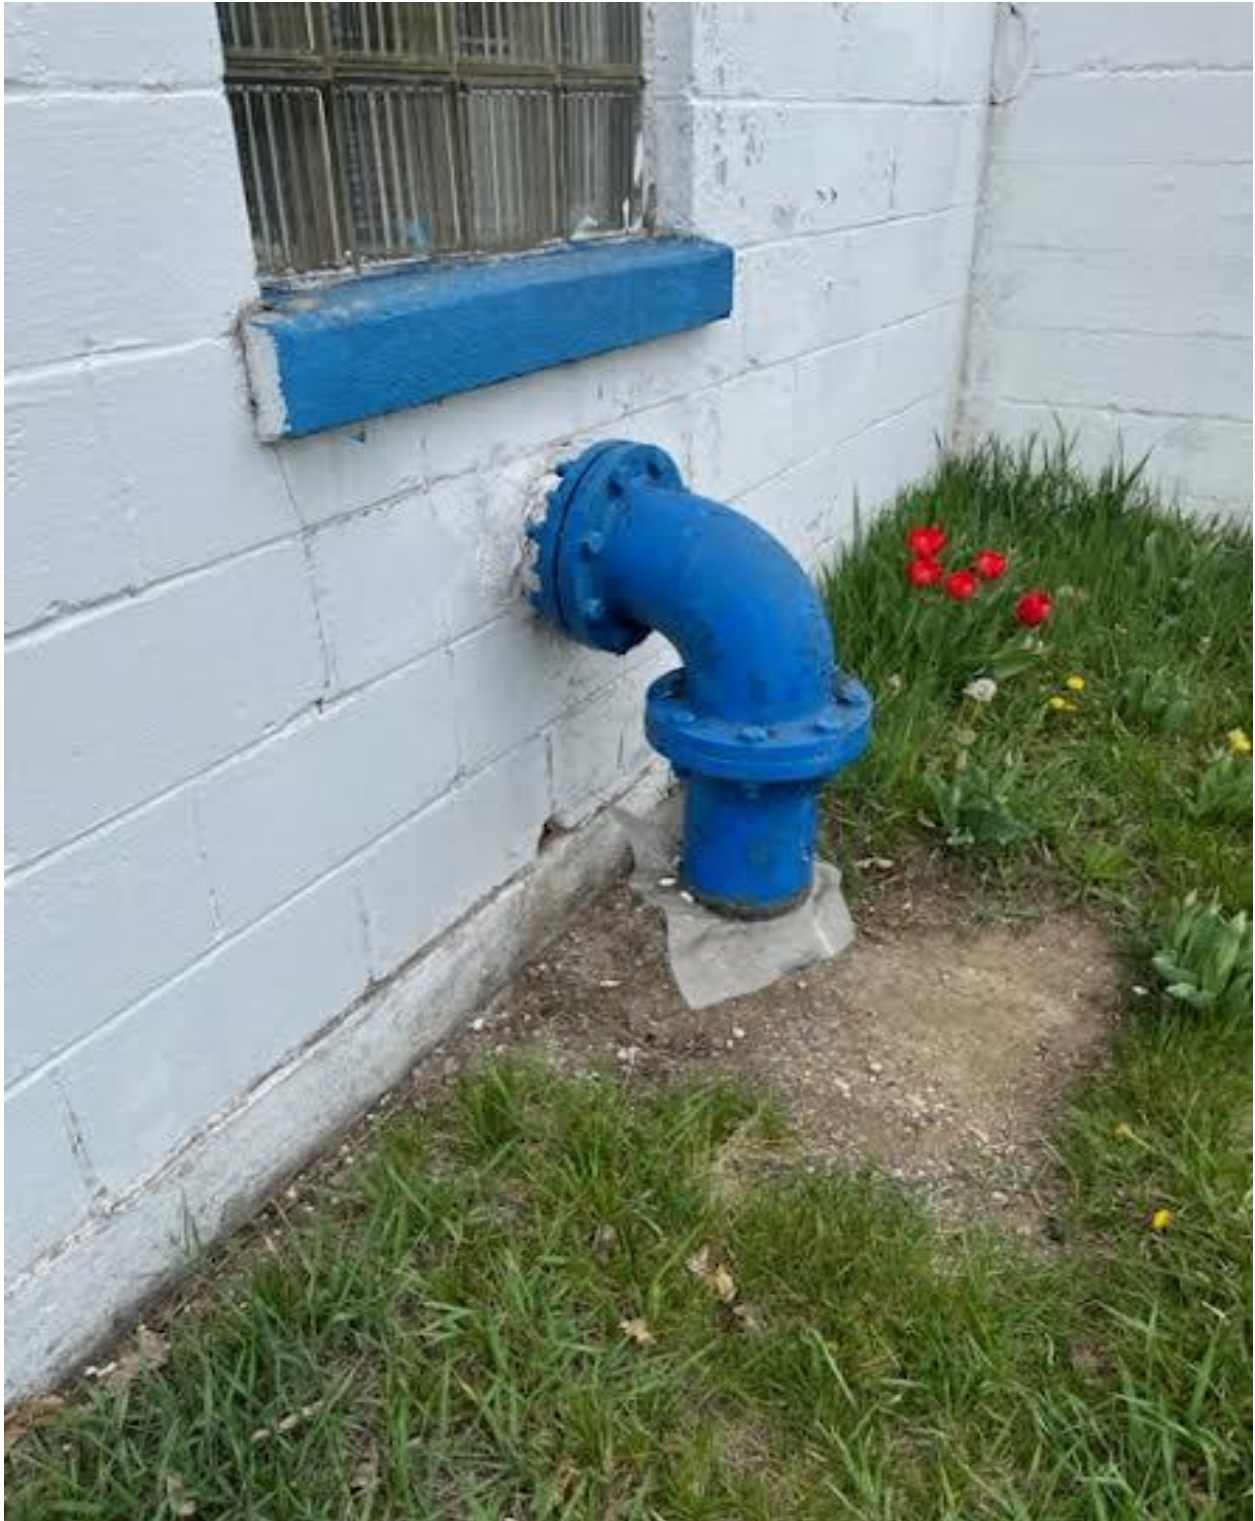
The overflow pipe is in good condition

Overflow Pipe is in Good Condition

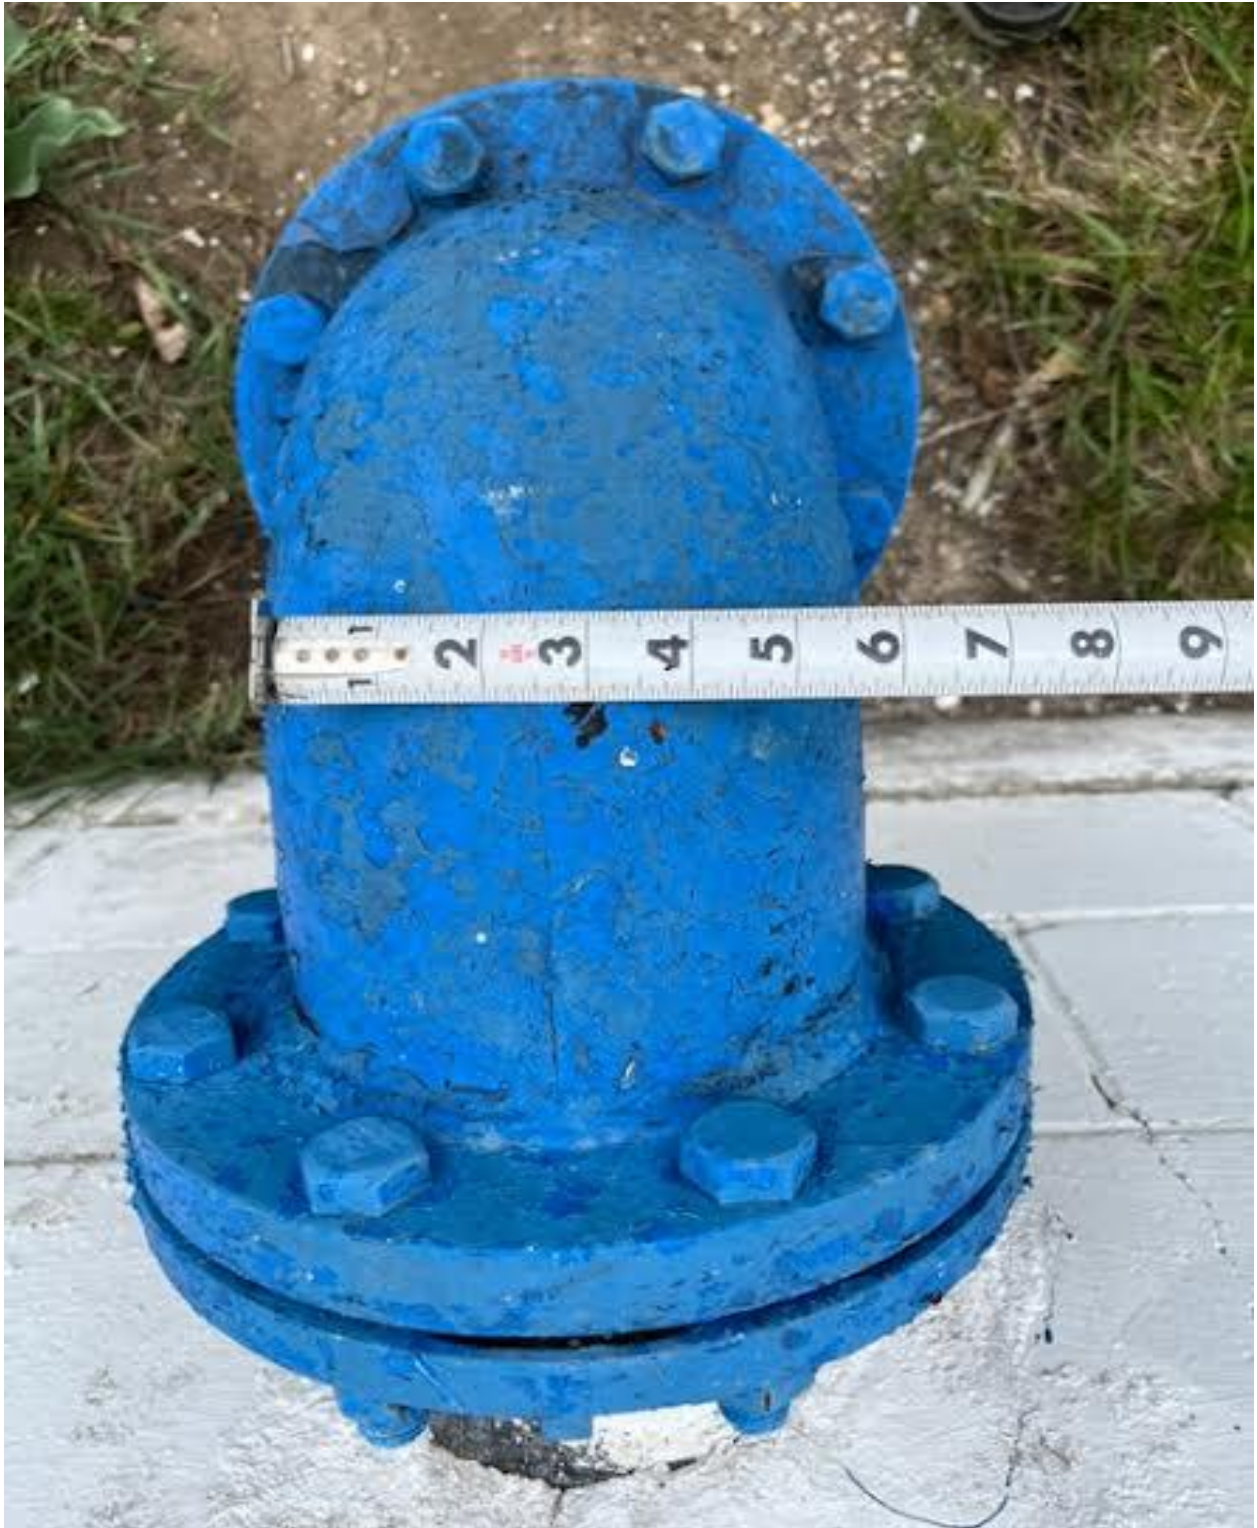
6" Overflow Pipe is in Good Condition

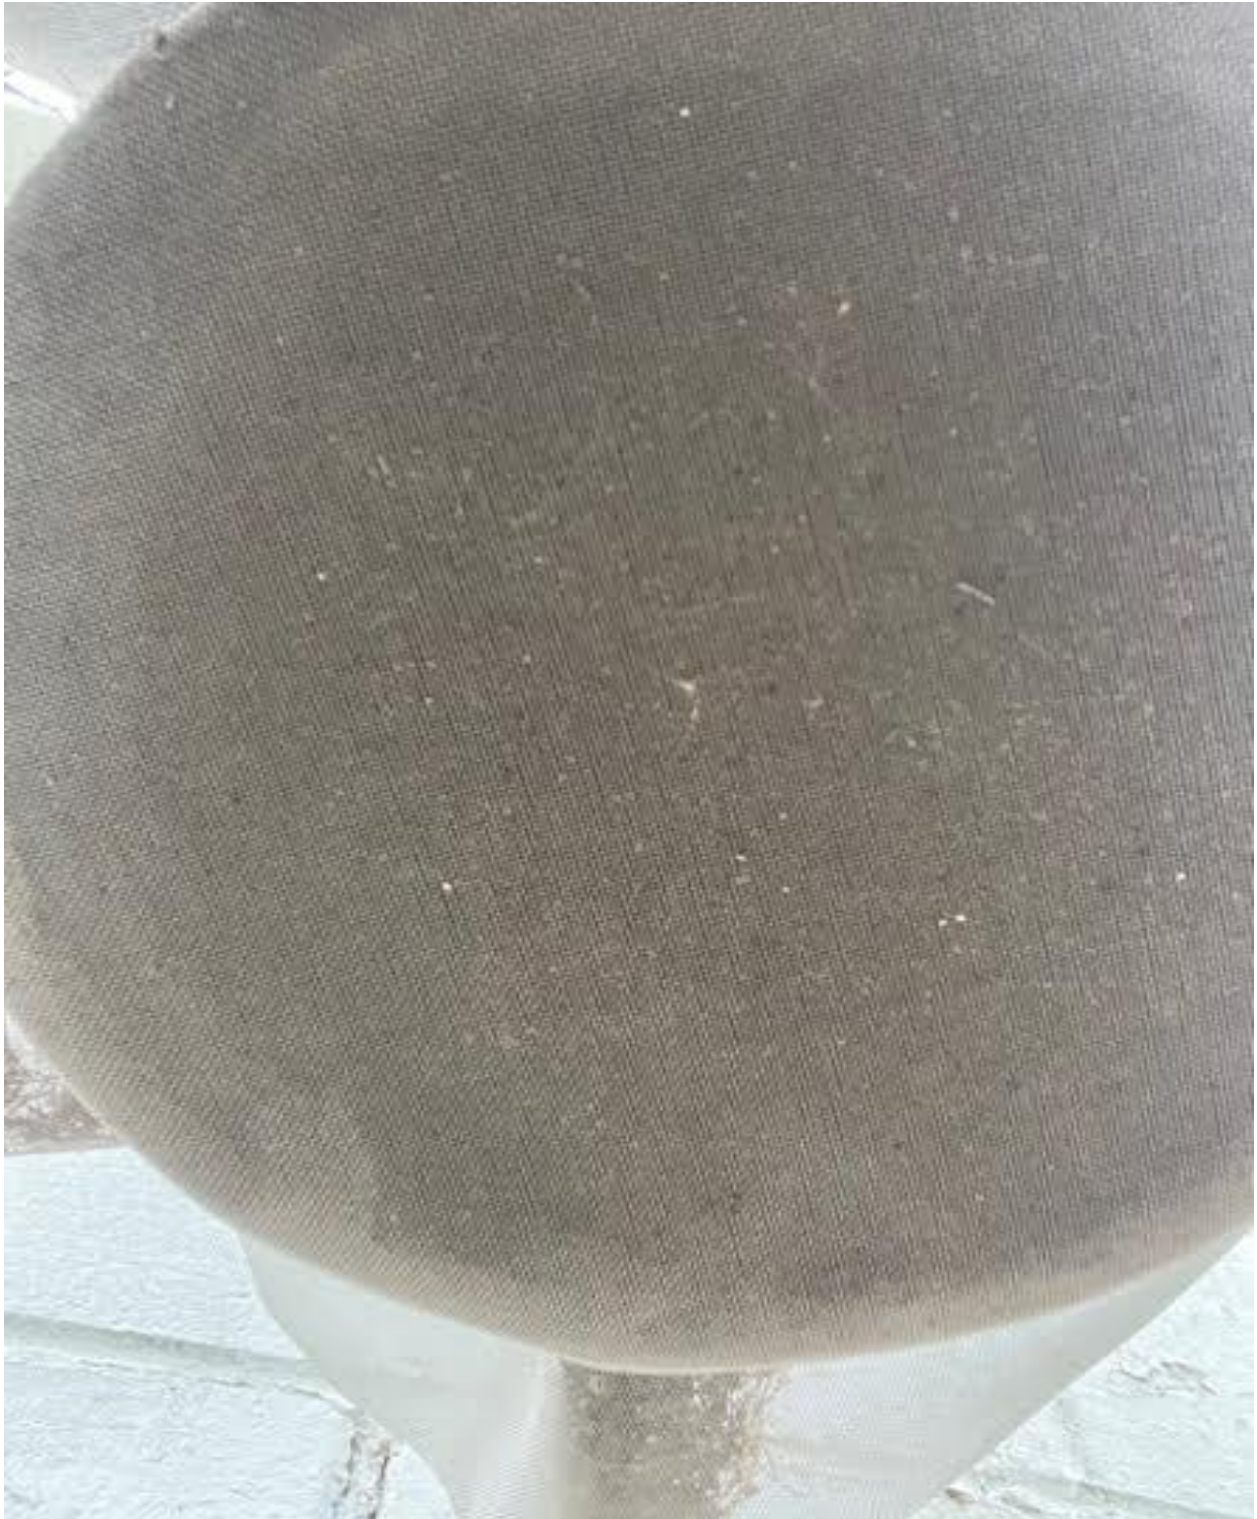
The overflow screen is in good condition

Overflow Screen is in Good Condition

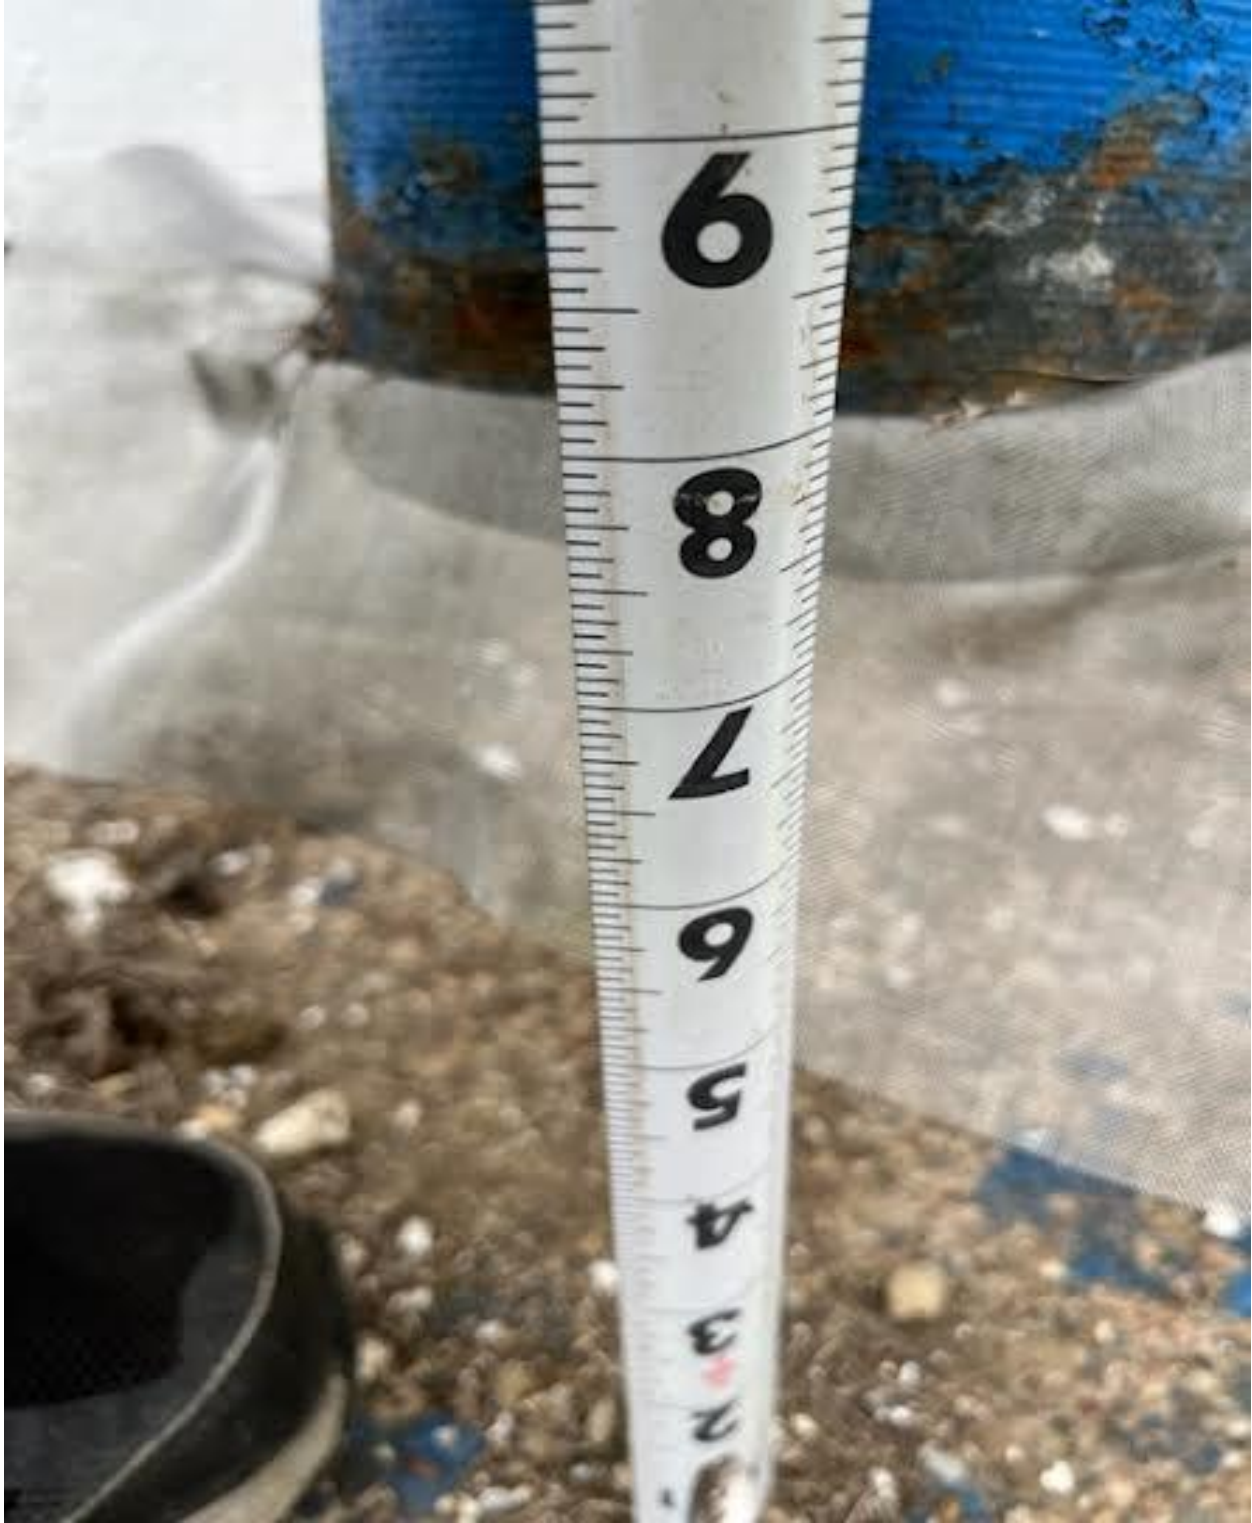
The Overflow Air Gap is at 8"

The concrete reservoir is generally in very good condition. The roof hatches would benefit from new installed hinges. Raise the air gap on the overflow pipe to 12” along with fixed flanges.
