Drain Out Maintenance Inspection

40,000 Gallon Ridgeway

Ridgeway Water Utility, Ridgeway

Inspection Performed on Tuesday, April 16, 2024

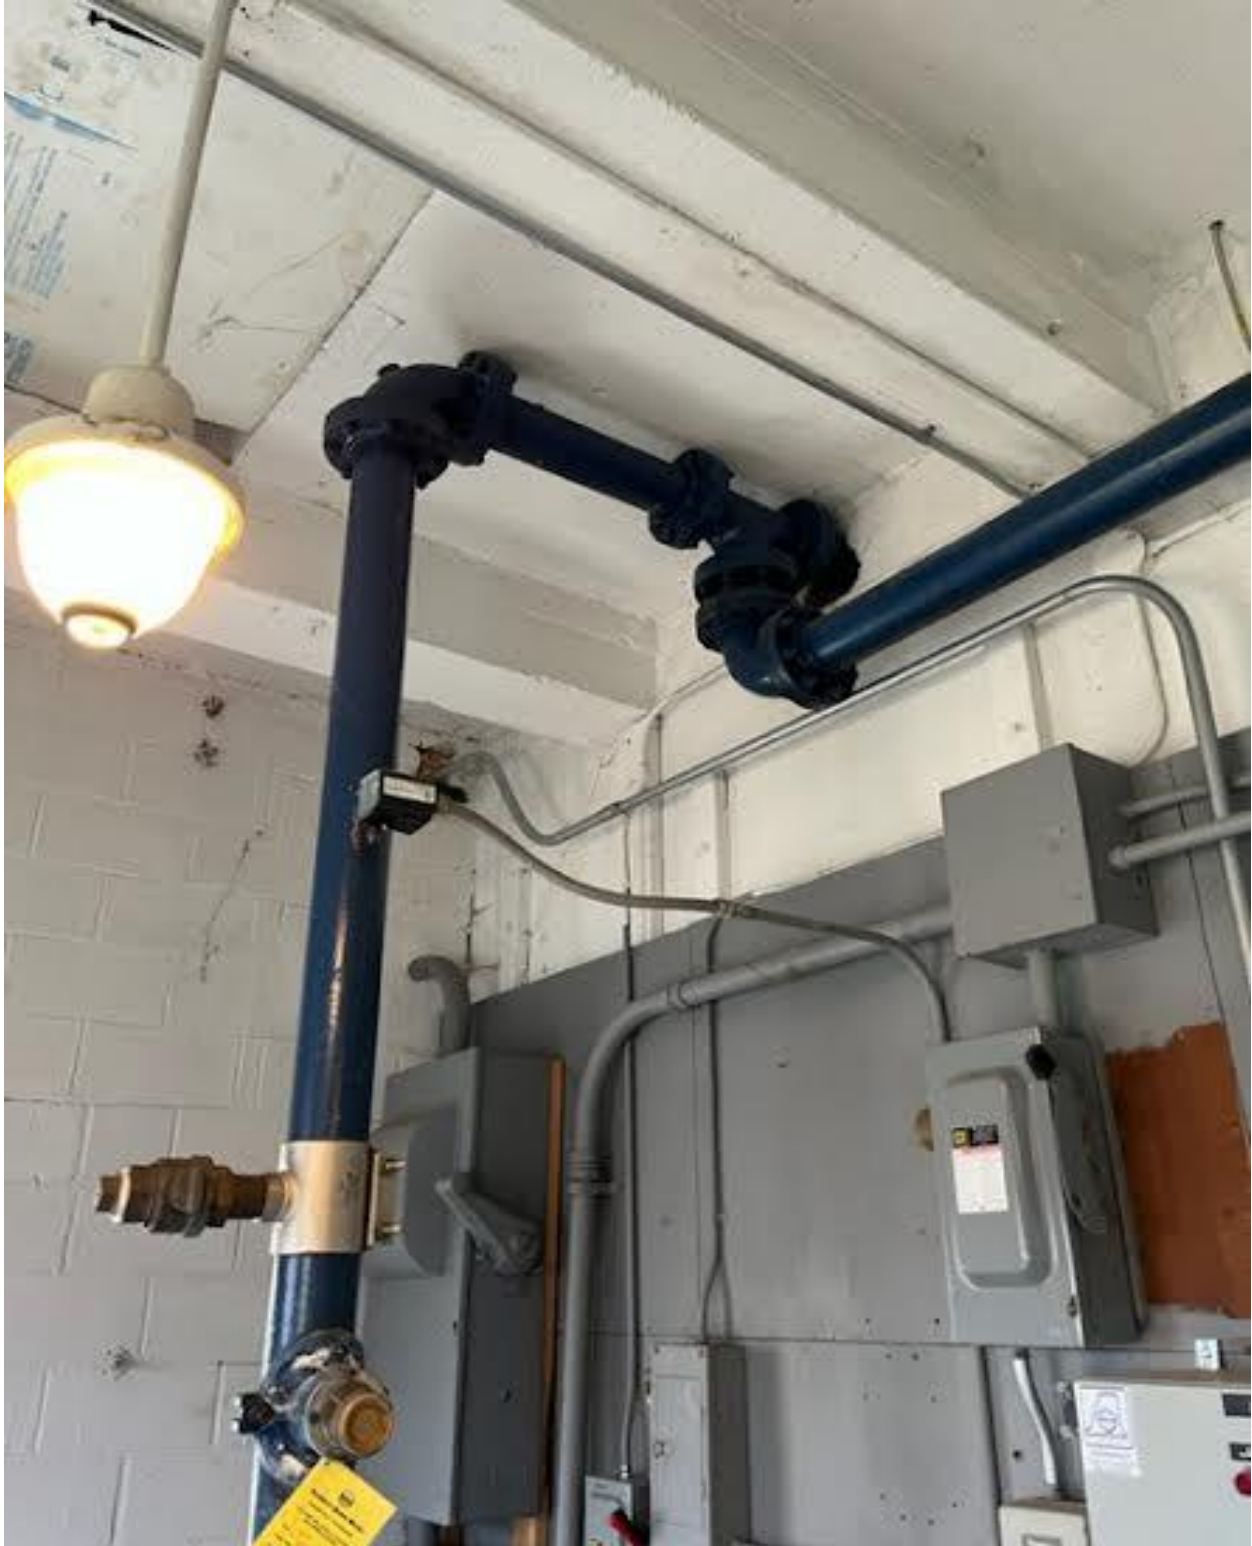
The fill pipe is in good condition

The Fill Pipe is in Good Condition

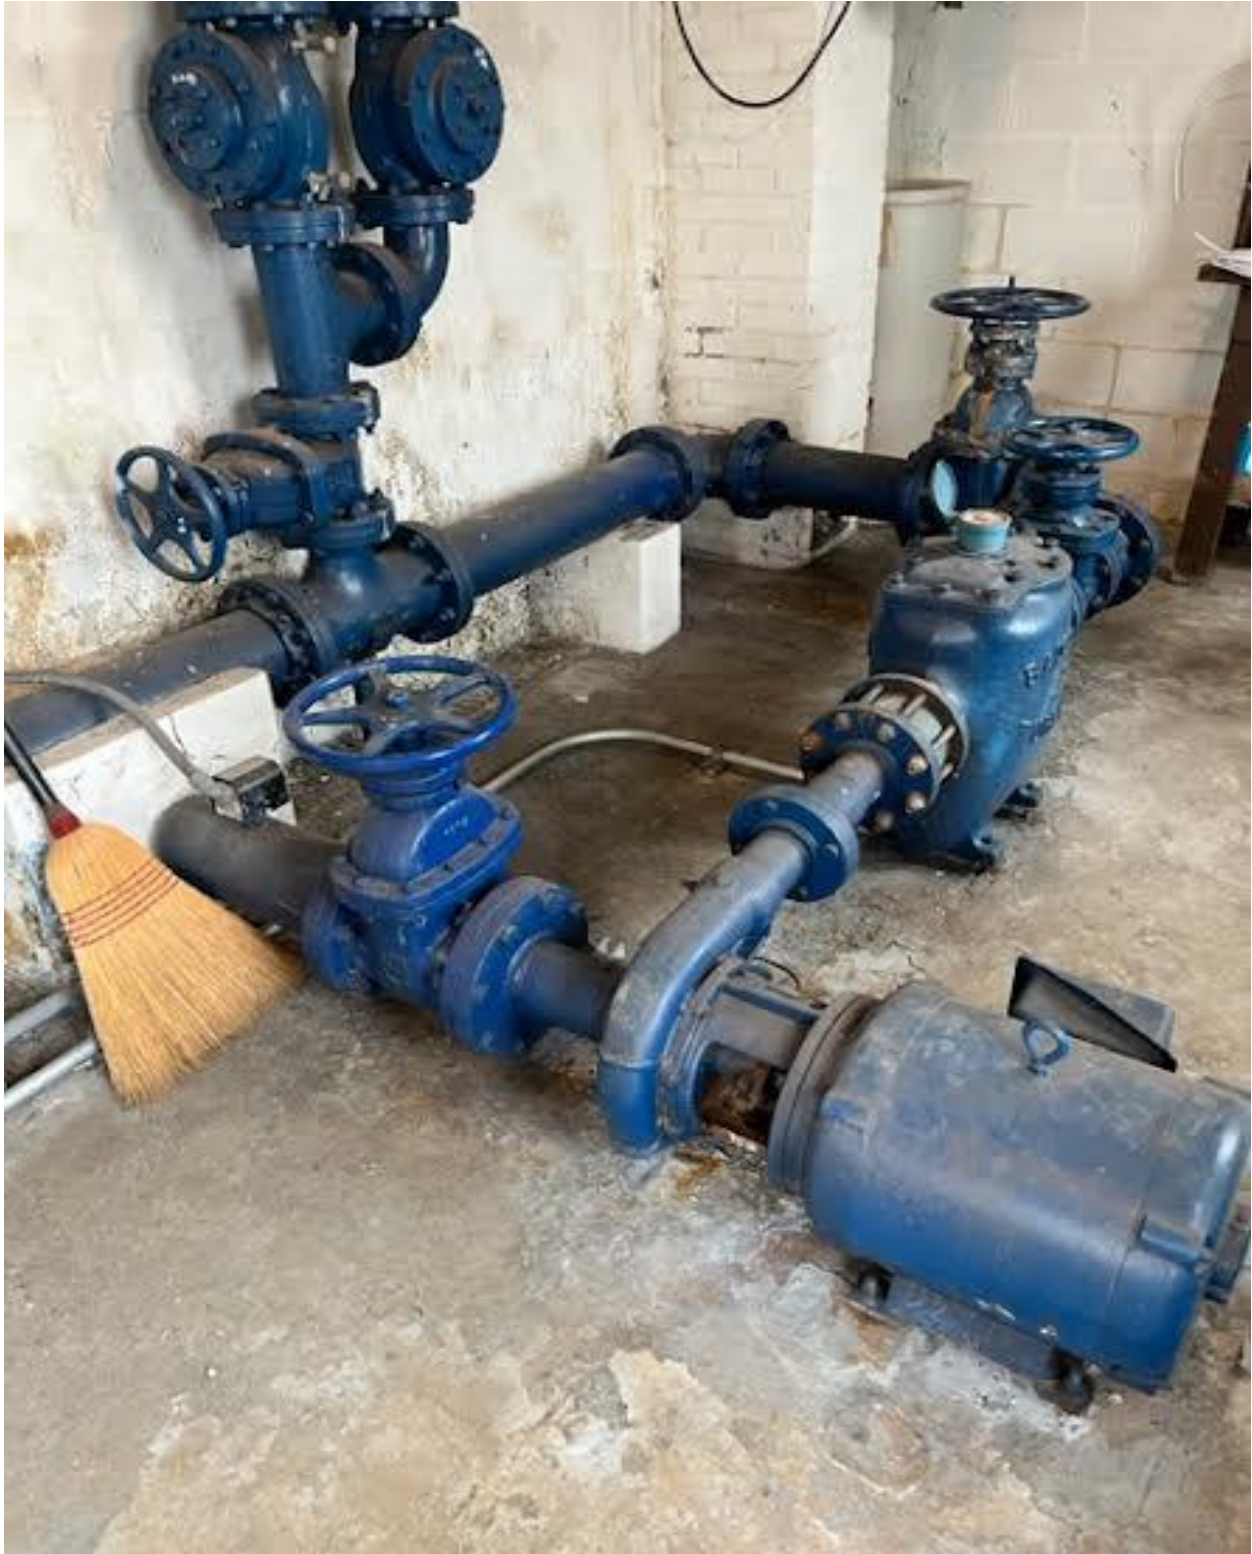
The outlet pipe is in good condition

The Outlet Pipe is in Good Condition

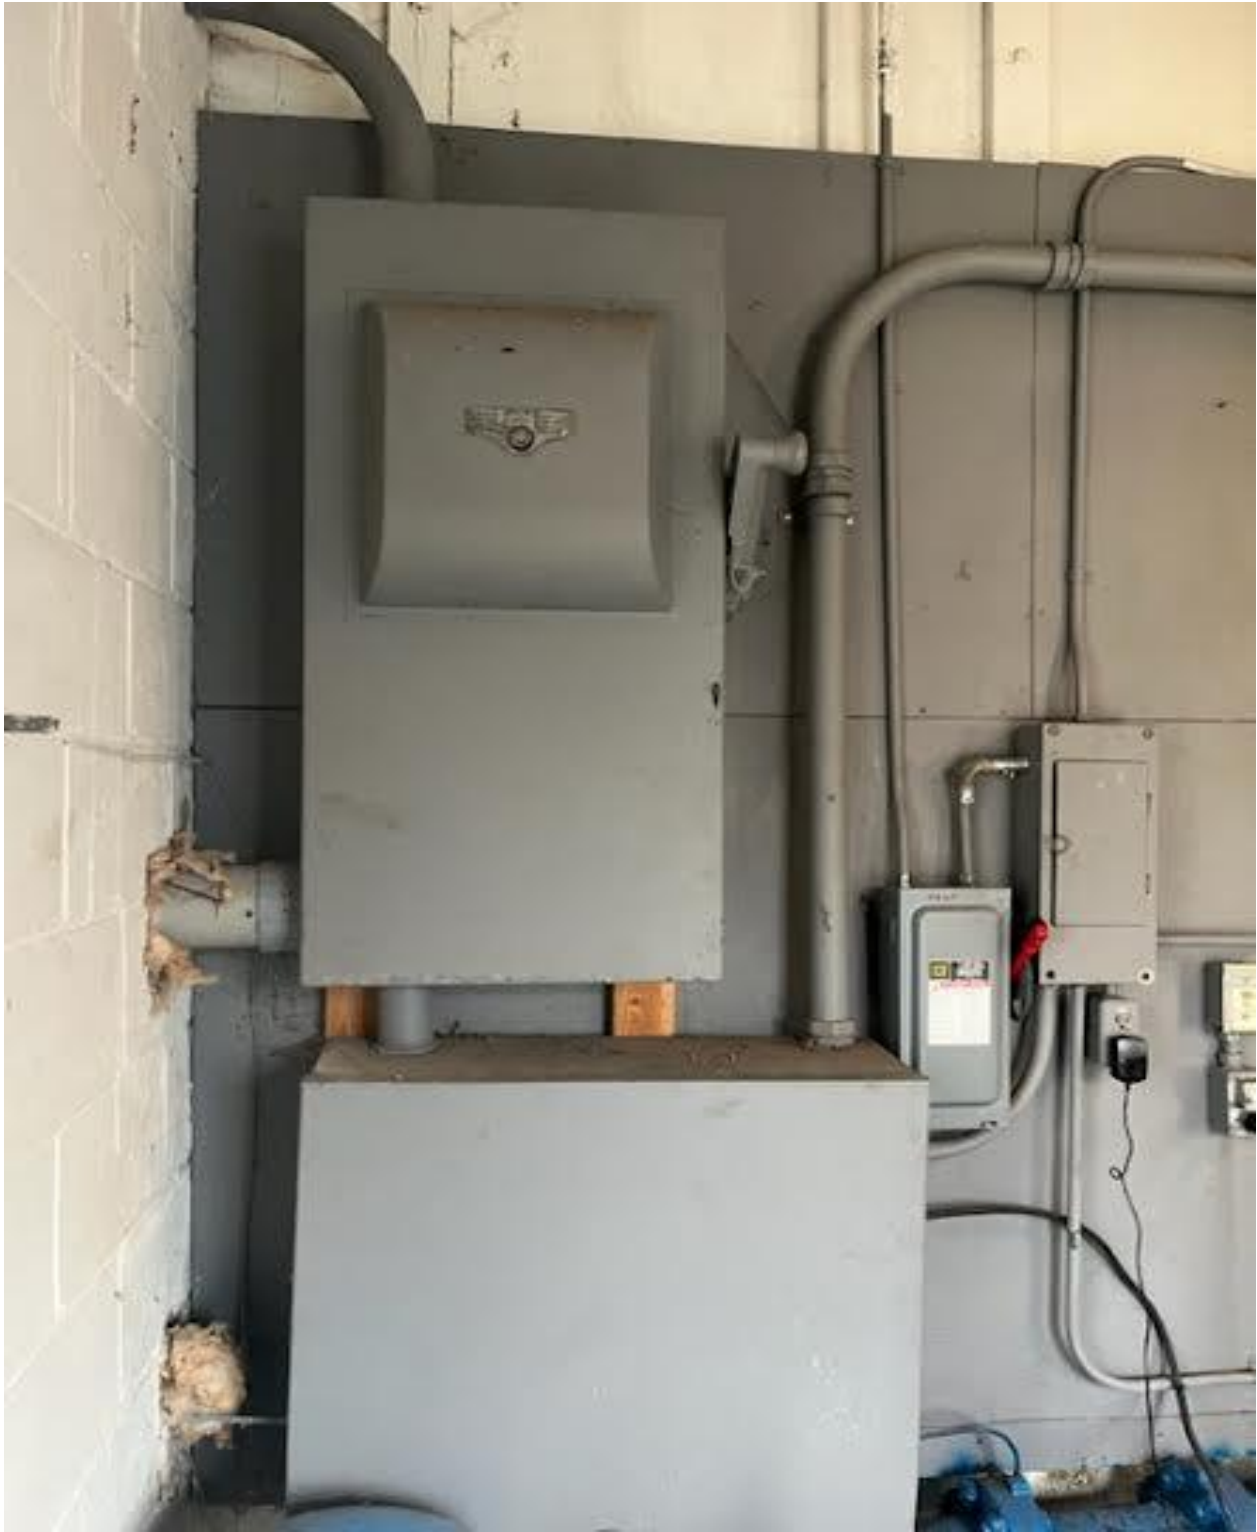
The electrical fill panels are in good condition

The Electrical System Is in Good Condition

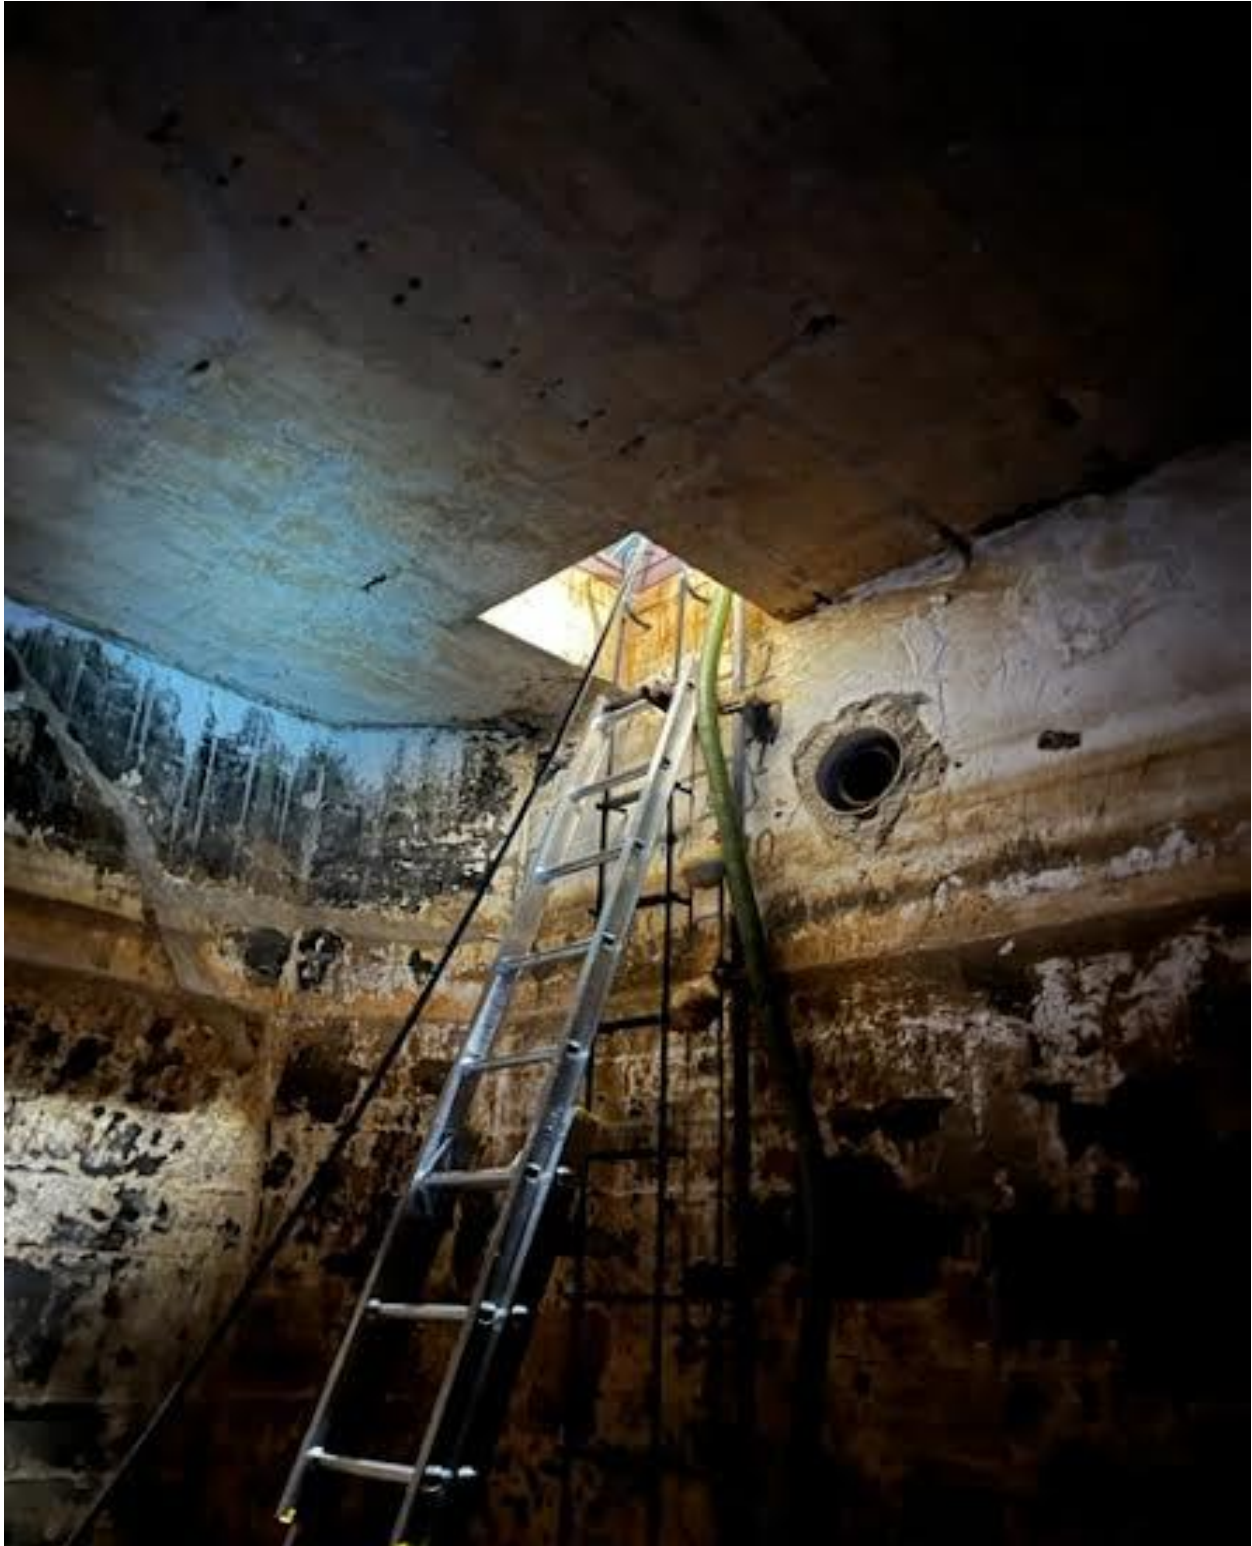
The concrete reservoir is in good condition

The Concrete in the Reservoir is in Good Condition

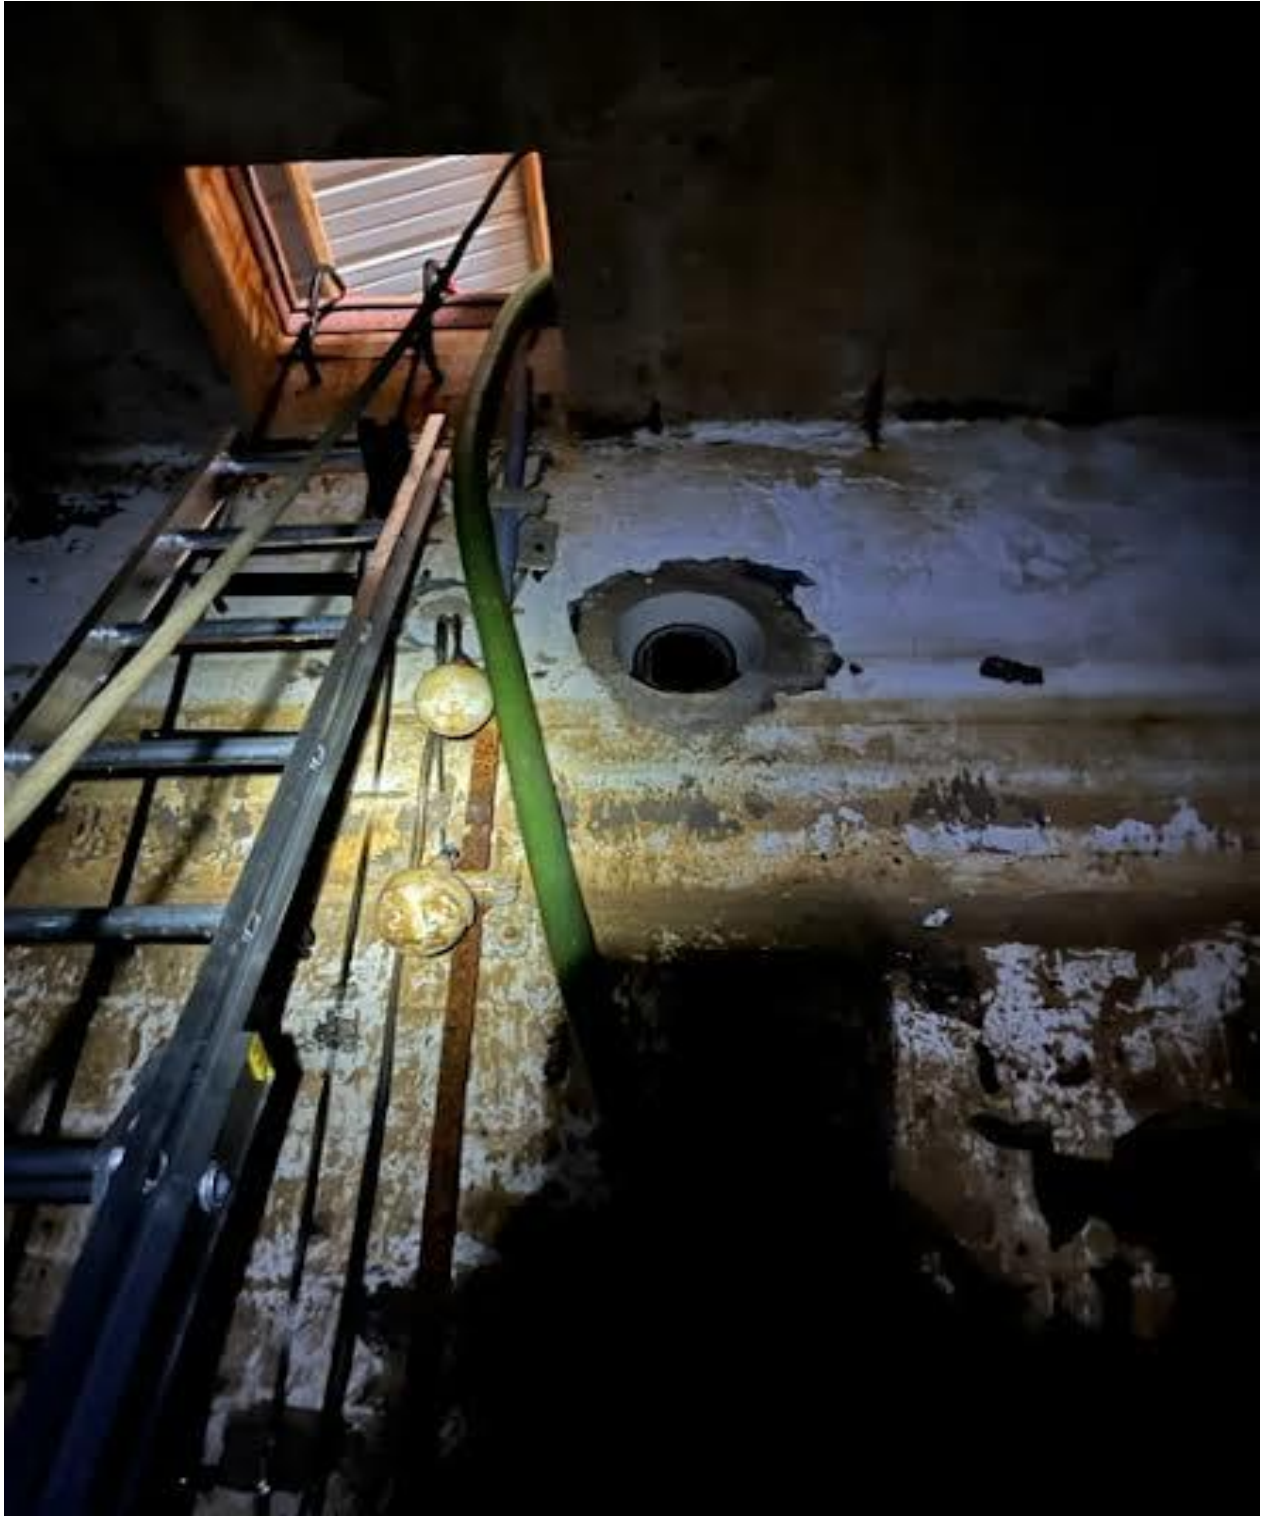
The reservoir floats are in good condition

The Overflow Opening and Floats are in Good Condition

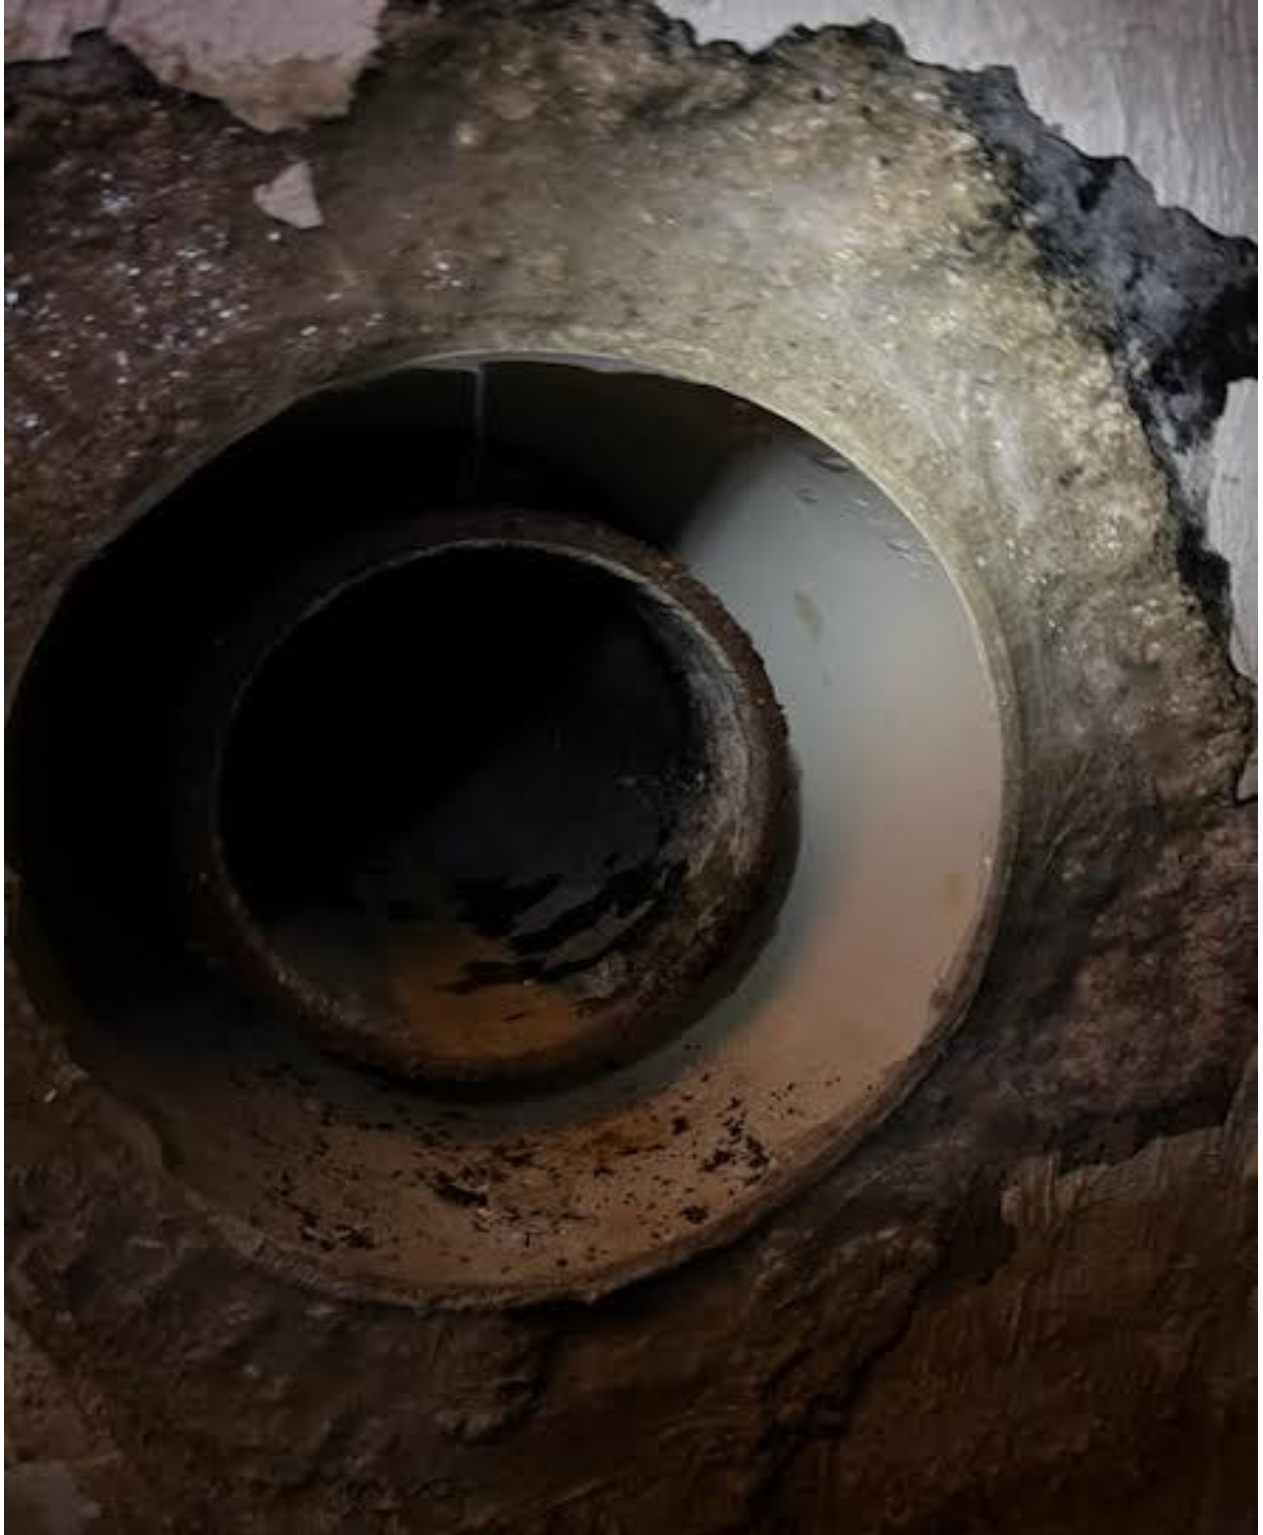
The overflow pipe opening are in good condition

The Overflow Opening is in Good Condition

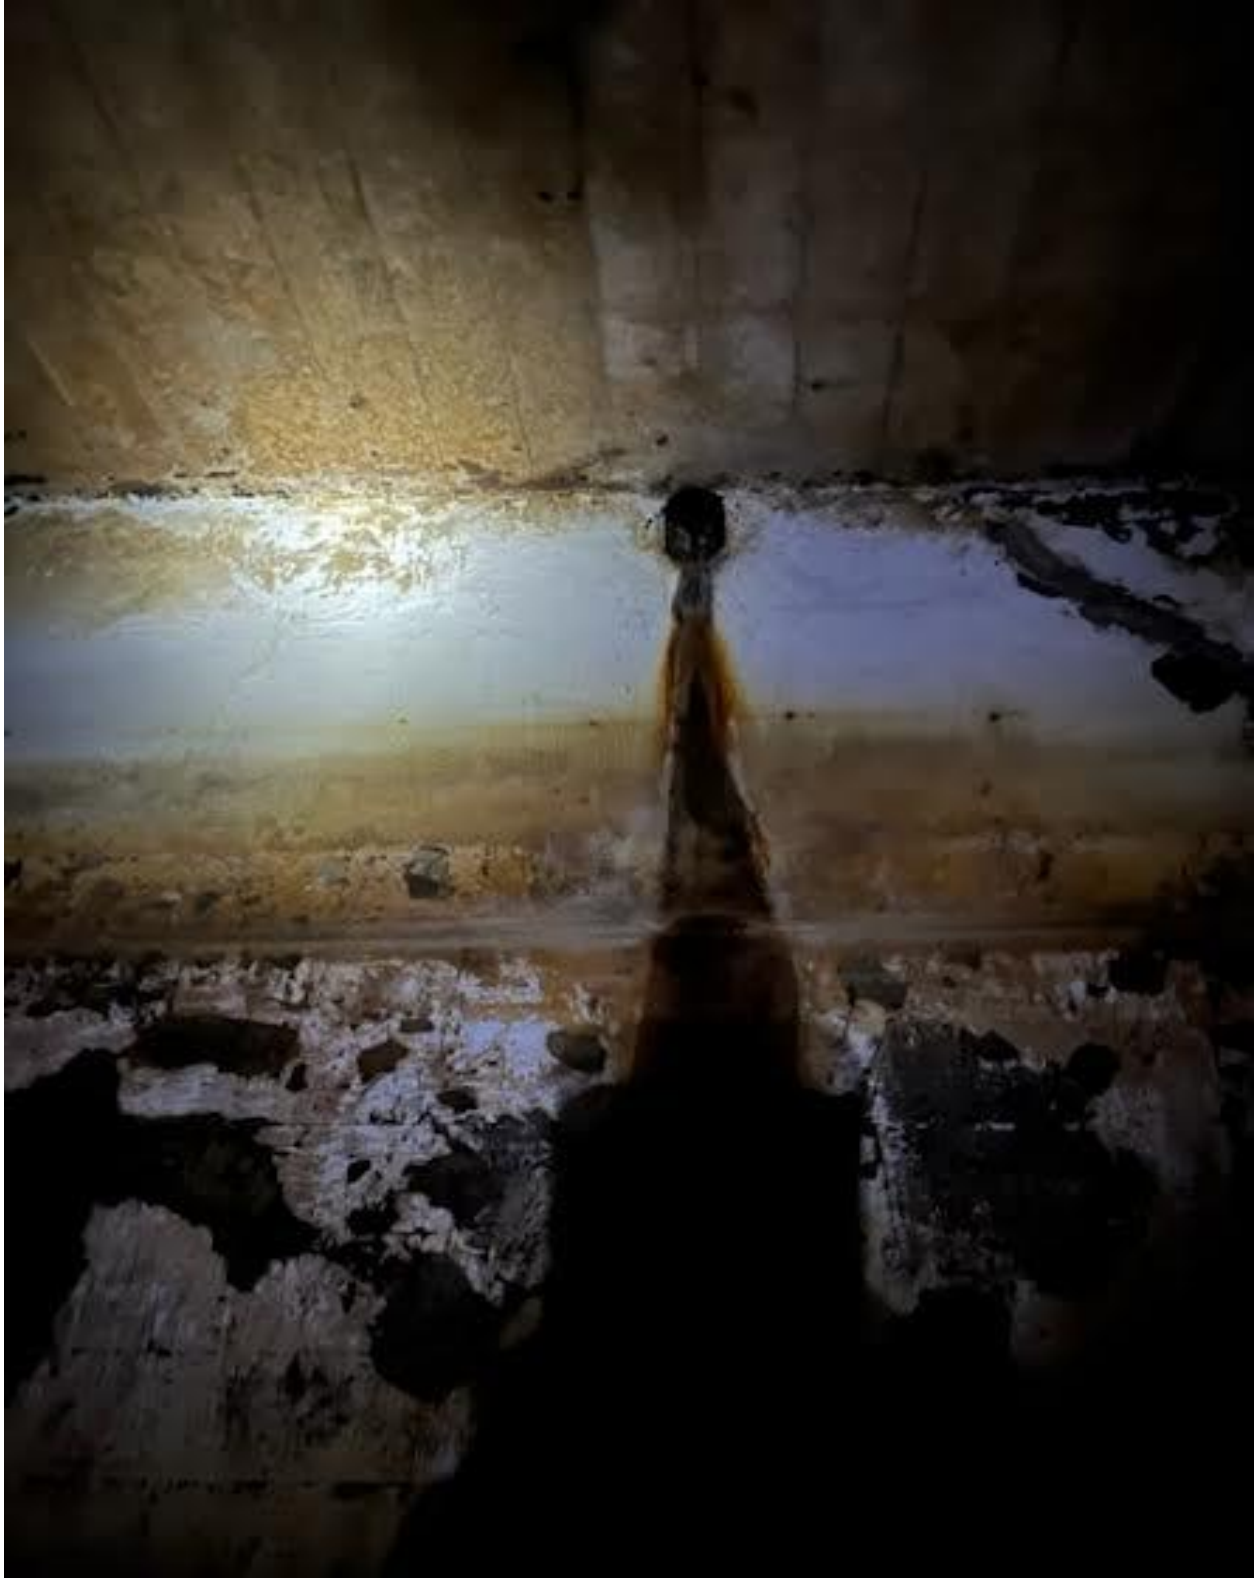
The fill pipe opening are in good condition

The Fill Pipe is in Good Condition

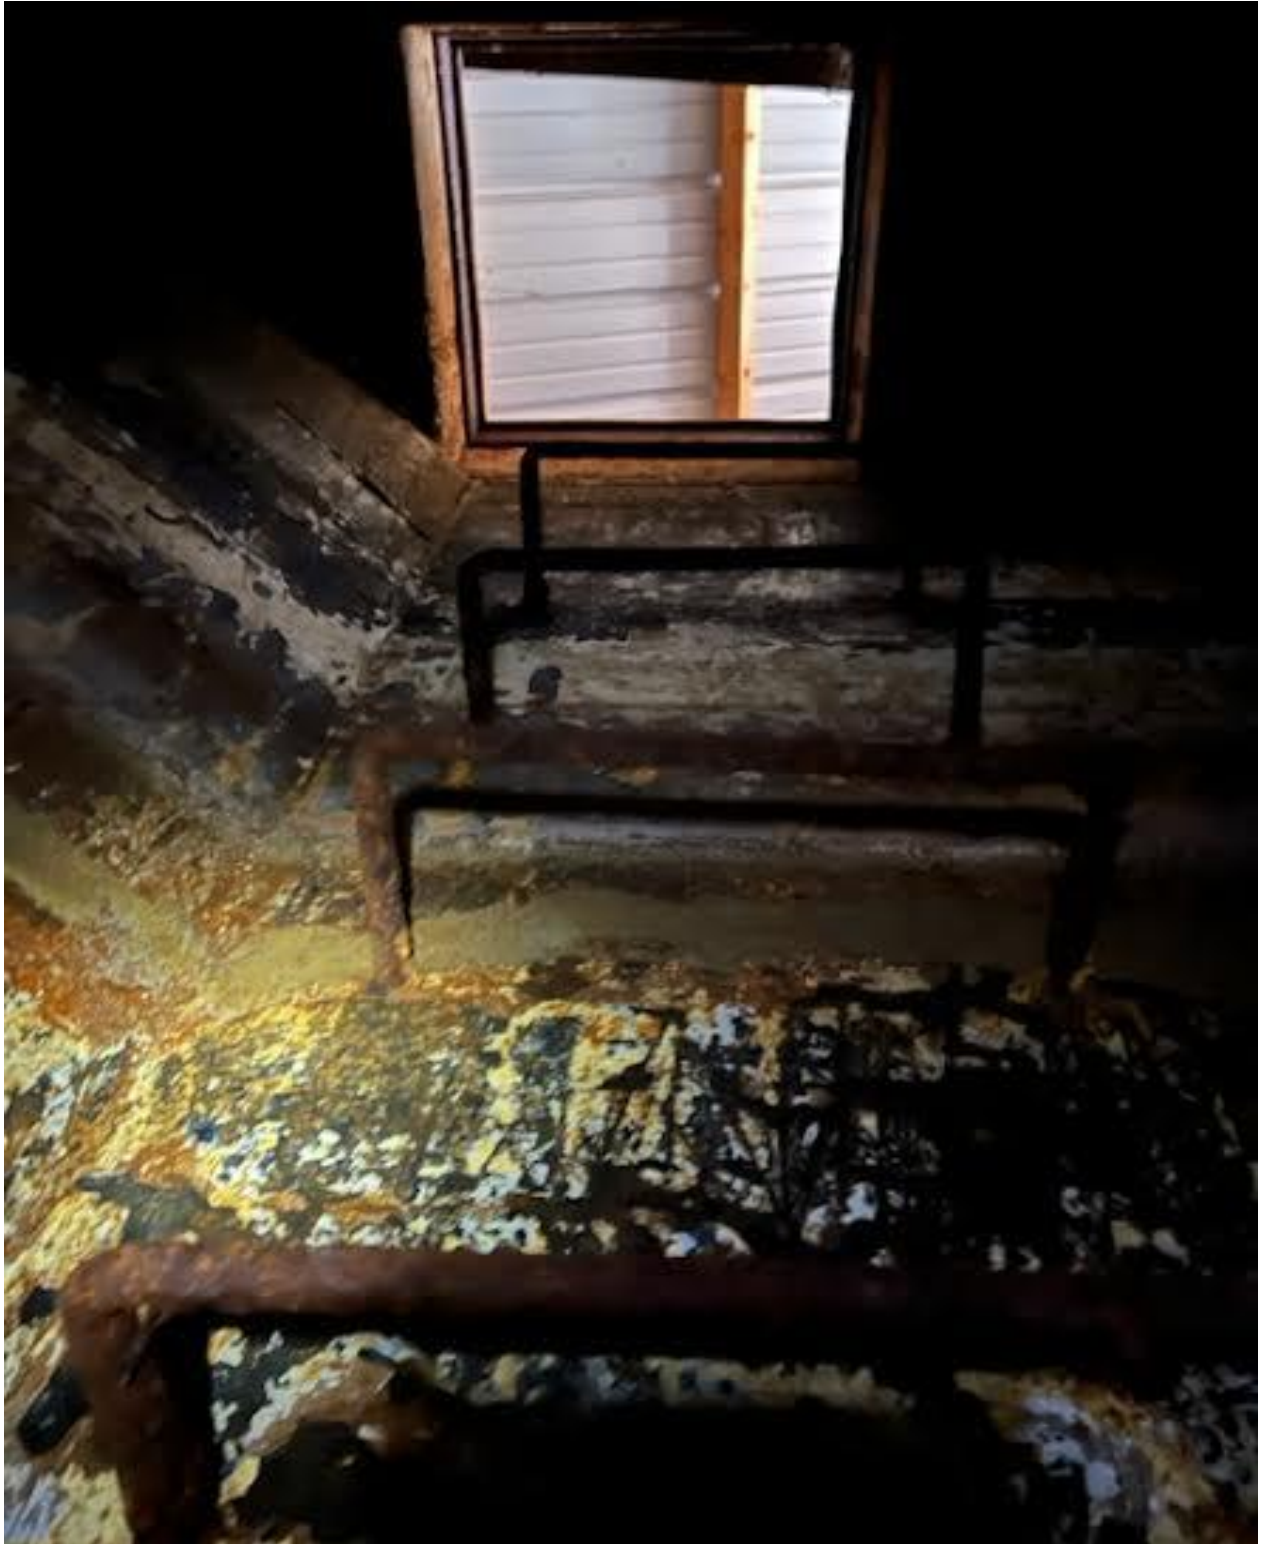
The metal ladder is in poor condition

The Metal Ladder at the Northwest is in Poor Condition

Do not use the metal ladder.

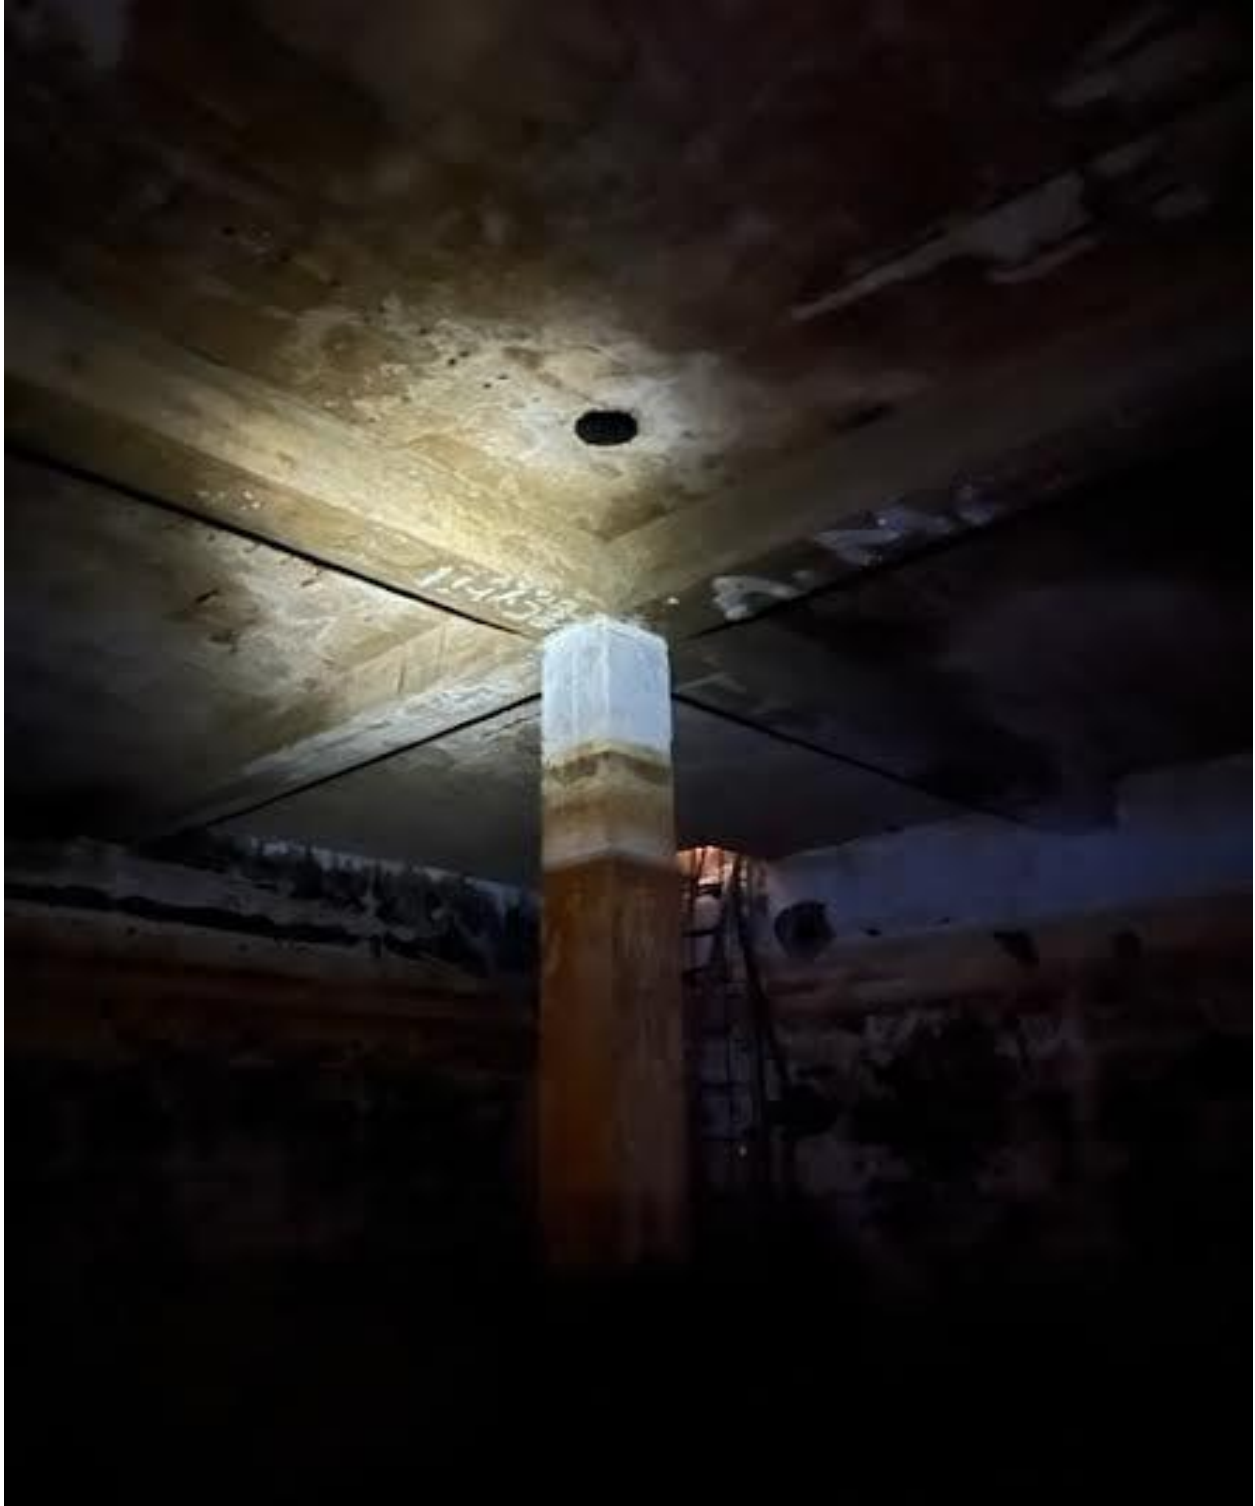
The concrete roof and beams are in good condition

The Concrete Ceiling and Roof Vent Opening are in Good Condition

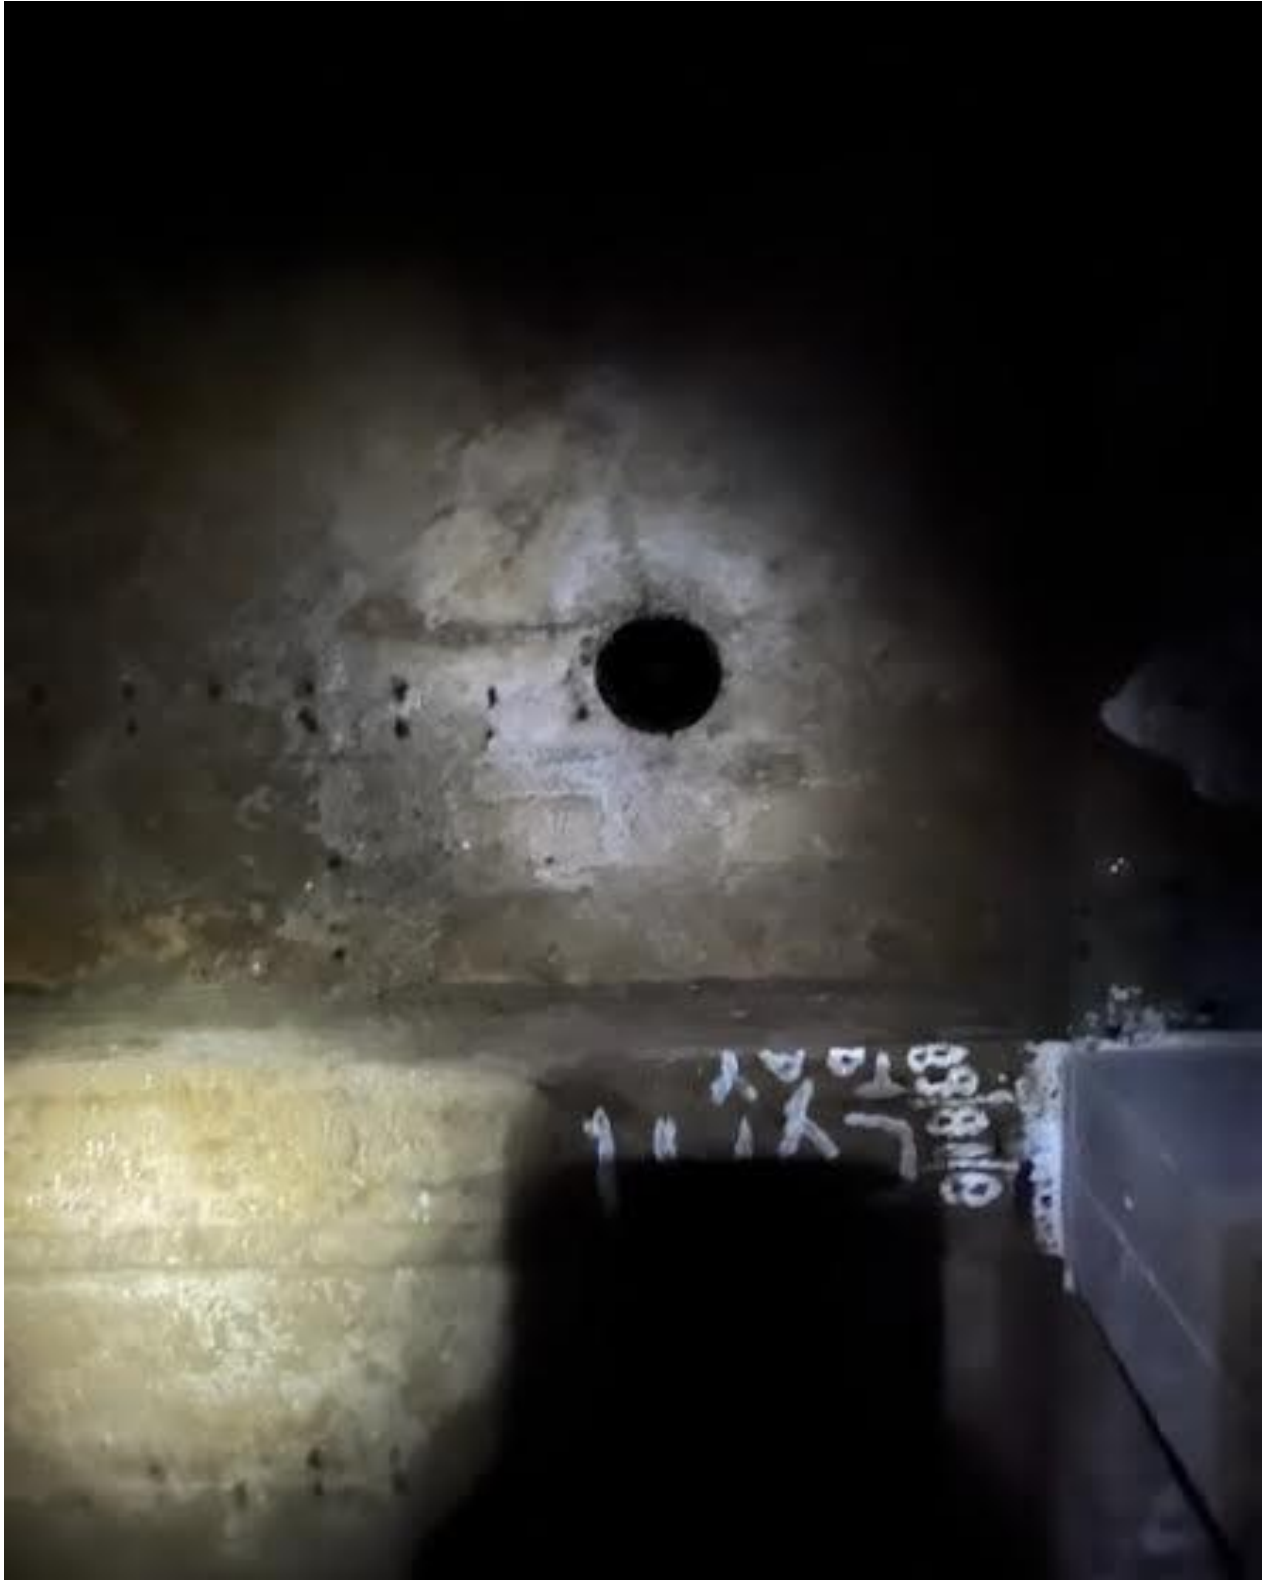
The roof vent opening is in good condition

The Roof Vent Opening is in Good Condition
