Drain Out Maintenance Inspection

40,000 Gallon Ridgeway

Ridgeway Water Utility, Ridgeway

Inspection Performed on Tuesday, April 16, 2024

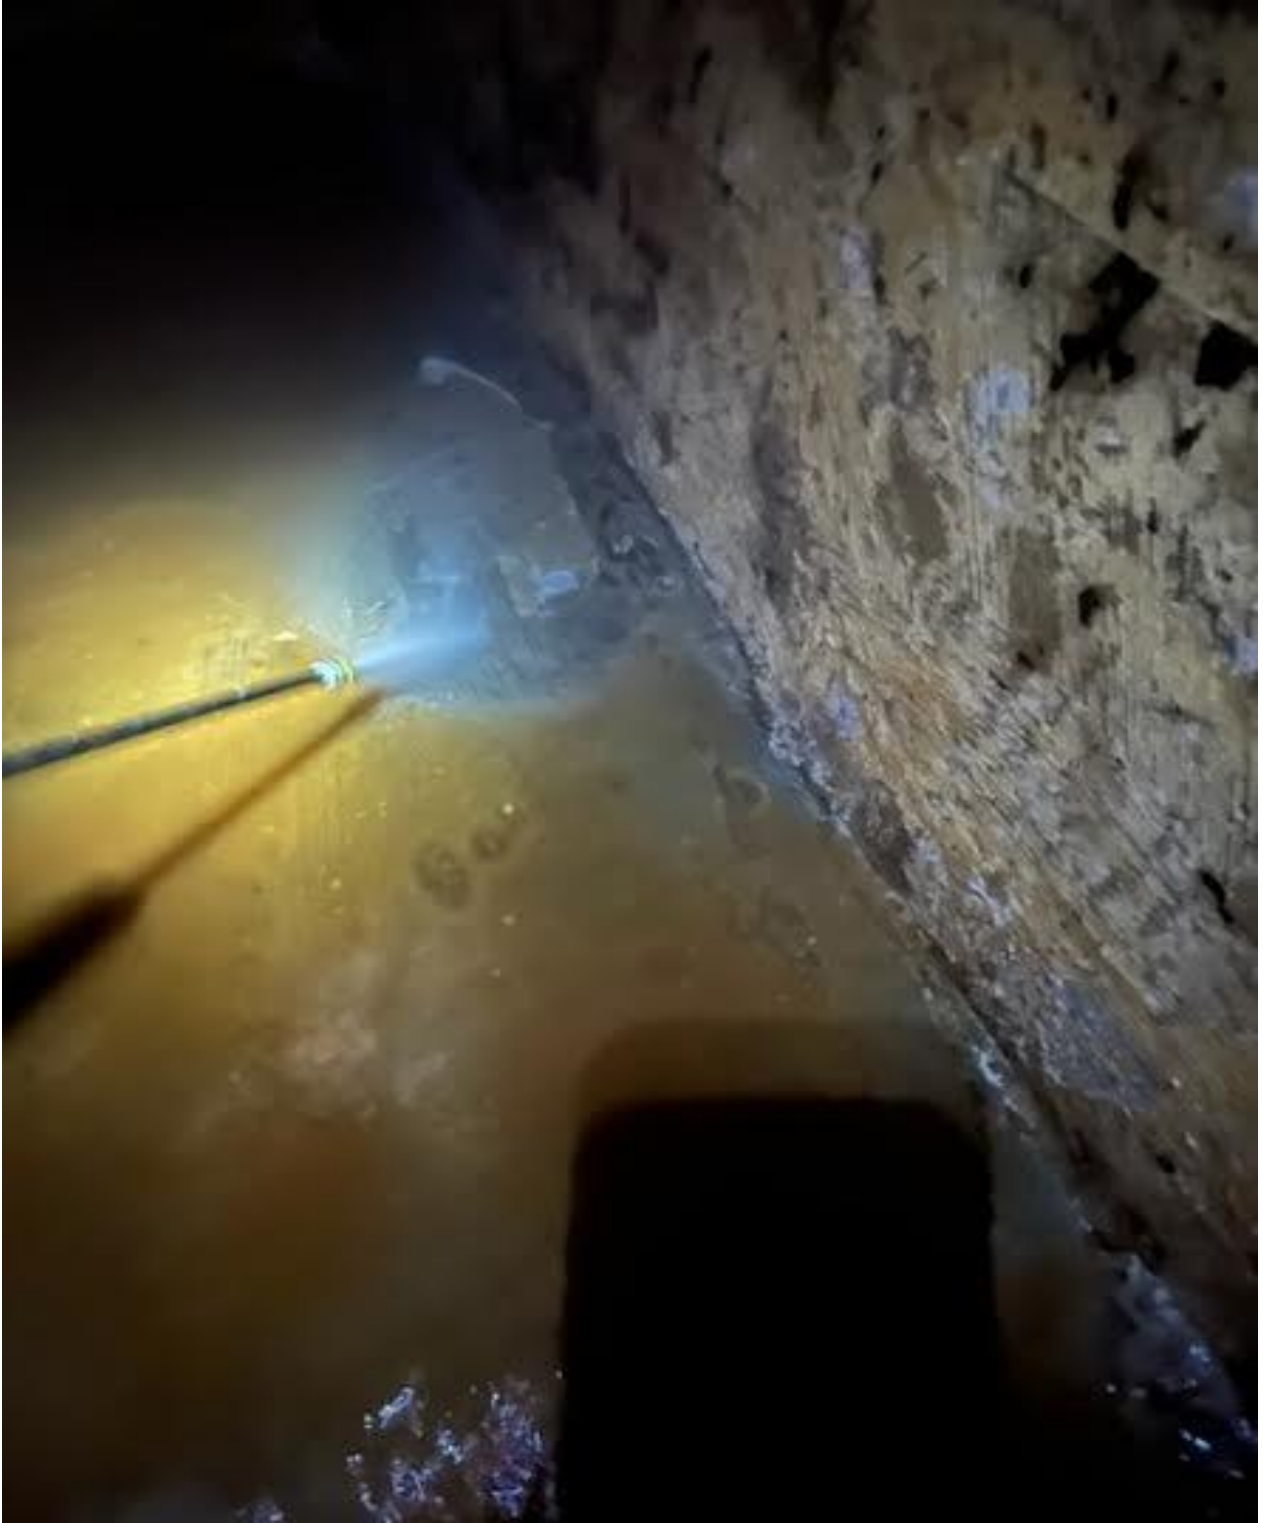
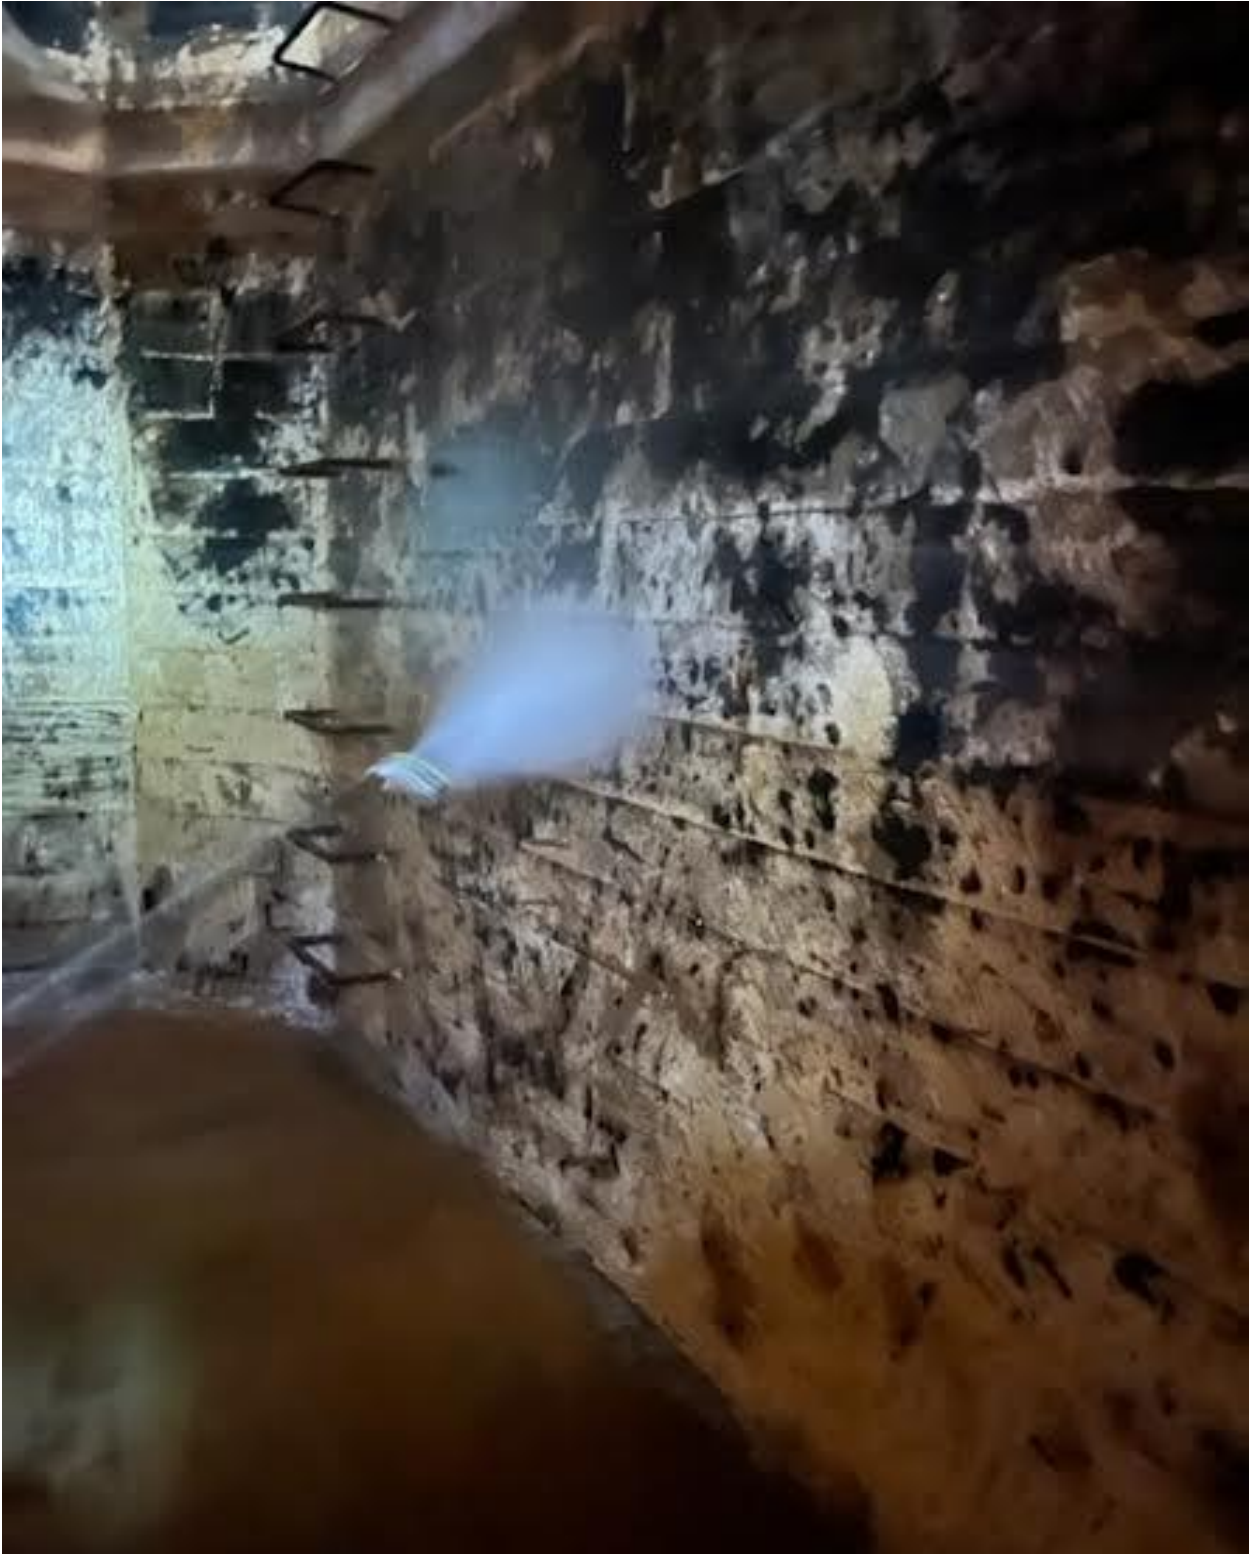
The Concrete Walls and Floor was Power Washed

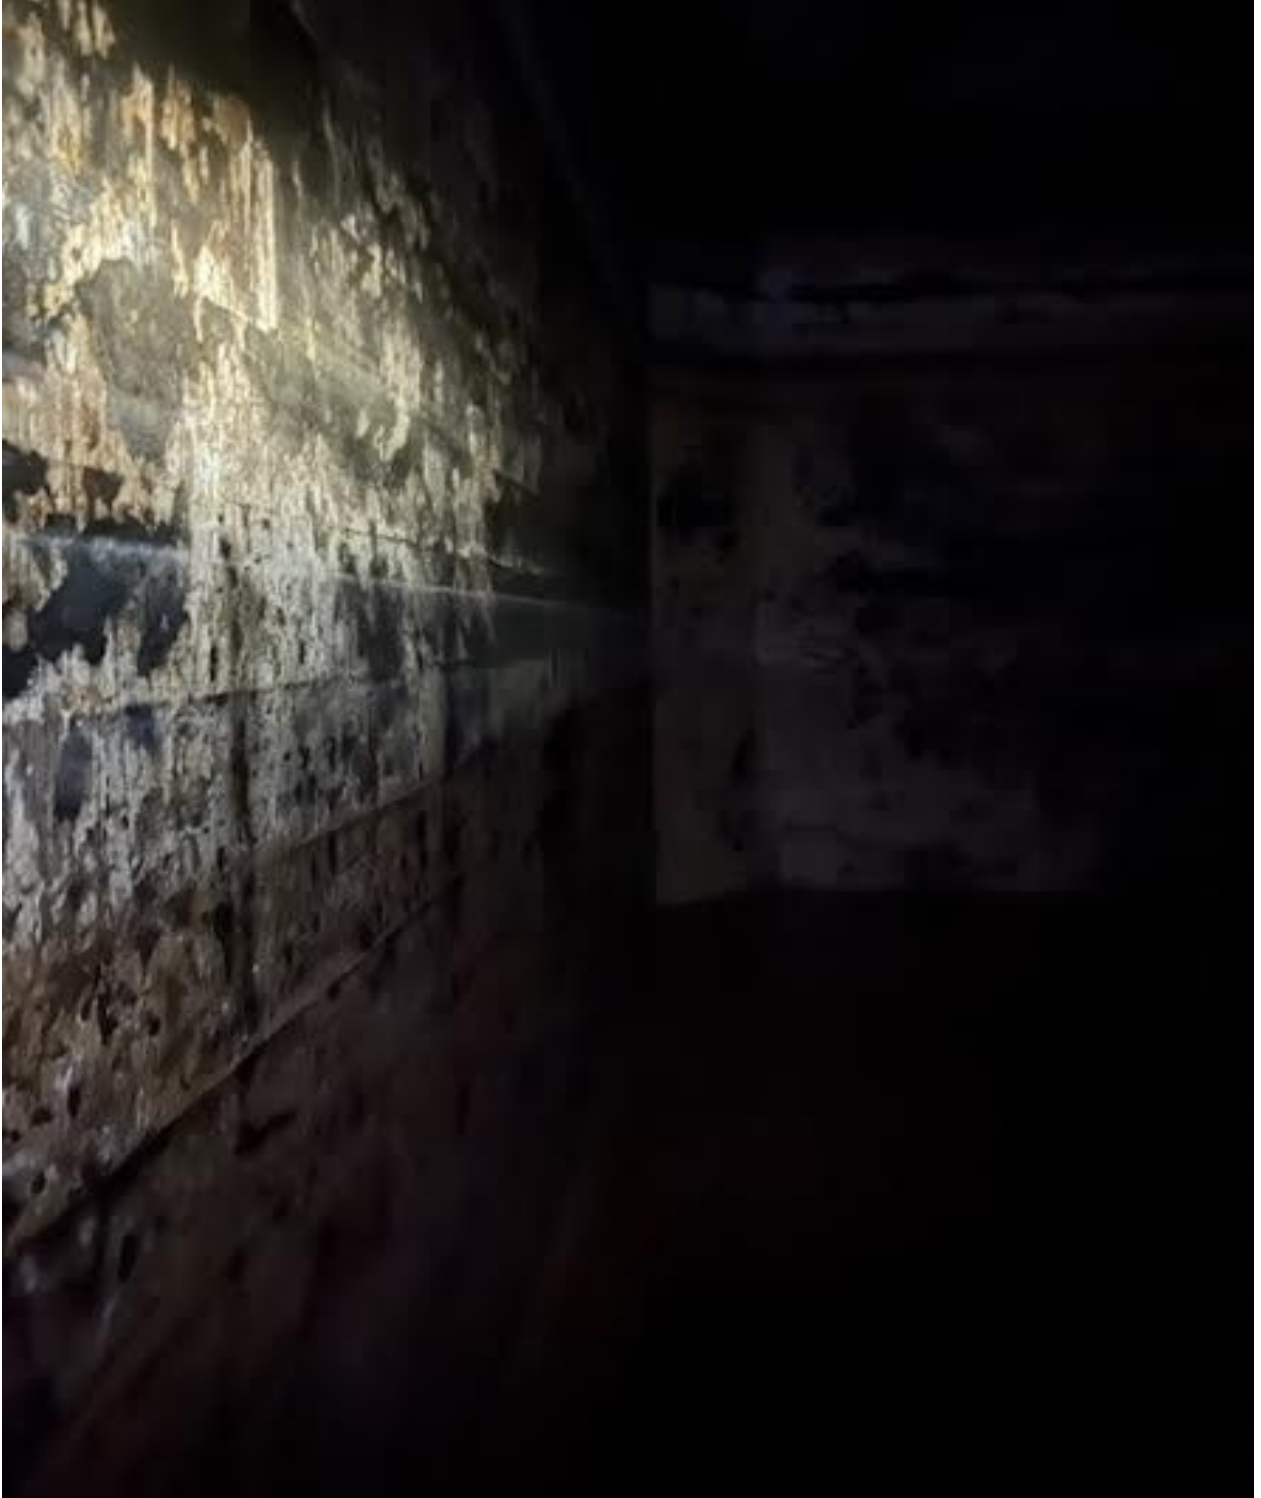
The concrete walls and floors are in good condition

The Concrete Walls are in Good Condition

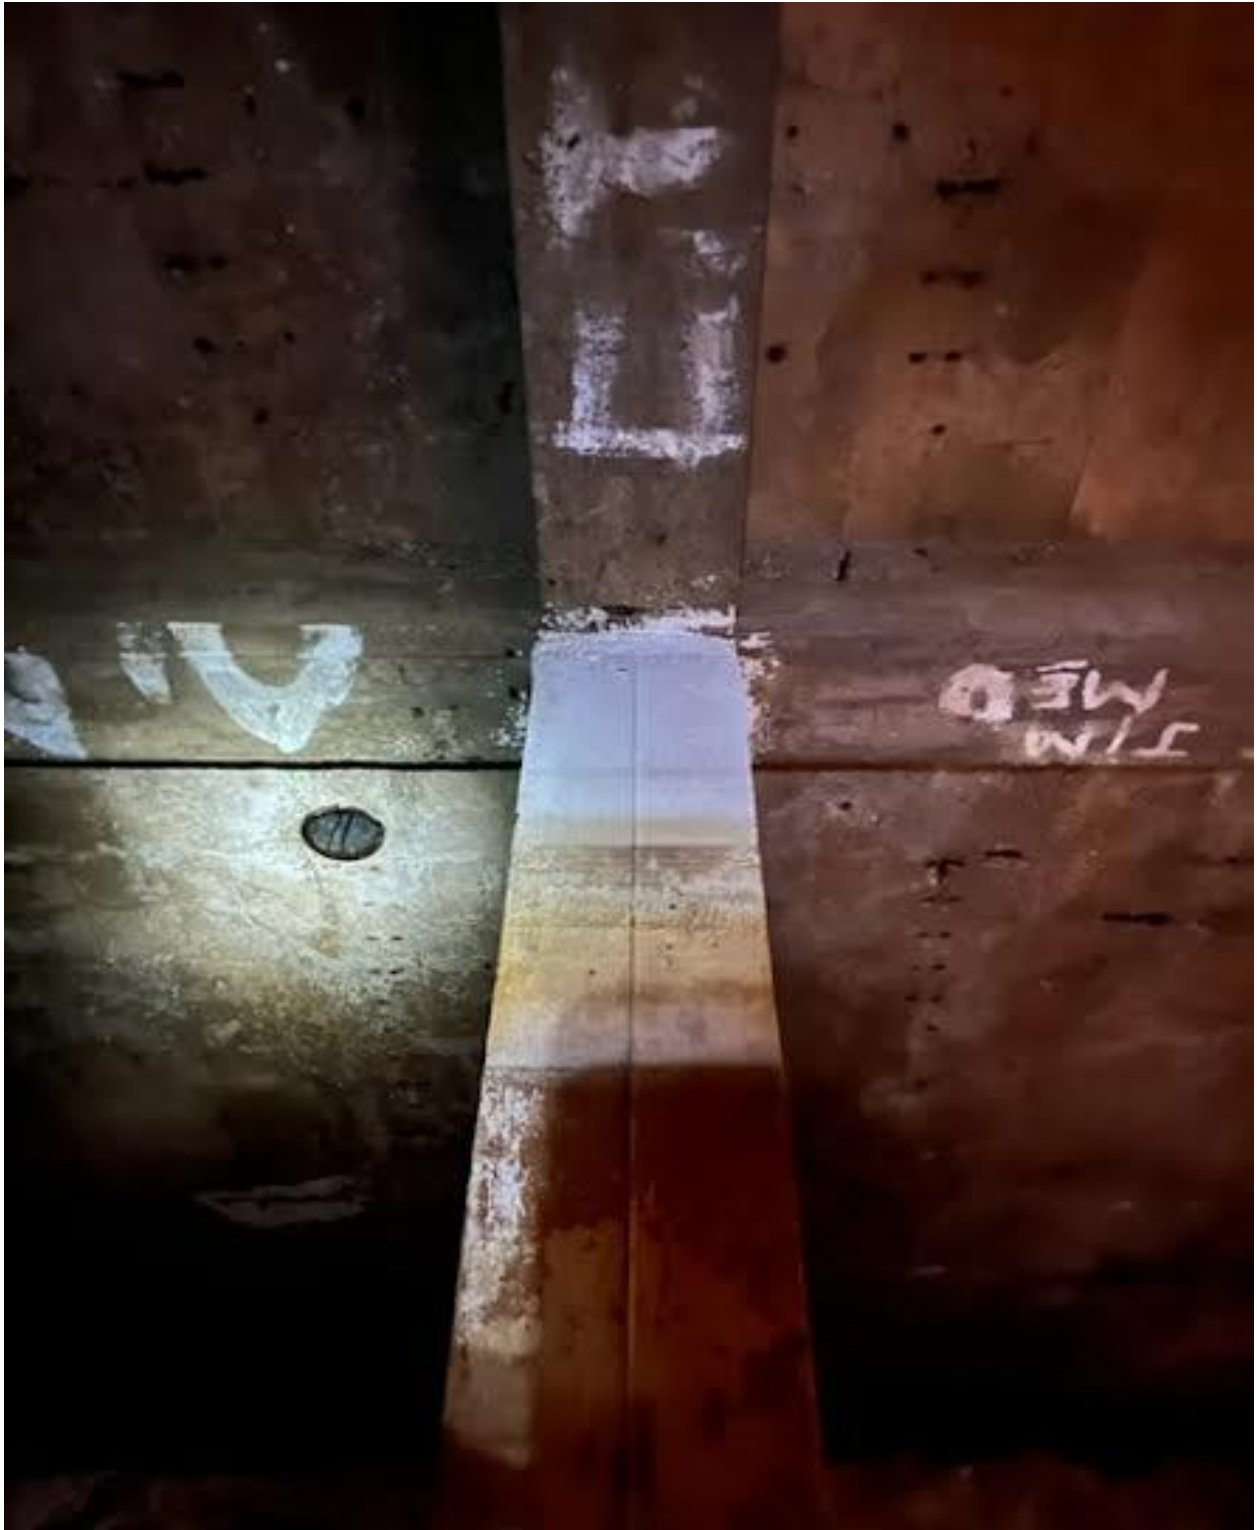
The Concrete Beams are in Good Condition

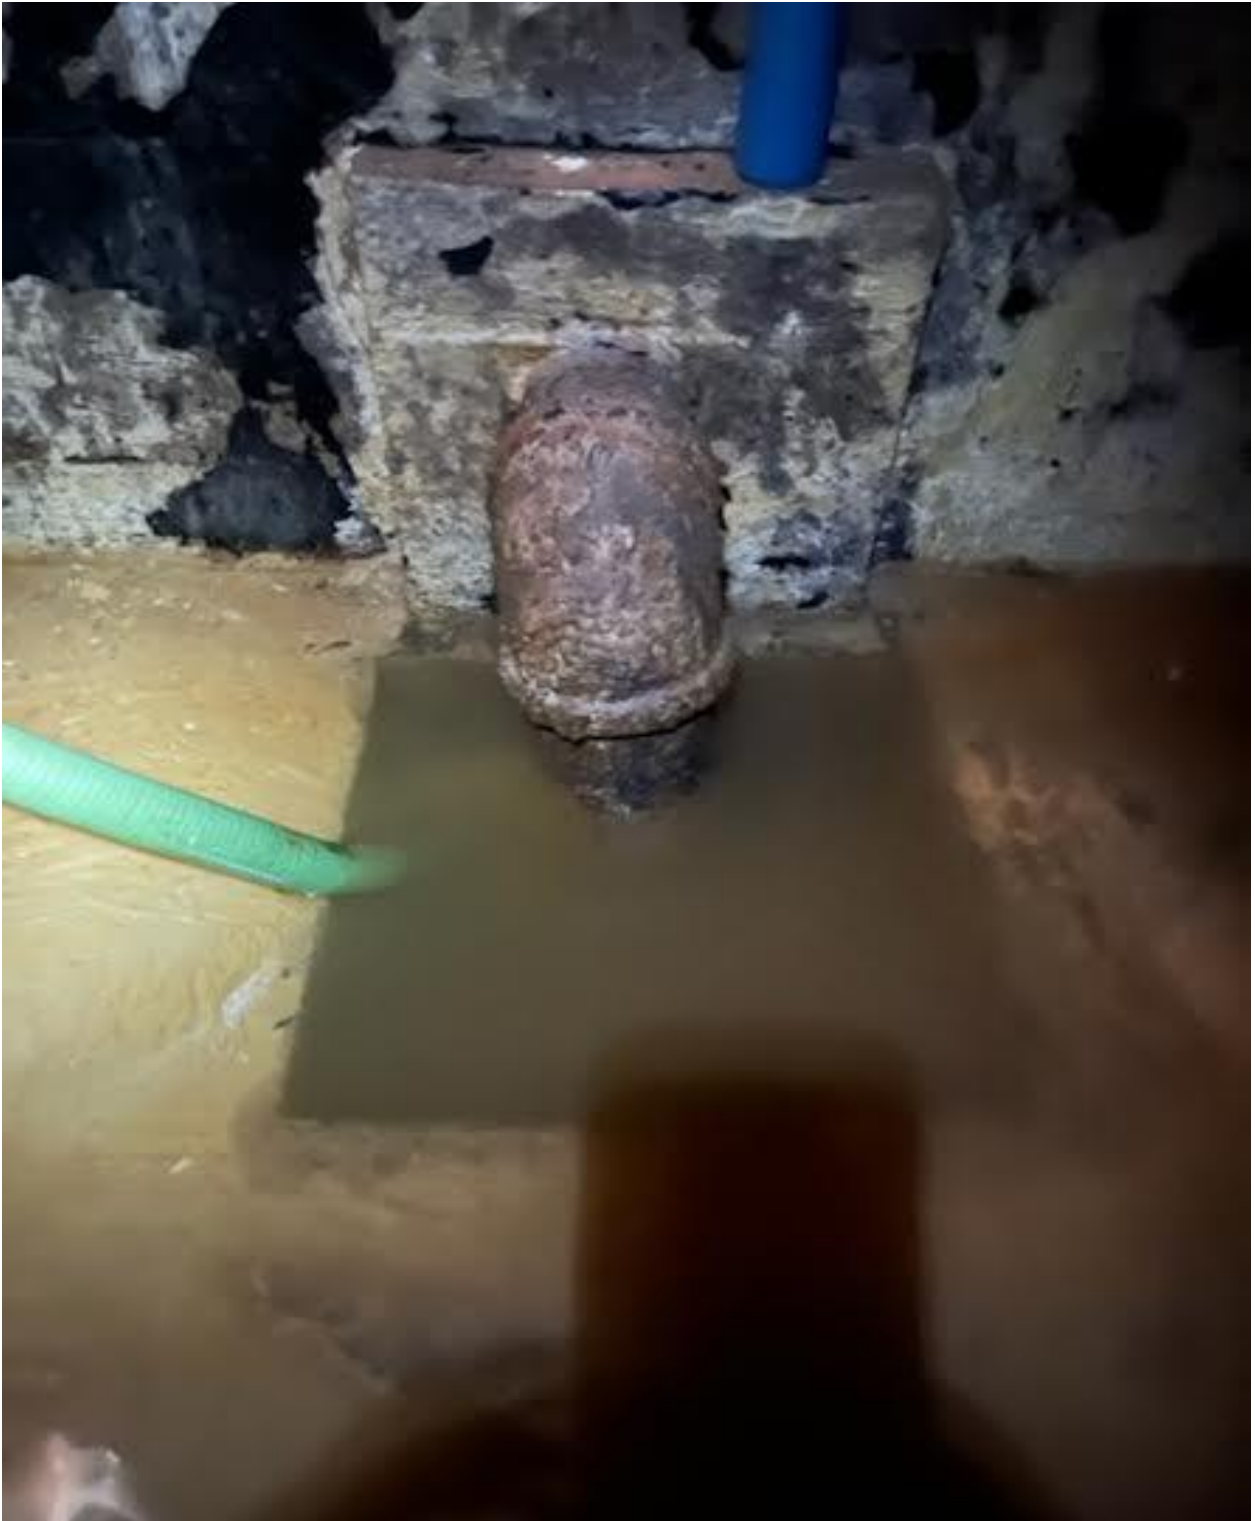
The outlet pipe is in good condition

The Outlet Pipe is located in Sump

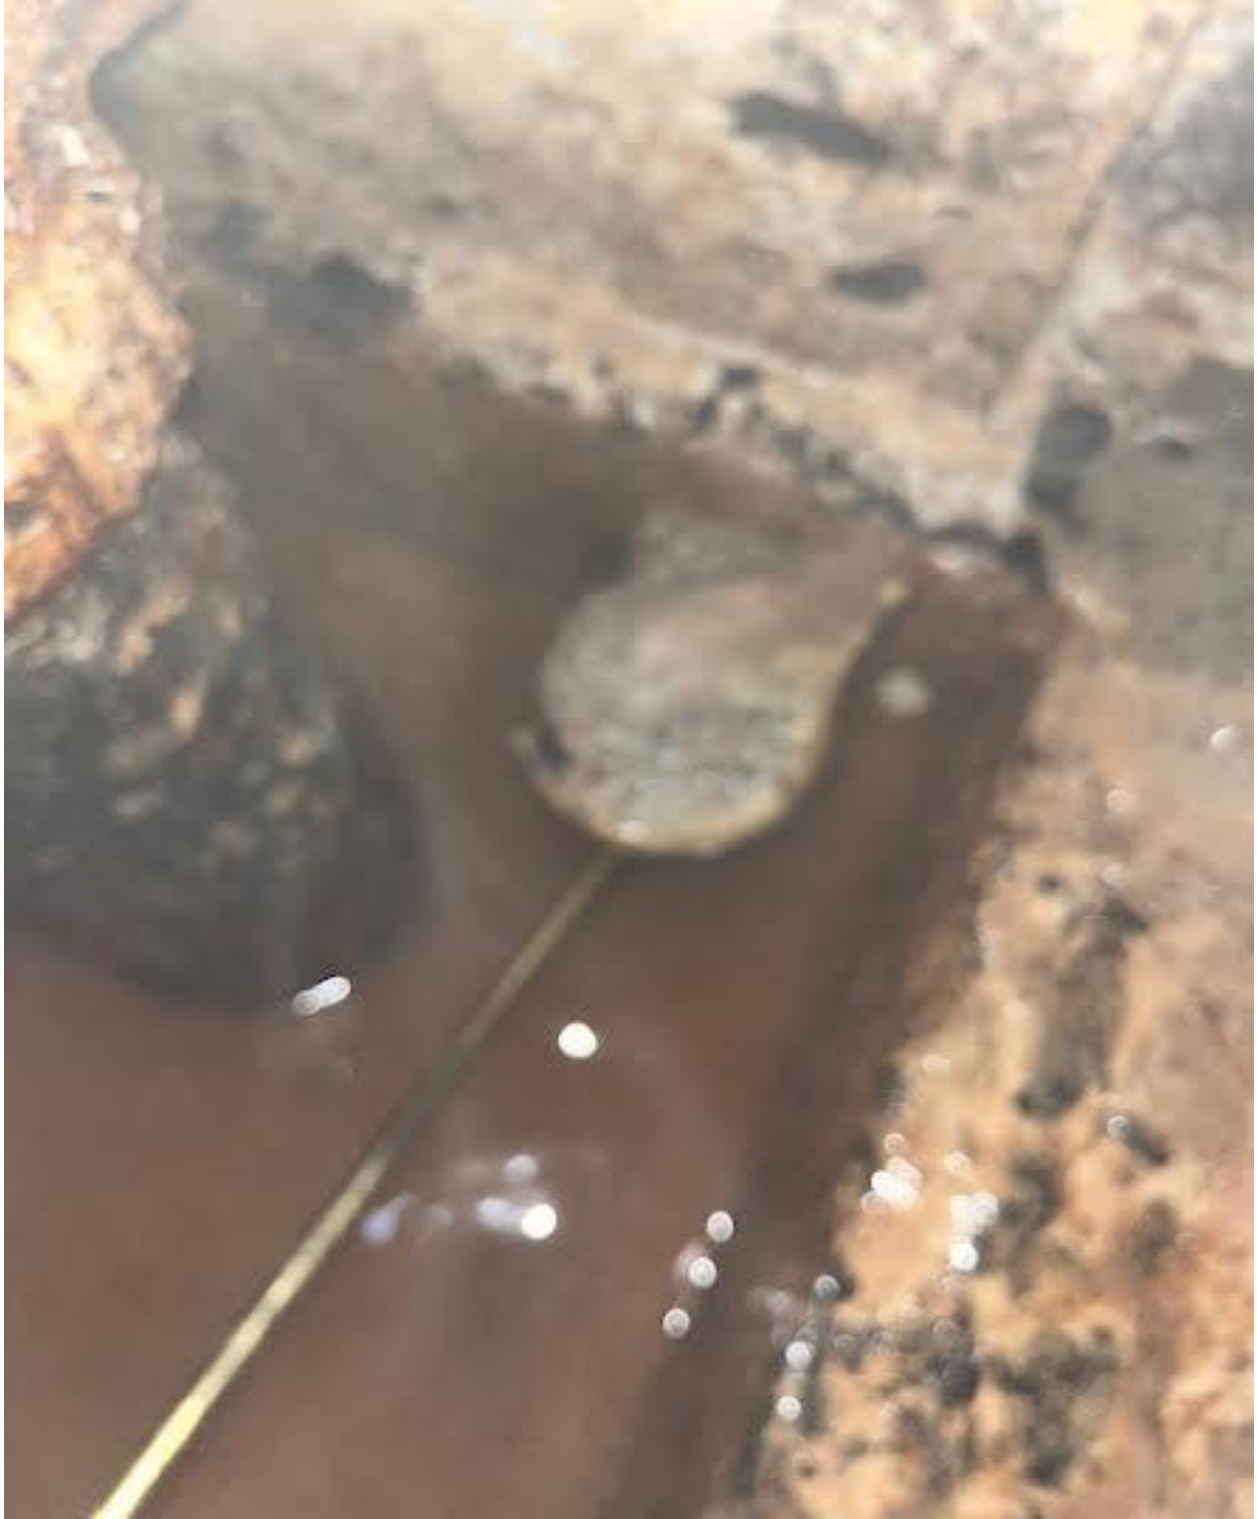
The Sump was Filled with Sediment

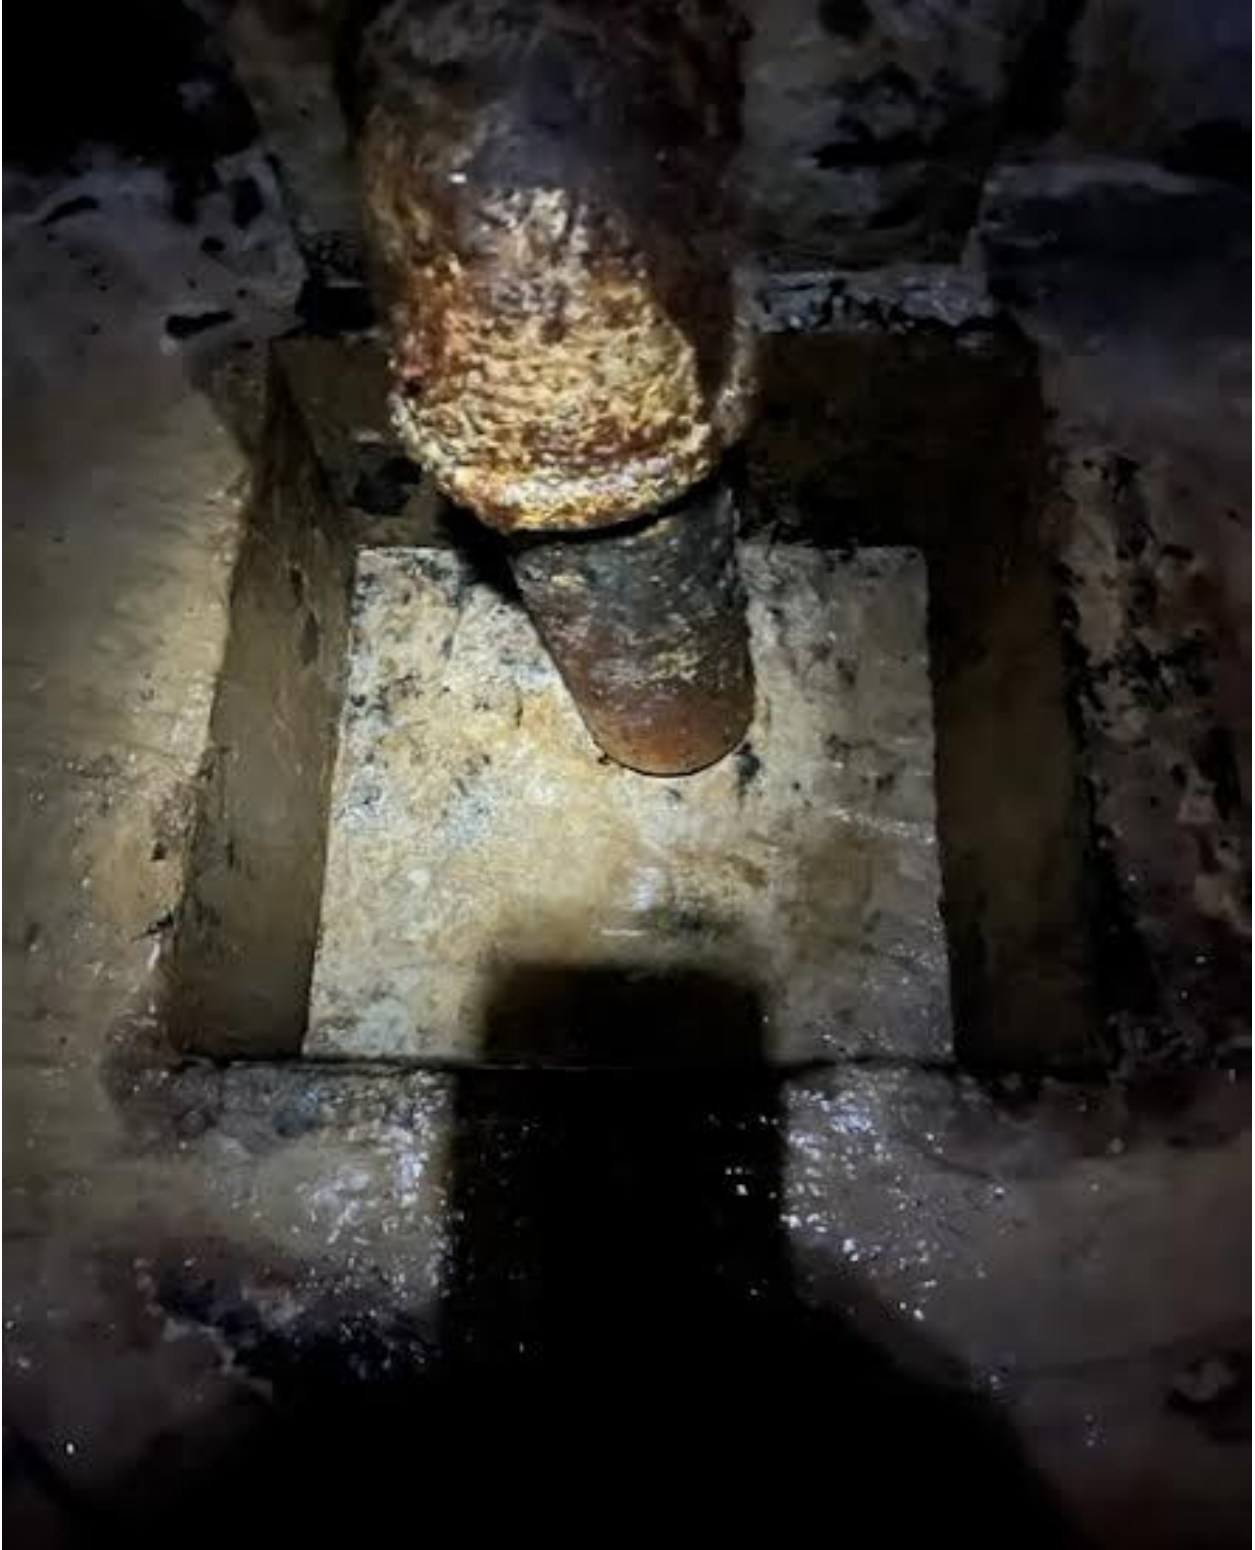
The sump area is in good condition

The Sump Area was Cleaned Out
