ROV & Drone Maintenance Inspection

ROV Warranty Inspection

Ridgeway Tank, 150,000 Gallon Sphere

Ridgeway Water Utility, Ridgeway, WI

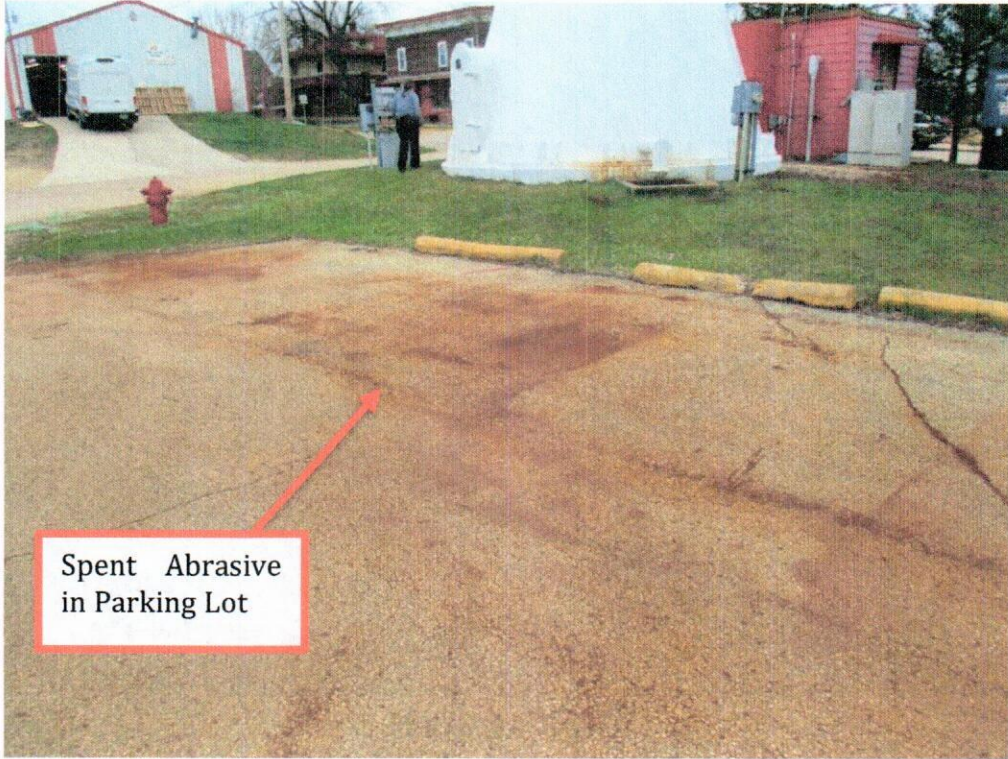
The spheroid tank is located in the corner of a park and small industrial zone. The site is generally in good condition. There is still a moderate amount of corroding spent abrasive in the parking spots that house the machinery used during the renovation.

Spent Abrasive
in Parking Lot

Site Parking Lot - Residual Spent Abrasive

Overall, the tank is in good condition. Minor issues such as replacing the overflow pipe screen and removing all miscellaneous items from the base bell of the tank should be completed when possible. Removal of the spent abrasive from the platforms should be completed soon, as the abrasive is corroding and will likely lead to the platform corroding prematurely in the future. The minor pinhole corrosion in the transition cone should be monitored and may need to be dealt with when the riser is coated in the future.

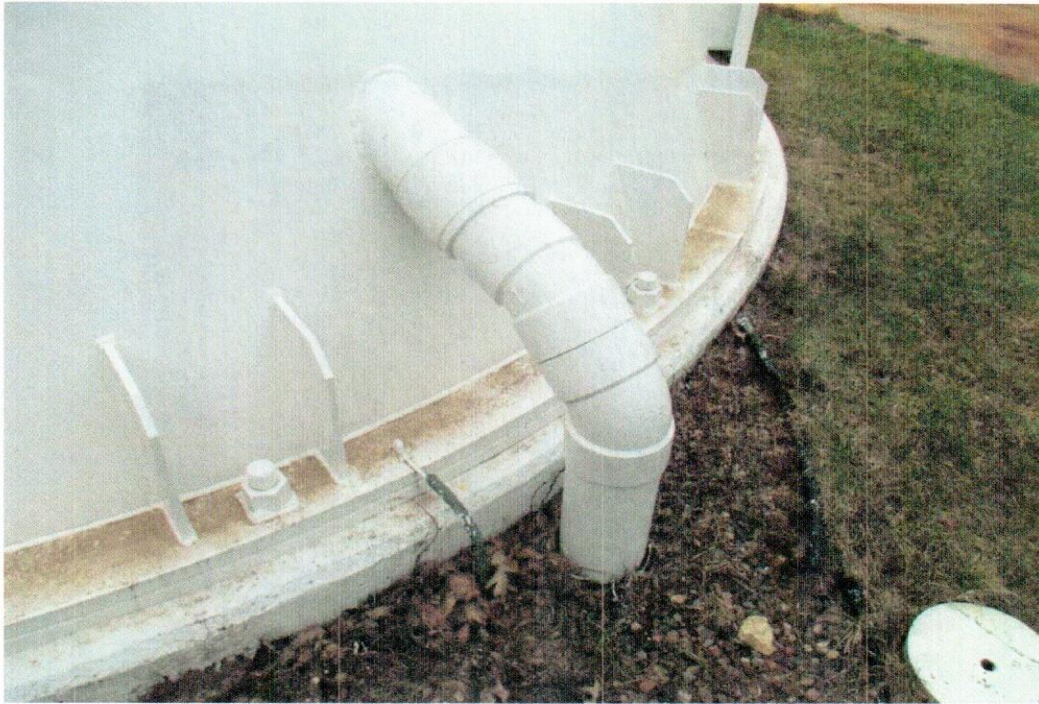
The concrete of the foundation is in good condition. The grouting around the base of the tower is also in good condition.

Exterior Foundation - Good Condition

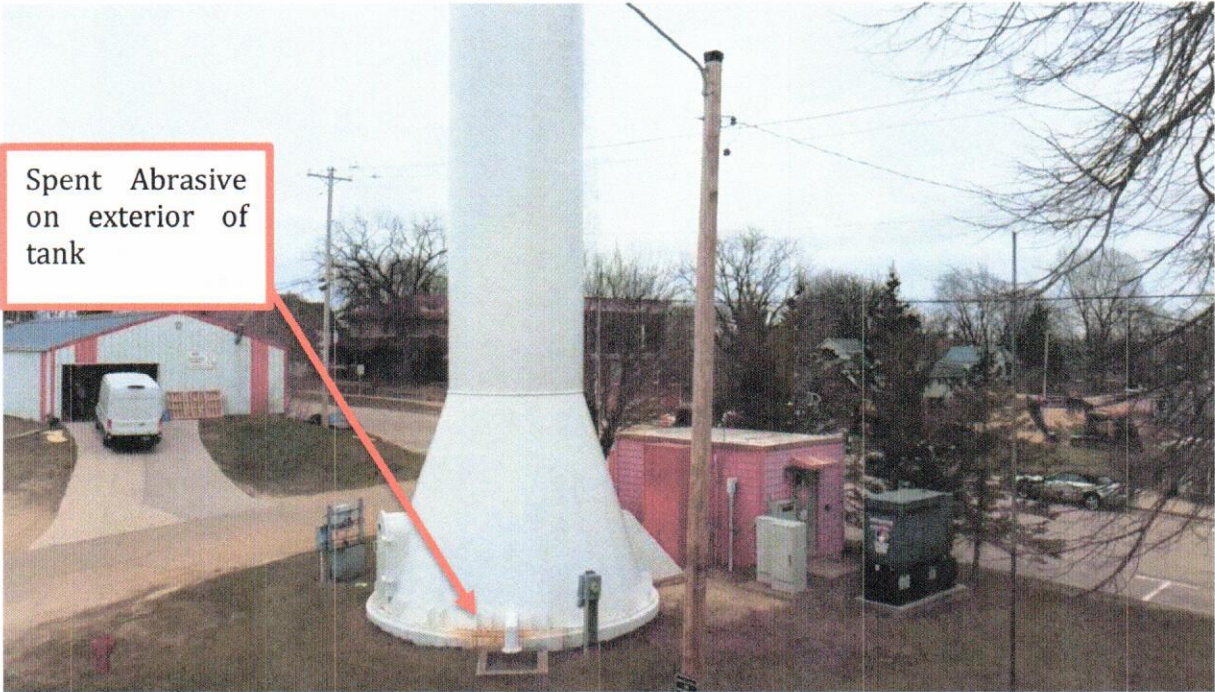
Spent Abrasive
on exterior of
tank

Exterior Base Bell - Good Condition

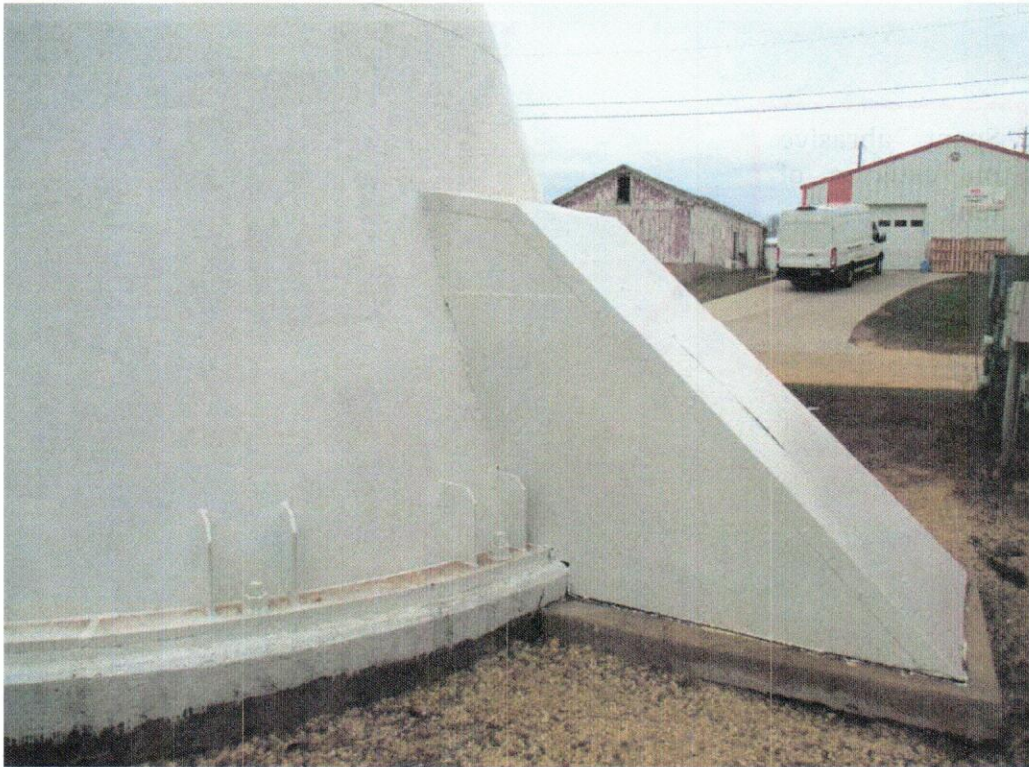
The coating on the exterior base bell of the tank is in good condition. The additional small structure attached to the base of the tank is separating from the base bell. There appears to have been sealant used, but this is leaving ½" gaps around this structure. There is also a small collection of spent abrasive corroding near the overflow pipe.

Exterior Base Bell - Gap in Telecom Structure

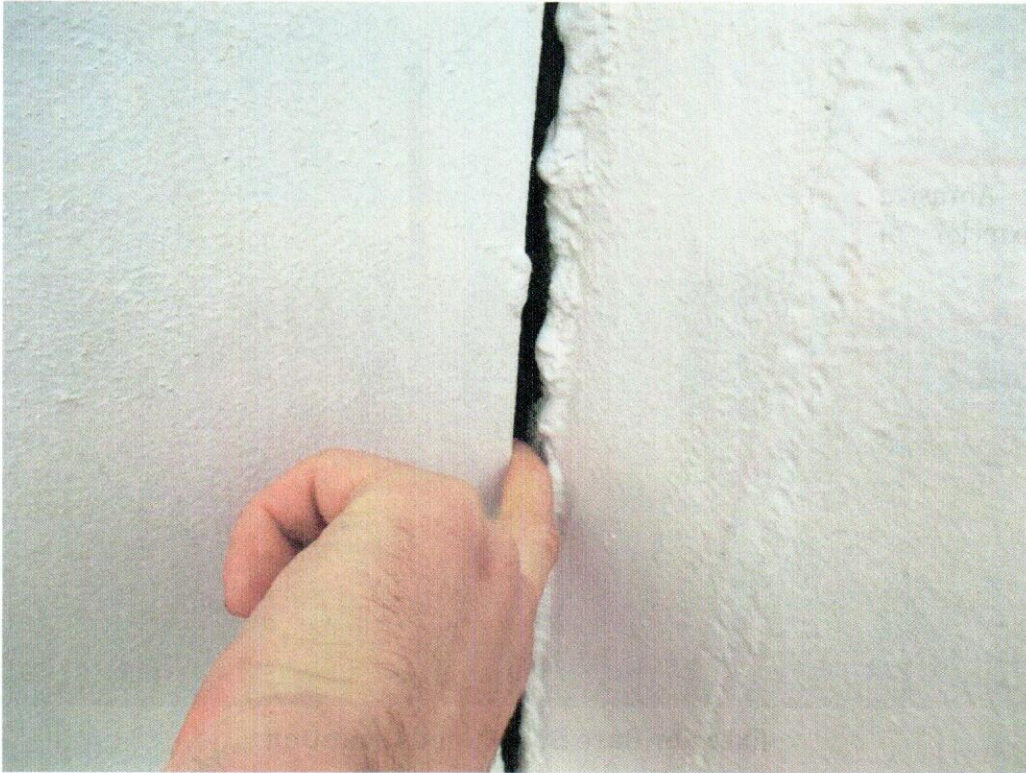
Exterior Base Bell - Gap in Telecom Structure

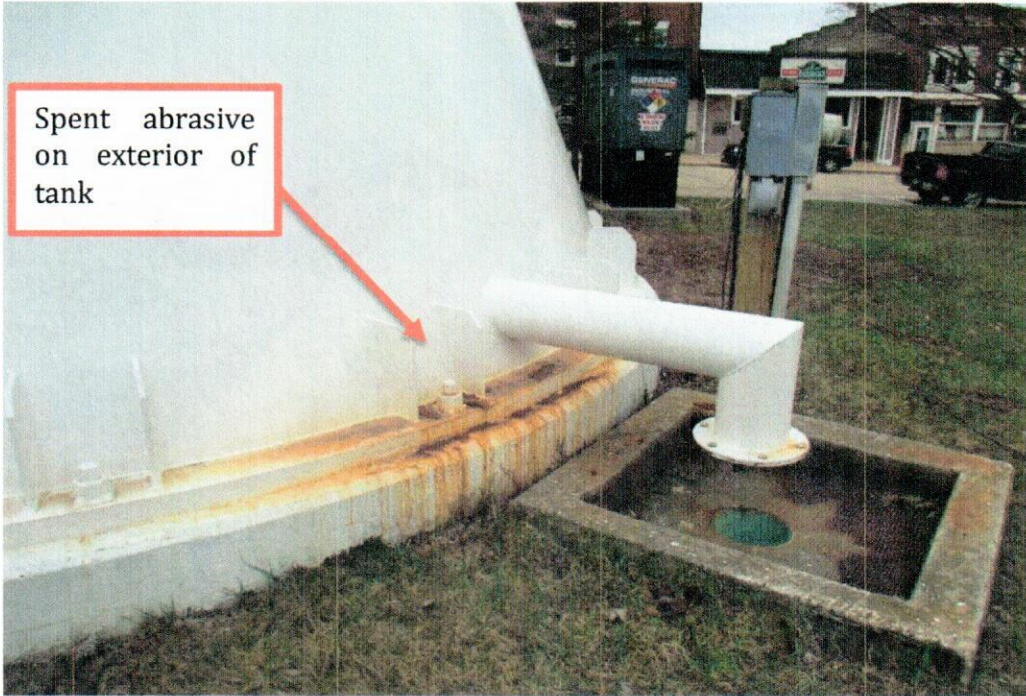
Exterior Overflow - Good Condition

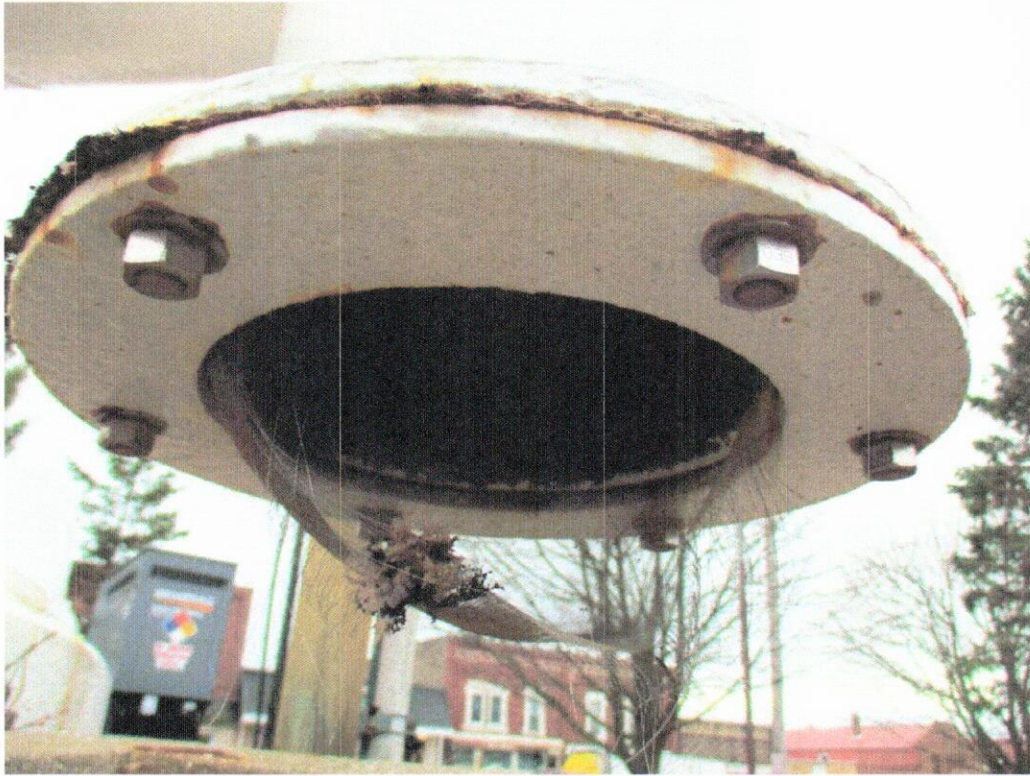
The coating on the exterior overflow pipe is in fair condition. Moderate surface corrosion is showing where the screen is bolted into the exit of the pipe. The 24 mesh screen is currently broken.

Exterior Overflow – Poor Condition – Broken Mesh

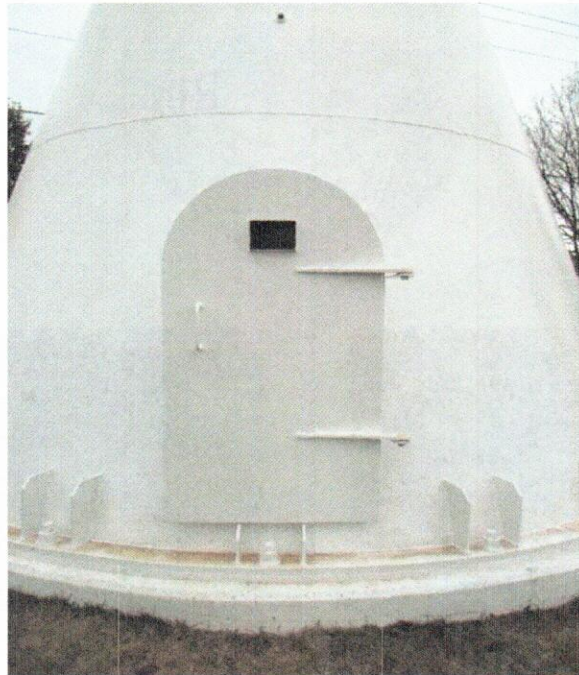
The base bell door is in good working order and has a functioning lock. Corrosion has formed on the door hinges and in several spots on the inside of the door where coating has been rubbed off.

Exterior Door – Good Condition

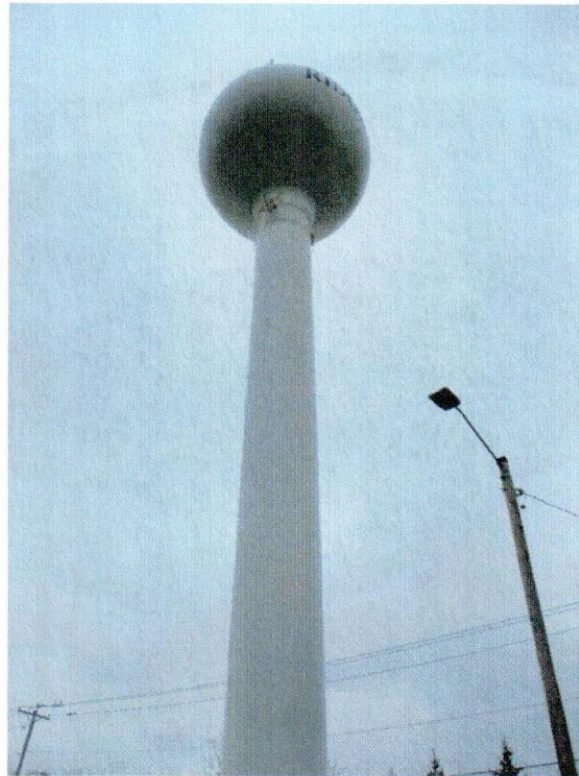
Exterior Riser - Good Condition

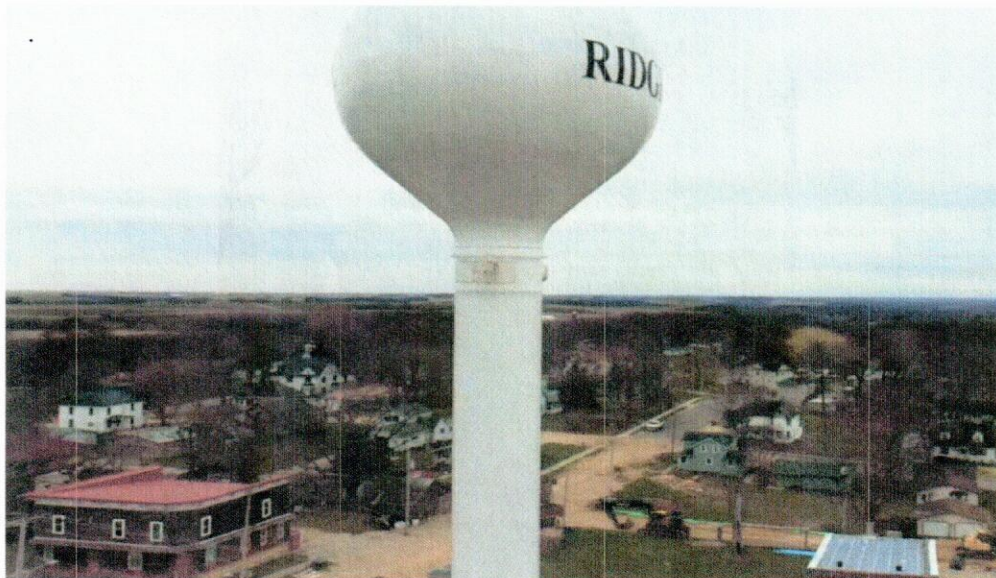
Exterior Bowl - Good Condition

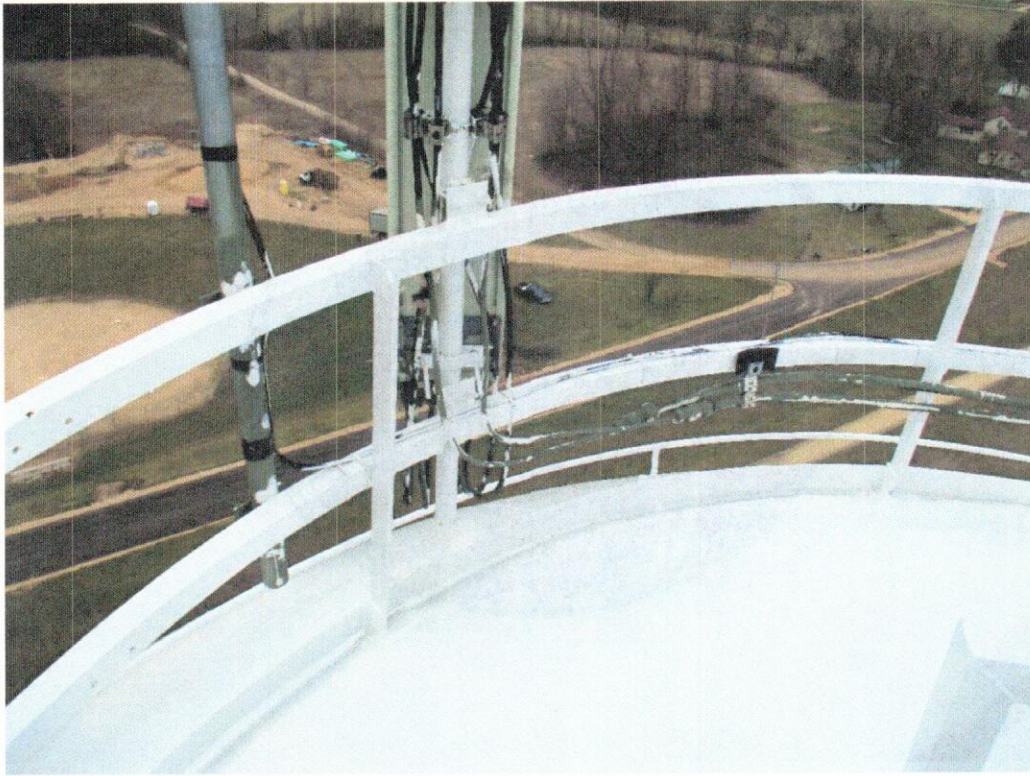
Exterior Roof and Handrail – Good Condition

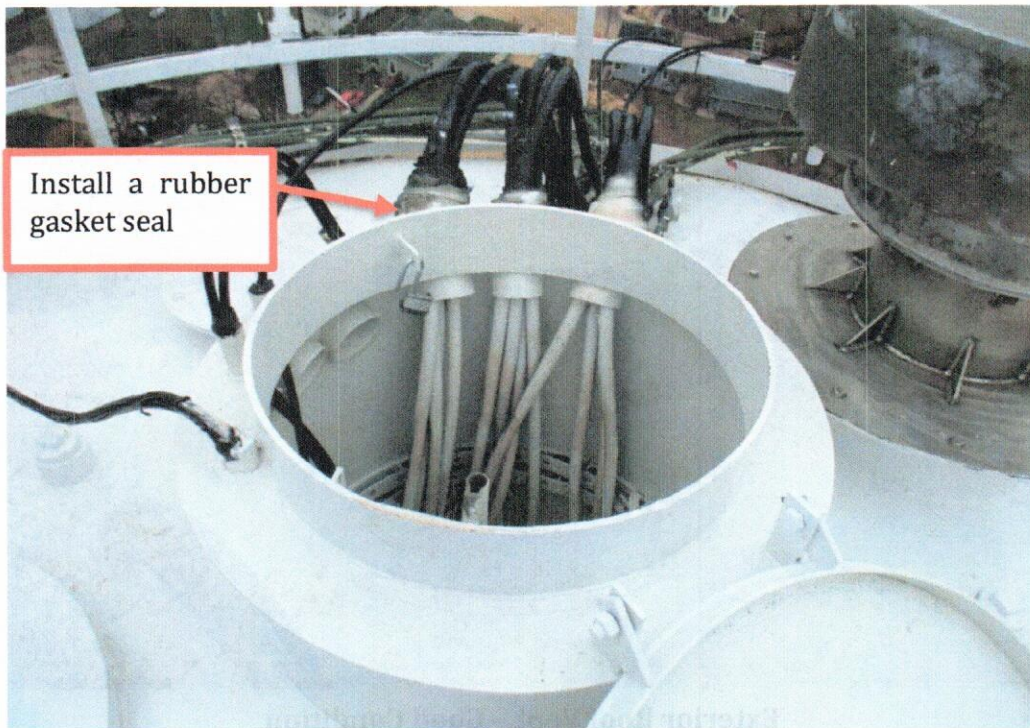
The roof hatches are in good condition. A rubber gasket is installed on the wet access hatch, but no gasket is installed on the dry access hatch. The dry access hatch has a lock present.

Exterior Dry Hatch – Good Condition – No Gasket

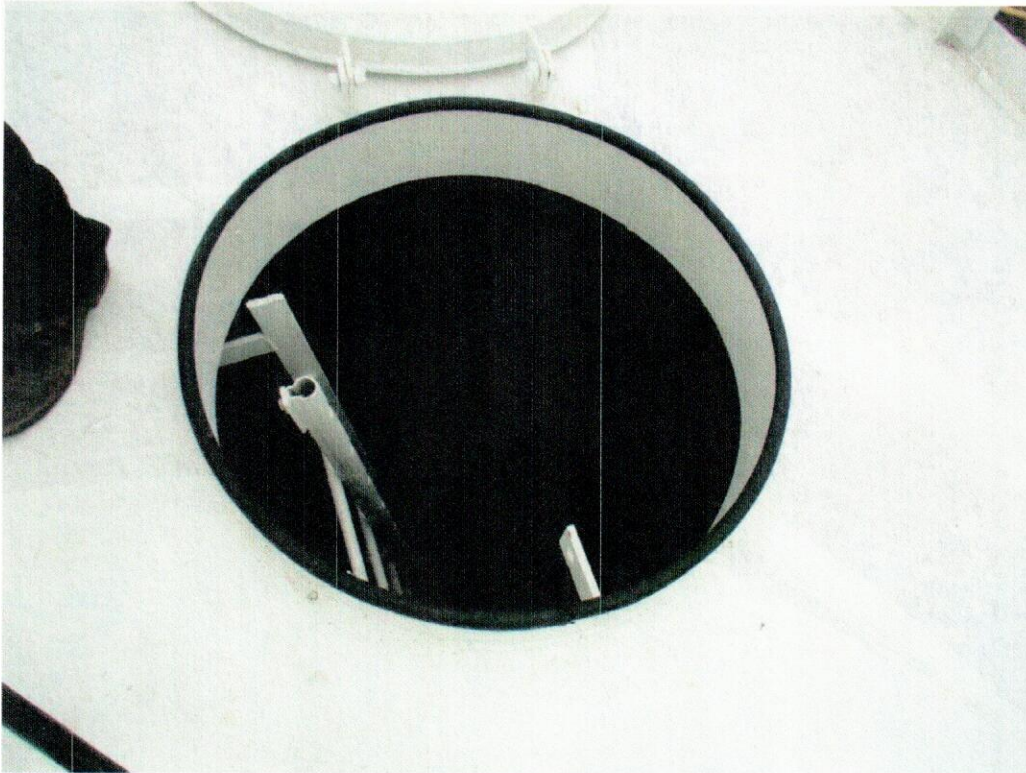
Exterior Wet Hatch - Good Condition

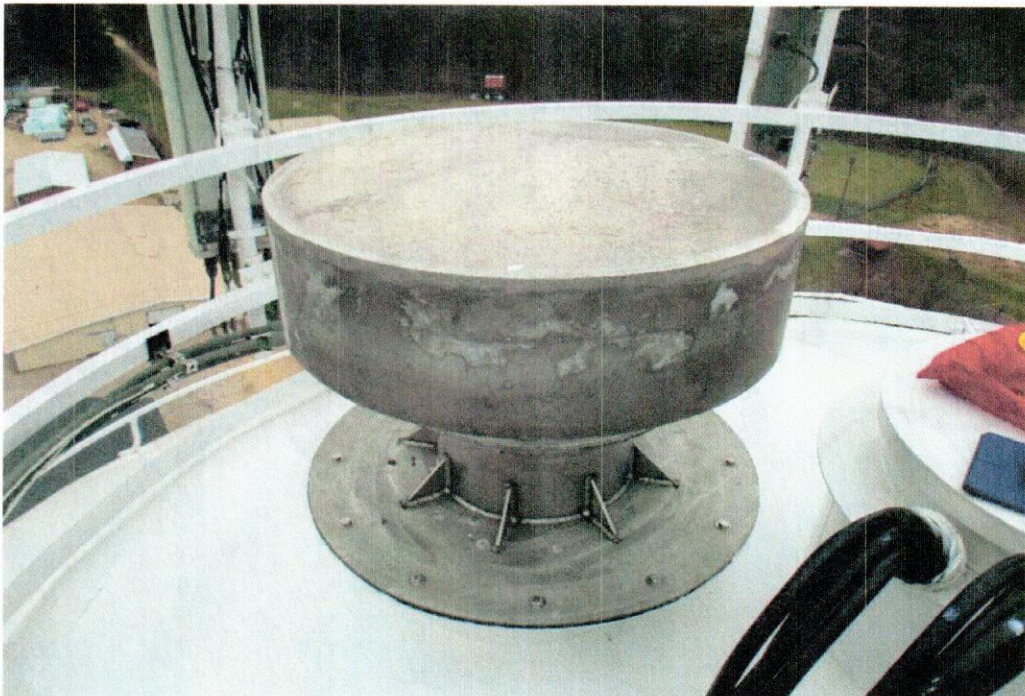
Exterior Roof Vent - Good Condition

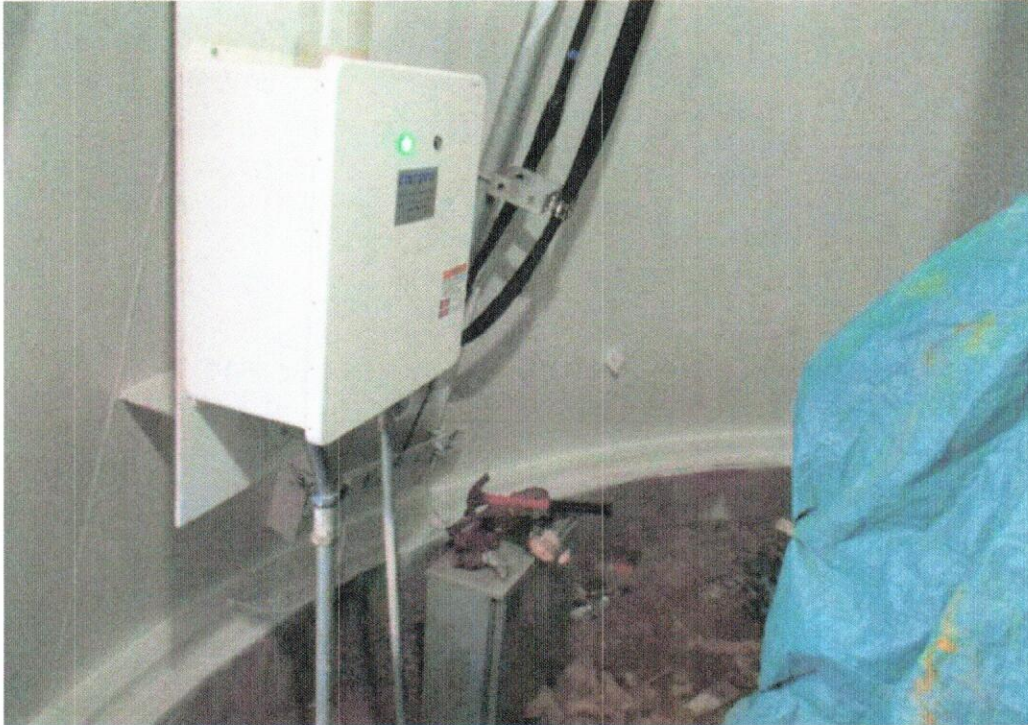
Interior Dry Base Bell - Good Condition

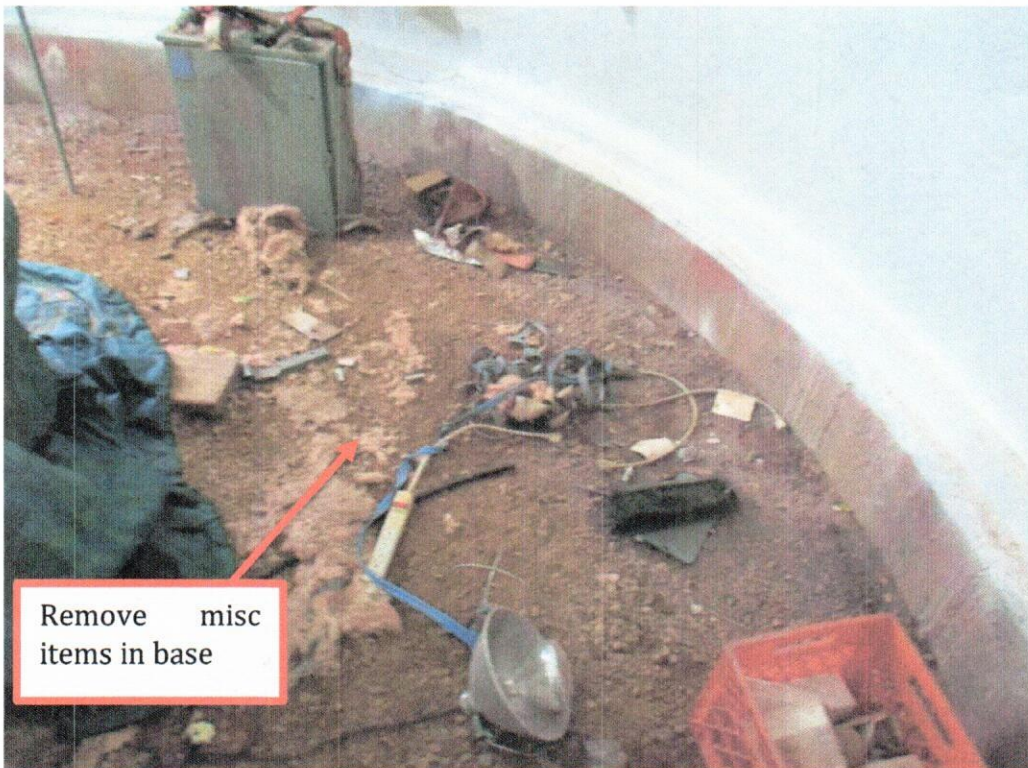
The coating in the interior base bell is in good condition. There is a fair amount of miscellaneous items laying on the floor that should be removed. A small pallet is currently being used as the interior step into the base bell. All electrical and telecom equipment appears to be in working condition although several wires are loosely run across the floor.

Interior Dry Base Bell - Miscellaneous Cables and Debris Left in Tank

Remove misc
items in base

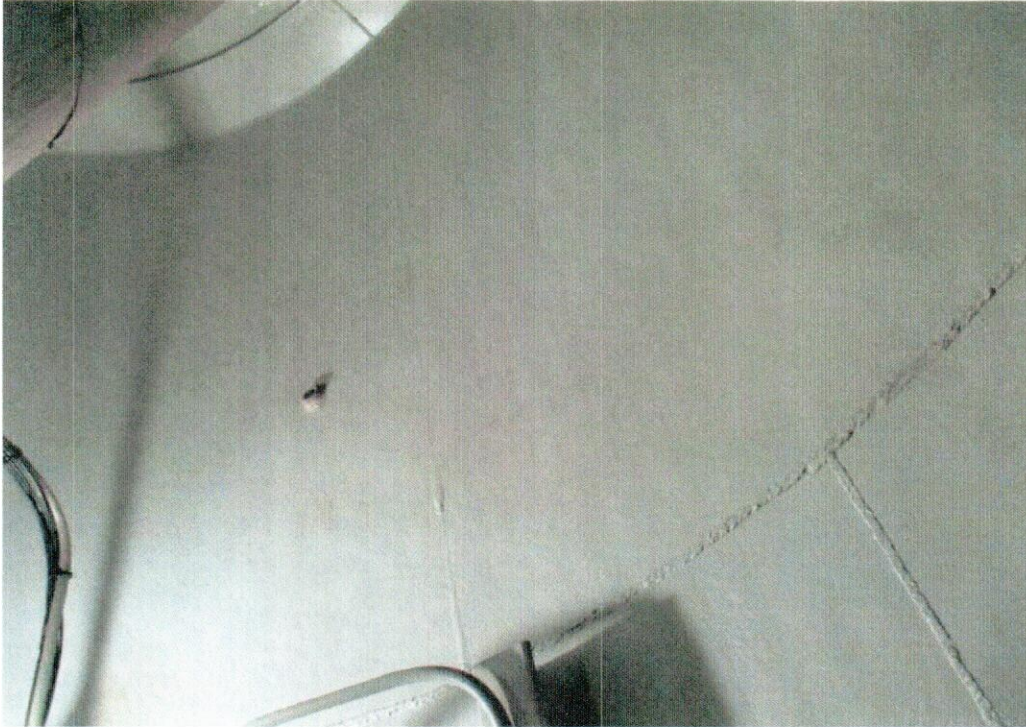
Interior Dry Base Bell - Good Condition

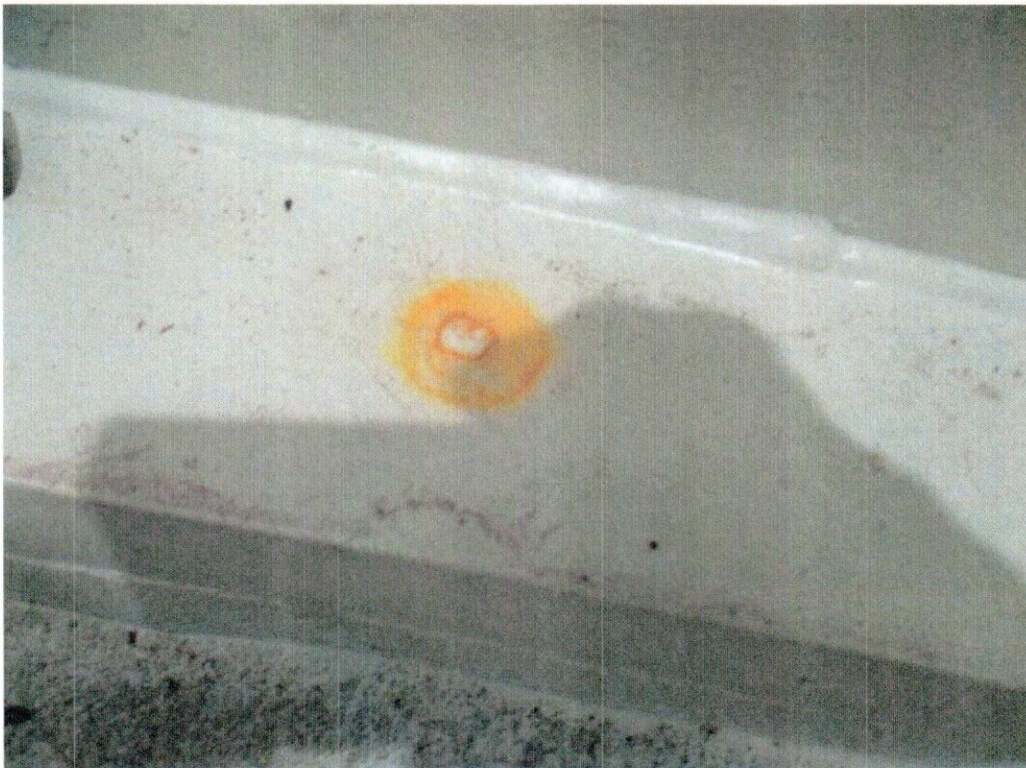
Interior Dry Base Bell - Good Condition - Washer Stain

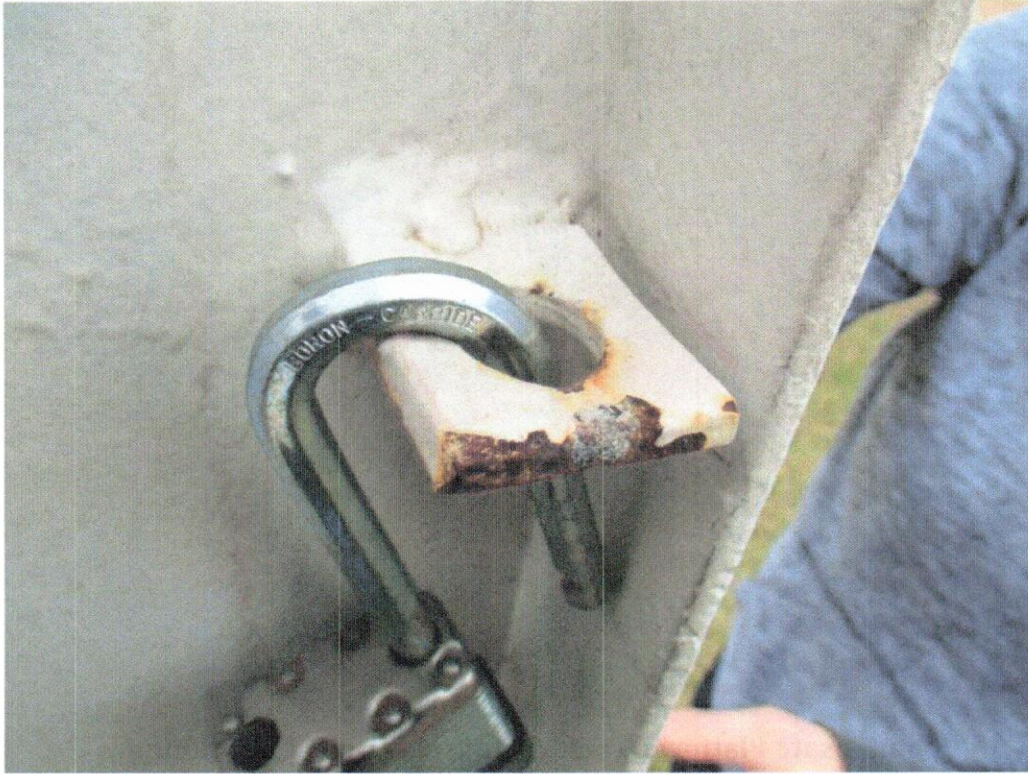
Tank Lock - Good Condition

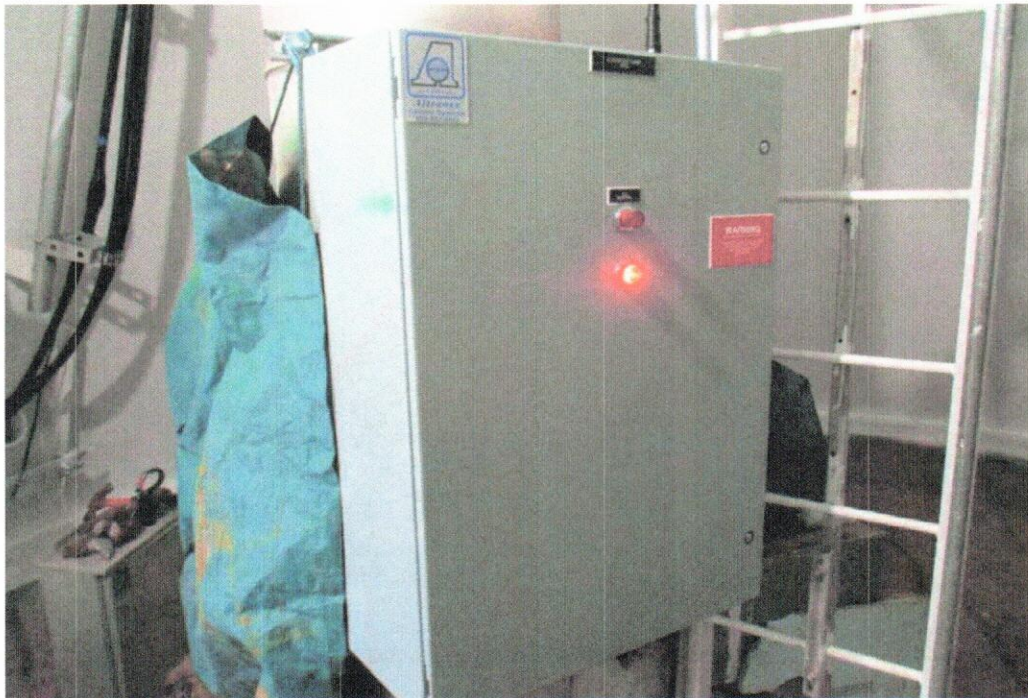
Scada Fill Panel - Good Condition

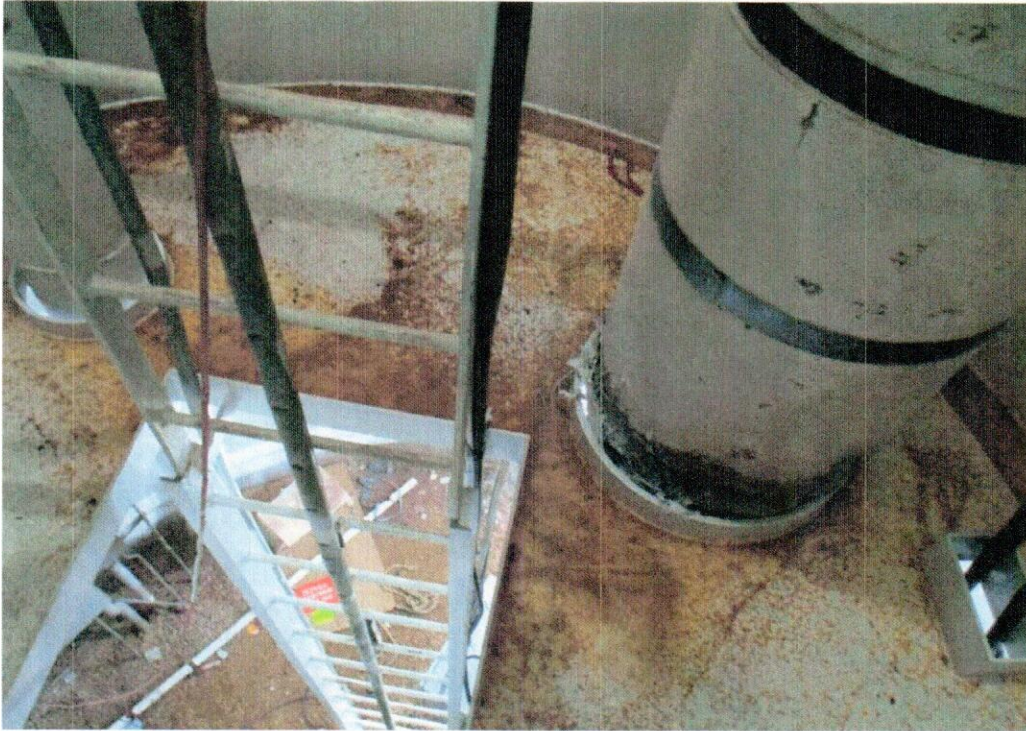
The condensate platform is in good condition. There is a significant amount of corroding and spent abrasive resting on the platform.

Condensate Platform - Fair Condition - Debris & Staining

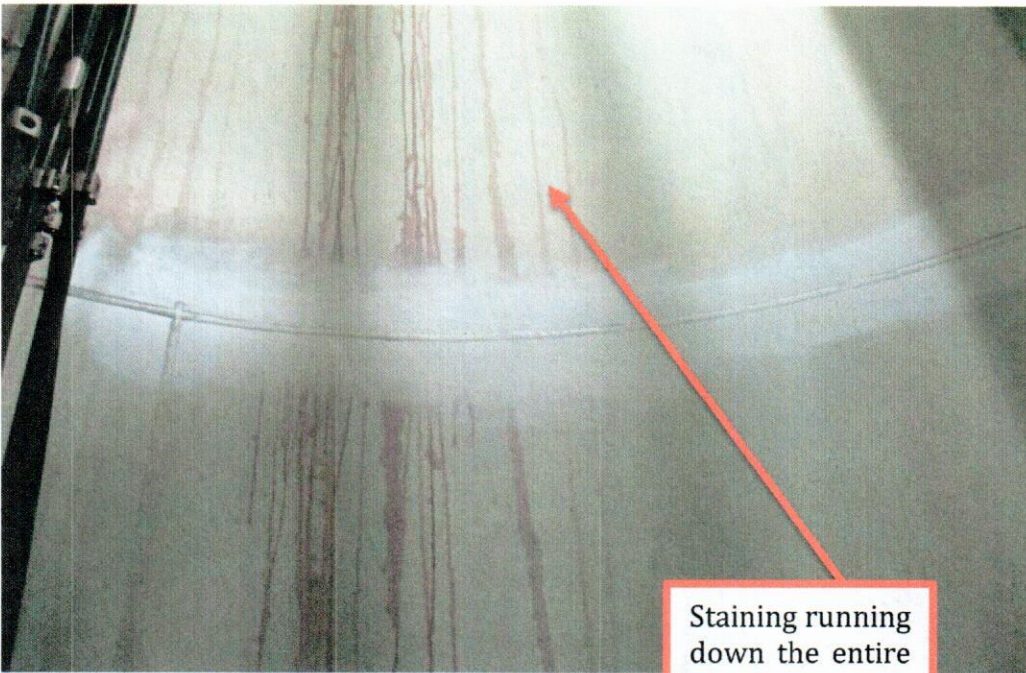
Riser Staining

Staining running
down the entire
riser

It is recommended to begin budgeting for recoating the riser and replacing the foam insulation in 5-10 years. Most of the coating is in moderate to good condition, but the coating on the weld seams is light in many spots. This could be handled by preparation, spot priming and finish coating the riser pipe.

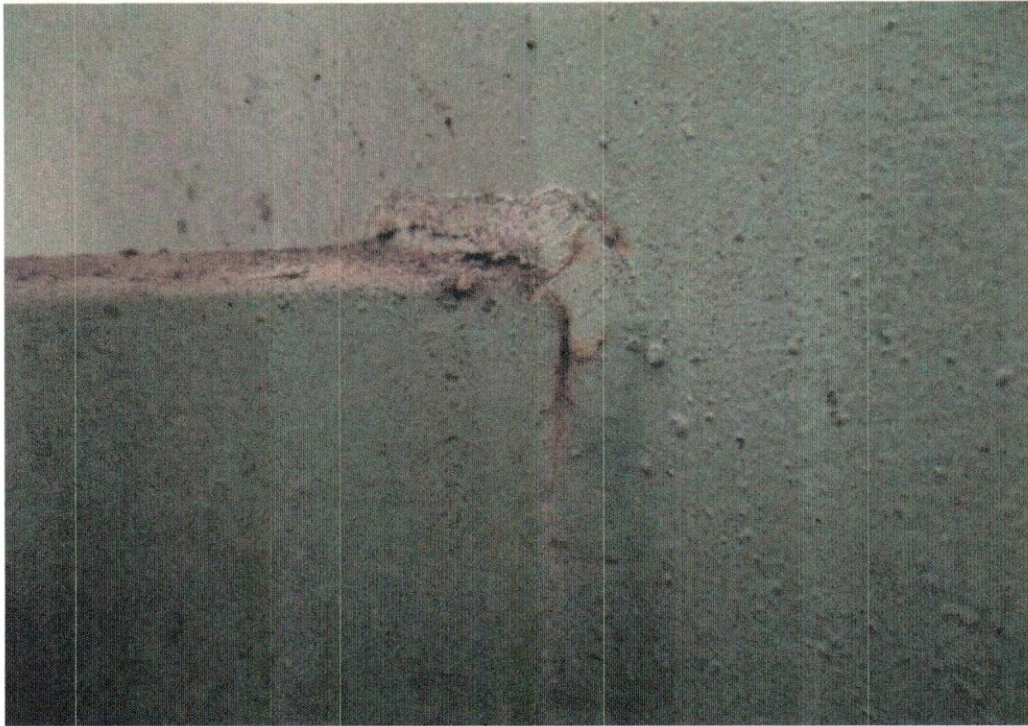
Riser - Coating Crack

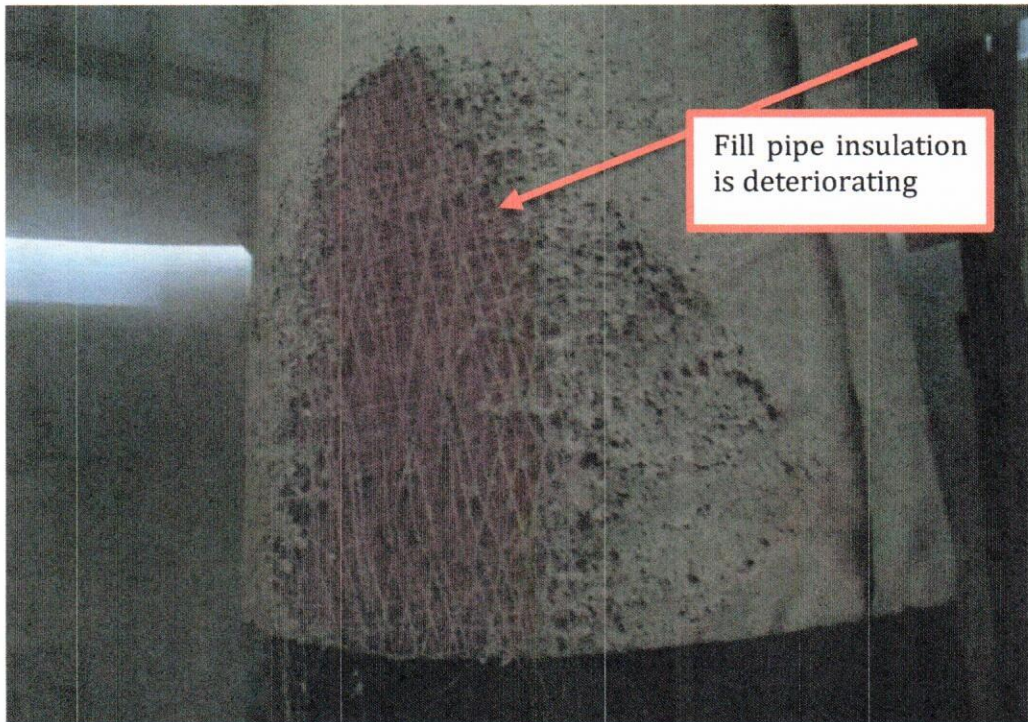
The interior fill/draw pipe is in good condition. The foam insulation is beginning to deteriorate in several locations.

Fill Pipe Insulation - Roughed Up

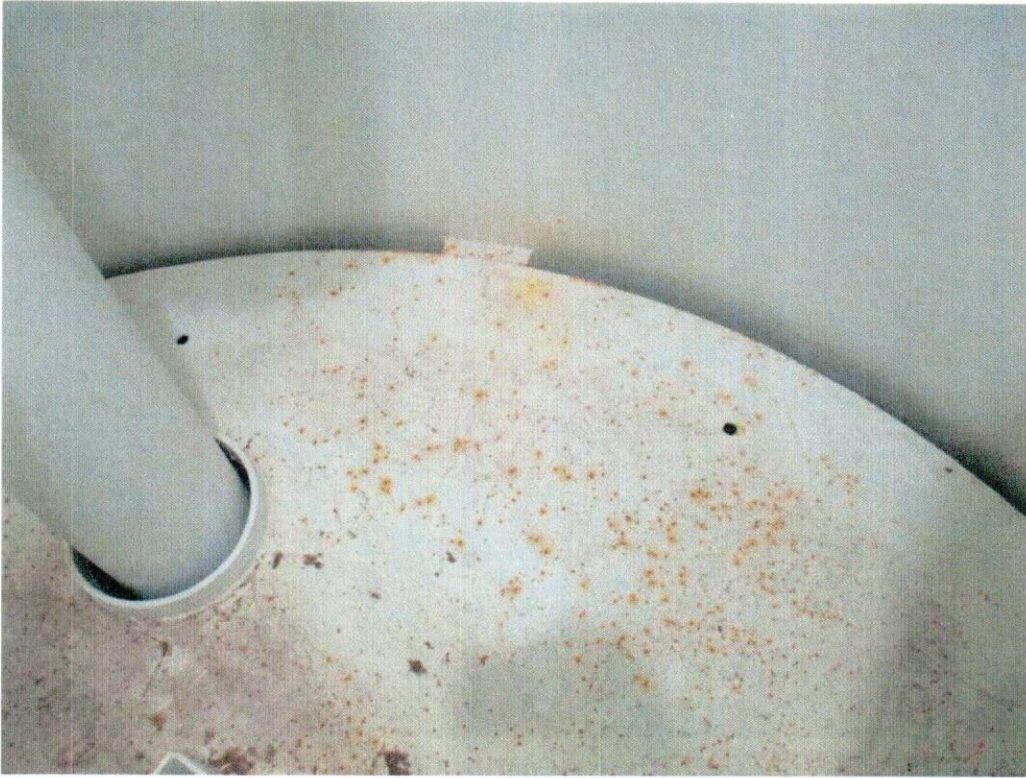
The top platform is in good condition. There is also a moderate amount of spent abrasive corroding on the platform causing discoloration.

Top Platform - Good Condition - Minor Debris and Staining

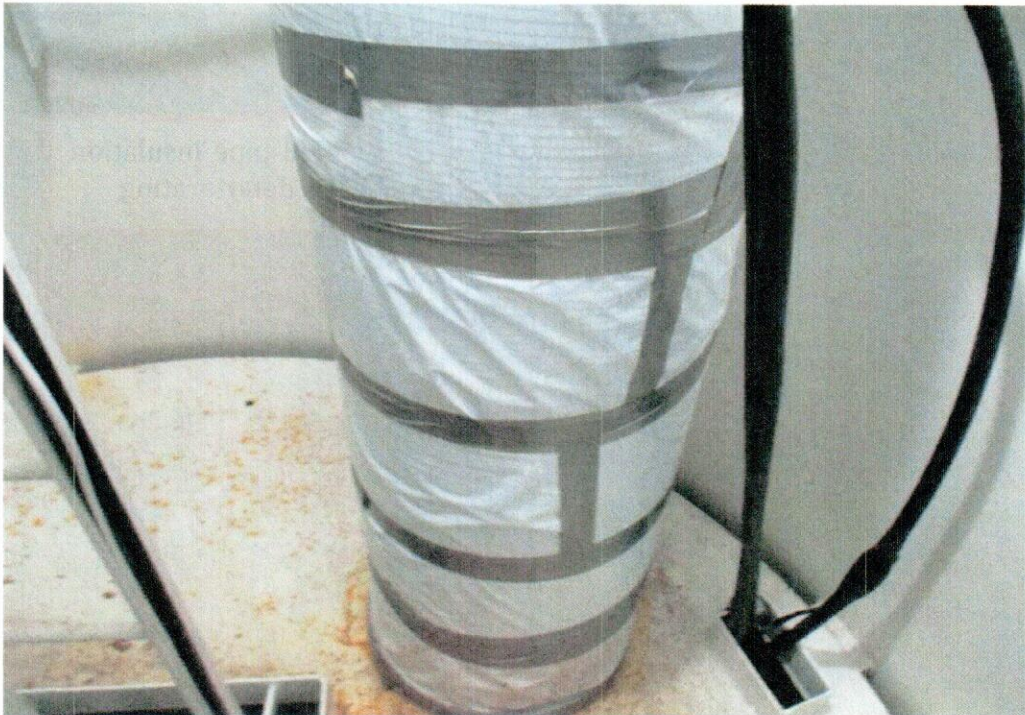
Top Platform - Good Condition - Minor Staining

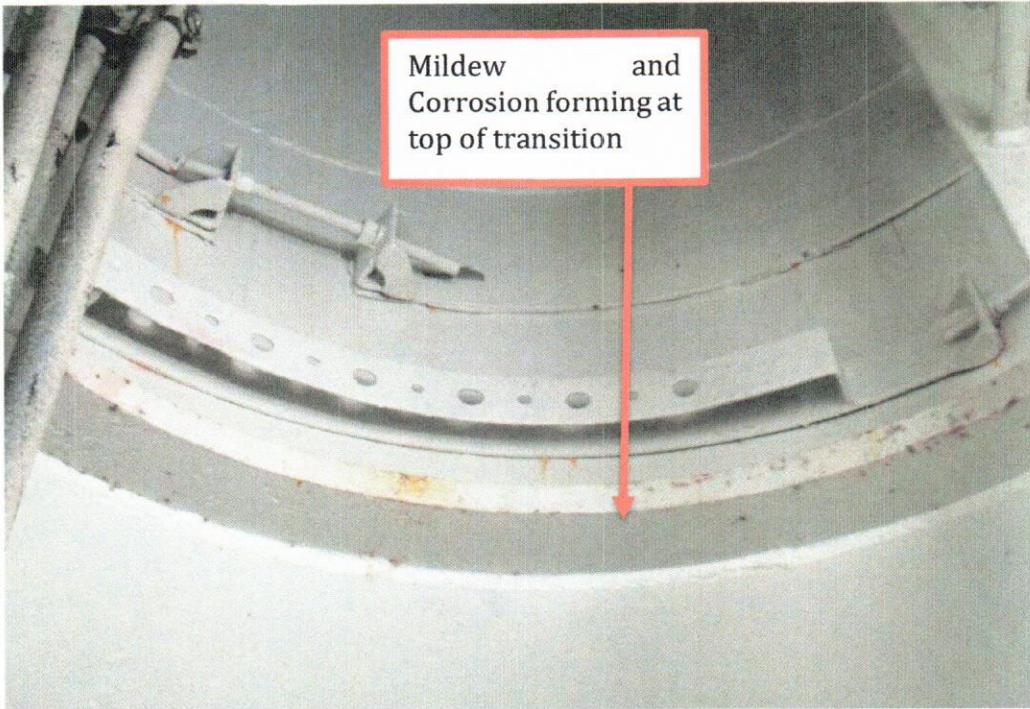
The transition cone is in good condition. Some minor pinholes exist in the coating. There is also some minor mildew beginning to grow in the upper part of the transition cone. The wet access hatch also has some minor amount of corrosion forming on the nuts and bolts.

Transition Cone - Good Condition - Minor Mildew and Staining

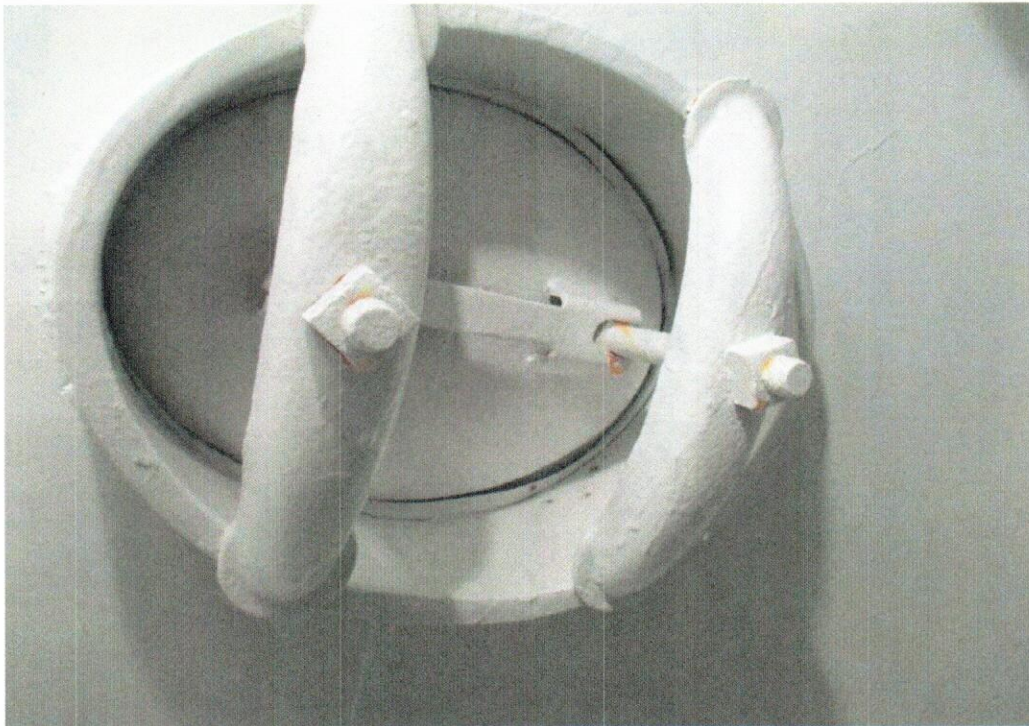
Access Tube - Wet Hatch - Good Condition

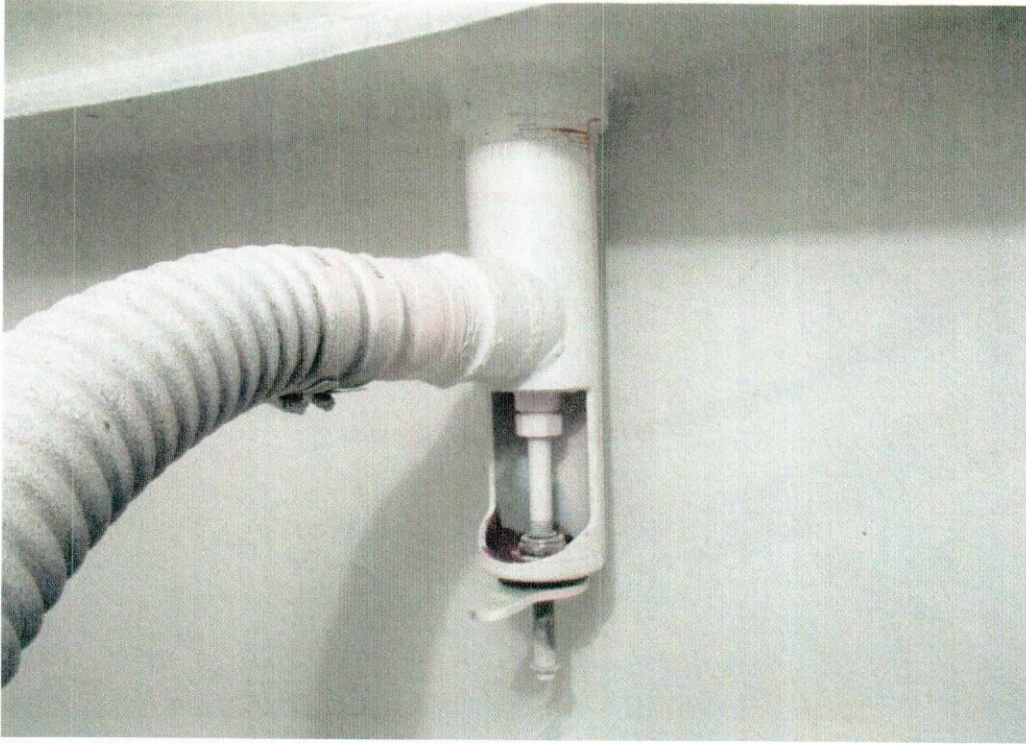
Mud Valve - Good Condition

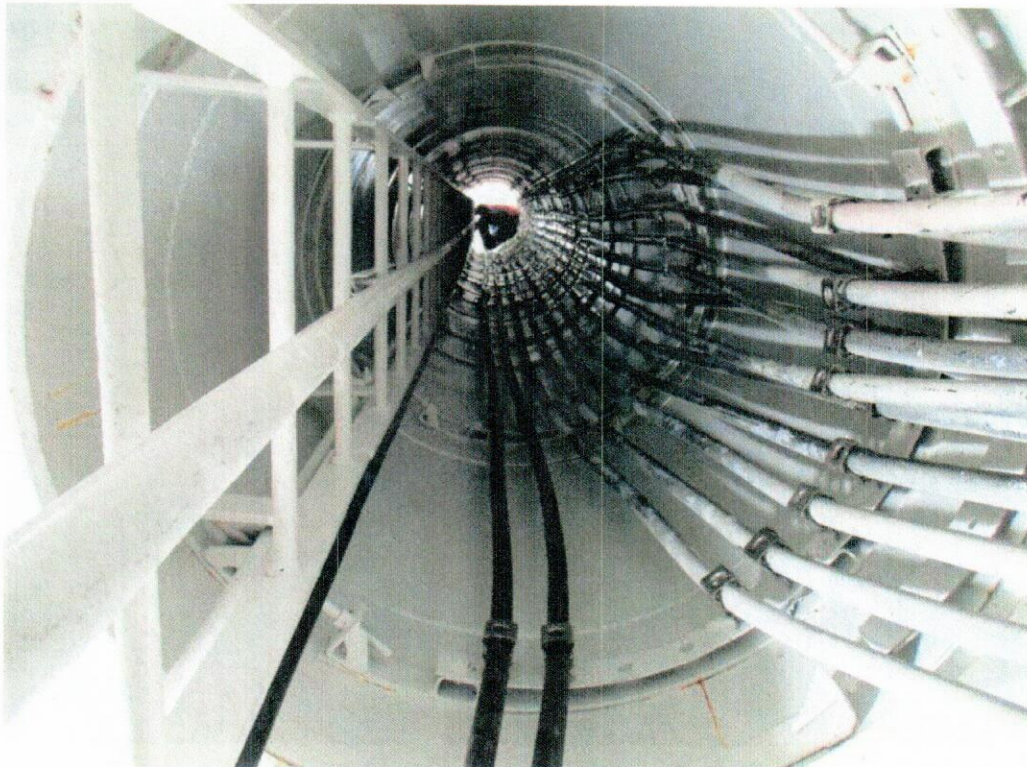
Access Tube - Good Condition - Very Busy
