ROV & Drone Maintenance Inspection

ROV Warranty Inspection

Ridgeway Tank, 150,000 Gallon Sphere

Ridgeway Water Utility, Ridgeway, WI

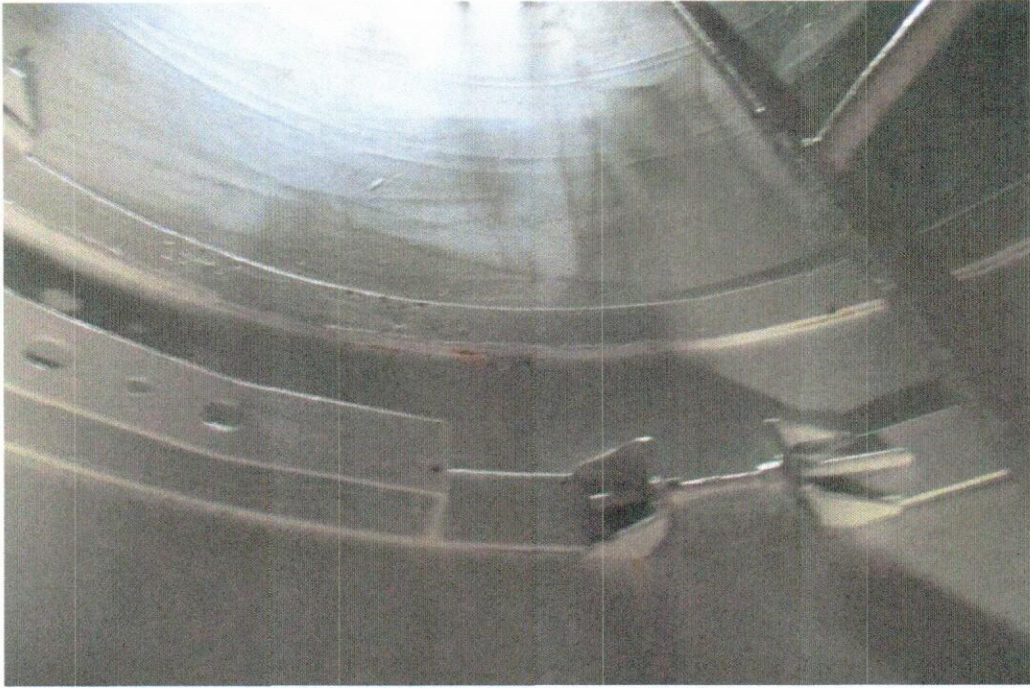
Access Tube – Good Condition

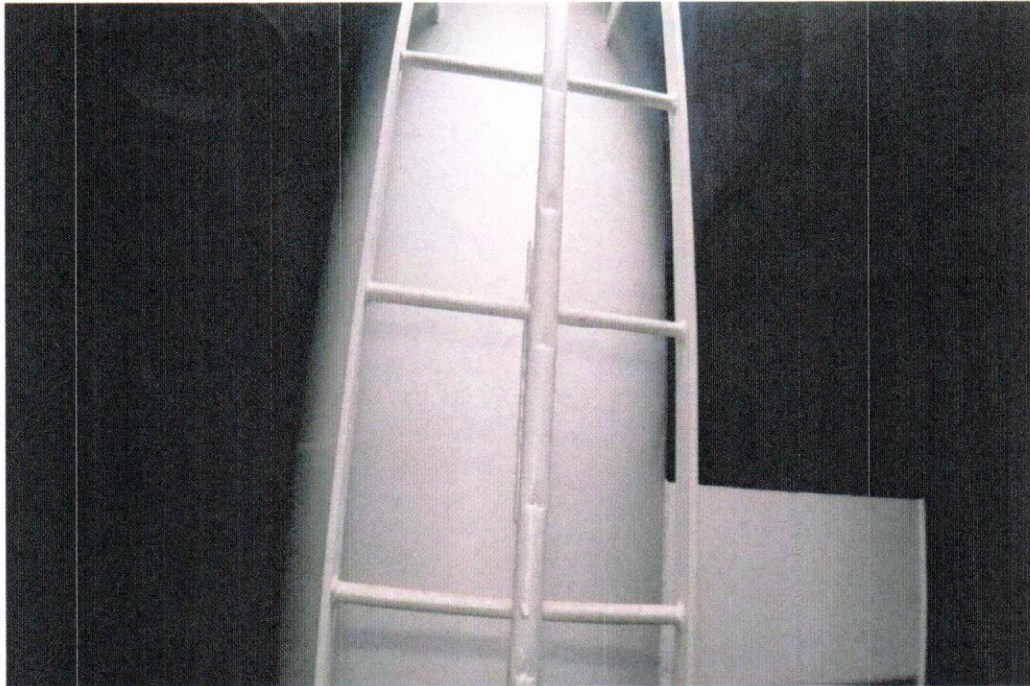
Interior Wet Ladder – Good Condition

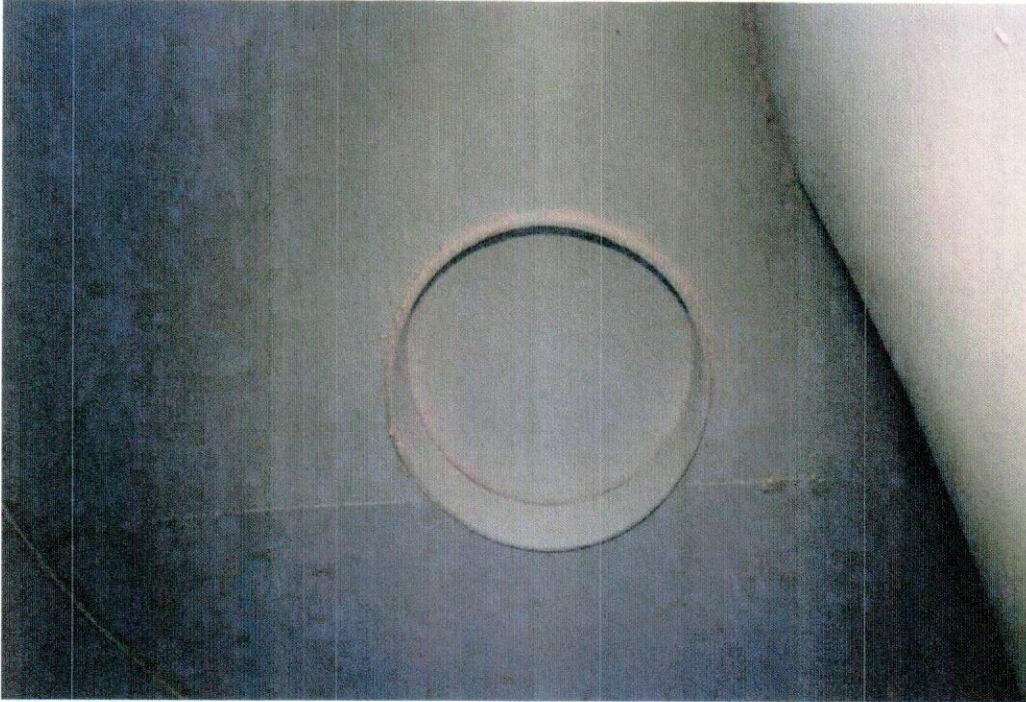
Interior Wet Roof - Good Condition

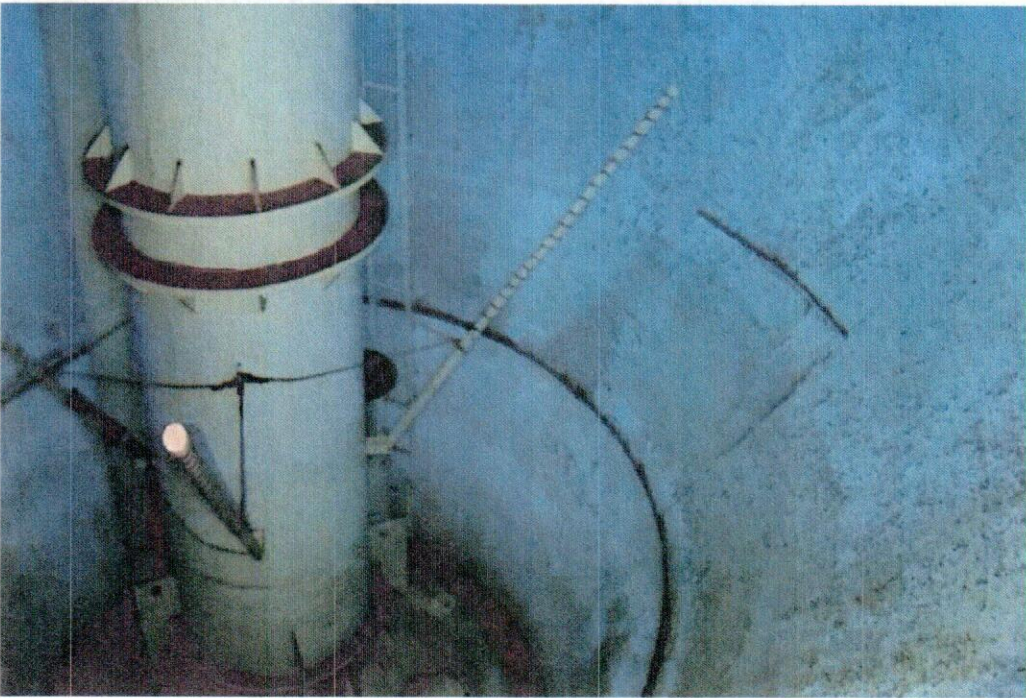
Interior Wet - Good Condition - Minor Sediment

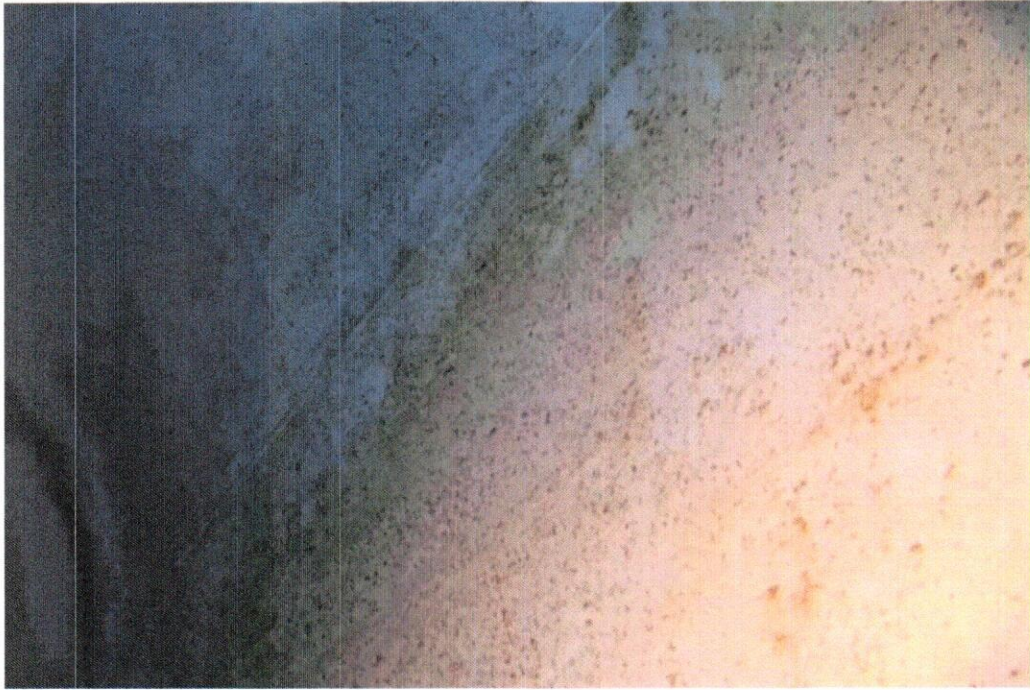
Interior Wet Sidewalls – Good Condition – Minor Staining

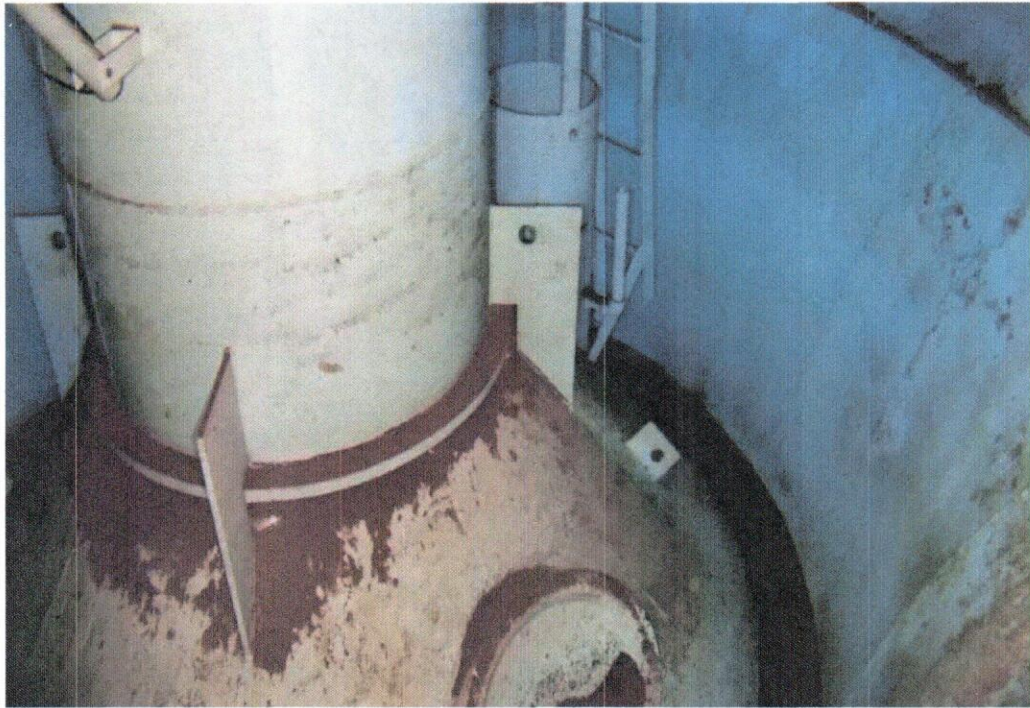
Interior Wet Tank Bottom – Good Condition – Minor Sediment

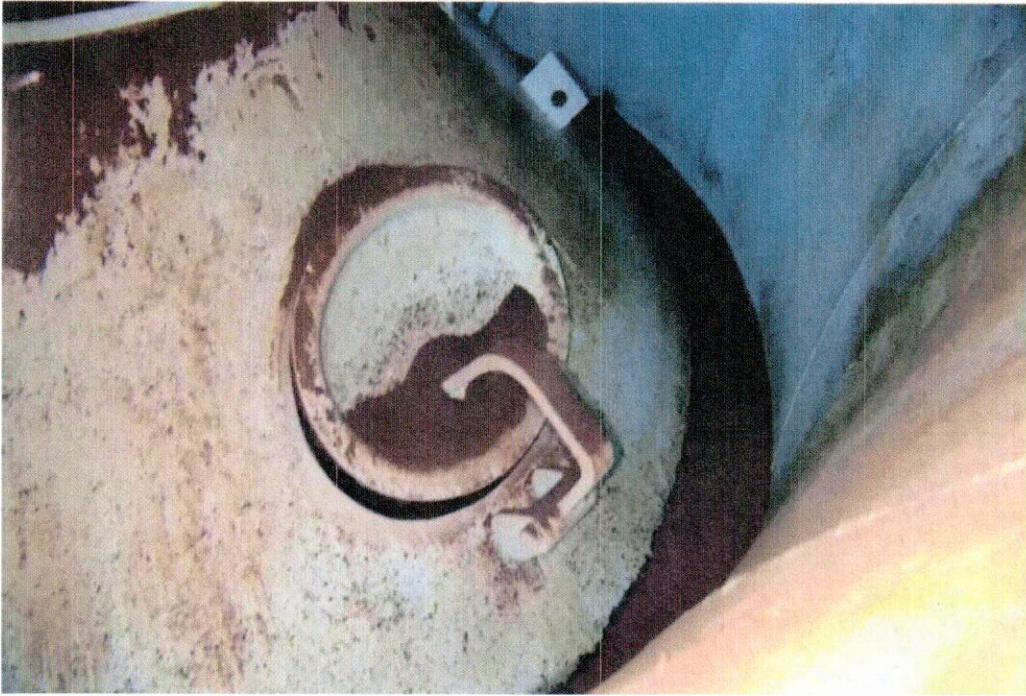
Interior Wet Access Hatch - Good Condition - Minor Sediment

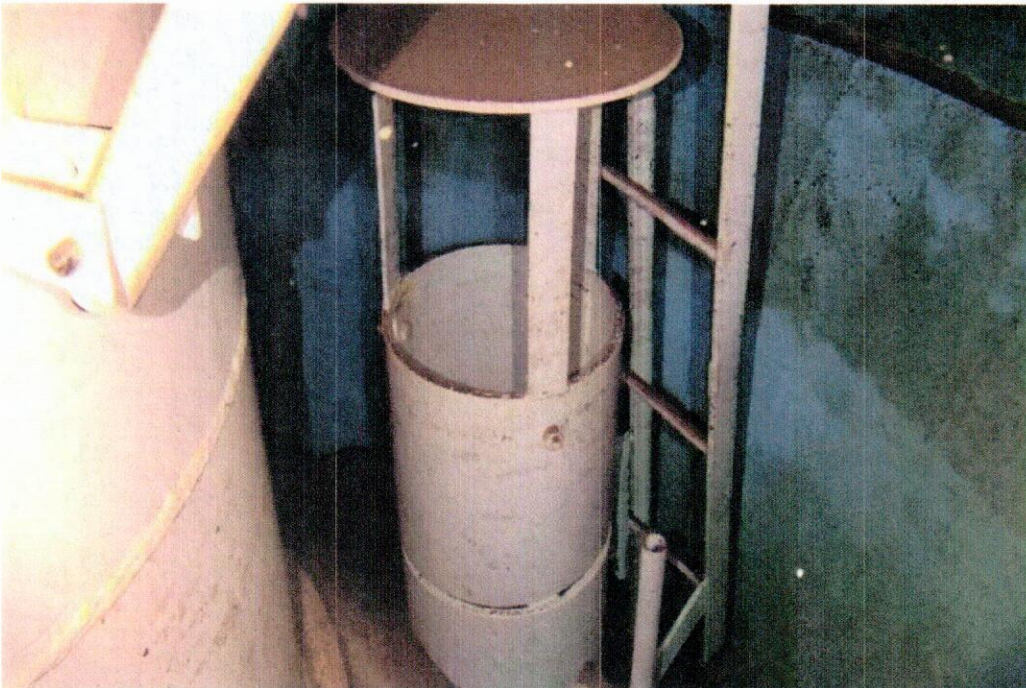
Interior Wet Fill Pipe & Deflector Plate- Good Condition
