2023-2024 Road Paving Improvements

NMDOT Cooperative Agreement Program

March 15, 2023

**City of Rio Communities
360 Rio Communities Blvd.
Rio Communities, NM 87002
505-861-6803**

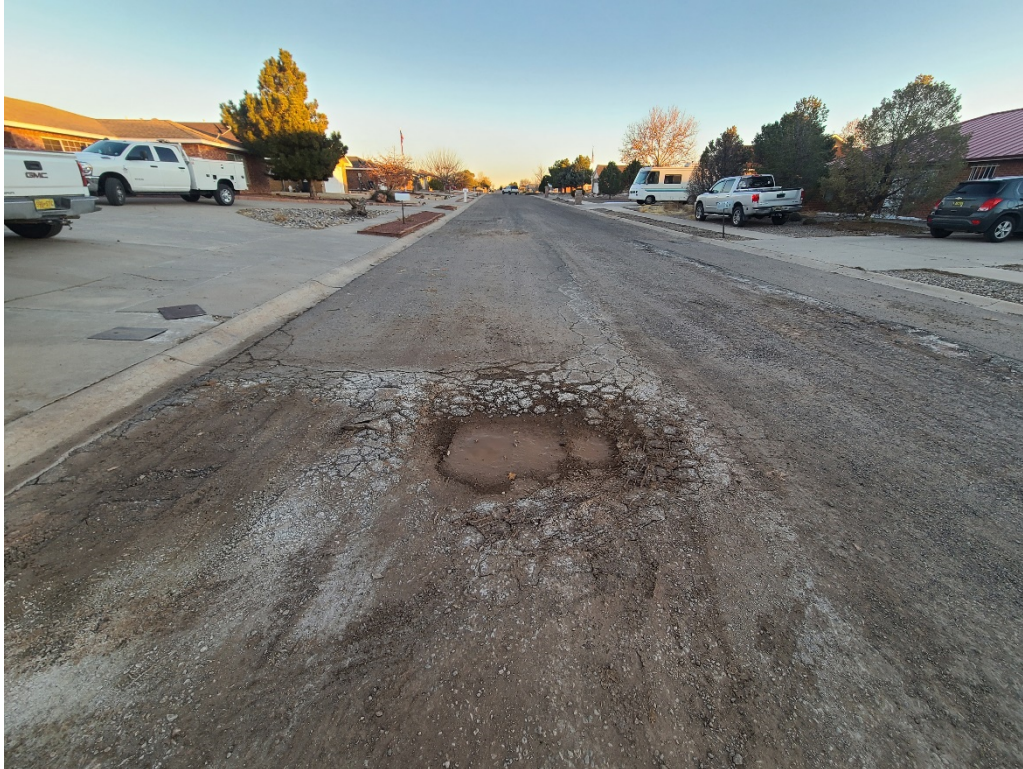
A site review was performed to assess the severity and extent of material and structural distress in the existing pavement. After a careful evaluation, it was determined that the existing pavement has reached its life span and it needs immediate replacement.

Figure 1: Subgrade exposure

Don Diego Road is one of the streets that is at the top of the priority list for immediate repair. The city intends to develop a construction plan set to remove and replace approximately 2,400 linear feet of existing roadway pavement from Dulcinea Lane (BOP) to Kaghan Loop Drive (EOP). Due to the high severity and extent of distress in the pavement, the road will require full reconstruction. There are no apparent drainage structures nor other infrastructure for stormwater runoff conveyance within the project limits. Field review has indicated several depressed sections with the roadway section which appear to result in ponded water after storm events. Therefore, the profile of the road will be revised and modified as needed to provide a construction staking plan which will provide positive conveyance of stormwater concentrating along the gutter pan of the roadway.

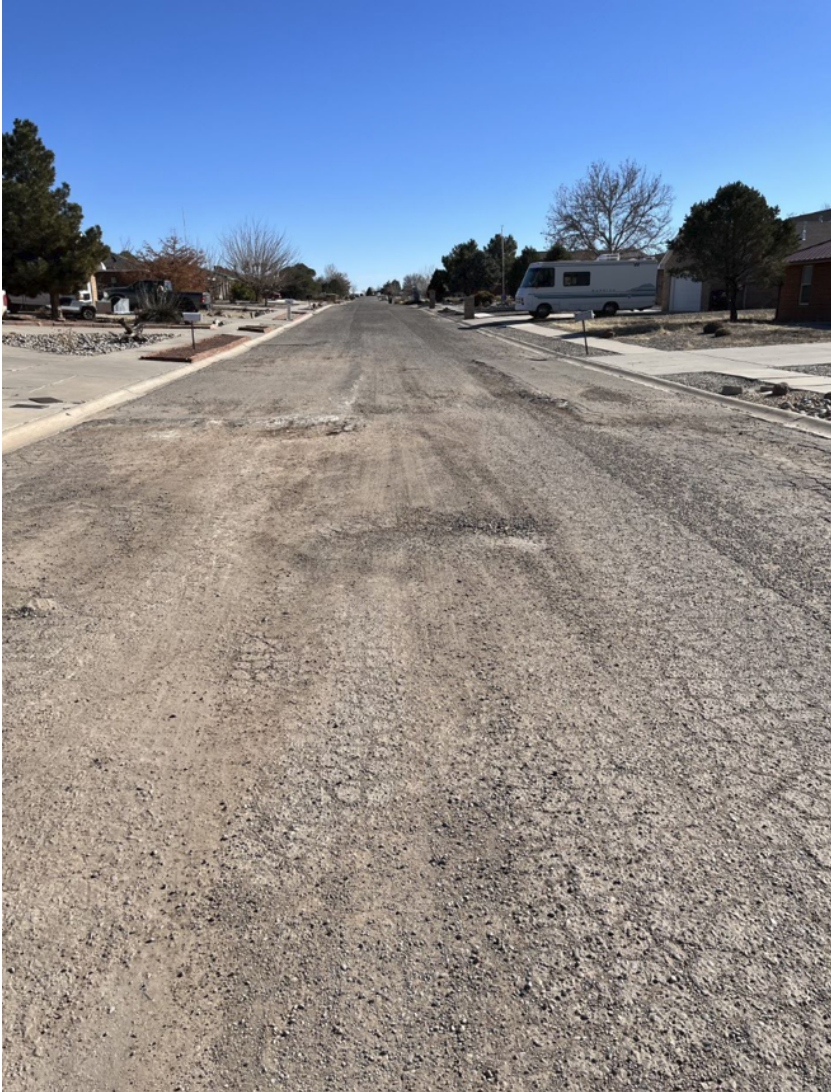
Figure 2: Excessive cracking and subgrade exposure

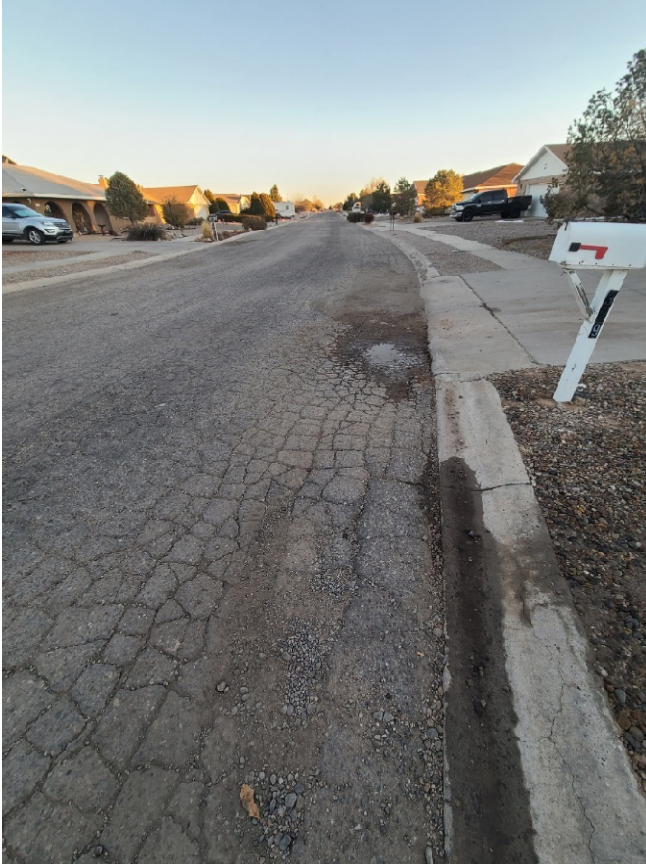
Figure 3: Alligator cracking

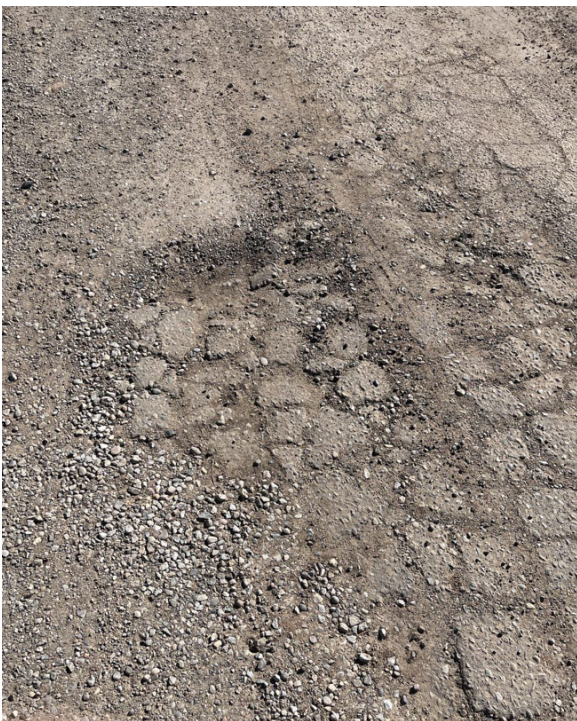
Figure 4: Alligator cracking and subgrade failure
