## Leak Adjustment Request Form

Service Address: 2602 Pickwick Lane

## POOL SERVICE CALL

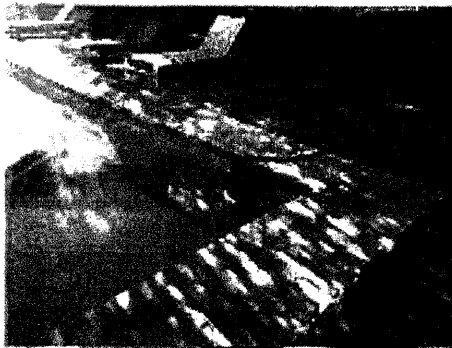
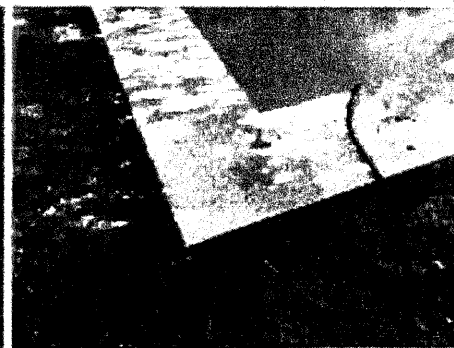
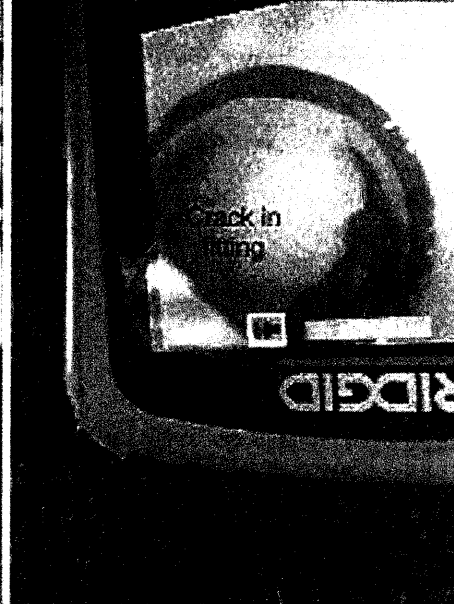
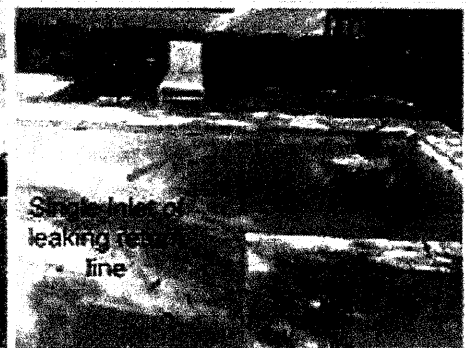
#### Pictures of Work Performed

We scanned the pool/spa off with the Leakvue and found it to be losing -2.55" water loss per day. This is above normal evaporation rates.

We located a single inlet return line leaking. This line is fed off of a water feature pump. We located the leak on the line in the beam of the pool. We marked the leak with a blue X on the coping. We were able to run a camera into the line and get eyes on the broken fitting. We isolated this leak by calling it off at the equipment and plugging it off pool side. We then ran another Leakvue scan and our rate of loss was -0.11" water loss per day. This is within normal evaporation rates.

We marked the leaking pipe at the equipment with black tape.
