May 12, 2014

Subject: Drainage at Rollingwood Community Park

EXHIBIT 1

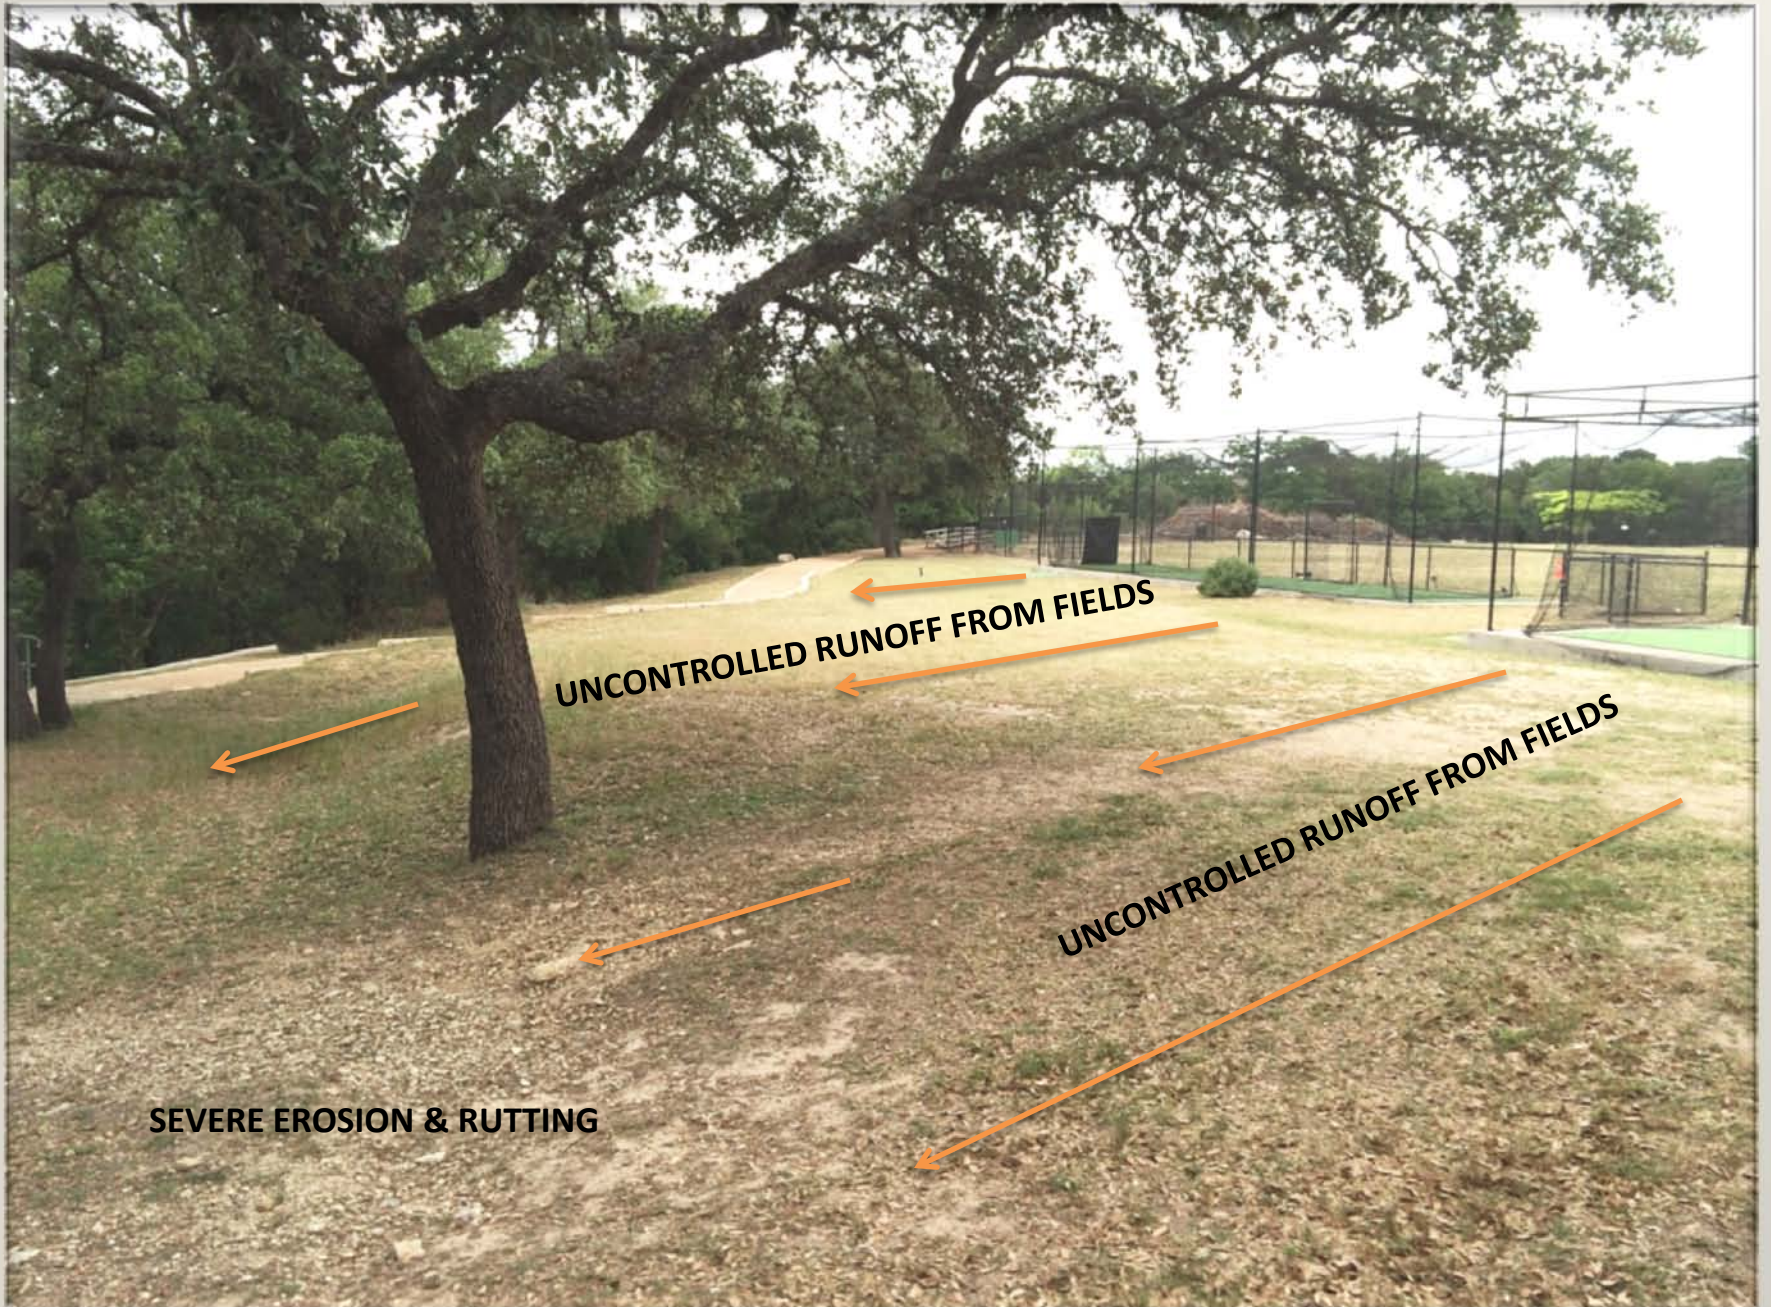
EXHIBIT 2

SEVERE EROSION & RUTTING

UNCONTROLLED RUNOFF FROM FIELDS

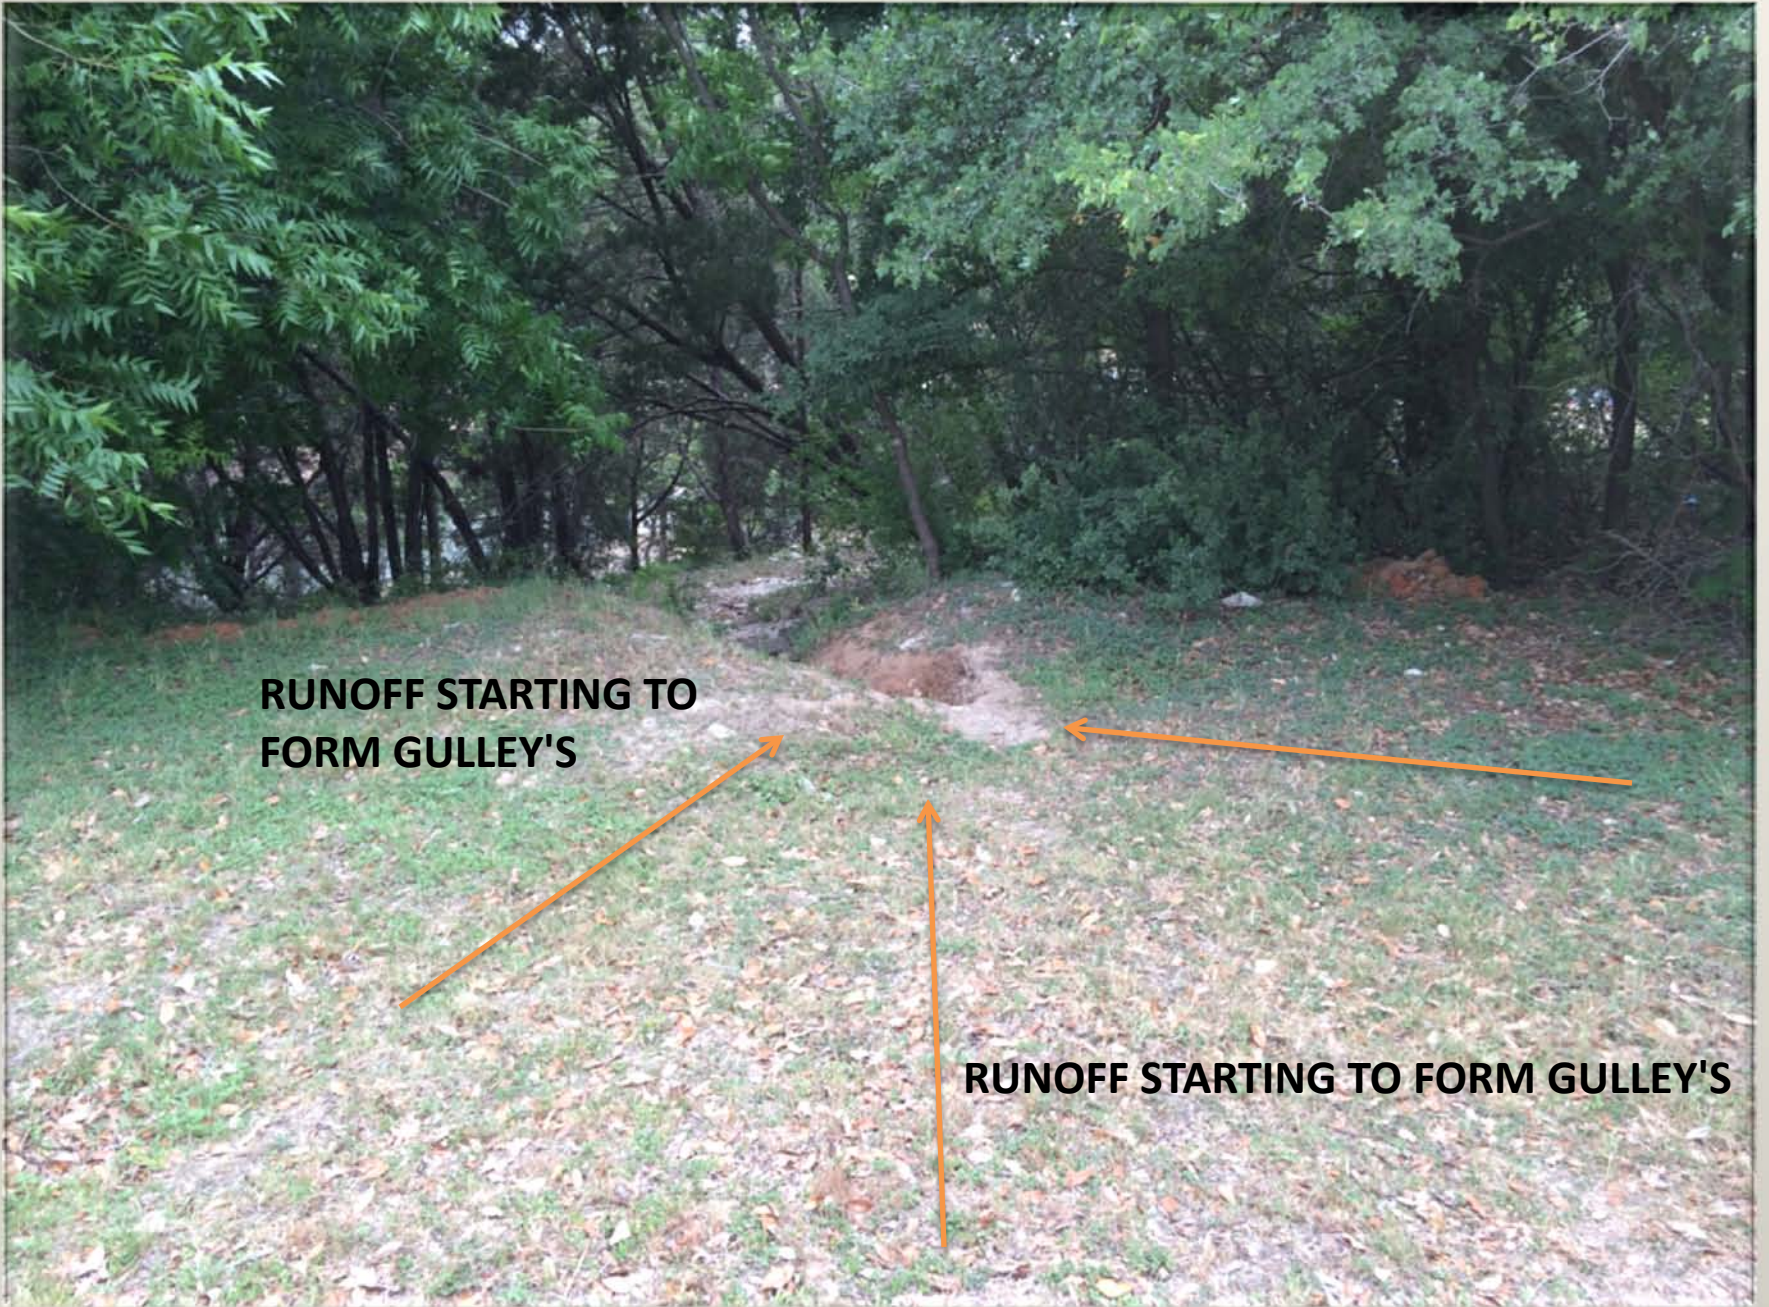
**RUNOFF STARTING TO
FORM GULLEY'S**

RUNOFF STARTING TO FORM GULLEY'S

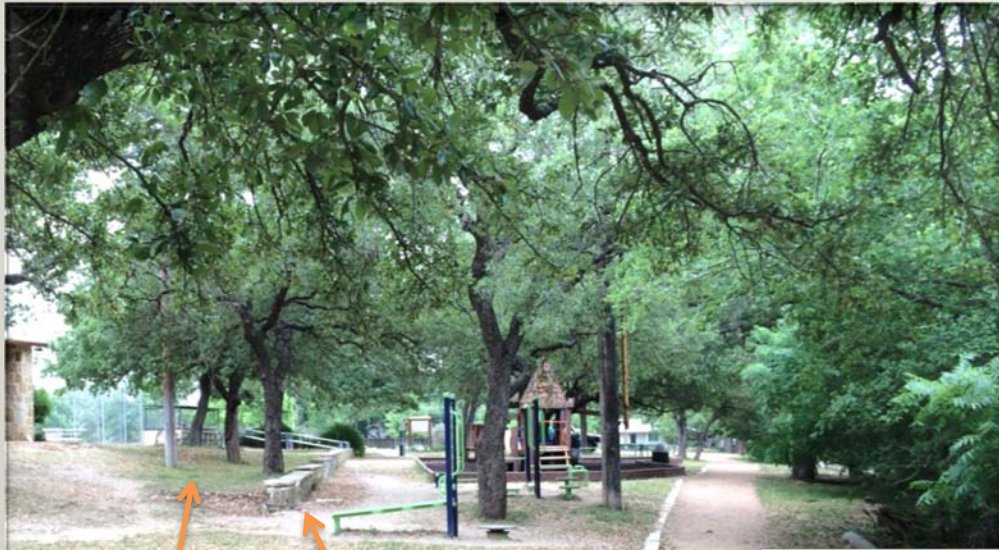
**THESE TREES
NEED TREE
WELL**

**NATURAL GRADE
AT TRAIL YOU CAN
SEE HOW MUCH
DIRT ADDED**

**NON STANDARD TREE
WELL MADE AFTER THE
FACT SHOULD USE
STANDARD DETAIL**

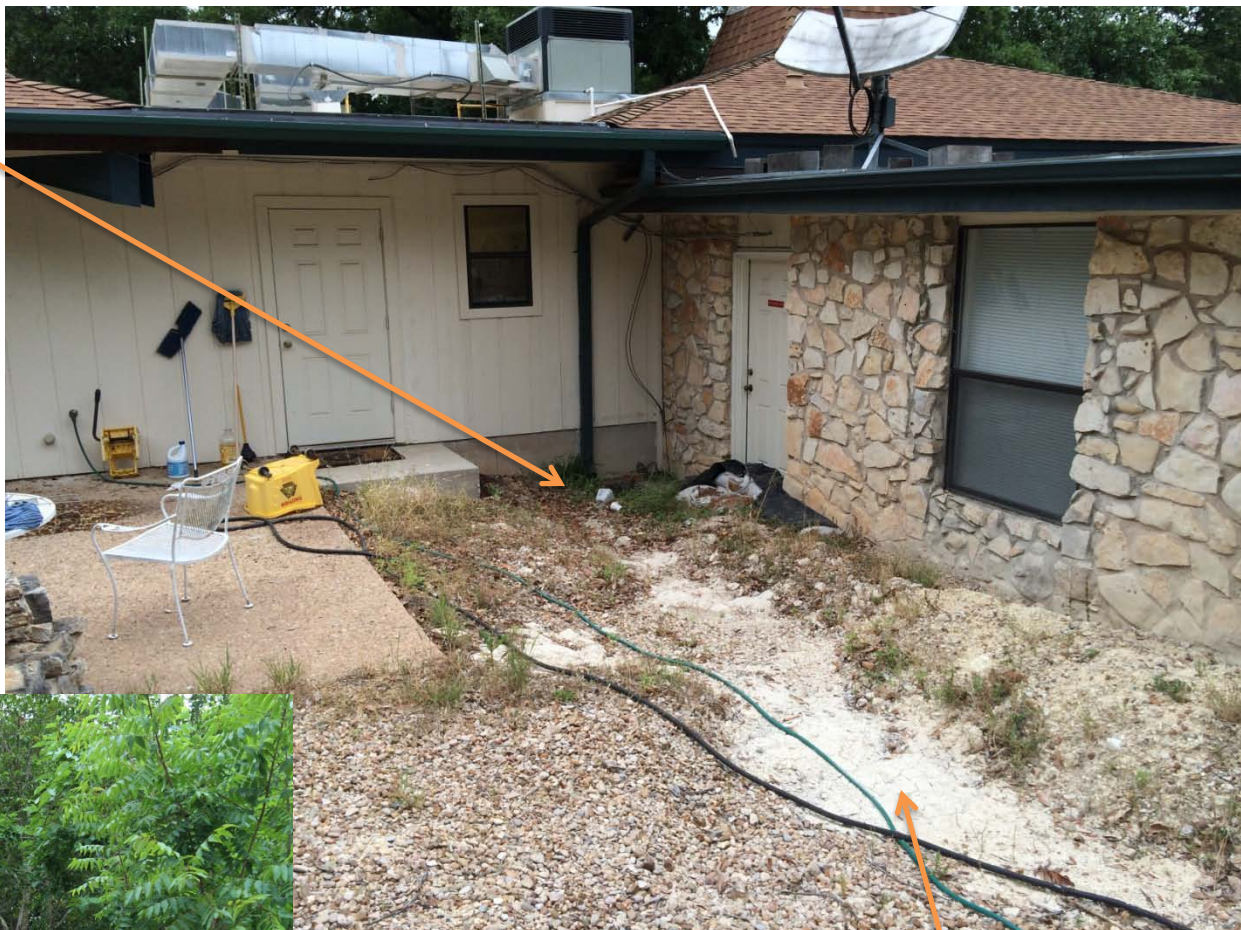
EXHIBIT 4

The main issue with City Hall is the rear corner of the building which backups to the bluff. It appears that the corner between City Hall and the police station is a low point which collects water and could cause water to backup into the building unless handled properly. For this reason at some point in time a drain was installed in this corner to handle the up gradient stormwater and prevent the building from flooding. It appears that the catch basin drains to a pipe which runs under the building. There are no drawings for this pipe

so the exact route and discharge location is unknown. However there is a 4" diameter pipe in the northwest corner of City Hall property which appears to be the discharge location. The water exits the pipe and discharges to the police station driveway thence into Nixon Street. Even though it is common to have some pipes installed under the foundation of a building, it is uncommon to have a stormwater pipe installed under a building. One reason is because the stormwater pipe is larger, thus carries a larger flow and in turn will develop a higher velocity. Also the stormwater pipe will be subjected to these conditions for a significant longer time than your typical drain pipe. If the storm drain pipe under the building were to develop a leak due to the higher flows, velocities and durations the damage would be significantly greater. A picture of the back corner of City Hall is provided in Exhibit 4.

BACK CORNER OF CITY HALL AT LOW SPOT WHERE WATER FROM THE BLUFF COLLECTS. SAND BAGS AT DOOR HELP REDUCE FLOODING. THIS WHOLE AREAS ELEVATION SHOULD BE BROUGHT UP AS HIGH AS POSSIBLE TO FORCE WATER AROUND THE BLDG

One mitigation method would be to review the elevations around the building and add some fill in the back corner to force the water around to the sides away from the back corner. If we can't carry the water all the way around an inlet basin at the furthest location we could carry the water would be installed. A pipe would then be utilized to carry the water from the inlet basin to the street for the final discharge spot.

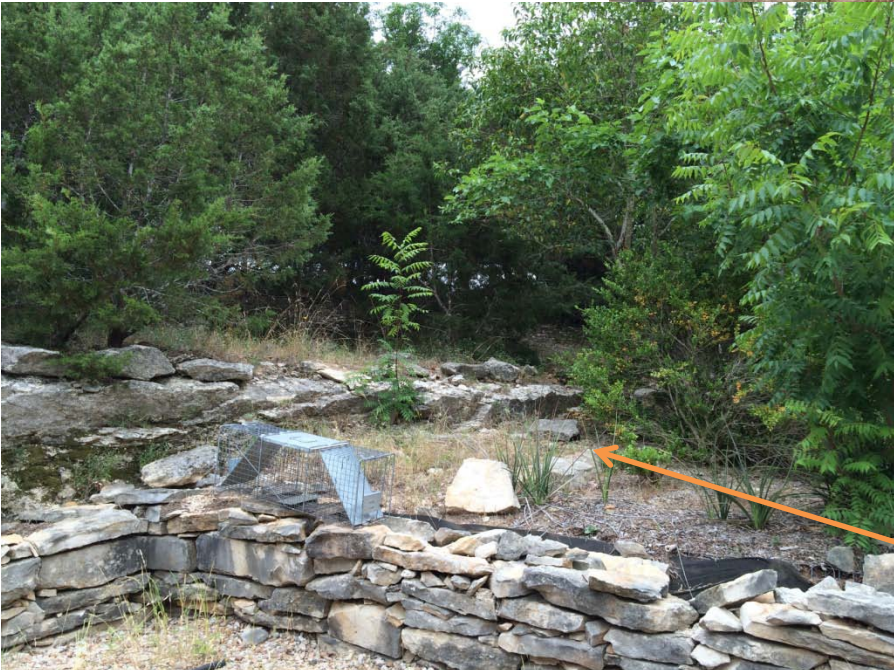
GULLY/RIFL IS FORMING FROM THE AMOUNT OF WATER COMING FROM UPGRADIENT

THIS IS WHERE THE WATER IS COMING FROM

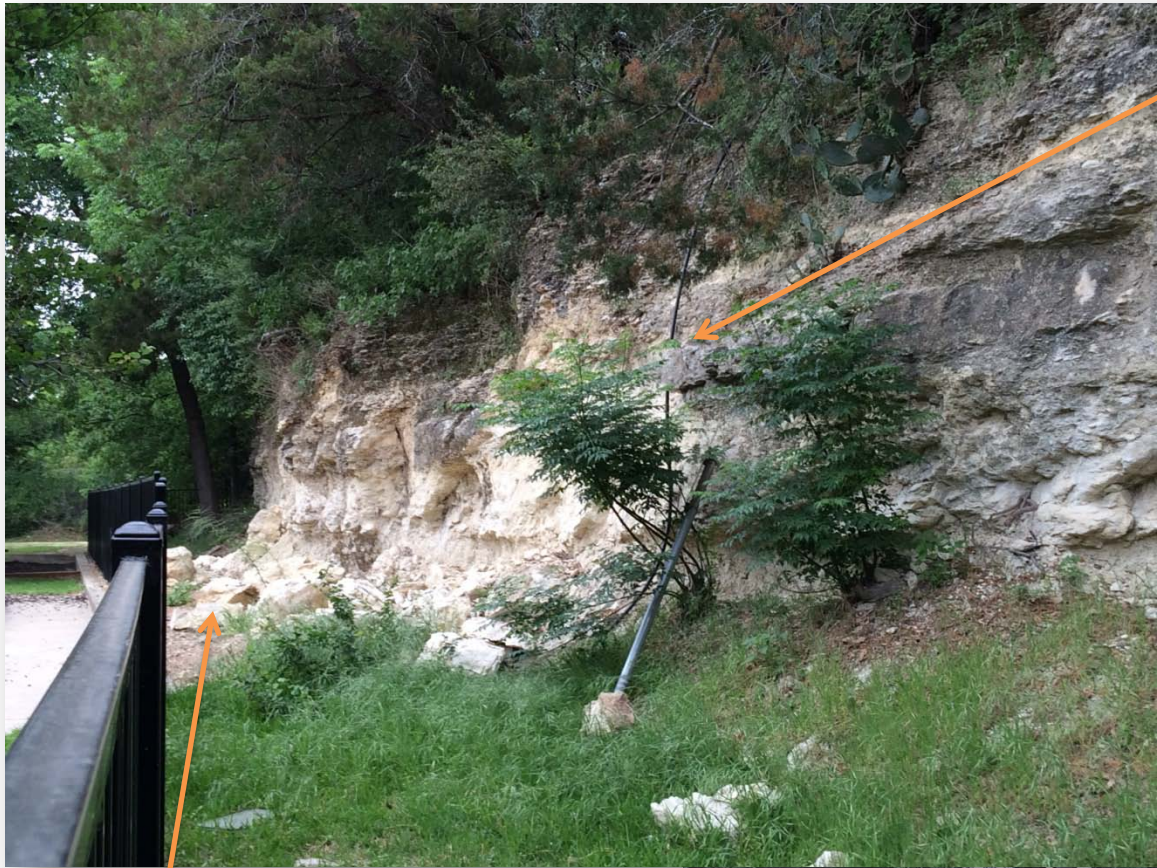
EXHIBIT 5

The lower park is an area that is frequently used by the residents of Rollingwood. This is where the pavilion is located, the playscape, community garden and rainwater harvesting system. The two main issues within this area are drainage/routing of the stormwater through the park and the bluff that is eroding away at an increasing rate due to the stormwater flow. See Exhibit 5 for pictures of the bluff and erosion issues.

DIFFERENT COLOR ROCK BECAUSE WATER HAS BEEN FLOWING OVER ONE AREA BUT NOT THE OTHER

THIS AREA NOT AS STEEP AS 1:1 BUT YOU CAN IT IS ERODING AND BUSHES AND TREES ARE STARTING TO SLIDE DOWN BECAUSE THE WATER IS CARRYING AWAY ALL THE DIRT LEAVING NOTHING FOR THE ROOTS TO HOLD ONTO

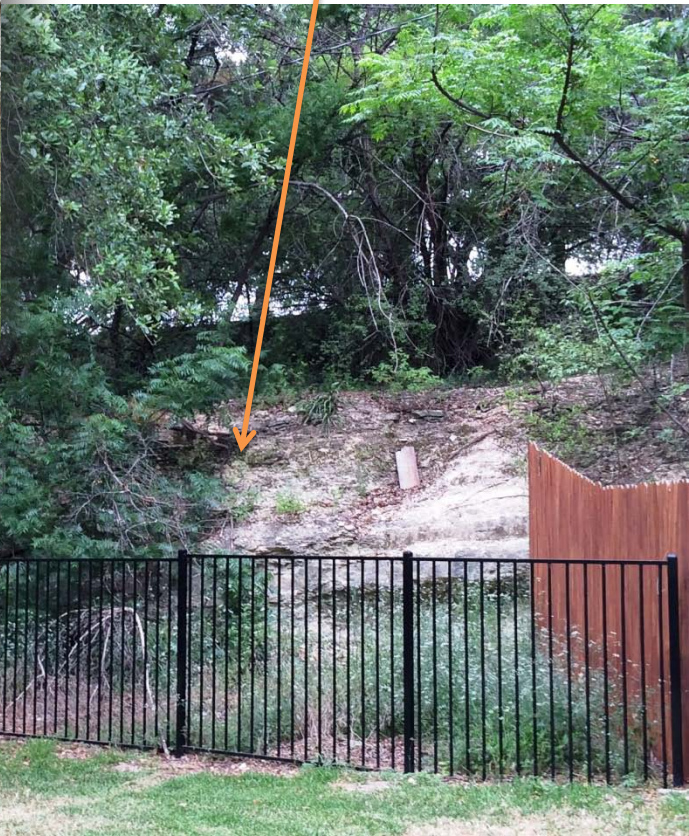
Once improvements are completed upgradient of this area there may be a minimal amount of work to be done in this area. This area should be the last one to be studied, with the exception of the exposed bluff, because improvements upstream will have an effect on the stormwater in this area. A wrought iron fence has been installed along the bluff to prevent kids from playing in this area and keeps some of the rocks from rolling onto the trail or from hitting someone. The exposed bluff could be considered a safety

issue and at minimum this should be examined to determine the likely hood that larger chunks may break loose and actually hurt someone.

PORTIONS OF THE FACE OF THE BLUFF ARE BREAKING AWAY. FENCE KEEPS PEOPLE OFF AND SOME PIECES OUT OF THE PARK BUT IT STILL MAY A SAFETY CONCERN

One mitigation method for this area could be that a living wall be constructed in front of this area to allow for vegetation to take hold and help protect the face from further damage. The living wall would be considered a “green” solution such that it would beautify the area and add some color depending on the type plants utilized. Another benefit would be that the plants would stabilize the face of the bluff to limit future erosion. An alternative method could be limestone block stack wall that could be terraced or arranged such that some plants could be installed but the main purpose would be to protect the public from rocks falling onto the trail or actually hurting someone. A third method would be to shotcrete the exposed face and then build a concrete wall in front of this area to construct a large tank. This tank would then become part of a rain water collection system in which the water could used at the park or residents could come and take it and utilize it for their own house.
