September 25, 2024

Re: Village of Roscoe
Riverside Park
South Pavilion Review
McM No. R0714-07-24-00114

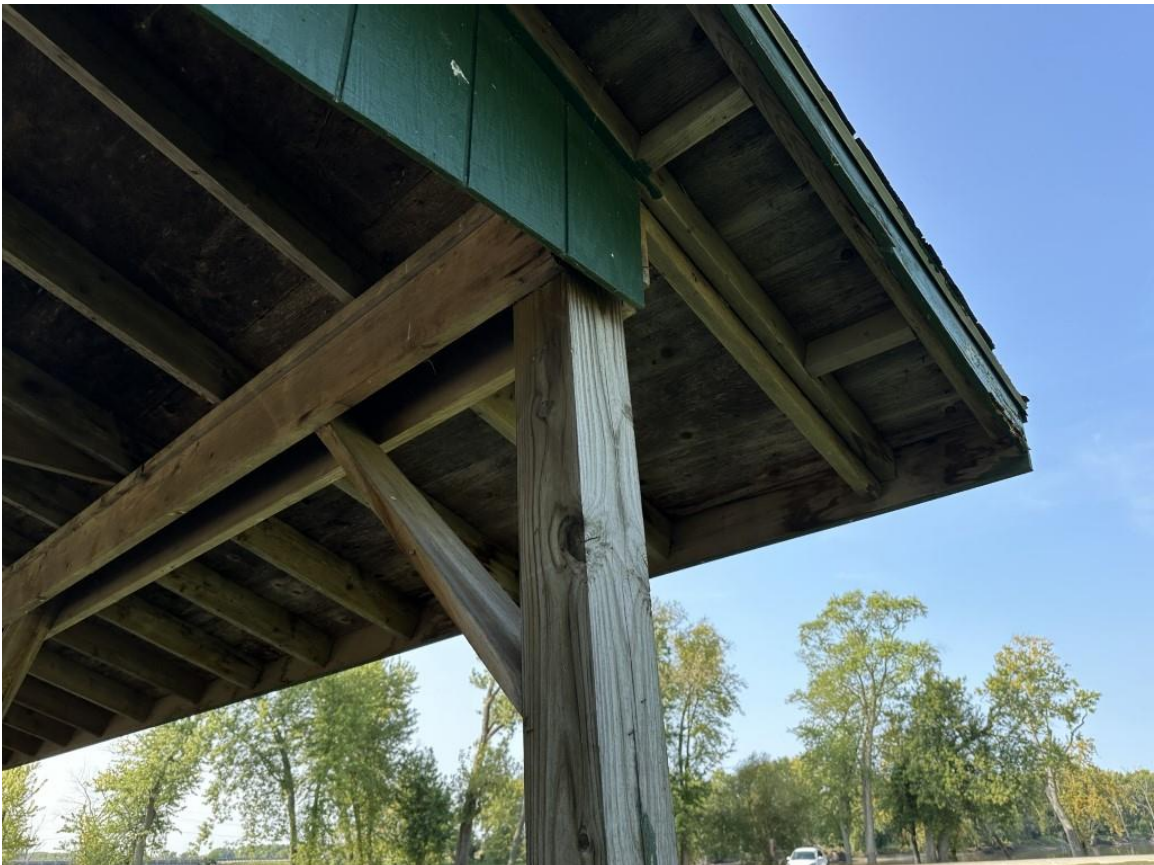
The pavilion roofing is damaged in multiple locations, and appears to be past its serviceable life.

Photo 04 - Pavilion Roof Corner

Overall, the existing wood pavilion appears to be in serviceable condition. The structural integrity of the pavilion structure appears sound. Most notably, the roofing is past its service life and should be fully replaced.

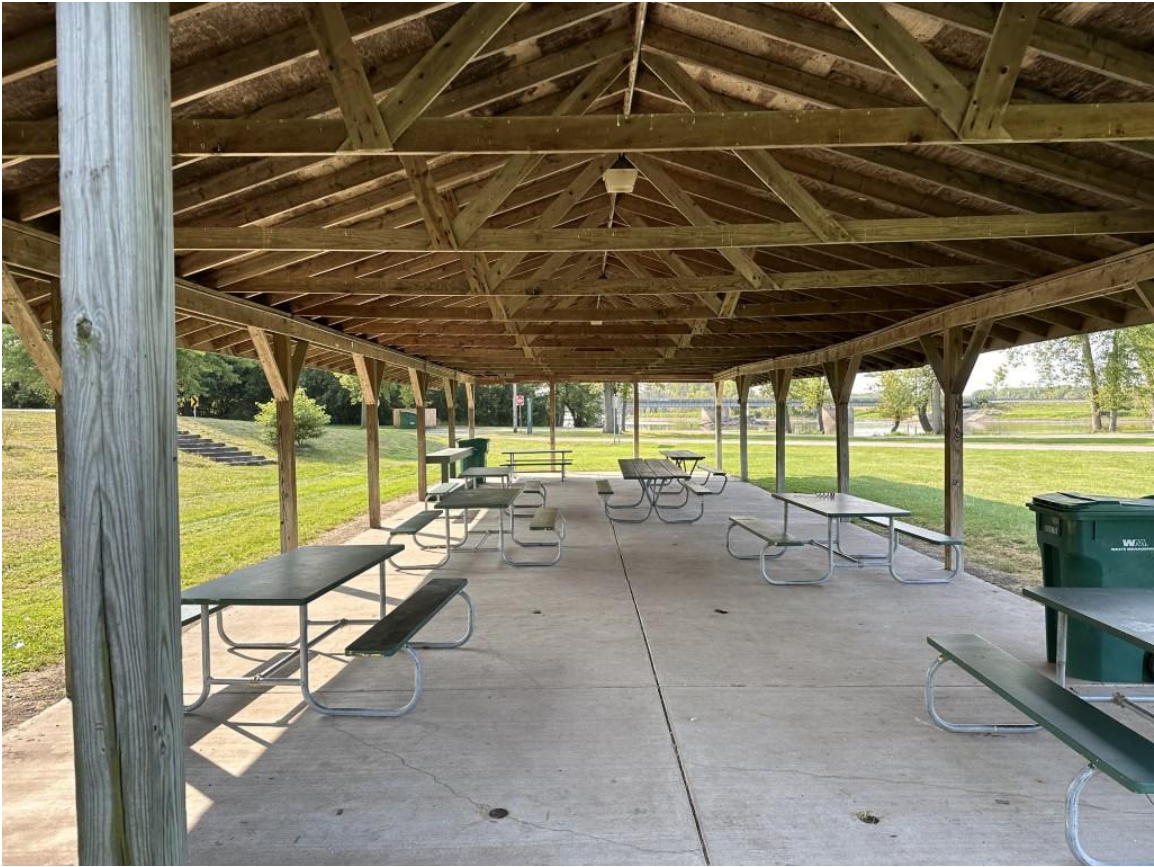
The roof structure consists of wood purlins at 2-foot spacing, supported by a central board and side wood beams spanning between support posts. Wood trusses appear to have been constructed within the plane of the building at 6-foot spacing; the truss nodes are built from nailed connections, as opposed to the conventional system of truss connector plates. Connections between the purlins and trusses and the supporting wood beams are not readily visible. Knee brace kickers are located between the wood posts and beams, along the long sides of the building. Wood posts are located at 12-foot spacing along the long (bearing) sides of the pavilion, and at 8-foot spacing at the short (non-bearing) ends of the pavilion; the posts are embedded into the ground. A concrete floor slab is poured between the posts.

Photo 05 - Interior Roof Framing

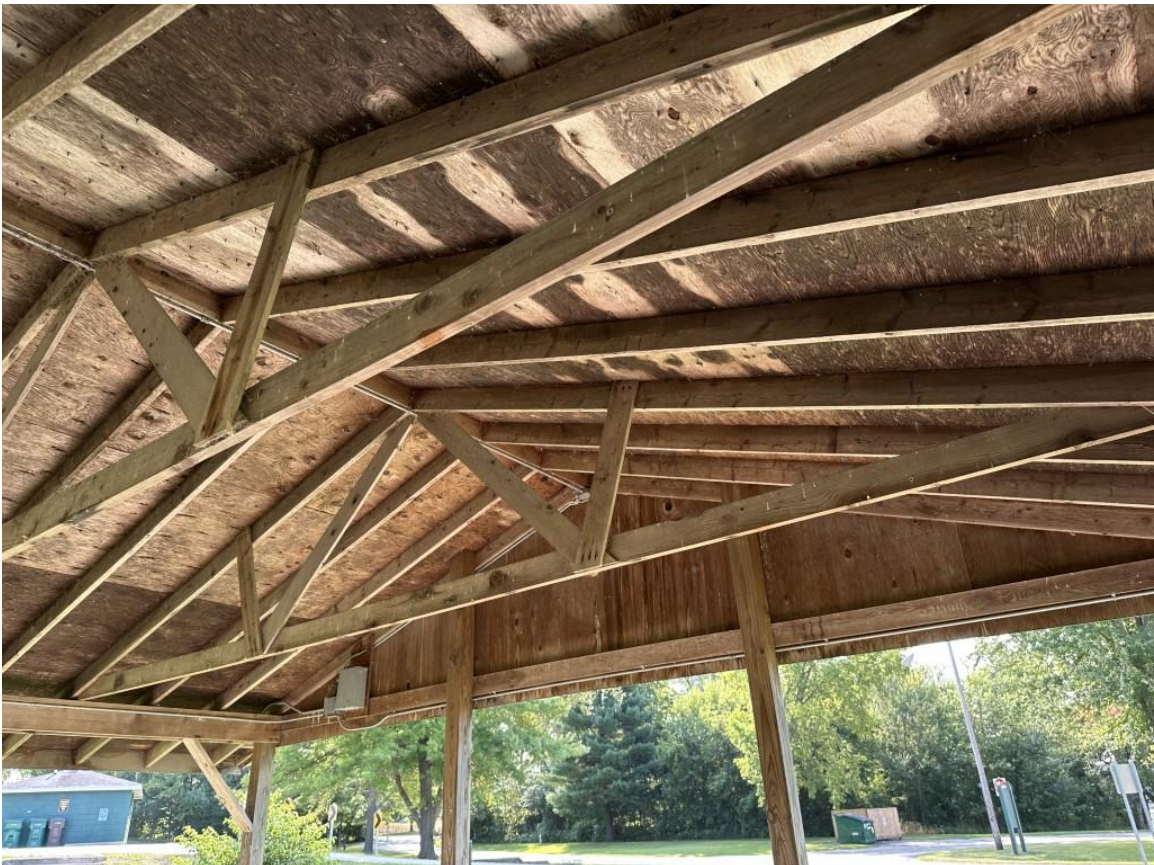
The roof framing has a noticeable deformation at several locations. The central roof trusses have a slight sag in the middle of the span. The roof at the middle of the western side has a notable vertical drop; this is likely the result of posts settling into the ground. The roof at the northeast end of the east side has a slight dip at the edge of the overhang.

Furthermore, the roof framing, specifically the wood trusses, appears to have been field constructed as opposed to shop fabricated trusses with conventional truss connector plates. While certainly valid, this style of construction is not as frequently utilized in current construction. When combined with the observed settlement and checking of the wood posts, the longevity of the structure is in question.

Photo 06 - Interior Trusses

It is McMahon's recommendation that the Village of Roscoe consider replacement of this pavilion structure, rather than rehabilitation of the existing framing and/or reroofing. The pavilion structure itself does not require immediate replacement, though the roof is in poor condition. Therefore, the Village may want to consider replacement of the pavilion in the near future in lieu of reroofing only. The visual misalignment of the framing will continue to be present over the remaining lifespan of the building.

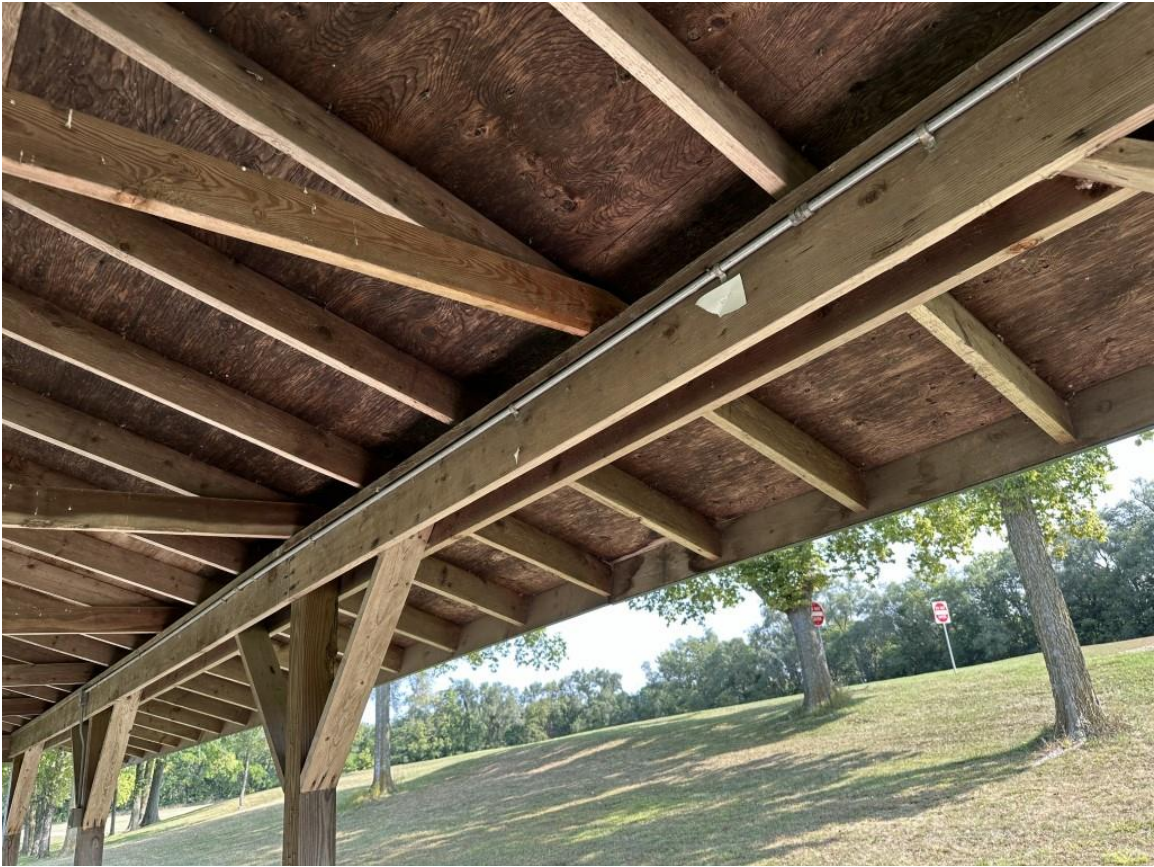
Photo 07 - Typical Beams To Posts

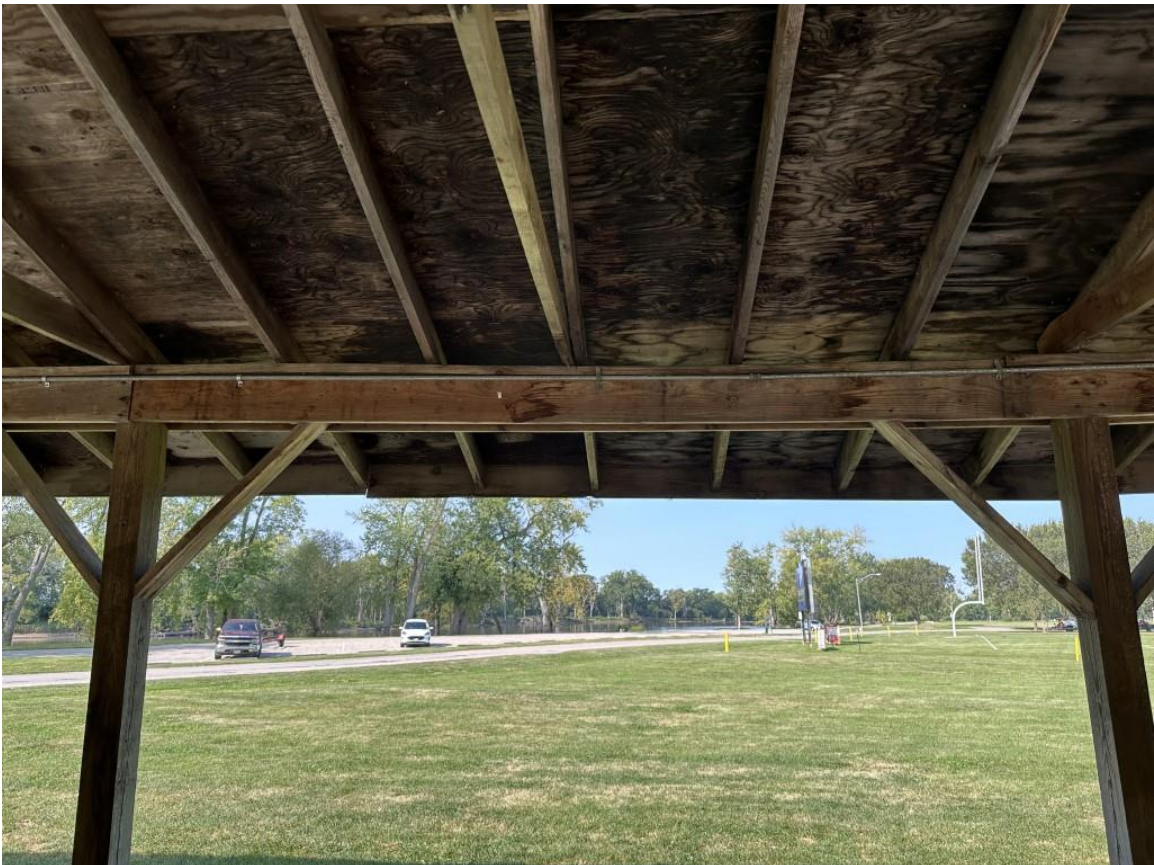
Photo 08 - Roof Beams At Settled Posts

However, the overall pavilion appears to have shifted or settled, most notably on the west side. With the style of construction (wood posts and beams, with posts embedded in the ground) it would be difficult to vertically plumb the roof framing without reconstructing portions of the building. Recommended repairs would include new concrete foundations and/or new wood posts.

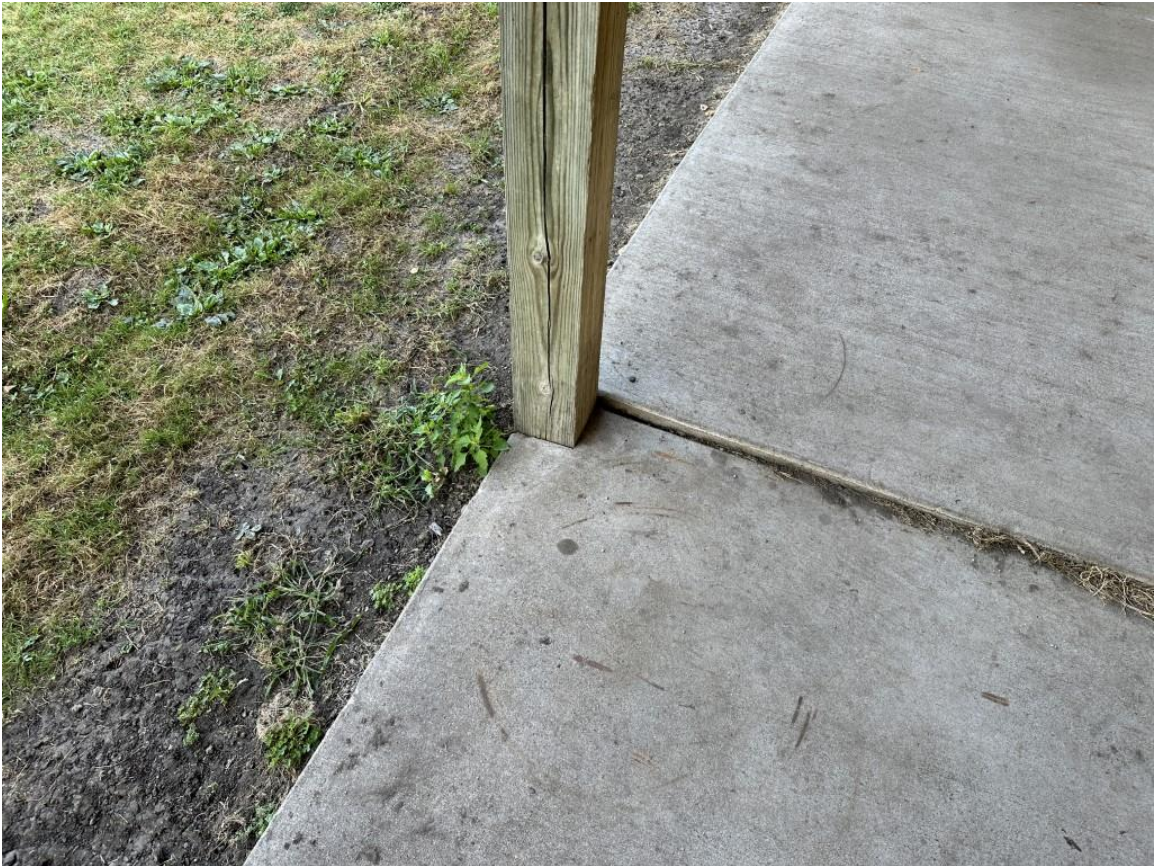
The concrete slab appears to be in good condition overall, with minimal cracking observed. The central portion of the slab has either heaved or settled, resulting in a vertical step in the slab.

Photo 09 - Slab Step At Post

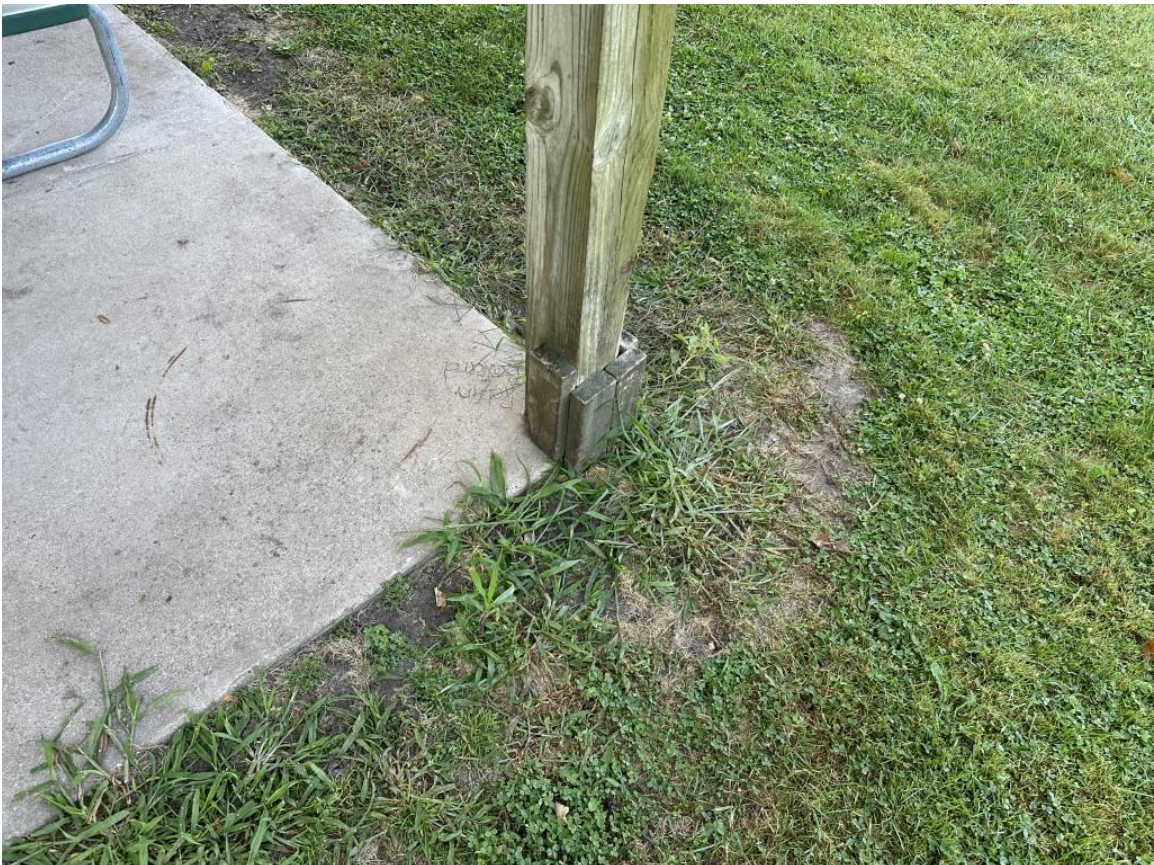
The wood posts appear to be in decent condition overall, and appear vertical. Vertical wood checks (cracking) are present in most posts, many on multiple faces of the same posts. Posts appear to have shifted, as there is a gap between the slab edge and the posts at several locations. At least one post at the central west side has settled into the ground, with notable vertical deflection present in the roof framing. The northwest column has been damaged, and has been reinforced with wood boards at the concrete slab.

Photo 10 - Northwest Post Base
