Facility and Needs Assessment

Salida Fire Department, Salida, Colorado

12.09.2020

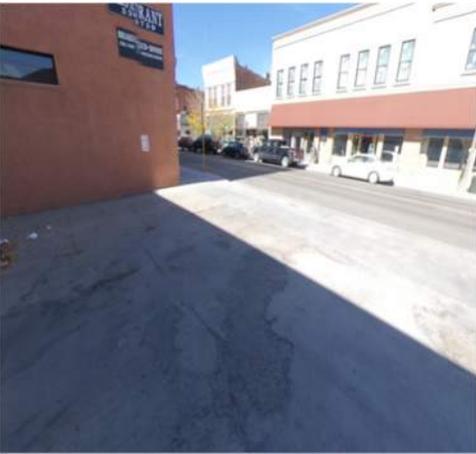
| System analysis (existing condition and deficiencies) | Some repair needed at spalling areas. No marked onsite parking area. |
| Risk Evaluation | Low |

| Recommendation for improvement | Coat with epoxy |

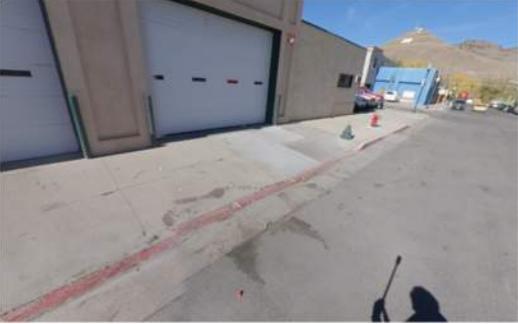
Traffic Flows

| System analysis (existing condition and deficiencies) | Not enough room between building and street for fire trucks. Fire trucks must be backed in from a busy, downtown City street and over a pedestrian way. |
| Risk Evaluation | High liability risk |

| Recommendation for improvement | Cannot increase distance to street. Could add a traffic light to reduce risk. |

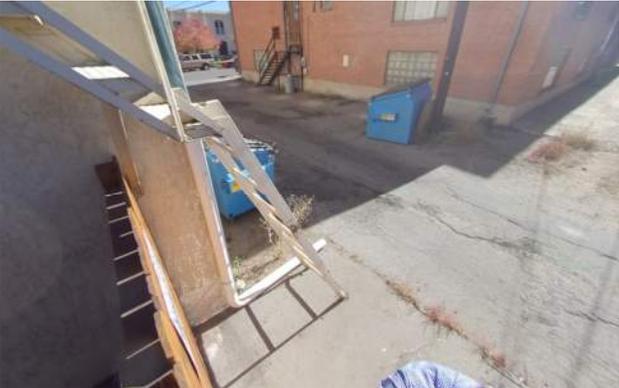
ADA Compliance – site and building access

| System analysis (existing condition and deficiencies) | Exterior stair for 2 nd story is not code compliant. |
| Risk Evaluation | Medium |

| Recommendation for improvement | Replace with code compliant fire escape stair. |

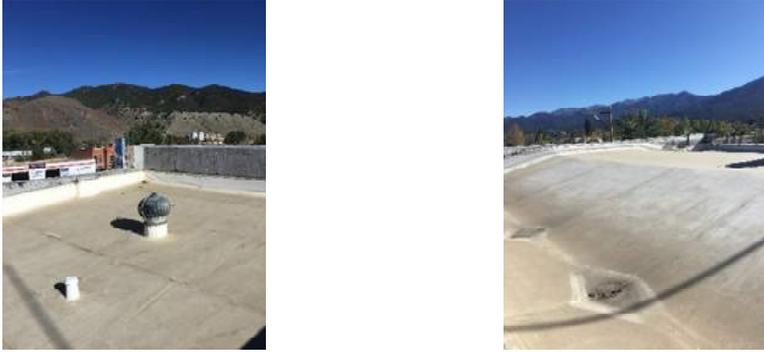
| System analysis (existing condition and deficiencies) | Membrane roof has evidence of puddling and flashing failures. Noticed leak in 2 nd floor area. |
| Risk Evaluation | Low |

| Recommendation for improvement | Repair roof |

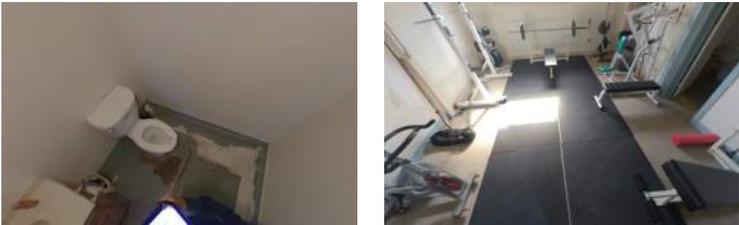
| System analysis (existing condition and deficiencies) | Sleep area carpet is older and shows wear. Flooring in kitchen, bathrooms, and offices is in good shape, exercise room flooring needs to be replaced. |
| Risk Evaluation | Low |

| Recommendation for improvement | Replace exercise room flooring and add flooring in exercise room bathroom. Budget to replace sleep and living area flooring in two to three years. |

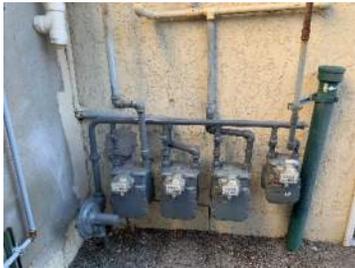
| System analysis (existing condition and deficiencies) | There are (2) separate gas meters: one for original building and one for converted garage. |
| Risk Evaluation | Low |

| Recommendation for improvement | Adding fixtures could have the possibility of maxing out one of the meters. This would require a new meter and line. |

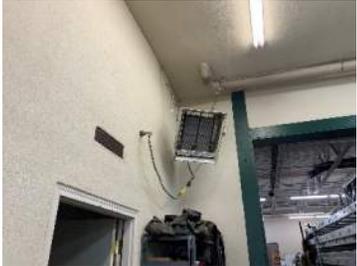
| System analysis (existing condition and deficiencies) | Garage areas are currently served by gas unit heaters. One in the truck bay and one in the converted garage. A second unit was removed from the truck bay because it was located too close to items. | |
| Risk Evaluation | Risk to employee health and safety | |

| Recommendation for improvement | Vehicle exhaust reels that attach directly to the vehicle and general exhaust (0.75 CFM/sq ft) are required for the garage to be brought up to code. This would require at least (1) exhaust fan for the vehicle exhaust and (1) exhaust fan for the general exhaust. | |

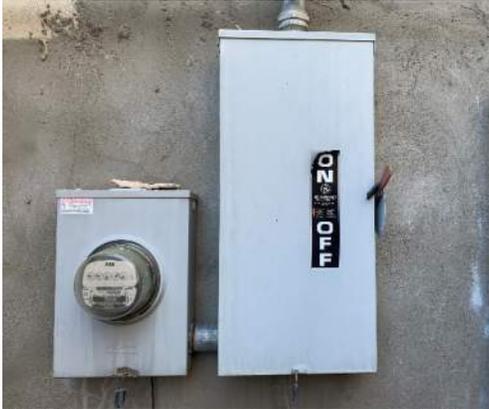
| System analysis (existing condition and deficiencies) | The first service to this facility feeds the south portion of the building. The service is fed overhead from a pole in the alley. The main disconnect and associated meter appear to have been updated at some point and appear to be in good working condition. |
| Risk Evaluation | Size of electrical service to facility is smaller than would be provided for this type of facility to allow typical Owner and mechanical equipment and future flexibility. Since there are two smaller services to this facility instead of one larger service, this future flexibility is further limited because any spare capacity is split up into smaller chunks on the different services which could become an issue if a larger compressor or mechanical equipment is desired. |

| Recommendation for improvement | There are multiple services to this building but labeling at main disconnects indicating multiple services (which is required per National Electric Code) is not present. This is intended to alert emergency responders that more than one disconnect must be shut-off to kill power to the whole building. |

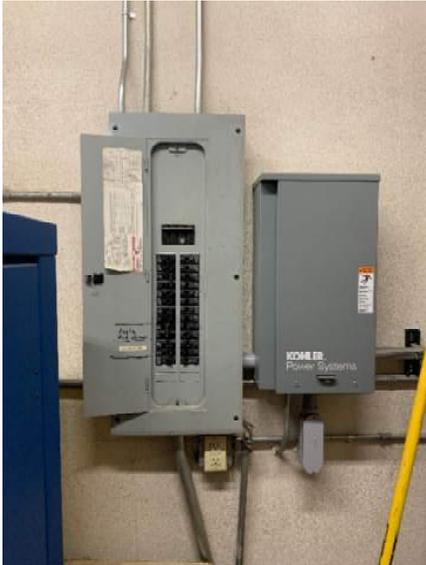
Electrical Distribution Service #1

| System analysis (existing condition and deficiencies) | Interior distribution consists of a 200A main breaker Siemens panel that feeds a variety of loads. The panels appear to be in good working condition and was updated at some point. This panel feeds a small subpanel that is also fed from the generator. There are 4 spaces available in the panel which could be used for future loads which provides some flexibility. |
| Risk Evaluation | Total electrical load on this panel is unknown but it is possible that with compressor and rooftop unit being fed from this panel in addition to all the other general loads that it could be nearing its capacity which could limit future flexibility. |

| Recommendation for improvement | If more flexibility is desired, replace with panel that can accommodate more circuit breakers. |

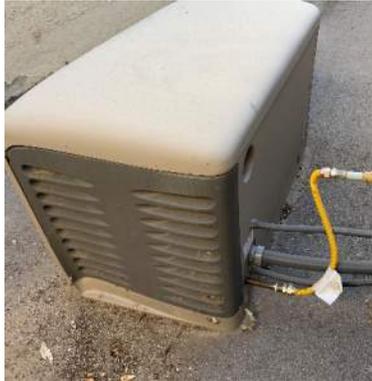
Generator System - Service #1

| System analysis (existing condition and deficiencies) | The generator is located at grade in the alley and looks to have been installed approximately 5 years ago and to be in good working condition. It is a Kohler brand, residential grade generator. Generally, a more reliable, robust commercial grade generator is recommended for a Fire Station application. In addition, it is not clear if, being on grade without a housekeeping pad, this generator is being protected adequately from snow or pooling water. This could impede air intake/exhaust from the generator and possibly impact its ability to operate at full efficiency. The size of the generator appears to be sufficient for the loads being fed. |
| Risk Evaluation | Issues presented are likely low risk in the short term, but the lifespan and durability of this equipment will not be as high as it would be with a commercial grade product. In the long term this could be a risk if equipment fails during a power outage. |

| Recommendation for improvement | If issues occur with existing generator then it would be recommended that it be replaced with a commercial grade generator on a housekeeping pad. |

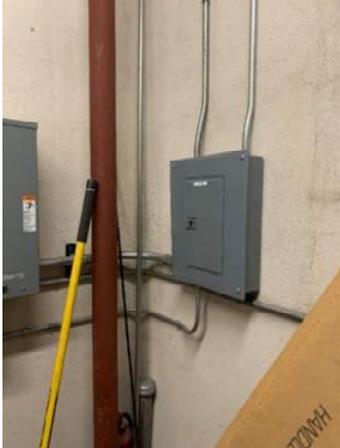
Generator System Distribution - Service #1

| <p>System analysis (existing condition and deficiencies)</p> | <p>Generator distribution consists of a 100A automatic transfer switch that feeds a 100A load center that mainly serves a few garage doors, receptacles, and lights. There are 6 spaces in this panel for future additions if desired. Equipment appears to be in good working condition. Depending on the reliability of power, the amount of loads covered by the generator may be insufficient to allow the Fire Station to operate adequately during a prolonged power outage.</p> |
| <p>Risk Evaluation</p> | <p>An extended power outage could impact the ability to operate efficiently out of this Fire Station. Depending on how this station is utilized this could present a risk if power is unreliable (which could be the case with overhead power distribution to the building).</p> |

| <p>Recommendation for improvement</p> | <p>In this climate it would be expected that some level of heating would be covered by the generator to allow the building to be occupiable during an extended power outage. This also allows the crew living quarters to be utilized since some level of comfort can be maintained. If greater functionality is desired during a power outage, more systems should be added to the generator. This would likely impact the generator size and distribution.</p> |

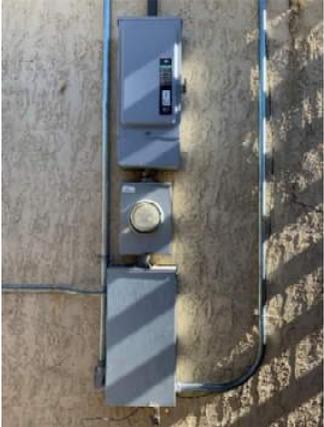
Electrical service #2

| Risk Evaluation | Size of electrical service to facility is smaller than would be normally provided for this type of facility to allow typical Owner and mechanical equipment and future flexibility. Since there are two smaller services to this facility instead of one larger service, this future flexibility is further limited because any spare capacity is split up into smaller chunks on the different services which could become an issue if a larger compressor or mechanical equipment is desired. |

| Recommendation for improvement | There are multiple services to this building, but NEC required labeling at main disconnects indicating multiple services is not present. This is intended to alert emergency responders that more than one disconnect must be shut-off to kill power to the whole building. |

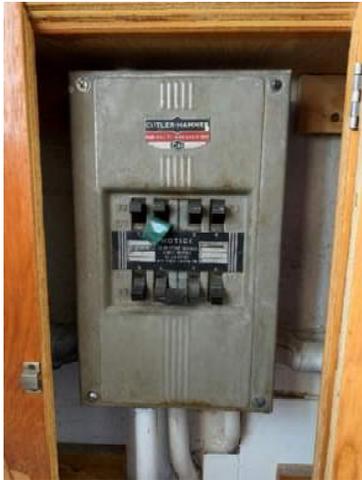
Electrical Distribution Service #2

| <p>Risk Evaluation</p> | <p>If a circuit breaker does not operate as intended, a circuit overload or short could occur on a branch circuit. This could degrade the integrity of the wire and insulation and lead to a fire.</p> |

| <p>Recommendation for improvement</p> | <p>This panel should be replaced with a new panel that meets current code requirements and can be counted on to operate as intended.</p> |

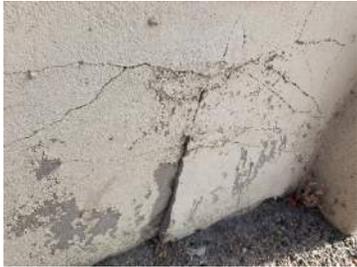
Foundations

| Risk Evaluation | Low |
| Notes | Overall, the foundation appears to be in good condition. |

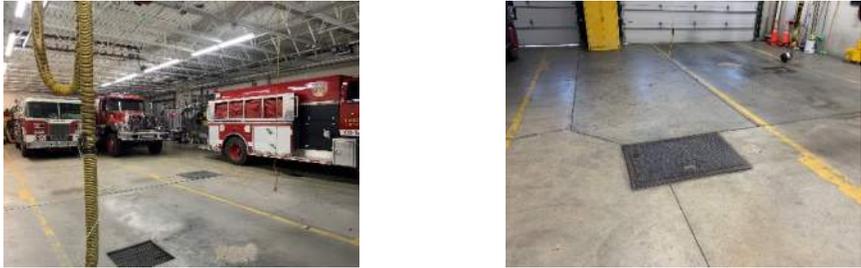
Slab on Grade

| Risk Evaluation | Low |
| Notes | Overall, the slab-on-grade appears to be in good condition. |

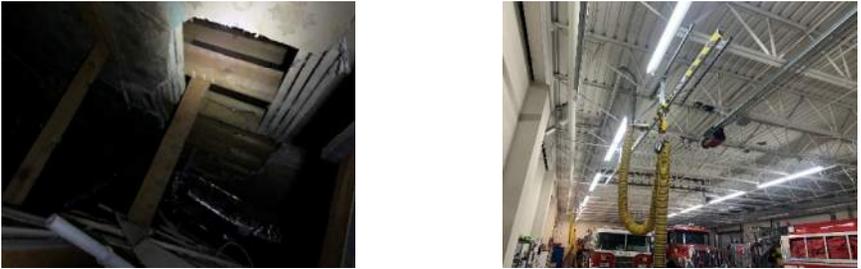
Structure – Roof Framing

| <p>Risk Evaluation</p> | <p>Low</p> |
| <p>Notes</p> | <p>Overall, the roof framing appears to be in fair condition.</p> |

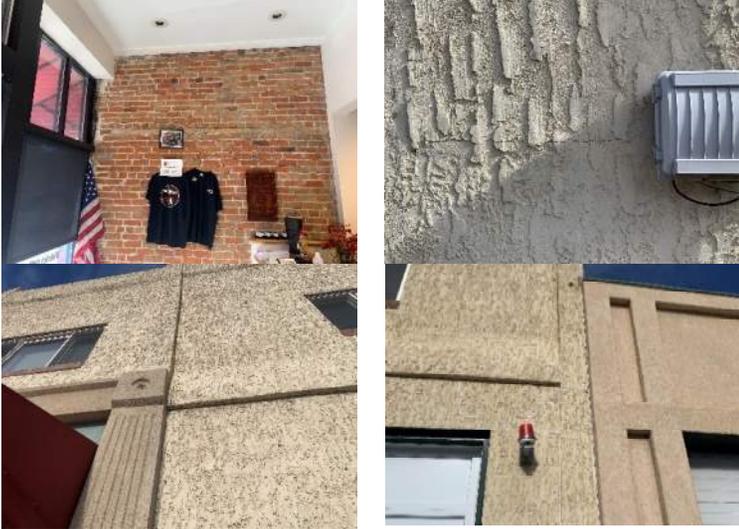
Exterior Walls

| Risk Evaluation | Low |
| Notes | Overall, the exterior walls appear to be in fair condition. |

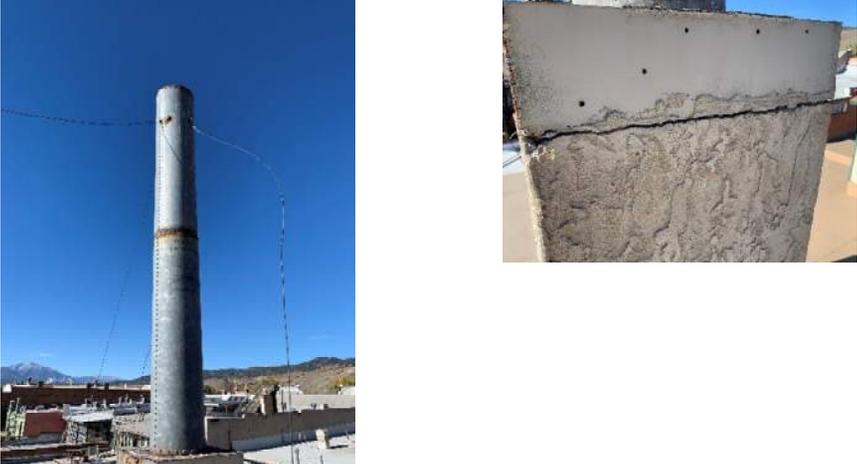
Other

| <p>Risk Evaluation</p> | <p>Not an immediate risk, but needs to be checked regularly.</p> |

| <p>Recommendation for improvement</p> | <p>From our understanding, the existing boiler has been decommissioned. It is recommended if the flue extension is not required to remove the flue completely.</p> |
