# Technical Memorandum

**TO:** City of Sandy – Jenny Coker, Public Works Director

**FROM:** Keller Associates, Inc. – Jason King, PE; Jesse Fields, PE

**SUBJECT:** Sandercock Reservoir Inspection and Recommendations

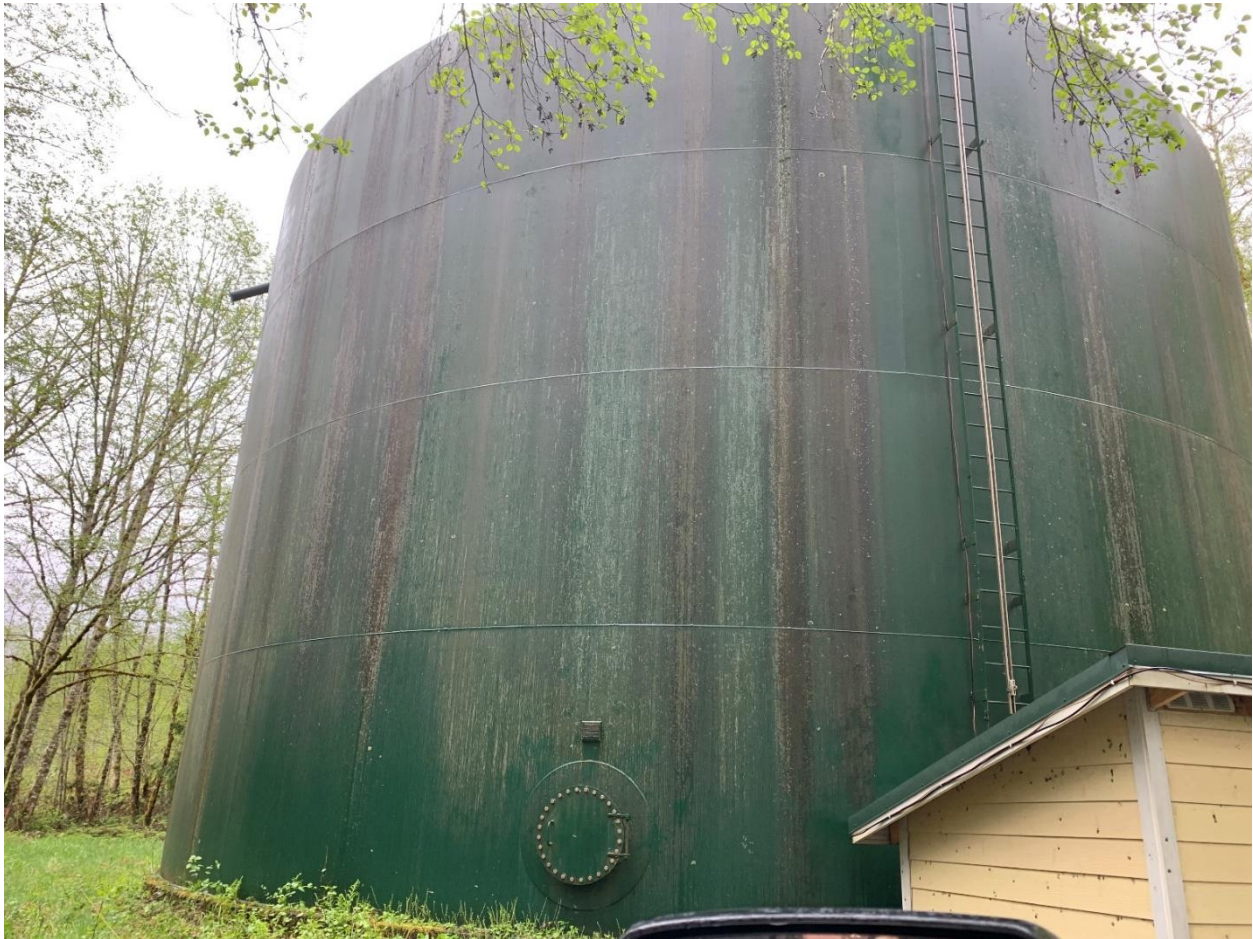
FIGURE 2 – TANK EXTERIOR

The exterior of the tank showed visible signs of dirt accumulation but did not show any indications of major paint degradation except in spots on the exterior roof access ladder. A simple tank wash down will remove the soil accumulation and facilitate future external coating assessment. Access to the roof ladder requires walking on the corrugated roof of the adjacent valve shed. This presents a safety concern and fall hazard. The roof appears in excellent condition. Several low points on the roof retain water and soil/debris.

The exterior of the tank, ladder, and ring wall should be cleaned and pressure washed for general maintenance. A safer means for accessing the ladder, such as a raised platform or catwalk type scaffolding, should be constructed to eliminate the existing fall hazard. In lieu of a raised platform or catwalk, the existing ladder could potentially be relocated to avoid the need for gaining access from above the valve house, these alternatives should be evaluated for cost/benefit in future design phases. In either alternative, the existing fall protection track should be removed as it is not in use and is now a hazard.

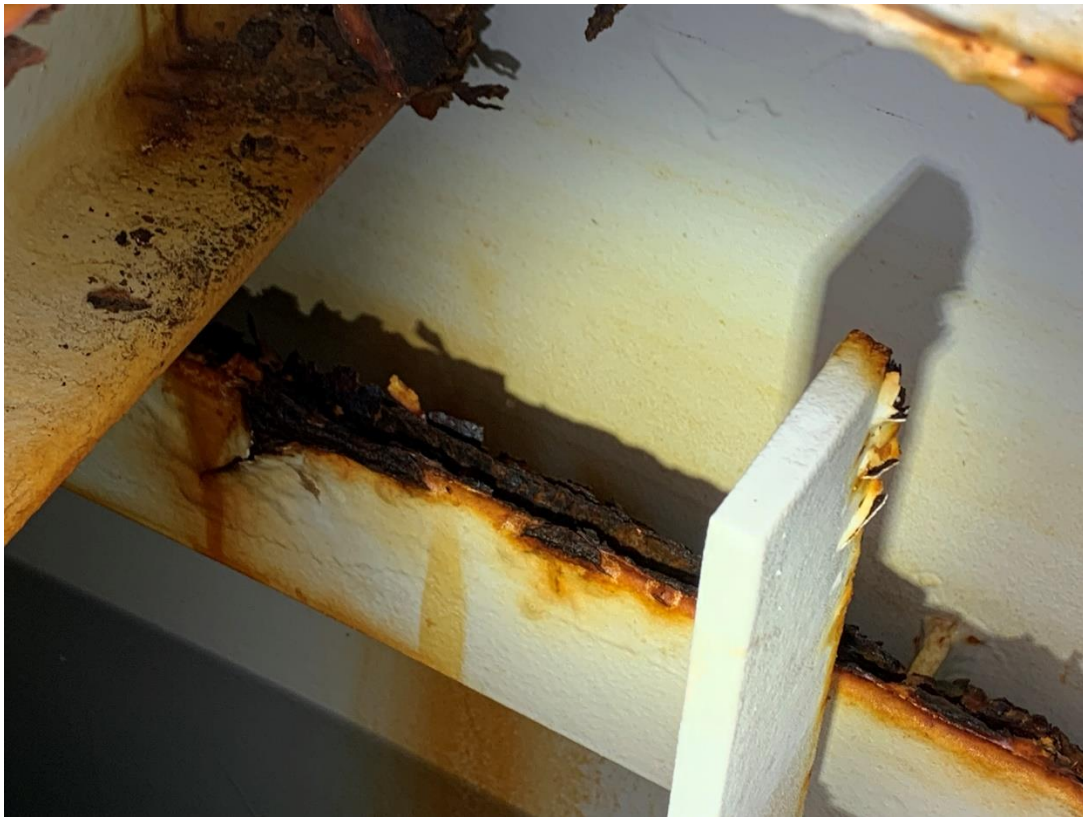
FIGURE 3 - DELAMINATION OF TANK STEEL AT ROOF ACCESS HATCH

Minimal coating loss or damage was observed on the inside tank walls in the water storage zone. The atmospheric zone above the water storage zone showed signs of metal loss in the form of dark rust staining and delamination of the structural steel, and several of the vertical support rods used for the original installation were corroded to the point of separation.

The internal surfaces of the tank walls and structural supports above the water storage zone should be sandblasted clean, inspected further, and repaired, as needed based upon the inspection results. Once repairs are completed, all surfaces in the atmospheric zone should be primed and painted with a high-quality NSF 61 coating system. The tank floor and walls should be pressure washed to remove the material deposits, and the integrity of the steel wall loss and corrosion locations should be evaluated. Areas identified with substantial floor and wall pitting should be repaired, prepped, and coated a high-quality NSF 61 coating system.

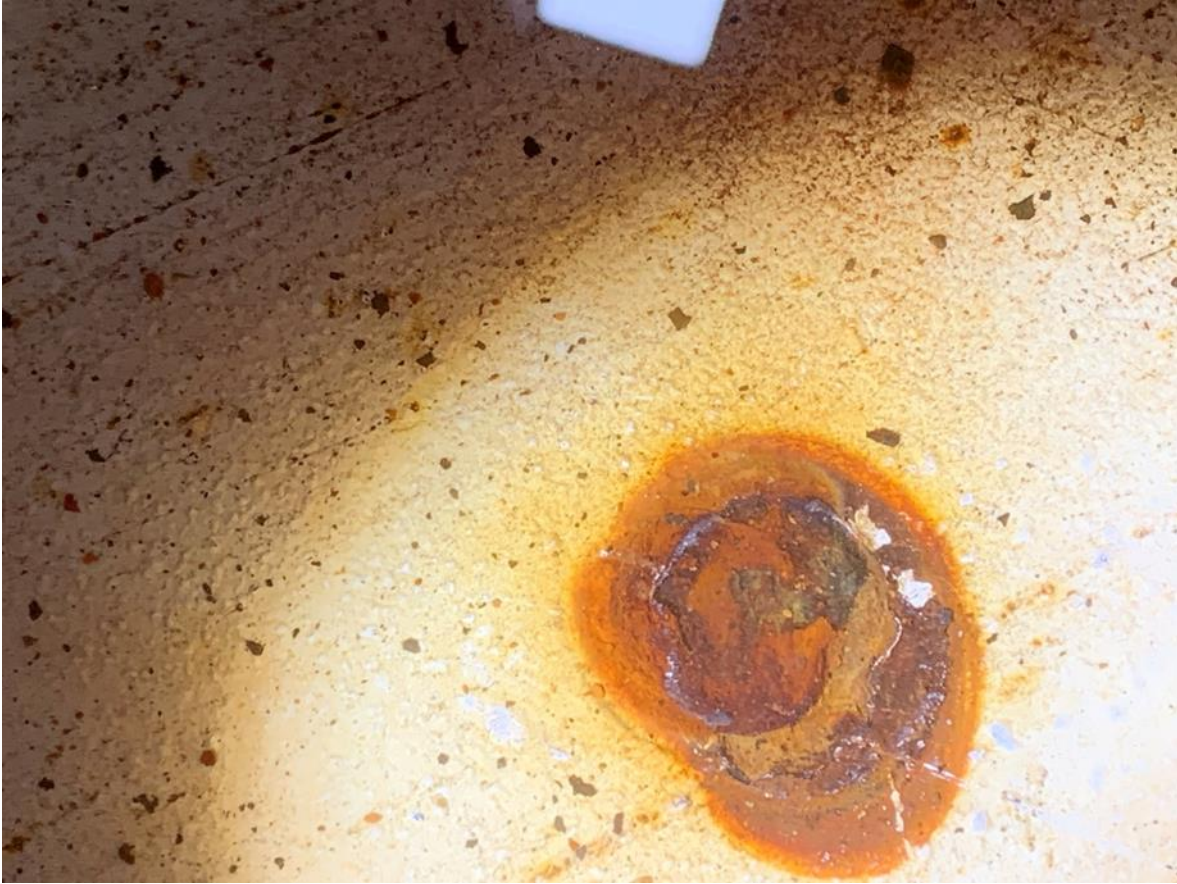
FIGURE 4 - TANK FLOOR PITTING

The tank floor was littered with random material deposits, approximately one inch in diameter, several of which showed signs of significant wall loss, up to a quarter inch deep. This likely results from galvanic corrosion from exposed steel coating pinholes. The welds for the tank floor panels all appeared to be in good condition.

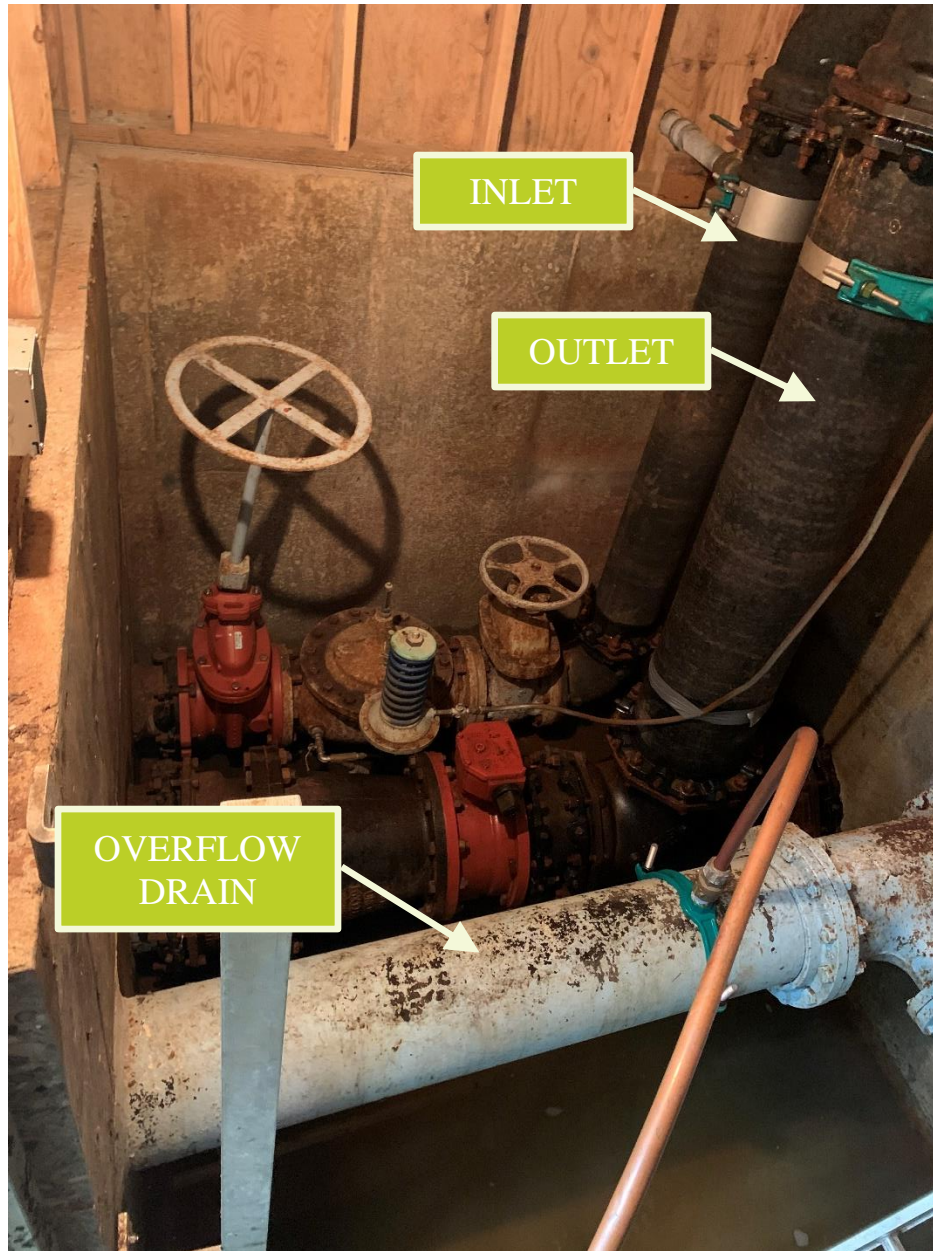
FIGURE 5 - VALVE SHED MECHANICAL

The valve shed is constructed of an open concrete vault foundation with an enclosed wood framed structure built over the top. Mechanical components inside include a dedicated inlet (looked to be 8-inch diameter), with a piloted control valve and two gate valves for isolation; a dedicated 12-inch outlet (increases to 16-inch before penetrating vault wall), with a butterfly valve for isolation; and a combined drain/overflow line that discharges to an onsite drainage way. A telemetry panel with a pressure transducer for monitoring tank level is also located in the valve shed. At the time of the inspection, a sump pump was hard piped into the reservoir drain line to remove leaked water from the vault. City staff indicated that the vault has a floor drain, but it is currently clogged.
