Re: Sullivan Senior Center
AVO: 37449.004

Per your request, Halff visited the Sullivan Senior Center (SSC) at 200 Bolivar St in Sanger on March 20. The intent of the visit was to observe the condition of the roof framing throughout the building and the floor framing at the rear or south end of the building. According to you, the roofing was due for replacement and the selected contractor had concerns about the condition of the structure that needed to be addressed before attempting the work. In addition, the SSC staff wanted to move equipment into the rear of the building so there was a need to confirm the capacity of the floor in that area.

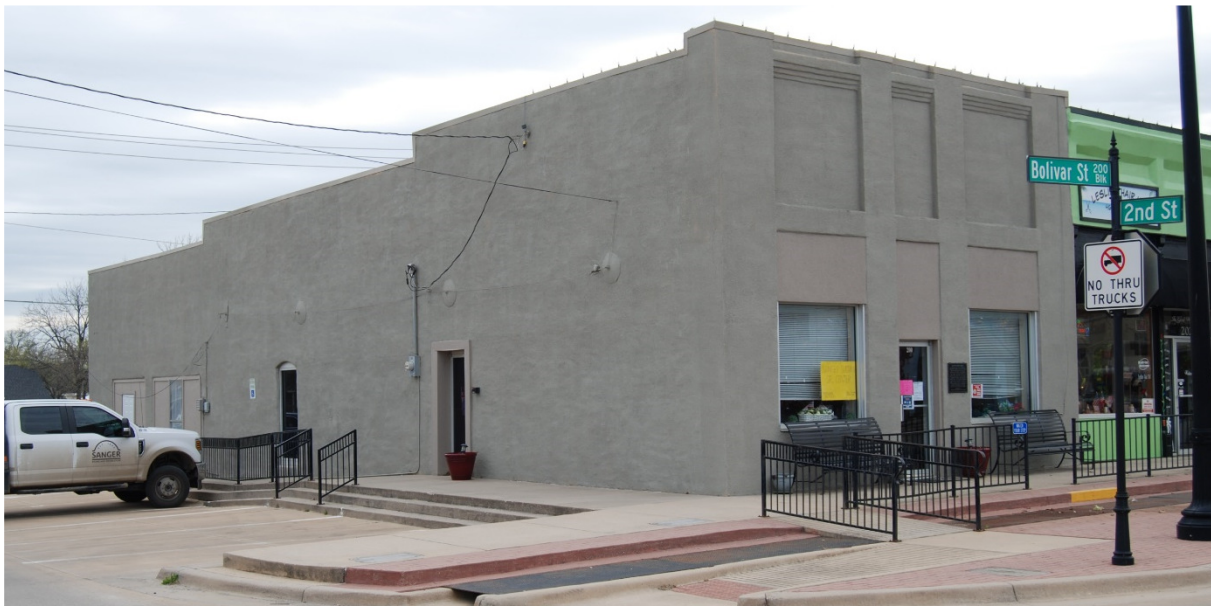
The building is a single-story structure located at the southwest corner of Bolivar St and N 2nd St in Sanger, TX. (See Photo 1)

Photo 1 - Sullivan Senior Center looking southwest

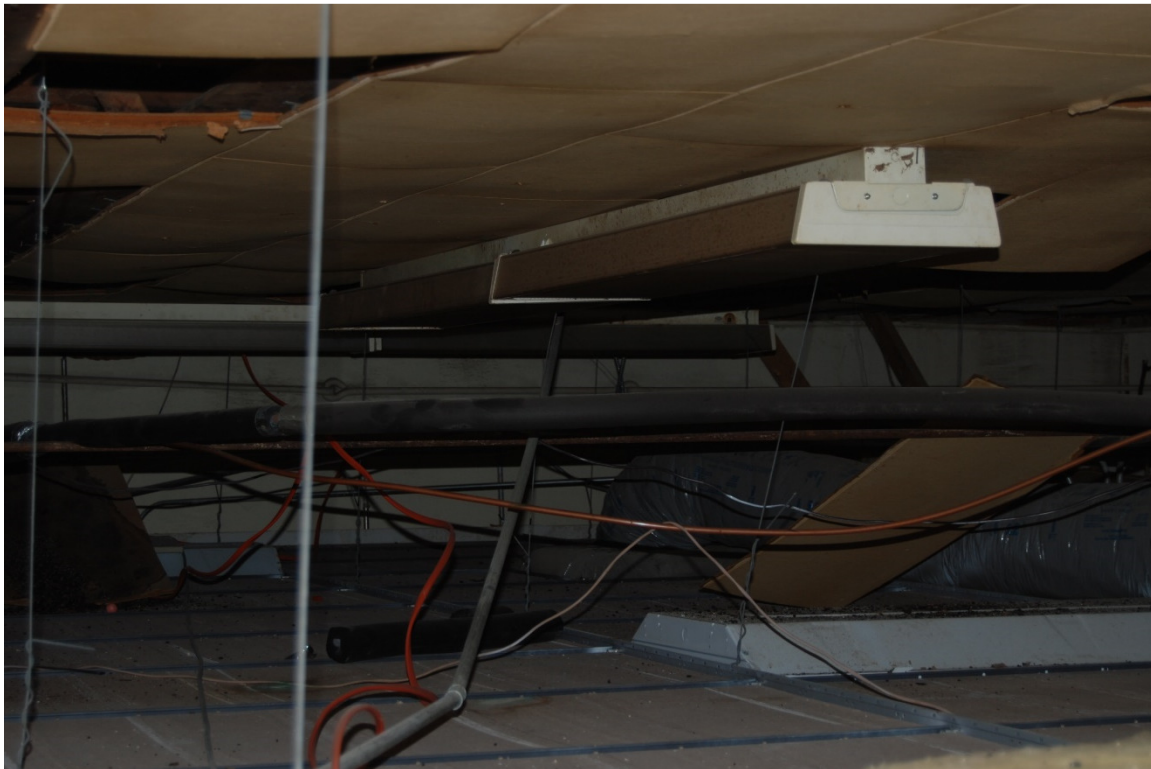
The acoustic ceiling tiles visible to occupants hide portions of an old ceiling, including tiles, light fixtures, and electrical wiring. Some of the old tiles are in reasonable condition, but many have fallen completely or in part from the ceiling framing. (See Photo 2)

Photo 2 - View above acoustic ceiling in front room

Given the obviously advanced age of the building, the old ceiling tiles could contain asbestos. ***It is highly recommended that these tiles be tested for the presence of asbestos, especially prior to the removal or repair of any of the roof and ceiling framing.***

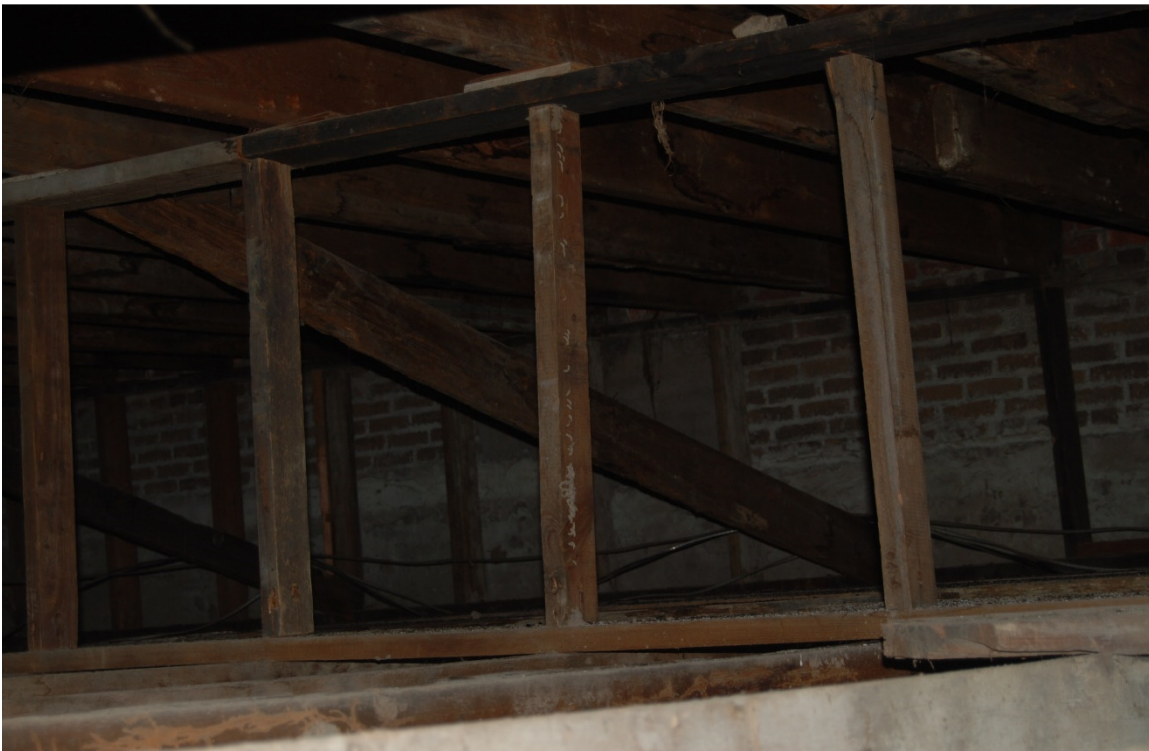
The building roof is framed in timber and is connected to additional timber framing that supports the ceiling. The main framing elements are supported by the perimeter masonry walls. Roof joists appear to be 2x8 dimensional lumber spaced 24 inches apart. The joists are supported at mid-span by the ceiling framing resulting in 11-foot spans at the front of the building and 12-foot spans at the rear of the building. The ceiling at the front of the building appears to be supported by 2x14 dimensional lumber at 16 inches on center, while the ceiling at the rear of the building appears to be supported by 2x8 dimensional lumber at 24 inches on center. Posts constructed of single 2x4s transfer load from the roof to the ceiling framing. (See Photo 3)

Photo 3 - View between ceiling framing and roof joists in back room

The condition of the framing varies depending on location. At the rear of the building, the joists and decking show significant discoloration and deterioration in places, especially at the southwest corner. It is apparent that water and insects have penetrated the roofing system over time, causing damage to both the roof and ceiling framing. In addition, the ceiling tiles (both levels) show signs of dripping and ponding water.

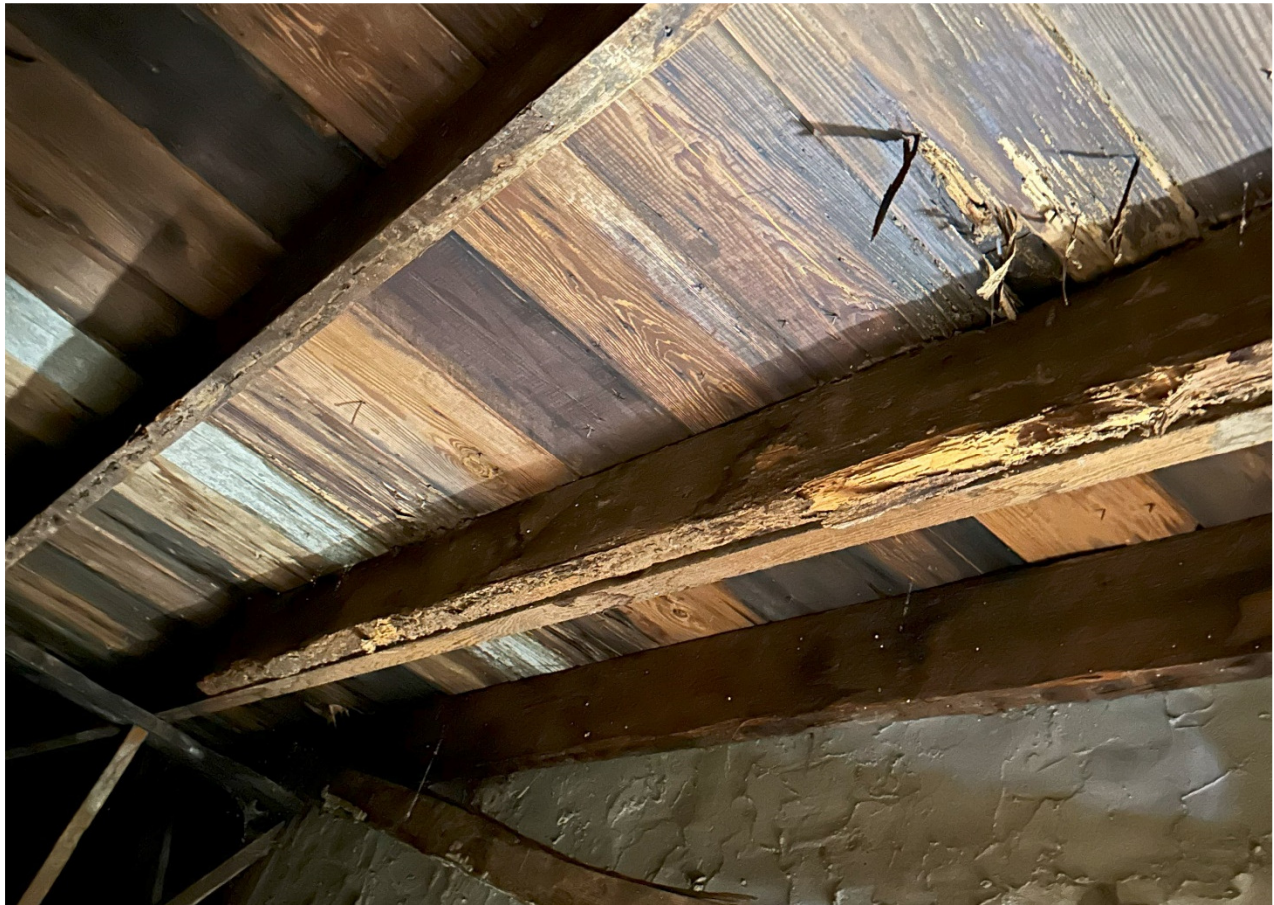
Photo 4 - View of damaged/deteriorated roof framing along south wall of rear room

The Sullivan Senior Center is an aging structure with roof and ceiling framing that has stood the test of time. However, the framing is showing its age and needs to be replaced. (See Photos 4 and 5) As stated previously, we recommend that the rear of the building remain closed for all purposes (except for limited storage) until the roof and ceiling framing are replaced. In addition, we recommend that the roof at the front of the building be closed to all access until the roof and ceiling framing in this area are replaced. If you have any questions, please feel free to contact me at (214) 346-6284.

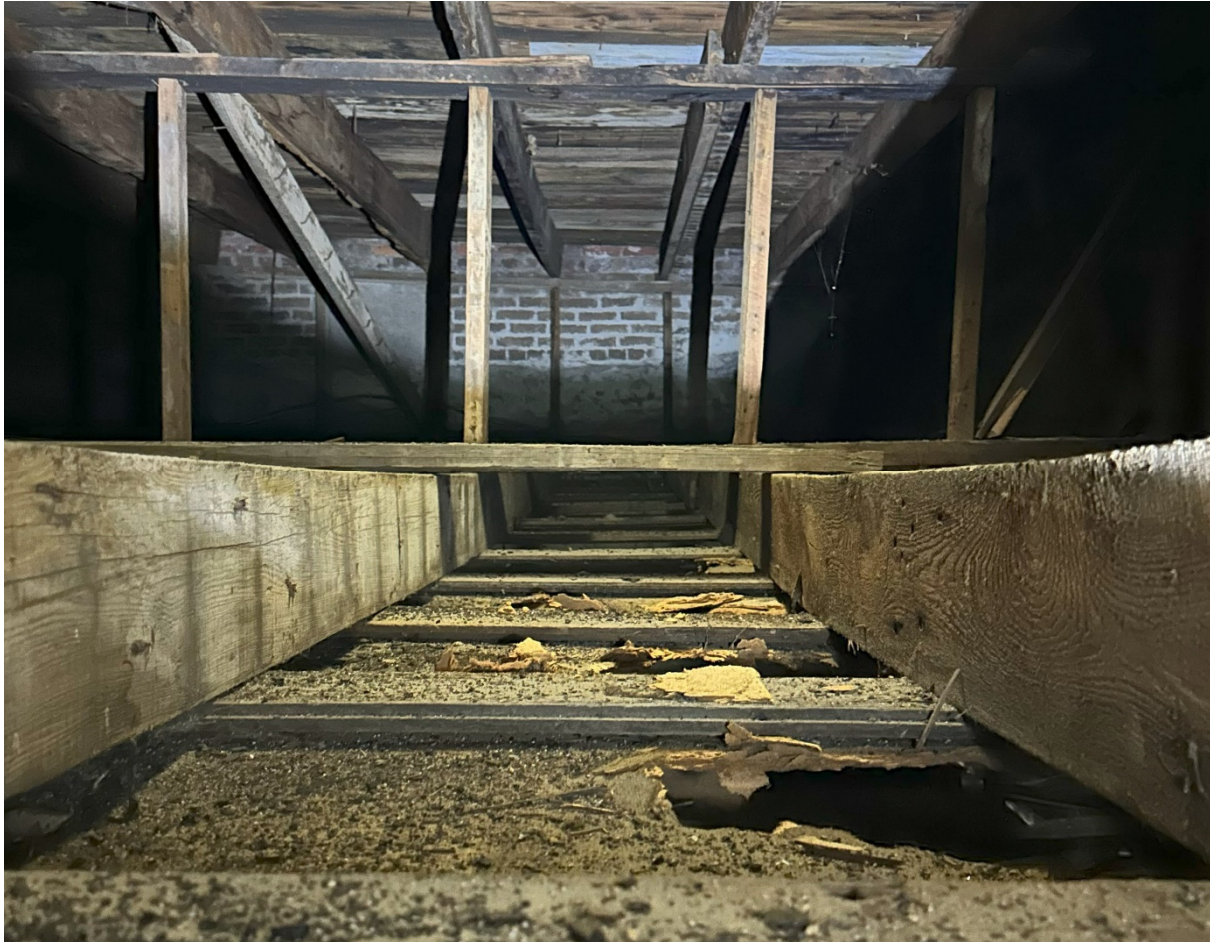
Photo 5 - View of damage/deterioration along ceiling framing from water intrusion at southwest corner of rear room
