October 18, 2023

### **Exploratory Test Pits on SFS 136, Sorenson Brothers Orchards, LLC**

#### **Santaquin Reach Pipeline Station 746+50 to Station 749+00**

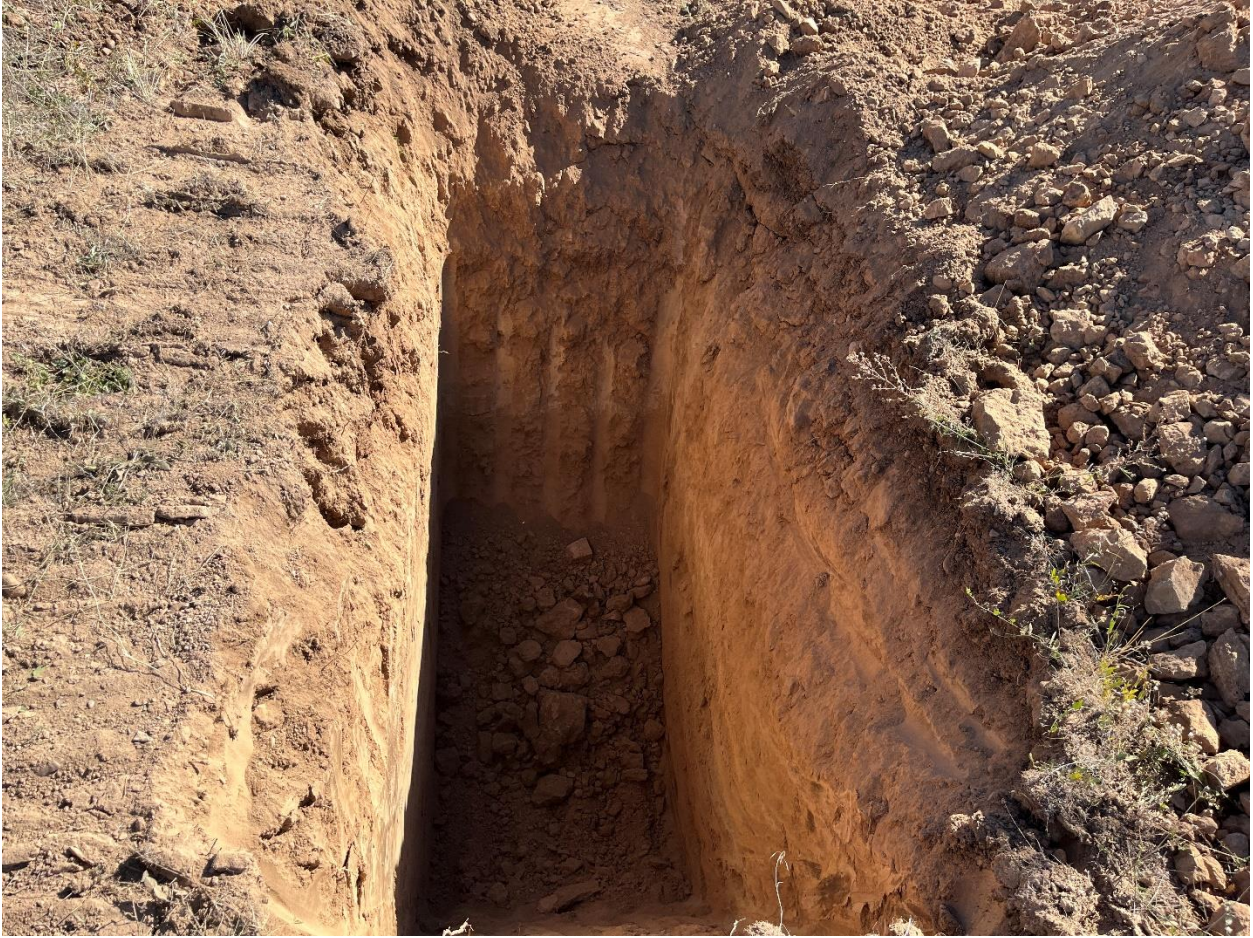
Two test pits were excavated on the pipeline centerline to 10 feet deep (Hole 1 - invert elevation 4748 near Station 747+00, rising to Hole 2 invert elevation 4749 near Station 747+75). The material was uniform fine native tan sandy silt the full depth of the pit without visible gravel. This material appeared the same as typically encountered for nearly the entire length of Salem Reach 1, Salem Reach 2, and the Payson Spring Lake reaches. The pits were on the north side slope of the original borrow pit likely excavated for the interstate. The pits were photographed and filled.

Hole 1 on Pipeline Centerline. Uniform sandy silt to 10 feet deep (pipeline invert)

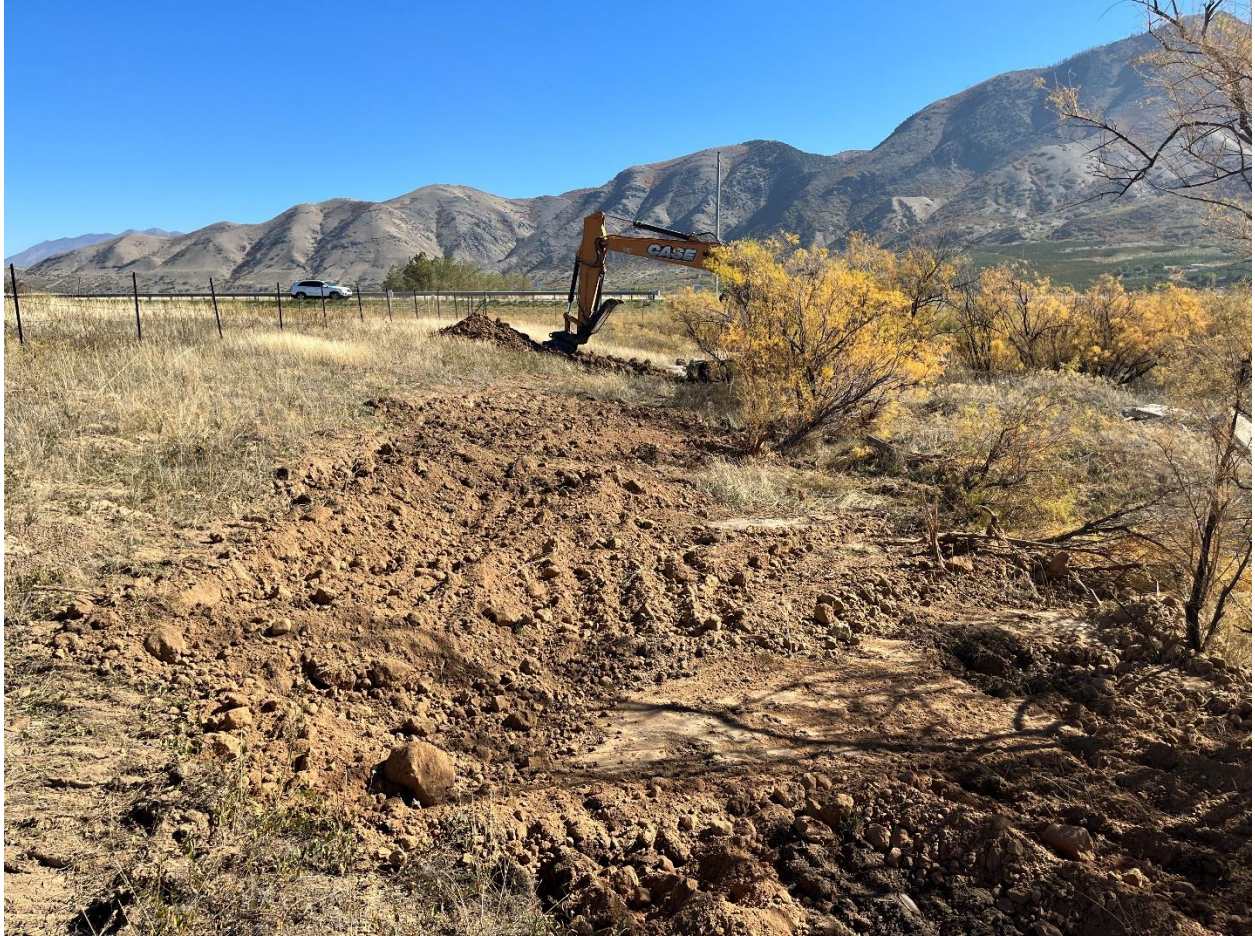
Looking East with Hole 1 filled in foreground and Hole 2 in background on pipe centerline. No surface or subsurface debris within the 50-foot perpetual easement. The edge of the trees are just outside the perpetual easement and within the adjacent 30-foot temporary easement area.

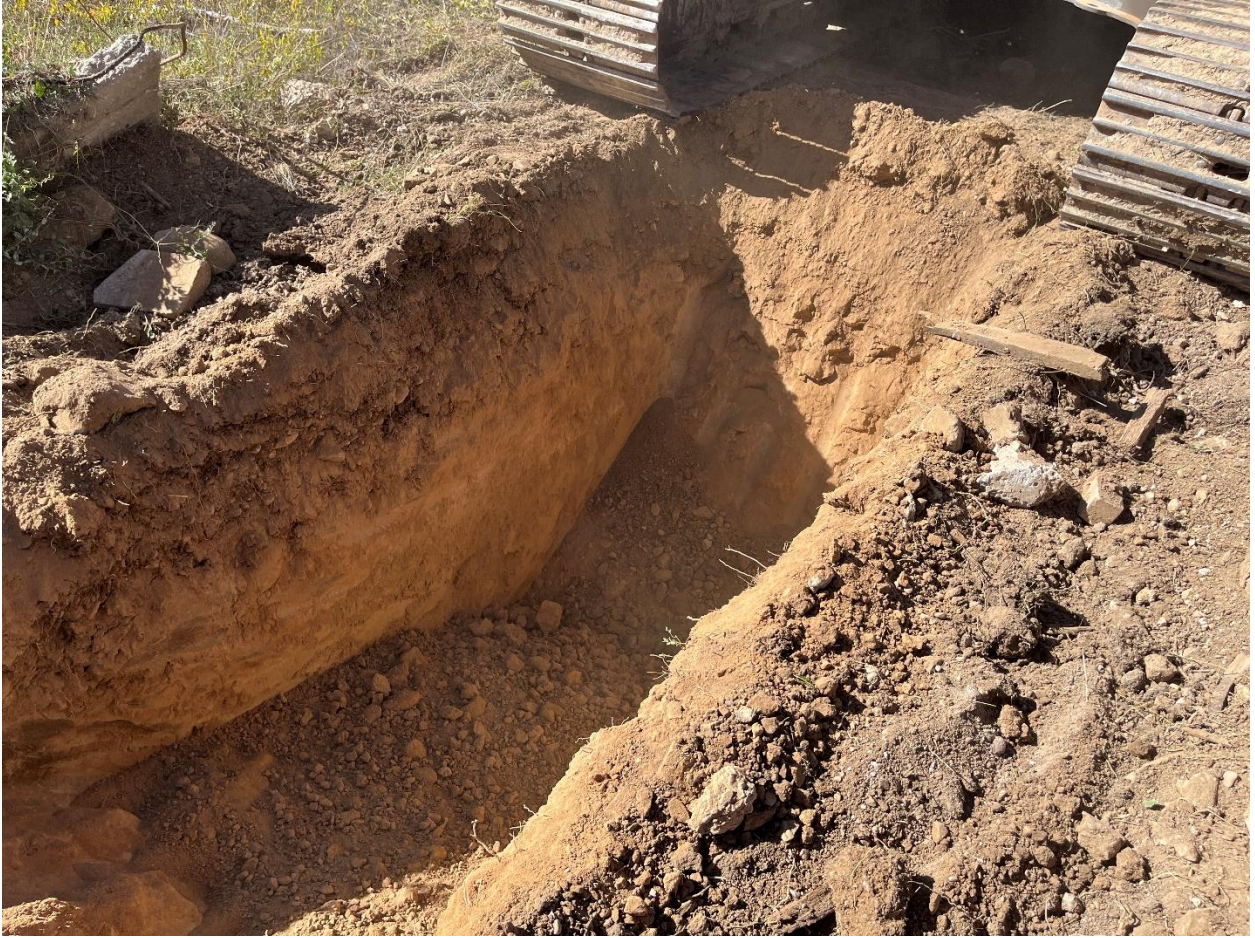
Unsure which hole.

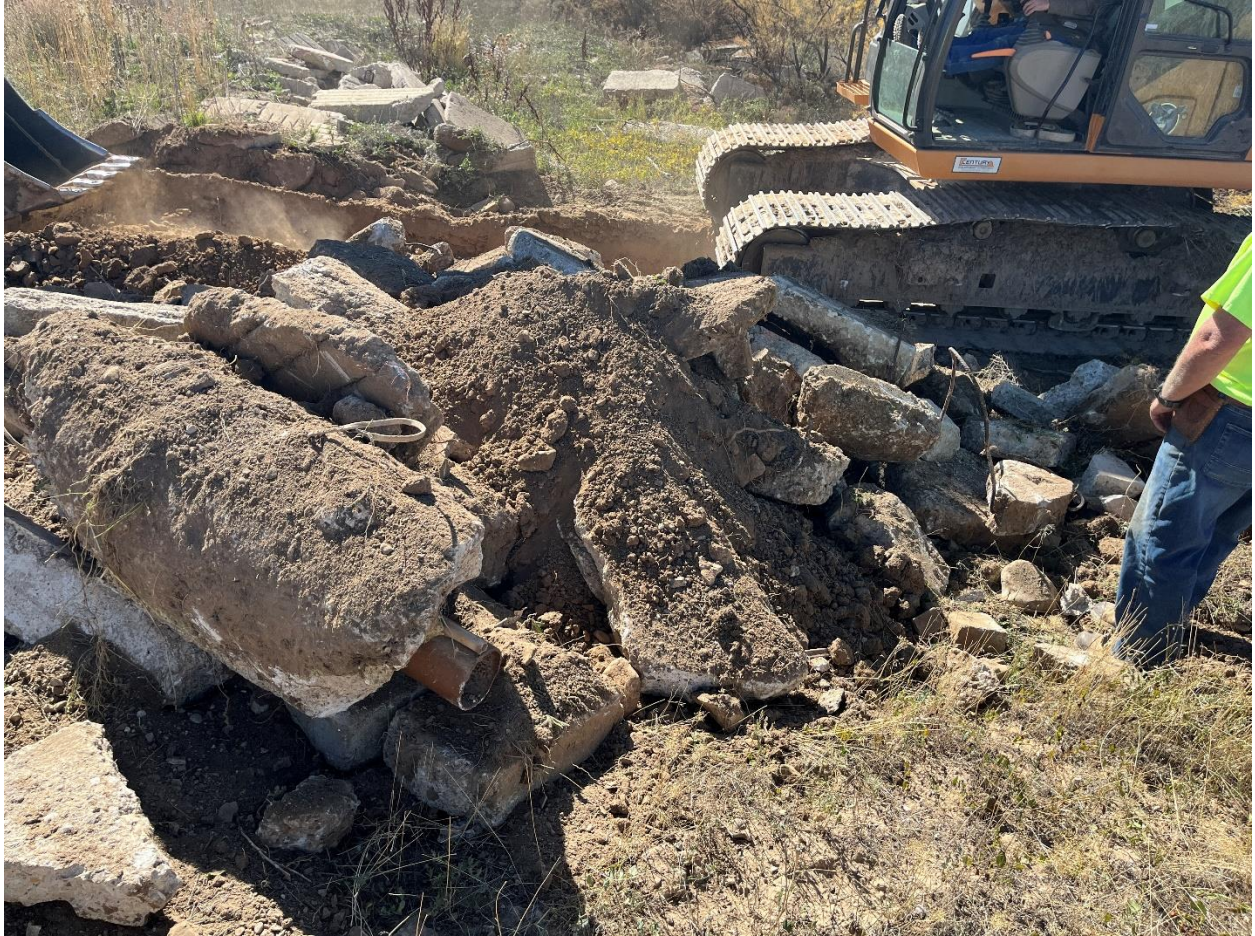
Holes 3 and 4 were excavated where there were surface concrete chunks with some rebar and metal gate posts embedded in concrete. These holes are shown on the attached diagram and were excavated near Station 746+75 and Station 747+00 about 20 feet left of centerline (10 feet outside the perpetual

easement but within the adjoining 30-foot-wide temporary federal easement). These holes were excavated 7 feet deep to about Elevation 4749 and contained the same native tan sandy silt underlying concrete and rebar debris only in the upper 15 inches. Only native soil material was encountered below 15 inches of depth from the surface.

Looking south at trench between Hole 3 and Hole 4. Surface concrete and rebar pile scraped to side to dig down 10 feet and verify that there is not something buried below the surface piles.

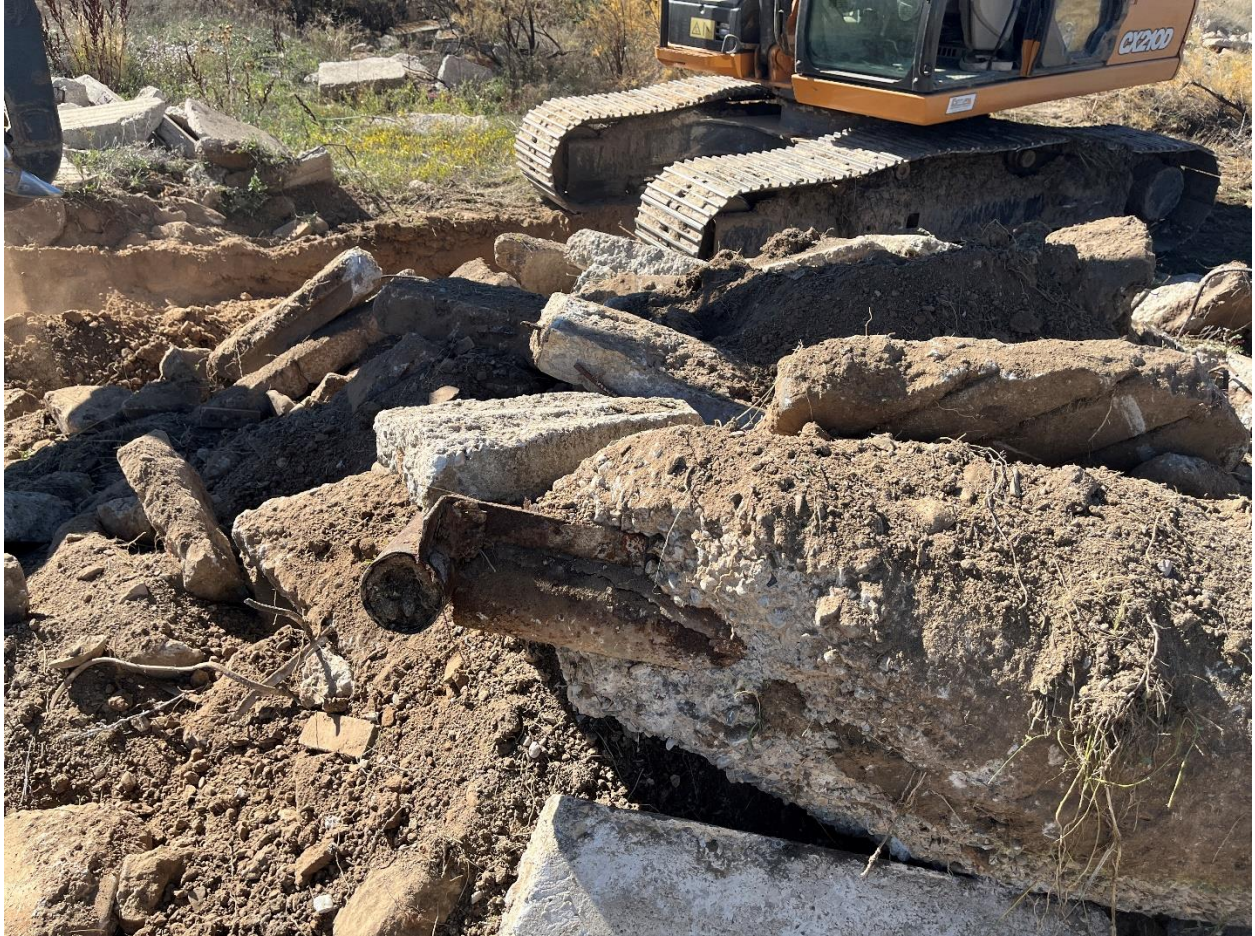
Looking south at trench between Hole 3 and 4. Note some rebar and metal gate post embedded. All material scraped at surface.

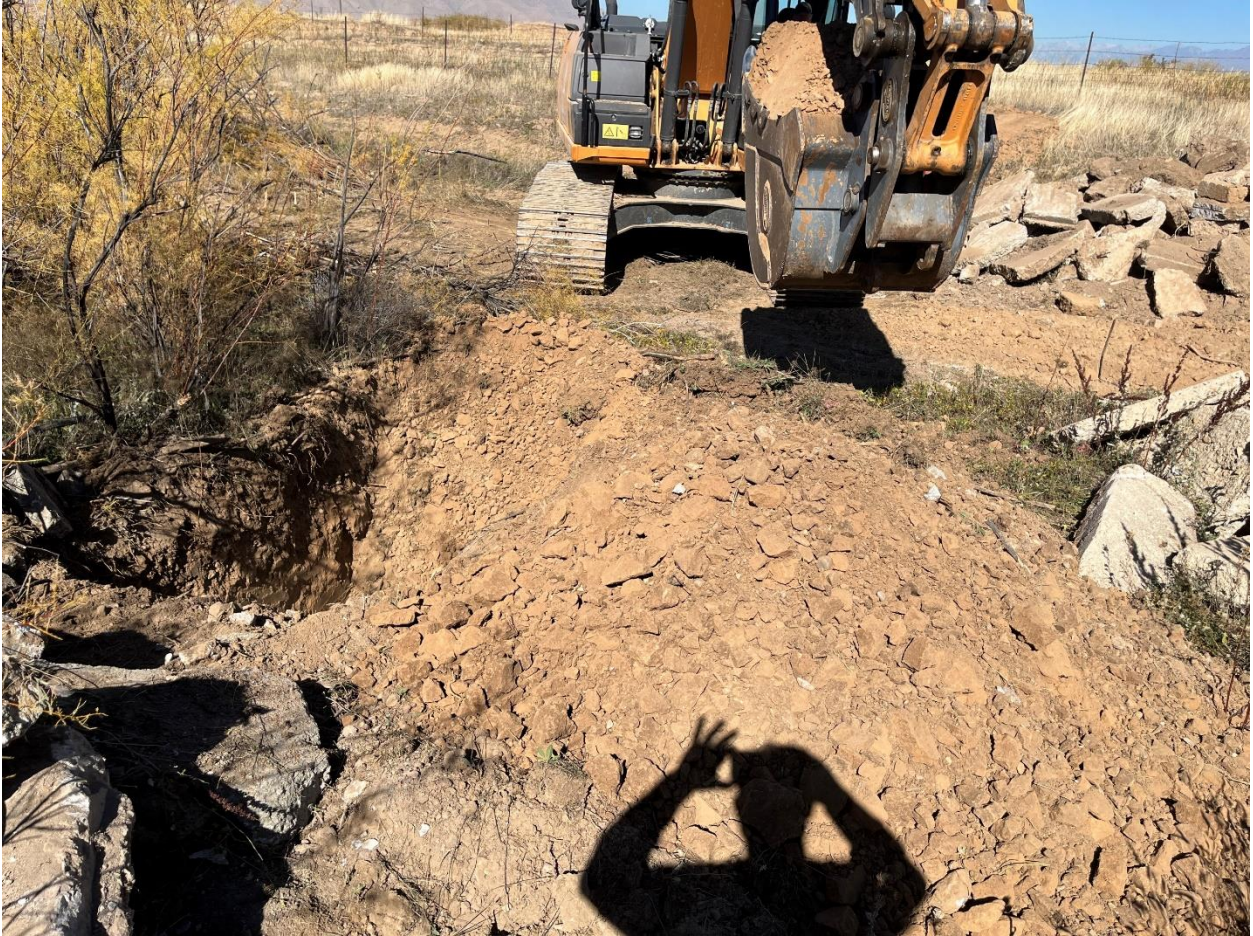
Hole 5 was dug a short distance south at the south edge of the temporary easement at Station 747+00 (about 40 feet south of the Santaquin Pipeline planned centerline). After scraping some surface concrete slab debris, the hole yielded a darker light brown silt that broke into shards rather than the more friable material in the other holes. The hole excavation was stopped at 6 feet of depth when it was apparent that there was no debris below the surface.

Hole 5 looking northwest. Tighter silt.

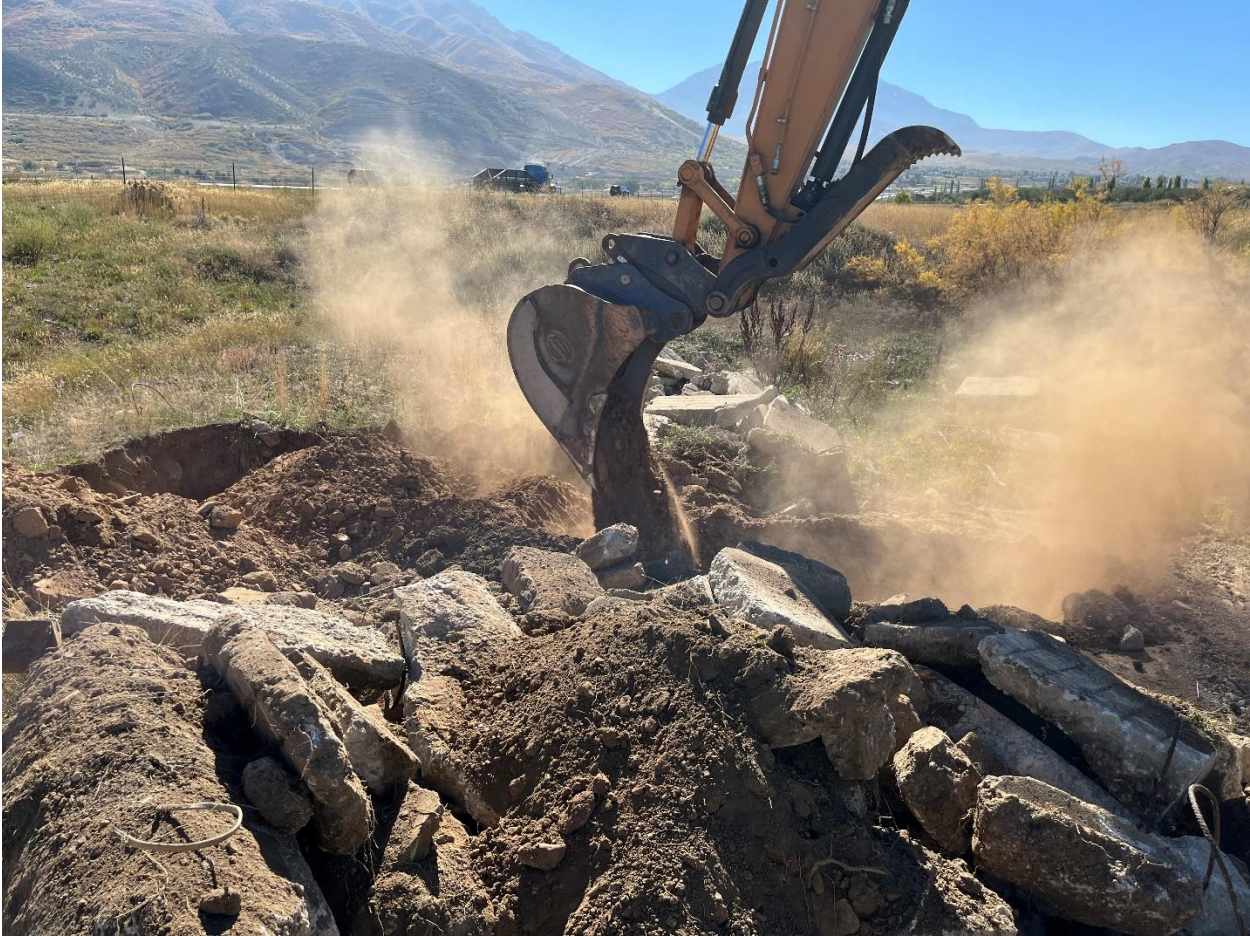
Filling trench between Holes 3 and 4. All surface debris left on surface for construction contractor to remove.

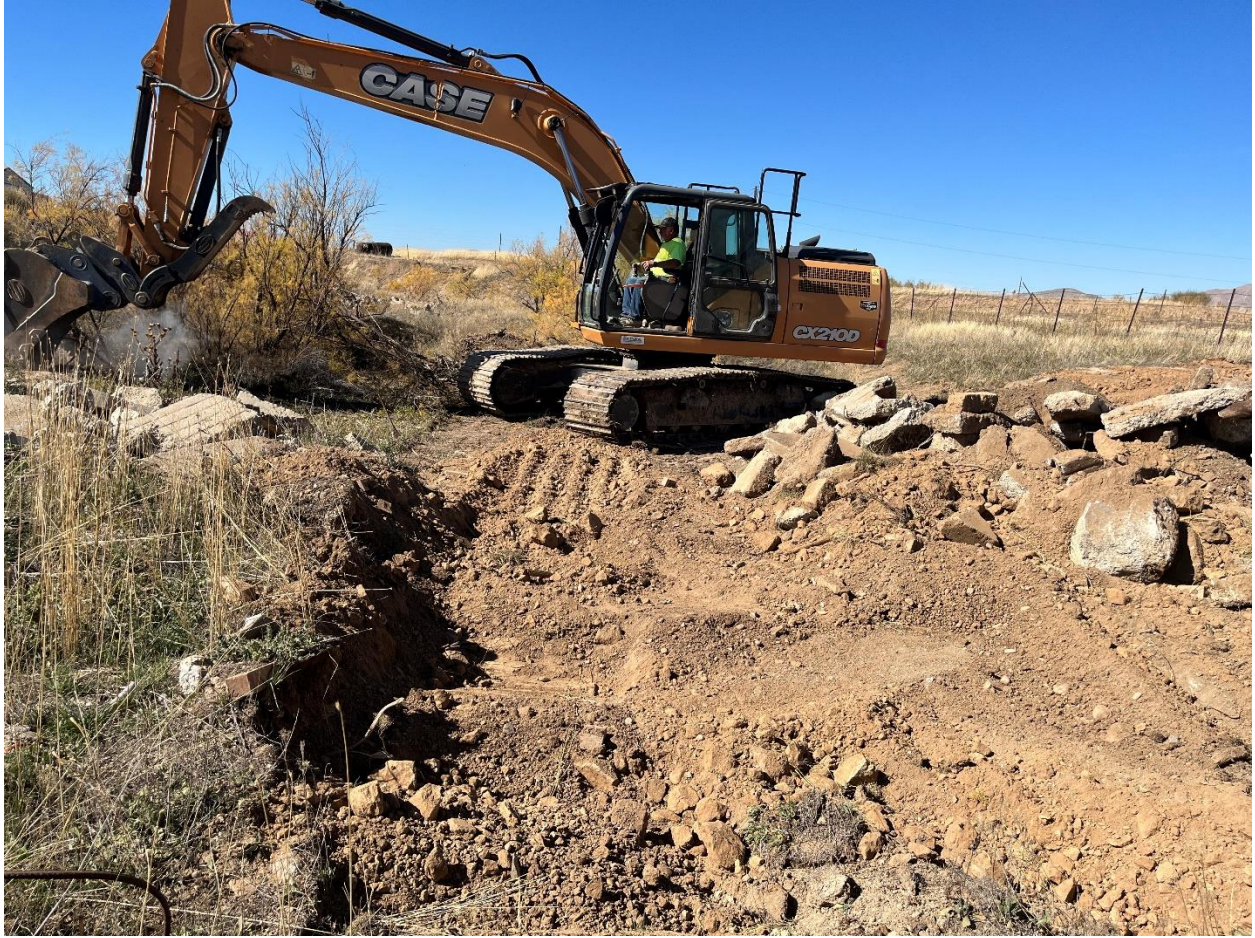
Looking west-northwest at the start of Hole 5. Trench between Holes 2 and 3 that are backfilled is shown.

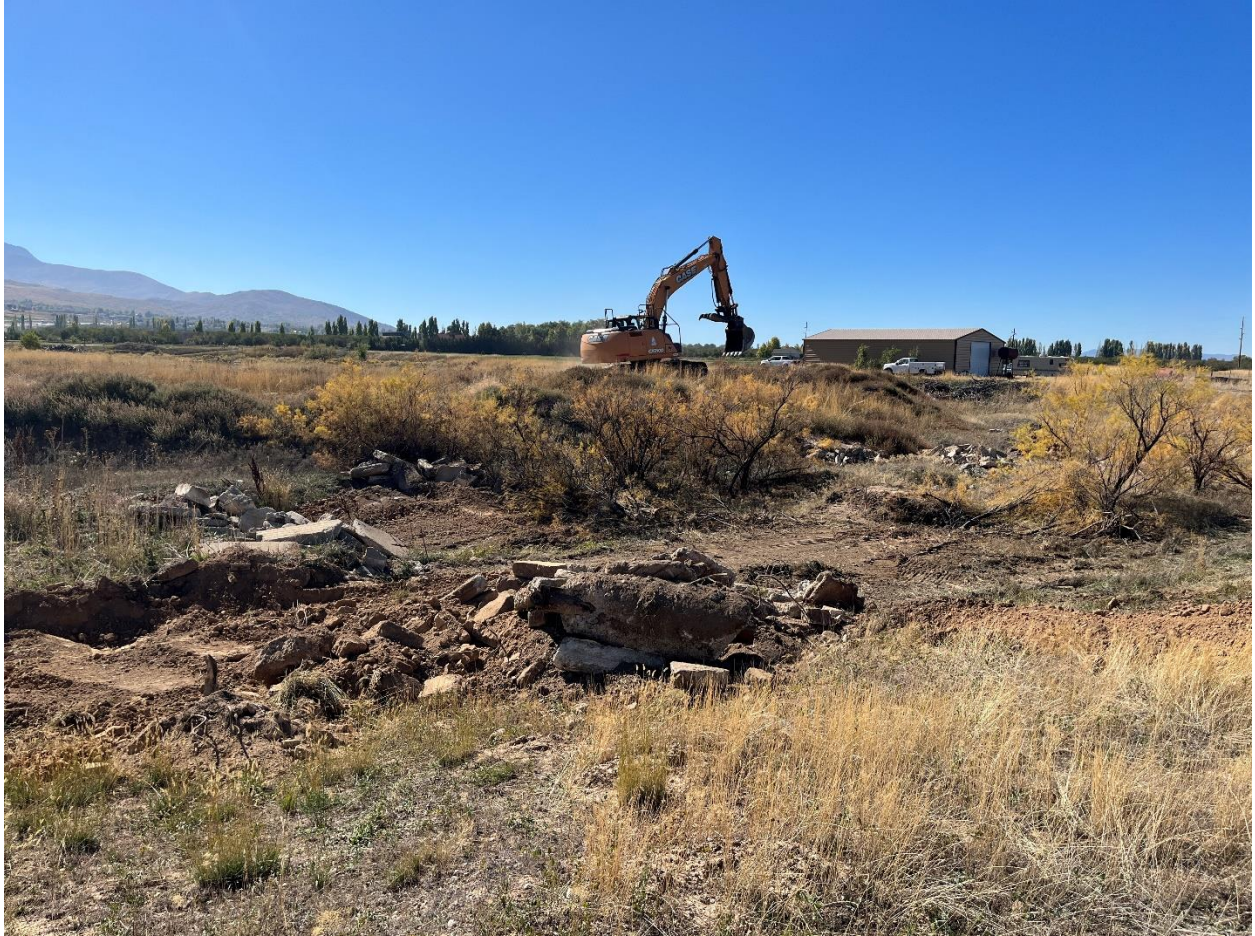
Hole 7 was dug outside the federal easements near Station 747+80 and about 55 feet to the left of centerline (about 15 feet south and outside of the temporary easement) where there was a higher ridge of imported material. The hole yielded brown topsoil the full depth that had apparently been stored for future spreading. No debris was found in the hole.

Looking west-southwest at Hole 7 location on higher filled ground south of federal easement determined to be imported topsoil. Holes 3, 4 and 5 in mid area of photo with surface debris in temporary easement scraped in piles.
