Saratoga, Wyoming

Advanced Measures Technical Assistance

March 2017

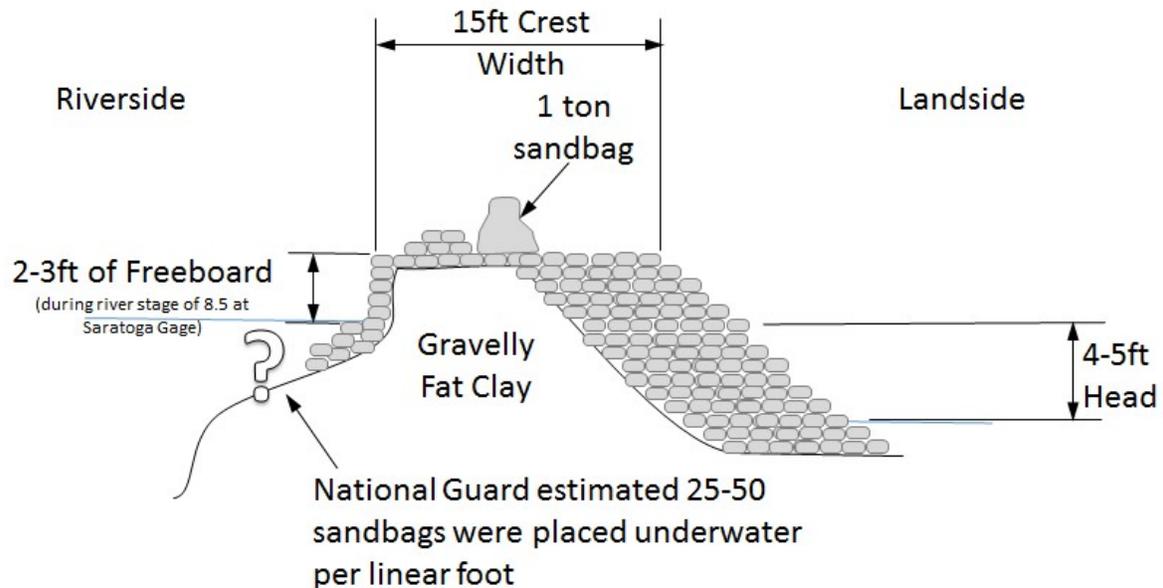
Diagram 1 - The above diagram was obtained from the USACE Saratoga Wyoming Technical Assistance Report, dated May 26, 2016.

NOTE: Flood fight measures were designed to a Saratoga Gage height of 10ft

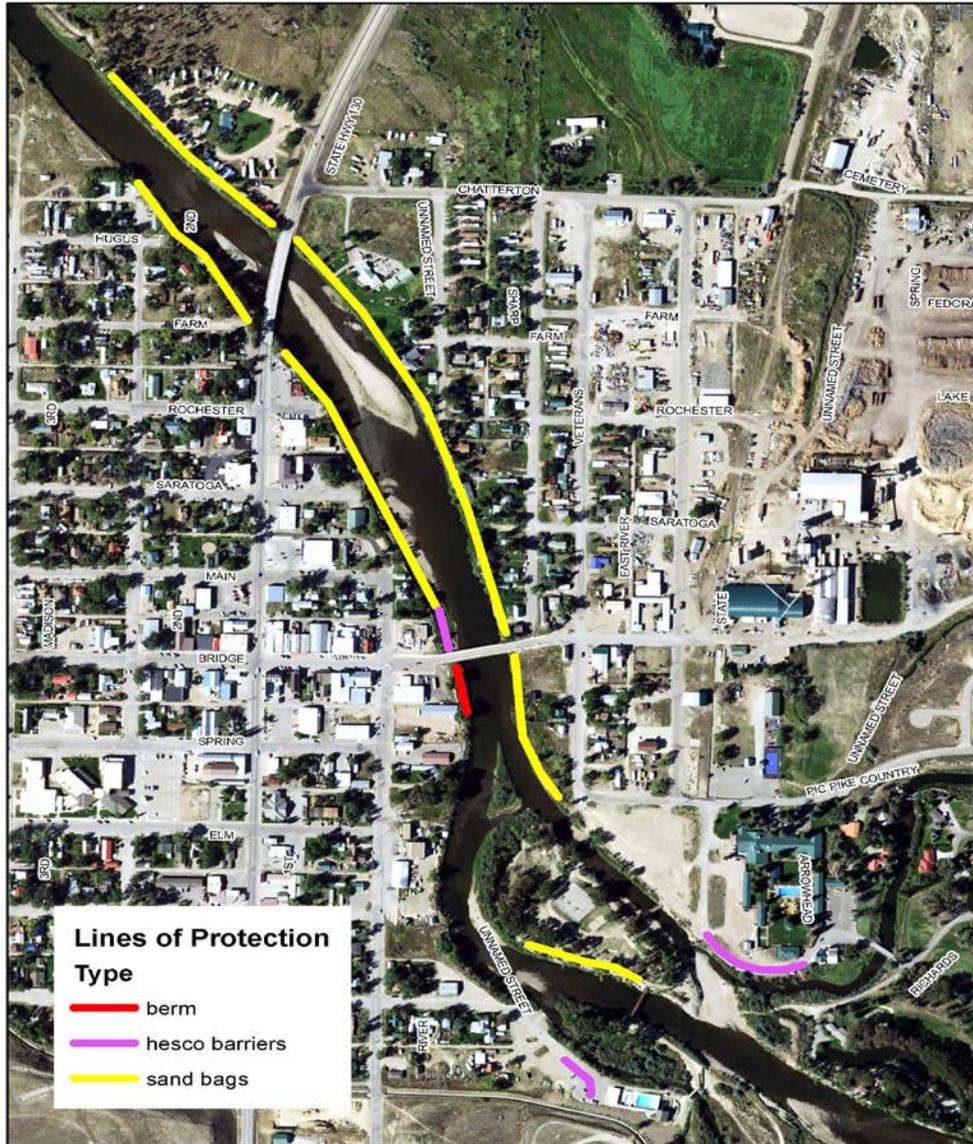
Map 1. Saratoga Lines of Protection – 2016 Flood

5.2 Sandbags and HESCO Baskets: Sandbag berms and HESCO baskets were placed at various locations along the North Platte River left and right banks as shown on the attached map. The sandbags were built to 2 to 3 feet high. This map shows the location of sandbags and HESCO's placed during the 2016 flood and during previous floods in 2010 and 2011 by various agencies, including the Wyoming Office of Homeland Security, the National Guard, and local agencies.

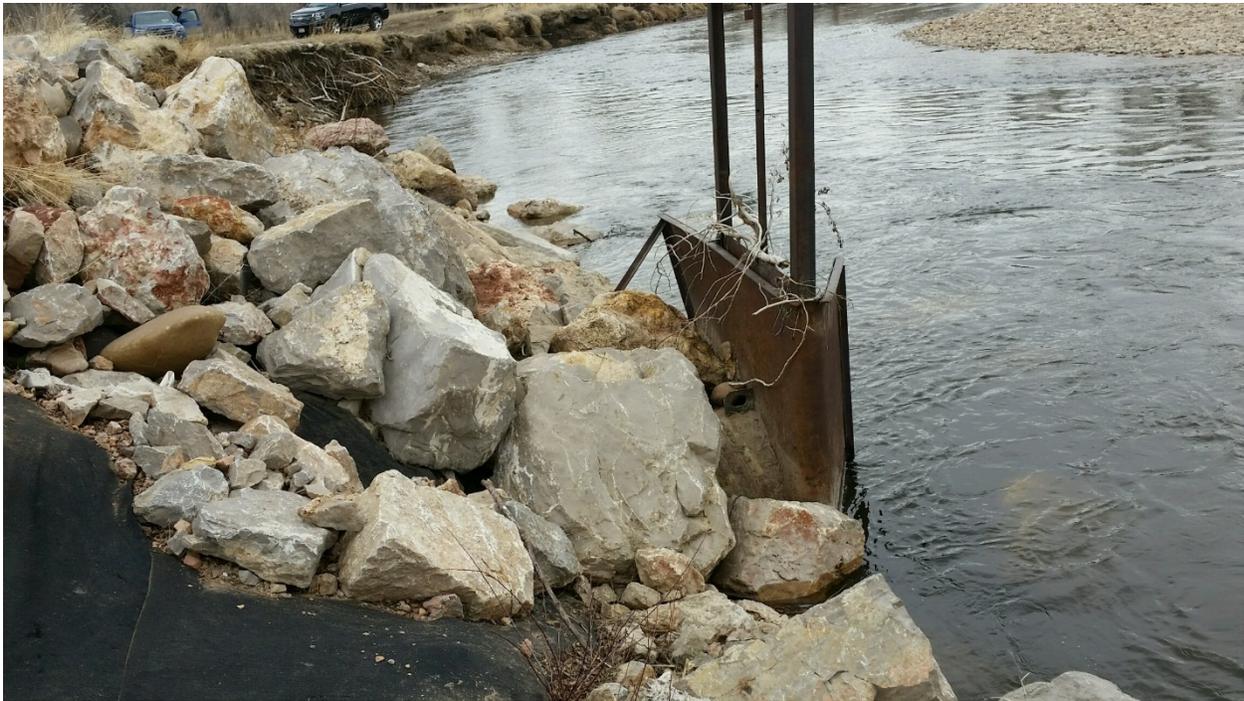
Photo No. 1 – View of the intact, downstream headgate. Riprap on the riverside face starts at this location on the embankment.

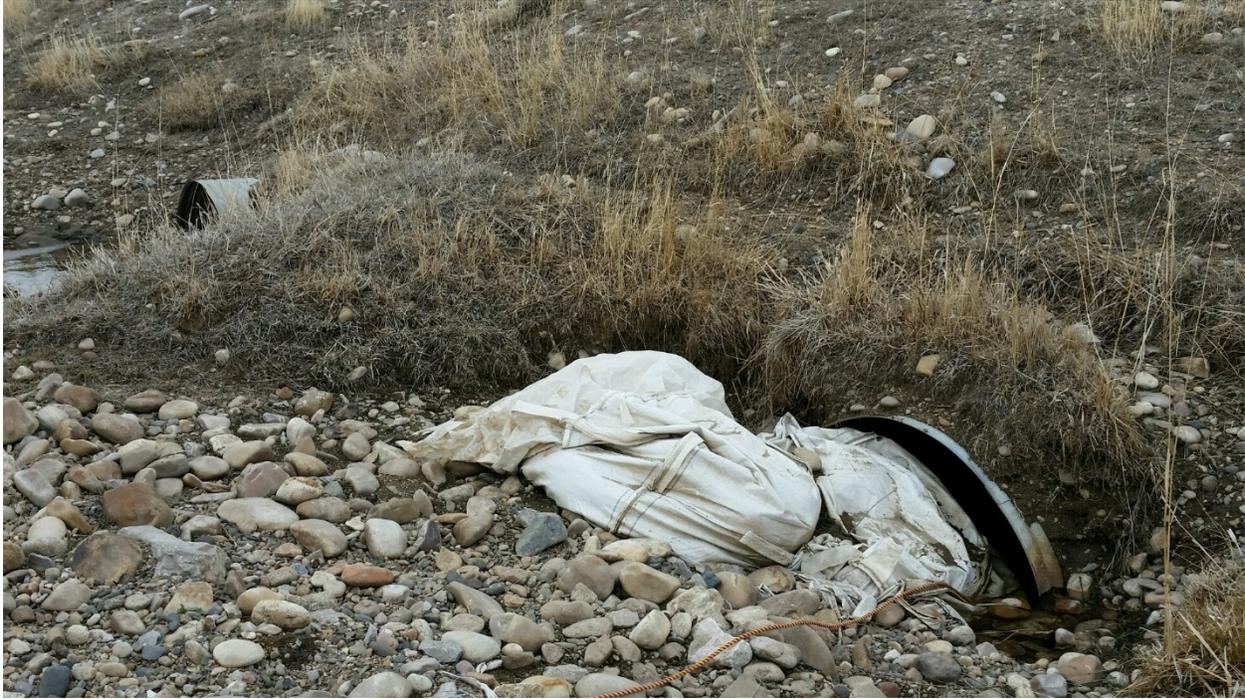
6.1 Boozers Creek: No work has been performed to repair, replace, or properly abandon the two headgates. The downstream headgate shows no signs of damage; however, the gate at the upstream structure was knocked off during the 2016 high water event, leaving no control mechanism at this structure. There are 1-ton sandbags currently located at the conduit entrance, exit, and there is possibly one sandbag inside of the conduit. The sandbag at the downstream end of the conduit is shown in Photo No. 2. Many of the sandbags placed on the riverside, crest, and landside of the berm in 2016 have ripped and/or are deteriorating. See Photos No. 3 and 4. In addition to deteriorating sand bags on the riverside slope, the geotextile filter fabric has ripped at several locations and has been punctured at numerous locations. Movement of sandbags on the riverside vertical slope during the 2016 event and/or deterioration of the sandbags have resulted in areas of exposed, unprotected soil in the embankment. See Photo No. 4.

Photo No. 2 – View of the sandbags at outlet end of the upstream structure.

8.2 Culverts: The two culverts are considered to be an extremely high risk for uncontrolled flows down Boozier Creek. The gate structure at the upstream culvert that broke off of the culvert has not been replaced since the 2016 flood. Currently this conduit is only partially blocked by two or three, 1-ton sandbags. Although the downstream gate structure is still in place, and functional, it also poses a serious risk. With the gate structure protruding into the channel due to scour along the bankline, and the location of the gate along the outside bend in the river, this gate is also subject to severe damage from debris strikes, similar to the upstream gate. To prevent flows through the upstream culvert, and uncontrolled through the downstream culvert should that gate structure be severely damaged or break off, it is recommended that both culverts be filled full with a lean concrete/flowable fill after discussing any permit requirements with the USACE Cheyenne Regulatory Office. Flowable fill is a low strength, high slump concrete mix with Portland cement, water, fine sand aggregate, and fly ash can be added. Mix design specifications can be obtained from Federal Highway Administration and State DOTs. This effort would require removing the sandbags from the upstream culvert; blocking off the downstream end of the culverts with plywood, or some other material; partially blocking the upstream end of the culverts in a manner that will prevent the flowable fill from exiting, but having an opening at the top where the flowable fill would be placed. Depending on the bracing at the ends of the conduits, it may be necessary to place the flowable fill in two lifts, with the second lift being placed after the first lift has started to set. In addition, filling of these culverts with flowable fill will also prevent the potential of embankment materials from piping into the conduits if there are any breaks in the corrugated metal pipe culverts due to corrosion or separation at the joints.

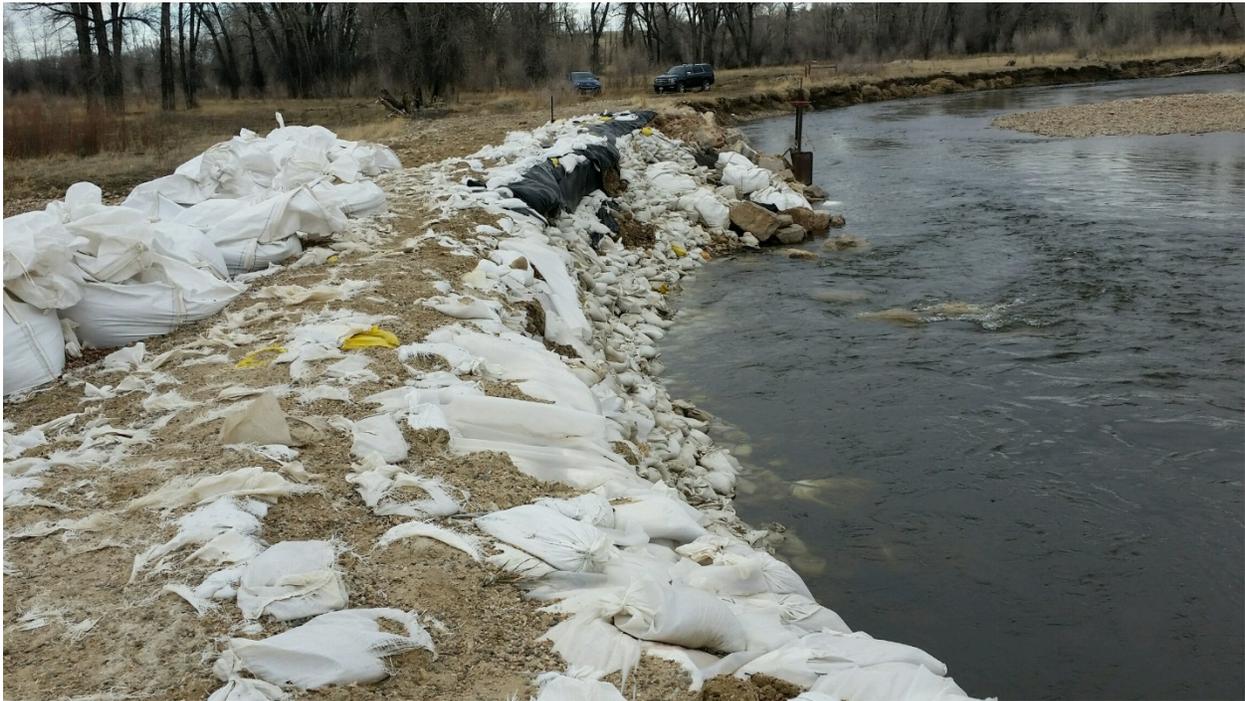
Photo No. 3 – General view of the embankment, looking downstream.

8.4 Embankment Crest and Landside Slope: The crest and landside slope of the embankment is covered with the thick layer of sandbags placed in 2016. See Diagram 1 and Photo No. 3. Many of the sandbags on the surface are deteriorating; however, since the underlying sandbags have been protected from UV degradation, there is a possibility that they may still provide adequate protection. In addition, the row of 1-ton sandbags placed on the narrowest section of the embankment, to serve as launchable riprap should there be a riverside erosion related slope failure, are still in good condition. Based on the short time frame available, in order to act prior to the anticipated high river flows, the following two alternative temporary measures are recommended:

- Some of the sandbags on the crest and landside slope surface should be pulled back and the condition of the underlying sandbags evaluated. If the underlying bags still appear to be sound, an additional two rows of sandbags placed up the entire landside slope may be sufficient to provide stability and seepage resistance. Rows of additional sand bags should also be placed along the crest to assure that overtopping does not occur at this location. The 1-ton sandbags on the levee crest should stay in place.

- IF time permits, there would be a much higher comfort level and probability of the embankment holding during this pending high water event if all of the existing sand bags were removed and a widened levee section was constructed on the landside of the embankment. Prior to the 2016 Flood, the upper three feet of the embankment only had a thickness of approximately five feet. Currently, it can be assumed that the thickness of the embankment is now less than five feet in some areas. This potentially subjects the embankment to slope failures on the riverside face and/or an adverse through seepage condition resulting in piping of embankment material. By placing a full height levee section on the landward slope, the potential of embankment failure could be minimized. It is recommended that a 15 foot wide full height section of compacted clayey soil be placed on the landside slope. Fill material should also be placed on the crest to approximately six inches above the surrounding ground surfaces to limit the possibility of overtopping. This alternative would provide a sufficient embankment section even if some sloughing on the upper portion the riverside slope did occur, and resistance against through seepage piping concerns.

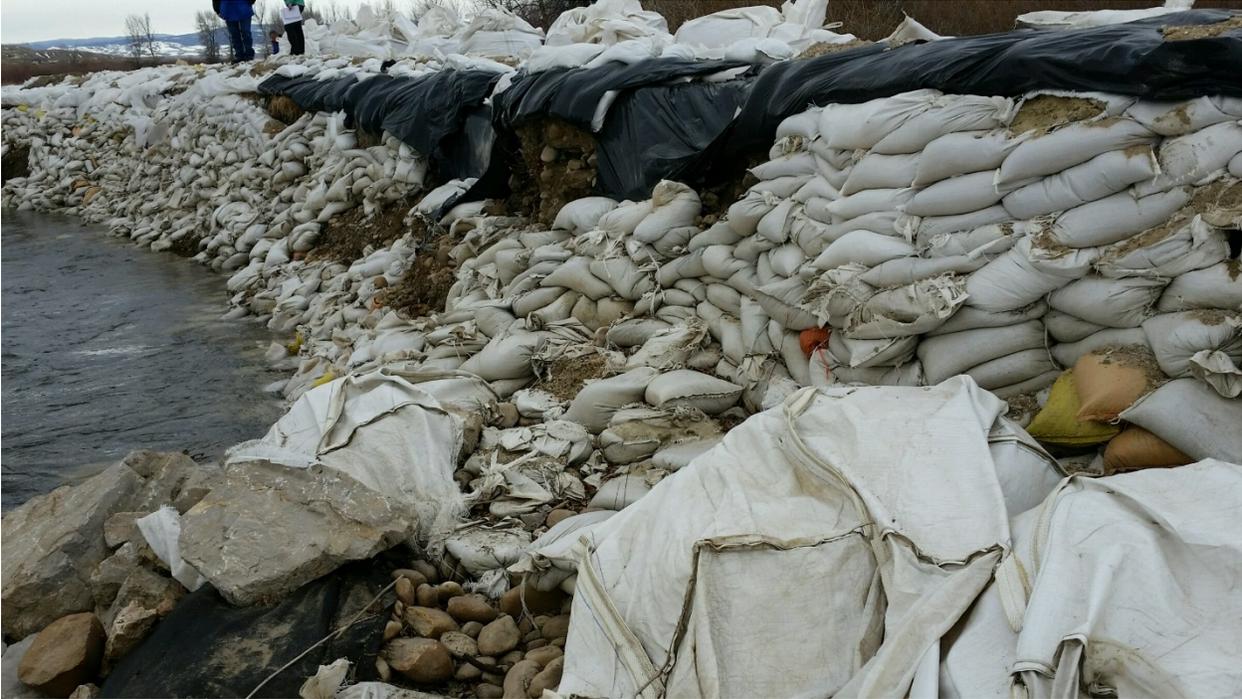
Photo No. 4 – View of the upstream face of the embankment, from near the upstream culvert, looking upstream. Note the vertical embankment face, deteriorating sandbags, and exposed embankment material.

8.3 Embankment Riverside Slope: The upper three feet of the embankment riverside face is vertical and some of the sandbags that were placed in 2016 have fallen into the river, leaving exposed embankment material. At other areas on the riverside face, the sandbags have deteriorated to the point where they would be ineffective of protecting the embankment from erosive forces from river flows or from floating debris. Only placing additional sandbags on the riverside face will not provide adequate protection for the embankment due to the high probability that the sandbags will fall into the river after they are subject to high flow conditions (Reference Photo No. 4). Based on the short time frame available, in order to act prior to the anticipated high river flows, the following two alternative temporary measures are recommended:

- After discussing any permit requirements with the USACE Cheyenne Regulatory Office, stack, place, cover the riverside face of the embankment with sandbags as was performed in 2016, and then place riprap from the base of the embankment up the slope to the top of the embankment. The sandbags if continuously placed and in satisfactory condition, would be confined by the riprap to prevent movement of the sandbags, and would serve as a filter to prevent/limit fine grained soil particles from washing out. The riprap section would require a large base to allow

for sloping of the riprap at the angle of repose of the material to the top of the slope. The size of the riprap would need to be determined; however, previous designs or the gradation of effective riprap sections placed at other nearby areas along the North Platte River could be used as a basis.

- After discussing any permit requirements with the USACE Cheyenne Regulatory Office, remove all of the existing sandbags from the riverside face of the embankment and slope to a relatively smooth slope of no steeper than 1V:2H. This face should then be covered with a geotextile filter and riprap protected. With this alternative, the riprap section would still require establishing a base below water surface; however, the total amount of riprap required would be less since the riprap would be placed on a slope rather than a dumped section. With this alternative, the filter fabric would provide a more consistent layer of filtration.

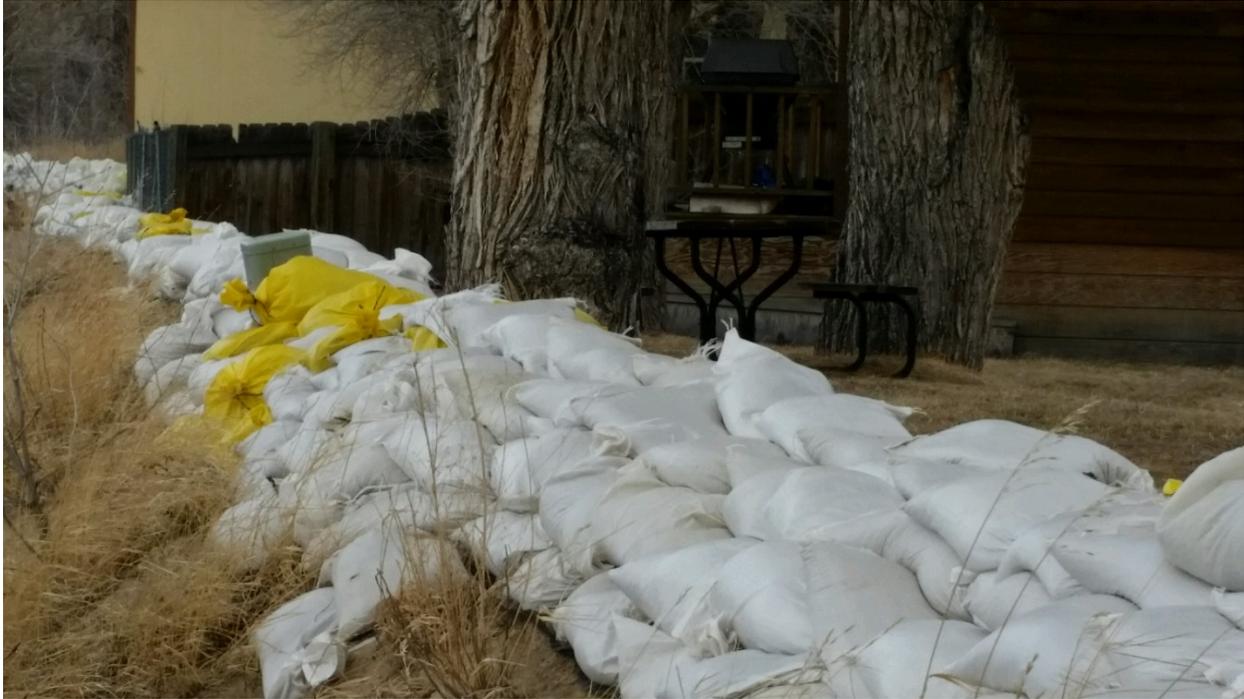
6.2 Hesco's and Sandbags: All of the Hesco baskets placed in 2016 have been removed; however, the majority of the sandbags placed in 2016 are still in place. Some of these sandbags still appear to be in satisfactory condition, while others have deteriorated. It was noted during the site visit that the 2016 sandbags were placed along the same alignment and, in many cases, on top of sandbags that were placed during 2010 and 2011 flood fights. See Photos No. 5 and 6.

Photo No. 5 – View of 2016 sandbags that are still in satisfactory condition.

- The majority of the sandbags placed in 2016 are still in place. It is recommended that the condition of these sandbags and the continuous line of protection are verified along both sides of the North Platte River. Areas of deteriorating sandbags may still be utilized by wrapping the existing sandbags with visqueen and anchoring the visqueen with new sandbags.

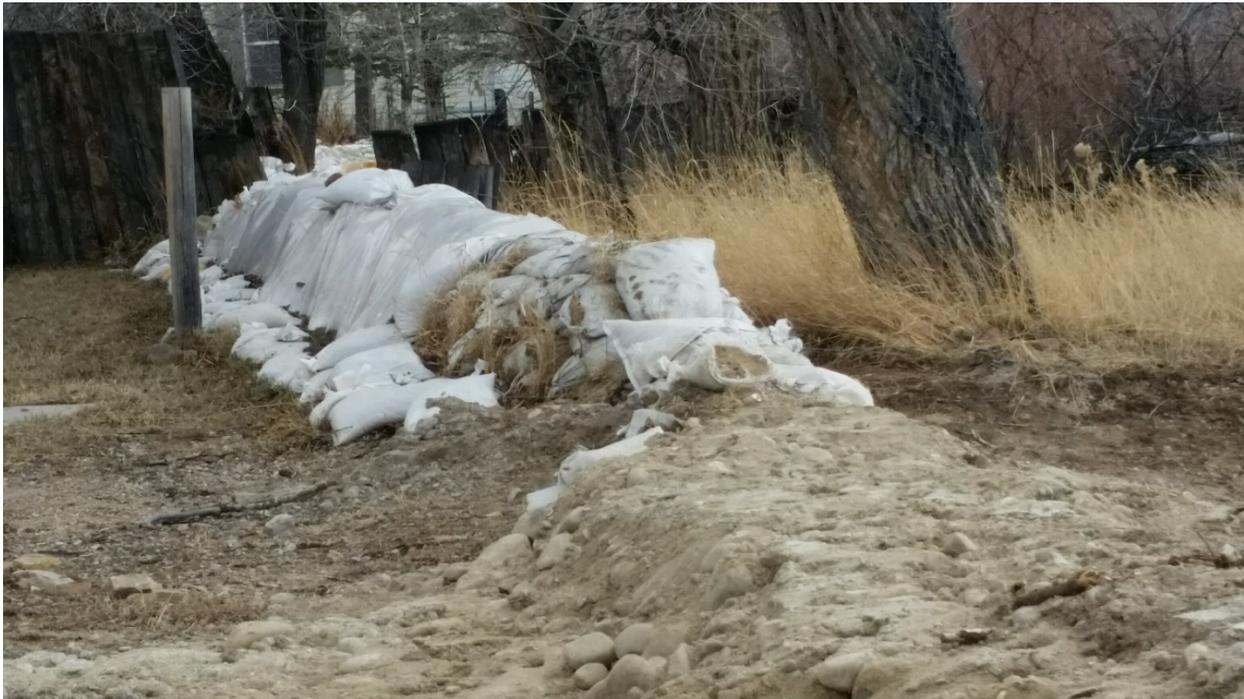
Photo No. 6 – View of 2016 sandbags that are badly deteriorating, and an adjacent area where a portion of the sandbags have been removed.
