**Draft**  
**Saxman Sewer Condition Assessment**

May 24<sup>th</sup>, 2024

**Stephl Engineering, LLC.**  
**3900 Arctic Blvd., Suite 204**  
**Anchorage, Alaska 99503**  
**907-562-1468**

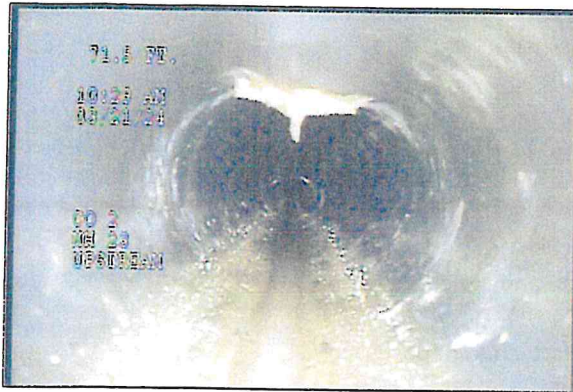
*CO 2 to MH 23, 1-2" bulge in pipe with mineralization*

| Saxman Sewer Pipe Summary Table | | | | | | | | | | LOF Score: 0=No defect, 1=Minor Defect, 2=Minor to moderate Defect, 3=Moderate defect, 4=Significant defect, 5=Most significant defect | | | | | | | | | |
|---|---|---|---|---|---|---|---|---|---|---|---|---|---|---|---|---|---|--|--|
| CO 2 | MH 23 | Wolf Ave. | 8 | HOPE Truss Pipe | 306 | No | March 2024 | 102 | Upstream | <1 | 3 | 2 | - 15 LF, 12% cavity at joint<br>- 74 LF, 1-2" bulge with mineralization at 12:00 position<br>- 67 LF, 1" bulge at 11:00 position<br>- 102 LF, 2x4" hole with 1-2" of soil protruding from 10:00 to 12:00 position | | | | | | |

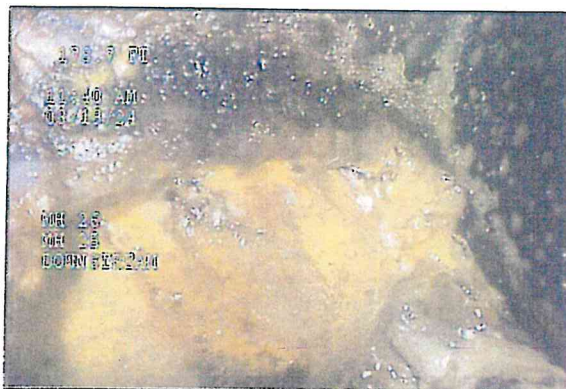
*MH 26 to MH 25, infiltration runner*

| Saxman Sewer Pipe Summary Table | | | | | | | | | | LOF Score: 0=No defect, 1=Minor Defect, 2=Minor to moderate Defect, 3=Moderate defect, 4=Significant defect, 5=Most significant defect | | | | | | | | | |
|---|---|---|---|---|---|---|---|---|---|---|---|---|---|---|---|---|---|--|--|
| MH 26 | MH 25 | Eagle St. | 8 | DI | 380 | Yes | March 2024 | 373 | Downstream | 1 | 2 | 2 | - 125 LF, staining/surface corrosion from 7:00 to 9:00 position<br>- 178 LF, infiltration runner at service connection at 1:00 position<br>- 281 LF, mineralization with infiltration dipper at service connection at 12:00 position<br>- 281 LF, mineralization with infiltration dipper at service connection at 12:00 position | | | | | | |

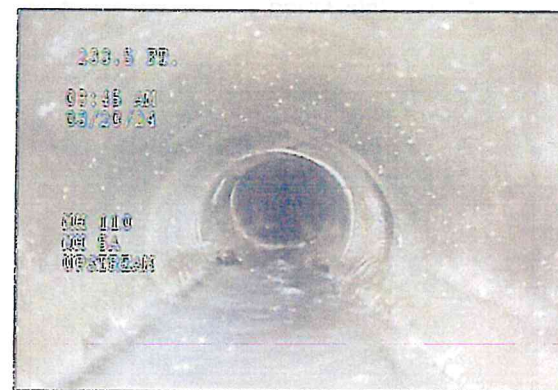
*MH 110 to MH 5A, belly*

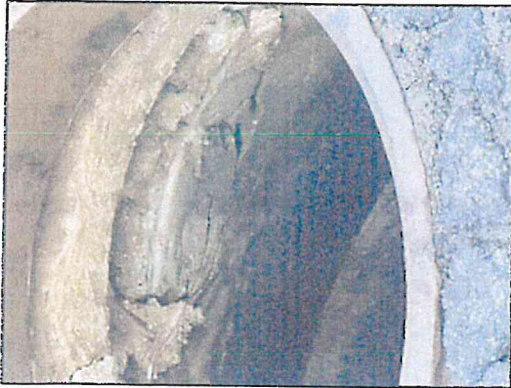
*MH 101, cone damage*

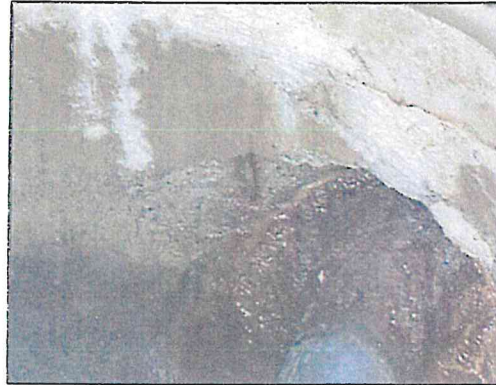
*MH 105, exposed rebar*

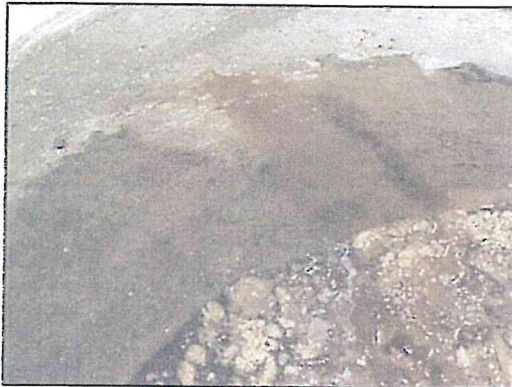
*MH 110, infiltration*

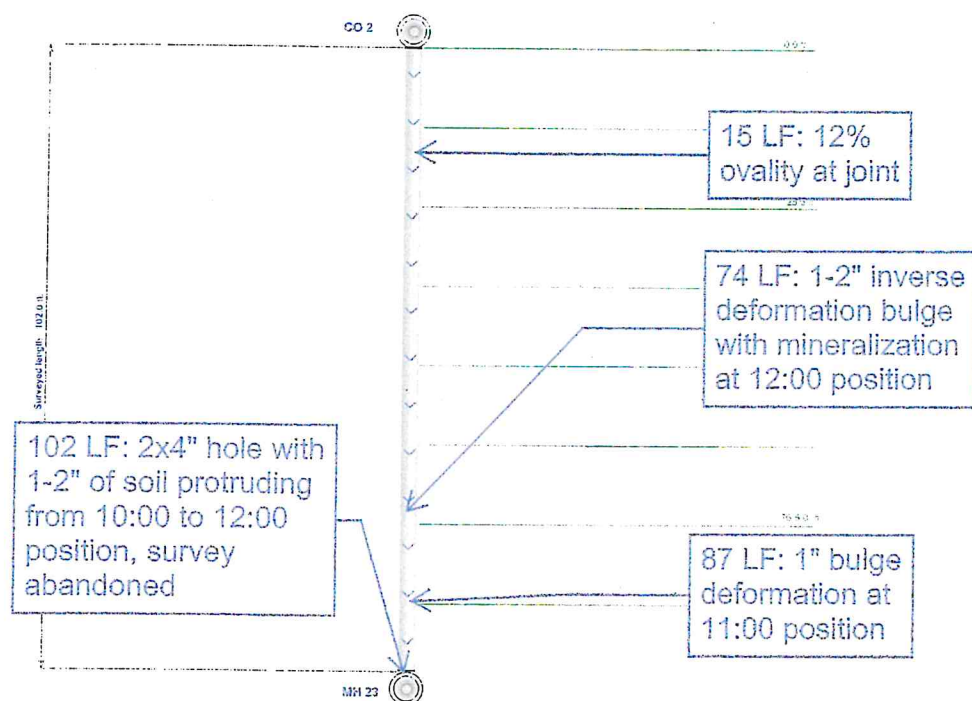
| Project Name:<br>Saxman Sewer | Pipeline segment ref:<br>CO 2 to MH 23 | City:<br>Saxman | Street:<br>Wolf Ave. |

- Water level <1" from 0 LF to 102 LF
- Grade: 3

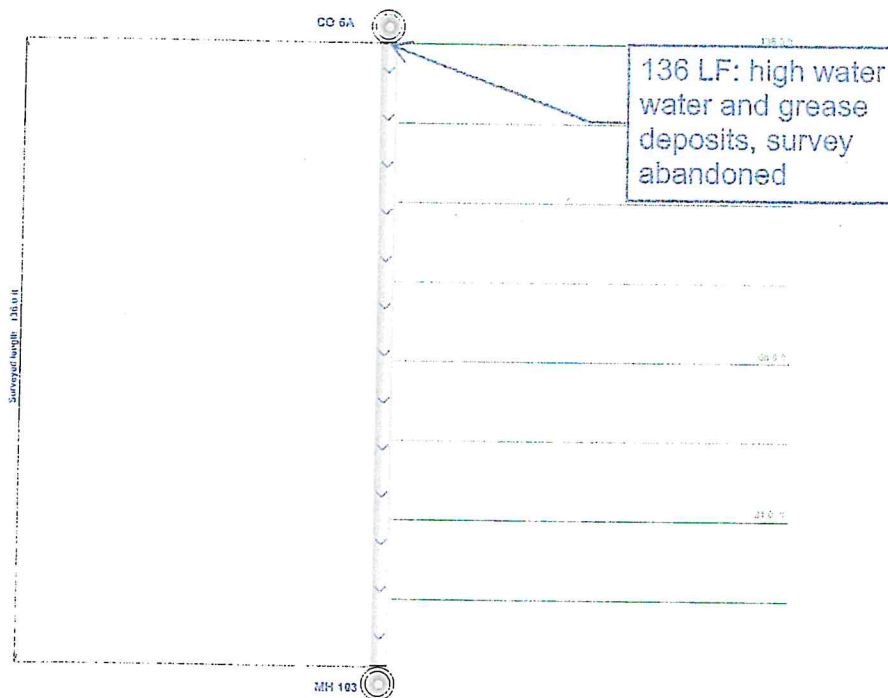
| Saxman Sewer | CO 6A to MH 103 | Saxman | Killer Whale Ave. |

- Water level <1" from 0 LF to 37 LF, 66 LF to 91 LF, 2-3" from 37 LF to 66 LF, 4-5" from 91 LF to 136 LF
- Grease deposits at 3:00 and 9:00 position from 42 LF to 66 LF, 91 LF to 136 LF
- Grade: 2

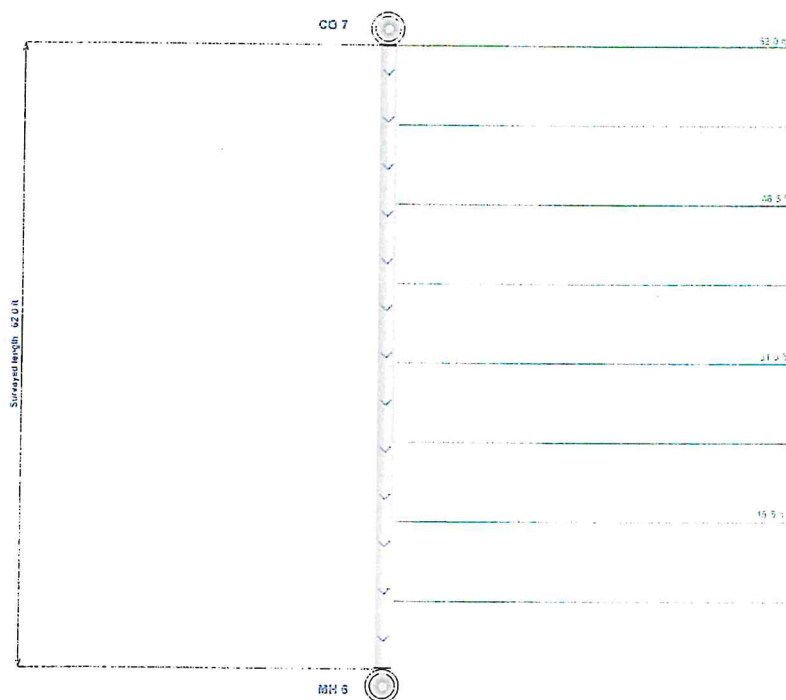
| Project Name:<br>Saxman Sewer | Pipeline segment ref:<br>CO 7 to MH 6 | City:<br>Saxman | Street:<br>Raven Ave. |

- Water level 1" from 0 LF to 7 LF, <1" from 7 LF to 62 LF
- Grease deposits at 5:00 and 7:00 position from 0 LF to 9 LF
- Grade: 1

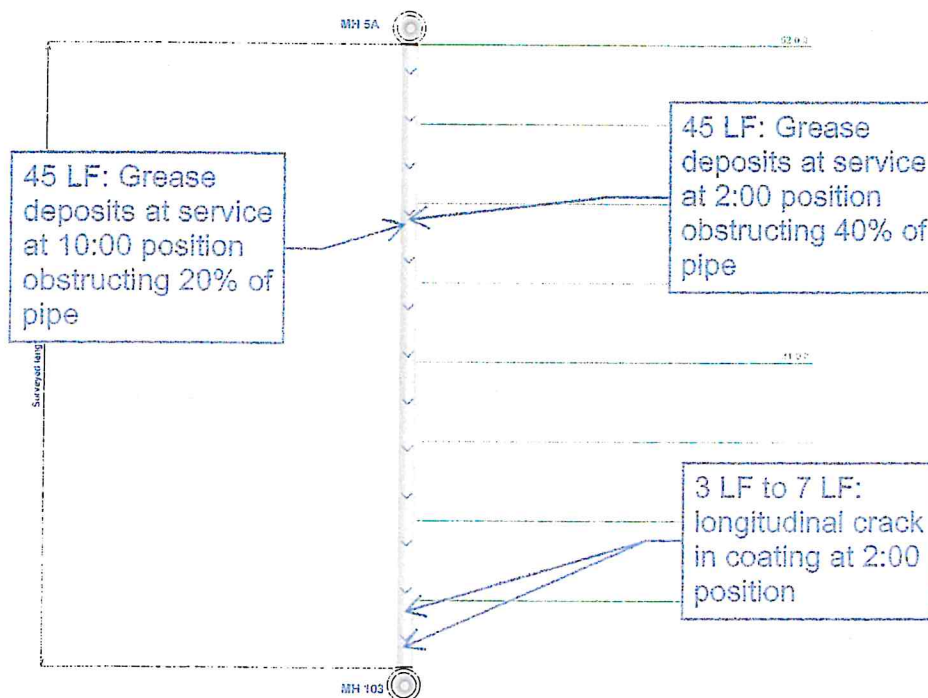
Pipeline segment ref:  
MH 5A to MH 103

- Water level 4" from 0 LF to 13 LF, 1-2" from 13 LF to 62 LF
- Grease deposits at 5:00 and 7:00 position from 17 LF to 62 LF
- Grade: 2

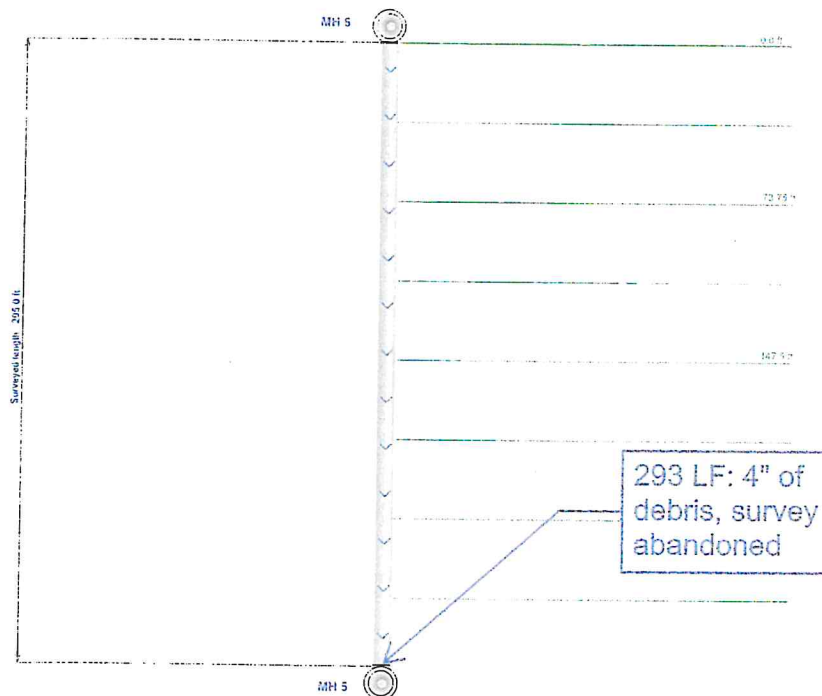
| Saxman Sewer | MH 6 to MH 5 | Saxman | Tongass Hwy. |

- Water level <1" from 0 LF to 272 LF, 2-3" from 272 LF to 293 LF
- Grease deposits at 5:00 and 7:00 position from 150 LF to 169 LF, 237 LF to 241 LF, 272 LF to 295 LF
- Grade: 1

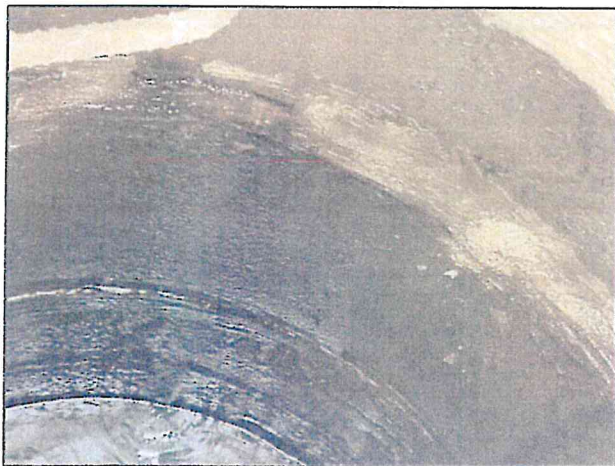
*Image 5 – Barrel section infiltration*

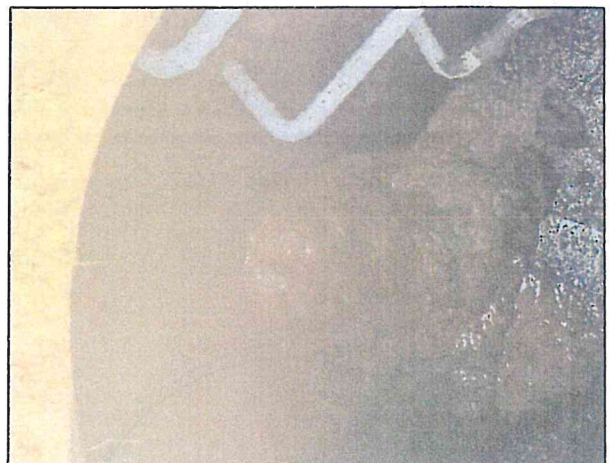
*Image 6 – Infiltration deposits*

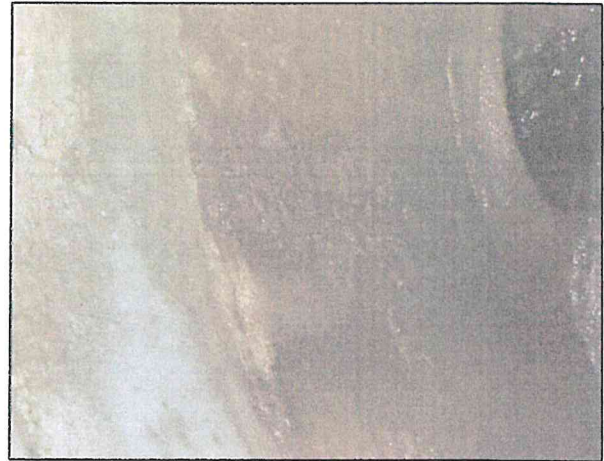
*Image 4 – Connection 2, joint infiltration*

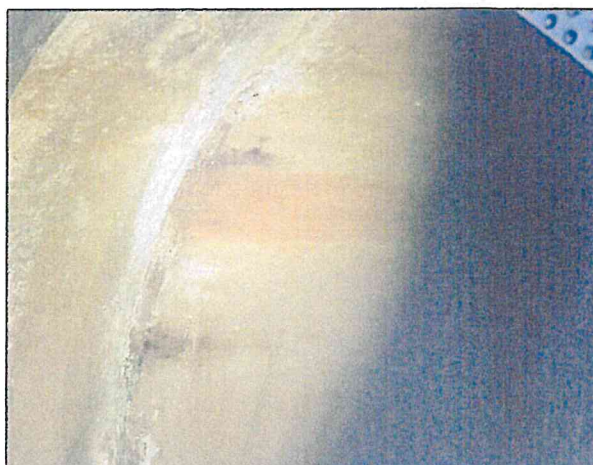
*Image 6 – Cone and barrel section infiltration*

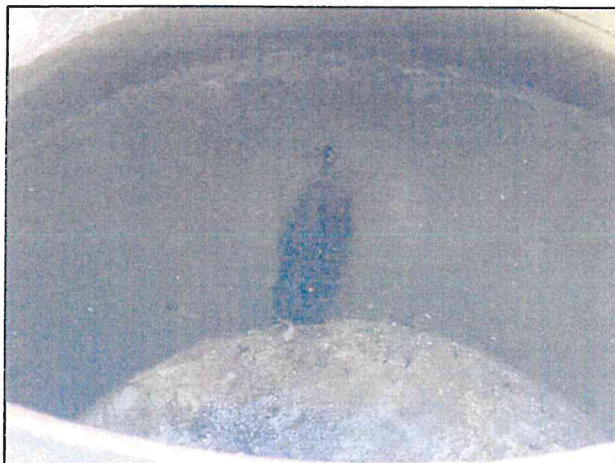
*Image 5 – Base infiltration*

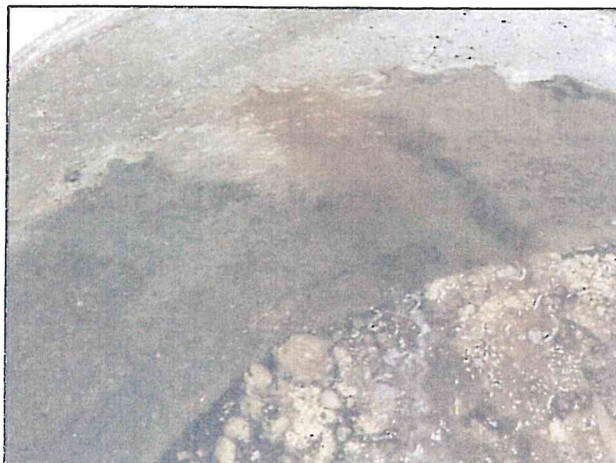
*Image 5 – Base infiltration*
