Date: September 9, 2022
To: Joe Trueblood, Utility Superintendent
From: Bill Swearingen, Operations Supervisor
Subject: Filter 5 Summary Report

This report is meant to provide a timeline of events in identifying filter #5 IMS cap failures and discussions with the underdrain representative and manufacturer.

Filter 5 Event Timeline

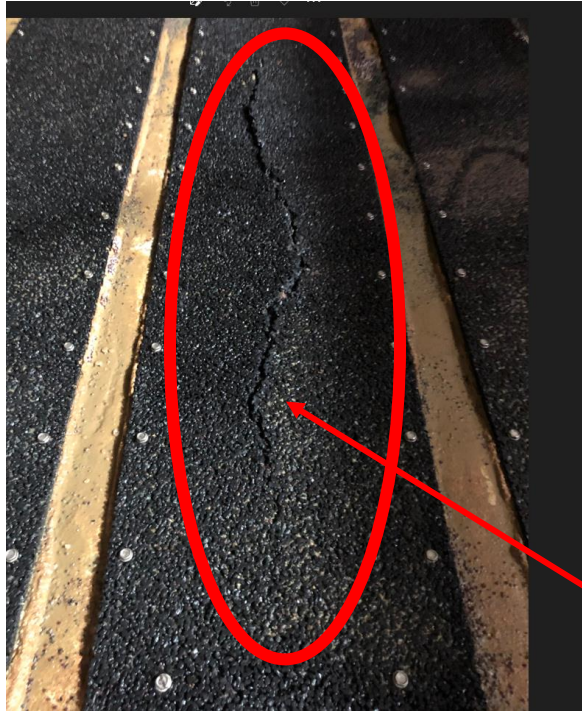
IMS Cap Failure

One IMS cap fail.

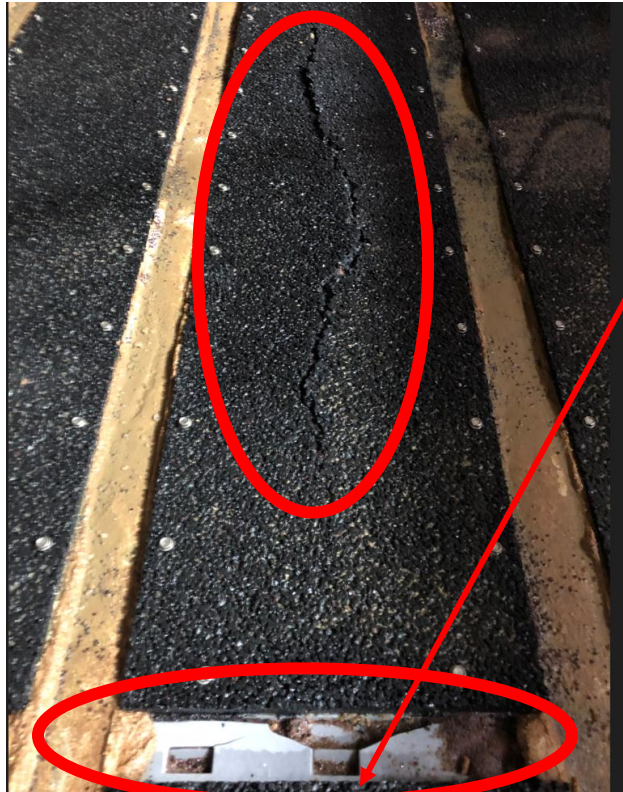
No grout is present at the filter underdrain bell/spigot connection.

Filter underdrain bell/spigot connection is also cracked in multiple areas

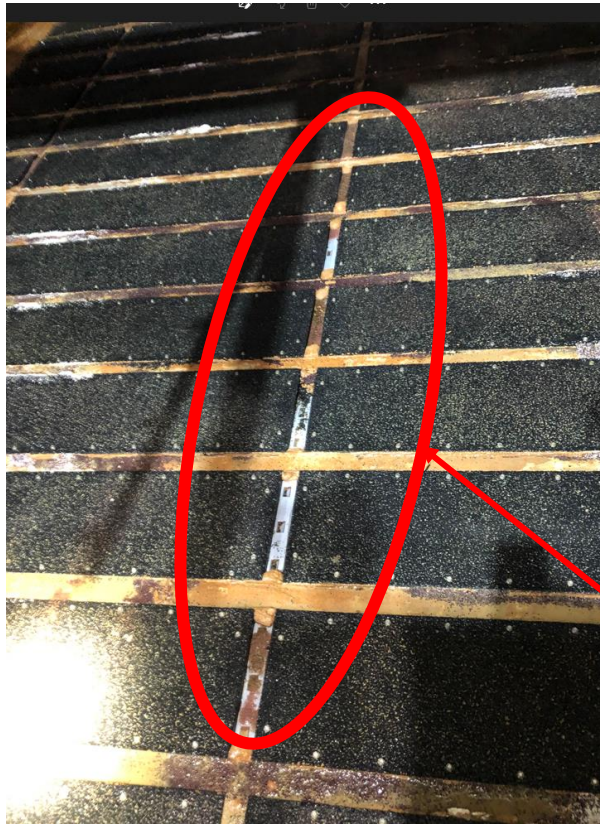
Filter underdrain bell/spigot connection, grout, & sealant failure

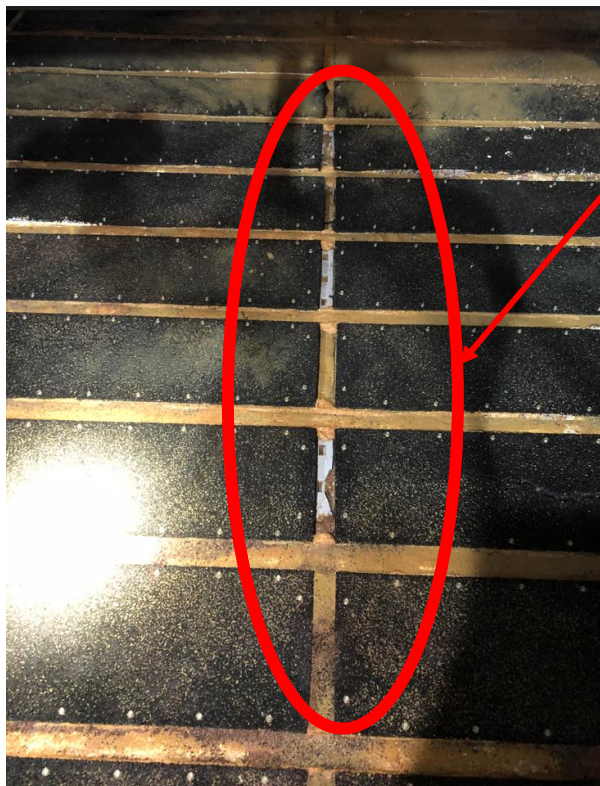
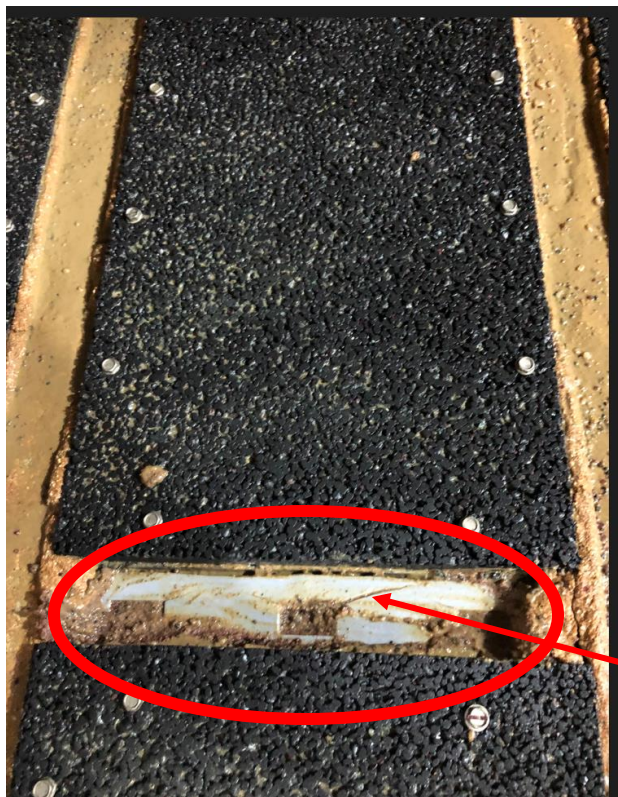
No grout is present at the filter underdrain bell/spigot connection.

Filter underdrain bell/spigot connection is also cracked in multiple areas

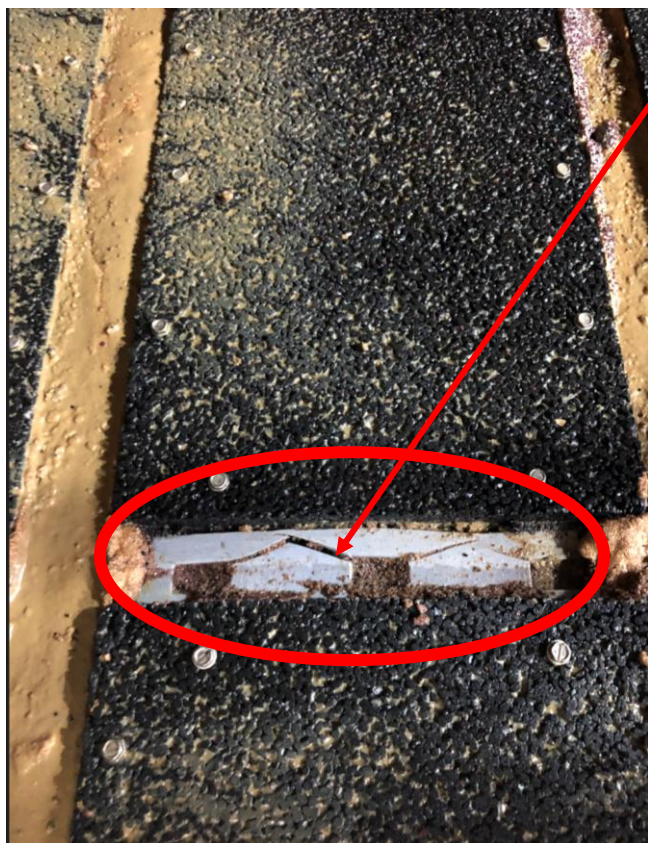
No grout is present at the
filter underdrain
bell/spigot connection.

Filter underdrain
connection is cracked

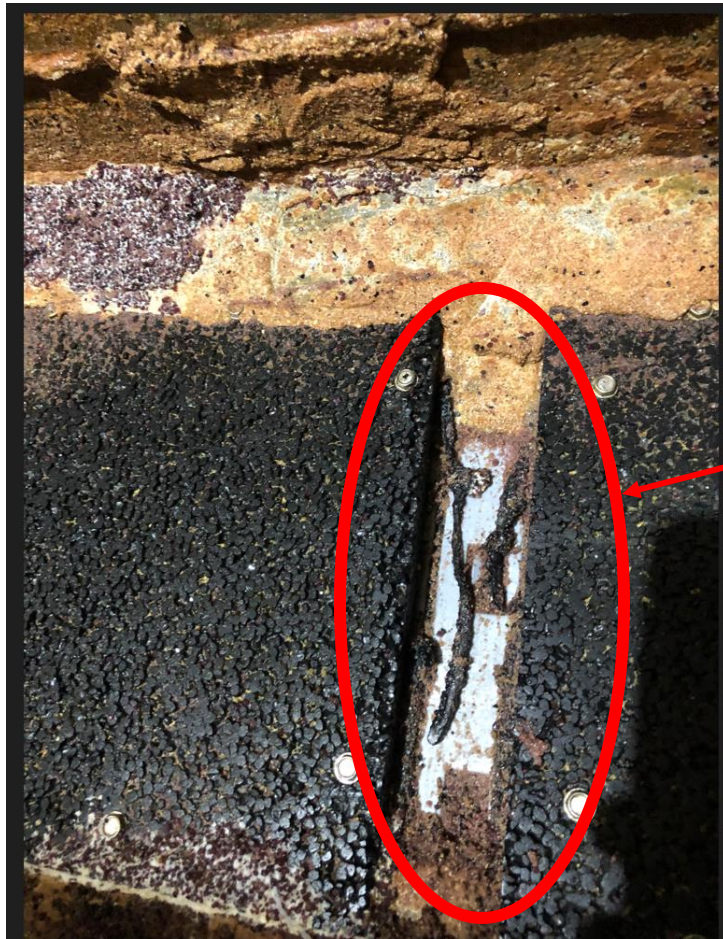
No grout is present at the filter underdrain bell/spigot connection.

Sealant material is present and appears to have failed.
