**Underdrain and IMS Cap  
Trip Report**

## **Filter #6**

**Sheboygan WTP**

**February 14, 2023**

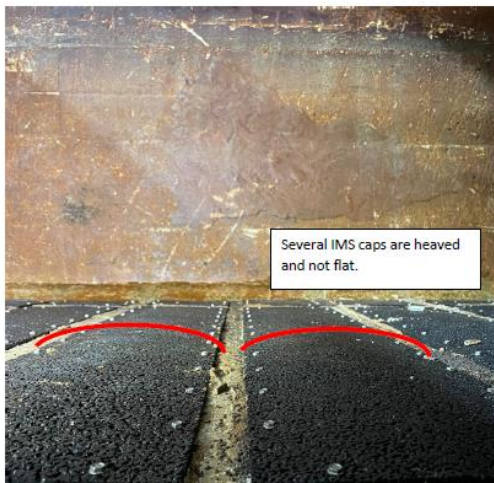
Filter 6 IMS Cap Fail

As previously stated, Filter #6 Type S underdrains are in good condition but the I.M.S caps need to be removed and replaced. We recommend a similar procedure to what was done on filter #5. Remove the I.M.S Caps, flush the effected laterals and replace with I.M.S 200 media retainer. This process will provide many additional years of service for the existing system. Leopold will provide a proposal and price for I.M.S. cap replacement with I.M.S. 200 media retainers and field services along with procedures for flushing the underdrains to remove trapped filter media.

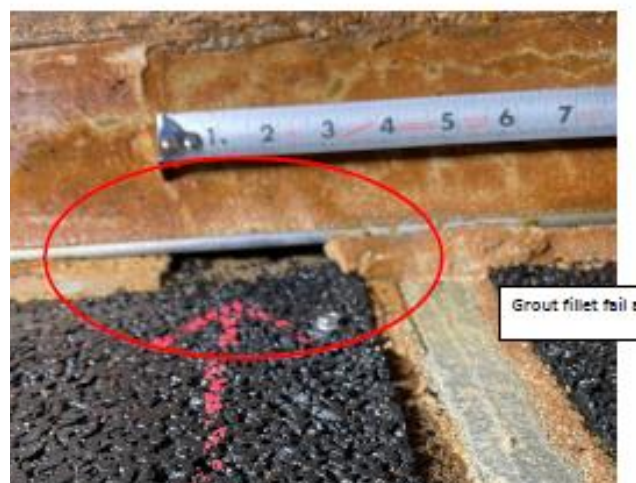
Filter 6 IMS Cap Fail

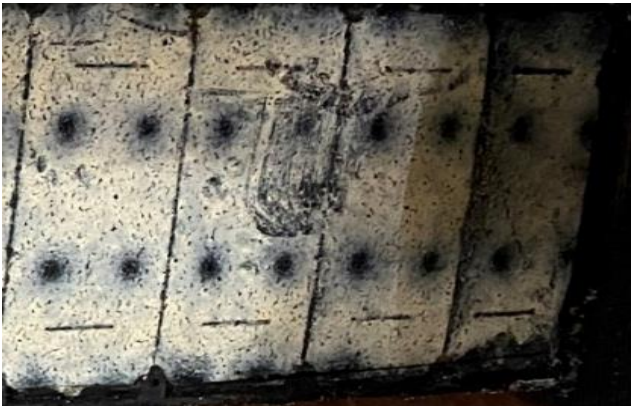
Several I.M.S Caps were removed prior to Leopold arrival. The caps removed had similar coating as filter #5. The bottom side of the caps had a white coating.

Leopold did a visual inspection on filter #6. The seal breach under the hold down angle as shown on the above photo was the cause of media inflowing into the underdrain primary chamber. The media was then pushed into the filter underdrain laterals during backwash causing the caps to bow upward and, in some cases, split the caps down the middle. Other caps within the filters had screws that were also lifted due to the excessive pressure. The I.M.S Caps at this point are damaged beyond repair and will need to be replaced.
