Change Order

Project: Mulberry Street Roadway and Sidewalk Improvements	Owner: Town of Shallotte	Owner's Contract No.:
Contract: Mulberry Street Roadway and Sidewalk Improvements		Date of Contract: August 7, 2024
Contractor: J.P. Russ & Son, INC.		Engineer's Project No.: 22.07019

FOUNDATION OBSERVATIONS REPORT

Mulberry Street RT Wall
120 Mulberry Street
Shallotte, NC 28470

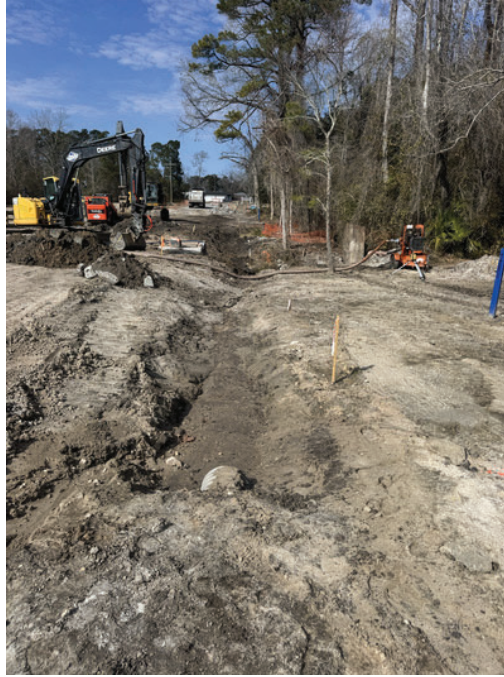
(P1) South end of wall

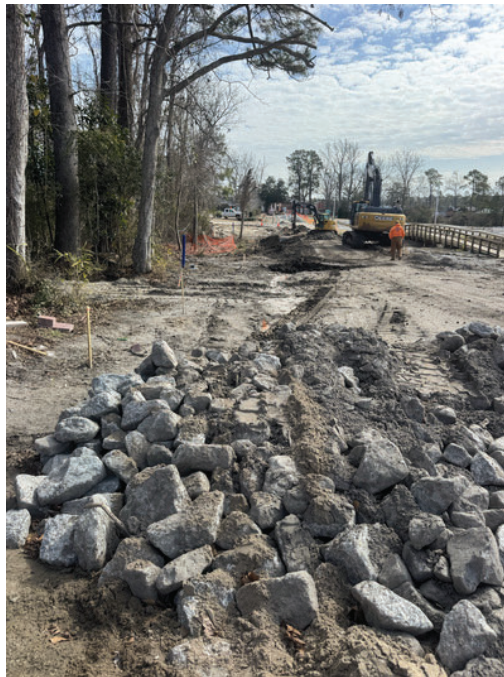
(P2) North end of wall

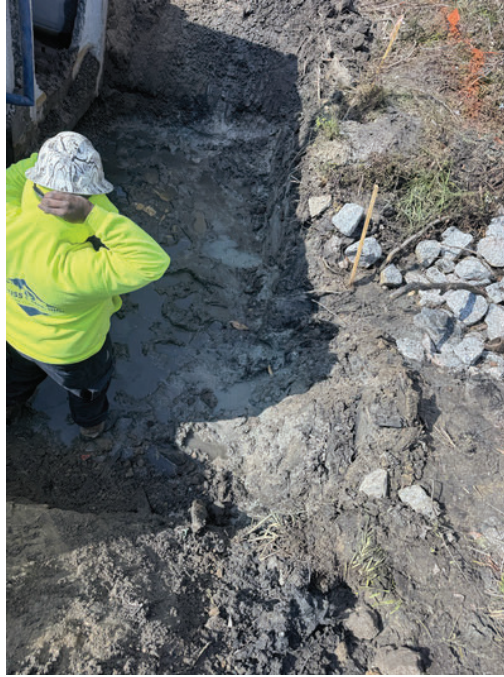
(P3) Footing

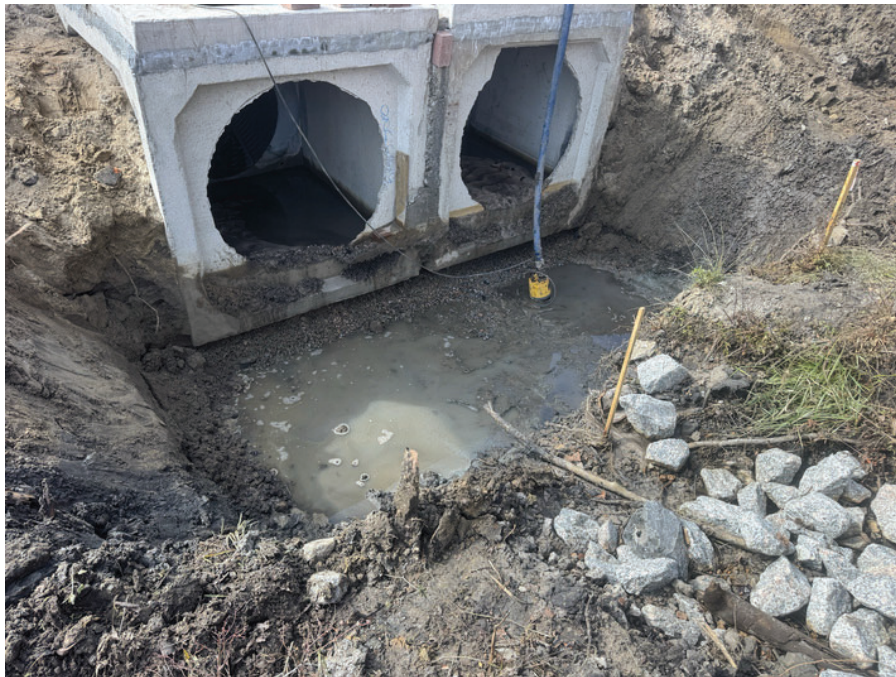
Water was being pumped during testing as it was running in from the side of the footing. Terracon recommends undercutting 1' of material and replacing with washed stone as water is continuing to pool due to elevation of -1.3' below the water table.

(P4) Footing on arrival

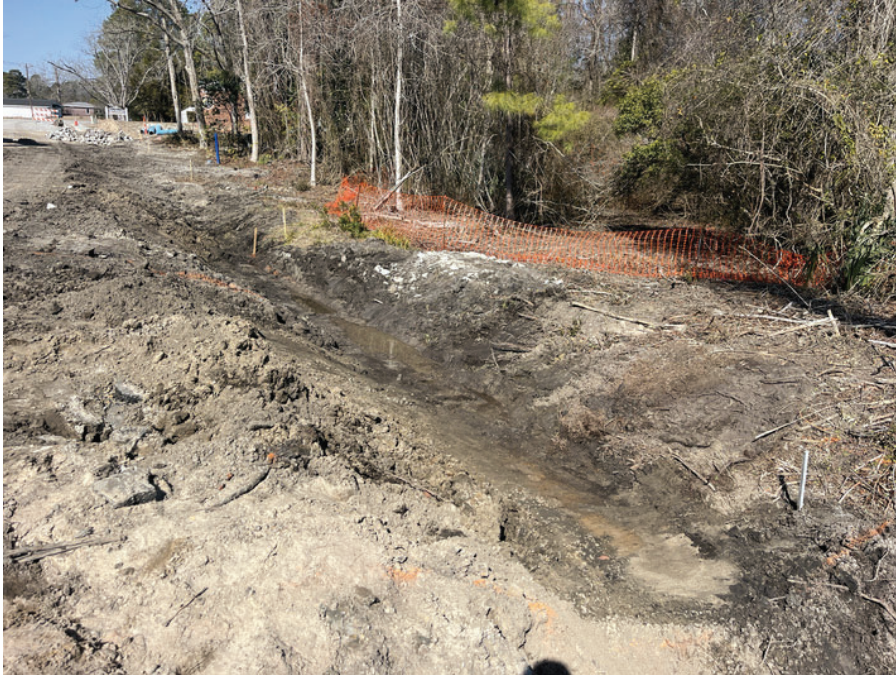
(3) Continuous Footing(s)/ North end of Northwest retaining wall footings	BOF: 2, 3, 5 -1: 3, 4, 8 -2: 10, 11, 7 -3: 2, 2, 3	Wet Grey clay Existing Subgrade	Complies (after remediation)	Undercut: 41' Length X 5' Width x 1' Depth = 205cf/27 = 7.6cy Geotextile Fabric: 41' Length x 1' Depth = 41sf/9 = 4.6sy (sides) x2 = 9.1sy 41' Length x 5' Width = 205sf/9 = 22.8sy (bottom)

(P1) North end of Northwest retaining wall footing

In area(s) 1, 2, and 3, Terracon recommends a 1 undercut and replacing with washed stone with fabric on the bottom and sides of footing.

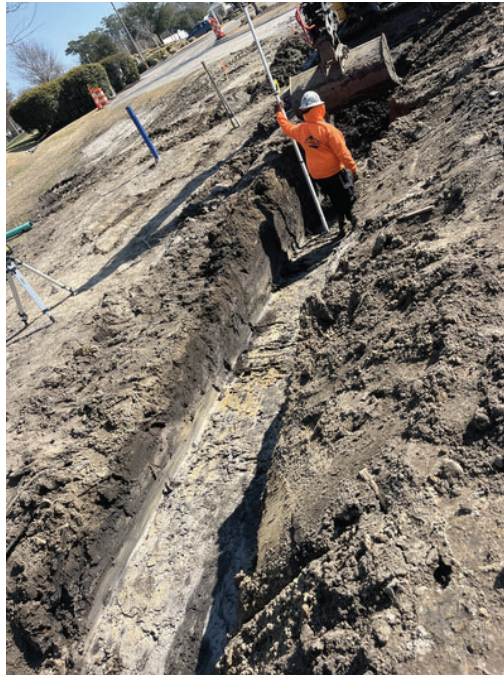
Test No./Element/ Location	Test Results	Bearing Strata	Status	Comments
(1) Continuous Footing(s)/ South end of Northwest retaining wall footings	BOF: 1, 1, 3 -1: 1, 2, 3 -2: 4, 4, 5 -3: 3, 3, 4	Moist Brown clay Existing Subgrade	Complies (after remediation)	Undercut: 48' Length X 5' Width x 2' Depth = 480cf/27 = 17.8cy Geotextile Fabric: 48' Length x 2' Depth = 96sf/9 = 10.7sy (sides) x2 = 21.3sy 48' Length x 5' Width = 240sf/9 = 26.7sy (bottom)

(2) Continuous Footing(s)/ South end of Northwest retaining wall footings	BOF: 2, 2, 2 -1: 2, 2, 3 -2: 2, 3, 4 -3: 7, 12, 13	Moist Brown clay Existing Subgrade	Complies (after remediation)	Undercut: 48' Length X 5' Width x 2' Depth = 480cf/27 = 17.8cy Geotextile Fabric: 48' Length x 2' Depth = 96sf/9 = 10.7sy (sides) x2 = 21.3sy 48' Length x 5' Width = 240sf/9 = 26.7sy (bottom)

(P2) South end of Northwest retaining wall

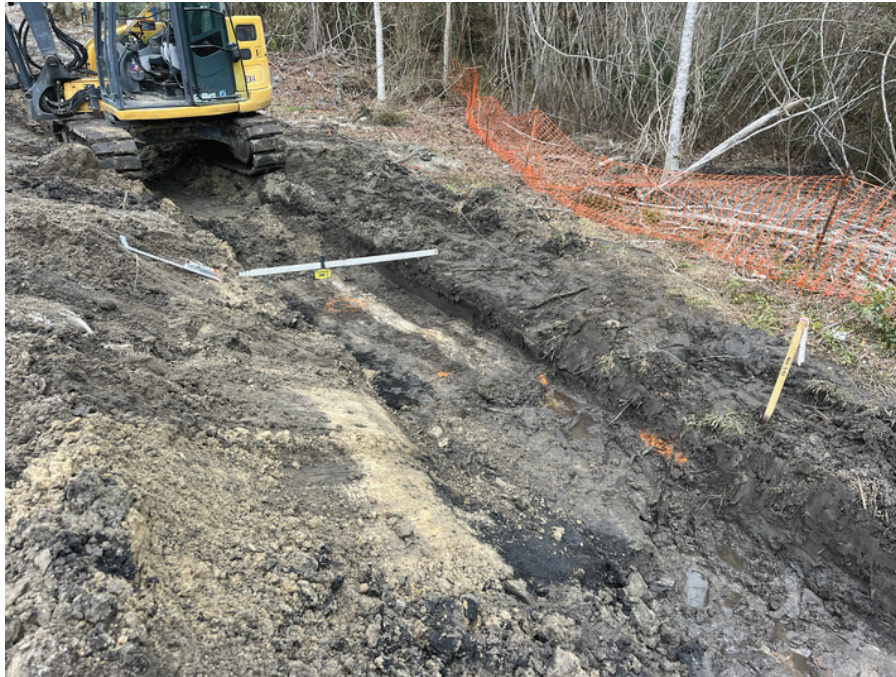
Test No./Element/ Location	Test Results	Bearing Strata	Status	Comments
(1) Continuous Footing(s)/ North end of Northwest retaining wall	BOF: 2, 2, 3 -1: 3, 3, 4 -2: 3, 6, 12 -3: 3, 6, 12	Dark Brown Silty Clay Existing Subgrade	Complies (After Remediation)	Undercut: 40' Length X 5' Width x 1' Depth = 200cf/27 = 7.4cy Geotextile Fabric: 40' Length x 1' Depth = 40sf/9 = 4.4sy (sides) x2 = 8.9sy 40' Length x 5' Width = 200sf/9 = 22.2sy (bottom)
(2) Continuous Footing(s)/ South end of Northwest retaining wall	BOF: 1, 1, 3 -1: 3, 4, 5 -2: 3, 4, 7 -3: 2, 2, 3	Moist Gray Clay Existing Subgrade	Complies (After Remediation)	Undercut: 20' Length X 5' Width x 1' Depth = 100cf/27 = 3.7cy Geotextile Fabric: 20' Length x 1' Depth = 20sf/9 = 2.2sy (sides) x2 = 4.4sy 20' Length x 5' Width = 100sf/9 = 11.1sy (bottom)

(P1) North end of Northwest retaining wall

In area(s) 1 & 2, Terracon recommends a 1' undercut and replacing with washed stone with fabric on the bottom and sides of footing.

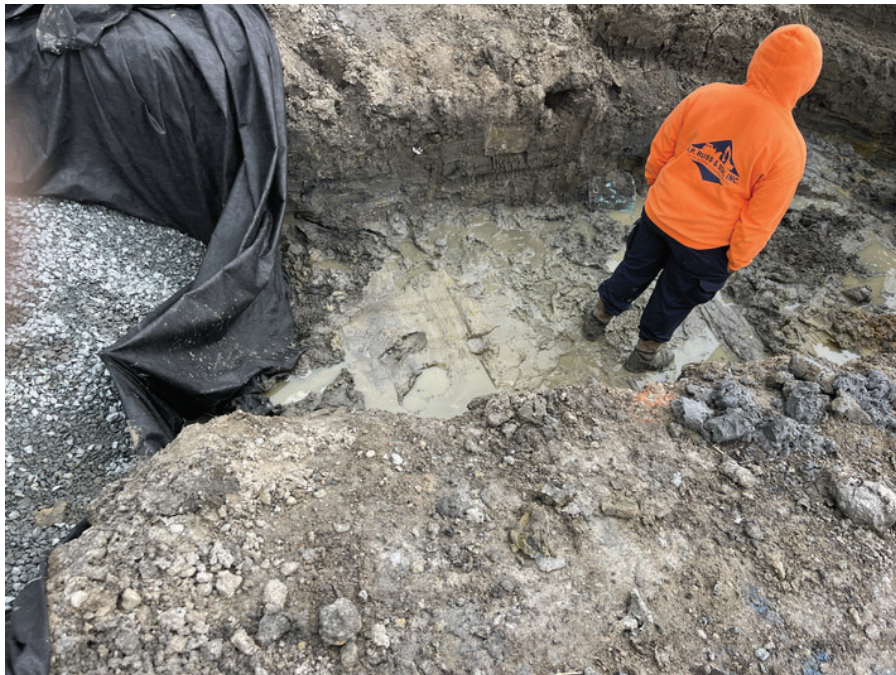
(P2) South end of Northwest retaining wall
