**CERTIFICATE OF SUBSTANTIAL COMPLETION**

Owner:	City of Sidney, Montana	Owner's Contract No.:	WR23-00-035
Contractor:	Advanced Lining LLC	Contractor's Project No.:	
Engineer:	Interstate Engineering Inc.	Engineer's Project No.:	WR23-00-035
Project:	200,000 Gal On-Ground Water Storage Tank Relining	Contract Name:	Base Bid

200,000 Gal. on-ground Water Tank Relining Punchlist  
Sidney, Montana  
WR23-00-035

Re: 200,000 Gal On-Ground Water Storage Tank Relining

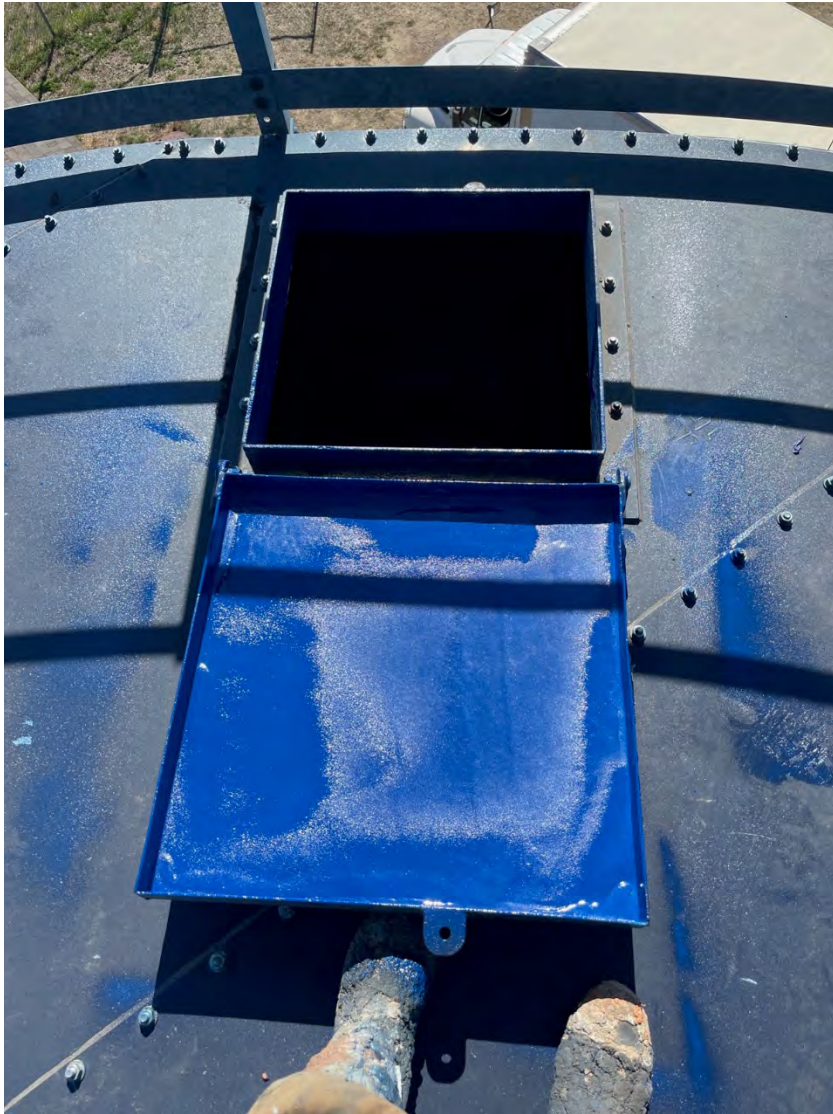
1. Visual spark testing needs to be completed in the presence of the RPR to the satisfaction of RPR. (Note: AL holiday detector not functioning. Unknown last accurate test)
2. Over Spray on exterior of tank around upper and lower hatches and vent, and on adjacent SCADA building. Picture of upper vent shown below for reference.

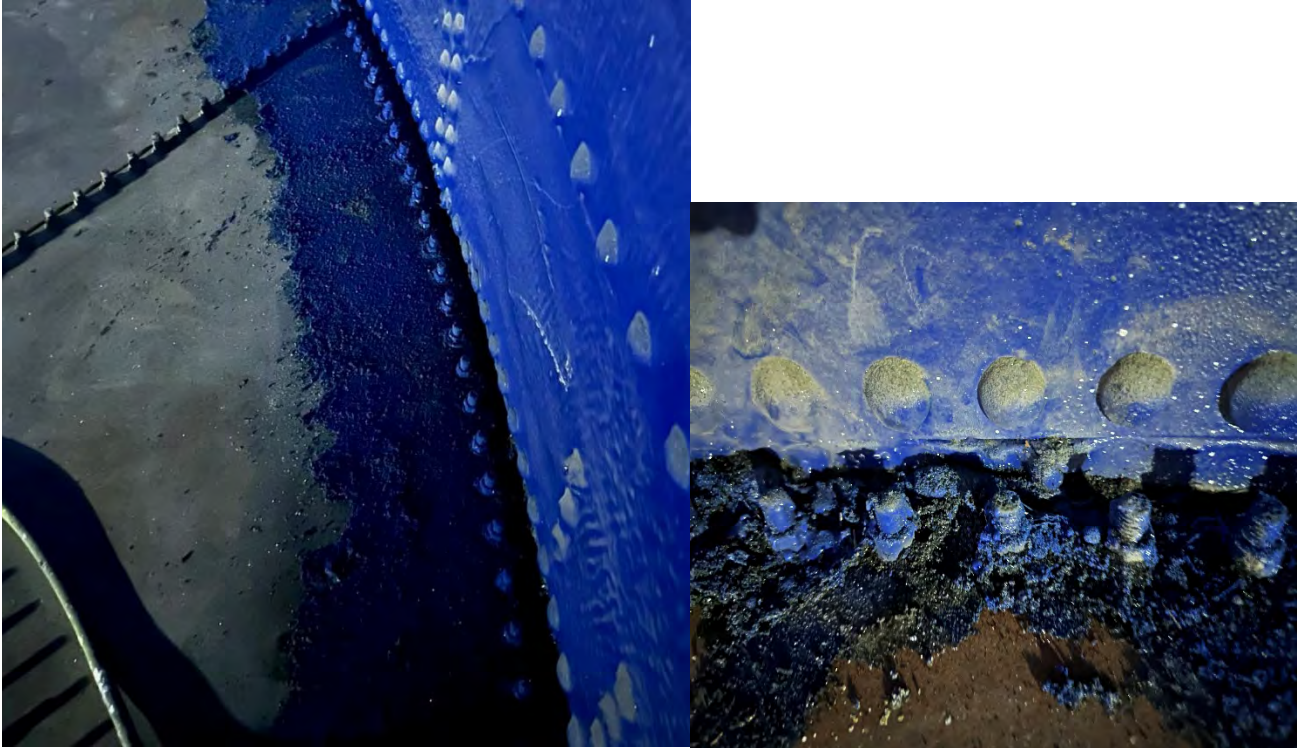
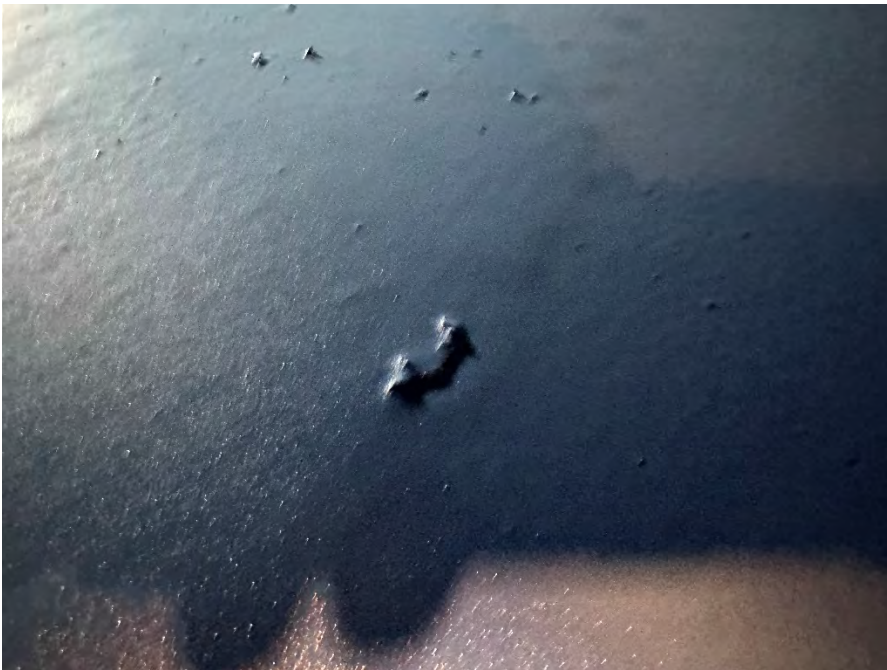
3. Overspray and debris on floor was primed over and relined.

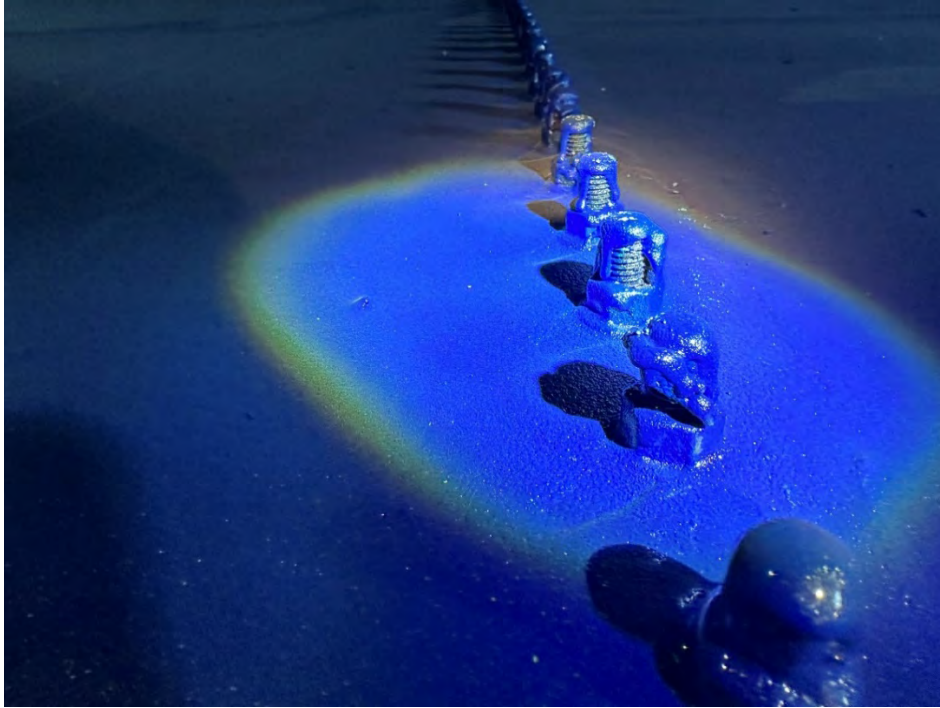
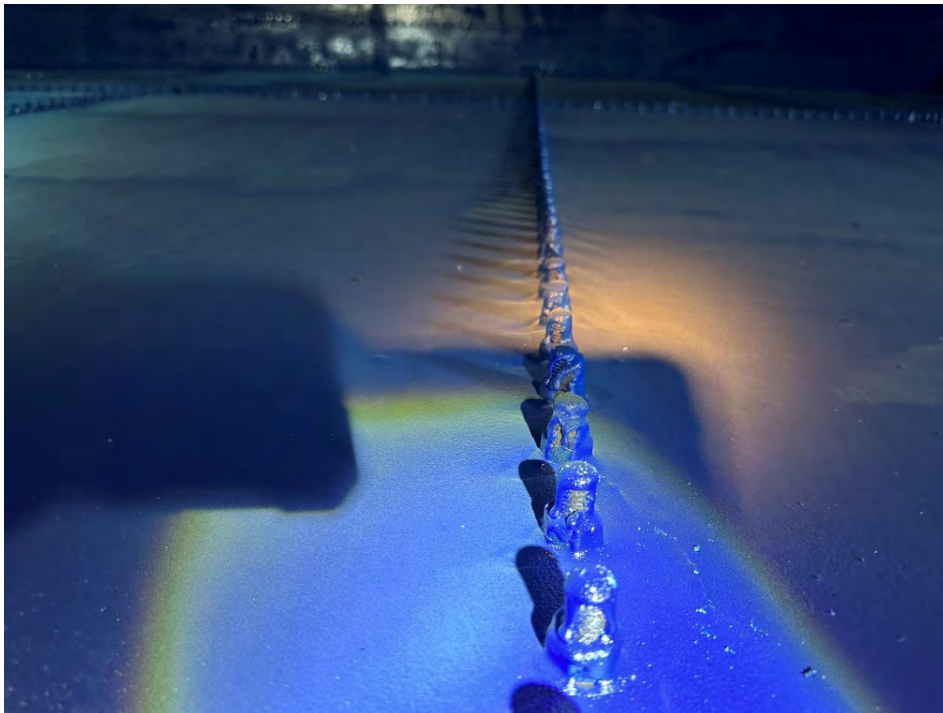
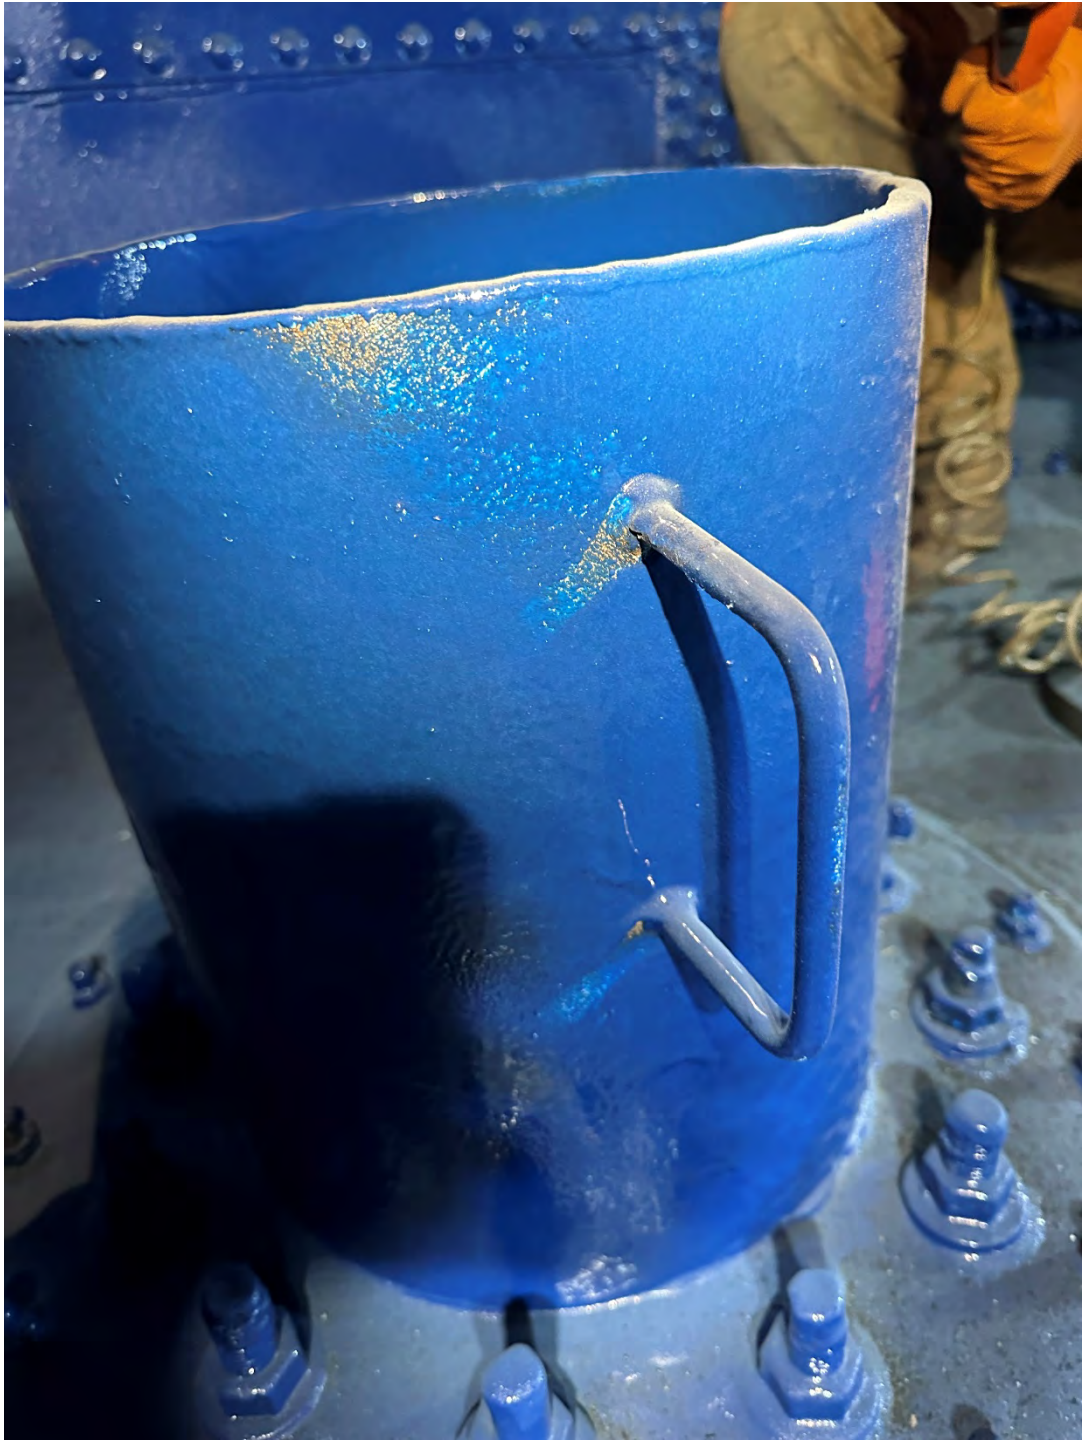
4. Numerous Areas on the floor show bare steel without coating, typically around the bolts. Locations also in and outside of the influent pipe. Representative photos.

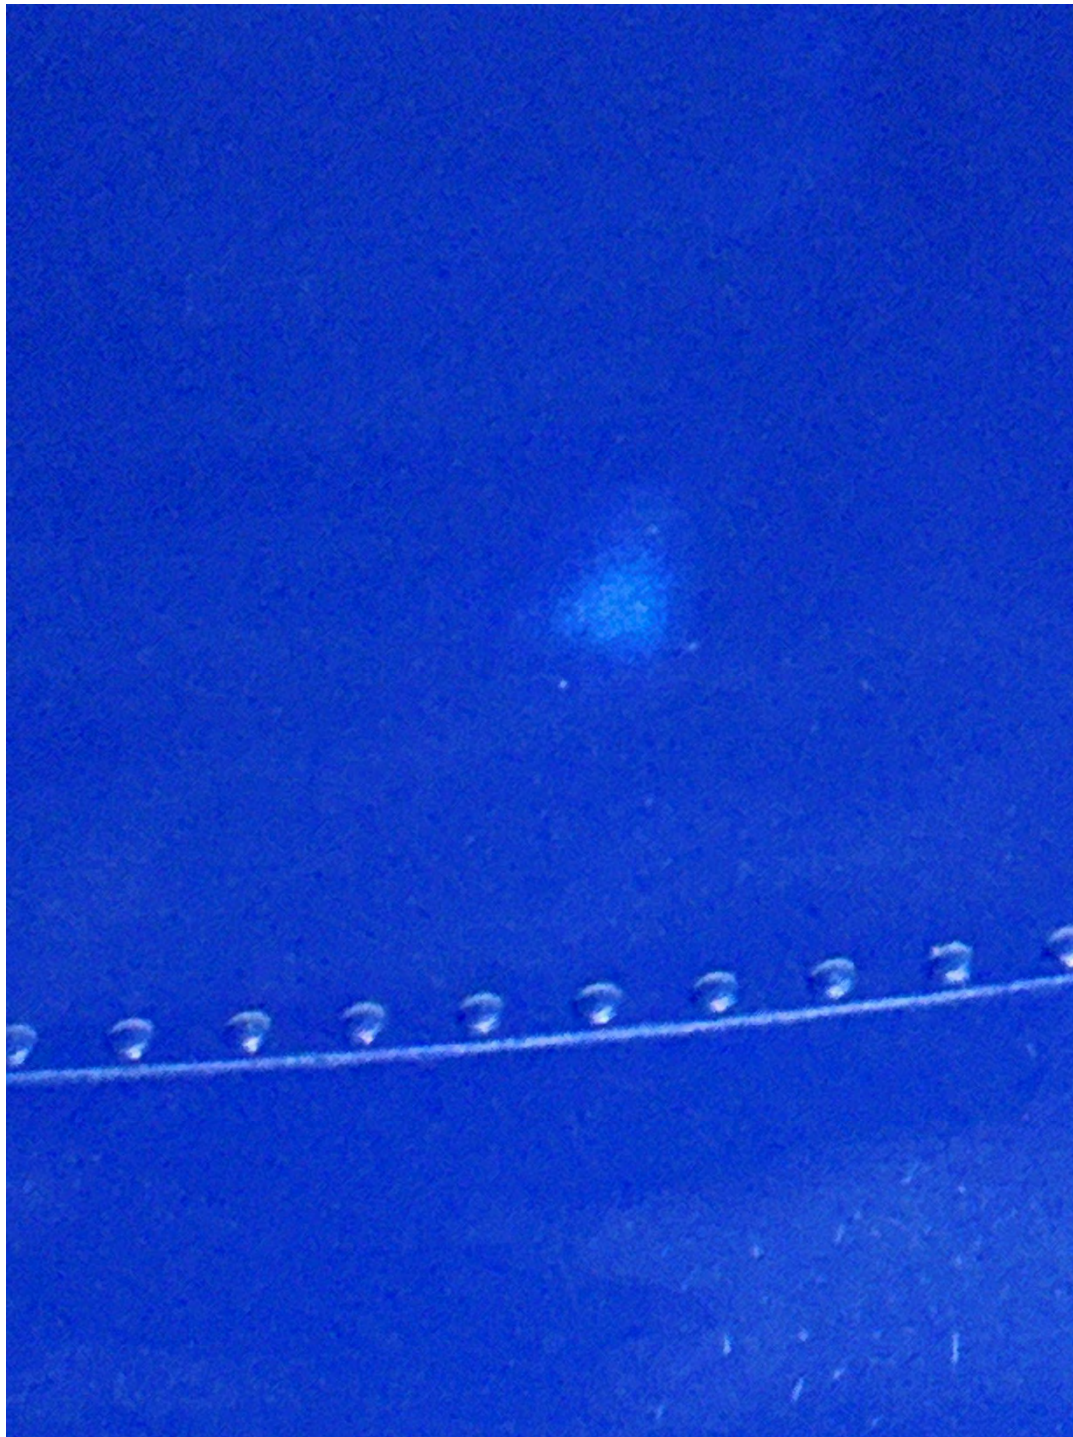
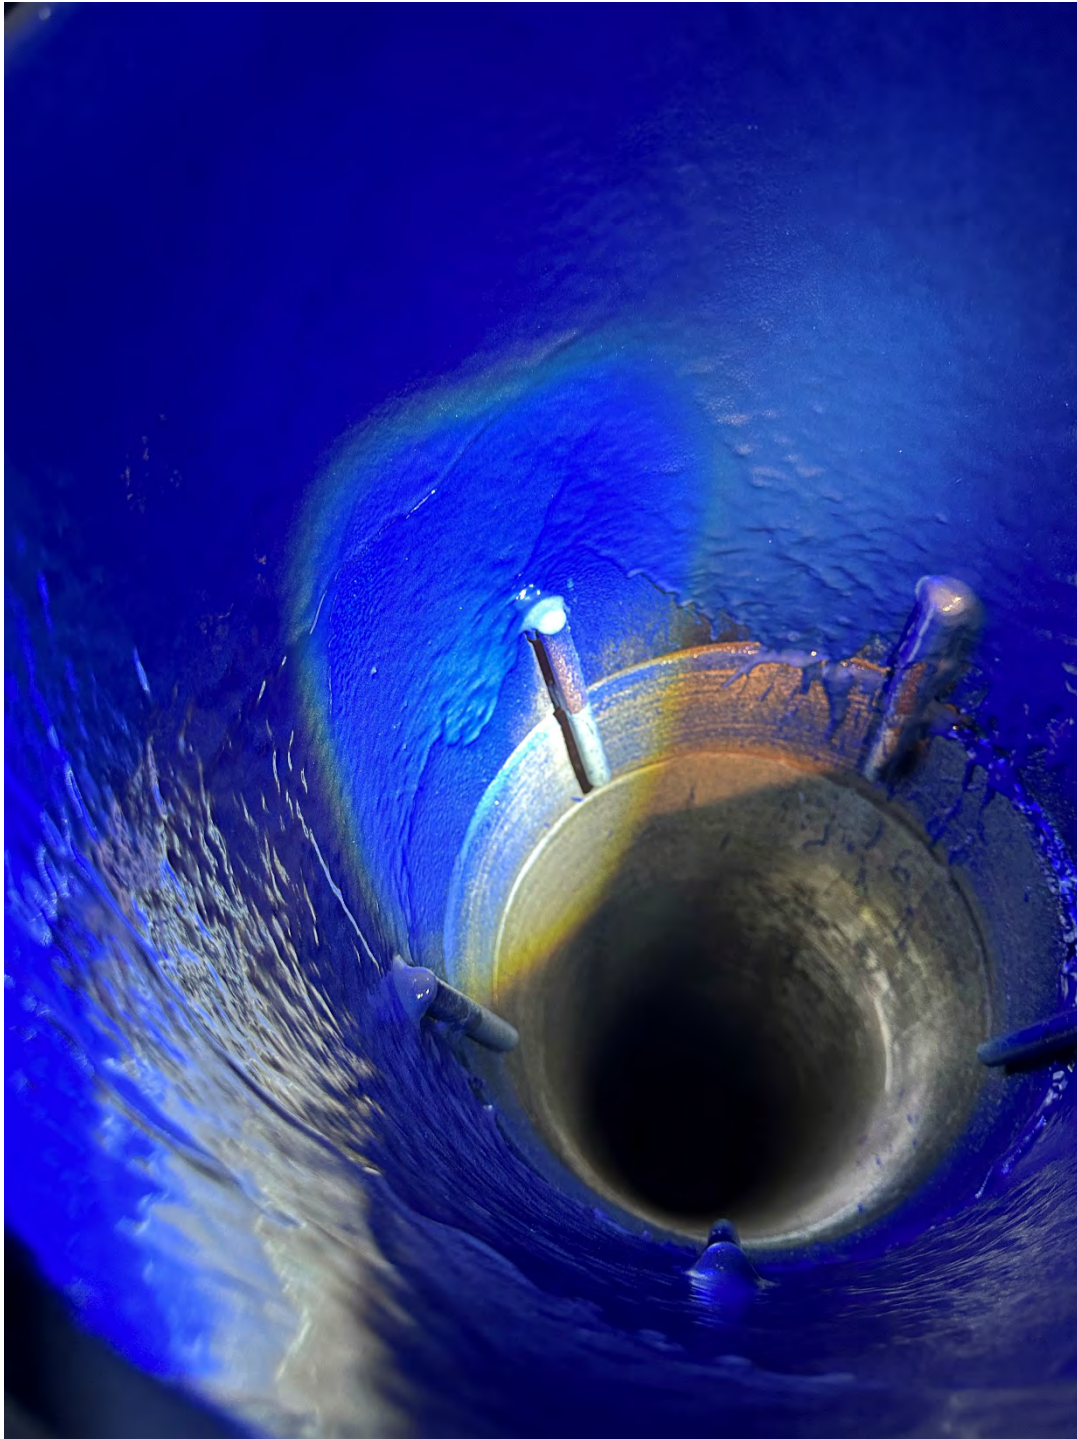
5. Areas of wall show primer through coating.

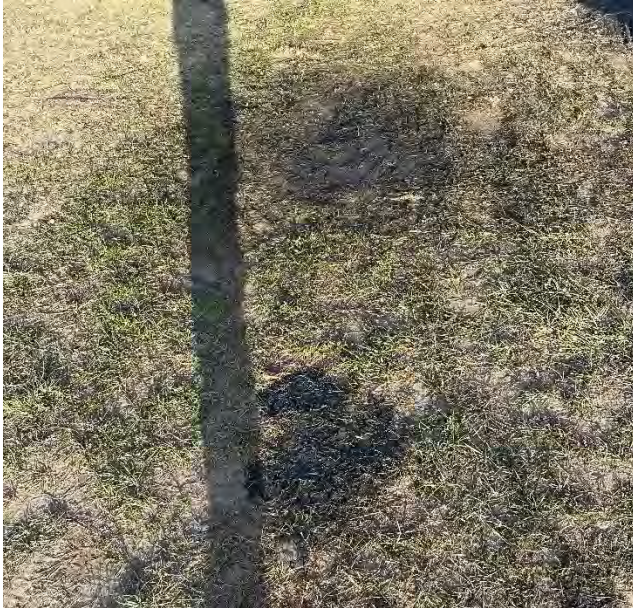
7. Oil spots on ground exterior of the tank from vac truck operation need to be cleaned up or rehabilitated. See Photo.

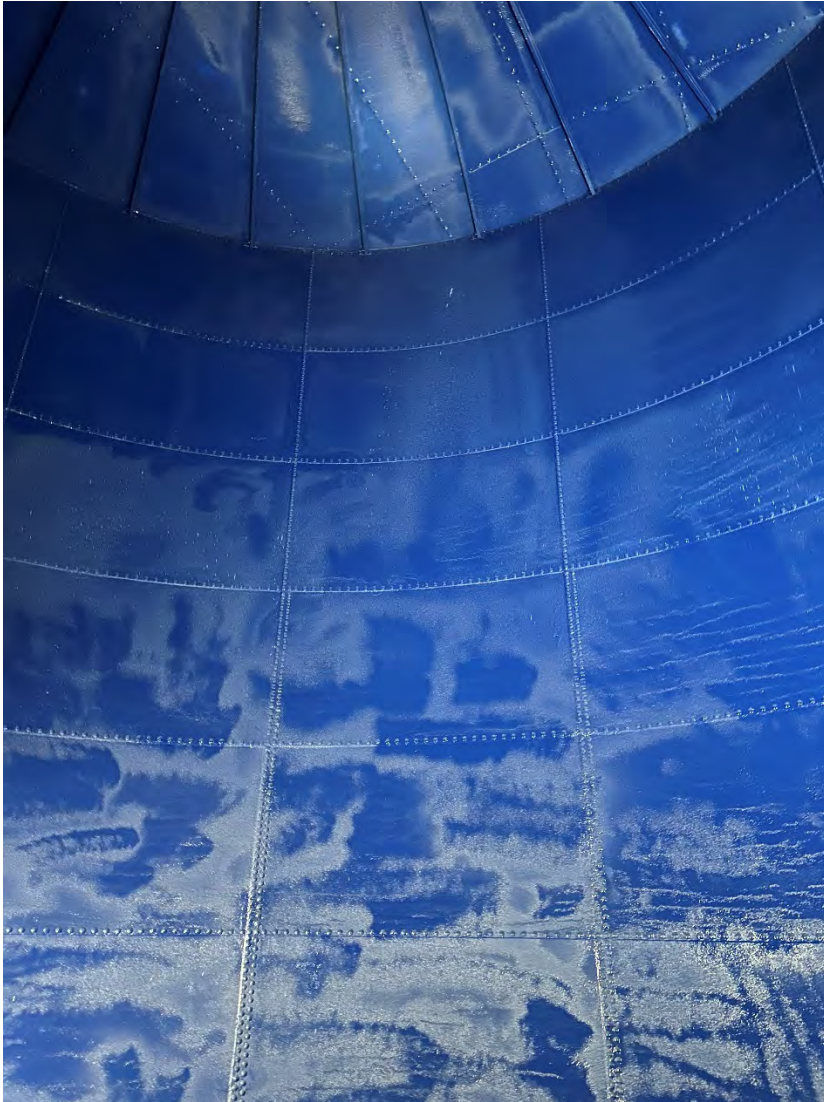
18. Quality Assure is needed on the Top two panels.

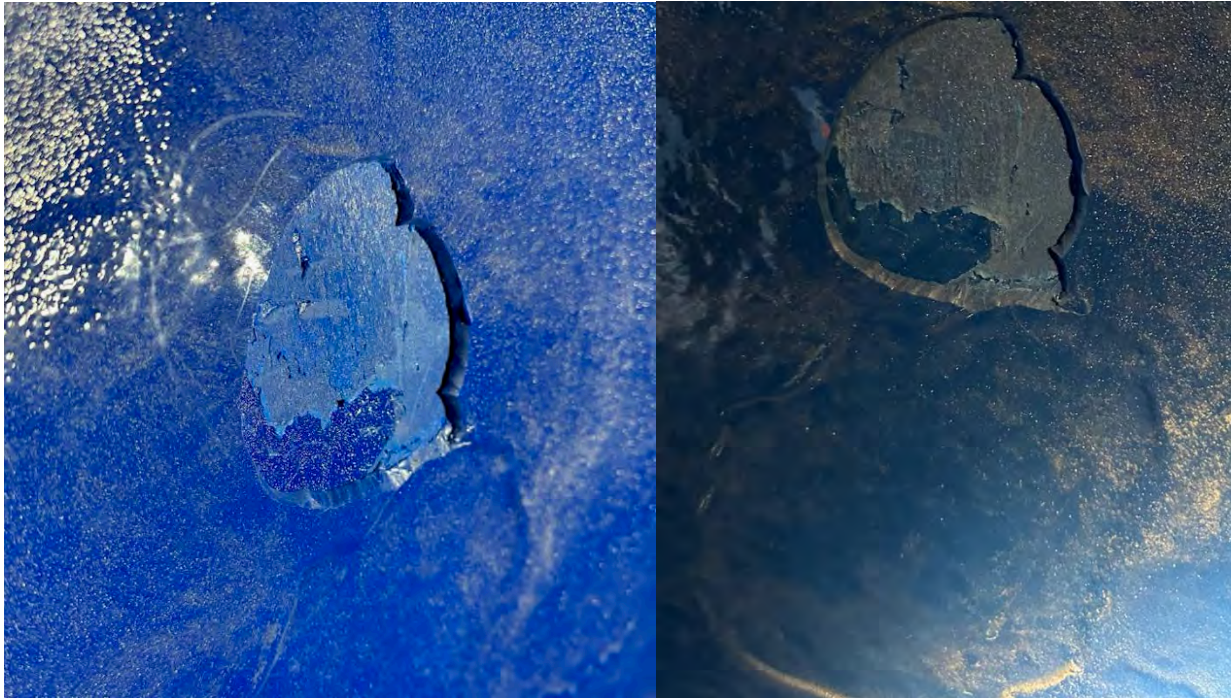
19. Repair areas of delamination

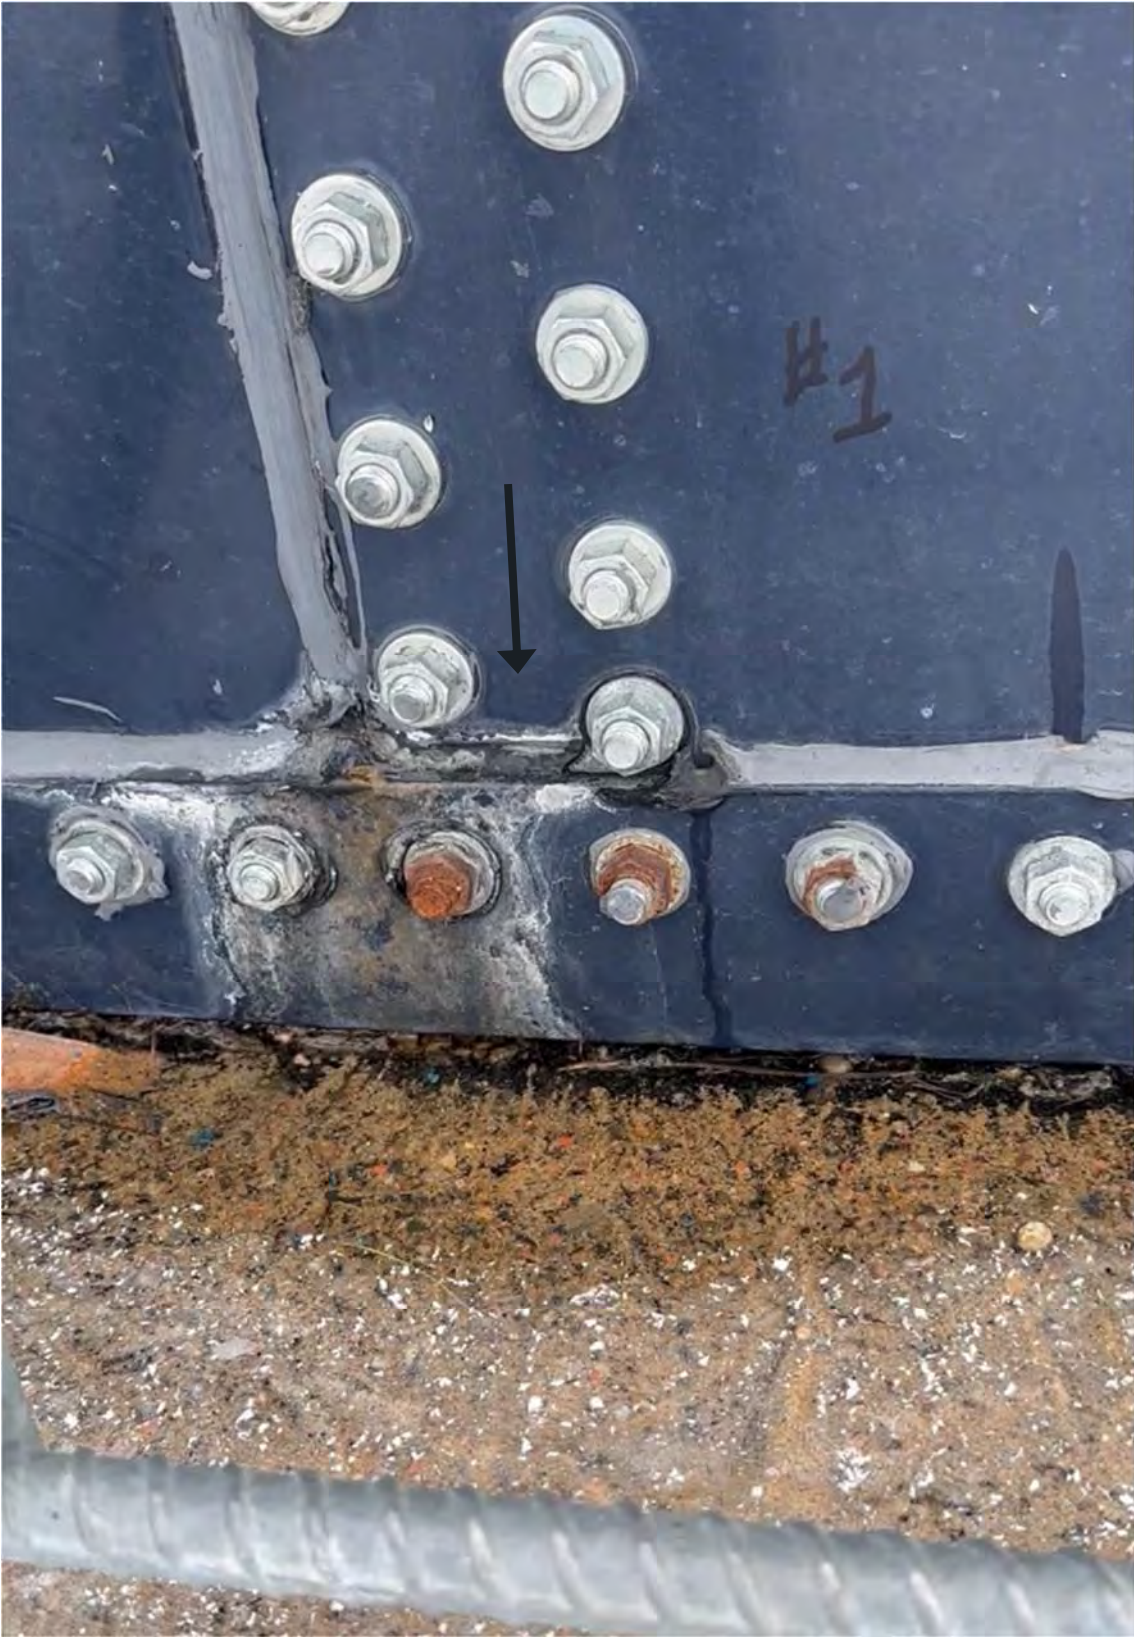
Leak #1: Tank position 11:40, Approximately 2.5 inches above ground level. This leak is visible outside of the tank at the seam.

FIGURE 1 - LEAK 1, LOCATION OF PREVIOUS AND EXISTING LEAK

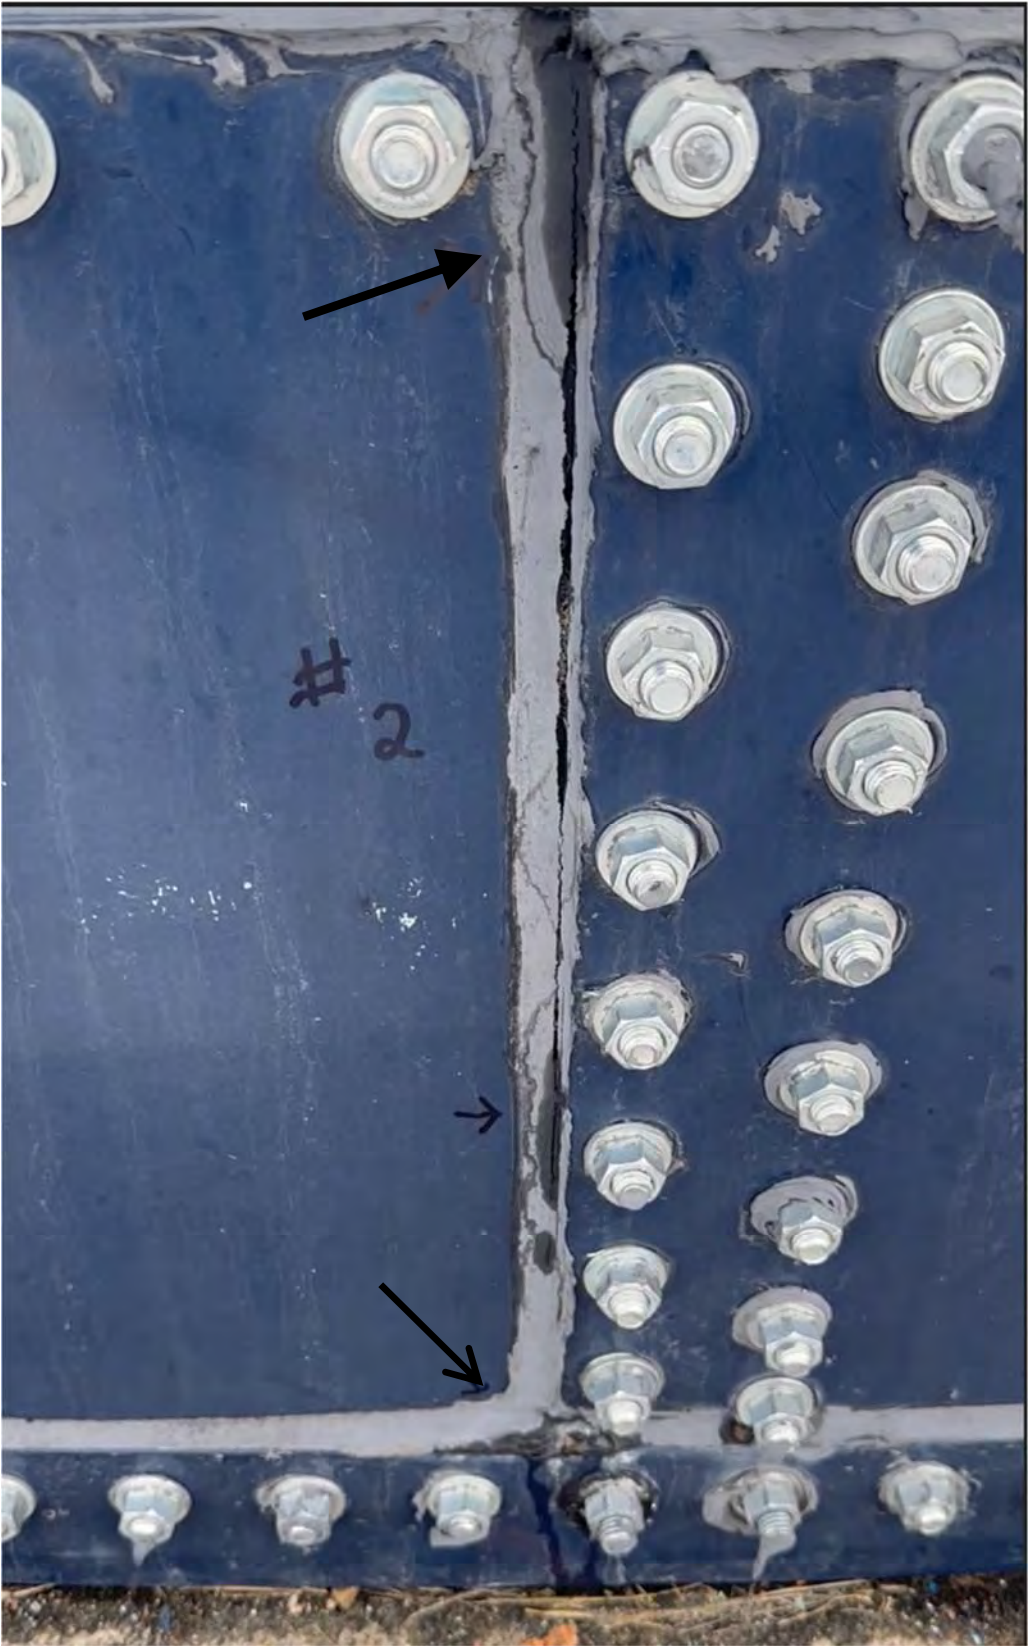
Leak #2: Tank Position 10:30, Three leaks approximately 2.5 inches, 8 inches, and 18 inches above ground level. These leaks are visible from the seam between tank panels. The arrows indicate areas where the leaks are visible. These leaks were not present prior to the project.

FIGURE 2 - LEAK 2, NEW LEAK APPEARED AFTER LINING

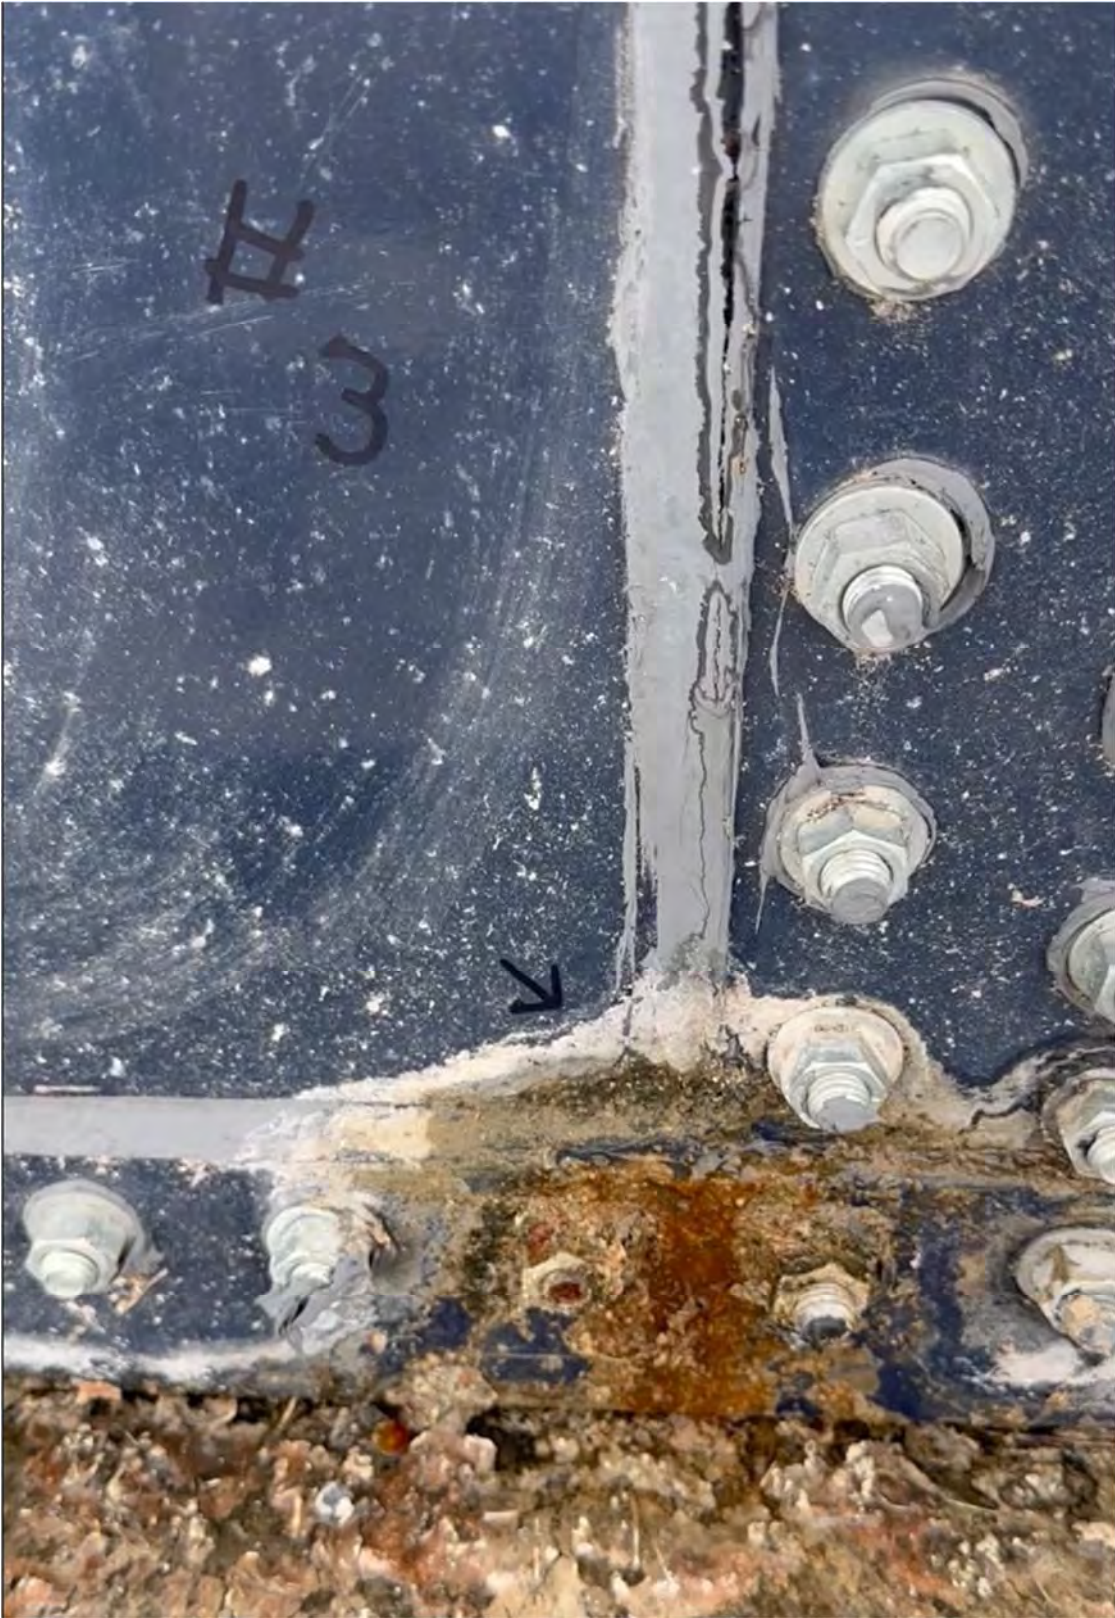
Leak #3: Tank Position 9:00, Approximately 2.5 inches above ground level. This leak is visible at the seam between the bottom flange, and the bottom wall panel.

FIGURE 3 - LEAK 3, LOCATION OF PREVIOUS AND EXISTING LEAK

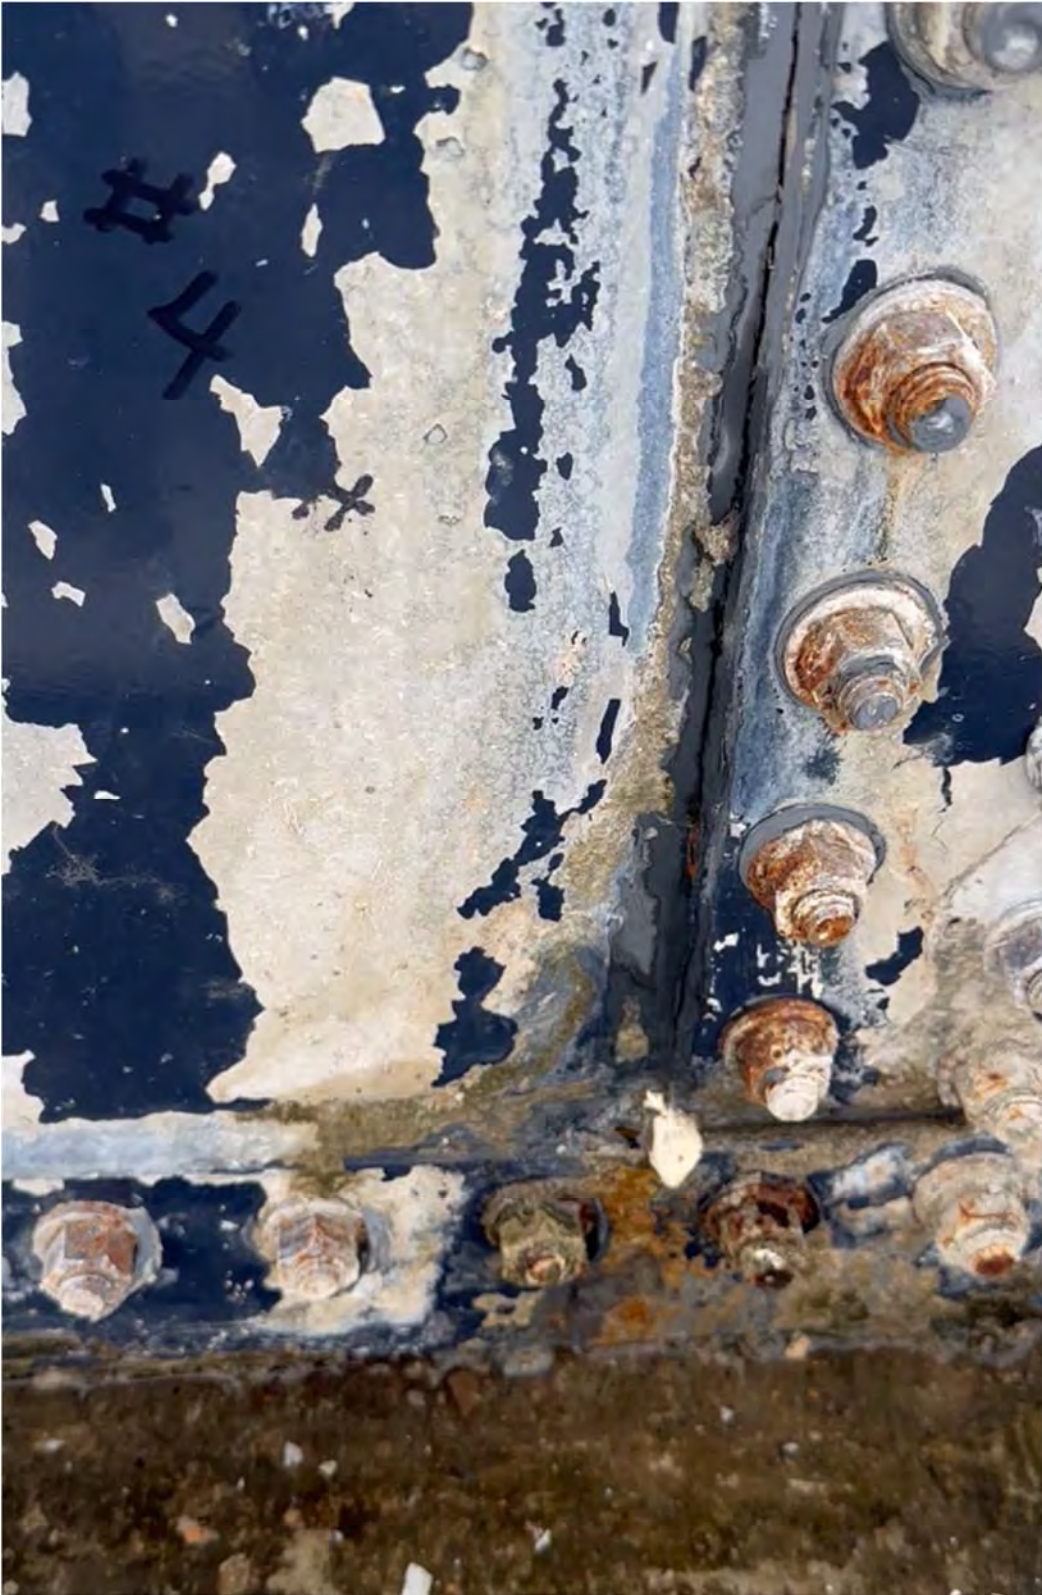
Leak #4: Tank Position 8:00, This leak is visible for approximately 9 inches along the tank seam on the bottom panel.

FIGURE 4 - LEAK 4, LOCATION OF PREVIOUS AND EXISTING LEAK

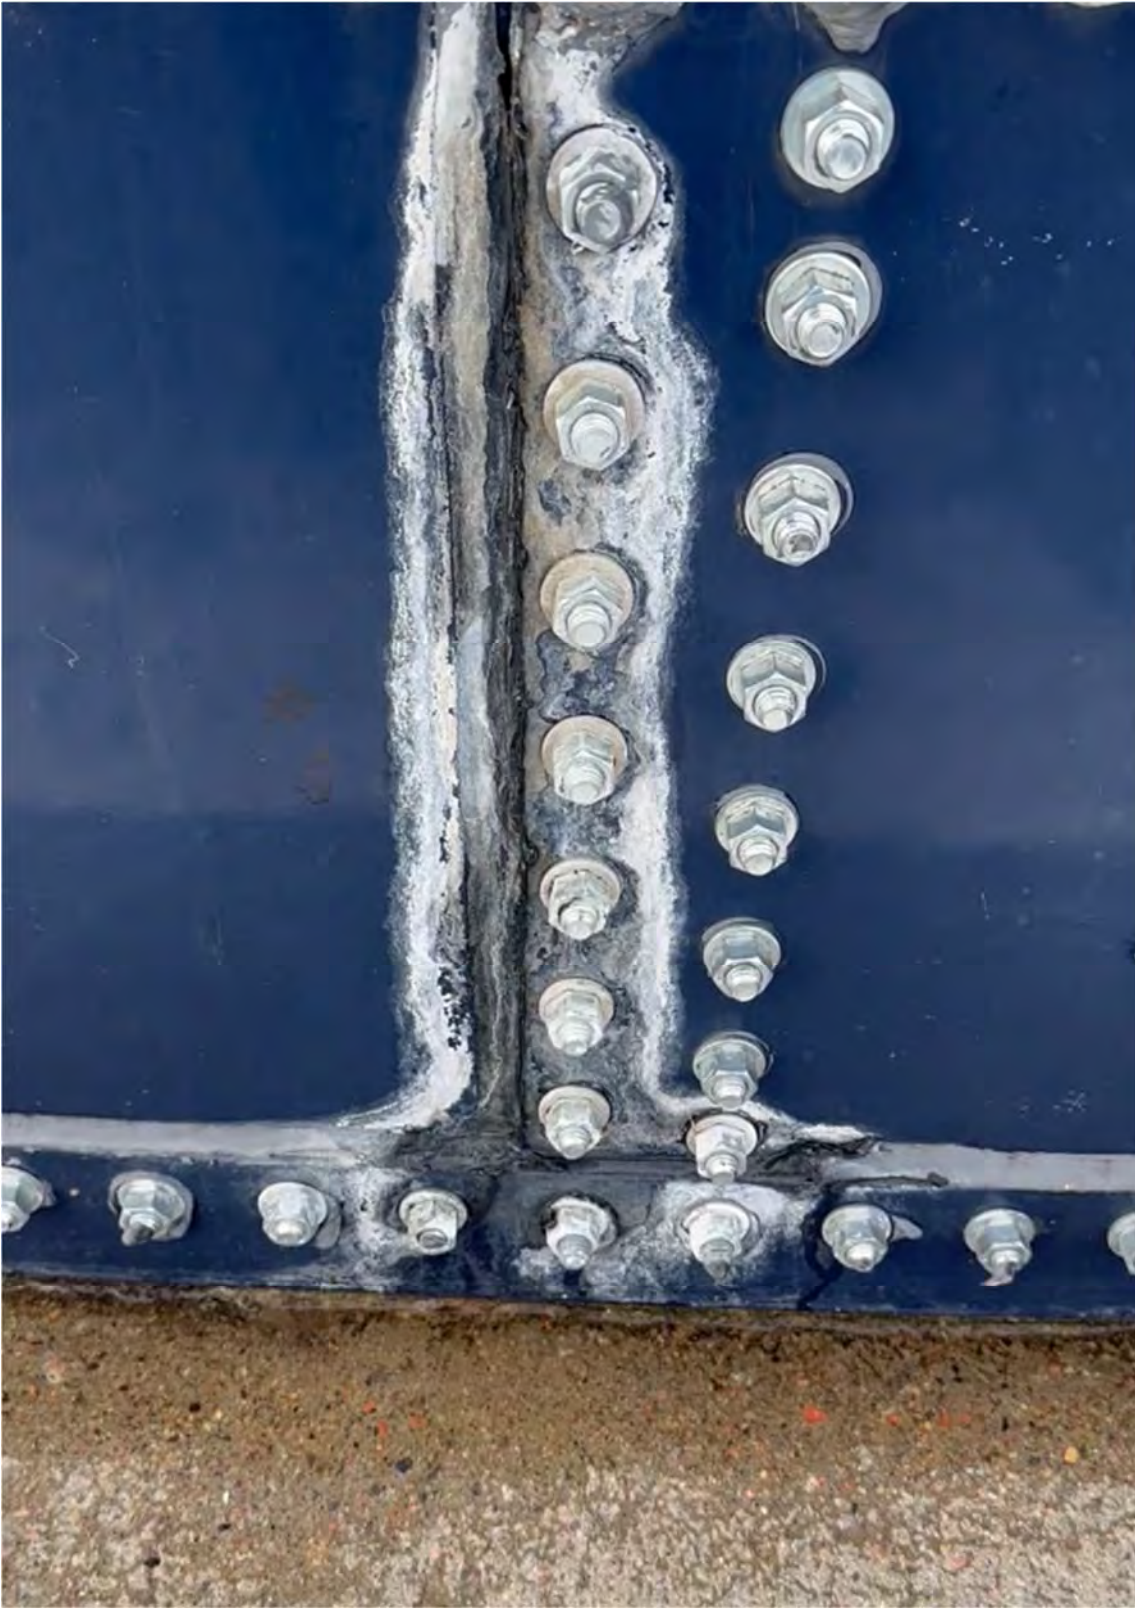
Leak #5: Tank Position 7:00, visible approximately 18 inches above ground level, along the seam.

FIGURE 5 - LEAK 5, LOCATION OF PREVIOUS AND EXISTING LEAK

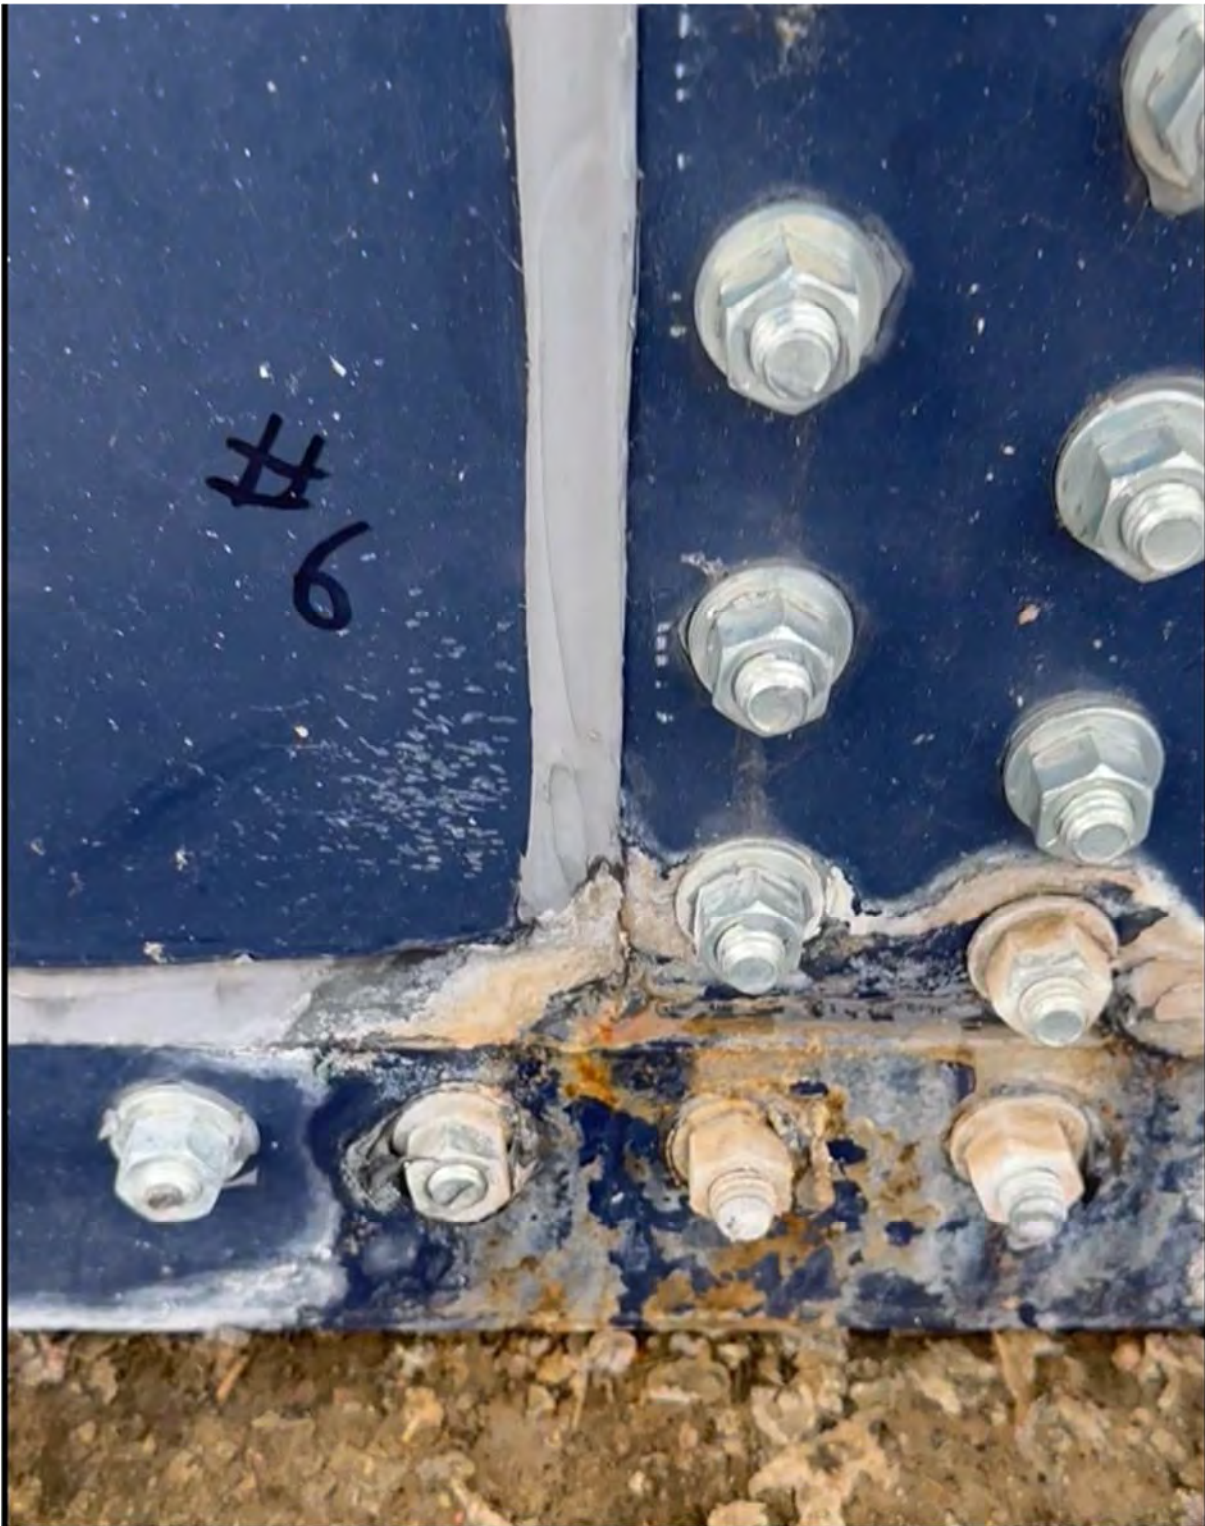
Leak #6: Tank Position 6:00, this is a flowing leak approximately 2.5 inches above ground level and is visible at the flange seam.

FIGURE 6 - LEAK 6, FLOWING LEAK
