**CERTIFICATE OF SUBSTANTIAL COMPLETION**

Owner:	City of Sidney, Montana	Owner's Contract No.:	WR23-00-035
Contractor:	Advanced Lining LLC	Contractor's Project No.:	
Engineer:	Interstate Engineering Inc.	Engineer's Project No.:	WR23-00-035
Project:	200,000 Gal On-Ground Water Storage Tank Relining	Contract Name:	Base Bid

200,000 Gal. on-ground Water Tank Relining Punchlist  
Sidney, Montana  
WR23-00-035

Re: 200,000 Gal On-Ground Water Storage Tank Relining

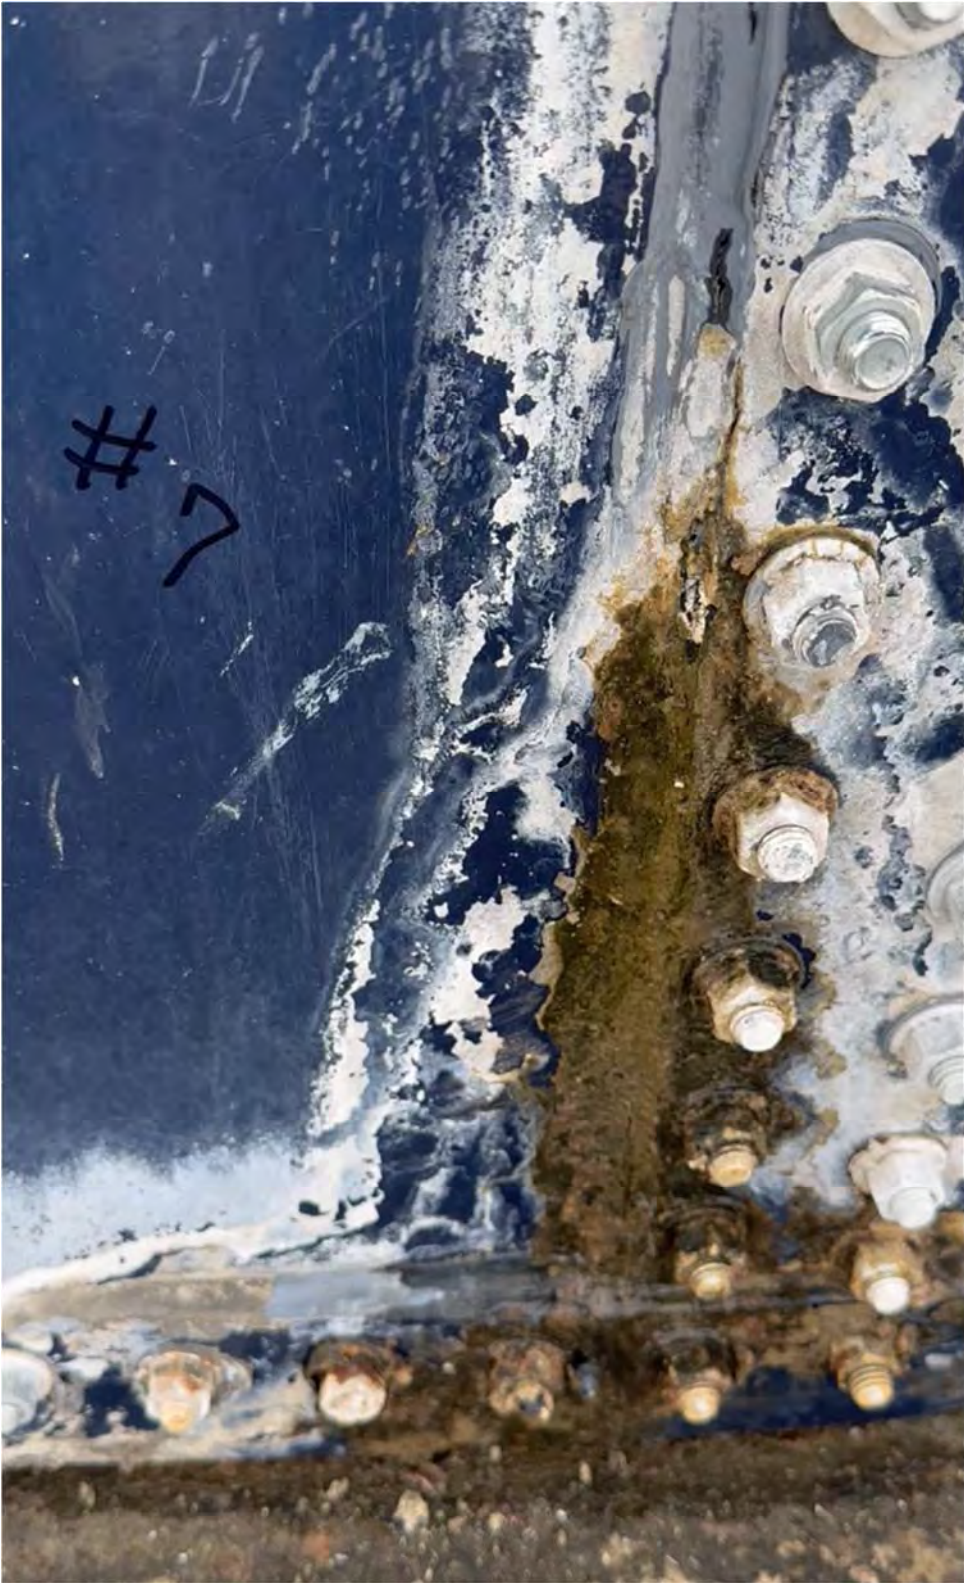
Leak #7: Tank position 5:00, is visible approximately 14 inches above ground level, along the tank seam.

FIGURE 7 - LEAK 7, LEAK AT SEAM

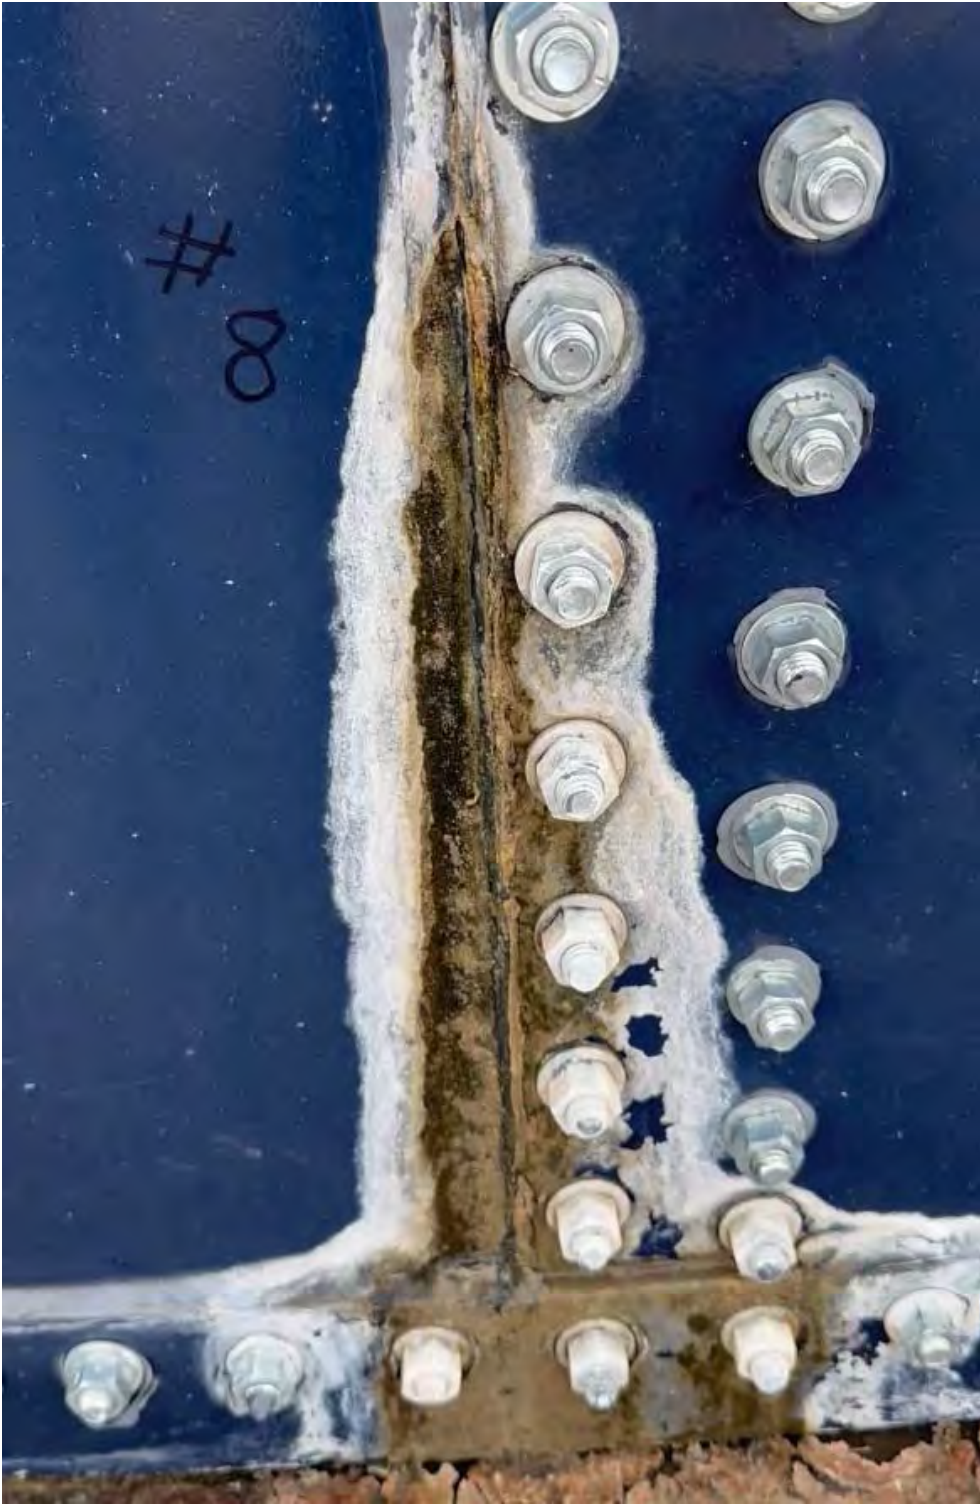
Leak #8: Tank position 4:00, is visible approximately 18 inches above ground level along the tank seam.

FIGURE 8 - LEAK 8, PREVIOUS AND EXISTING LEAK

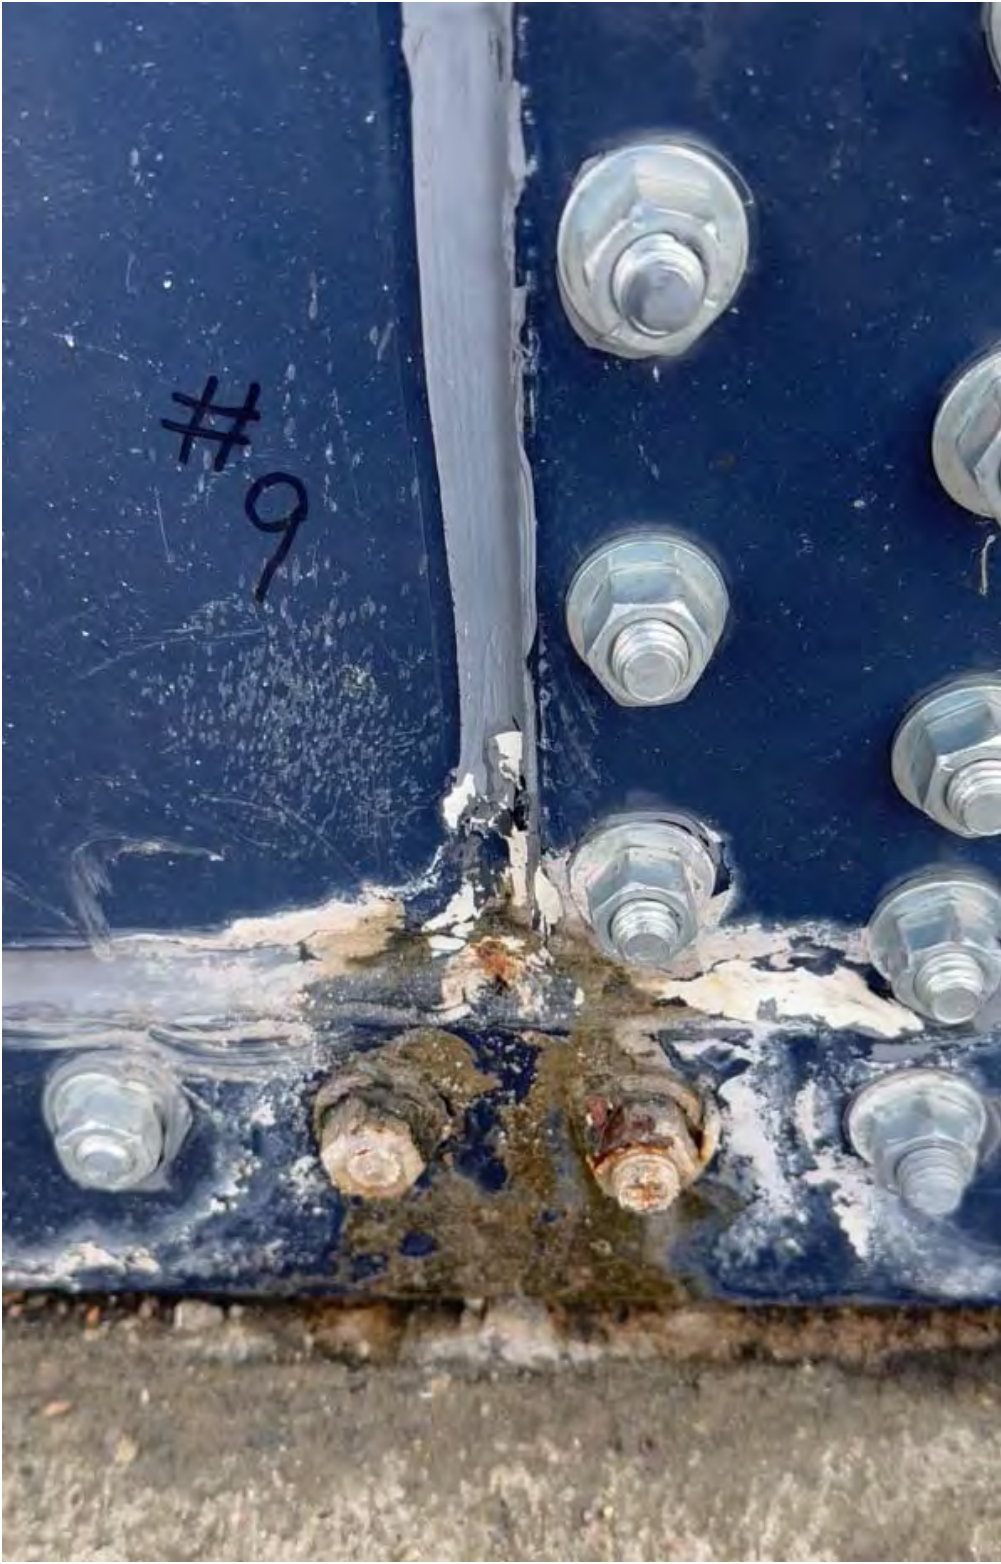
Leak #9: Tank position 3:00, is visible approximately 2.5 inches above ground level at tank flange seam.

FIGURE 9 - LEAK 9M PREVIOUS AND EXISTING LEAK AT FLANGE SEAM.

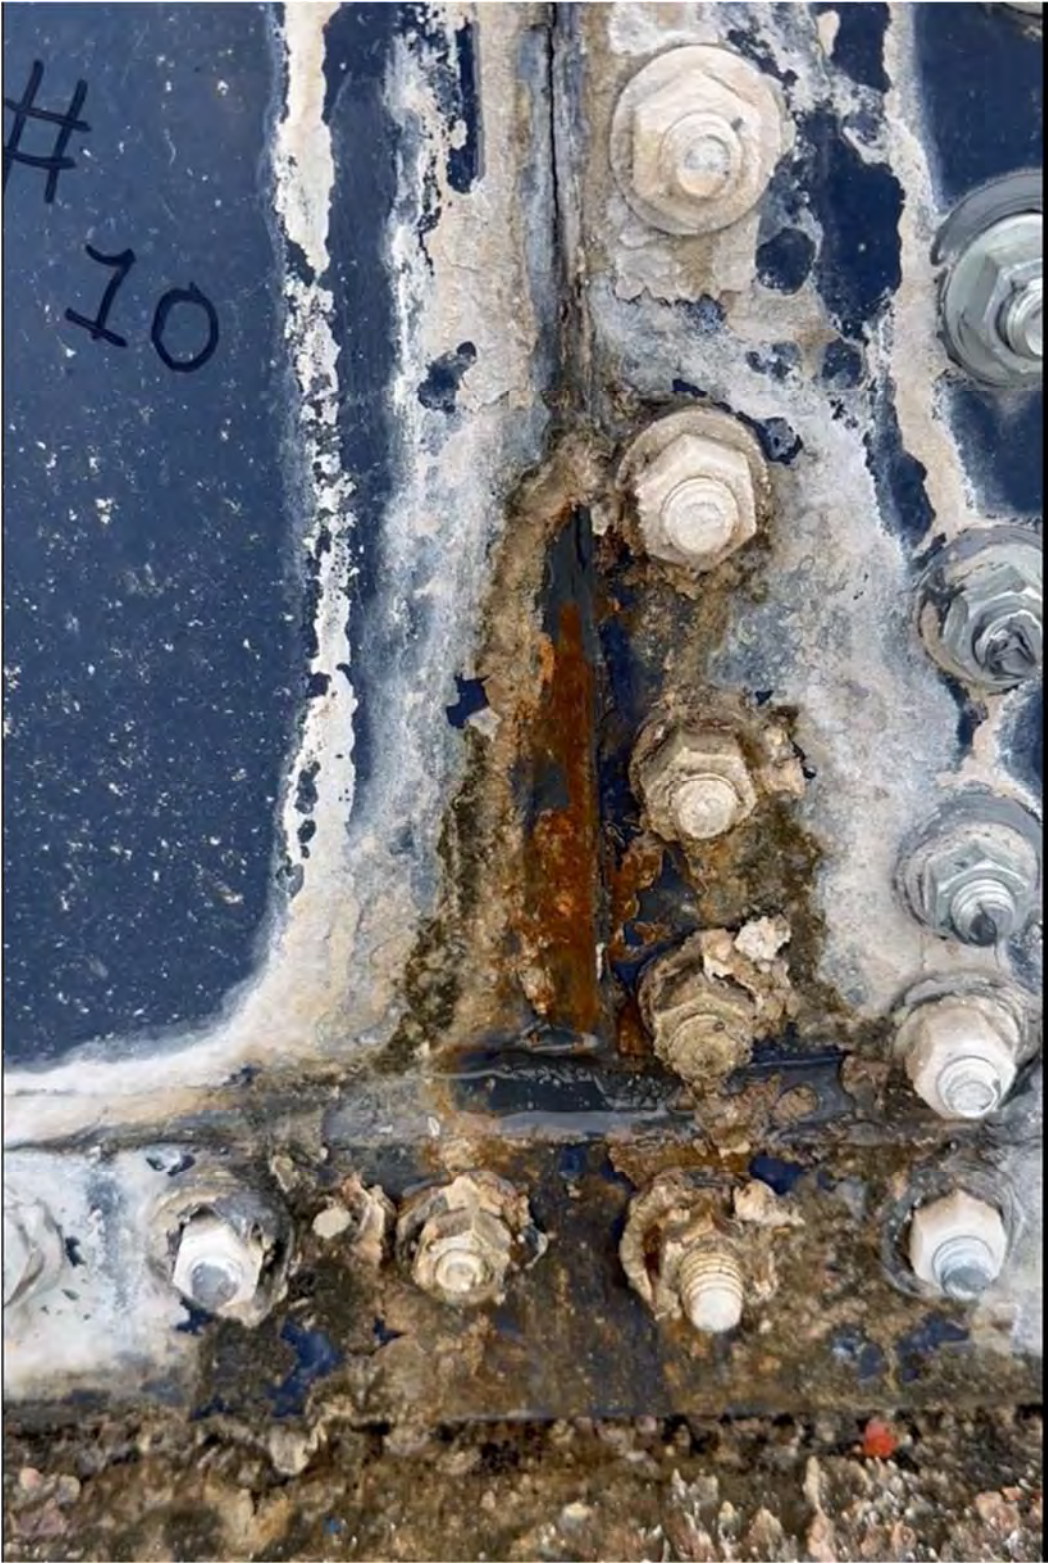
Leak #10: Tank Position 2:00, is visible approximately 6 inches above ground level at tank seam.

FIGURE 10 - LEAK 10, PREVIOUS AND EXISTING LEAK

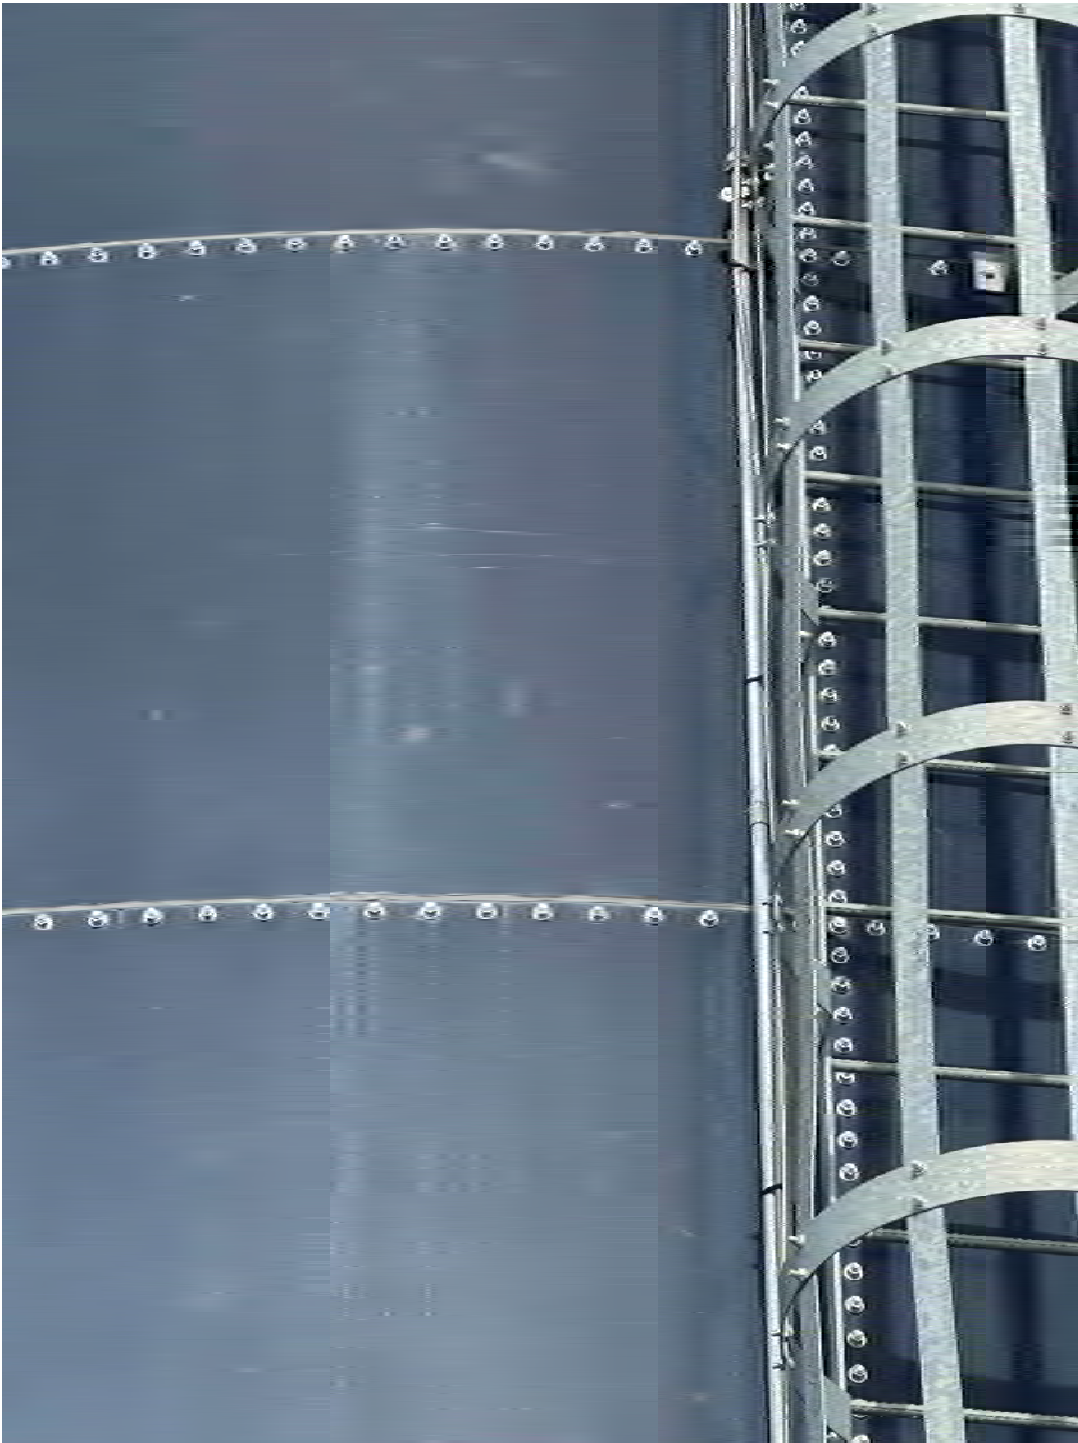
Leak #11: Tank Position 11:45, leak is visible approximately 26 feet above ground level, and flowing down the panel.

FIGURE 11 - LEAK 11, NEW LEAK FROM BOLTS

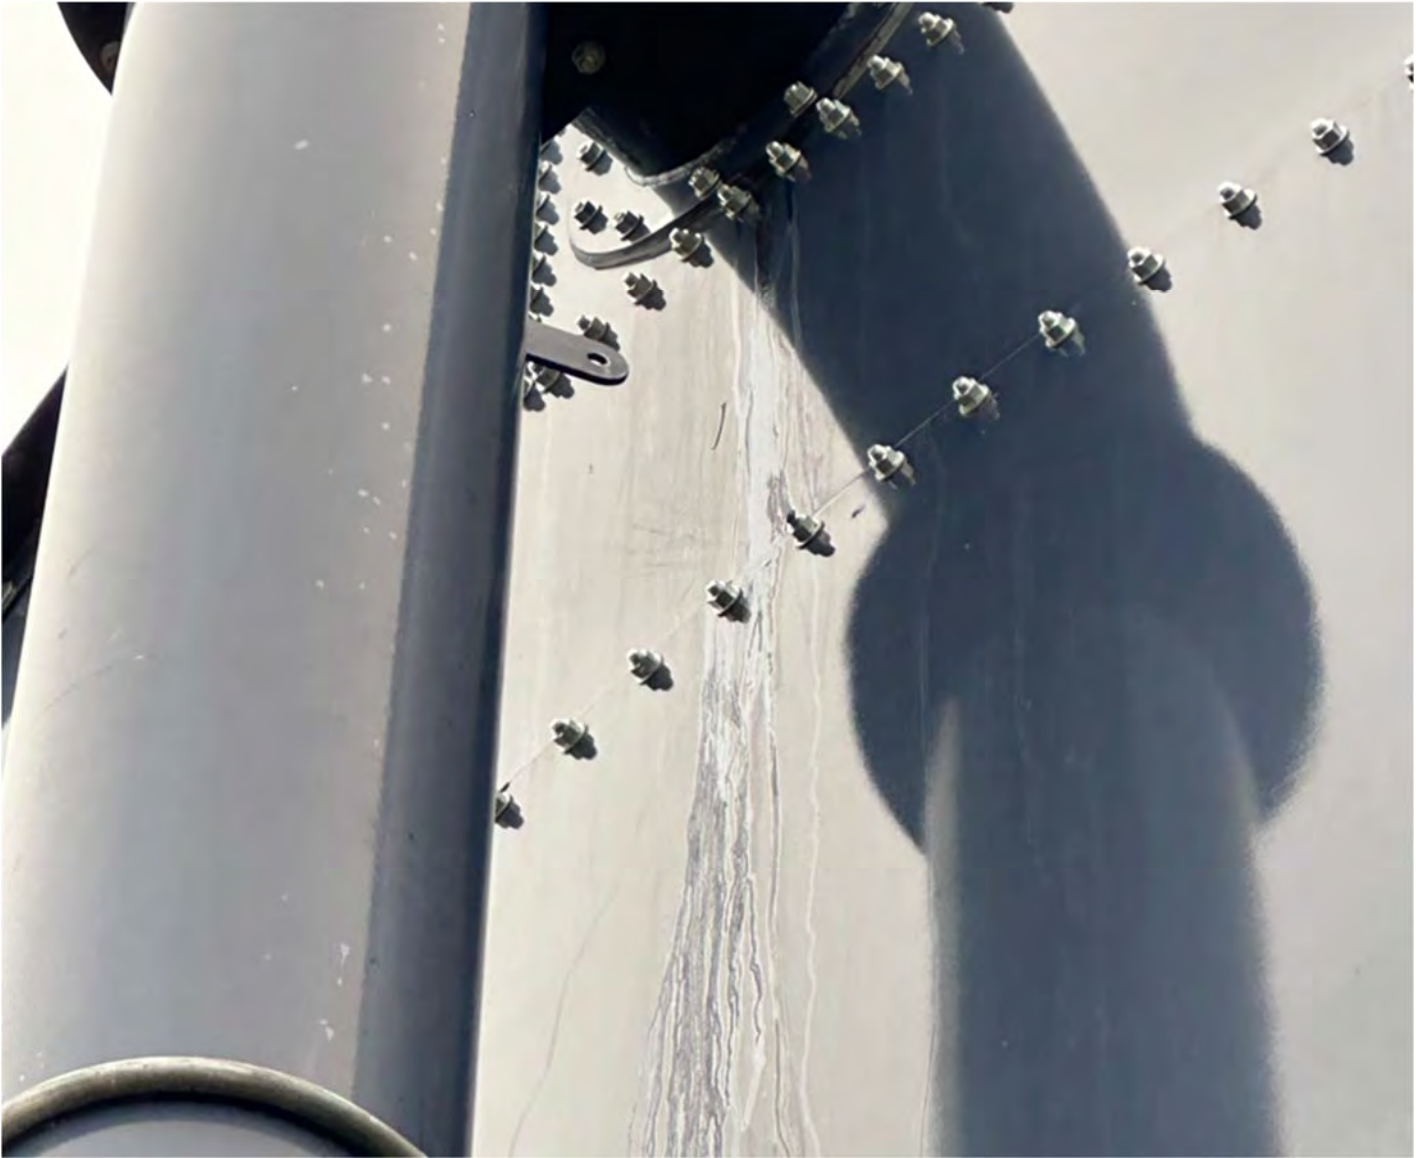
Leak #12: Tank position 3:30, is visible approximately 29 feet above ground level (Base of overflow). This leak is also leaking into the overflow pipe and is filling the overflow pipe with ice in freezing conditions.

FIGURE 12 - LEAK 12, OVERFLOW PIPE

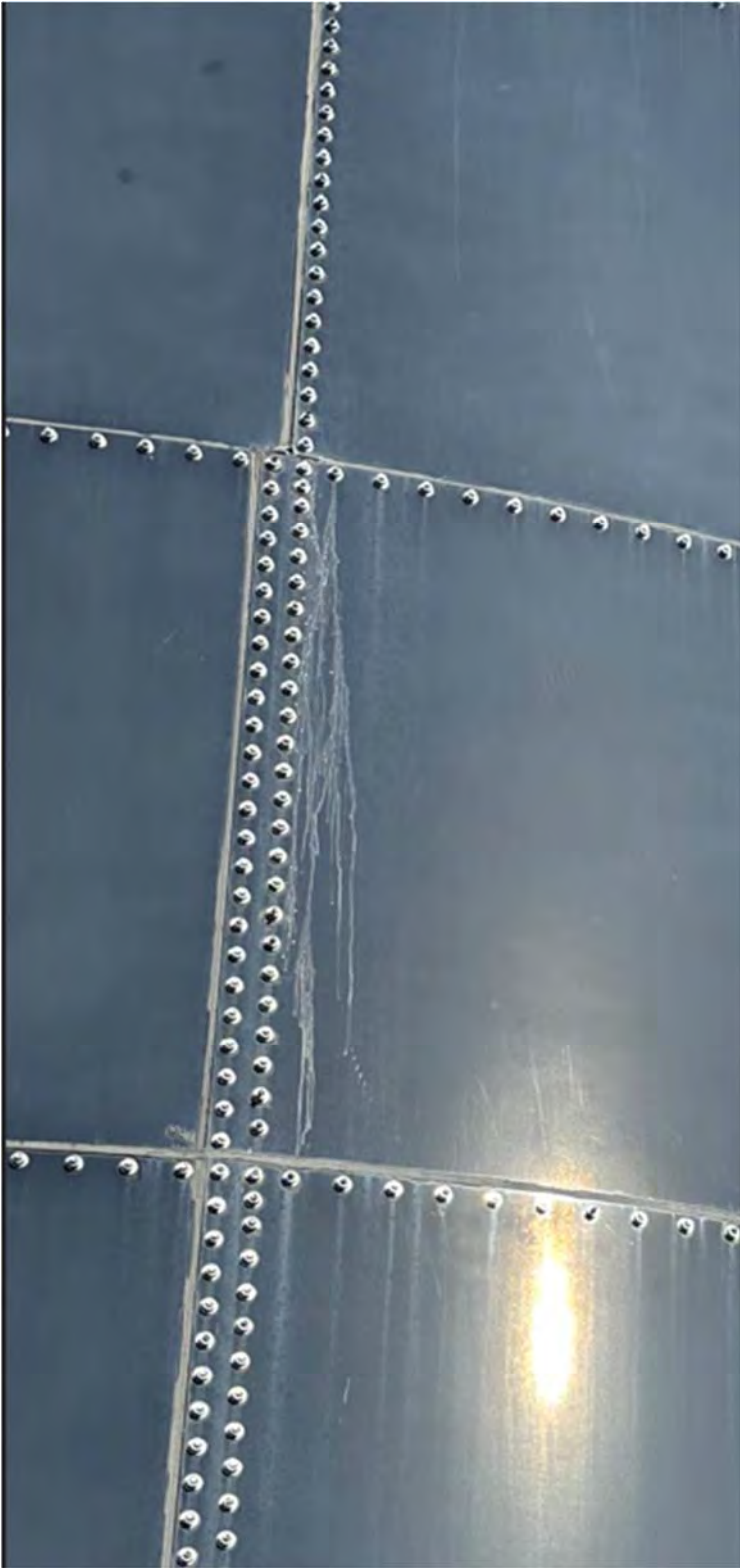
Leak #13; Tank position 1:00, approximately 13 feet above ground level. This is a new leak and is visible around the bolts. This was discovered on 11/7/23.

FIGURE 13 - LEAK 13, FROM BOLT HOLES

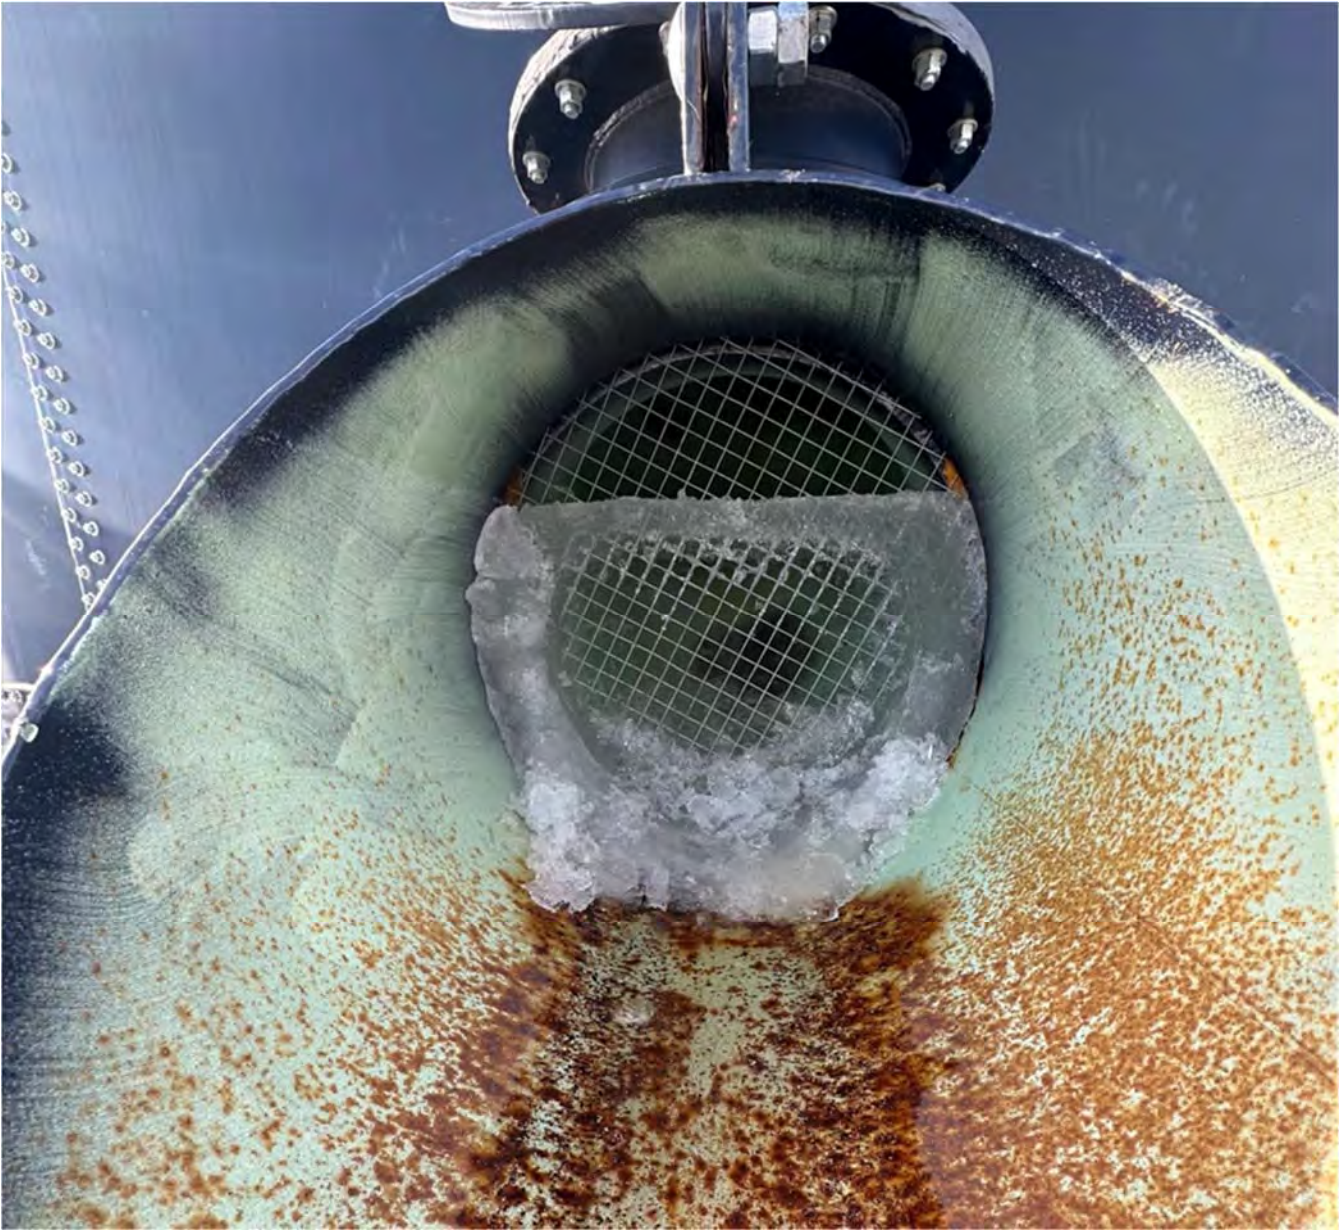
FIGURE 14 - OVERFLOW PIPE OUTLET ICE BUILDUP

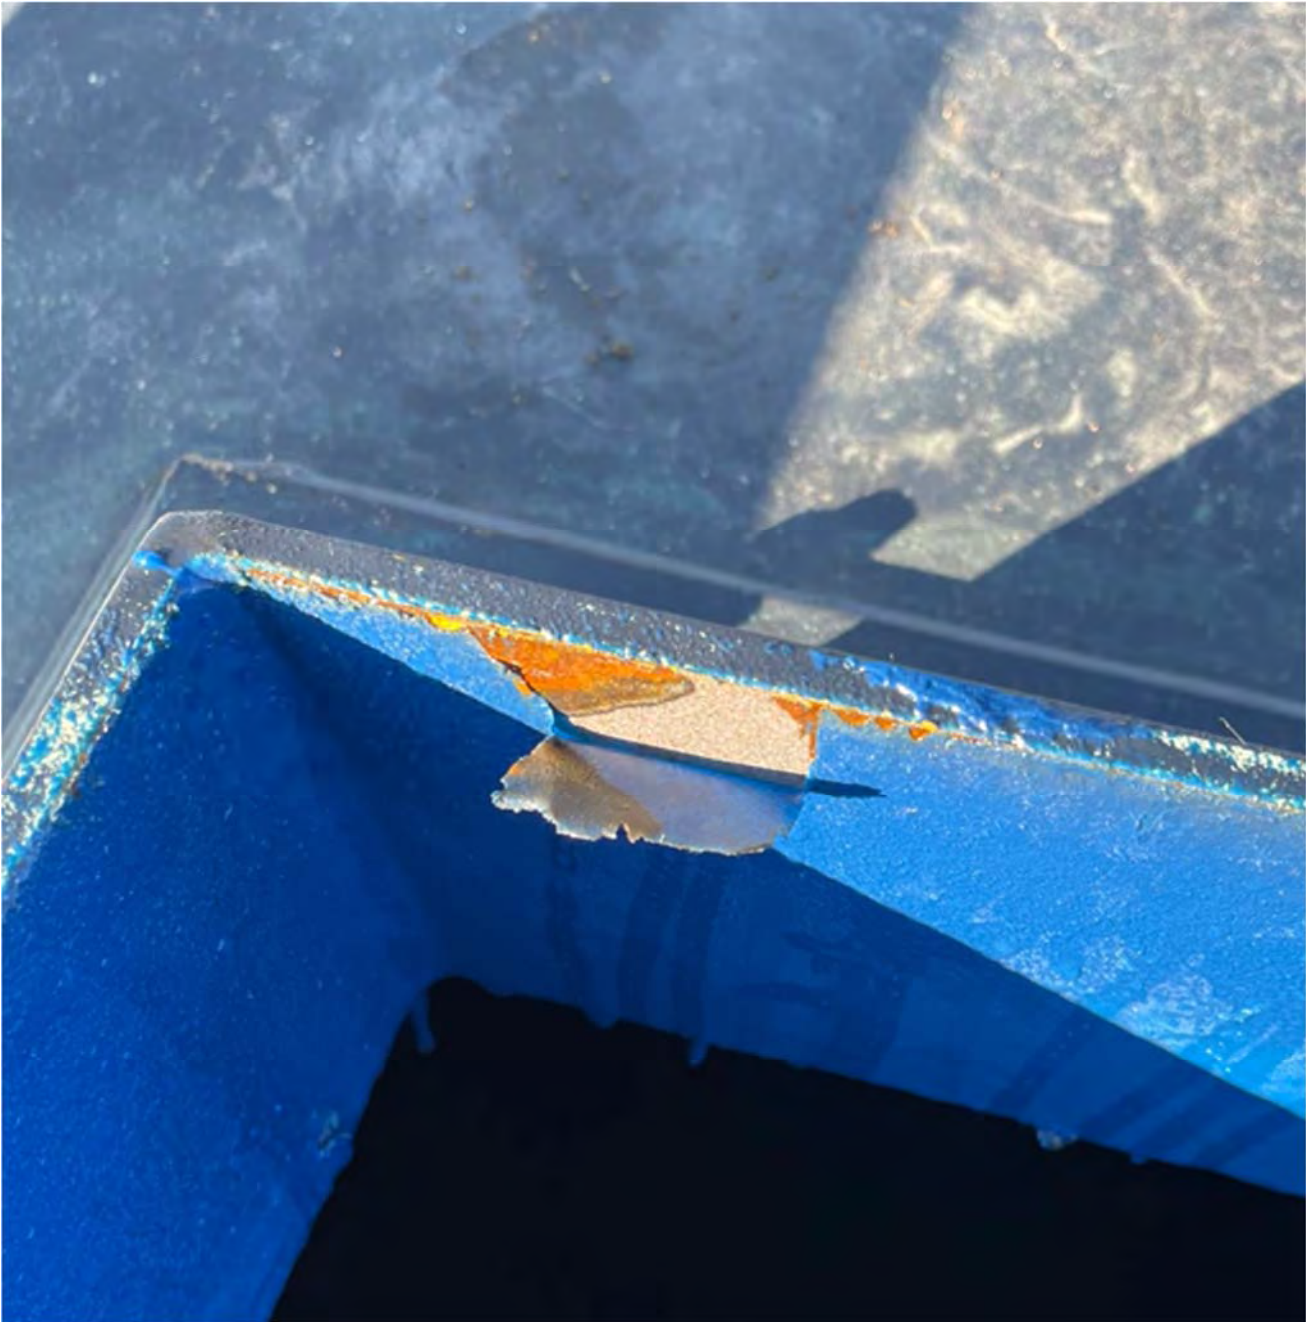
Defect #1: We have also discovered an area where the liner is peeling away from the upper roof access hatch.

FIGURE 15 - PEELING LINER, UPPER HATCH RIM

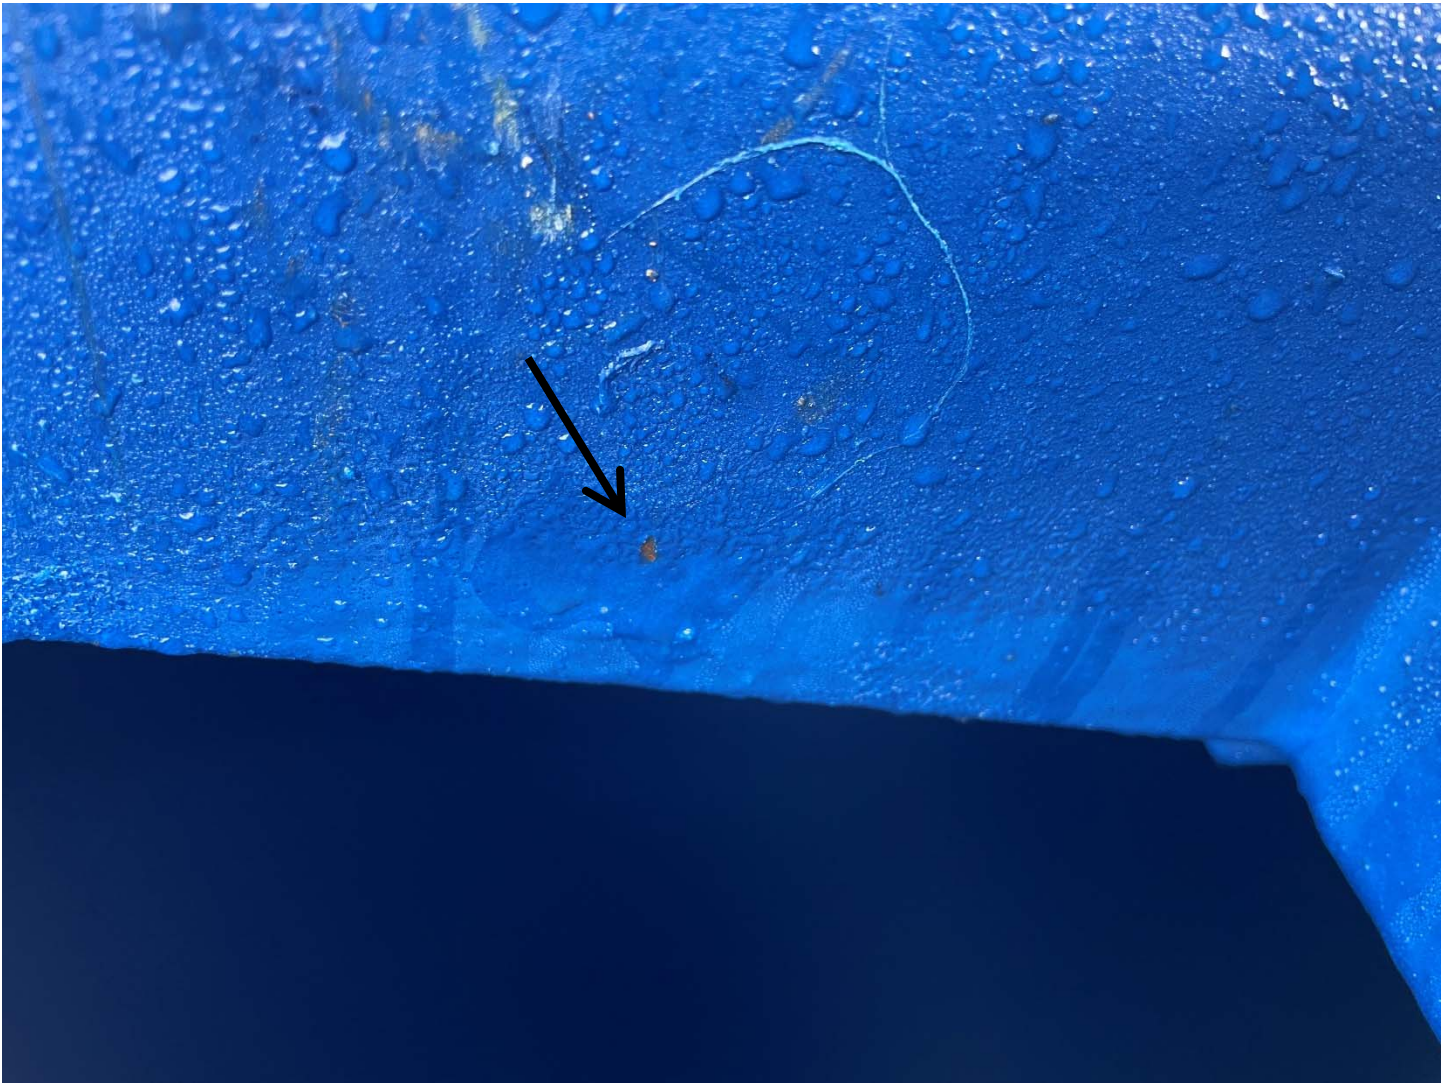
Defect #2: Rust spot identified on upper access hatch curb.

FIGURE 16 - INTERIOR BLEMISH, RUST ON TOP HATCH CURB
